## UPDATE HANDBOOK AODE, 4R70W, 4R70E, 4R75E

**AUTOMATIC TRANSMISSION SERVICE GROUP**  
**18639 S.W. 107 AVENUE**  
**MIAMI, FLORIDA 33157**  
**(305) 670-4161**

## AODE, 4R70W, 4R70E, 4R75E

*Printed  
October, 2006*

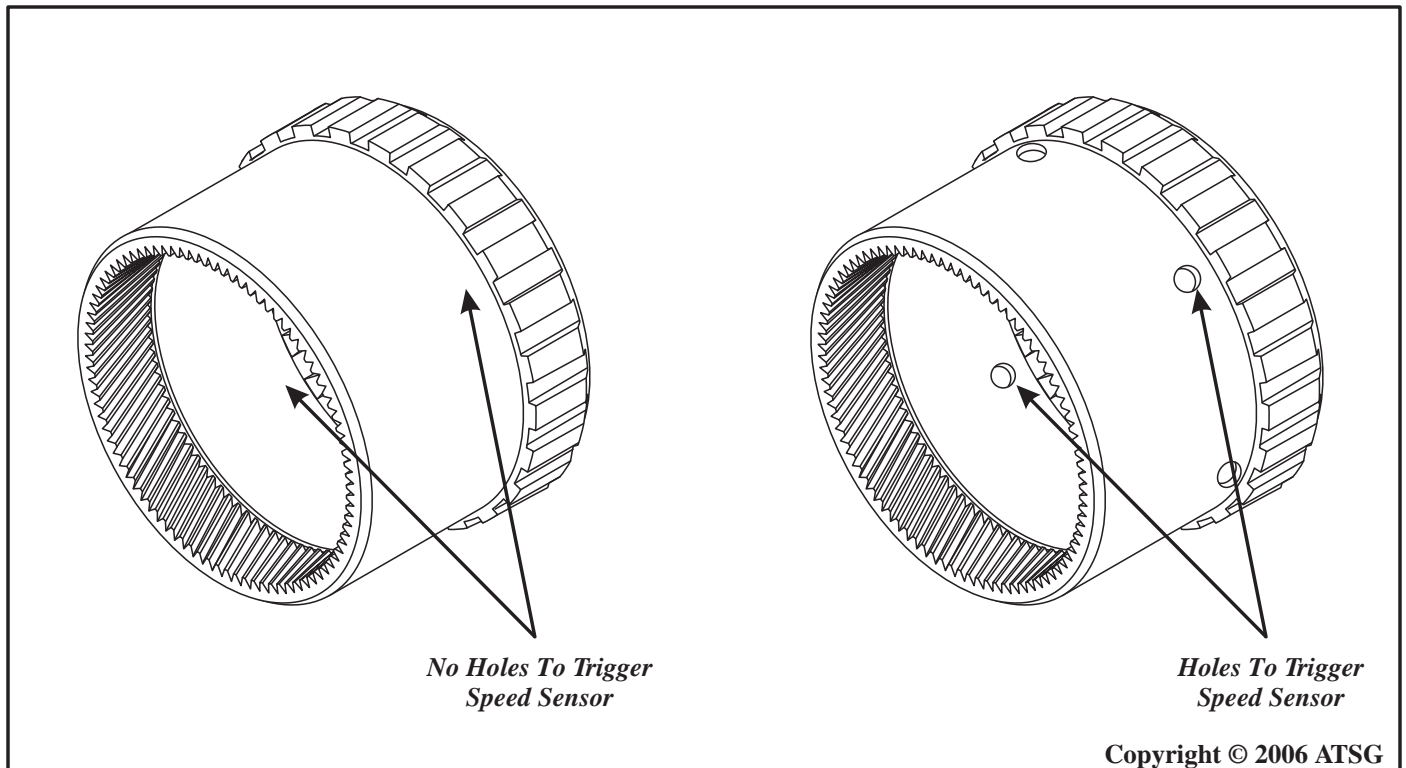
Figure 8

**CAUSE:** The cause may be, AOD internal ring gear that has no holes to trigger the output speed sensor has been installed by mistake.

**CORRECTION:** Install the AODE internal ring gear with the holes to trigger the output speed sensor, as shown in Figure 8.

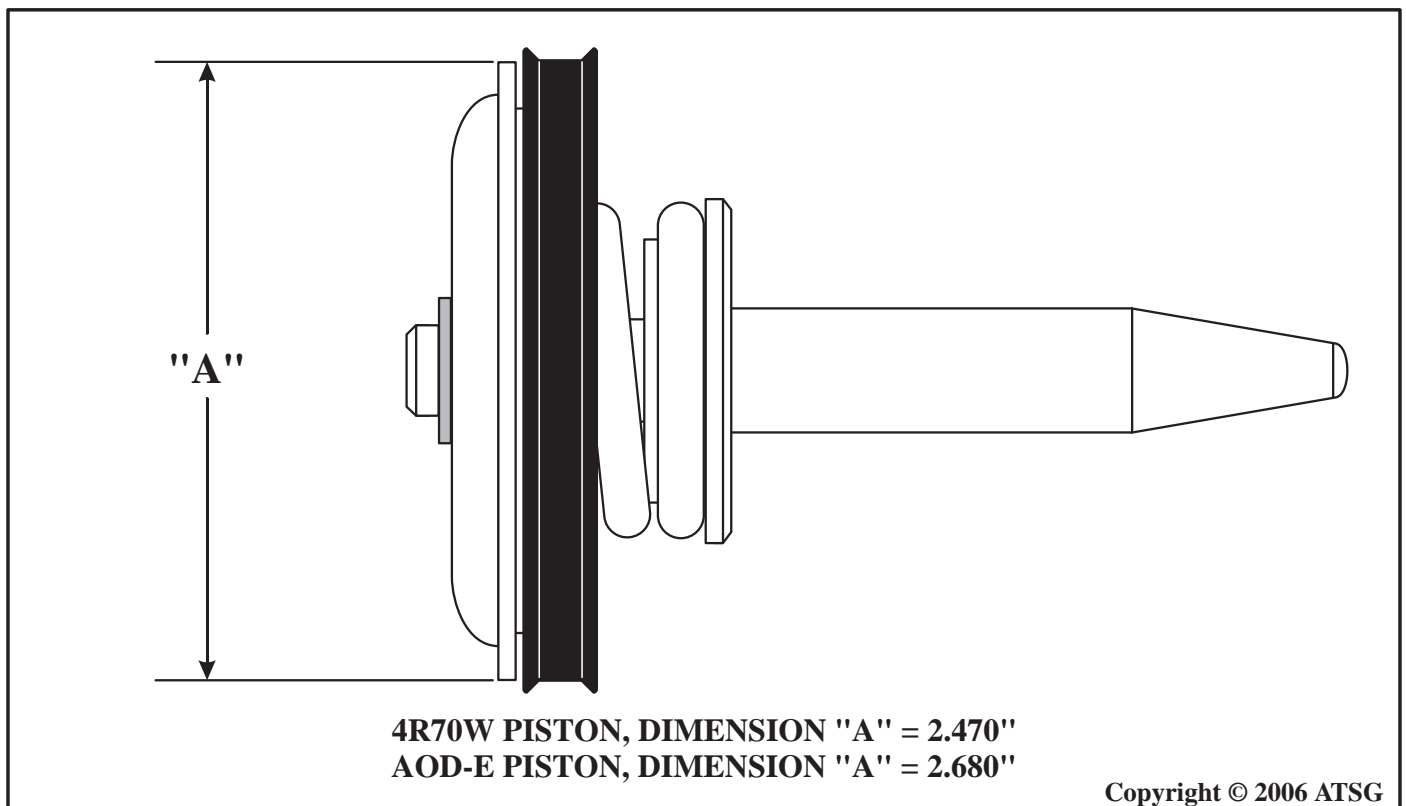
Figure 18

**CAUSE:** The cause may be, a mis-assembled Overdrive Servo Assembly, with the "Rubber Coated Sleeve" omitted. The 4R70W transmission is calibrated with a smaller diameter overdrive servo piston than is the AOD-E transmission. To retain a common case between the two transmissions, an additional "Rubber Coated Sleeve" is required on the 4R70W Overdrive Servo Assembly, as shown in Figure 19.

**CORRECTION:** Install the "Rubber Coated Sleeve" in the Overdrive Servo Assembly case bore, as shown in Figure 19. If your rubber coated sleeve is missing or lost, you **must** purchase the complete Overdrive Servo Assembly, available under part number F3LY-7H188-A. It is not available individually.  
Overdrive servo piston dimensions are shown in Figure 18, to identify the two different overdrive servo pistons.

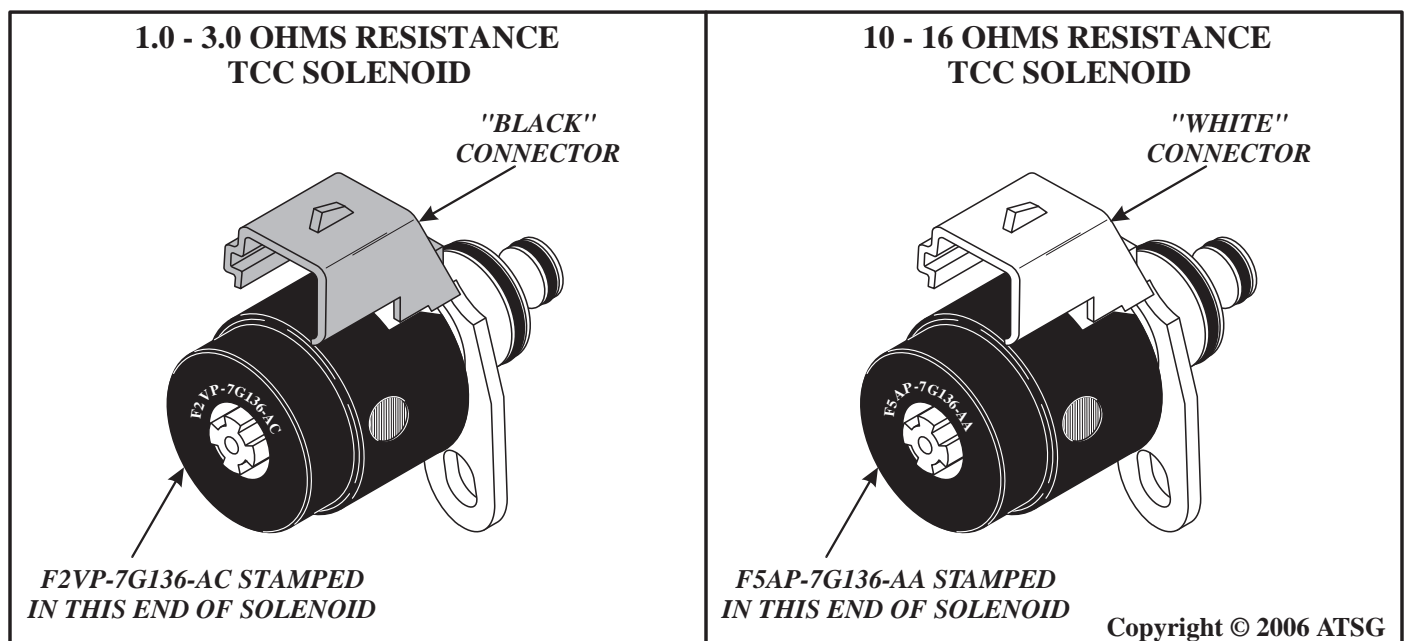
Figure 20

**CAUSE:** The cause may be, an incorrect Torque Converter Clutch (TCC) Solenoid, with low resistance (1.0 - 3.0 ohms), mistakenly installed in *some* 4R70W transmissions, as shown in Figure 20. The resistance should be 10-16 ohms on *some* models.

*Step 3:* *If* the valve body I.D. code is G2T, G3T, or G2U, *and* resistance on the TCC solenoid measures 1.0-3.0 ohms, *replace* the TCC Solenoid with OEM part number F5AZ-7G136-A. The resistance on these models should be 10-16 ohms.

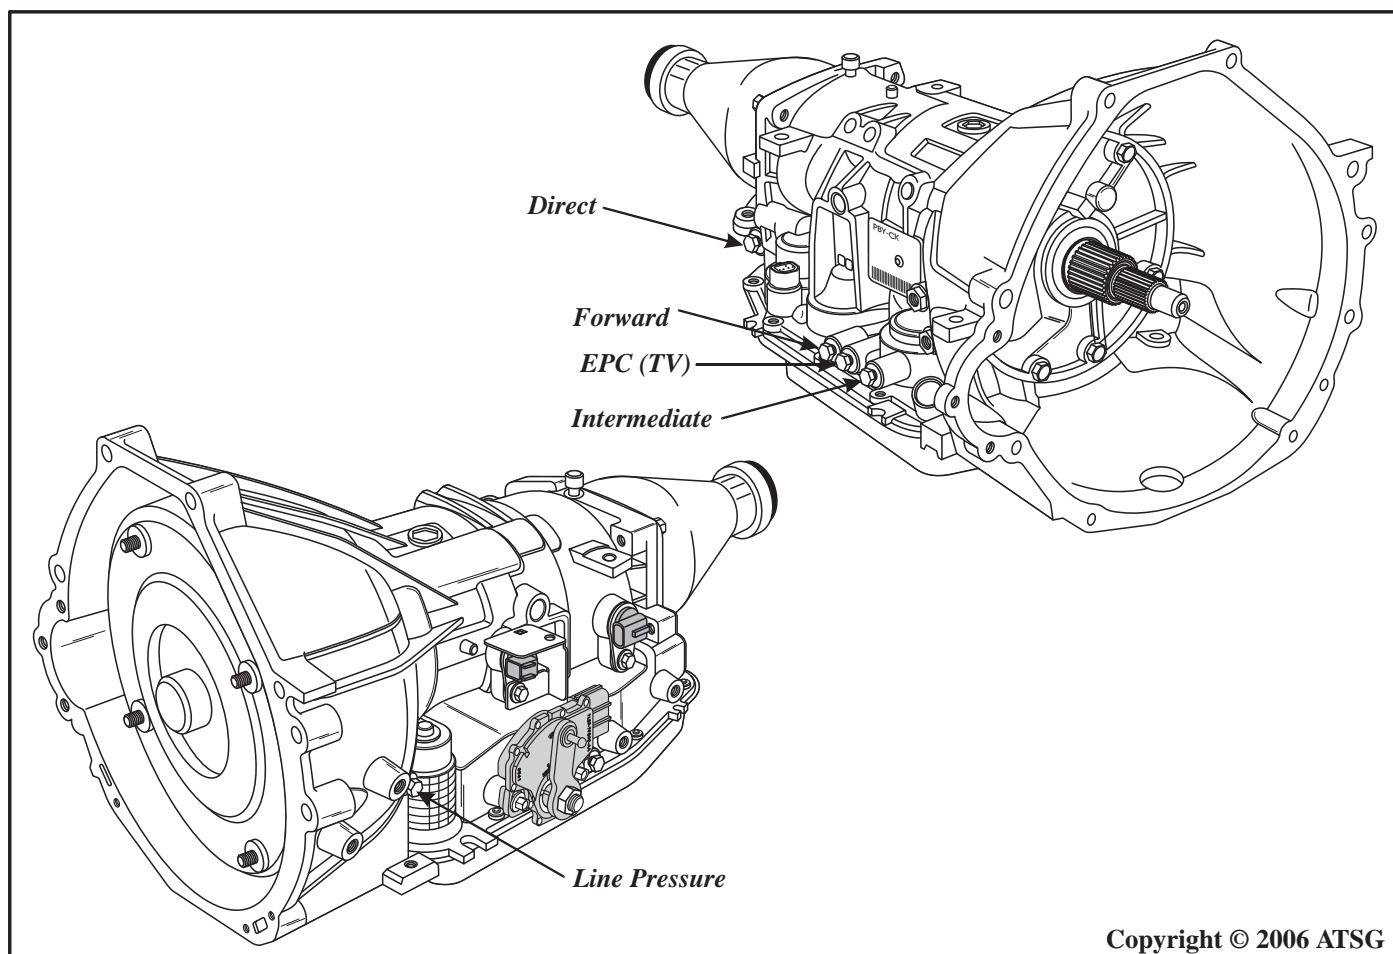
Figure 22

**CAUSE:** The cause may be, a partially clogged Shift Solenoid No. 2, which will stroke the 3-4 shift valve far enough to exhaust *some* of the forward clutch oil.

**CORRECTION:** Install two pressure gages to check line pressure and forward clutch pressure, as shown in Figure 22. With the transmission in Drive, both gages should read the same and should be approximately 55-75 PSI. If the forward clutch gage reads lower than the line pressure gage, ***and all internal parts are known to be good***, replace the Shift Solenoid Assembly with OEM part number F5AZ-7G484-A (See Figure 23).

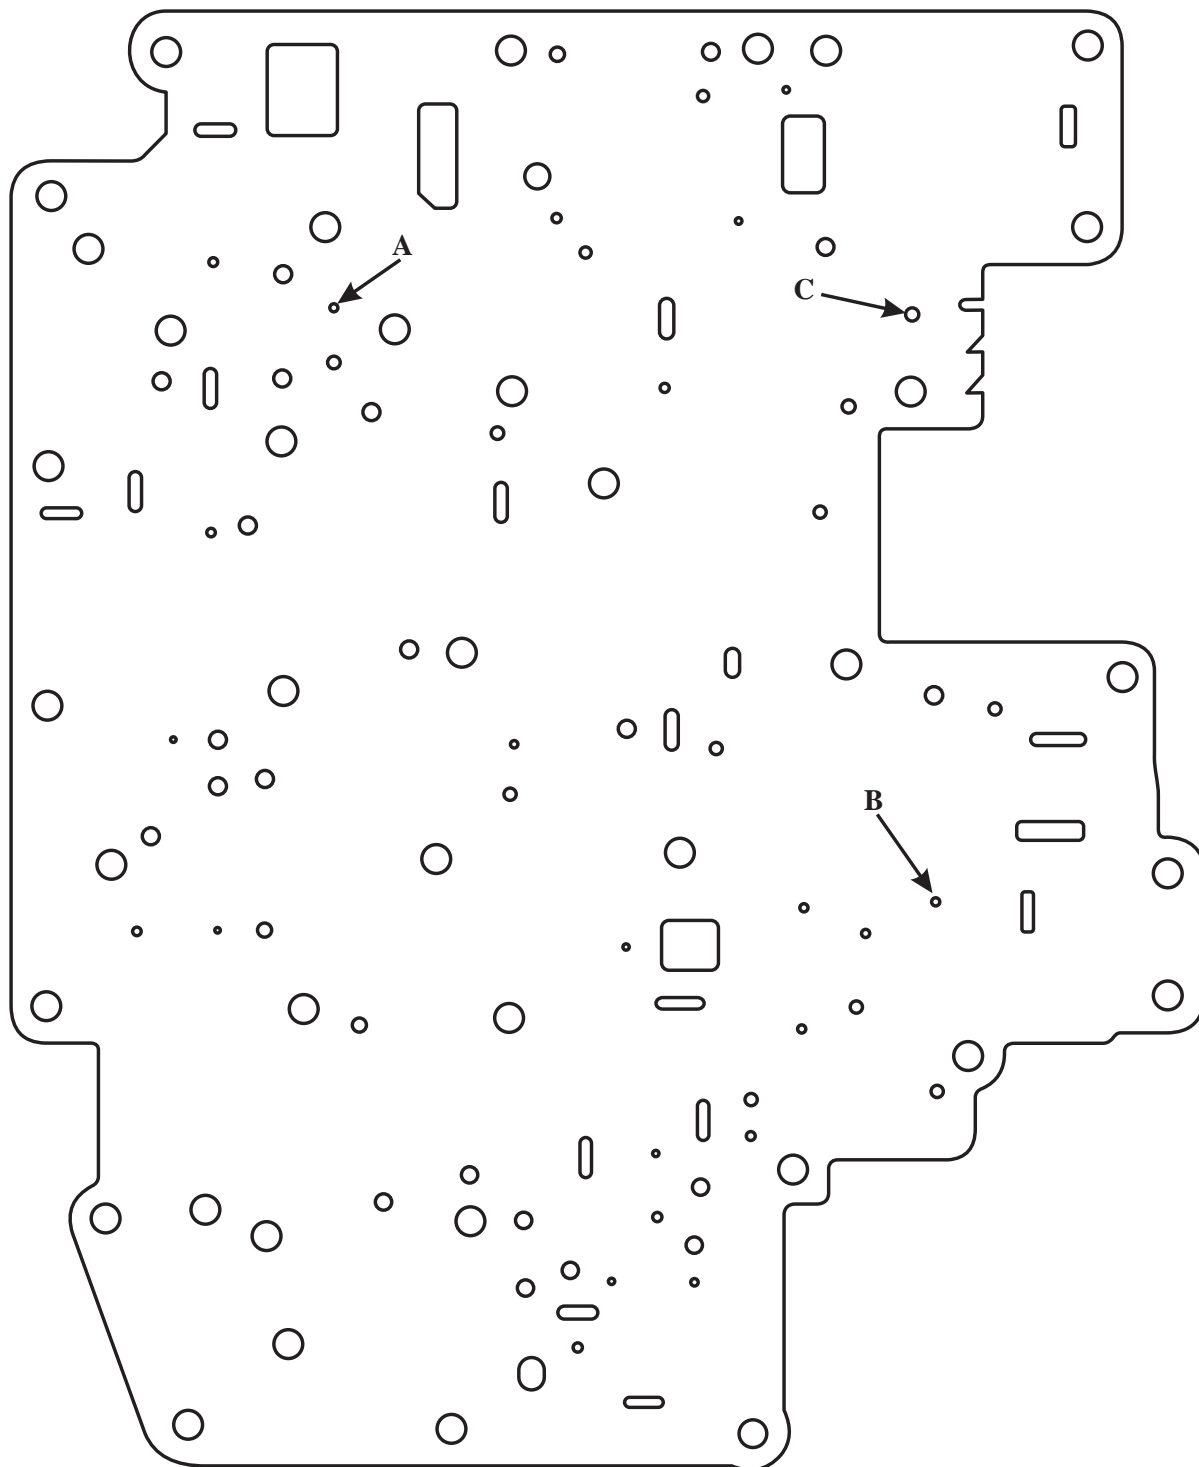
**CAUSE:** The cause may be, not enough oil to the converter clutch apply circuit.

***Restrict*** the hole marked "C" in Figure 24, to approximately .030" using a cotter key, which ensures that apply oil can overcome this balance circuit.

1. DRILL HOLE MARKED "A" OUT TO .062".
2. DRILL HOLE MARKED "B" OUT TO .062".
3. INSTALL COTTER PIN IN HOLE MARKED "C" TO REDUCE SIZE TO APPROXIMATELY .030".

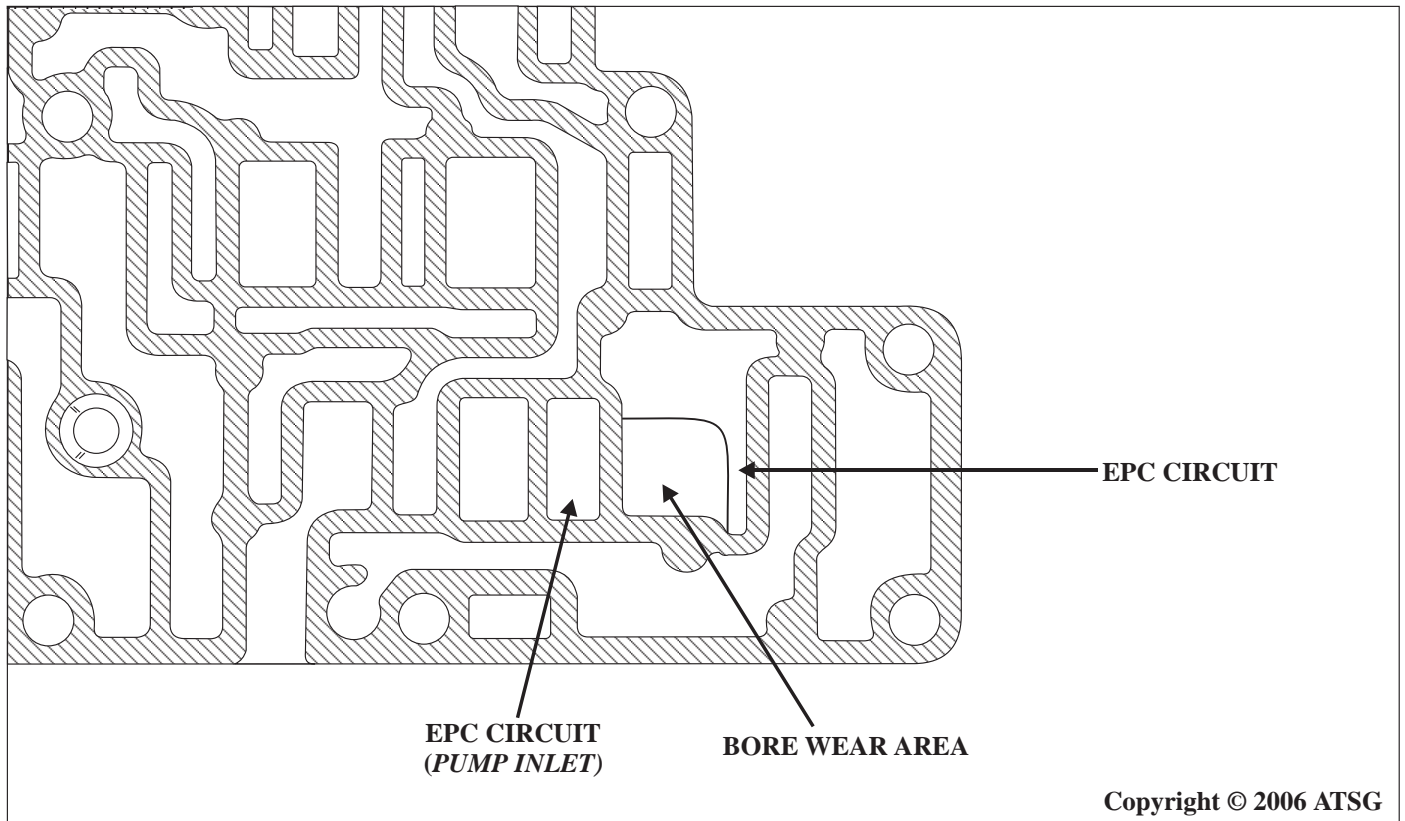
**CAUSE:** EPC pressure is routed to the Pressure Regulator Valve along side of a circuit that Ford identifies as the Boost Circuit. These oil passages can be identified in both the valve body and the case as seen in Figure 75 and 76. This is illustrated by the hydraulic schematic shown in Figure 77. This circuit is routed back to the inlet side of the pump. When the Pressure Regulator Valve or its bore is worn, (See Figure 78), EPC pressure is allowed to be sucked away by pump suction, (See Figure 79 and 80), preventing any line pressure rise from occurring when the throttle is opened.

**CORRECTION:** Always check the Pressure Regulator Valve and its bore for wear during the repair process. If it is worn use one of the repair kits that are available from Sonnax® to repair this condition, or, you must replace the valve body.

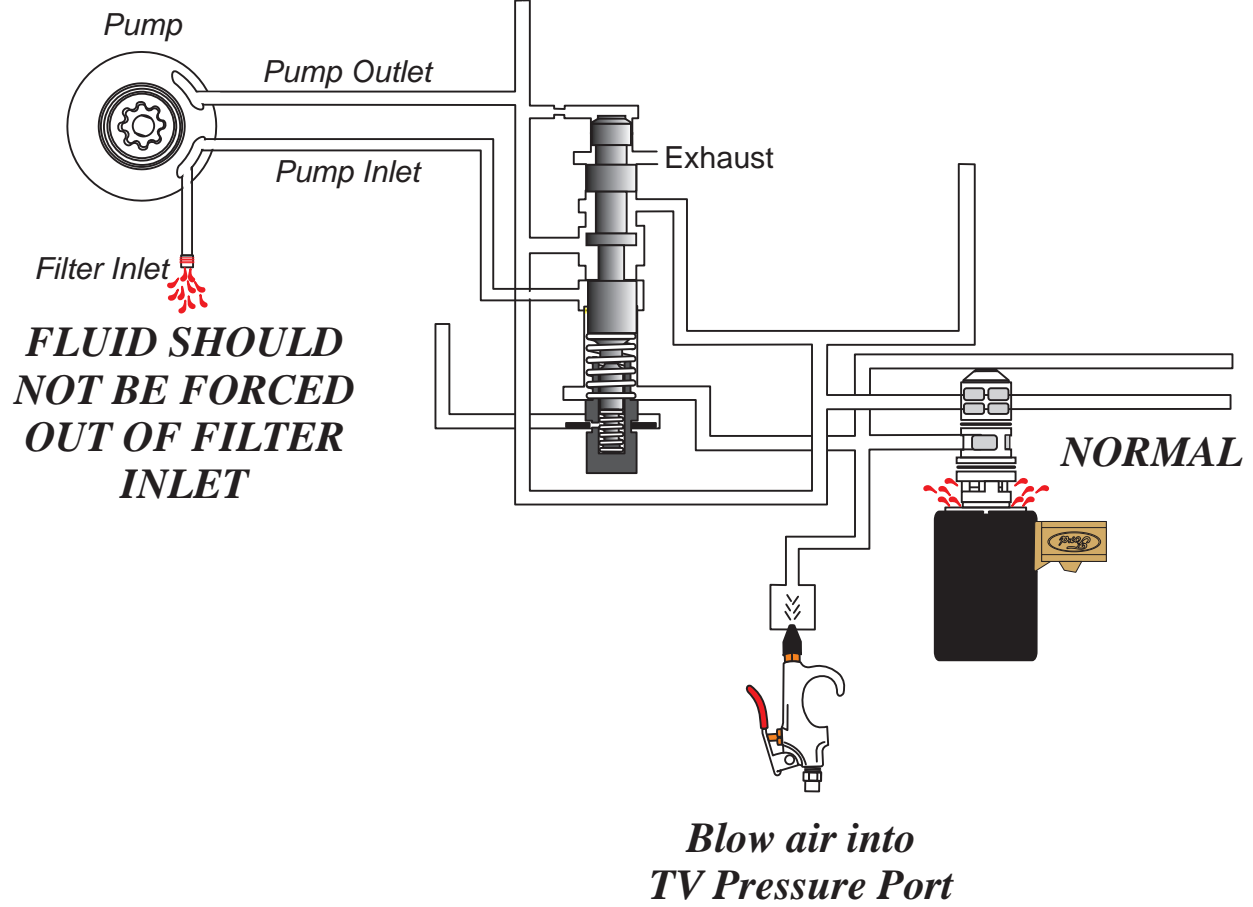
Figure 81

A quick test can be performed to verify if this condition exists. Remove the pan and filter. Blow compressed air into the TV pressure port in the case. It is normal to see some leakage around the EPC solenoid, but if you see *any* oil forced out of the filter neck bore by the air pressure, (Refer to Figure 81), ***PR valve and/or bore wear is the reason.***

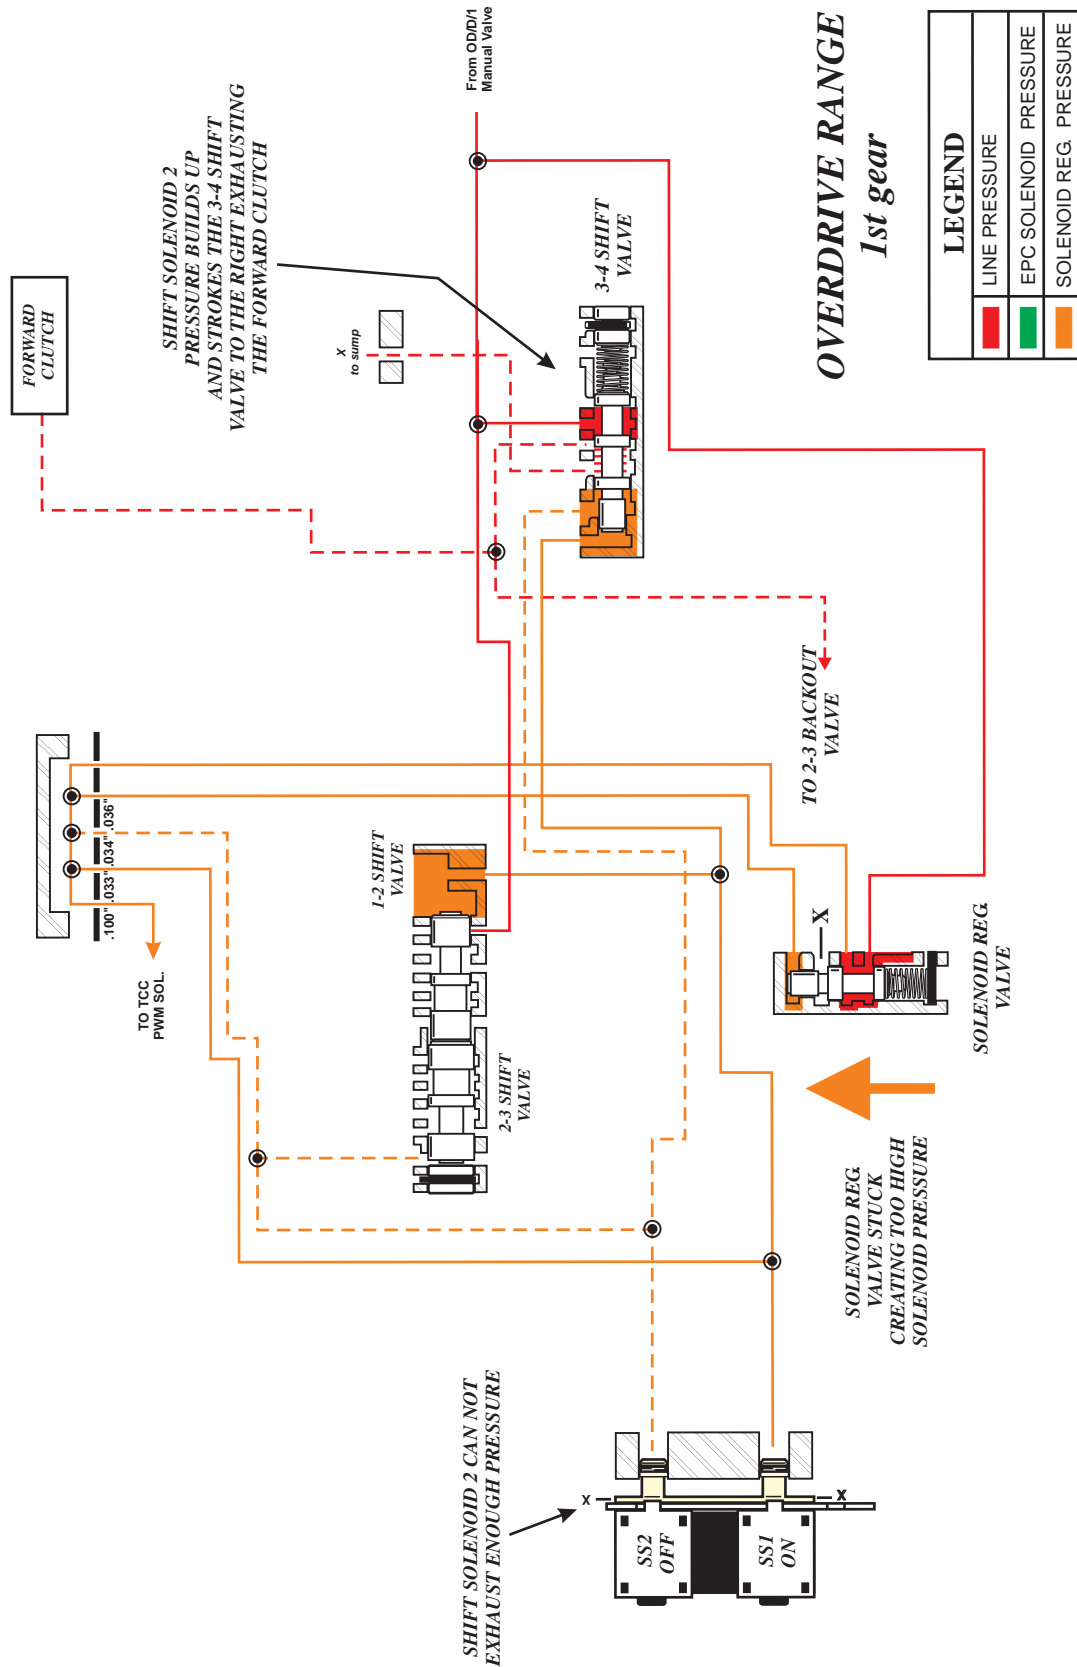
Figure 87

**Summary:** SS1 is ON and SS2 can not exhaust the High Solenoid Reg. pressure, which in-turn strokes the 3-4 Shift Valve turning the Forward Clutch OFF.
