AXOD/AXODE (AX4S) UPDATE HANDBOOK

AUTOMATIC TRANSMISSION SERVICE GROUP

INTRODUCTION

*Updated
October, 2002*

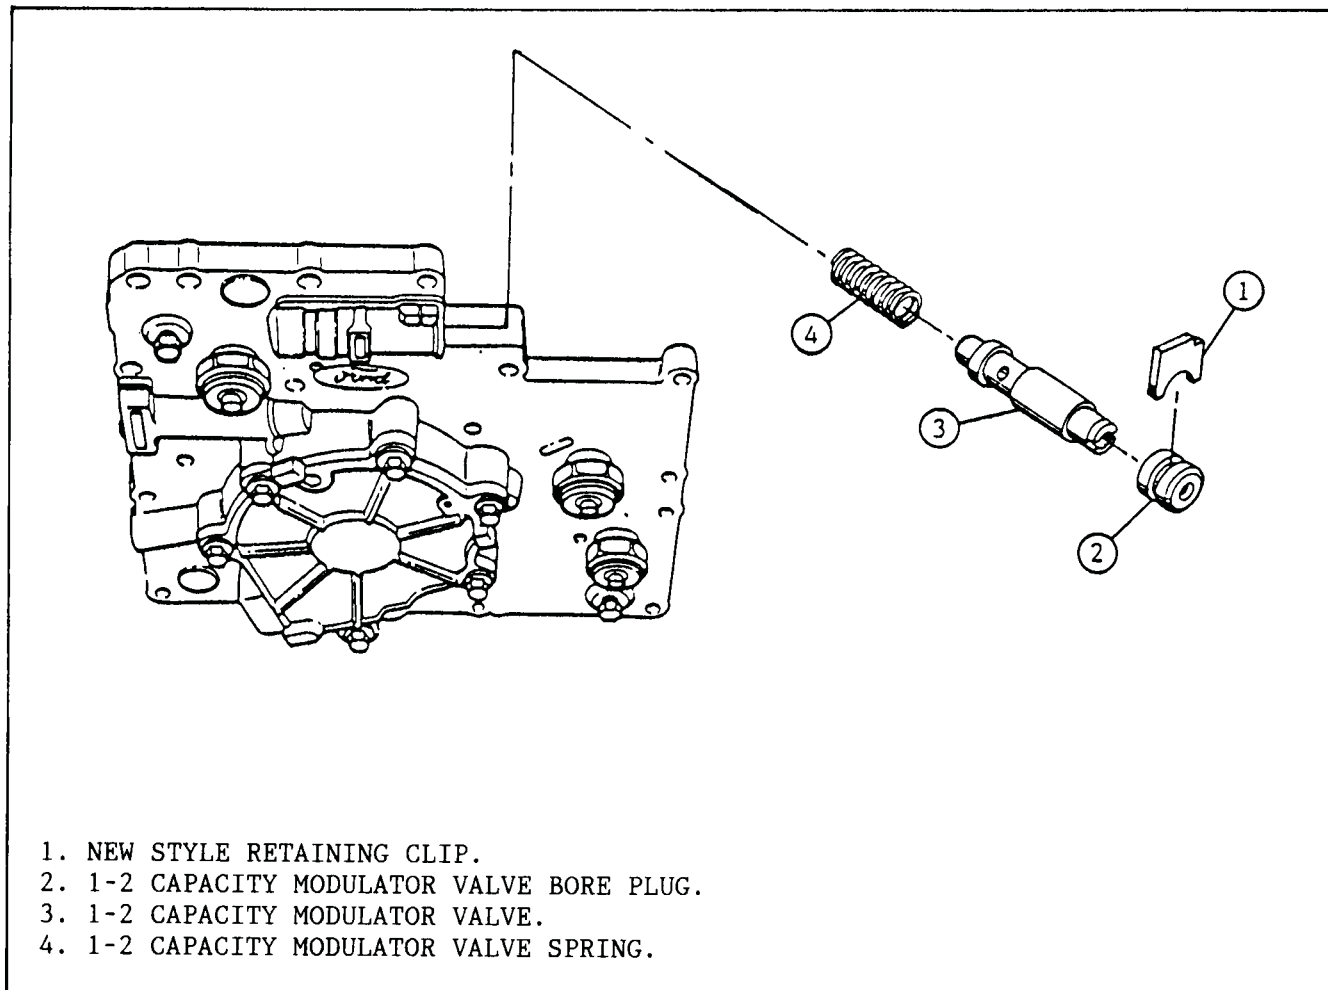
Figure 18

CAUSE: The cause may be a lack of oil volume to the intermediate and/or direct clutch packs.

CORRECTION: FOR SOFT 1-2 SHIFT:
Replace the 1-2 capacity modulator valve spring with the Red spring manufactured by Shift Technology Products (Part #K006). The kit also comes with a new style bore plug retaining clip. Assemble into the oil pump as shown in Figure 18. This modification should be made on all AXOD'S during rebuild.

NOTE: Do not install the valve backwards, as the result will be a one-neutral shift.

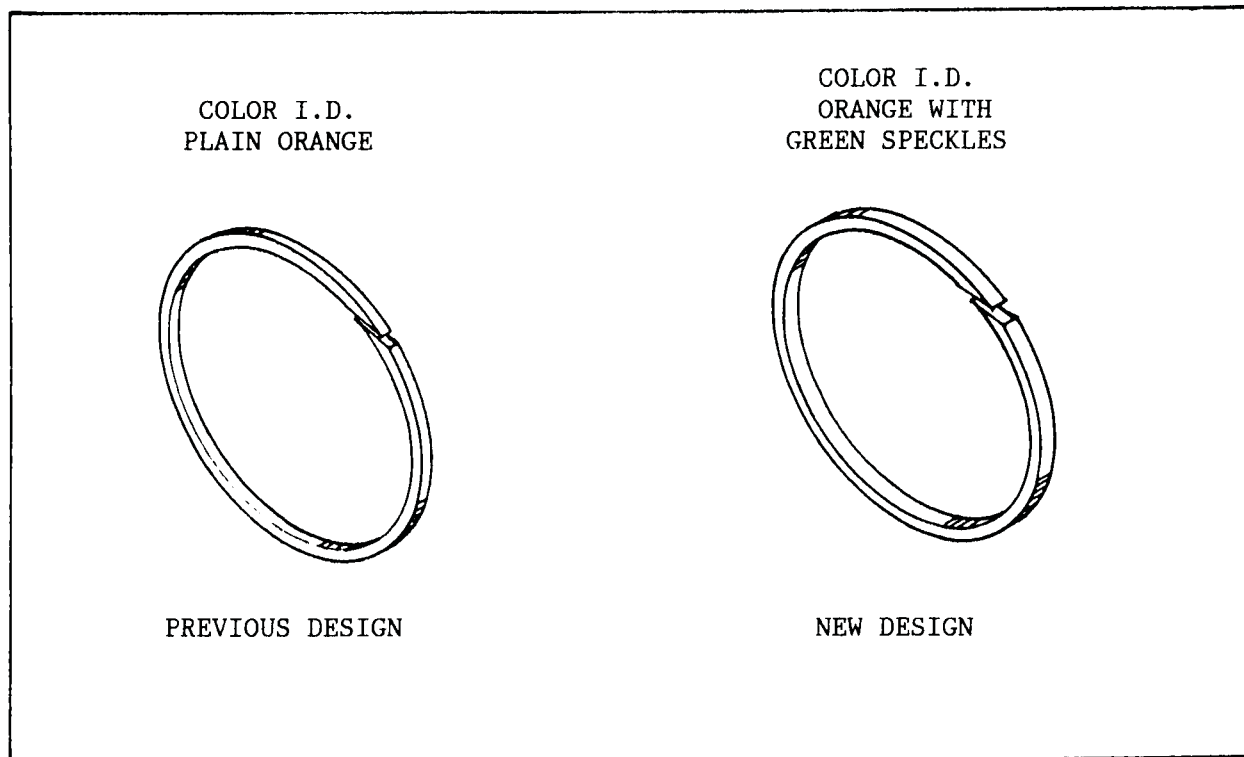
Figure 37

The five sealing rings on the driven sprocket support have been re-designed to help eliminate leakage in this area. The width of the sealing rings has been increased by approximately .015", and the new color identification is orange with green speckles (See Figure 37). The previous design sealing rings were plain orange in color.

DO NOT USE PREVIOUS DESIGN SEALING RINGS.

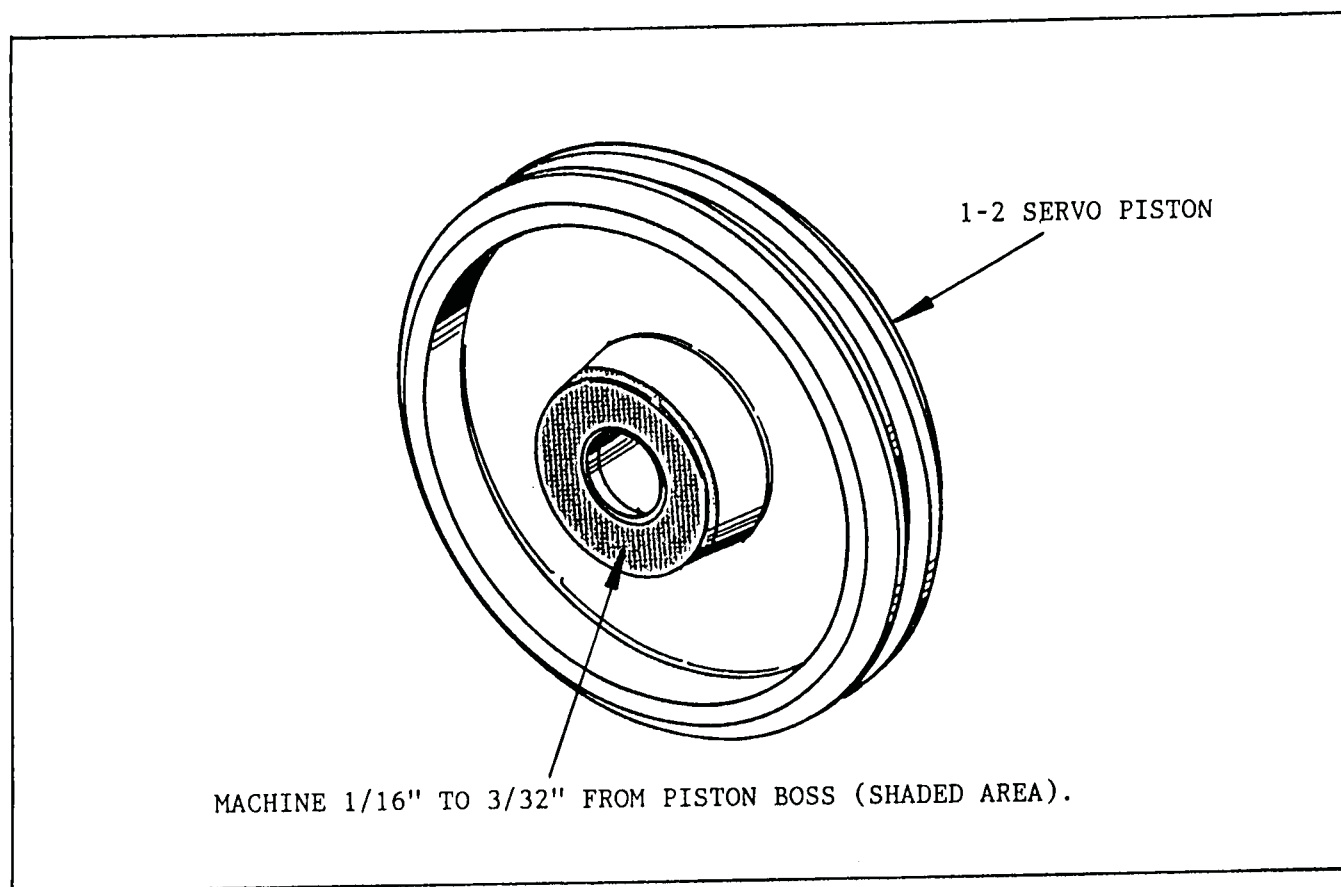
Figure 40

CAUSE: Insufficient travel of the 1-2 piston against the cushion spring.

CORRECTION: Remove 1/16" to 3/32" from the boss on the inside of the 1-2 servo piston as shown in Figure 40. We have shaded the area to be machined (See Figure 40).

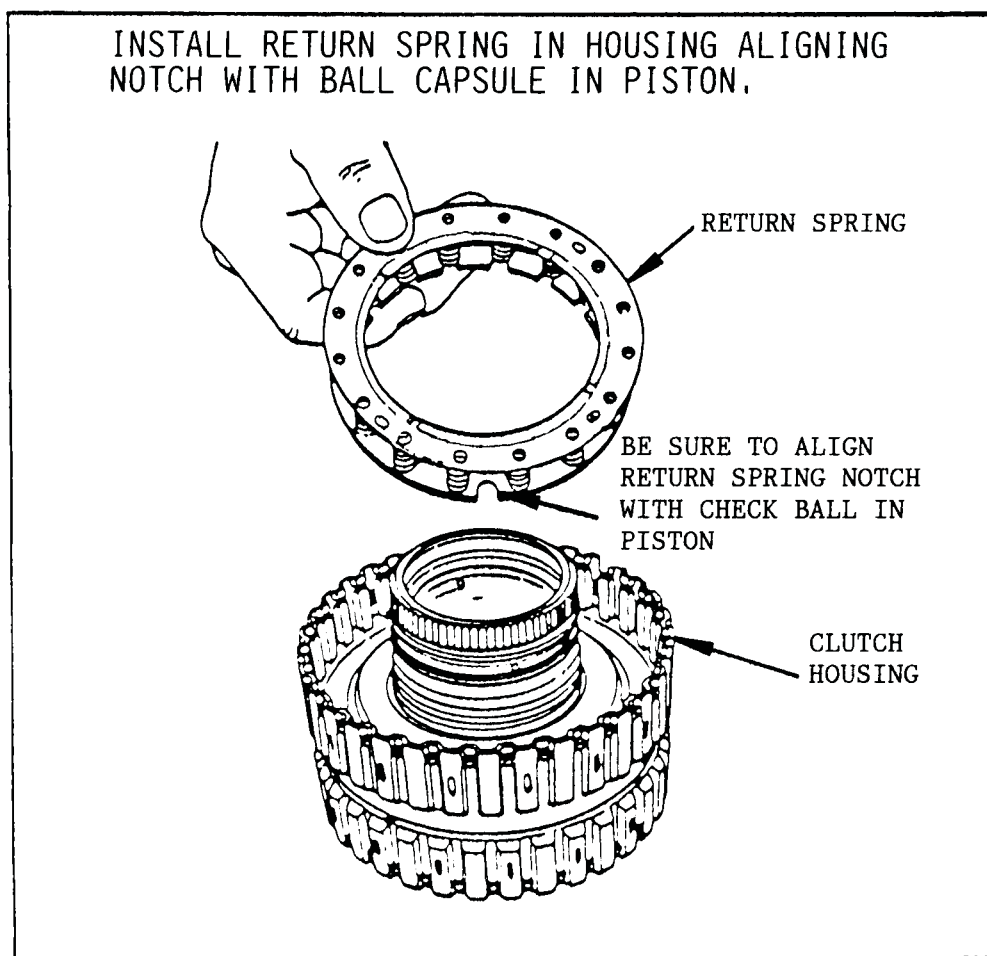
Figure 41

- COMPLAINT:** An extended 3-4 shift with possible direct clutch failure or a NO 3-4 shift condition.
- CAUSE:** This condition may be caused by a partially or fully blocked oil flow of the direct clutch piston check ball assembly.
- CORRECTION:** Special care must be taken during the overhaul operation when re-assembling the direct clutch return spring over the direct clutch piston. Make sure that the notch in the spring bottom retainer (See Figure 41) is positioned properly over the check ball capsule so as not to block or restrict oil flow of the check ball assembly. Refer to Figure 41.

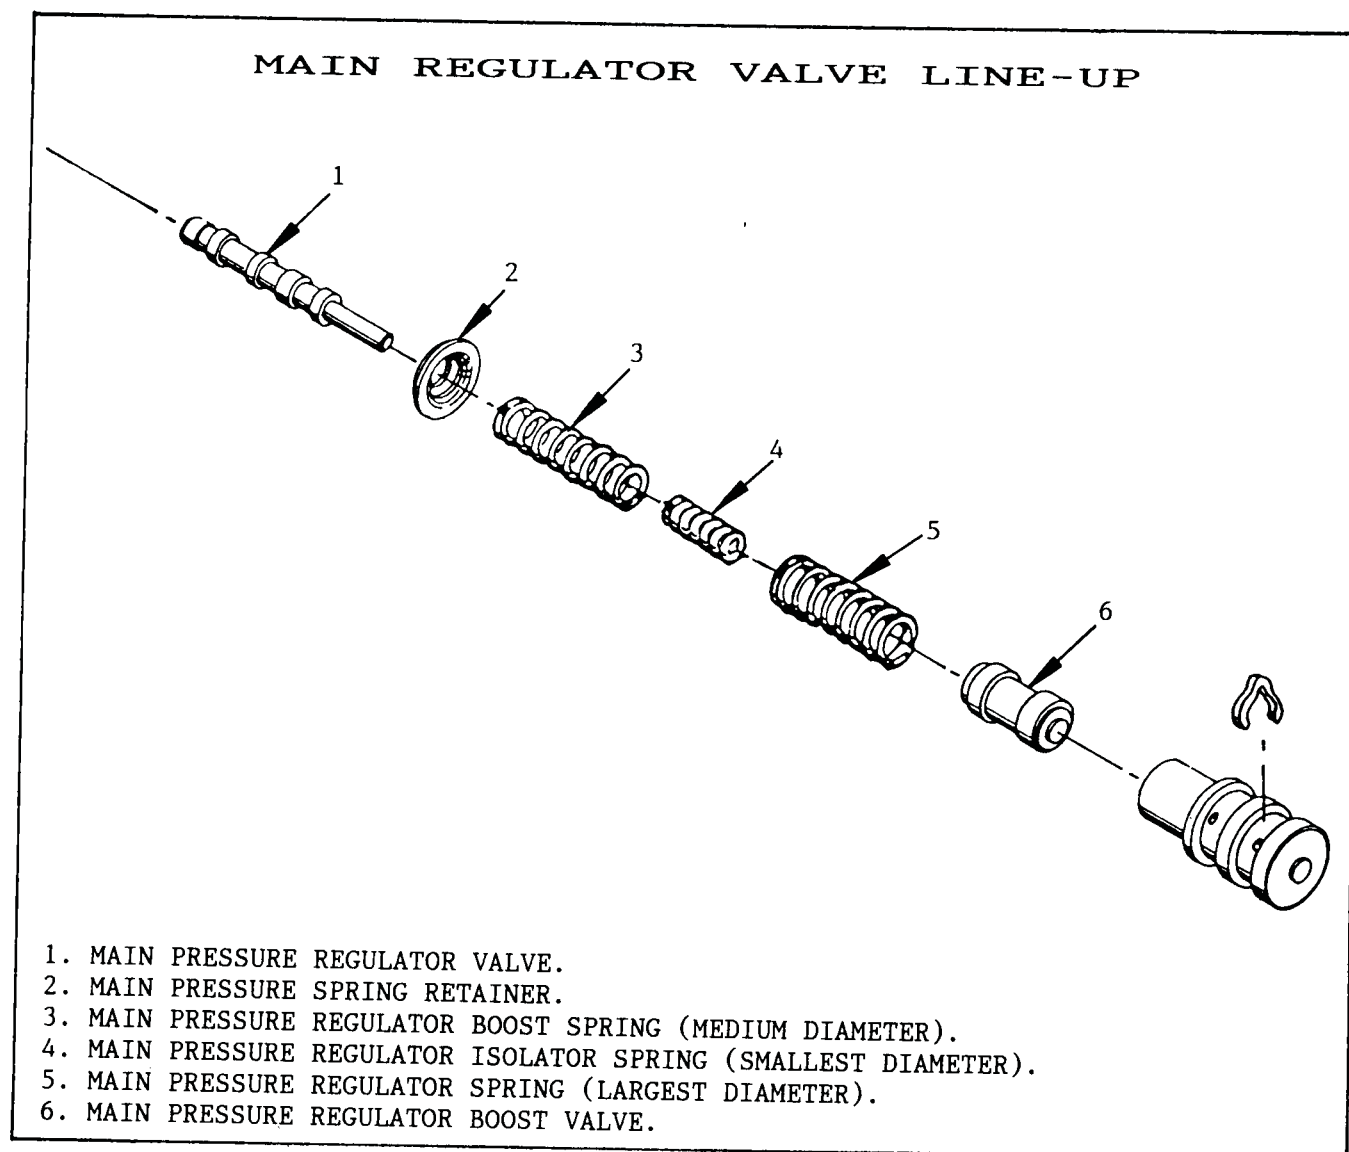
Figure 43

CAUSE: NO. 1. A "Shudder" during a 1-2 upshift will occur if the main pressure regulator "Isolator" spring is not installed after cleaning the valve body (See Figure 43). This is caused by fluctuations in main line pressure at the time of the 1-2 shift.

NO. 2. Delayed upshifts can be caused by the pressure regulator spring retainer being installed backwards (See Figure 43). This will create low main line pressure.

NO. 2. Insure that the main regulator spring retainer is installed in the proper direction (See Figure 43). The retainer is very similar to the one used in the AOD valve body, but is installed in the opposite direction of the AOD (See Figure 43).

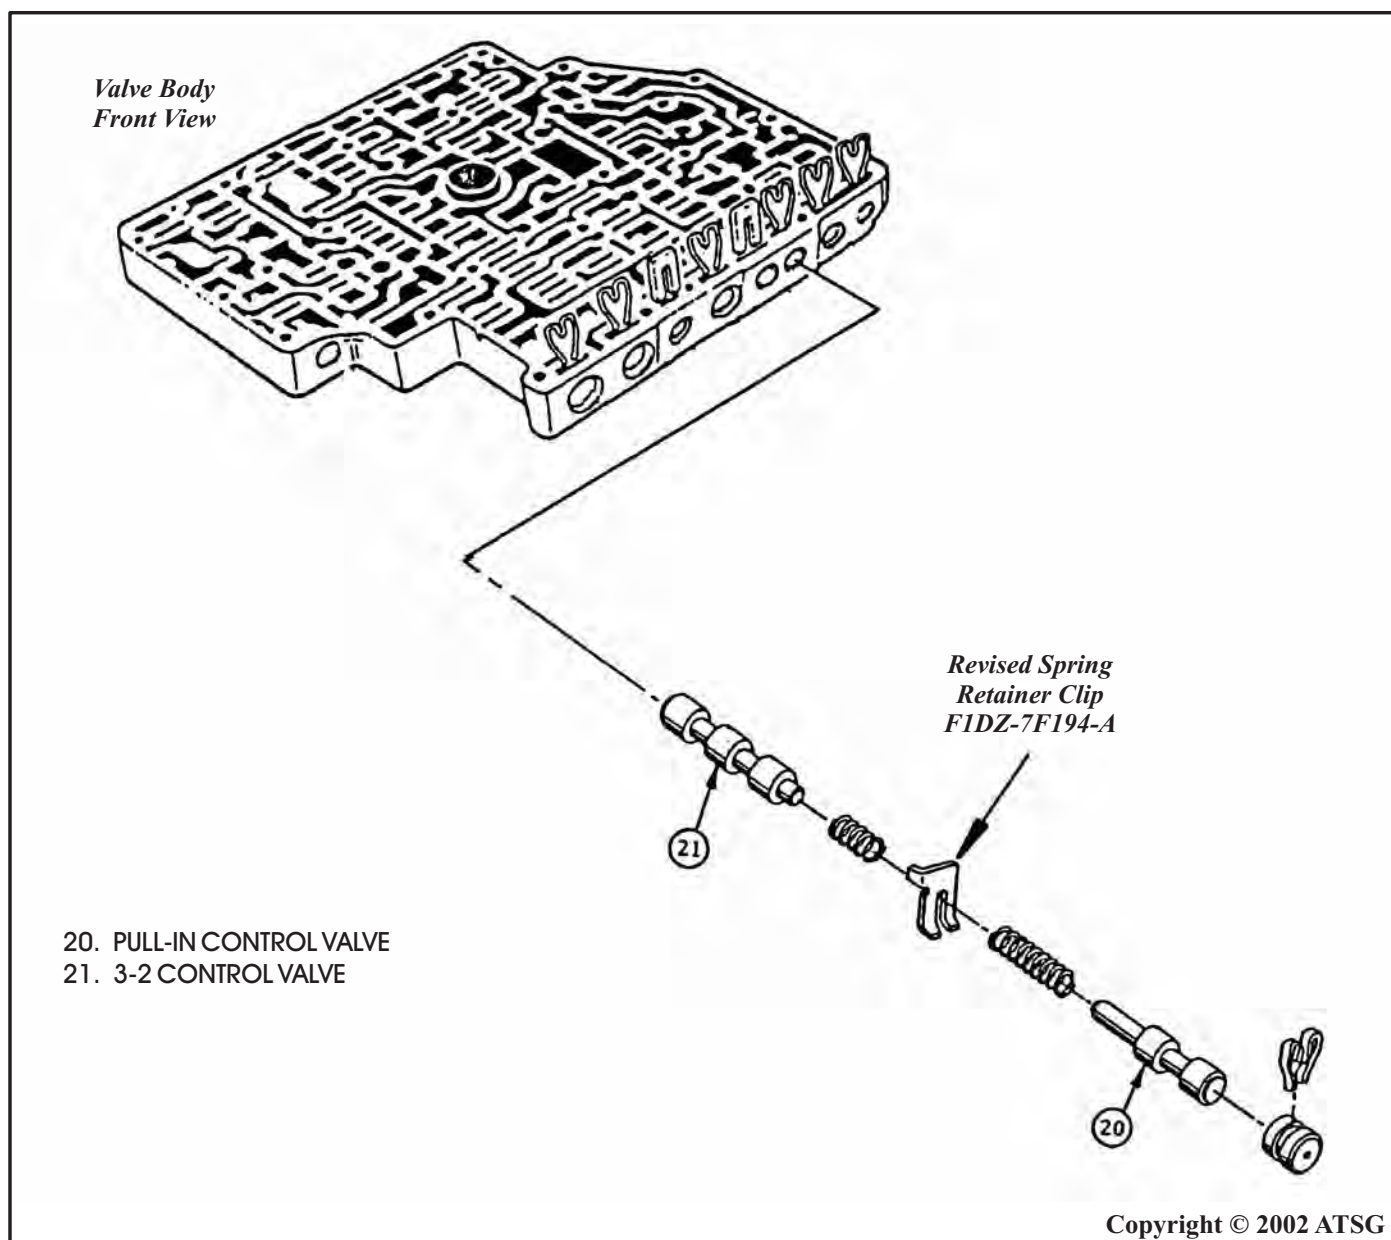
Figure 75

CAUSE: The cause may be, a broken spring retainer clip between the pull-in control valve spring and the 3-2 control valve spring, as shown in Figure 75.

CORRECTION: Replace the spring retainer clip with OEM part number F1DZ-7F194-A, as shown in Figure 75.

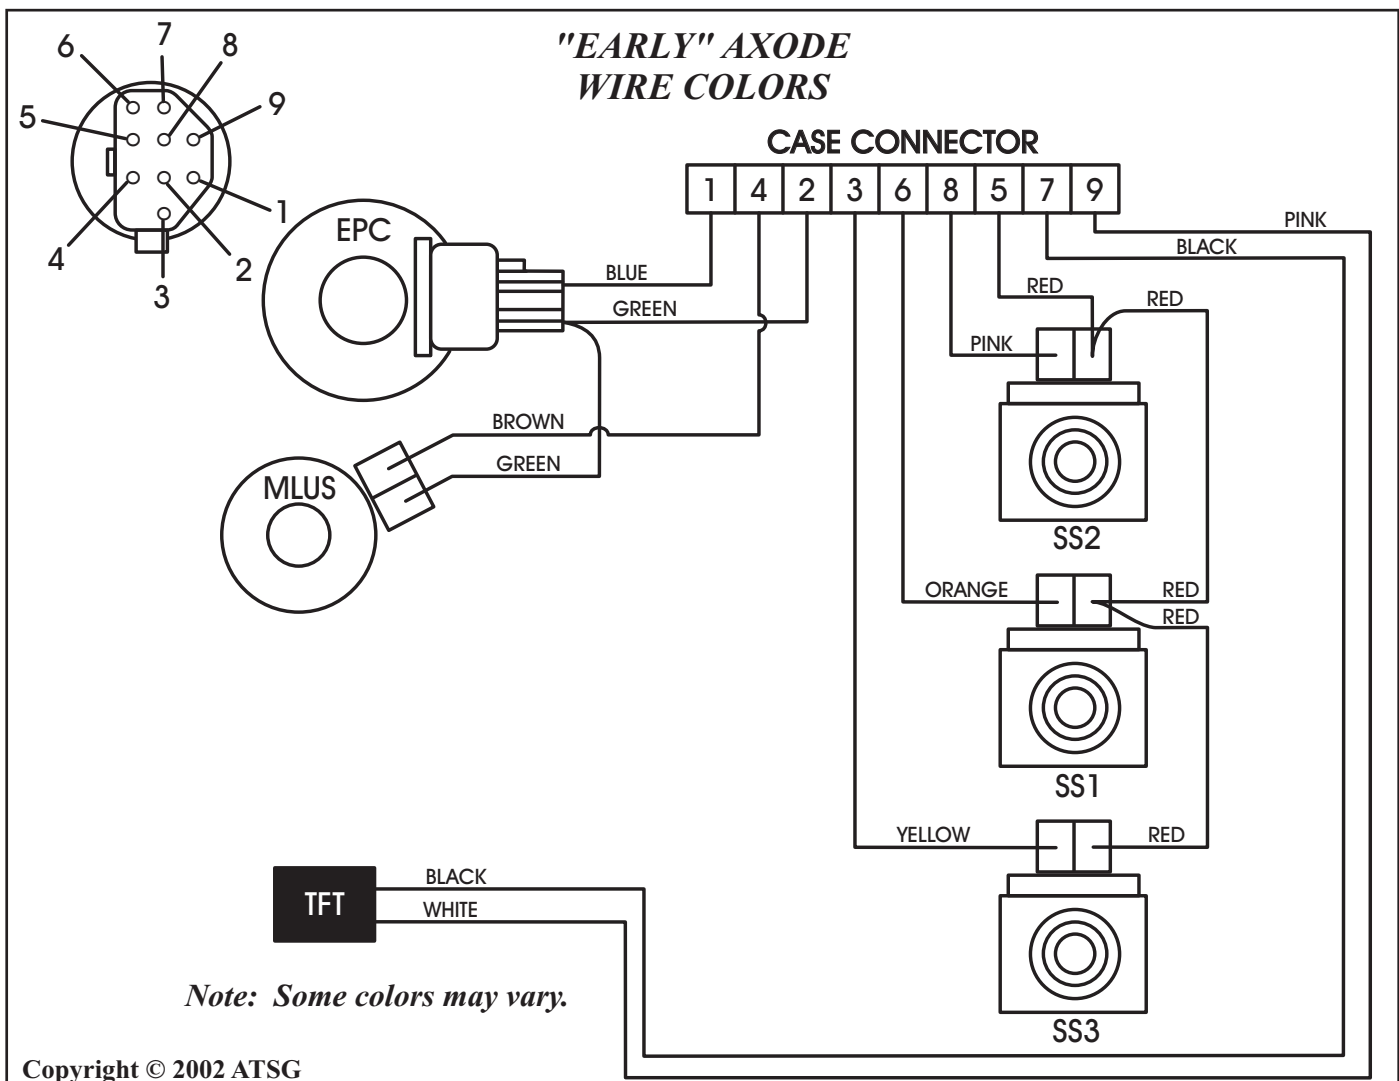
Figure 90

COMPLAINT: *After rebuild*, harsh shifts (High Line) and/or a "Clicking" or cycling noise may be heard from the side cover area, that is usually accompanied by an ON/OFF bind-up sensation that coincides with the "Clicking" noise. These symptoms may be accompanied with Diagnostic Trouble Code (DTC) 652 (MLUS Shorted or Open Circuit), DTC 624 (EPC Circuit Failure), and/or one Shift Solenoid DTC 621, 622, or 624.

CAUSE: The cause may be, solenoid wire connectors installed on the wrong solenoids.

NOTE: The internal wire harness normally is secured by wire-ties which would prevent improper connection of solenoids, however, not all wire harnesses have the wire ties necessary to prevent this problem and the chart must be used.
