FORD 4R100 "UPDATE HANDBOOK"

FORD 4R100 PRELIMINARY INFORMATION

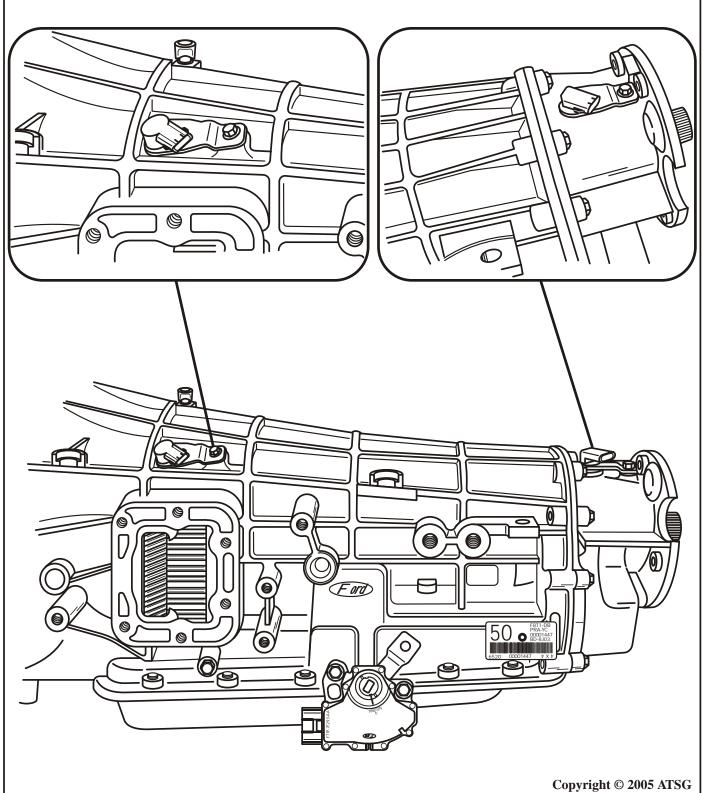
- (2) TURBINE SPEED SENSOR Added to the top front of the case on some models, as shown in Figure 2. We have also provided you with the resistance readings and OEM part numbers on both Turbine Speed Sensors, as the PTO and Non-PTO models use different sensors. Refer to Figure 2 for turbine speed sensor information.

- (3) OUTPUT SHAFT SENSOR Output Shaft Speed sensor was added to the top of the extension housing on some models, as shown in Figure 2. OSS is triggered by an added rotor pressed onto the output shaft, which requires a new tool to position the speed rotor properly *if* it is removed during overhaul, as shown in Figure 3. The park gear is also now pressed onto the output shaft, and the number 13 thrust washer has been changed to a thrust bearing as shown in Figure 3. We have provided you with the resistance reading and the OEM part numberfor the output shaft speed sensor. Refer to Figure 2 for output shaft speed sensor information.

Turbine Shaft Speed Sensor

PTO Models Only = 496-1244 Ohms Resistance Part Number F81Z-7M101-BA

Non PTO Models Only = 781-1979 Ohms Resistance Part Number F81Z-7M101-AA

Output Shaft Speed Sensor

All Models = 781-1979 Ohms Resistance Part Number F81Z-7M101-AA

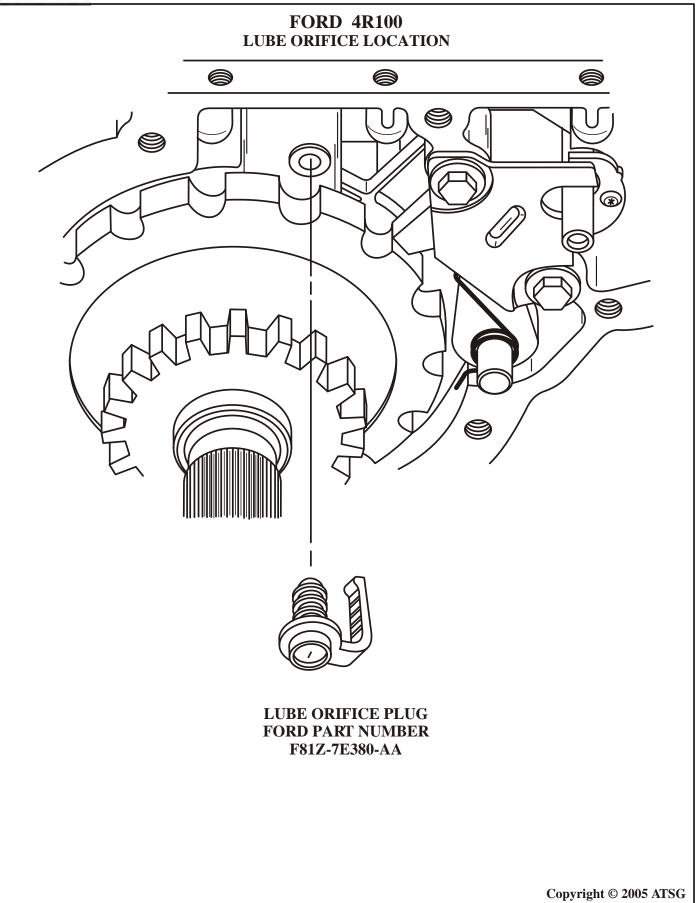
Figure 4

- (4) LUBE ORIFICE PLUG Added to the rear of the case in the lube circuit to provide added lubrication to the extension housing bushing on 2WD models. To retain common cases the 4WD models will also have the lube orifice plug installed, as well as E4OD cases produced after July 24, 1997. Lube Orifice Plug is available under OEM part number F81Z-7E380-AA, and should be replaced on rebuild. Refer to Figure 4.

4R100 TYPICAL 4 WHEEL DRIVE E4OD 4X4 WITHOUT LUBE PLUG

NO SHOULDER

SHOULDER

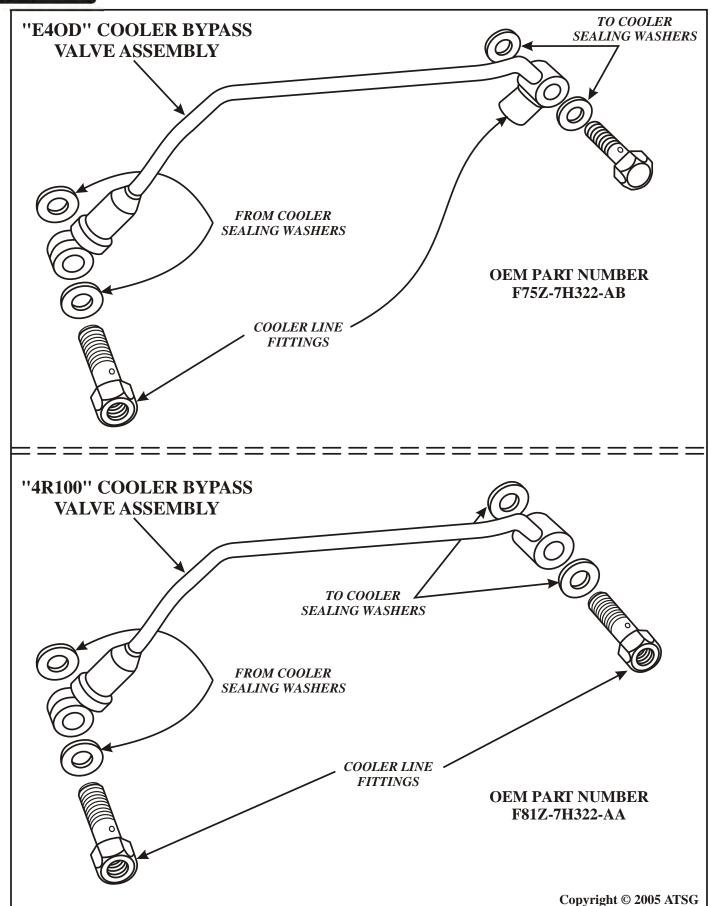
Figure 7

- (7) COOLER BYPASS VALVE Similar to the Cooler Bypass Valve on the E4OD that provides lubrication to the transmission in case of blocked or partially blocked coolers. We have given you OEM part numbers for both and both bypass valves are illustrated in Figure 7.

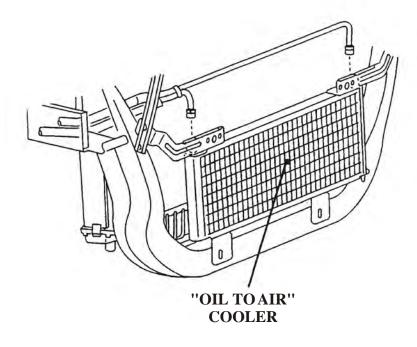
- (8) TRANSMISSION COOLERS Most F-Series vehicles over 8500 GVW equipped with the 4R100 transmission have an external "Oil-To-Air" cooler *only*. Due to the internal design of the "Oil-To-Air" cooler, it cannot be adequately flushed to remove contaminants, and requires replacement during transmission rebuild. The only exception is that F-Series vehicles over 8500 GVW equipped with the 5.4L engine also uses a radiator "In-Tank" cooler in addition to the "Oil-To-Air" cooler. Refer to Figure 8 for transmission cooler information.

Most F-Series vehicles over 8500 GVW equipped with the 4R100 transmission have an external "Oil-To-Air" cooler only. Due to the internal design the "Oil-To-Air" cooler cannot be adequately flushed to remove contaminants, and requires replacement during transmission rebuild.

The only exception is that F-Series vehicles over 8500 GVW equipped with the 5.4L engine also uses a radiator "In-Tank" cooler in addition to the "Oil-To-Air" cooler.

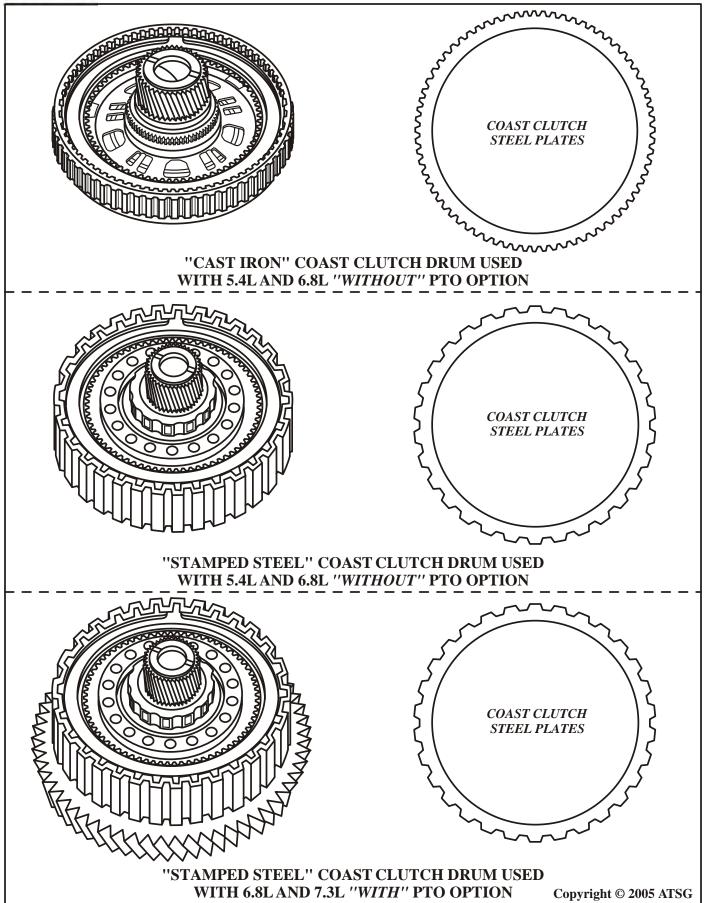
Figure 11

- (11) COAST CLUTCH DRUM AND STEELPLATES There is now a revised "Stamped Steel" coast clutch drum introduced with the 4R100 transmission. There are currently three different coast clutch drums used in production and all three are illustrated in Figure 11. One is the current E4OD coast clutch drum which is "Cast Iron" and uses the current steel plates. Two is the new design "Stamped Steel" coast clutch drum without the PTO gear pressed on it and uses a new design coast clutch steel plate to accommodate the new drum. Third is the new design "Stamped Steel" coast clutch drum with the PTO gear pressed on it and uses the new design coast clutch steel plates to accommodate the new drum. The new design "Stamped Steel" coast clutch drum now has the overdrive roller clutch inner cam made on the drum and the overdrive sun gear is pressed into the new design drum, which changes the assembly process of the overdrive roller clutch. Refer to Figure 11.

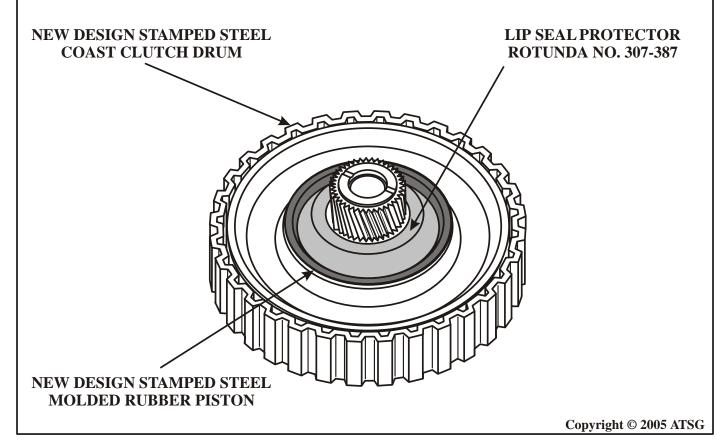
Figure 12

- (12) COAST CLUTCH PISTON The coast clutch piston in the new design coast clutch drum is now a stamped steel, molded rubber seals assembly and is illustrated in Figure 12. The new design piston assembly requires a new seal protector tool, Rotunda No. 307-387, to install the piston and seal assembly into the new design stamped steel coast clutch drum (See Figure 12).

STAMPED STEEL MOLDED RUBBER COAST CLUTCH PISTON FOR NEW DESIGN COAST CLUTCH DRUM

NEW DESIGN STAMPED STEEL, MOLDED RUBBER SEAL PISTON OEM PART NUMBER F81Z-7A262-AA

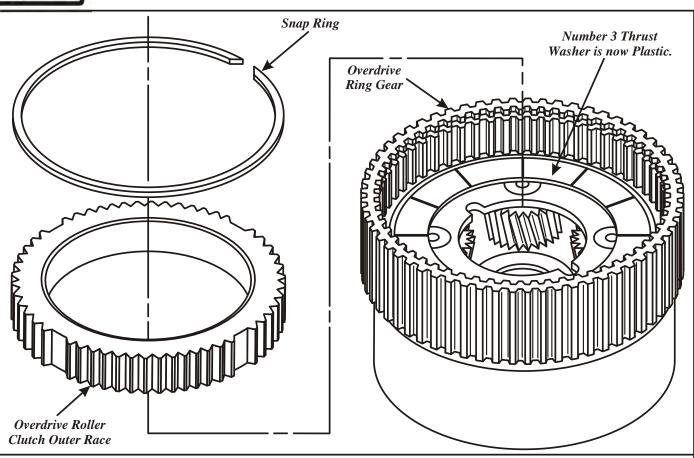
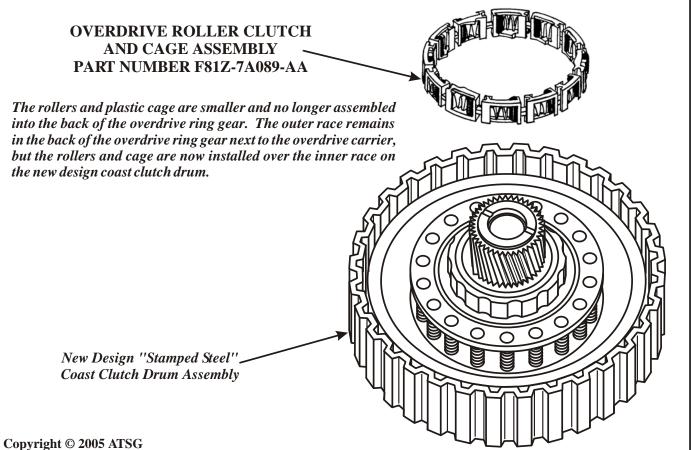
Figure 13

- (13) OVERDRIVE ROLLER CLUTCH The overdrive roller clutch inner cam is now made onto the new design coast clutch drum, instead of being splined like the previous models were, and is illustrated in Figure 13. The new design overdrive roller clutch assembly is now assembled onto the inner cam on the new design drum. The overdrive roller clutch outer race is still located in the overdrive ring gear next to the overdrive carrier and the number 13 thrust washer between the two is now plastic, but the cage and roller assembly are now assembled over the inner race on the new design coast clutch drum. Refer to Figure 13.

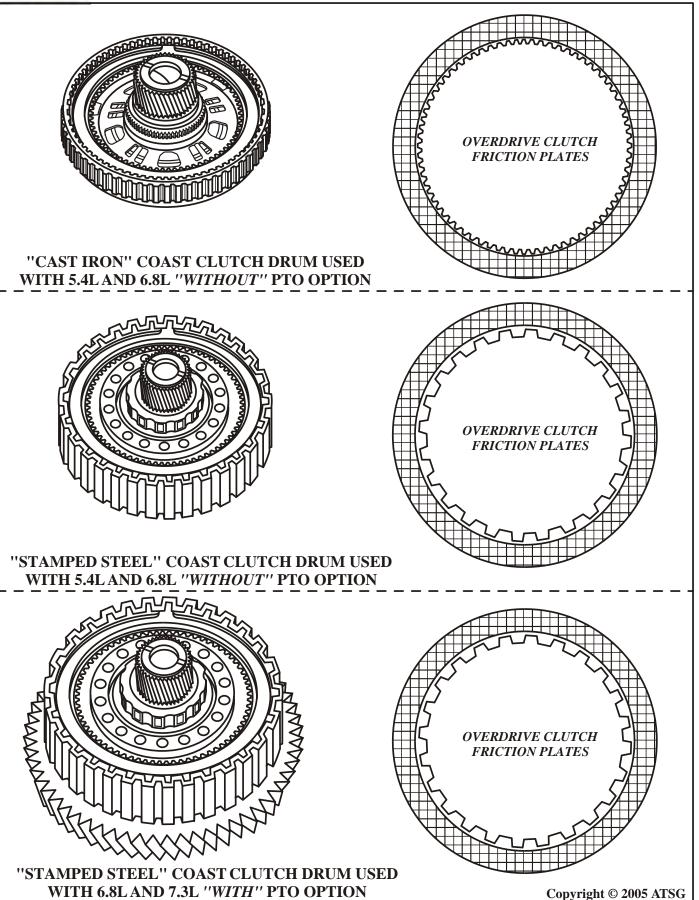
Figure 14

- (14) OVERDRIVE FRICTION PLATES Now have wider teeth to accommodate the new design stamped steel coast clutch drum assembly when it is used, as illustrated in Figure 14.

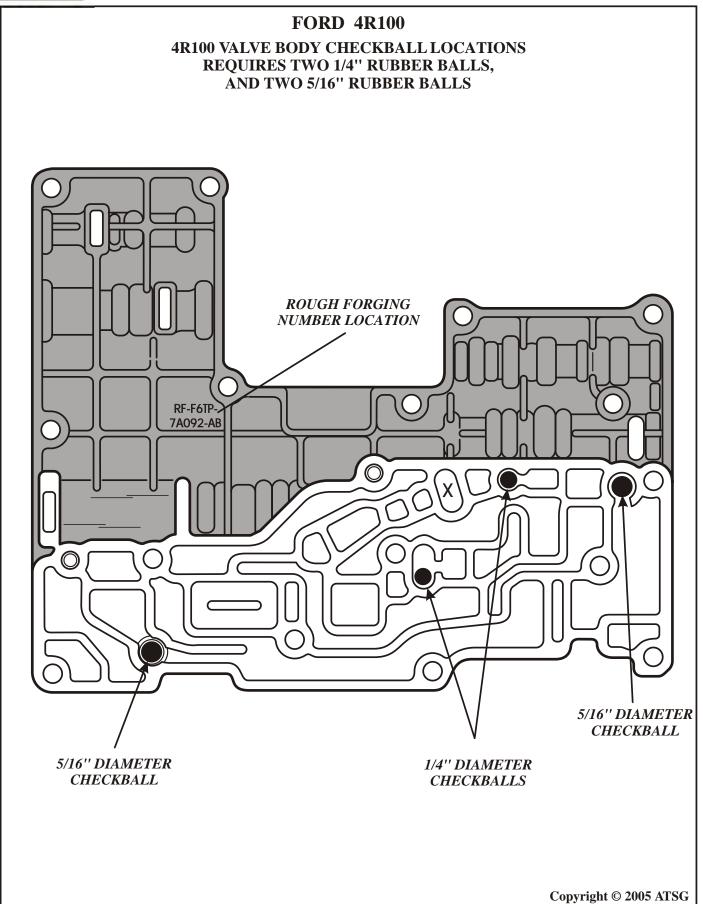
- (15) VALVE BODY CHECKBALL LOCATIONS Valve body checkball locations are illustrated in Figure 15 and now has two 1/4" checkballs and two 5/16" checkballs. This of course changes the lower valve body spacer plate as illustrated in Figure 16. The new design spacer plate has only one hole over the bathtub where the checkball was removed. The case checkball locations remain the same as the 1996-Up configuration, and this illustration is included for reference and shown in Figure 17.

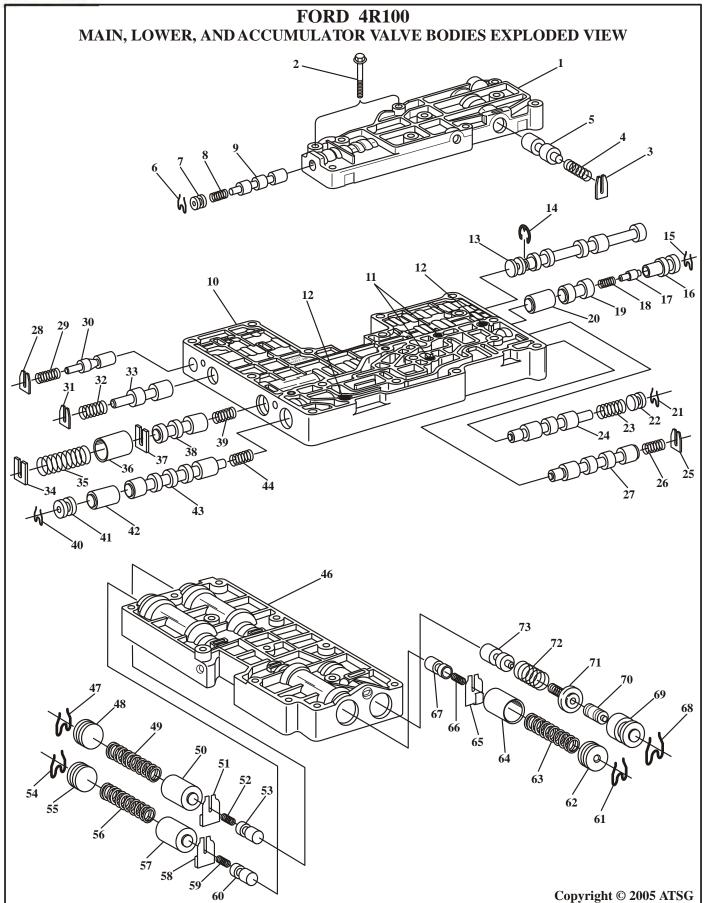
Figure 18

- (16) VALVE LINE-UPS IN VALVE BODY Have changed from the previous models and are illustrated in Figure 18, with a valve description and legend shown in Figure 19.

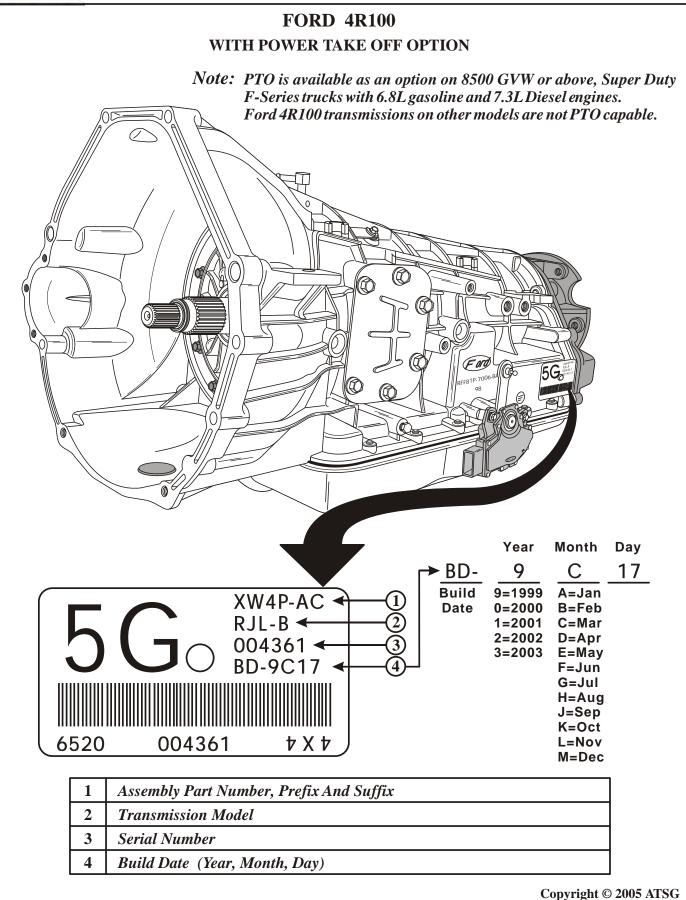
Figure 29

- (1) Obviously the case must be PTO capable with the cast-in window in the transmission where the PTO unit mounts to the transmission, as shown in Figure 29.
- (2) Designed for use during Mobile (Some Models) or Stationary conditions.
- (3) PTO is available as an option *only* on 8500 GVW or above, Super Duty F-Series trucks with 6.8L Gasoline and 7.3L Diesel engines. Ford 4R100 transmissions on other models *are not* PTO capable.
- (4) Battery voltage *must* be supplied to the Electronic Engine Control (EEC) input pin 4 on gasoline models, or pin 66 on diesel models, *when PTO is engaged*. The processor uses this information to raise EPC pressure to approximately 55 PSI so that you do not smoke the coast clutch. *This voltage must be provided by the PTO installer.*

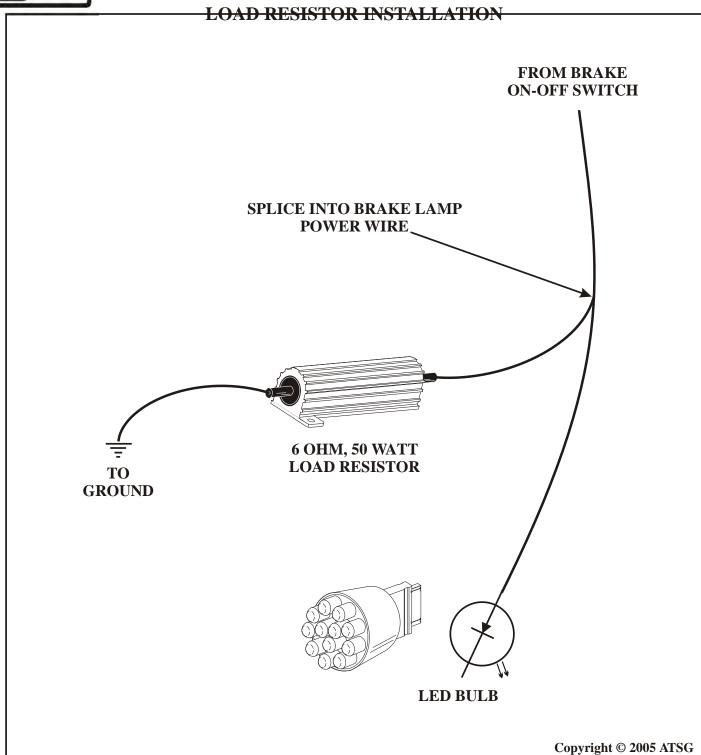
Figure 70

- CAUSE NO. 2: Recently there has been an increase in the popularity of replacing the stock incandescent brake lamp bulbs, with aftermarket LED lamp assemblies. Refer to Figures 67 and 68. The main advantages of switching to LED lamp assemblies is that there are no fragile filaments to burn out or break, which means that the LED lamp assemblies may possibly last for the entire life of the vehicle, and LED lamps consume much less energy than the stock incandescent bulbs. Due to the low power consumption, the PCM *may* view this reduced current draw as being a burned out bulb, resulting in a no Torque Converter Clutch apply at less than 30 percent throttle.

For those vehicles that have had the stock incandescent bulbs replaced with aftermarket LED bulb assemblies, it *may* be necessary to install a 6 ohm- 50 watt Load Resistor across the brake light power wire to simulate the load of the regular stock incandescent bulb (See Figure 70). *Note: One resistor is required for use on each LED bulb assembly.*

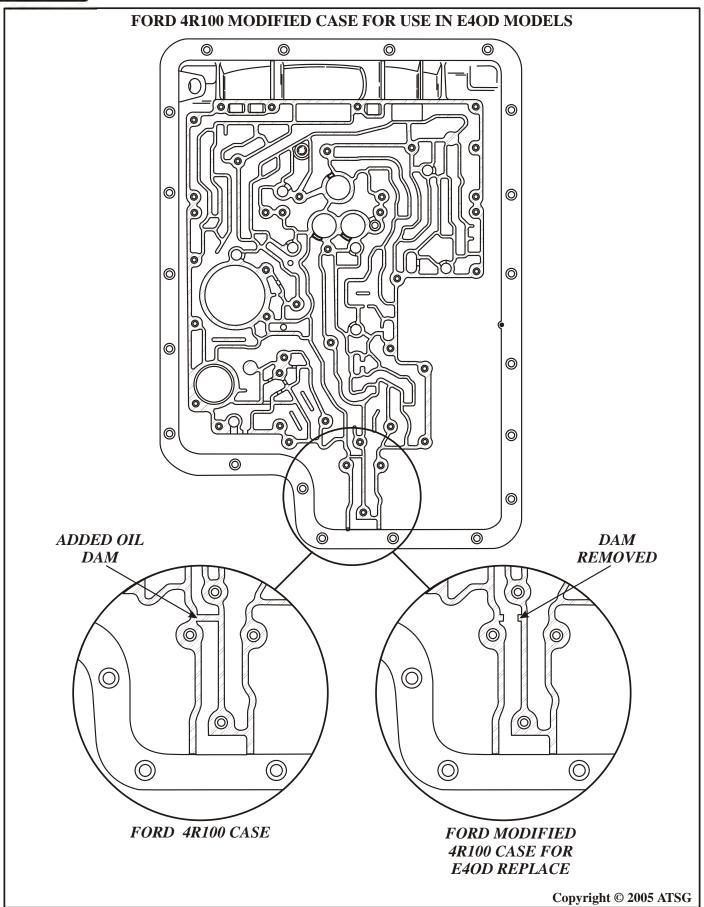
Figure 71

CHANGE: Currently, the "only" new case available from Ford Motor Company, for replacement in any E4OD equipped vehicles, is a modified 4R100 case. Ford has machined out the dam in the case that seperates center and rear lube, near the rear of the case, as shown in Figure 71.
