A4LD UPDATE HANDBOOK INDEX

FORD A4LD

"UPDATE HANDBOOK"

Since the start of production in 1985, the FORD A4LD transmission has received many major engineering design changes. These design level changes have affected nearly every part used in the A4LD transmission.

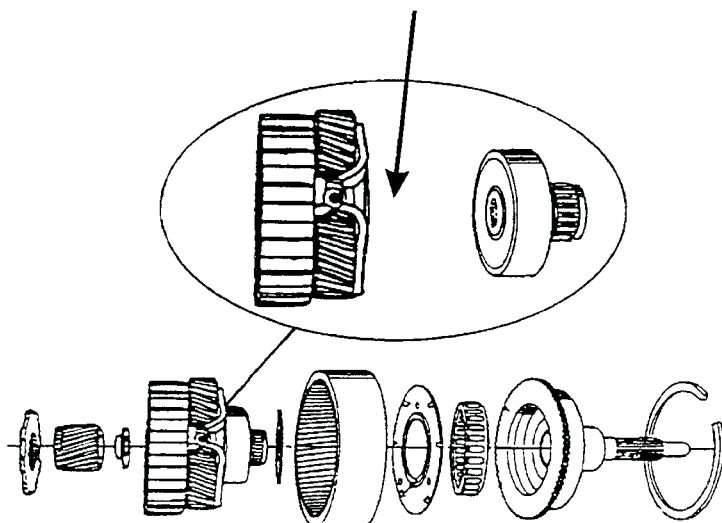
Figure 19

CAUSE: The cause may be, the overdrive sprag inner race broken loose from the carrier (See Figure 19). The problem is not always detectable because the bearing inside the carrier hides the broken area of the carrier. The sprag inner race and splined area for the input shaft "MUST NOT" turn. Use a little force if necessary to check this.

OVERDRIVE CARRIER BREAKS IN THIS AREA

CORRECTION: Replace the overdrive carrier. Remanufactured "HEAVY DUTY" planetary carriers are available from aftermarket suppliers (See Figure 20).

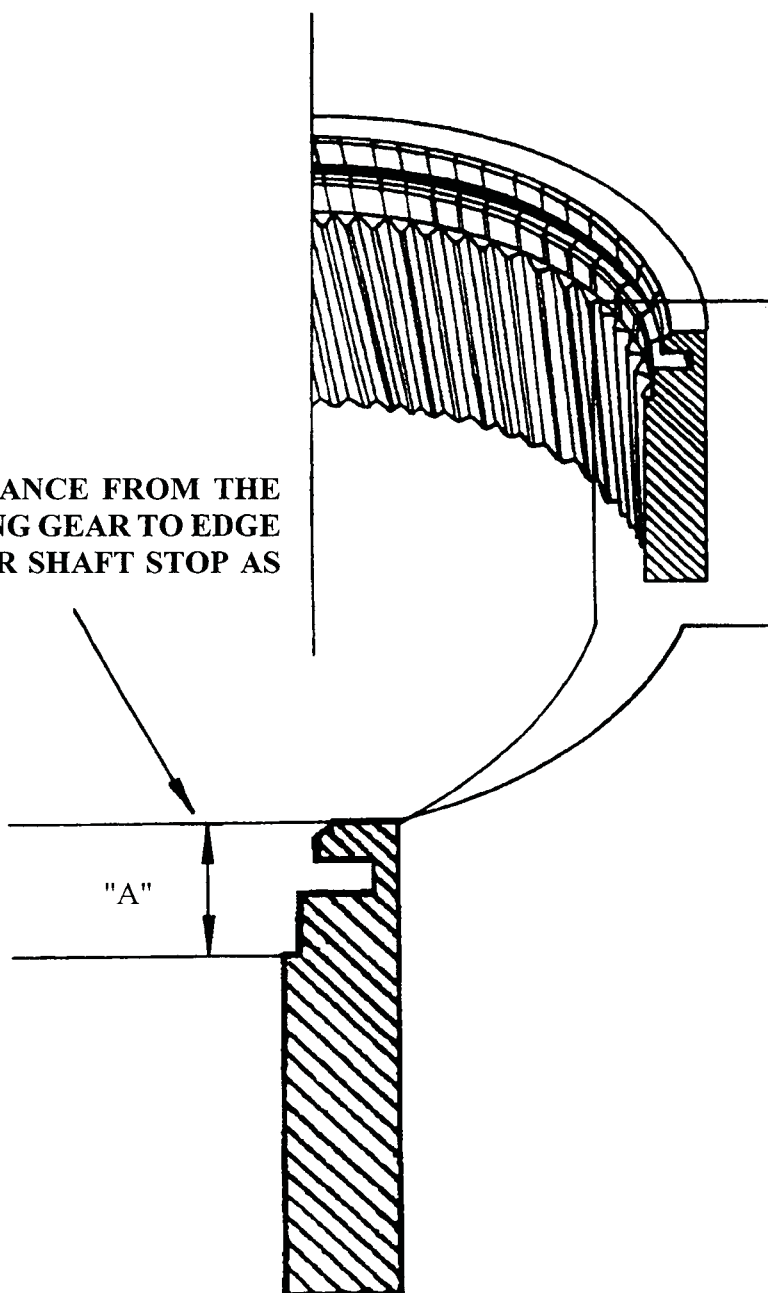
Figure 23

PREVIOUS DESIGN WITH STEEL CAGED SPRAG, "A" = .335"
DESIGN LEVEL WITH PLASTIC CAGED SPRAG, "A" = .295"

COMPATABLE PARTS MUST BE USED TOGETHER

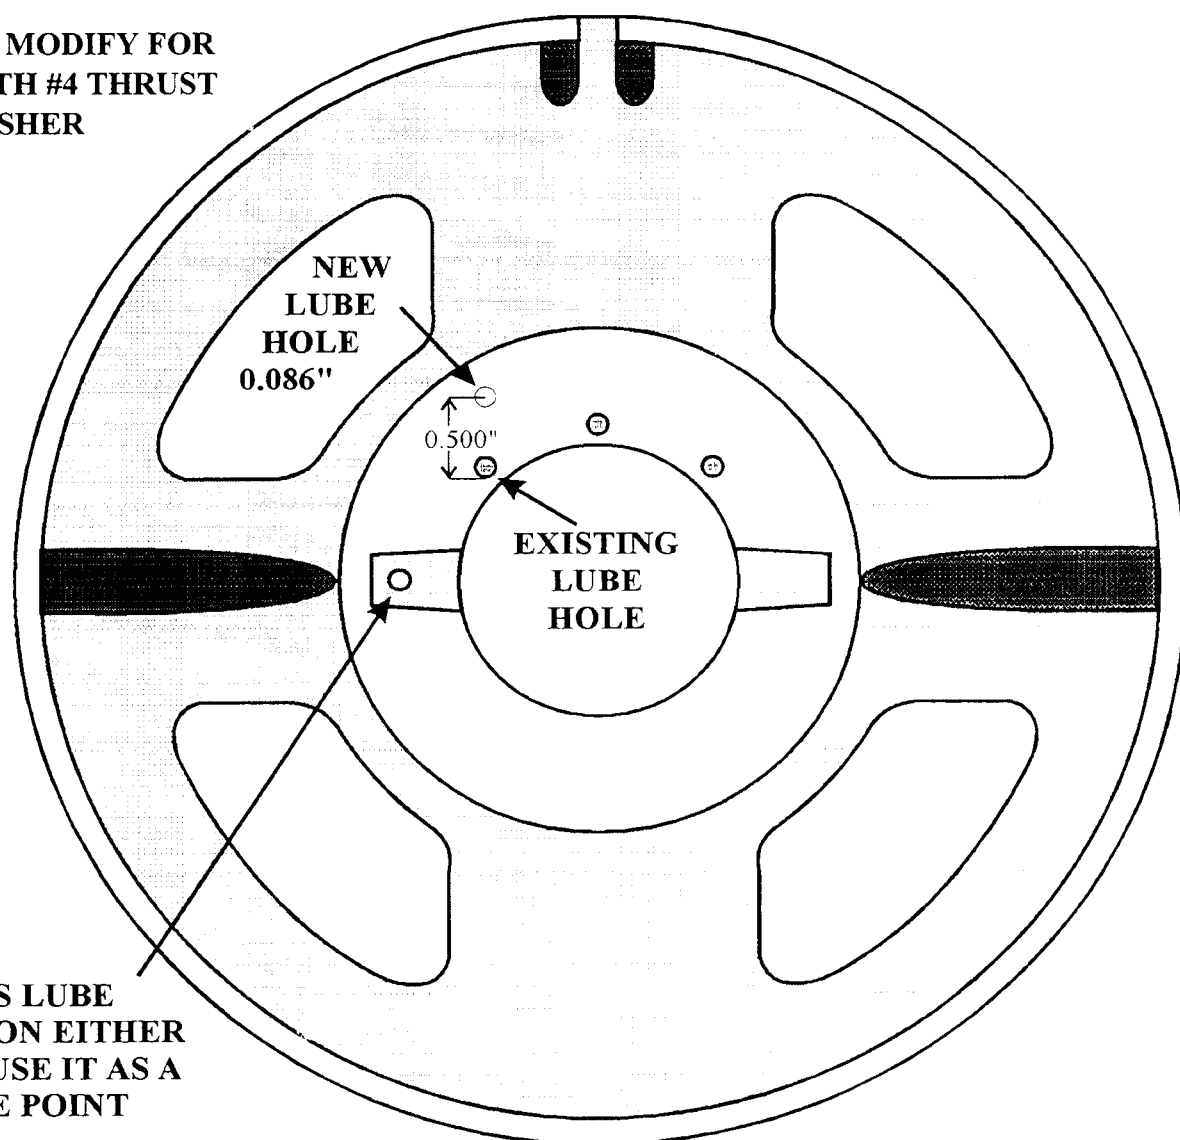
Figure 28

COMPLAINT: Failure of the selective #4 thrust washer between the center support and the direct drum.

CAUSE: The cause may be lack of lubrication to the #4 thrust washer.

CORRECTION: Drill a new lube hole in the center support. Measure 0.500" up from the bottom of the existing hole, drill a 0.086" hole all the way through the center support (See Figure 28).

**NOTE: ONLY MODIFY FOR
MODELS WITH #4 THRUST
WASHER**

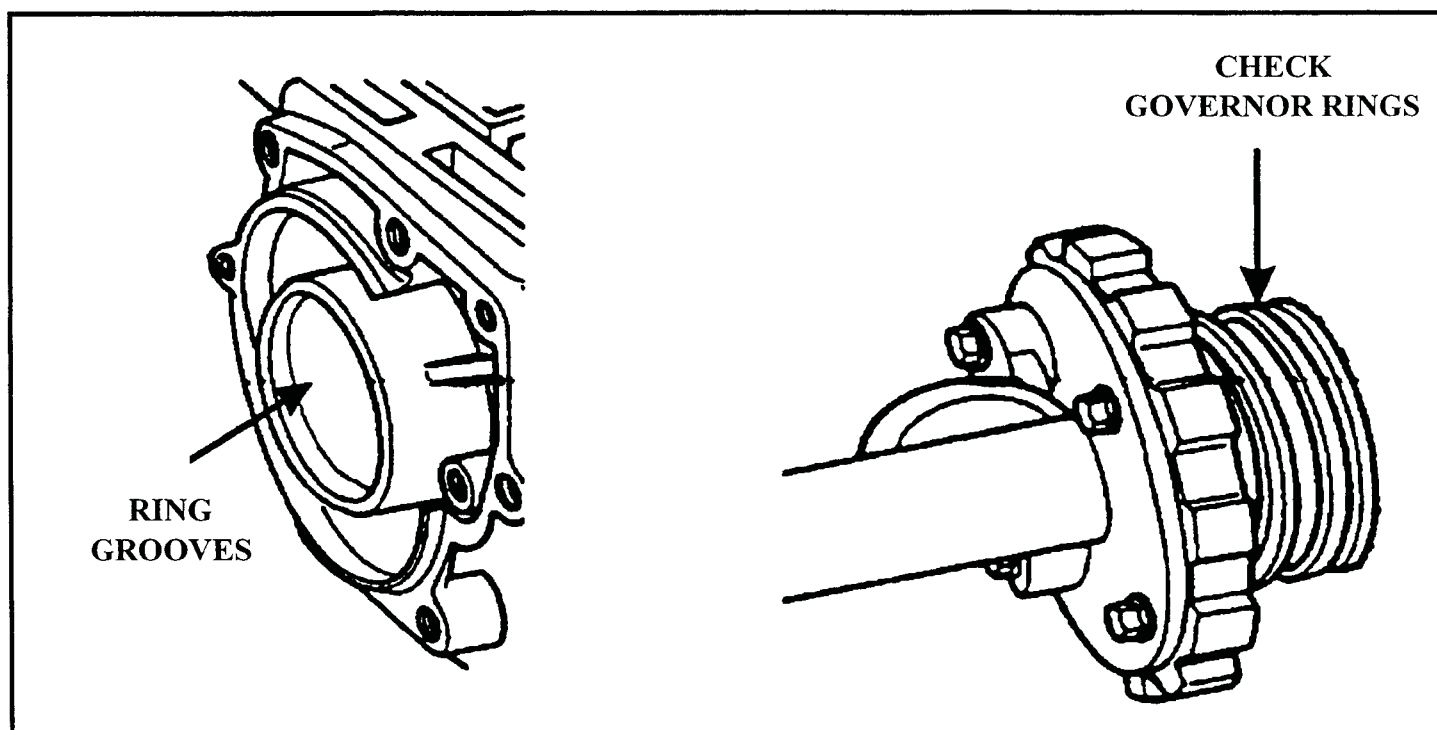
Figure 60

COMPLAINT: Fluid leaking out of the case air vent..

CAUSE: One possible cause may be governor rings leaking, causing pressure to build up in the case and blowing fluid out the vent.

CORRECTION: Check governor bore in case for ring grooves as shown in Figure 60. If ring grooves are present, replace the case, or install a sleeve kit. Also check governor rings for wear and/or damage as shown in Figure 60. Replace as necessary. It is recommended that the Tin-Nickel coated rings be used.

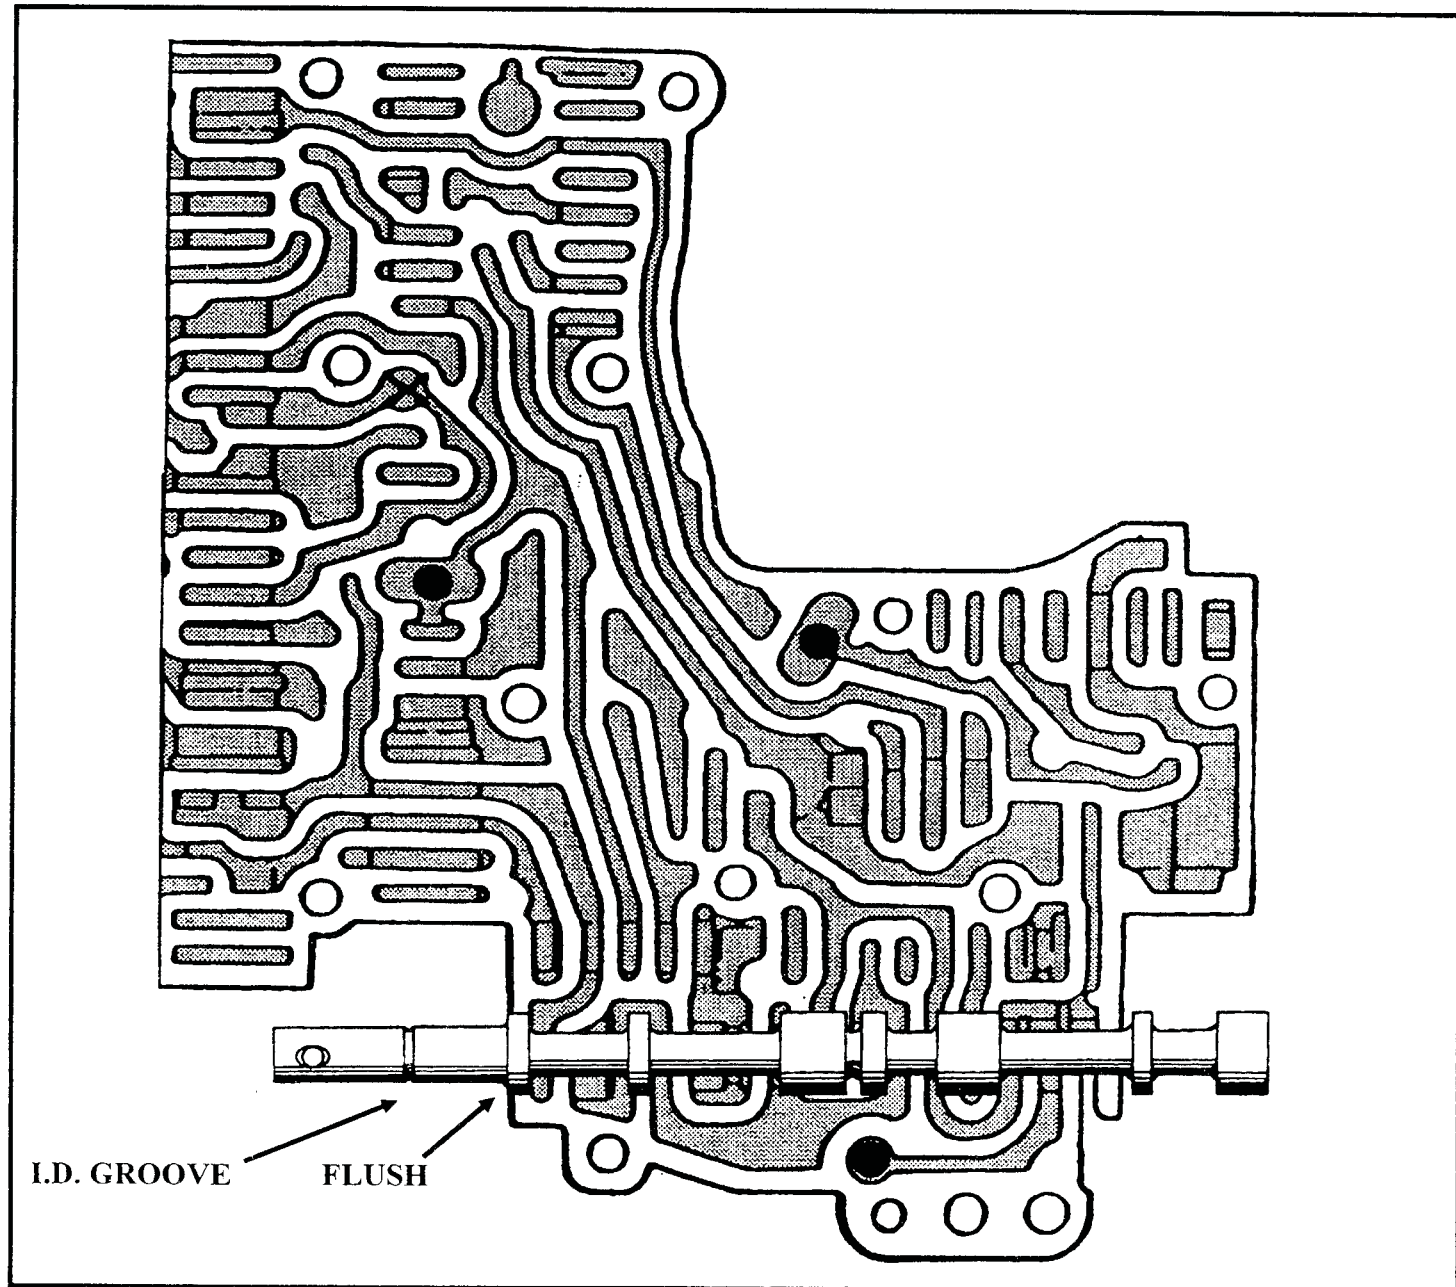
Figure 75

COMPLAINT: After overhaul, your A4LD transmission exhibits a "Tie-Up" condition, when the selector lever is placed into the park position.

CAUSE: The cause may be, an improperly adjusted manual valve. The .075" puck supplied in some gasket sets & some valve body kits WILL NOT WORK ON ALL MODELS. On SOME valve bodies, using the "Puck" to adjust the manual valve, will allow the manual valve to move past the Park position and apply the forward clutch.

- (1) Measure the link hole in the manual valve to ensure that it is .157" in diameter, and has not elongated due to wear. It is also recommended to use the latest manual valve, with the I.D. groove near the hole, OEM #E8TZ-7C389-A (See Figure 75).
- (2) With the valve body installed on the transmission, place the manual lever in the "D2" position.
- (3) With the selector in the "D2" position, the first land on the manual valve should be flush with the valve body casting, as shown in Figure 75. However .010" below flush to .020" above flush with the valve body casting is totally acceptable.
- (4) Bend the manual valve link as necessary to achieve the dimensions listed above.

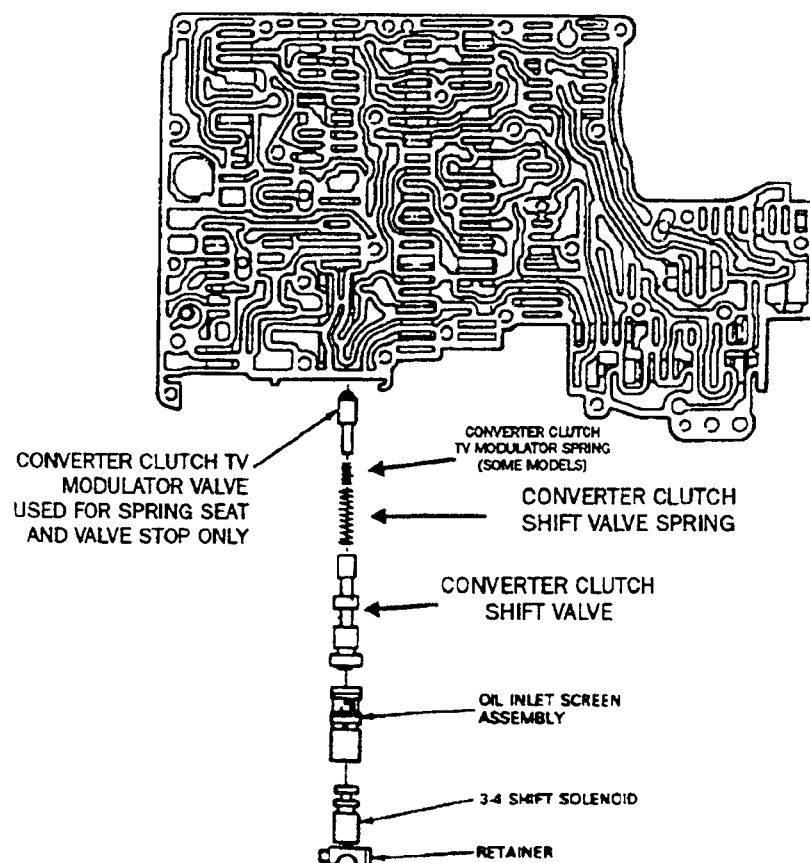
Figure 80

If the converter clutch shift valve spring in your valve body is weak (less than 5 1/2 lbs), make it stronger to prevent converter clutch hanging on during coastdown conditions. Total weight 5 1/2 max.

- (3) Replace the converter clutch shift valve spring with a stronger spring. This spring weighs about 5 lbs. in single solenoid valve bodies, and about 2 lbs in double solenoid valve bodies. (See Figure 80). Increase the tension in double solenoid valve bodies by 2 - 2 1/2 lbs. to about 4 1/2 - 5 1/2 lbs. maximum total weight.

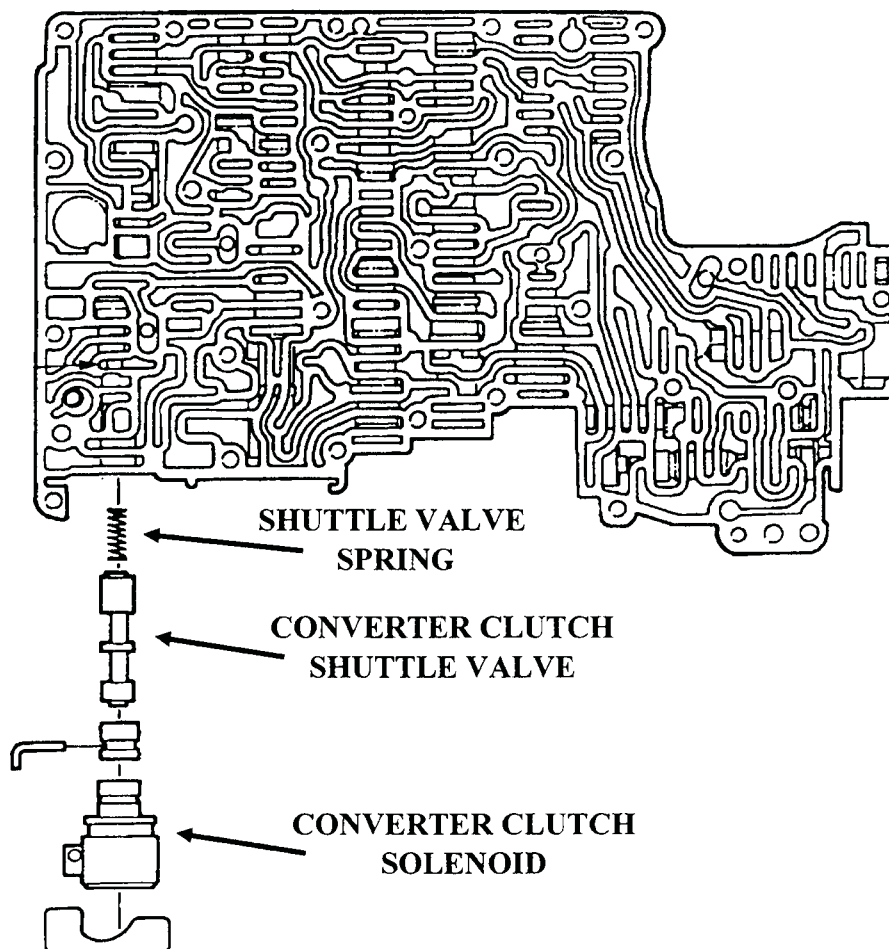
Figure 81

CAUSE: The cause may be a broken converter clutch shuttle valve spring.

CORRECTION: Replace the broken converter clutch shuttle valve spring with updated spring (See Figure 81).
