FORD E4OD "UPDATE HANDBOOK"

*Updated
April, 2004*

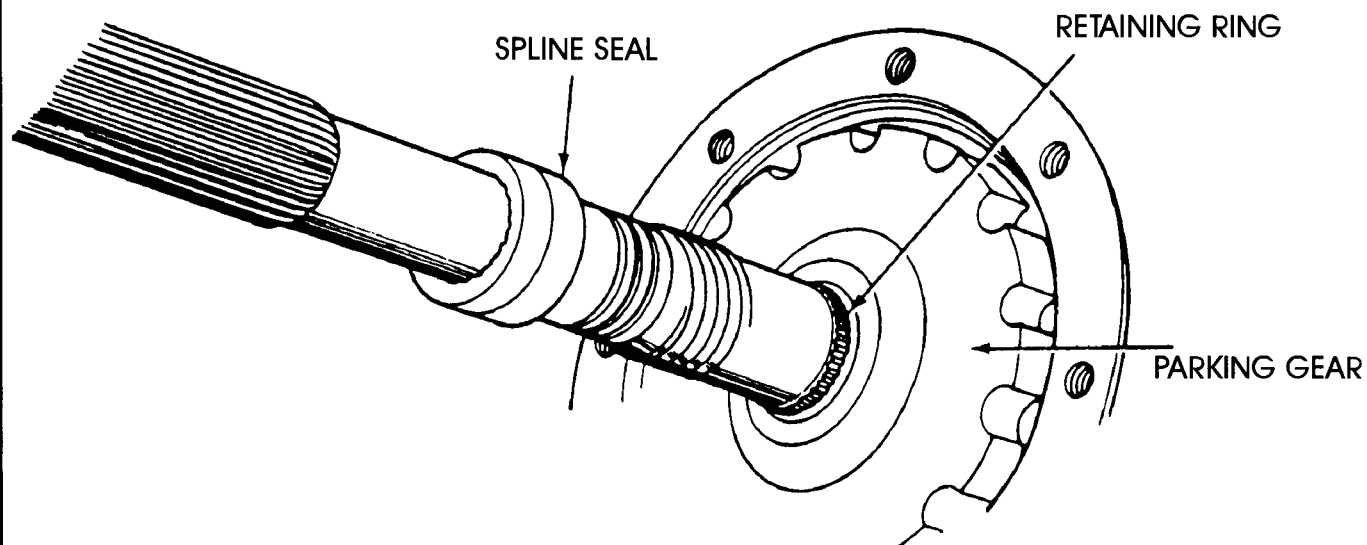
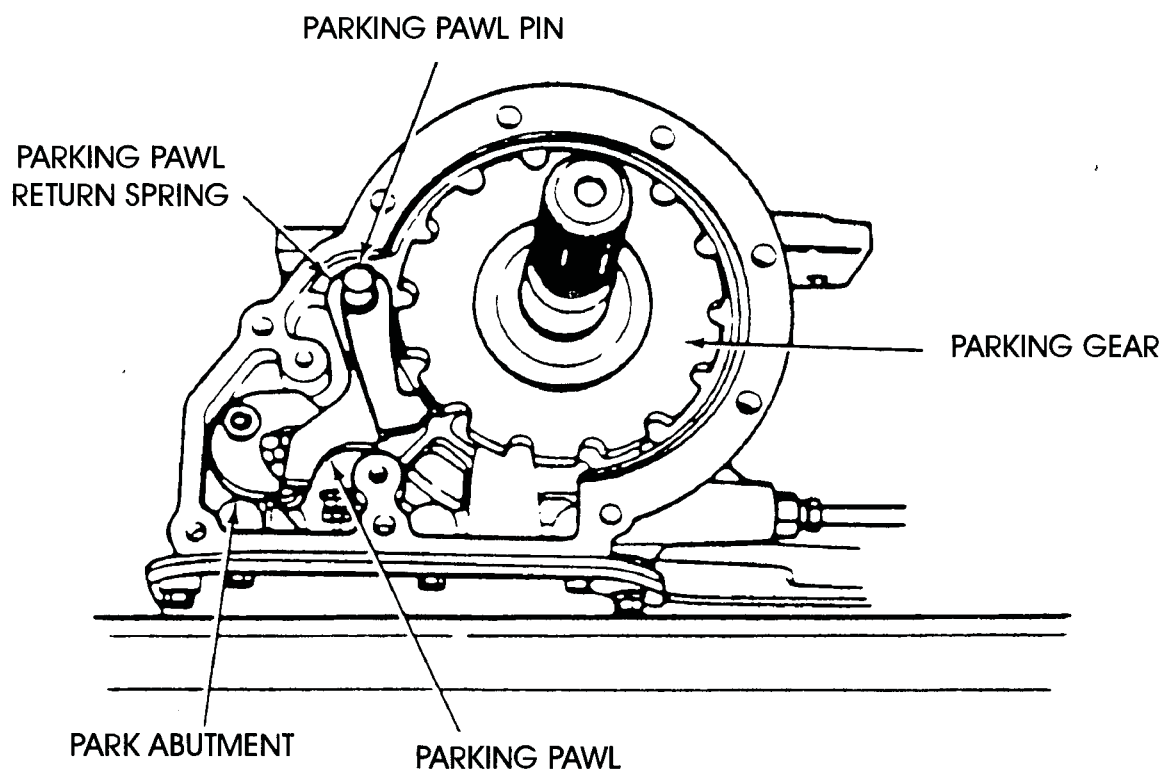
Figure 22

CAUSE: The cause may be a broken snap ring on the output shaft, allowing the parking gear to move rearward, and then the parking pawl cannot engage into the parking gear. Refer to Figure 22.

1. 2nd Design Extension Housing With Added Boss.
2. New Design "High Strength" Snap Ring.
3. Snap Ring Installation Aid.

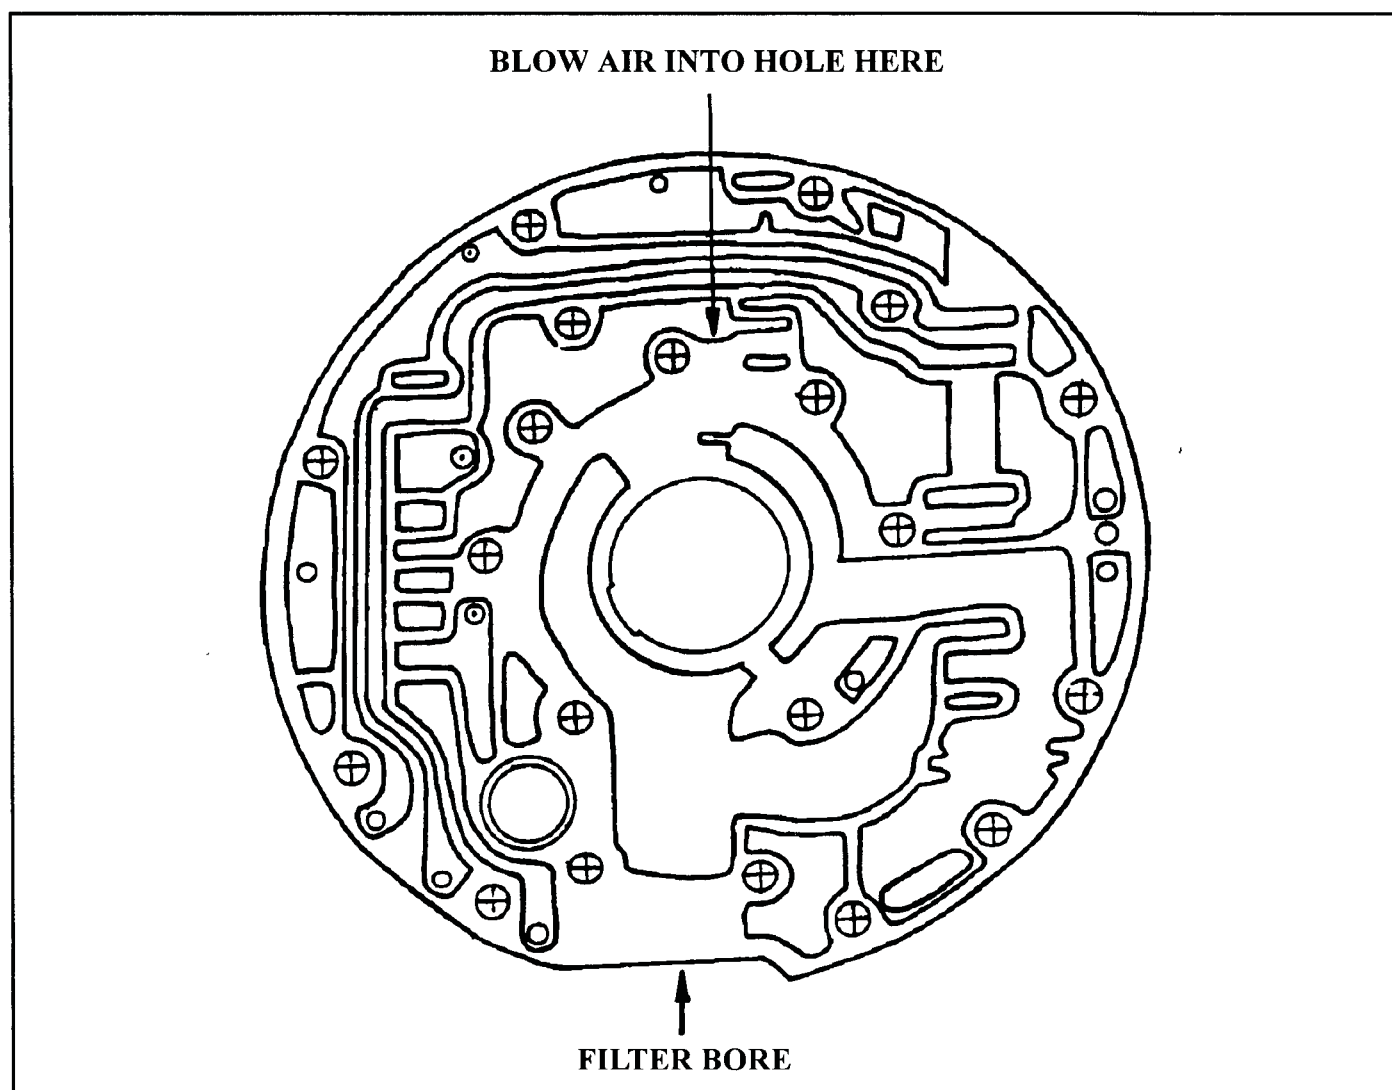
Figure 27

COMPLAINT: Overdrive planetary and overdrive sprag failure due to lack of lubrication.

CAUSE: The cause may be, a plugged or restricted lube passage in the oil pump cover. There is a valve and spring under the orificed cup plug in the pump cover. The valve is made of plastic and is prone to melting, and will restrict or block the passage.

CORRECTION: To check for restriction, blow air into the hole in pump cover as shown in Figure 27, and air should exit from the holes in rear of stator shaft, as shown in Figure 28. If the passage is restricted or blocked the orificed cup plug must be removed, the plastic valve assembly replaced, and the passage thoroughly cleaned (See Figure 28)

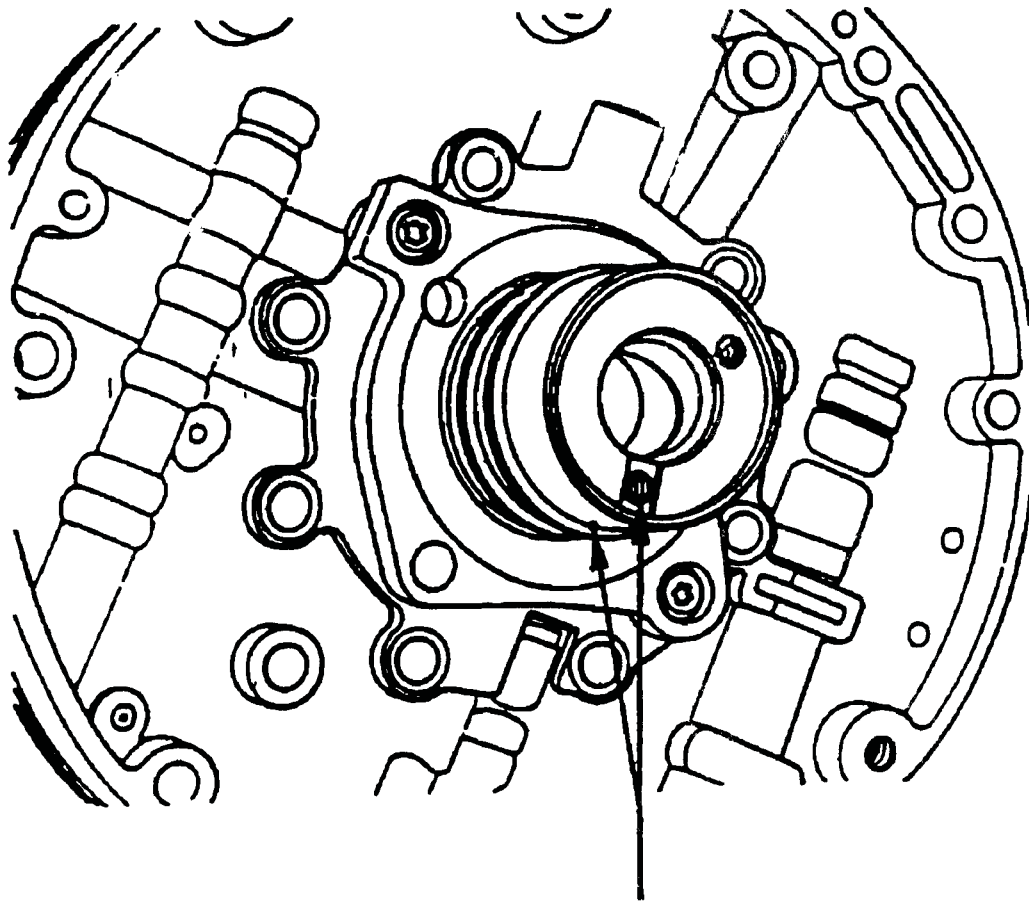
**AIR SHOULD EXIT FROM ORIFICED
CUP PLUG AND SMALL LUBE HOLE IN
FRONT OF BUSHING JOURNAL**

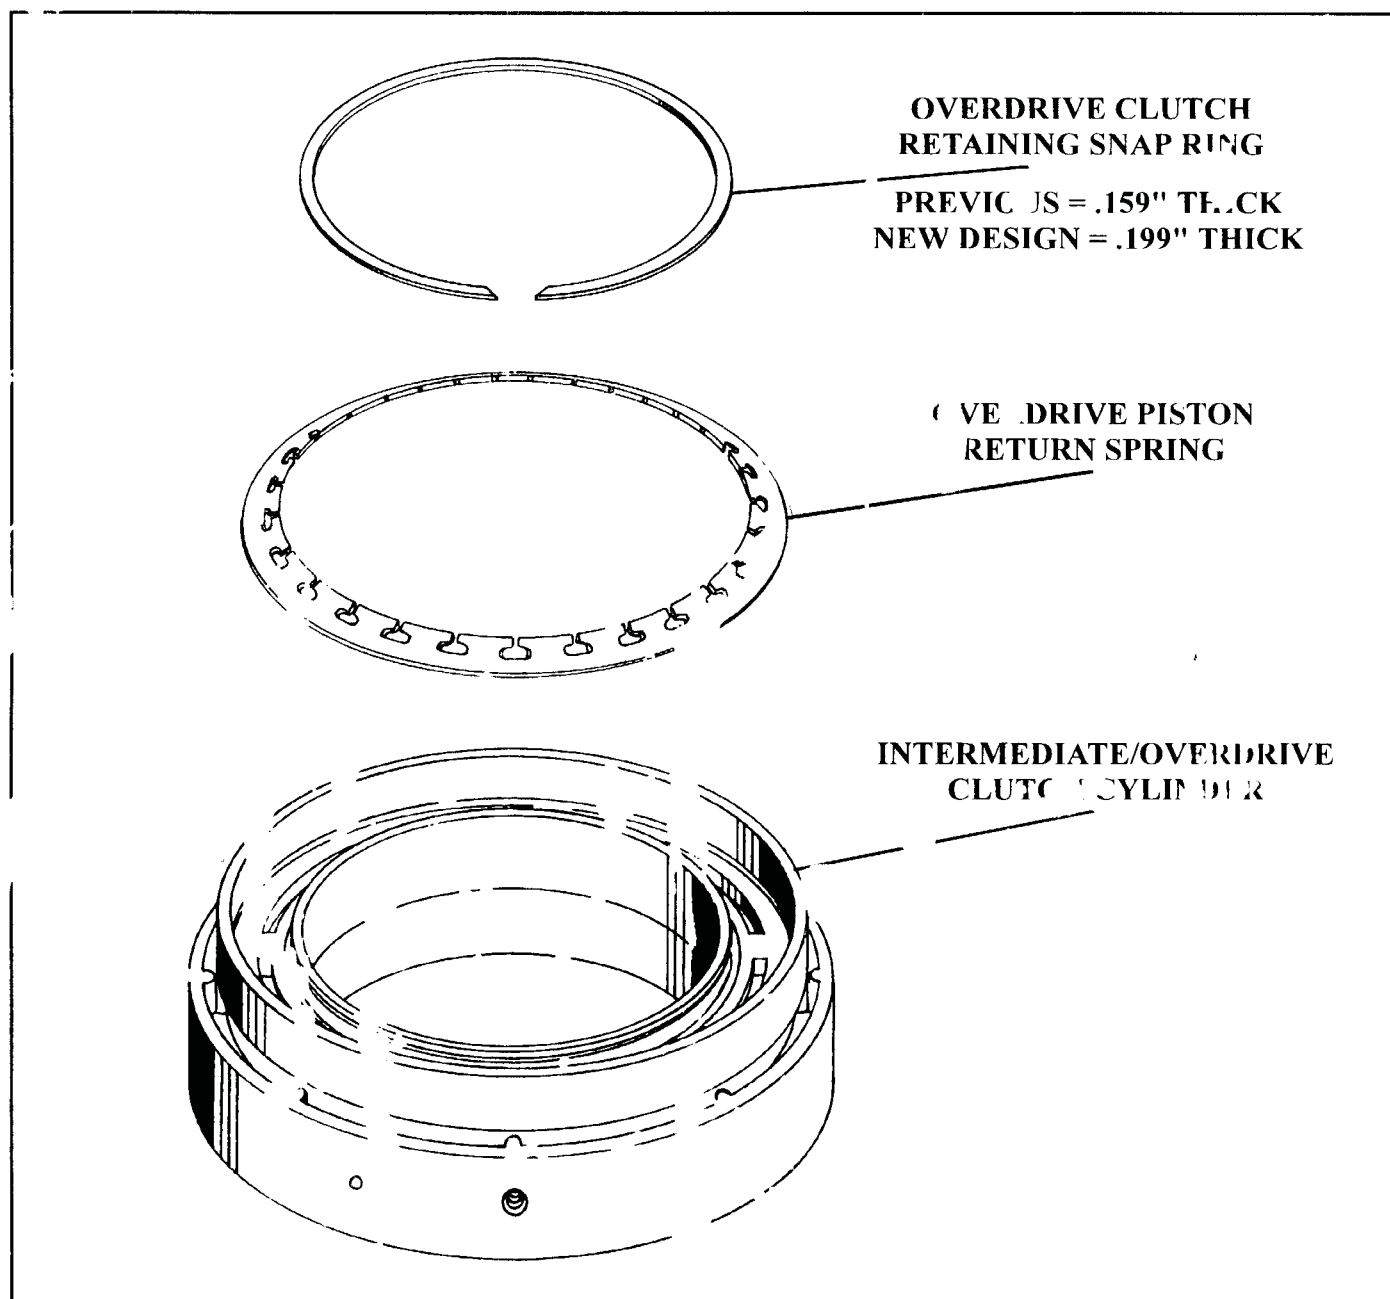
Figure 29

CAUSE: Insufficient tension on the Overdrive Clutch Snap Ring.

CORRECTION: Install a new design (Thicker) snap ring that has more tension than the previous design. The new design snap ring is .199" thick and the previous design is .159" thick, as shown in Figure 29.

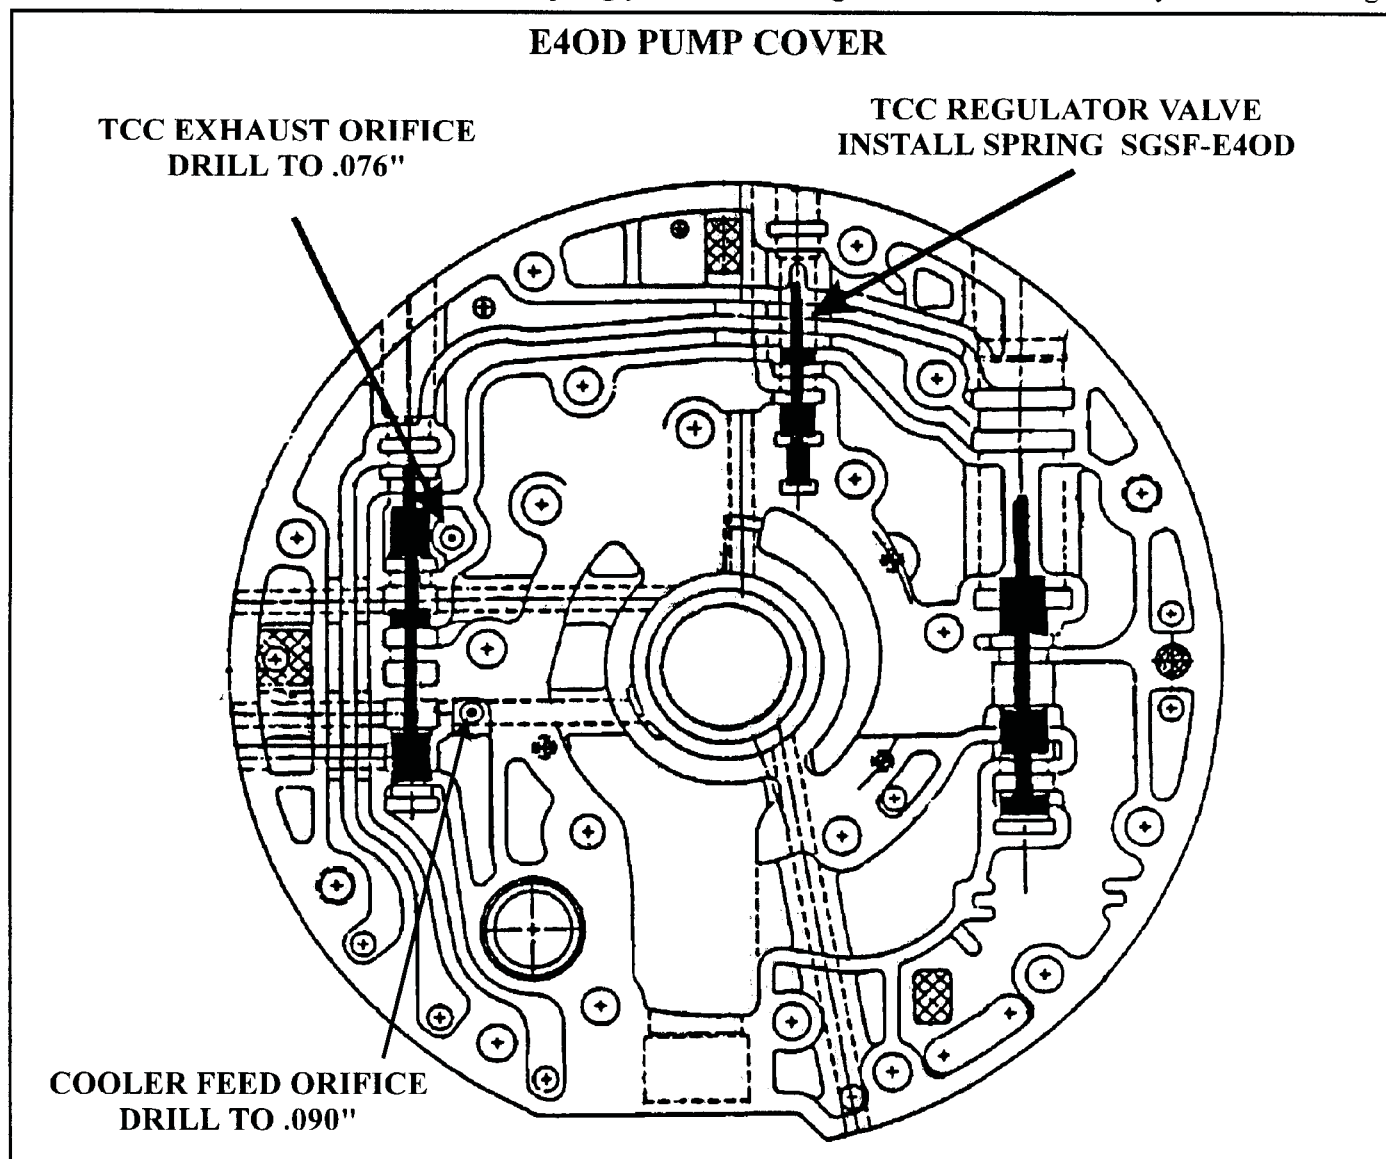
Figure 33

CAUSE: Low converter clutch apply pressure and/or converter clutch exhaust orifice too small.

CORRECTION: Replace the converter clutch regulator valve spring, located in the pump cover with a "SGSF E4OD" shudder fix spring as shown in Figure 33. Also drill the converter clutch exhaust orifice out to .076", as shown in Figure 33.

It is also recommended to drill out the cooler orifice to .090" for increased lube flow, as shown in Figure 33.

NOTE: Ford Motor Company replaced this spring with a heavier spring in 1992 and later models, so ensure the spring you are installing is **heavier** than the one you are removing.

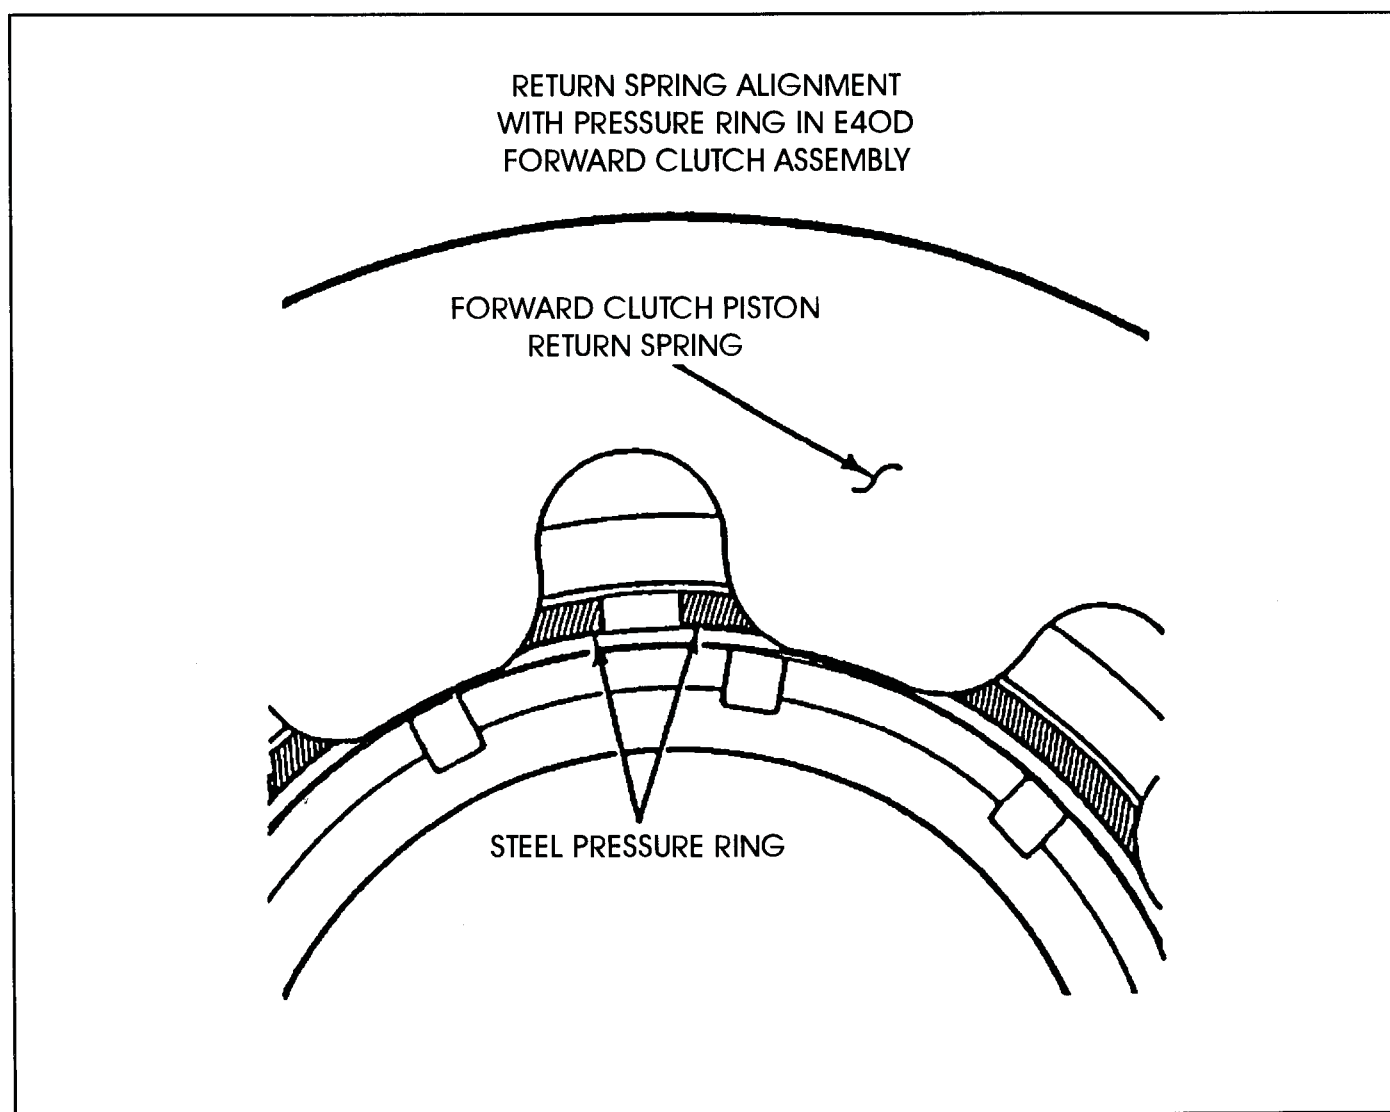
Figure 34

COMPLAINT: Forward clutch piston return spring fatigued, worn, and/or broken.

CAUSE: The cause may be, improper orientation of steel ring on top of the forward clutch piston, and the forward clutch piston return spring.

CORRECTION: Position the forward clutch piston return spring so that both ends of the steel ring are visible within the space between the two adjacent fingers of the return spring as shown in Figure 34.

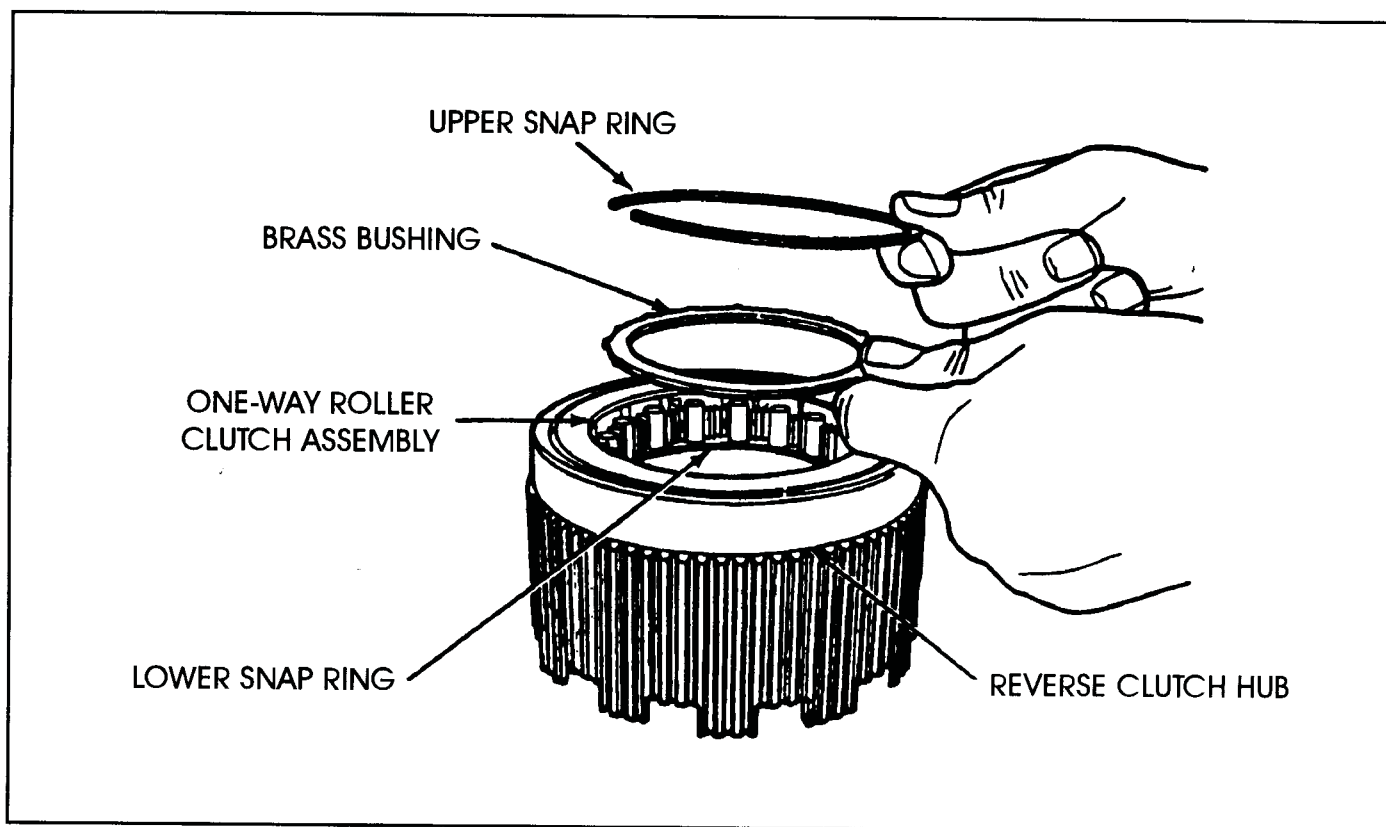
Figure 35

COMPLAINT: A no forward movement condition, until the manual shift lever is placed in the Manual Low position.

CAUSE: The cause may be, an incorrectly installed new plastic caged Low Roller Clutch Assembly, that was introduced in 1994.

CORRECTION: Use the following procedure any time the Low Roller Clutch is being replaced, using the New Plastic Caged Low Roller Clutch Assembly.

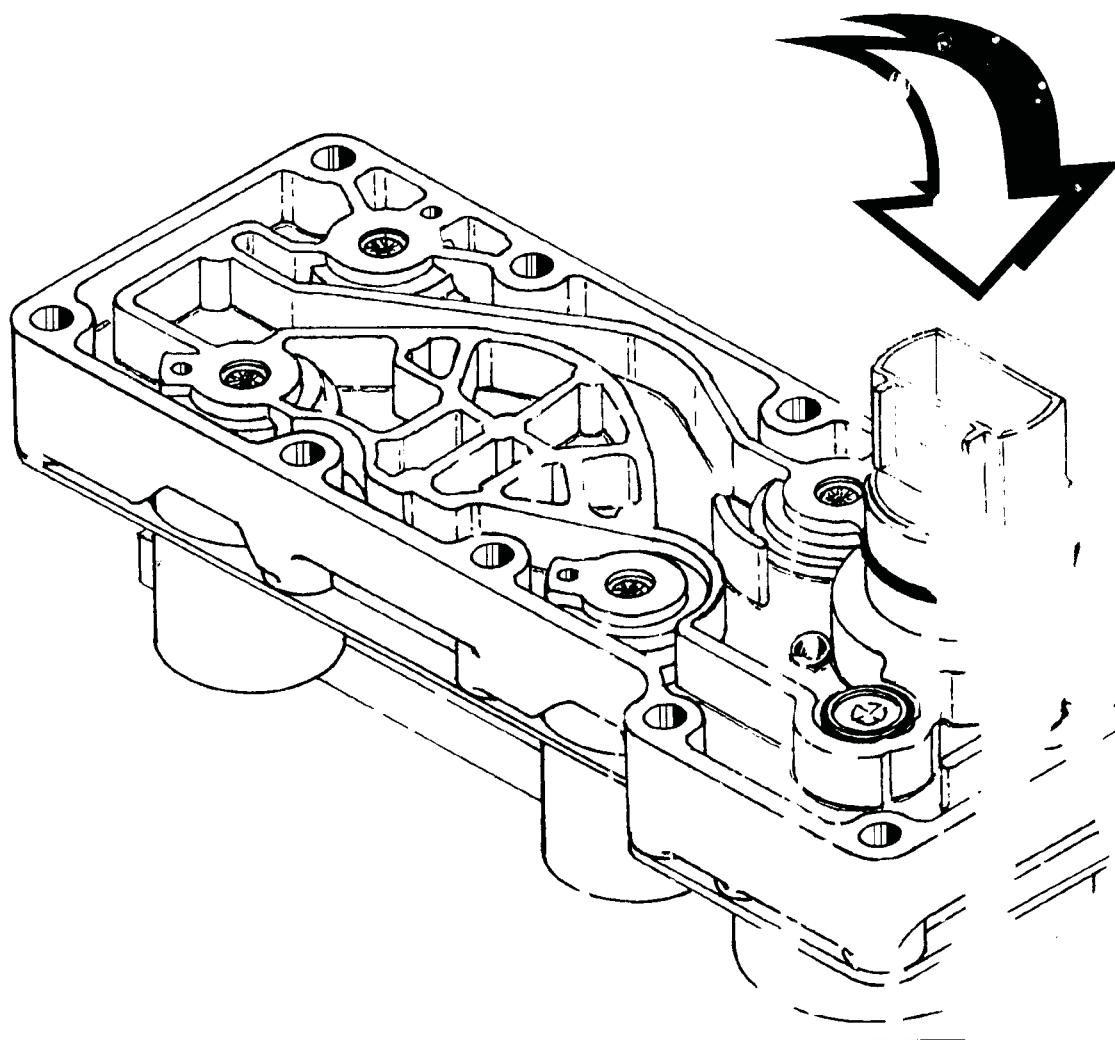
Figure 52

THERE IS NO SLEEVE ON 1995 SOLENOID PACK

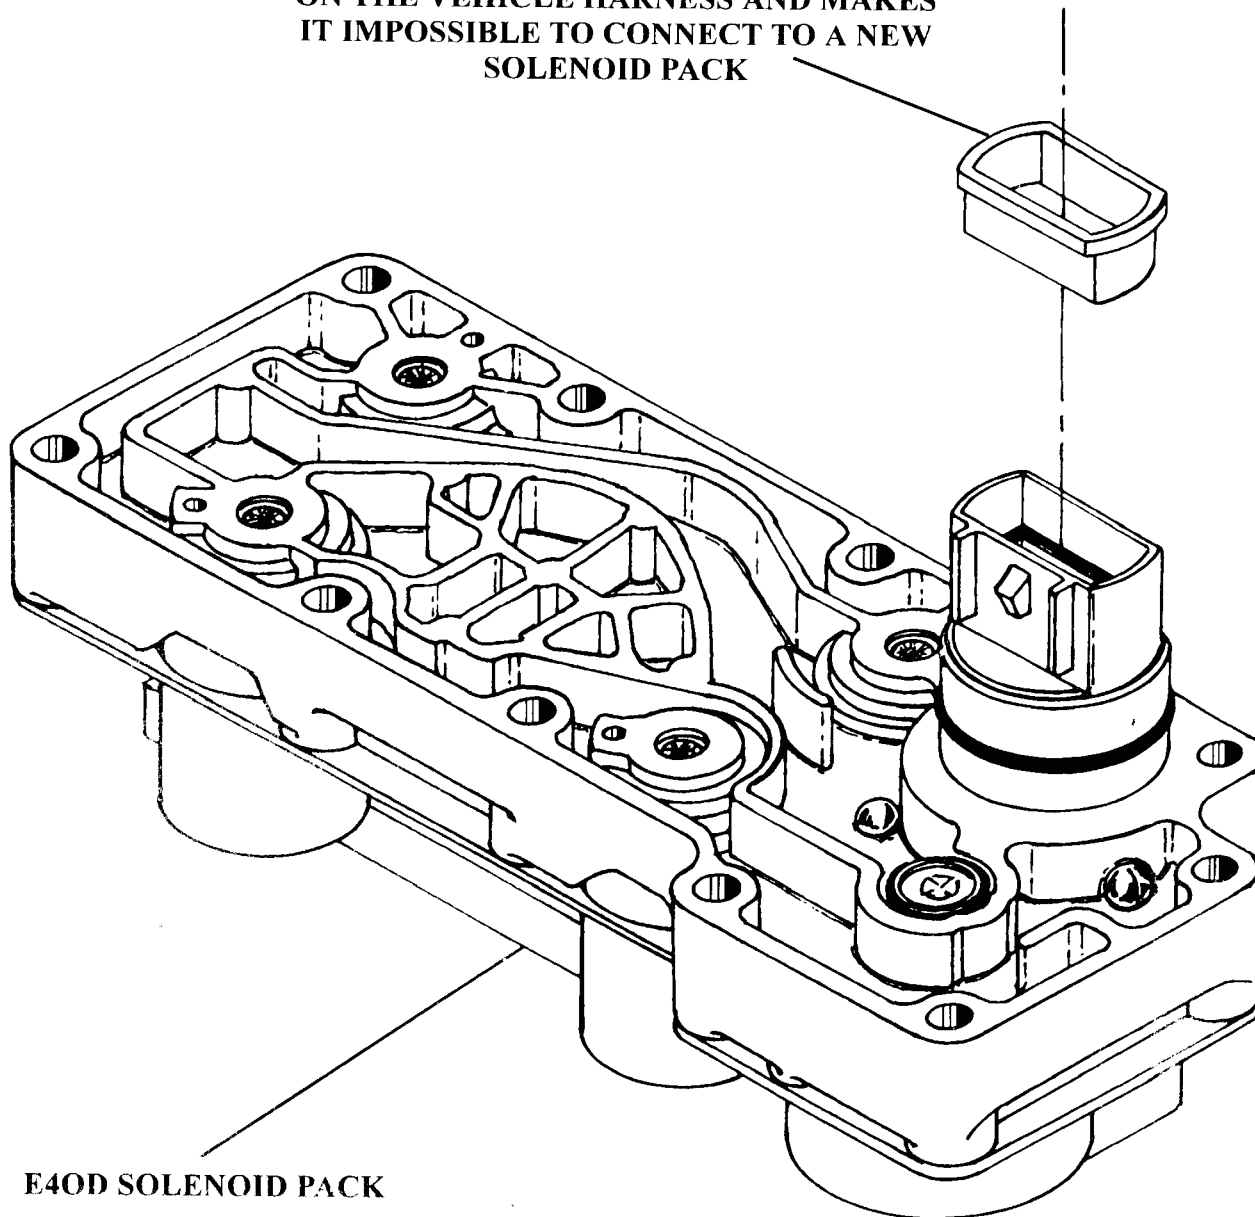
Figure 53

PLASTIC SLEEVE SOMETIMES REMAINS
ON THE VEHICLE HARNESS AND MAKES
IT IMPOSSIBLE TO CONNECT TO A NEW
SOLENOID PACK

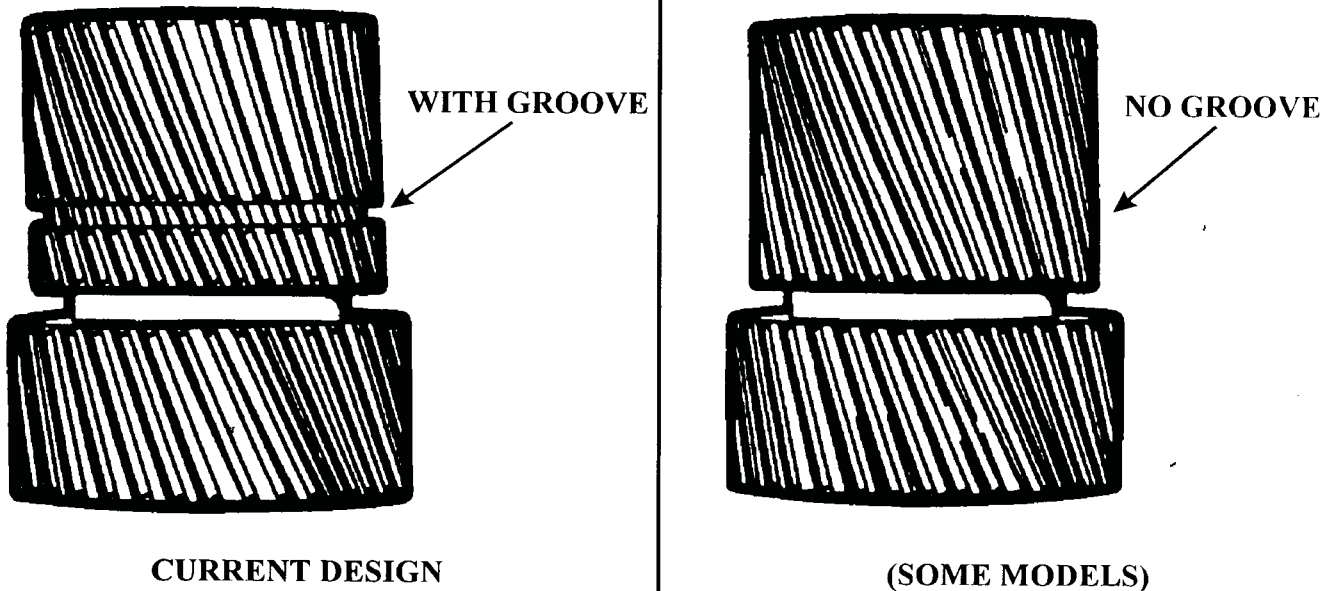
Figure 63

Some models of the E4OD transmission have been built with a Forward/Reverse Sun Gear that does not require a retaining snap ring, and has no groove for a snap ring, as shown in Figure 63. These transmissions are identified as model PRA-FA 12, serial number 00157935 thru 00158019. If internal transmission repair is required for these units, replace the Forward/Reverse Sun Gear with the current service sun gear with the snap ring groove, and the snap ring (See Figure 63).

***DO NOT REUSE THE FORWARD/REVERSE SUN GEAR
IF THE SUN GEAR HAS NO SNAP RING GROOVE.***
