**AUTOMATIC TRANSMISSION SERVICE GROUP**

## INTRODUCTION

Since the introduction of the THM 440-T4 Transaxle in April, 1984, there have been many major engineering design changes. These changes have affected nearly every part used in the THM 440-T4. This Update Handbook will explain each change, the parts affected by the change, and any parts interchangeability problems created by the change.

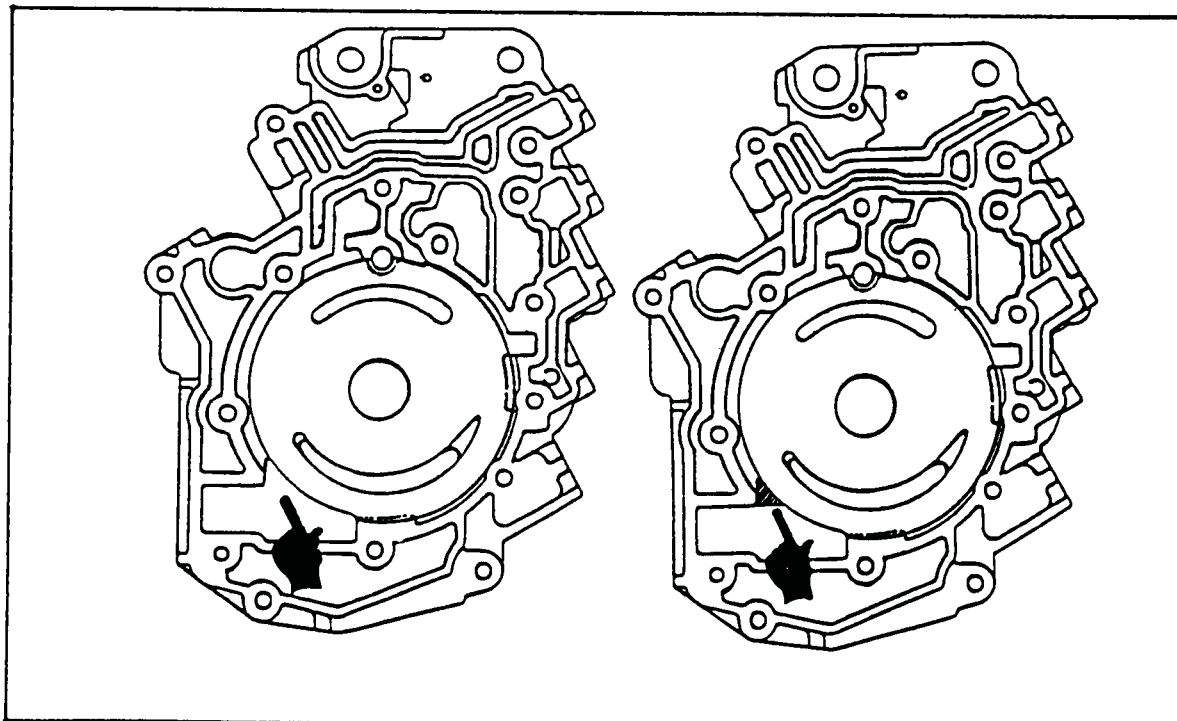
Figure 7

Some 1987 440-T4 transaxles built between November 26, 1986 (Julian Date 330) and January 12, 1987 (Julian Date 012), may exhibit a slip or no drive condition as a result of low line pressure.

This condition may be caused by the pump slide binding on excessive casting flash when the slide is in the low pressure position.

If pressures do not vary with vacuum signal changes, inspect for pump slide bind by removing the oil pump cover and slide springs. If present, excessive flash will cause the slide to bind when the cover is on and torqued.

If flash is present you will have to replace the oil pump assembly, or use a Dremel Tool with a carbide bit and remove flash from 87 model to match contour of 86 model (See Figure 7).

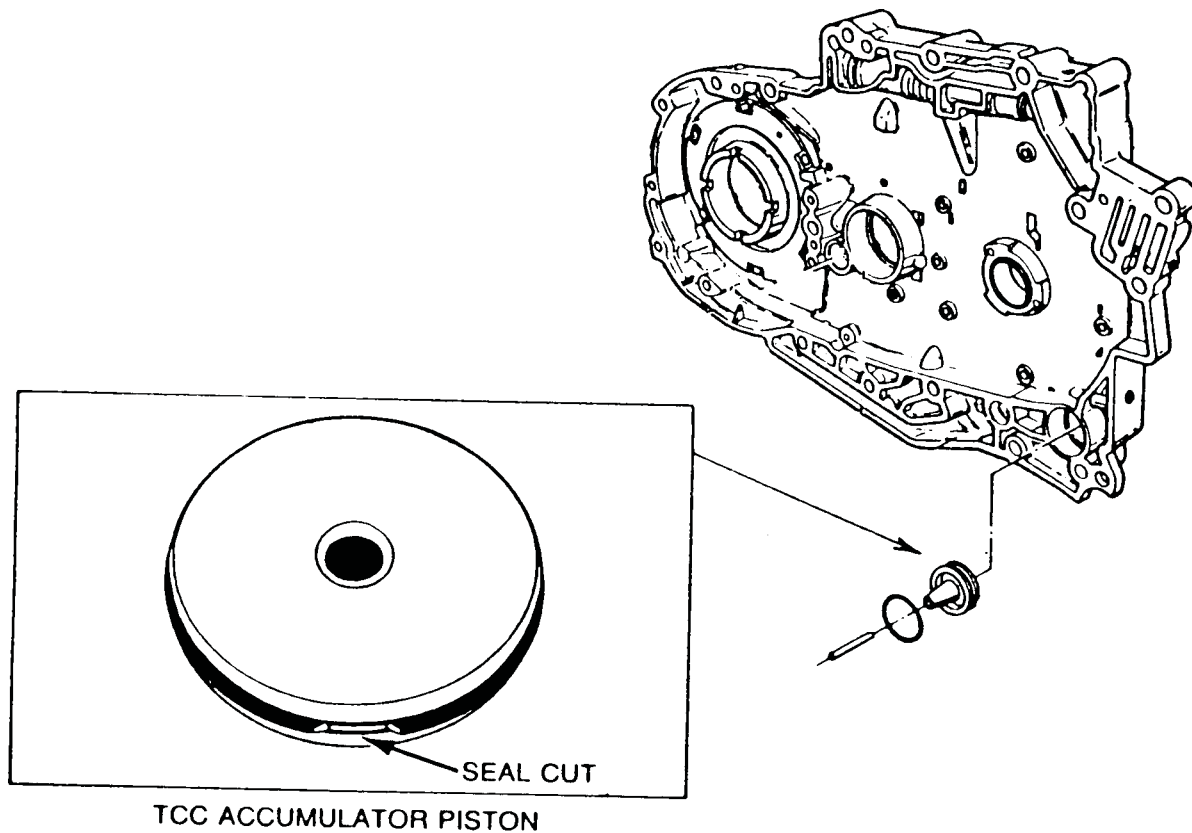
Figure 24

CAUSE: Some 1984 and some early 1985 THM 440-T4 transaxles may experience a no Torque Converter Clutch (TCC) apply or TCC shudder condition, which may be due to a cut or rolled TCC accumulator piston seal (See Figure 24).

CORRECTION: Install updated service package 8646926.  
Updated service package 8646926 contains the following:

1. 1-TCC ACCUMULATOR PISTON
2. 1-TCC ACCUMULATOR PISTON PIN
3. 1-TCC ACCUMULATOR PISTON SEAL

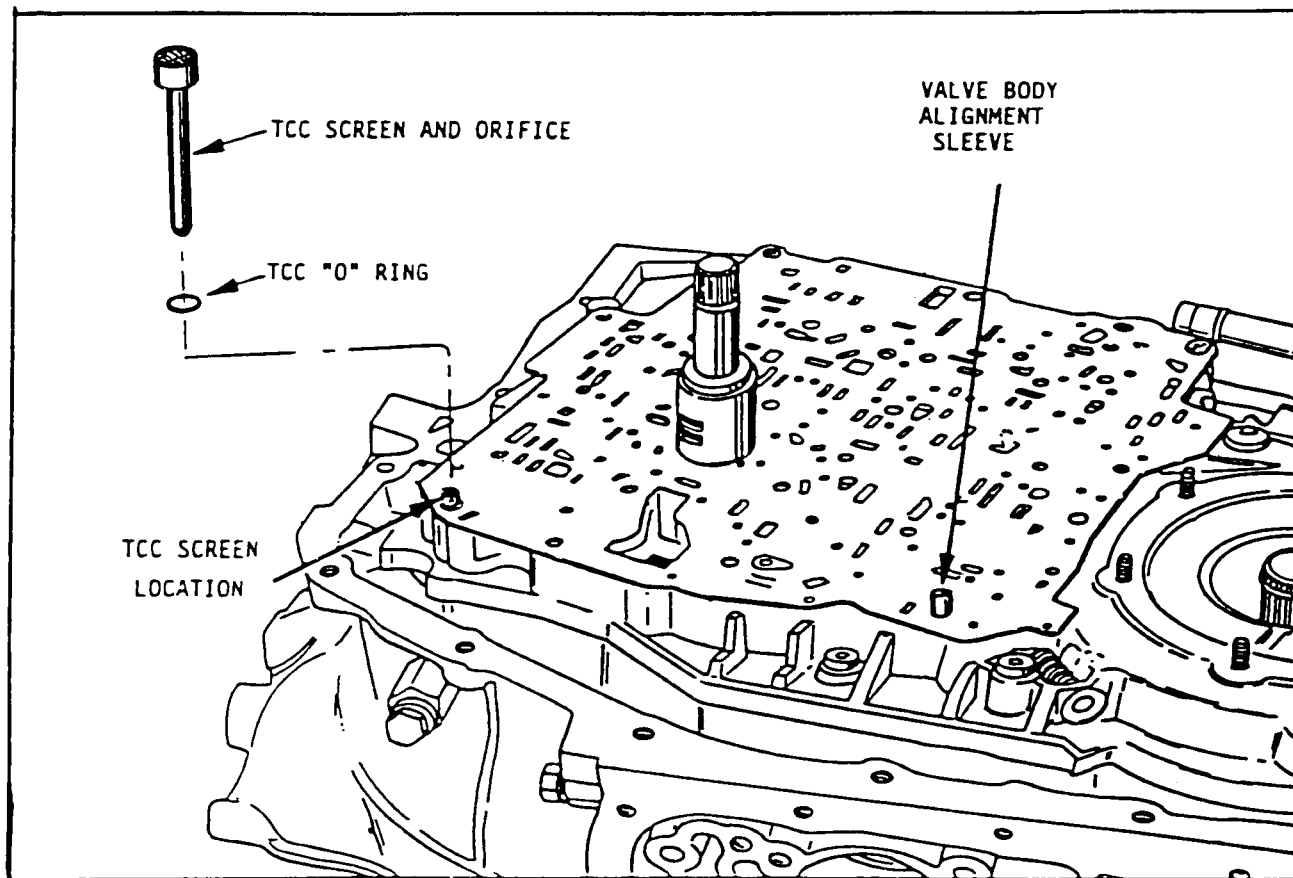
Figure 62

- COMPLAINT:** Premature lock-up - Sometimes described as no lock-up.
- CAUSE:** The cause may be a missing TCC screen and orifice (See Figure 62). If the TCC screen and orifice are left out of the 440-T4, the converter clutch will apply on the 1-2 shift because of the solenoids inability to exhaust TCC signal oil there by stroking the lock-up valve. The TCC screen and orifice must be in place, as well as the "O" ring (See Figure 62). The TCC screen "Snaps" into the spacer plate.
- CORRECTION:** Install the TCC screen and "O" ring into spacer plate in location shown in Figure 62. First install "O" ring on TCC screen and then "Snap" into place in the spacer plate. OEM part numbers as follows;
- TCC Screen and Orifice ..... 8658060  
"O" Ring, TCC Screen ..... 8658109

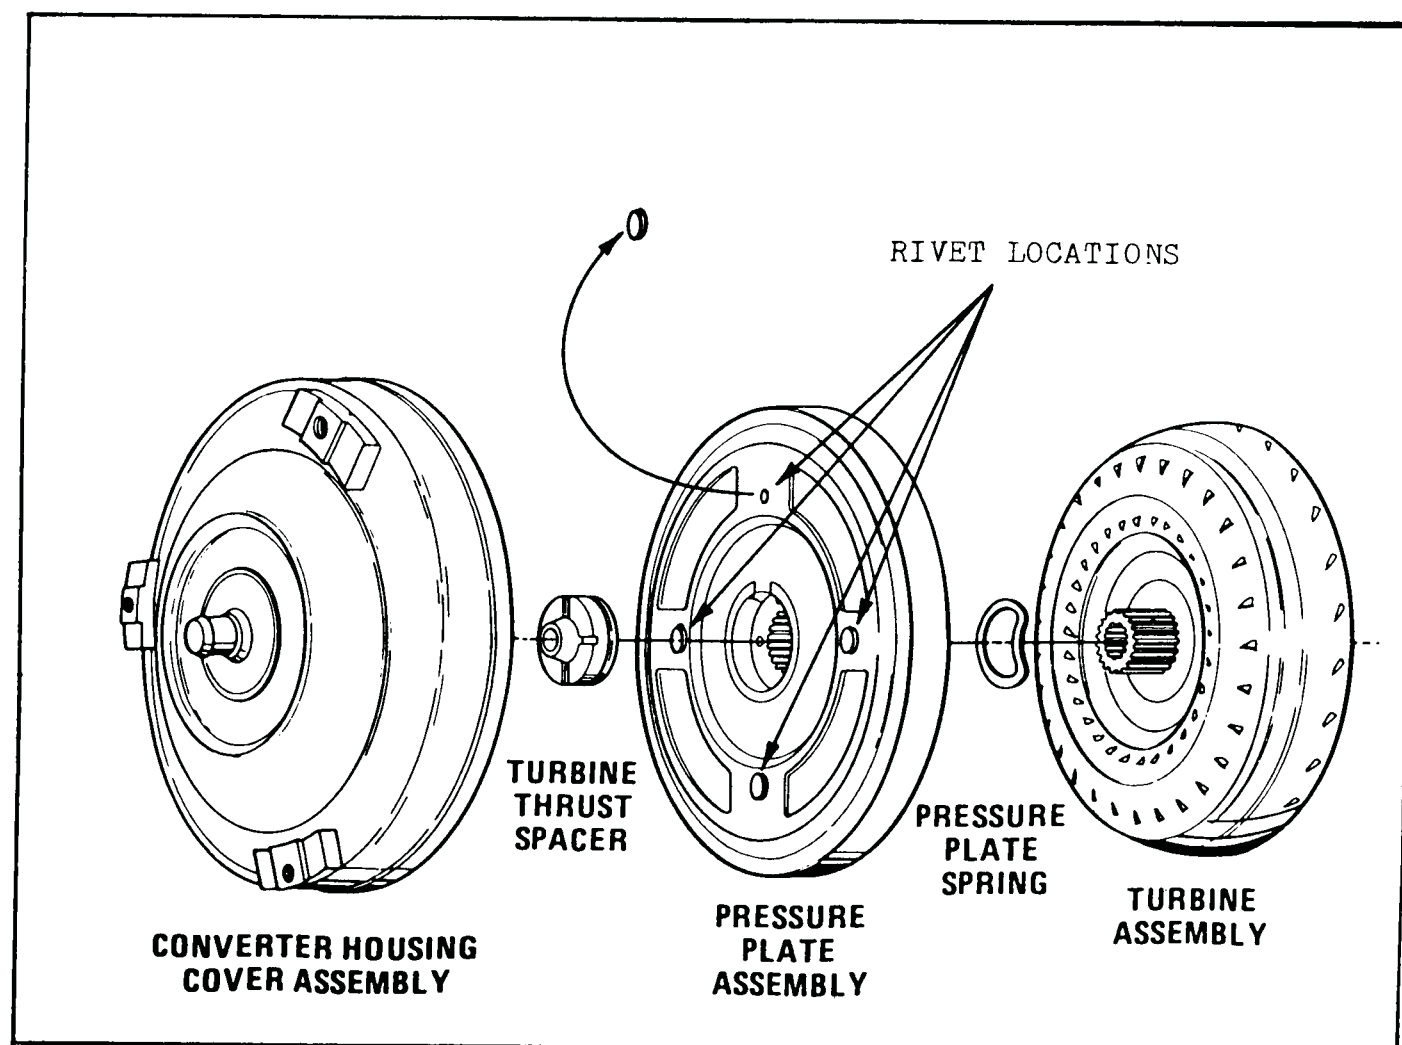
Figure 67

Some models of the THM 440-T4, usually with the 3.8L engine, may exhibit a TCC shudder condition or no torque converter clutch, because of a rivet head popping off that retains the damper assembly to the pressure plate (See Figure 67).

Great care must be exercised in the diagnosis procedure before making any modifications to cure TCC shudder. The check ball behind the TCC regulator valve will not fix a vehicle with this condition.

A torque converter checking fixture should be used on all 3.8L converters to verify converter clutch operation before installation.

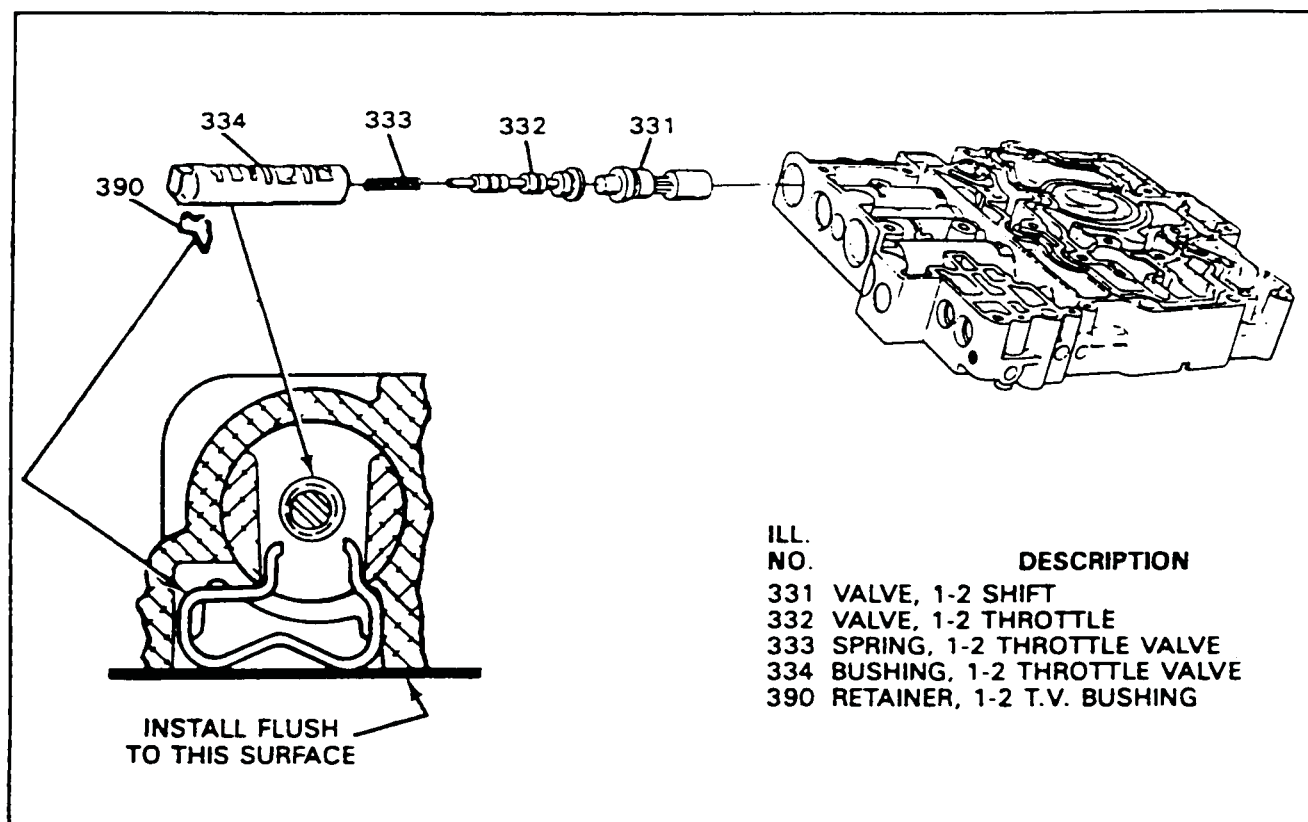
Figure 69

CAUSE: The cause may be the 1-2 throttle valve bushing retainer (390) pushed in too far (See Figure 69). If the retainer is pushed in too far the "Legs" of the retainer will grab hold of the 1-2 throttle valve, and the result will be 2nd gear starts.

CORRECTION: Install the retainer so that it is flush with the machined surface of the valve body (See Figure 69).

NOTE: The bushing must be installed as shown in Figure 69, with the angled surface on the end of the bushing toward the channel plate.

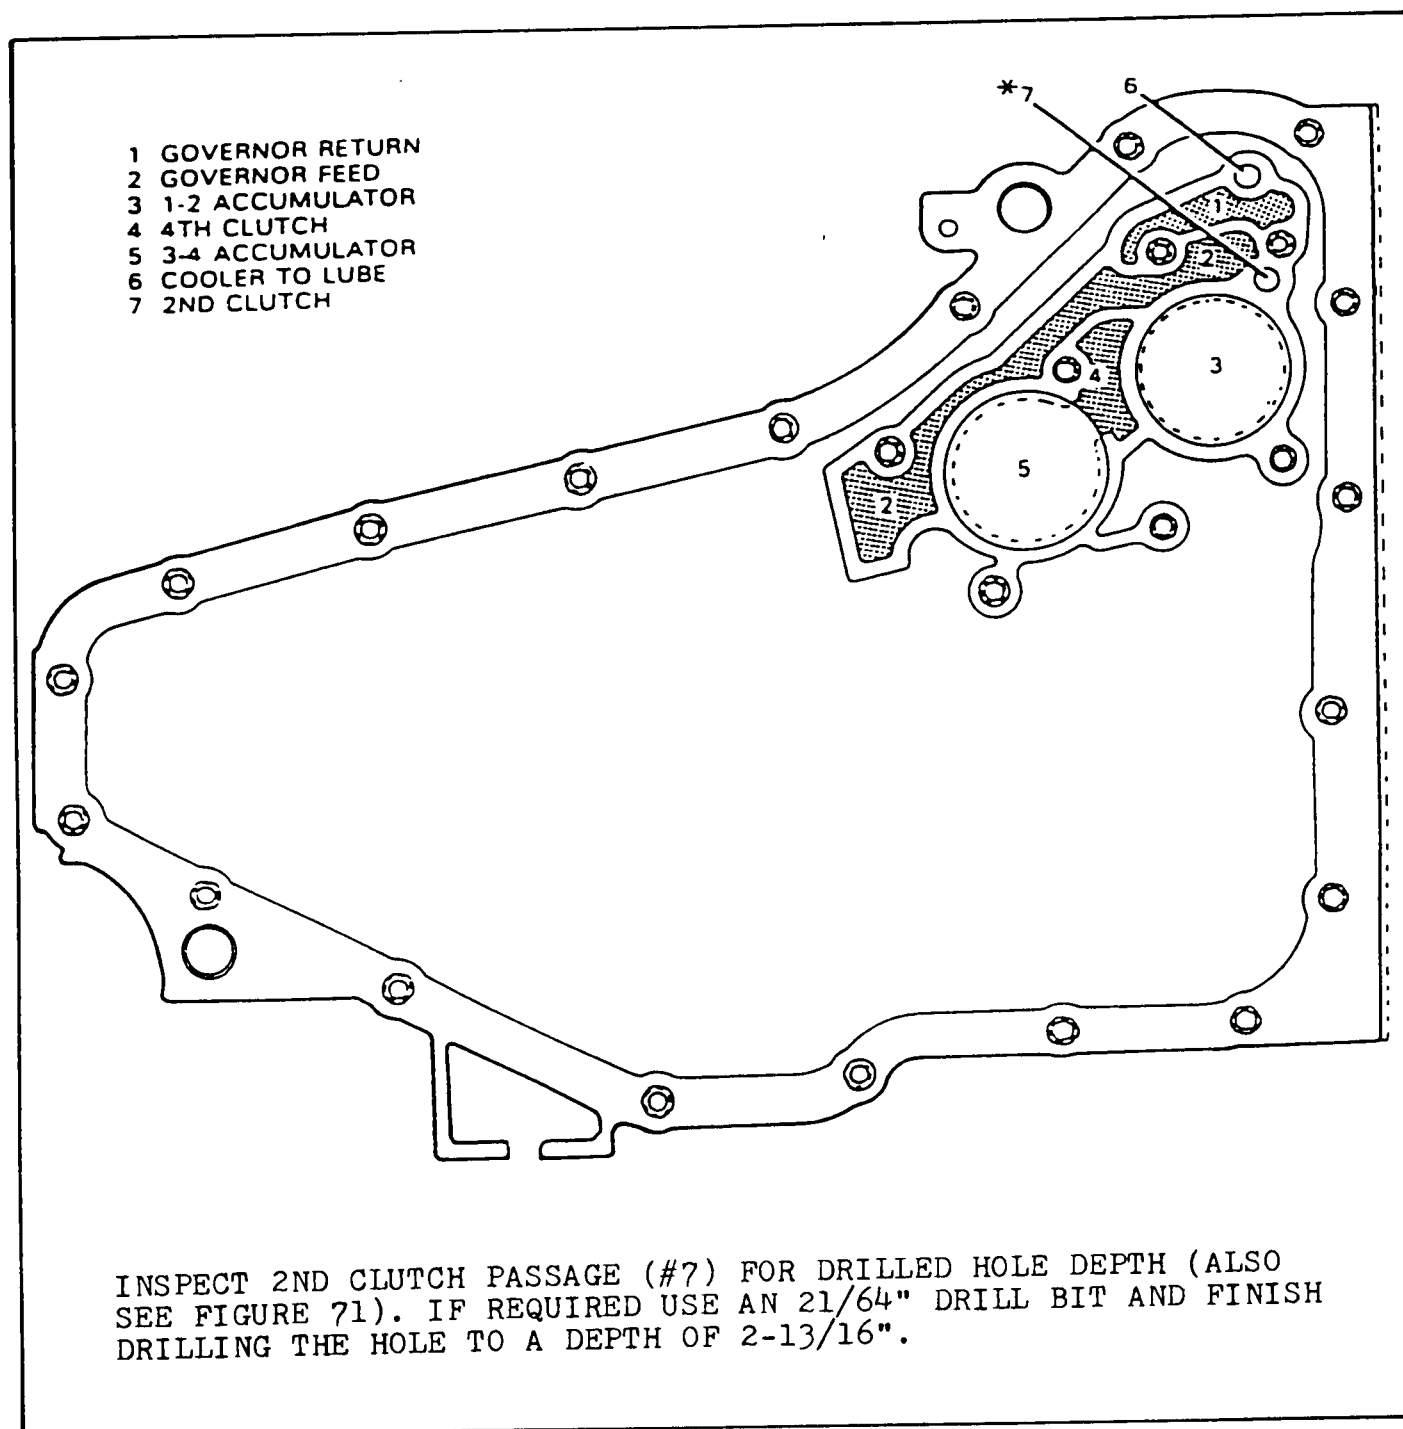
Figure 70

- COMPLAINT: Consistently harsh 1-2 shift condition at any throttle angle and any altitude.
- CAUSE: This harsh shift condition may be caused by a blocked, or partially drilled 2nd clutch feed passage in the case.
- CORRECTION: To repair this condition inspect the 2nd feed passage, #7 in Figure 70, for blockage or incomplete drilling operation. To perform this inspection, remove the trans-axle oil pan, filter, accumulator cover (With feed pipes and retainer), accumulator cover spacer plate and gaskets. Inspect the 2nd clutch passage by measuring the depth of the hole, which should be a minimum of 2-13/16" as shown in Figures 70 and 71.

NOTE: DRILLING TOO DEEP INTO THE 2ND CLUTCH PASSAGE WILL RESULT IN DAMAGE TO THE CASE.

3. Remove metal chips caused by drilling and thoroughly flush the repaired case passages with clean solvent.
4. Reassemble the transaxle.

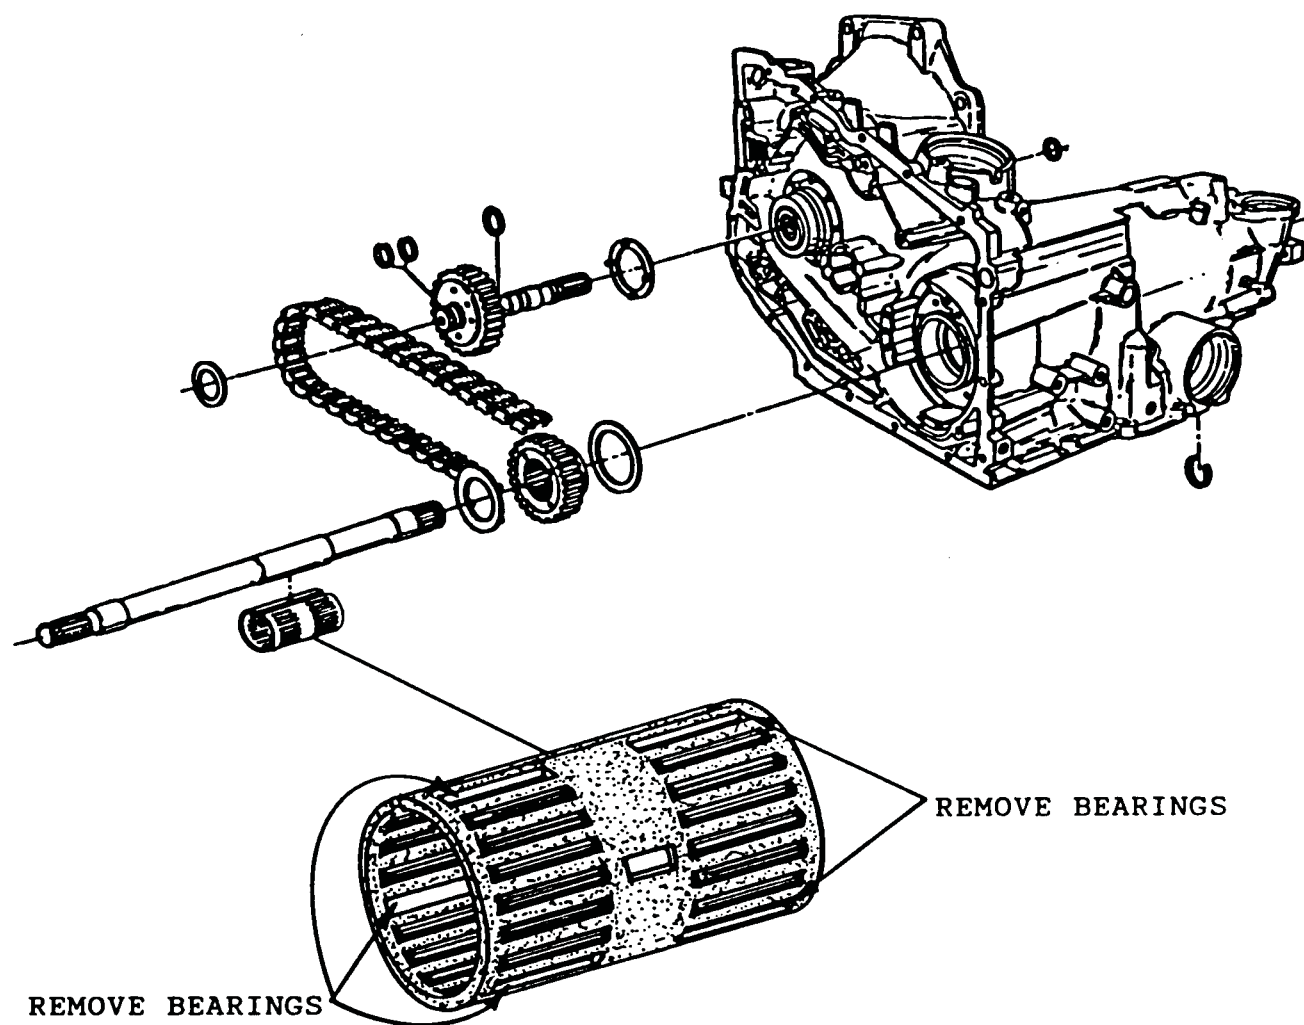
Figure 93

- COMPLAINT: Repeated failure of the 3rd Roller Clutch and/or the Input Sprag Assembly.
- CAUSE: Lack of lube oil to 3rd Roller Clutch and Input Sprag.
- CORRECTION: Modification as follows, of the parts indicated, will increase lube flow to both the 3rd Roller Clutch and the Input Sprag.

REMOVE INDIVIDUAL NEEDLE BEARINGS IN THREE EQUALLY SPACED LOCATIONS AROUND THE BEARING TO PROVIDE THREE "TROUGH" FOR ADDITIONAL LUBE OIL TO FLOW.

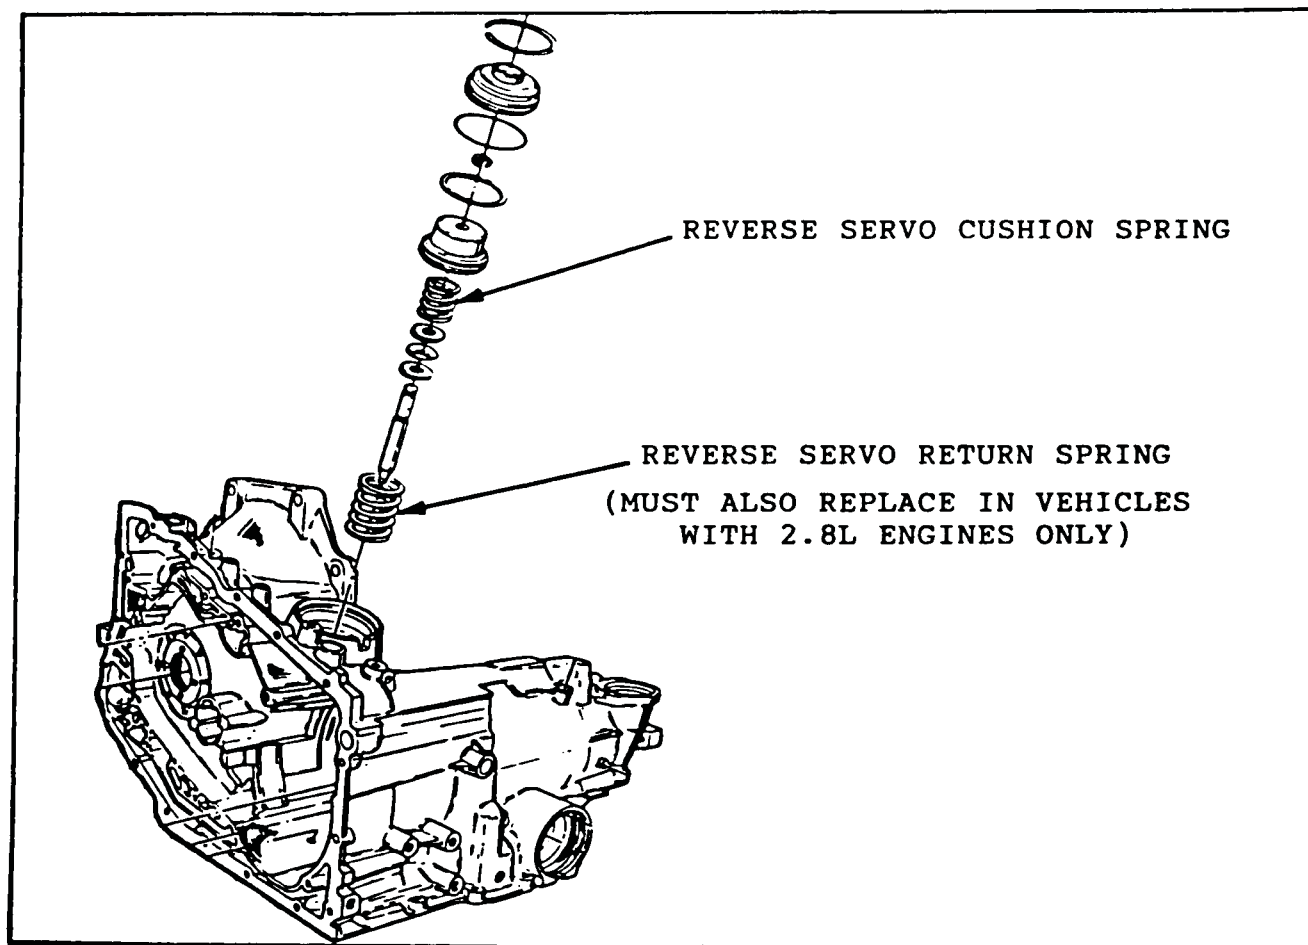
Figure 97

**CAUSE:** The cause may be:

1. Low vacuum supply to the vacuum modulator.
2. Stuck modulator valve in case.
3. No. 9 checkball missing or off location.

**CORRECTION:** AFTER ALL OF THE ABOVE ARE ELIMINATED:  
There is now available a new Reverse Servo Cushion Spring, and a new Reverse Servo Return Spring. Replacing these springs should correct the harsh reverse condition. The reverse servo return spring should only be replaced on the 2.8L engines.

Spring, Reverse Servo Cushion (All).....8668121  
Spring, Reverse Servo Return (2.8L Only)...8668127

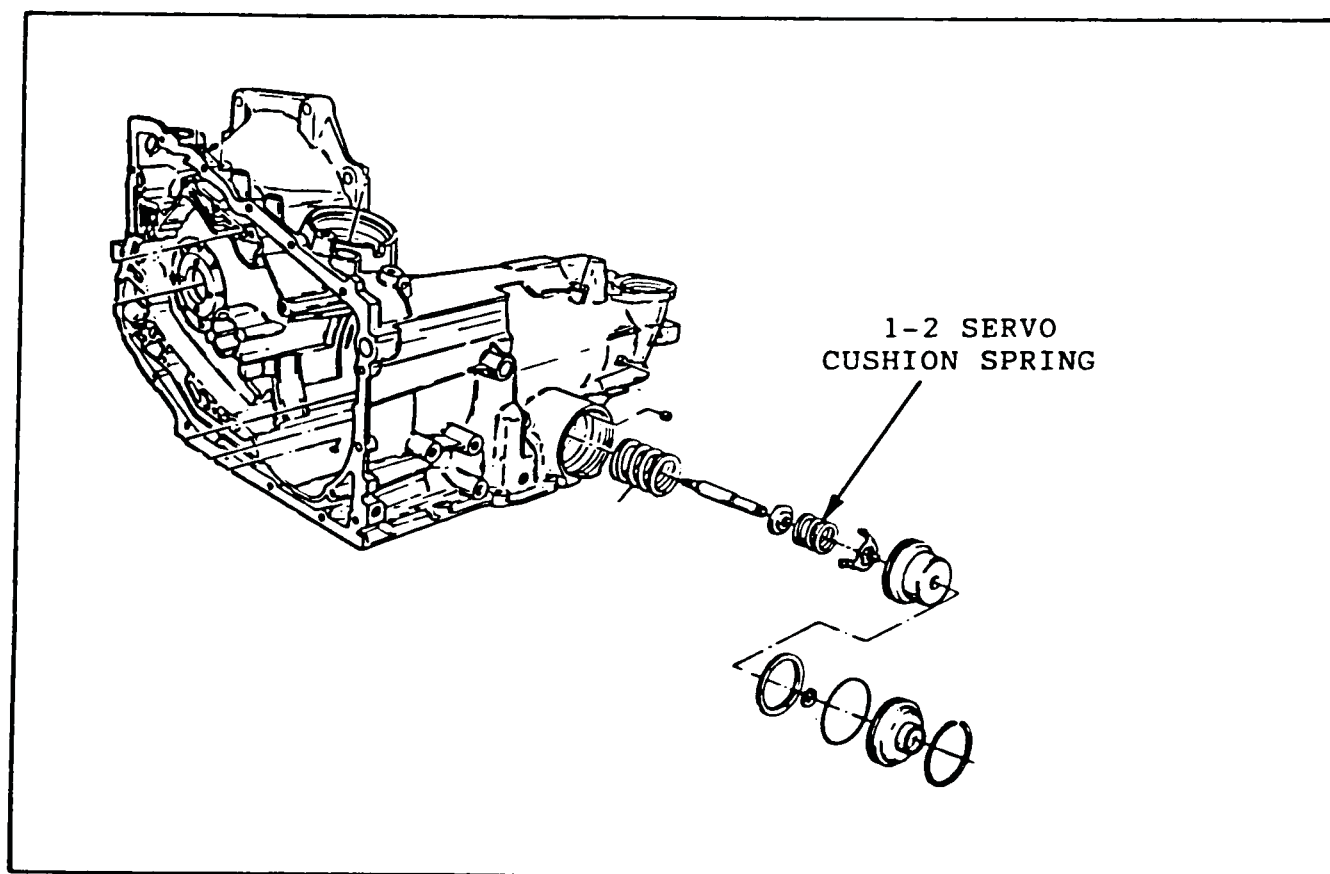
Figure 98

**CAUSE:** The cause may be:

1. Low vacuum supply to vacuum modulator.
2. Stuck modulator valve in case.
3. No. 12 checkball missing or off location.

**CORRECTION:** AFTER ALL OF THE ABOVE ARE ELIMINATED:  
There is now available a new 1-2 Servo Cushion Spring.  
Replacing this spring should correct the harsh drive condition (See Figure 1).

Spring, 1-2 Servo Cushion (A11).....8668123
