AUTOMATIC TRANSMISSION SERVICE GROUP

"VOLUME II"

INTRODUCTION

THM 440-T4 (4T60)

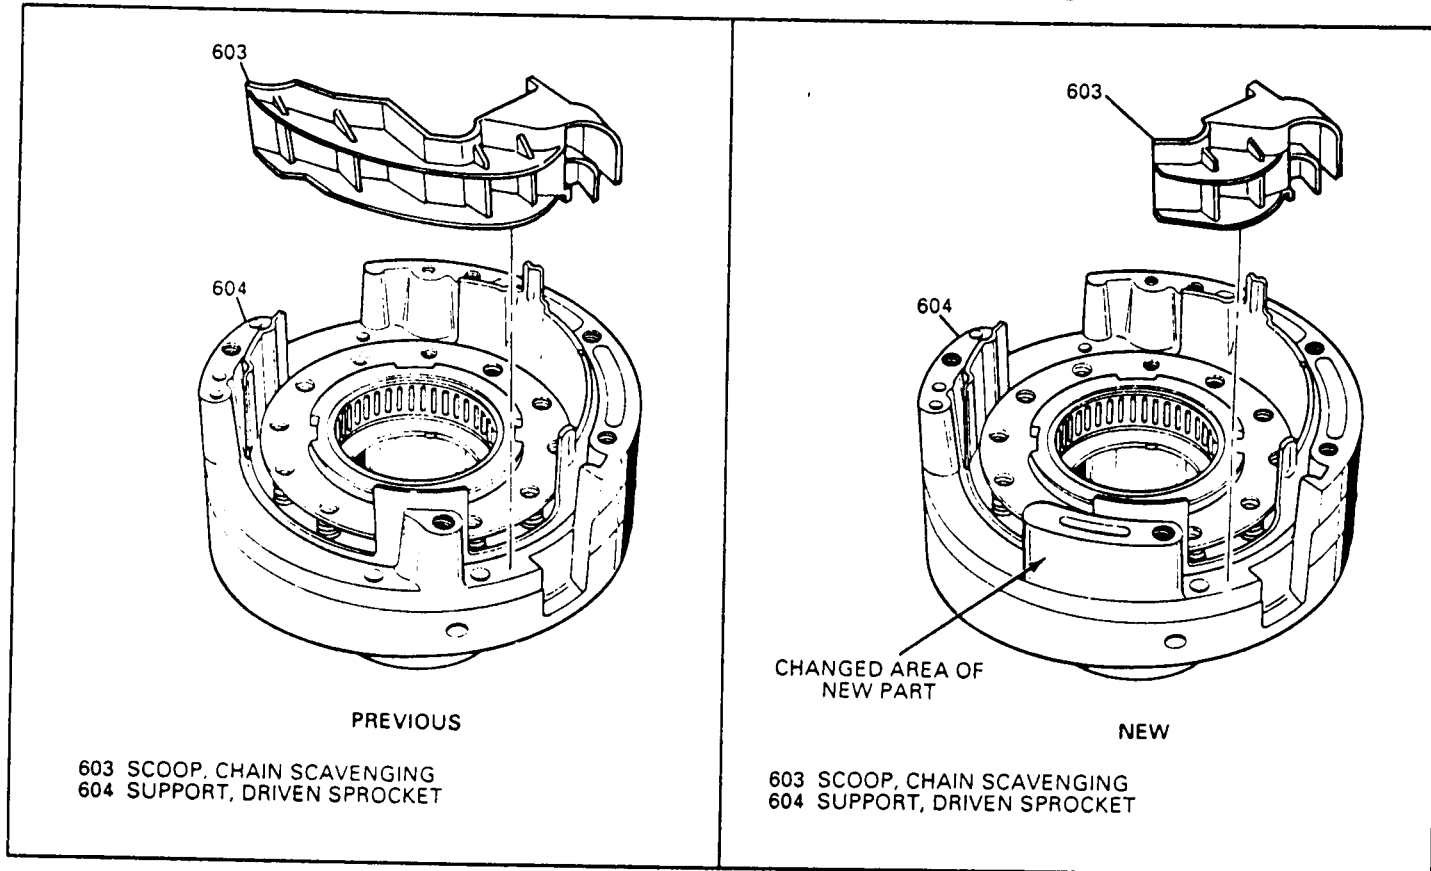
Figure 1

CHANGE: A new Driven Sprocket Support and Chain Scoop is now used in production on all 1990 vehicles equipped with a THM 440-T4 (4T60) transaxle. (See Figure 1).

- (1) **DRIVEN SPROCKET SUPPORT** - The new design sprocket support has an increased width of one leg on the support (See Figure 1). The wider leg on the new support will accomodate a new lube feed passage for the new THM F-31 (4T60-E) transaxle. Lube feed for the THM F-31 (4T60-E) will be thru the channel plate, instead of the pipe from the accumulator cover as on the THM 440-T4 (4T60) (See Figure 2).
- (2) **CHAIN SCOOP** - The new sprocket support requires the chain scoop, both black and white, to be about 1/3 the length of the previous chain scoop. (See Figure 1).

The new driven sprocket support will service all past models, but the new length (Short) chain scoop must be used with it. The previous (Long) chain scoop will not fit, but can be cut to fit the new support. Lay the previous chain scoop on the actual size drawing in Figure 3 and cut straight down, as indicated, with a hack saw. Smooth off the rough cut edge with sandpaper. The new length (Short) chain scoop must be used ONLY with the new design driven sprocket support.

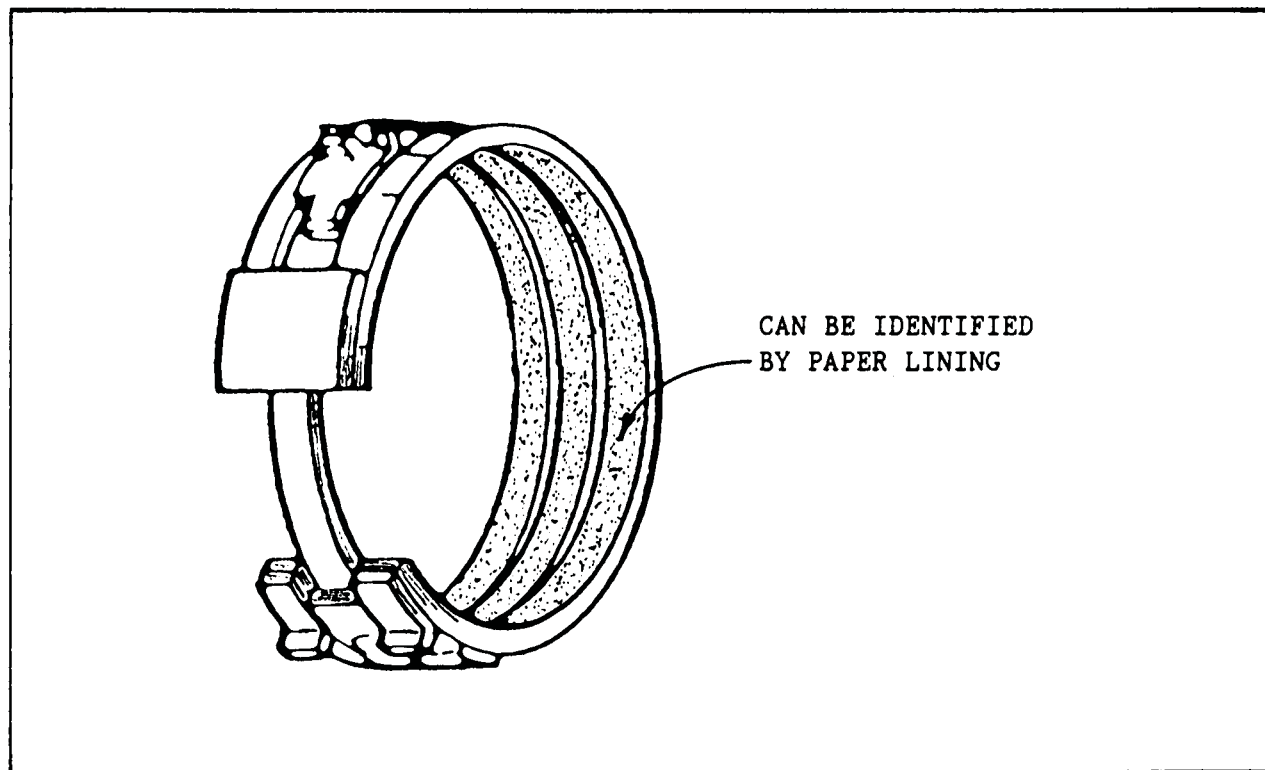
Figure 4

REASON: To help eliminate a harsh reverse apply condition.

- (1) REVERSE BAND ASSEMBLY - The lining on the reverse band has once again been changed, and can be identified by the "Paper" lining on the band itself (See Figure 4).

It will retro-fit back to all previous models and is highly recommended, to help eliminate a harsh reverse apply condition.

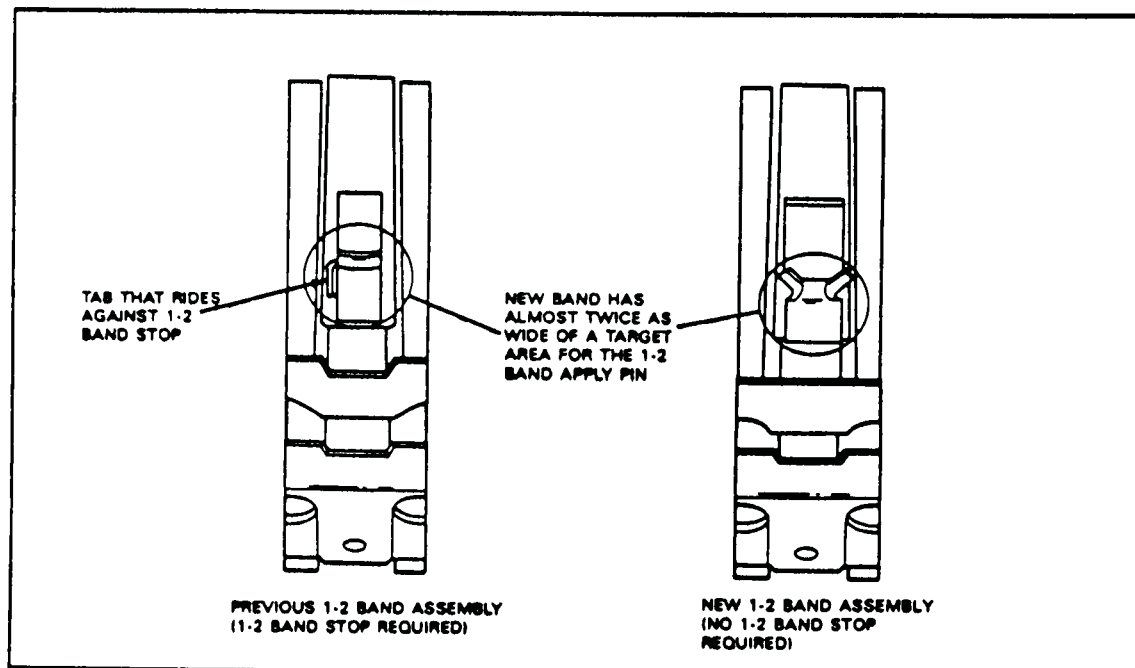
Figure 5

REASON: To eliminate the possibility of a intermittent "No Drive" condition.

- (1) 1-2 BAND ASSEMBLY - The target area on the new 1-2 band, where the band apply pin engages, has been made wider and has "Wings" added to prevent the pin from ever missing the "Target" area (See Figure 5).
- (2) 1-2 BAND STOP ASSEMBLY - The 1-2 Band Stop has been eliminated as it is no longer needed (See Figure 6).

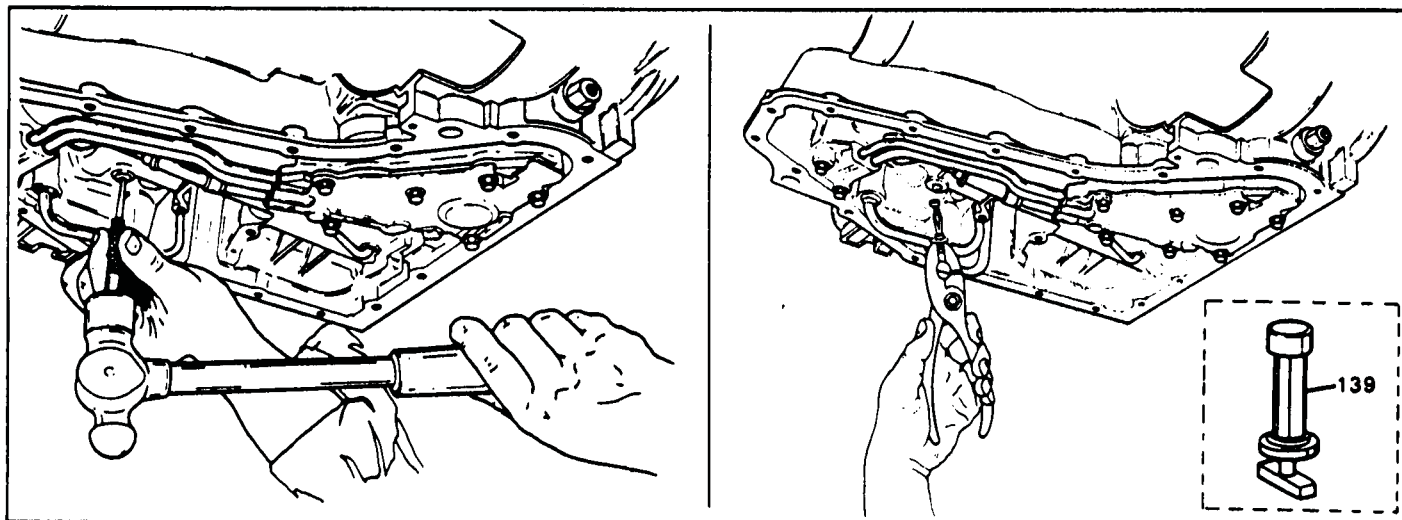
Figure 6

If the new 1-2 Band Assembly is used in a case with a 1-2 Band Stop, interference may result and band durability may be affected.

The new style 1-2 Band Assembly can be used to service ALL past models, but the 1-2 Band Stop MUST be removed and discarded (See Figure 6).

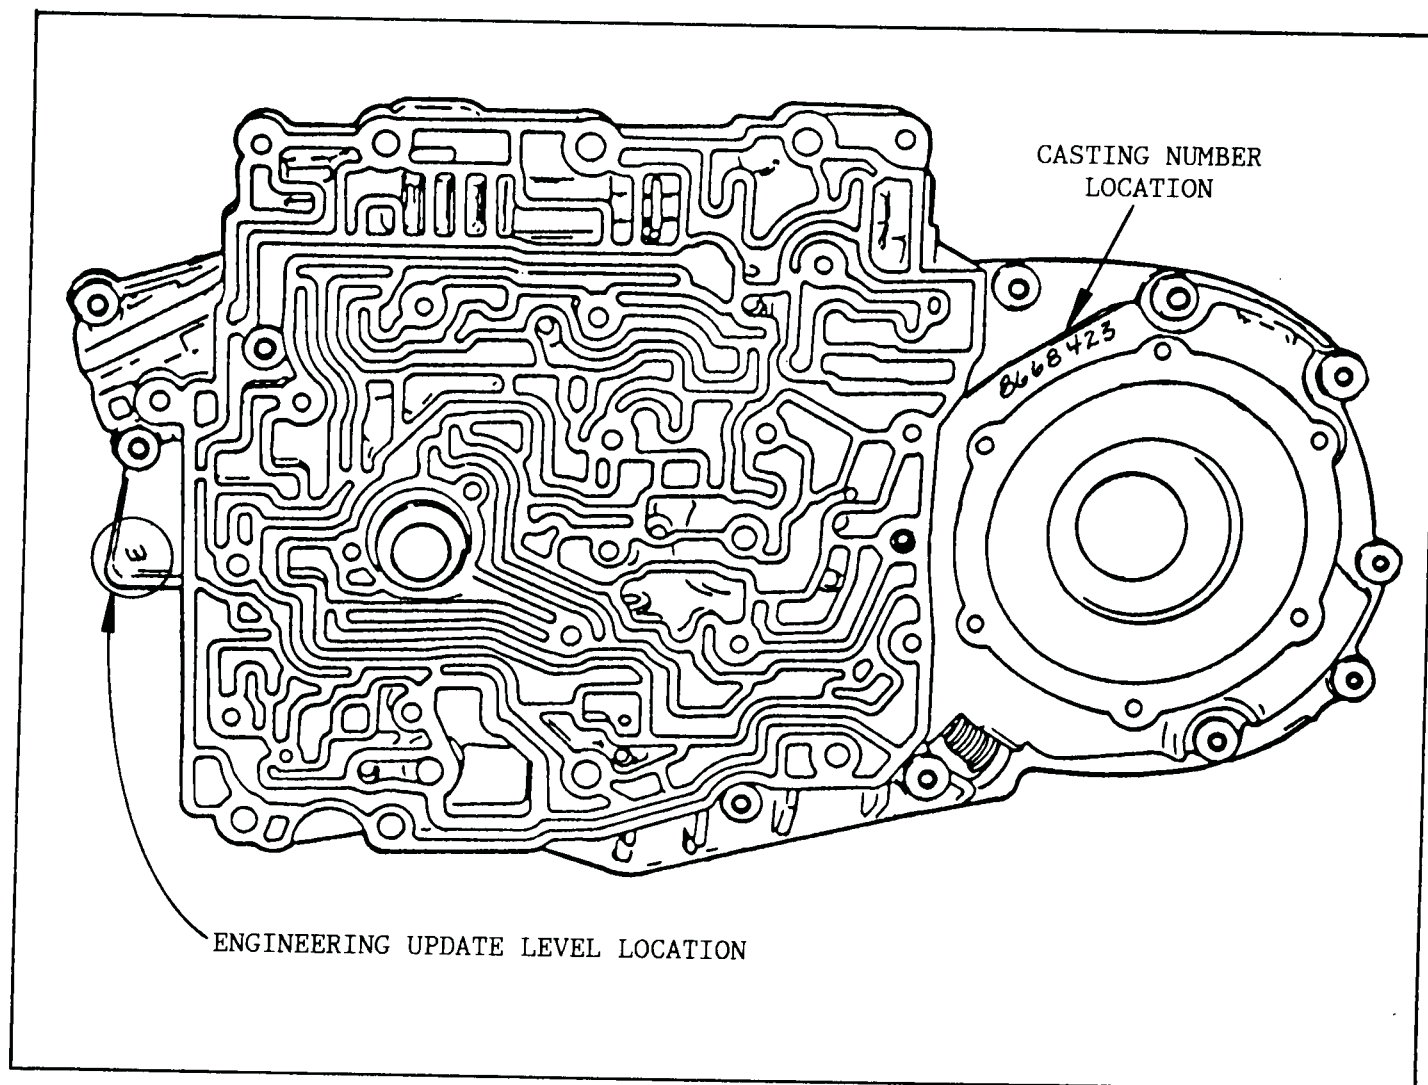
COMPLAINT: ON 1989 AND 1990 MODELS ONLY, the fourth clutch lined and steel plates burnt to the point that it has melted the channel plate in the fourth clutch area.

CAUSE: The cause may be the manual valve being positioned between the neutral and D4 position, which would allow the input clutch to be applied in 4th gear.

This was created by a change in the channel plate porting, in the manual valve area. The questionable channel plate can be identified by the casting number "8668423", with engineering update level "E". Refer to Figure 15 for locations. Casting number "8668423" with engineering update levels "A", "B", "C", and "D" are OK to use.

DO NOT USE CASTING NO. "8668423" WITH ENGINEERING UPDATE LEVEL OF "E" OR HIGHER - REFER TO FIGURE 15 FOR LOCATIONS.

CORRECTION: Install an earlier model channel plate that does not have the questionable casting number 8668423.

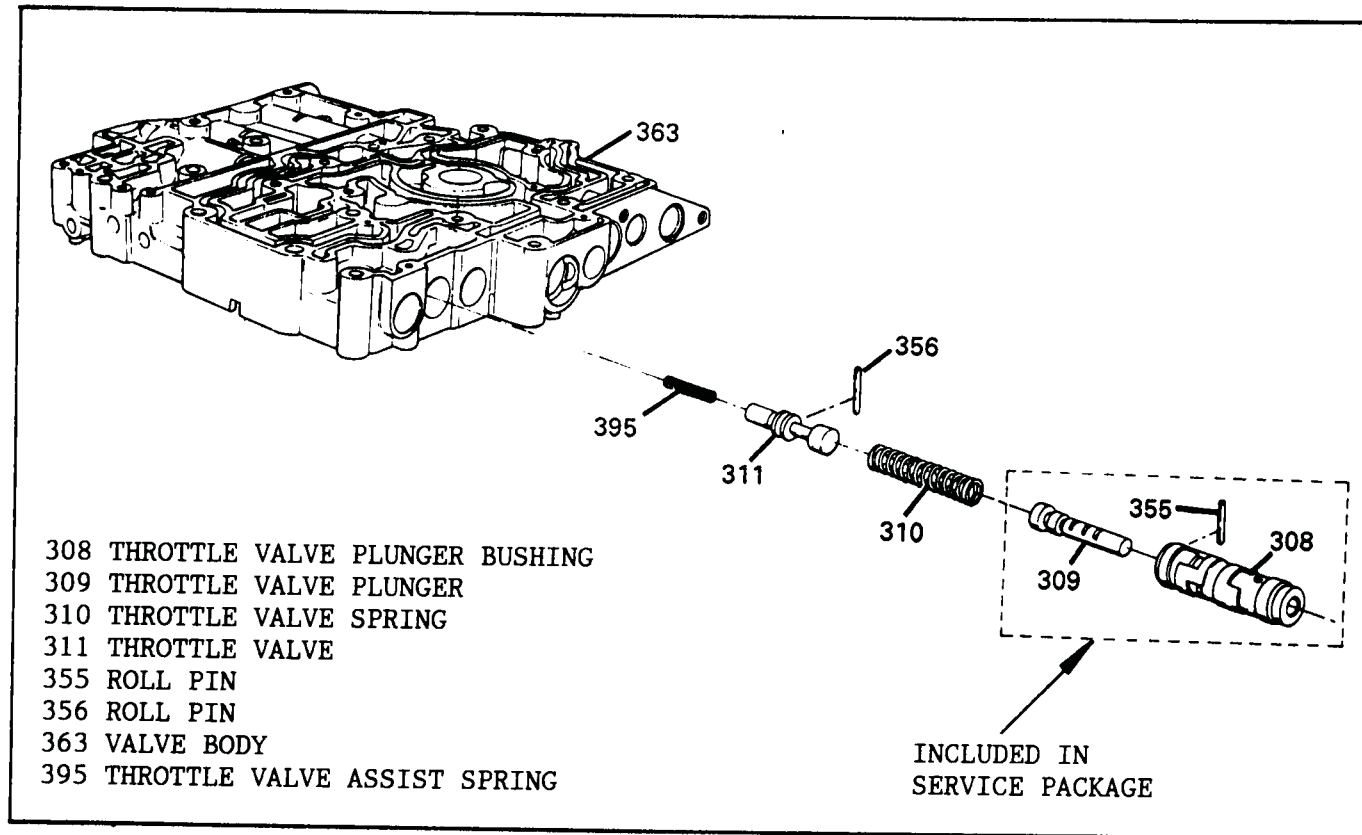
Figure 35

The T.V. Plunger and Bushing Assembly are now available from OEM in a service package, so that buying a valve body is no longer necessary when the TV plunger is broken or cracked (See Figure 35). Refer to the following OEM part numbers as it IS a model sensitive part.

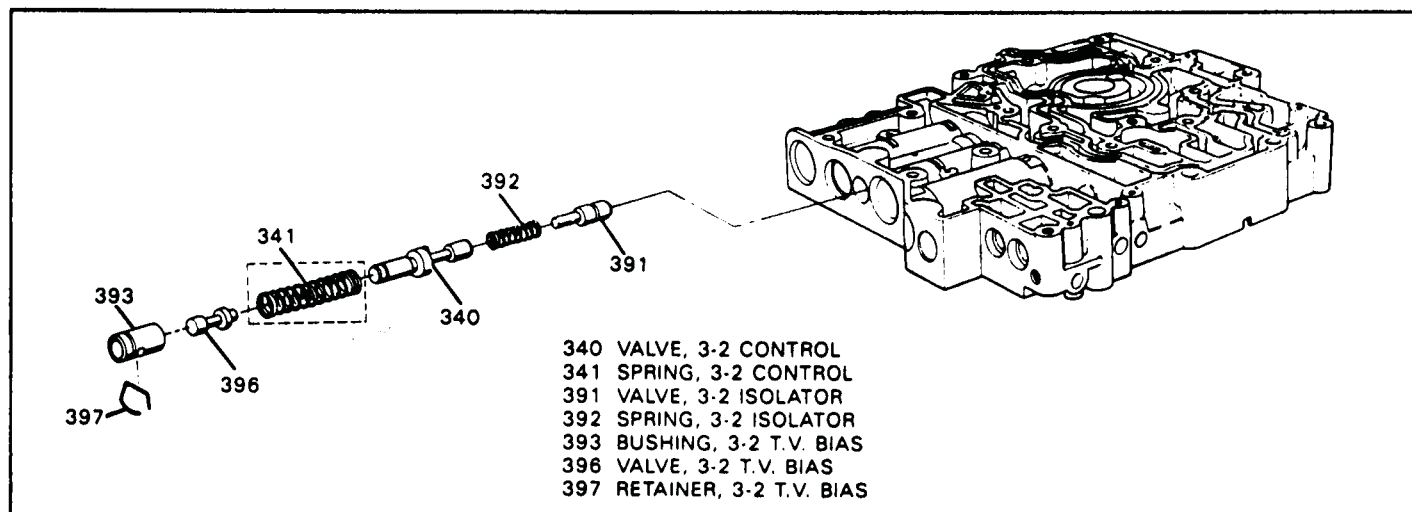
CAUSE: Improper timing for release of the third clutch and reapplication of the 1-2 band.

CORRECTION: Install a new 3-2 Control Valve Spring, now available in a service package from OEM. See "Service Information" on pages 43 and 44 for proper OEM part numbers. Refer to Figure 36 for proper installation. This IS a model sensitive part.

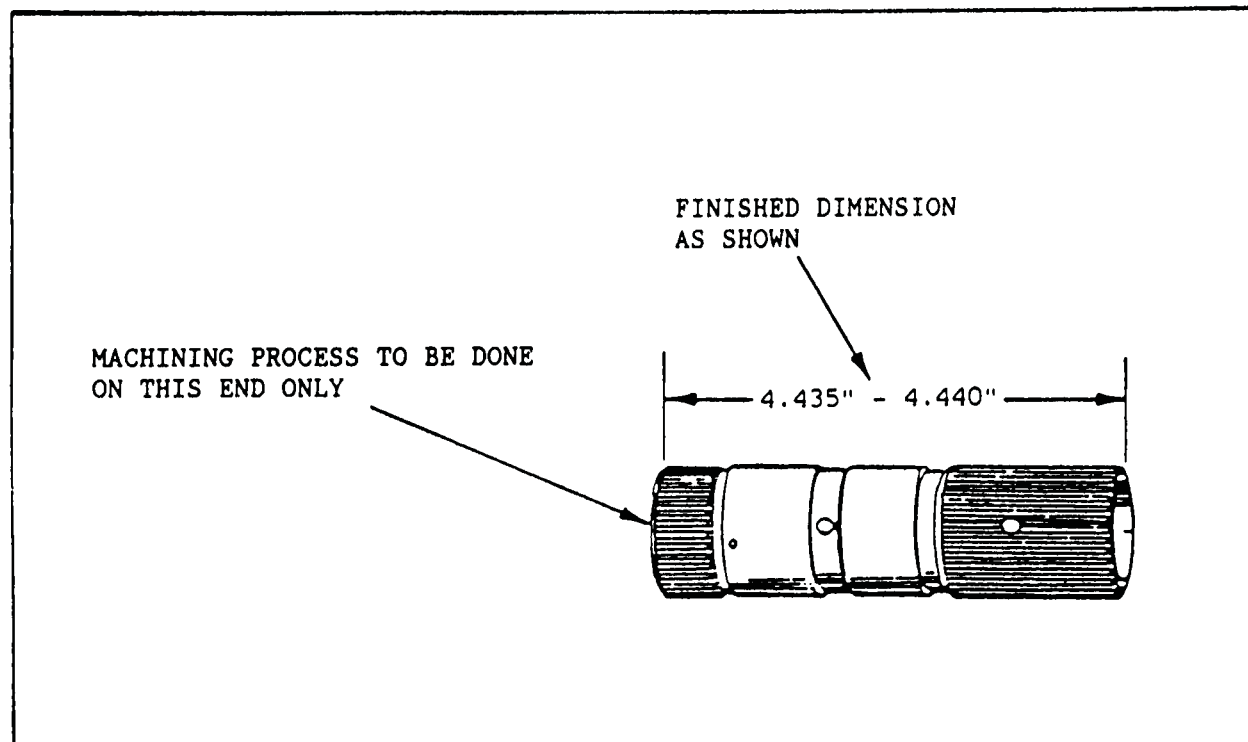
Figure 37

CAUSE: Final drive sun gear shaft is too long, and cuts or machines plastic lube dam in half.

CORRECTION: Machine or grind the final drive sun gear shaft, ON THE SHORT SPLINED END ONLY, to the dimension shown in Figure 37. Finished dimension should be 4.435" - 4.440". Non-machined final drive sun gear shaft will measure 4.480" - 4.490".

NOTE: MEASURE ALL FINAL DRIVE SUN GEAR SHAFTS TO INSURE PROPER LENGTH.

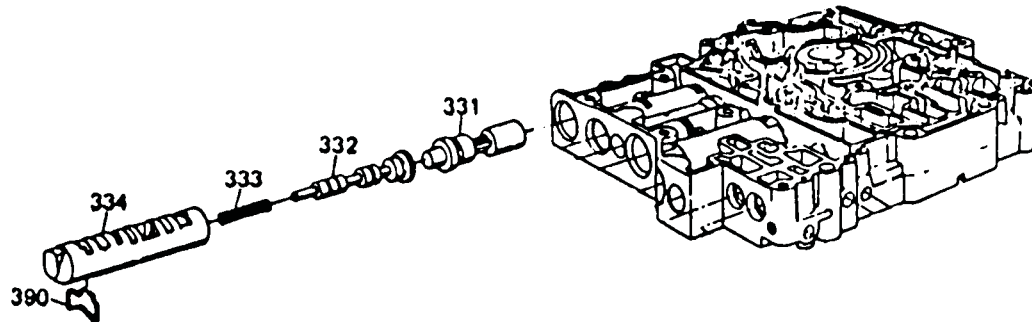
Figure 38

CAUSE: The cause may be the 1-2 shift valve sticking in the upshifted position (See Figure 38). The 1-2 shift valve is aluminum and might have a tendency to "Mushroom", caused by hitting the valve body casting in the bottom of the bore.

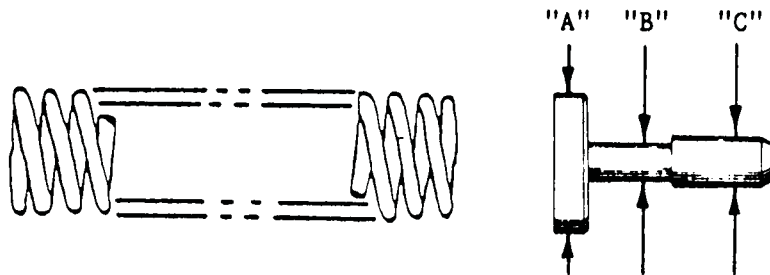
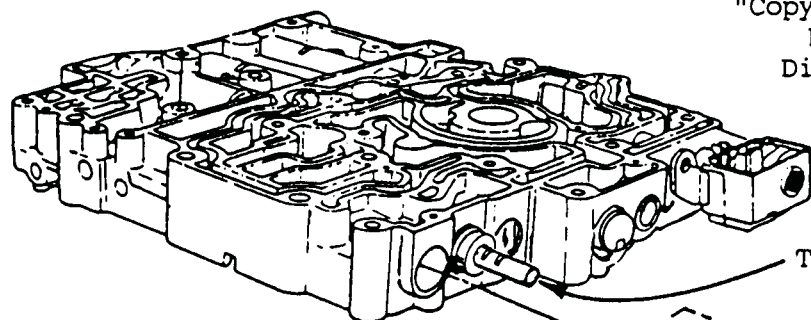
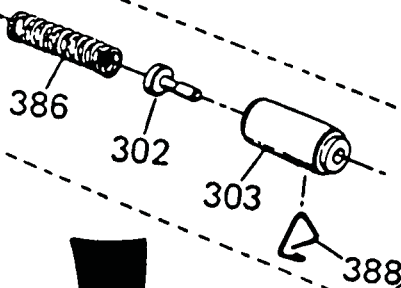
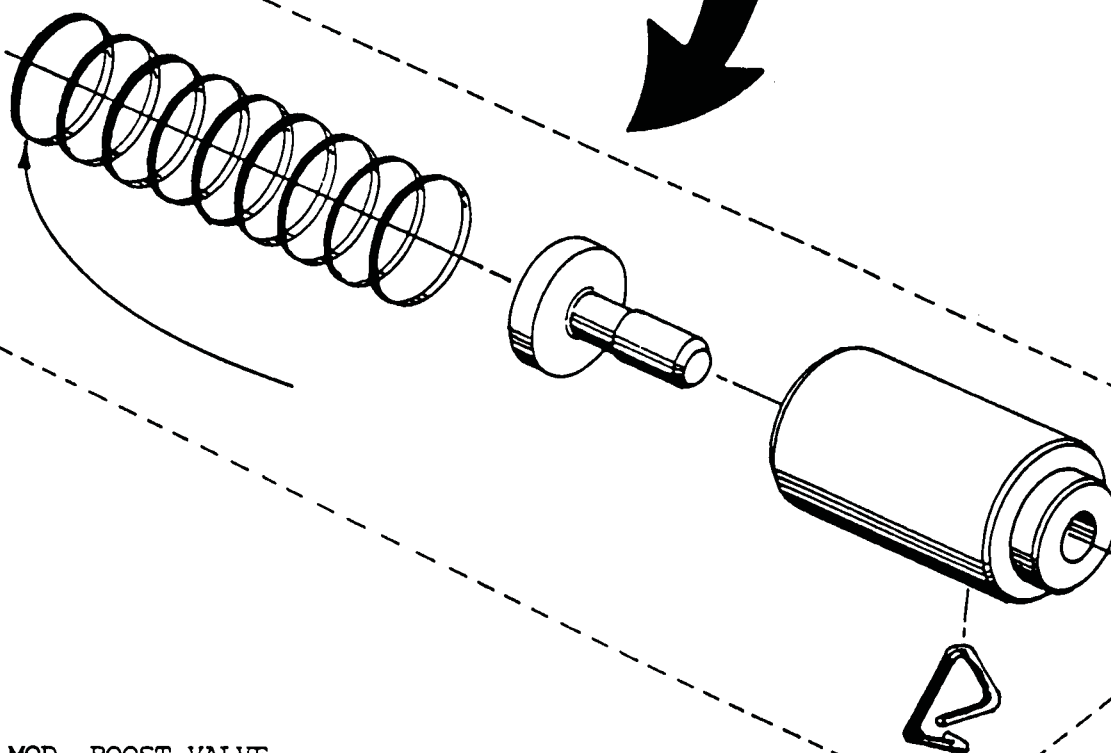
MODULATOR BOOST VALVE
LINE UP

- COMPLAINT:** 2nd clutch pack with a very short life span, usually associated with a 1-2 slip, or a 1-2 slide bump.
- CAUSE:** The cause may be a lack of line pressure rise to sufficiently apply the second clutch pack. We also recommend OEM "Koline" steel plates in this pack, and "Vespel" sealing rings on the driven sprocket support.

- CORRECTION:** Shorten the modulator boost valve spring by 1/4" or approximately 1 to 1 1/2 coils. The modulator boost valve spring is located in the pressure regulator line-up, which is directly next to the T.V. plunger in the valve body (See Figure 40). This will allow line pressure to rise at less of a throttle opening and greatly increase 2nd clutch durability. This modification should be done on "ALL" THM 440-T4 transaxles during the rebuilding process.

- SPECIAL NOTE:** There are currently 3 different diameters of modulator boost valves, and 3 different spring calibrations (See Below). This equation will work on all 3 calibrations.
