THM 4L60-E/4L65-E "UPDATE HANDBOOK"

INTRODUCTION

THM 4L60-E/4L65-E

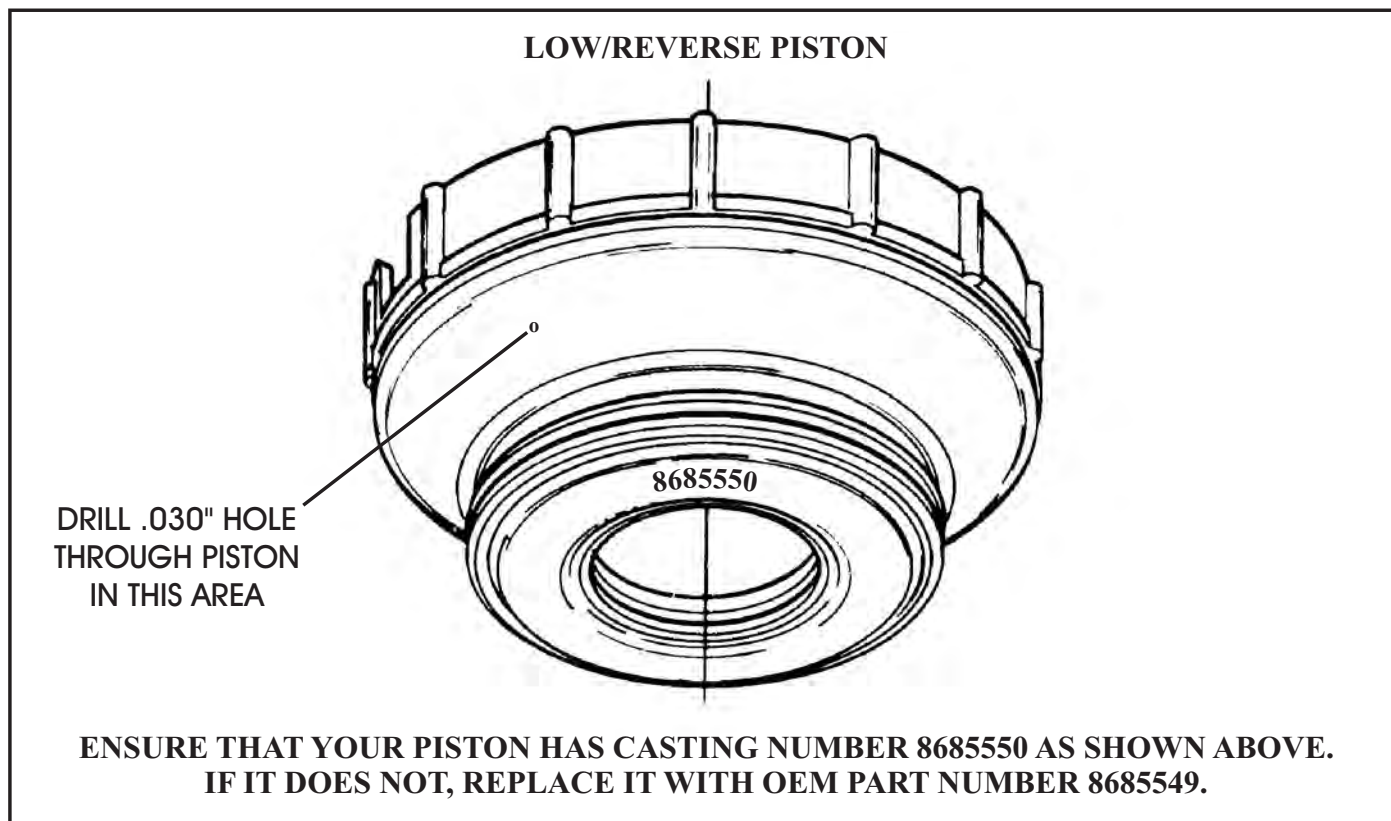
Figure 1

COMPLAINT: Premature and/or repeat failure of the Low/Reverse Clutch pack, on 1993-1995 models only, and may occur in as little as 5000 miles.

CAUSE: The cause may be, the Low/Reverse Clutch not totally exhausting the apply oil when the shift lever is moved from Park to the Drive position. On 1993-1995 models, the exhaust path for L/R apply oil is not large enough.

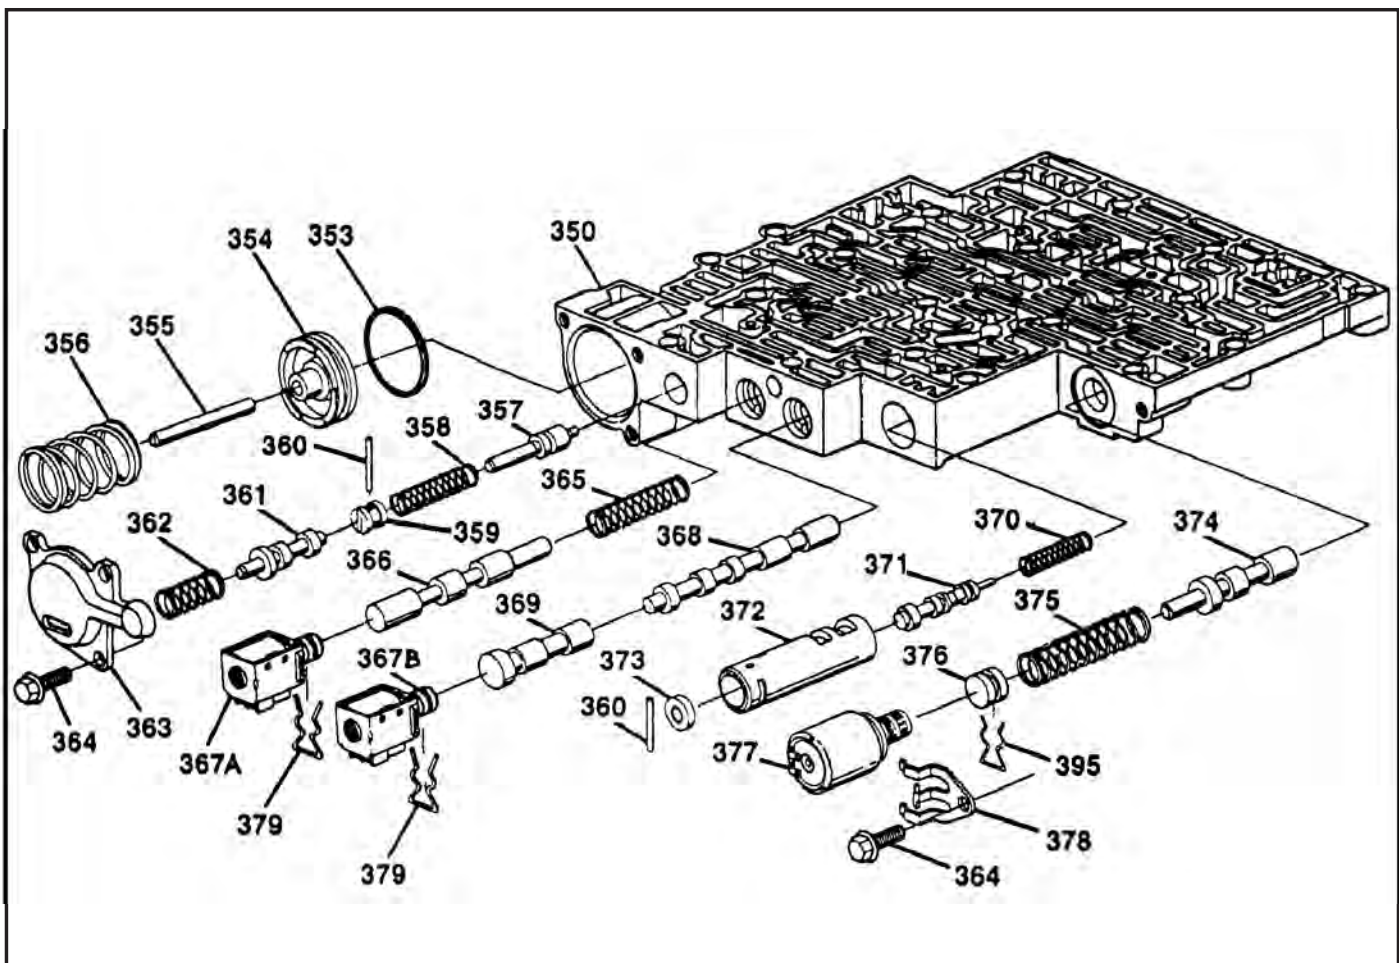
Figure 1

COMPLAINT: Some 1994 model vehicles, equipped with the THM 4L60-E transmission may exhibit a soft 1-2 upshift condition.

CAUSE: The cause may be, calibration of the 1-2 accumulator valve in the valve body.

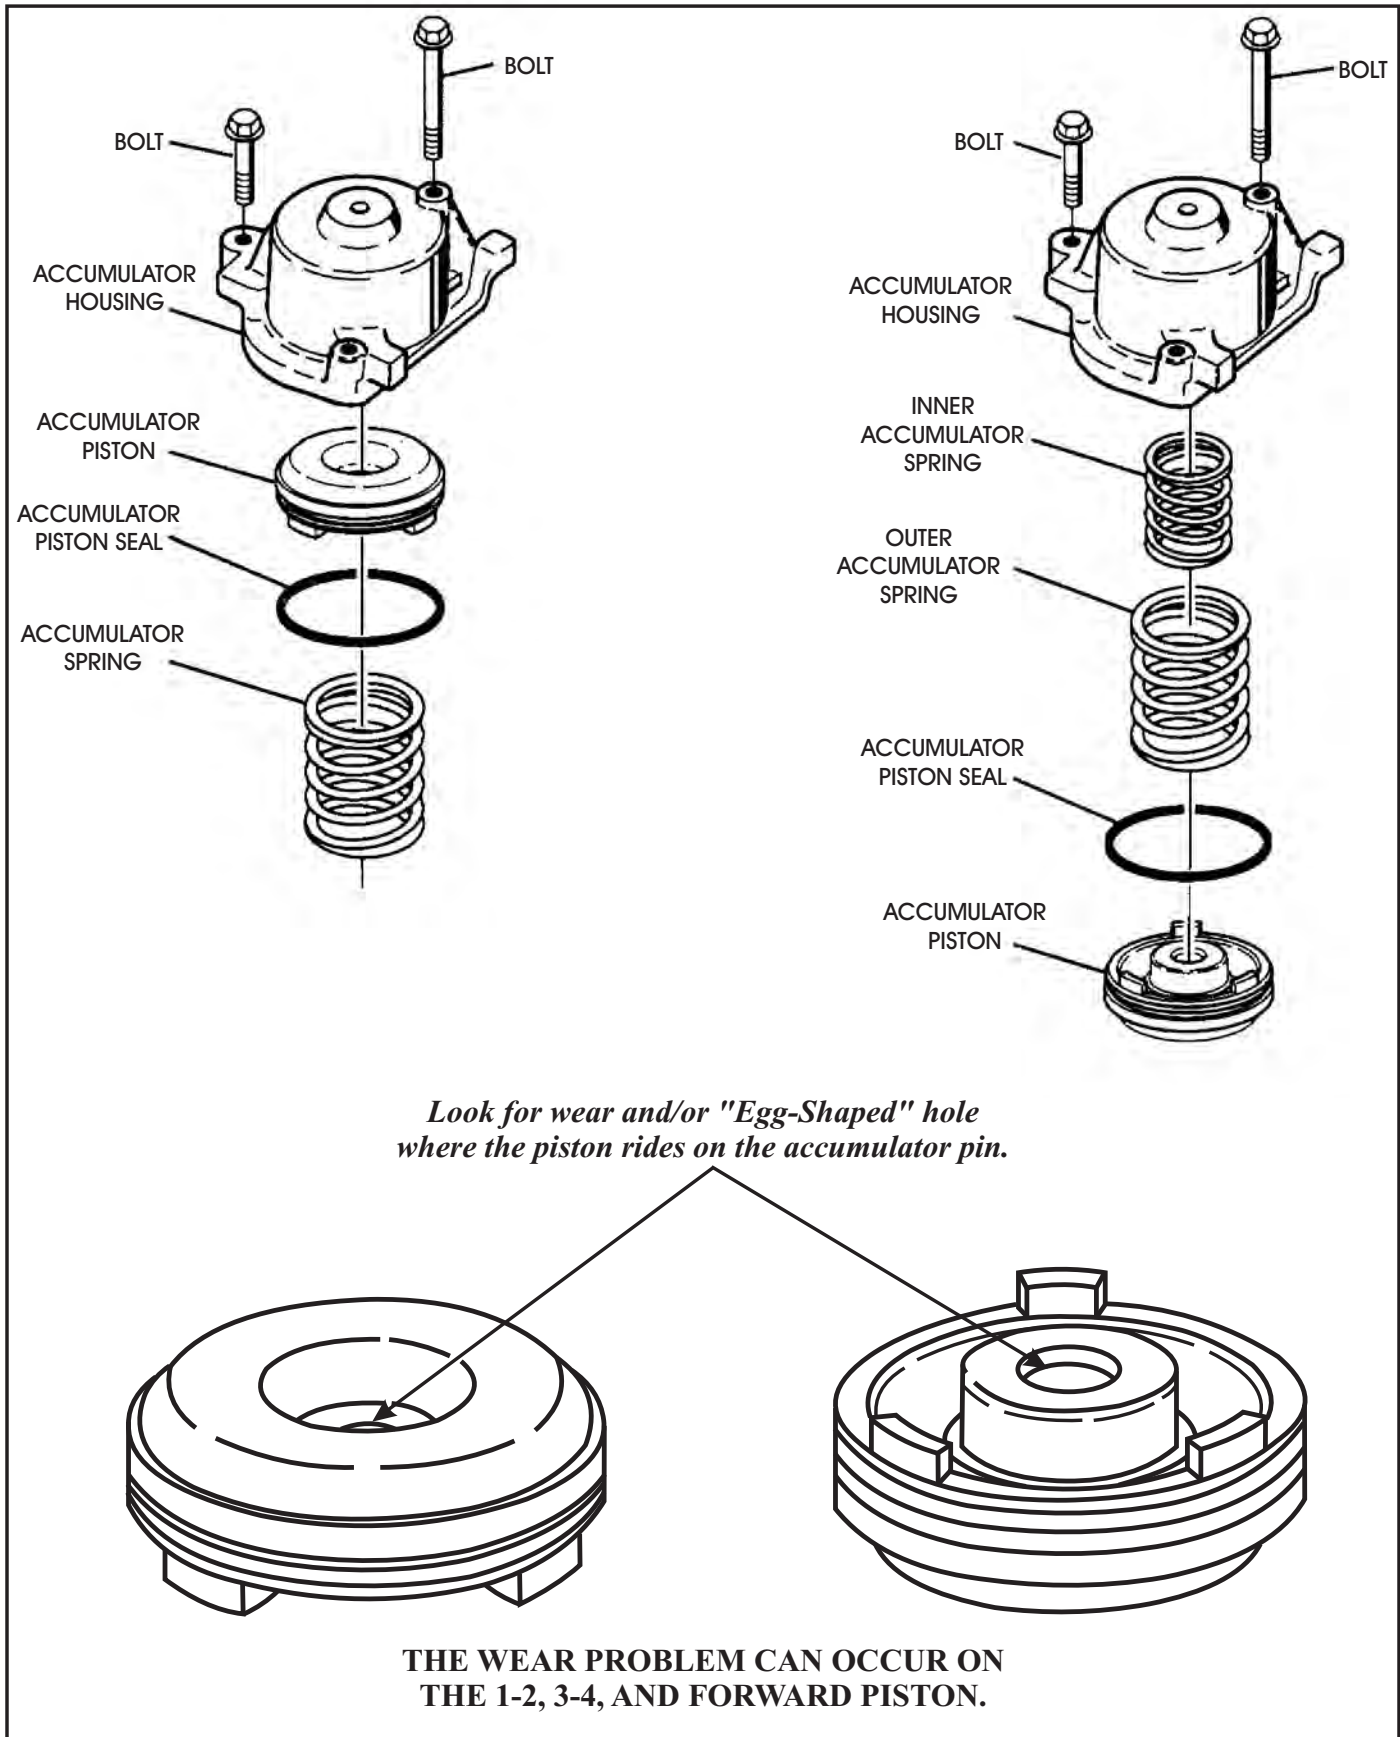
Figure 1

COMPLAINT: When the accumulator piston wears with an "Egg-Shaped" hole where the accumulator piston strokes, it can create a delayed engagement to drive, slipping condition in forward gears, slipping 1-2 shift, slipping 3-4 shift, depending on which accumulator piston is worn, and how bad it is worn.

CAUSE: The cause may be, a worn accumulator piston pin bore (See Figure 1).

The THM 4L60-E, 1-2 accumulator piston has a smaller pin diameter.

The THM 4L60-E, forward accumulator piston is a smaller outside diameter.

CORRECTION: Replace the accumulator piston with the proper part number from "Service Information" as shown below.

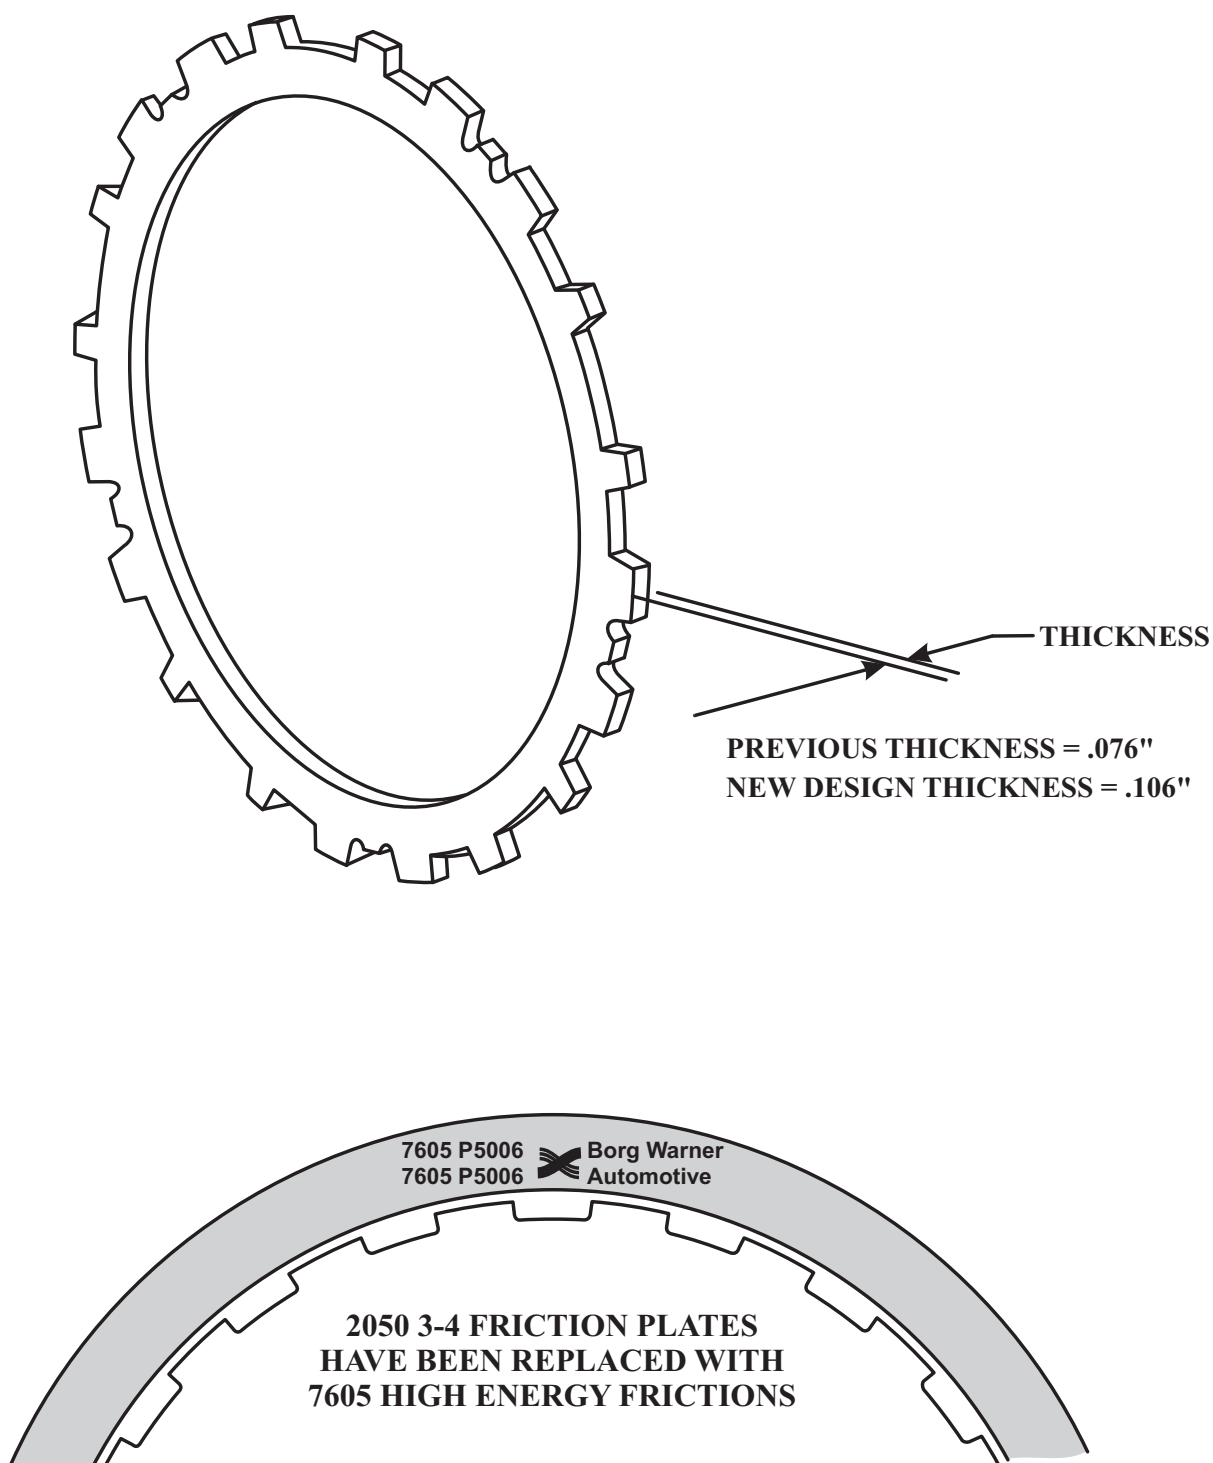
Figure 1

COMPLAINT: After rebuild, the vehicle exhibits premature 3-4 clutch failure, sometimes in as little as 2000 miles of use. Usually associated with Police, Taxi, or heavy duty use.

CAUSE: The cause may be, not using the high energy clutch plates, and the thick (.106") steel plates, or not enough line pressure rise with throttle opening.

3-4 CLUTCH LINED AND STEEL PLATES

The 2050 high energy friction plates normally associated with the above kit have been replaced with the 7605 high energy friction plates for increased durability. Refer to Figure 1. The 2050 high energy friction plates have been discontinued.

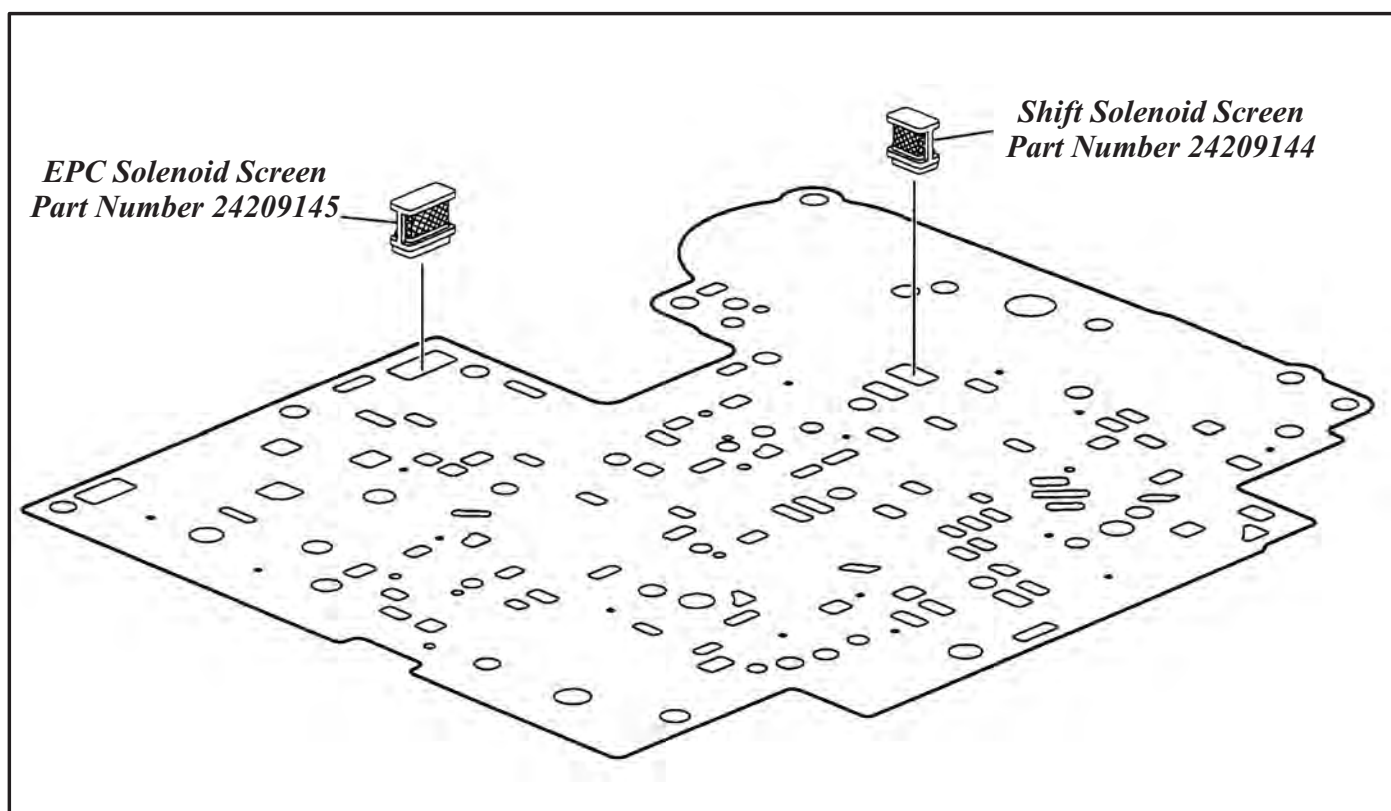
Figure 1

CAUSE: The cause may be, one or both of the screens in the spacer plate collapsed shut, and restricting solenoid feed oil or actuator feed oil to the Pressure Control Solenoid.

CORRECTION: Replace both screens in the spacer plate as shown in Figure 1, with the part numbers listed below. These *new part numbers* are screens with a larger micron screen that will pass more oil easier.

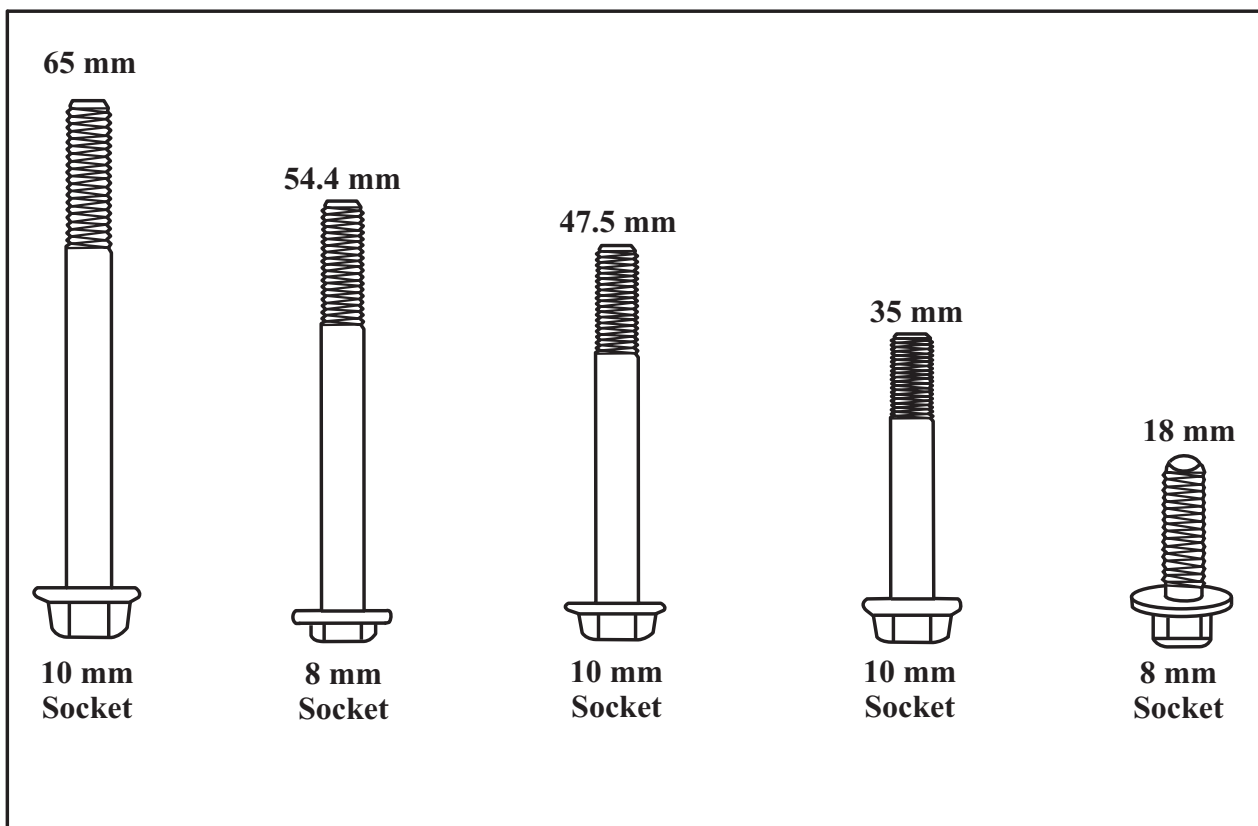
Figure 1

CAUSE: There are different length valve body bolts which can be easily mis-positioned (See Figure 1). A **common** error is placing a 54.4 millimeter length bolt into a location designed for a 47.5 millimeter length bolt (See Figure 2). The mis-located bolt will extend into the barrel of the case and into the sun shell. The bolt now being screwed into the sun shell inhibits the rotation of the shell causing the above complaint.

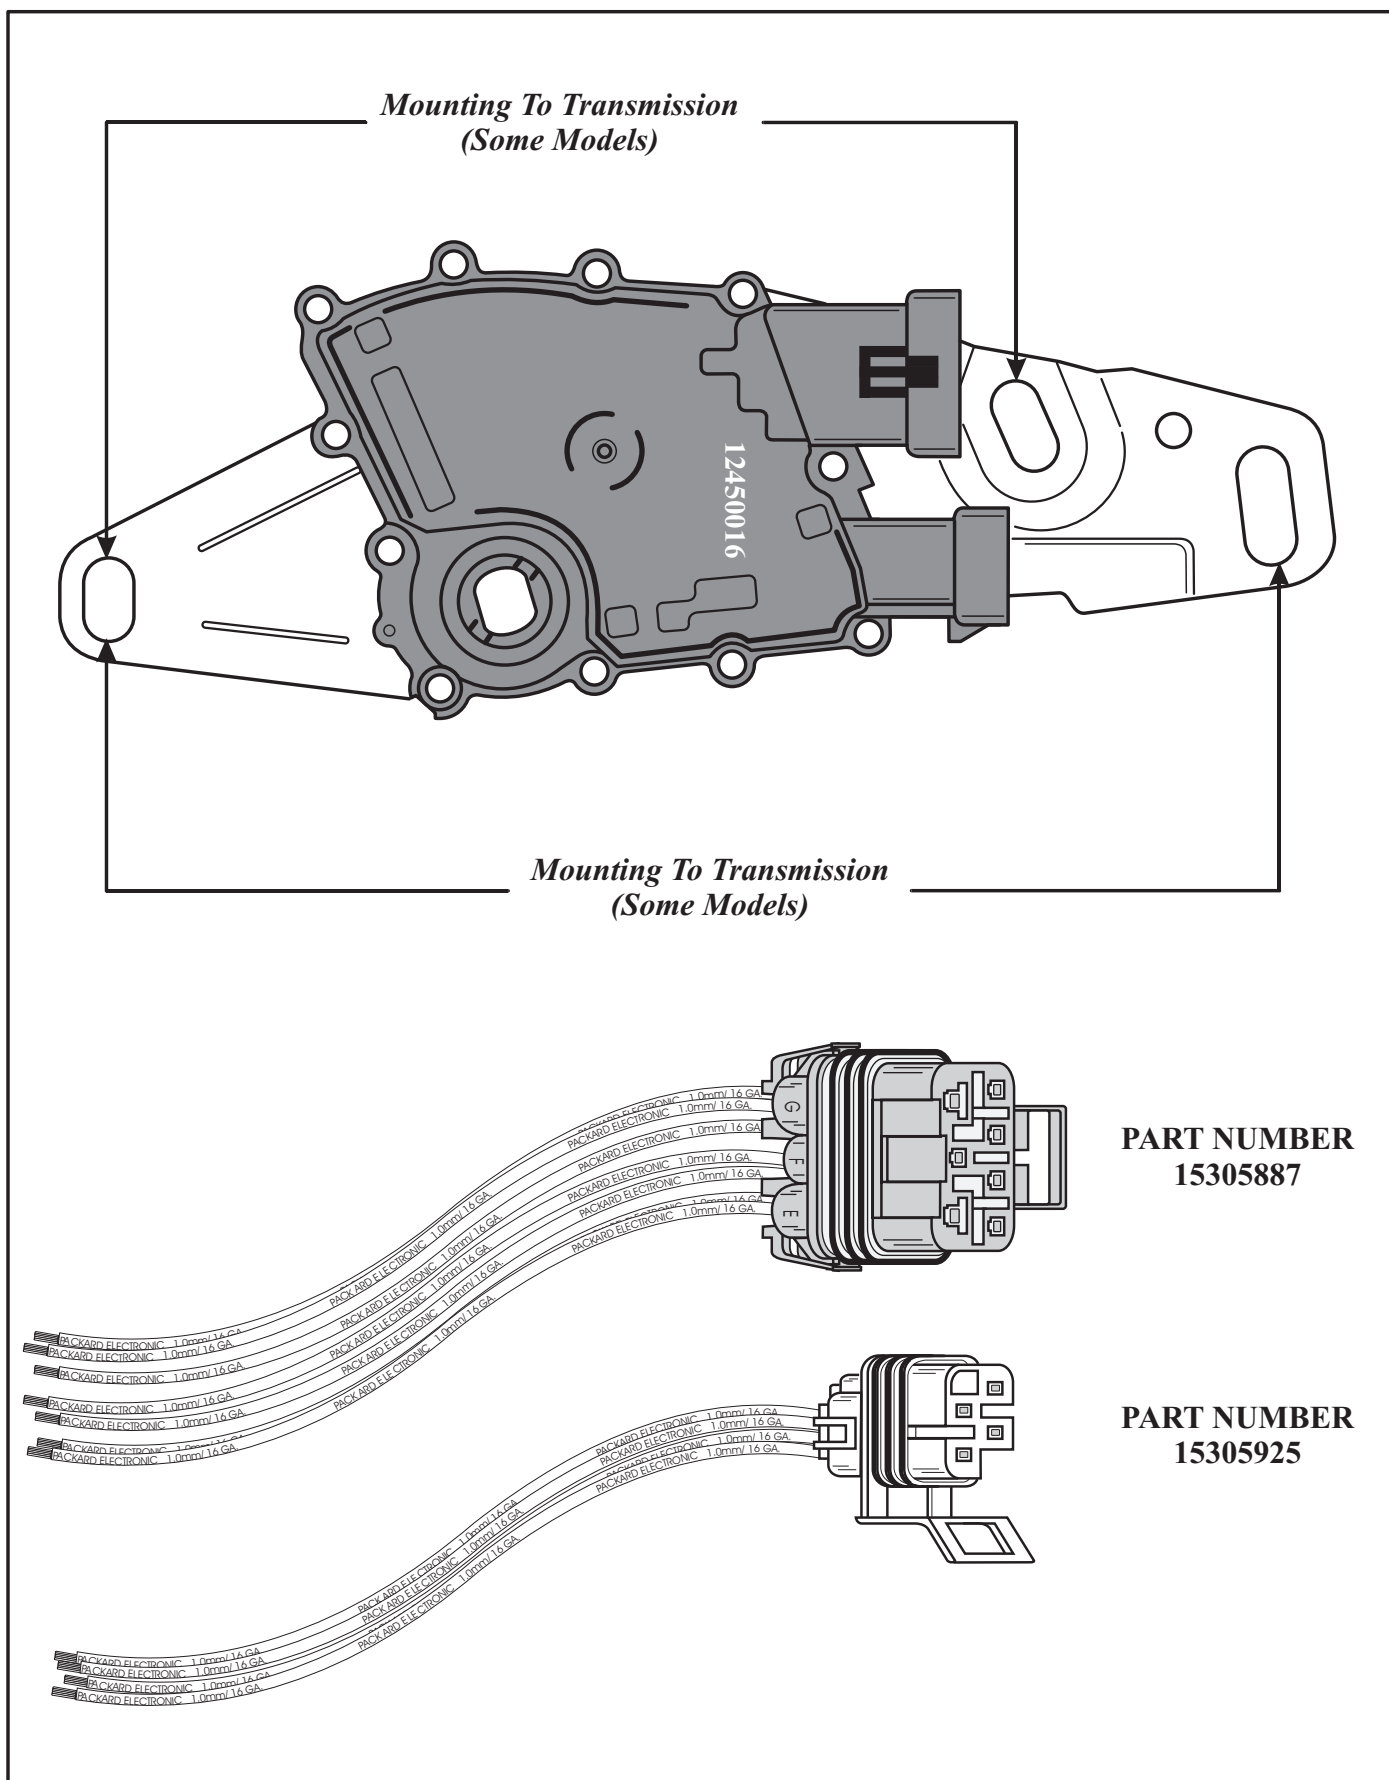
Figure 3

CAUSE: The cause may be high ambient heat causing the sealing compound in the switch to melt and flow into the connectors, sealing the connectors to the switch. This normally causes no customer concerns, but may cause an open electrical circuit in rare cases.

CORRECTION: If the switch is being removed as part of transmission service, *and there are no switch related concerns*, the switch can be removed without removing the connectors, and left hanging until time to be re-installed. However, some models have a mounting bolt directly behind the switch connectors, which requires removing the connectors, and the switch *will be damaged* in the process (See Figure 3).

There is now available from OEM sources, service repair connectors for both the 7-way and the 4-way connectors under part numbers 15305887 and 15305925 (See Figure 3).
