2004

TECHNICAL SEMINAR

The Automatic Transmission Rebuilders Association

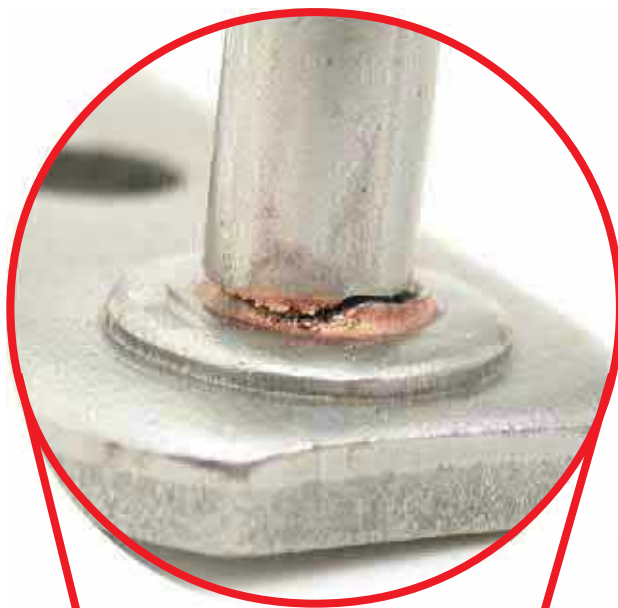
Cracked Oil Feed Tube

A cracked Oil Feed Tube may be the cause of a no forward or slips in forward condition. When installing the tube assembly to the case make sure there is no debris caught under the plate area before torquing the tube bolts. This may cause the tube assembly to crack. Make sure to check all tubes during disassembly and reassembly.

**Torque the feed
pipe bolts to
106 inch lbs**

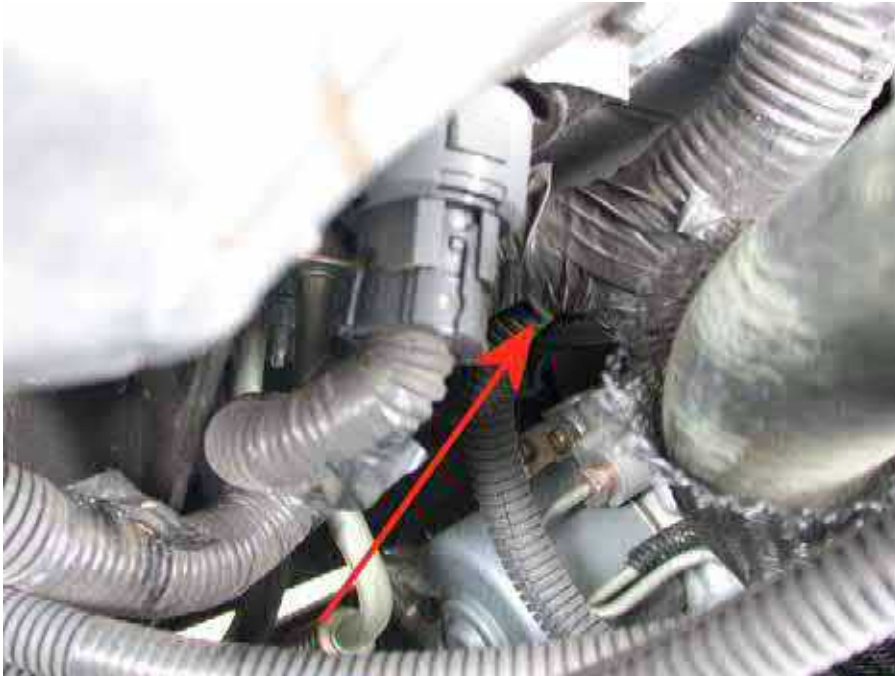
Cause #1:

Possible water intrusion at the transmission to the front end vehicle harness. This harness is located near the transmission breakout and is protected by plastic split tube type conduit and electrical tape. In some cases, the split may be facing upward which will increase the tendency of the conduit to hold water. Eventually, the #107 splice to the transmission may become corroded and become non-conductive.

Locate the conduit for the transmission breakout directly above the transmission oil cooler lines. Remove the electrical tape wrap from the plastic conduit and peel the conduit open. With the conduit open, examine the splices inside for signs of corrosion. Splice #107 (part of circuit 439, PINK) is located approximately 13 in forward of the transmission breakout point. Examine the splice for signs of corrosion. If corrosion is found, repair the splice. Use only a GM Crimp and Seal splice. Strip back the wire until clean, non-corroded wire is available.

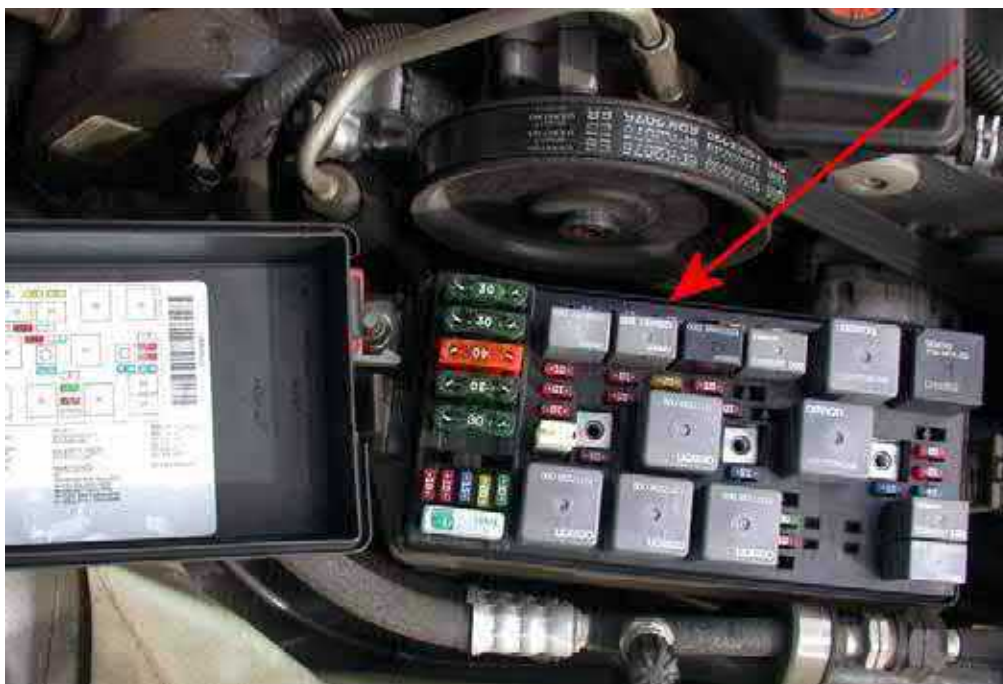
Several items may cause the conditions listed above. One of the common areas that seems to occur with great frequency, is a poor connection at the “under hood fuse block”. The pin and its location vary based on the vehicle model. On H-car applications inspect connector C-3 pin E7 for damage. On C- car applications inspect connector C-2 pin E4 for damage. In most instances you will find the terminal lock tab damaged. This will allow the terminal to back out, leading to the intermittent concern.

To repair the condition, replace the terminal or repair the collapsed locking tab.

Remove the under hood fuse block or under hood junction block and flip it upside down.

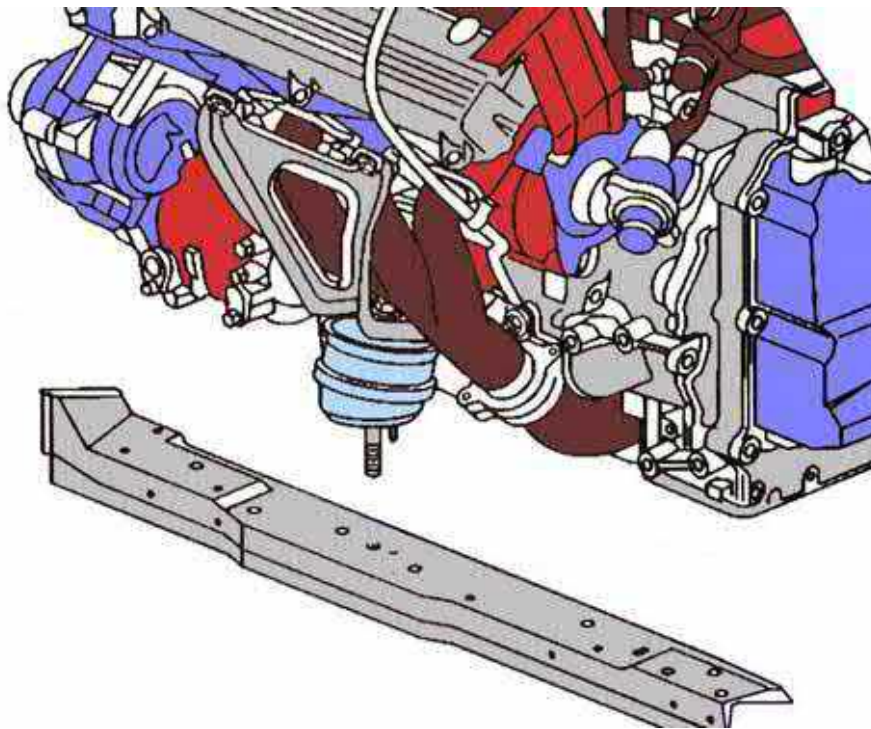
Many (K- Car) Northstar equipped 4T80E vehicles may have aggressive garage shifts. The condition may have gotten progressively worse or may have developed all at once. In addition a “Thud” noise when accelerating from a stop may also be felt. An oil leak from the motor mount may also be present on the garage floor or drive way.

This is a common issue on the Northstar applications and it is generally caused by a cracked front engine mount. The mount generally cracks in the area of the stud where it mounts to the frame.

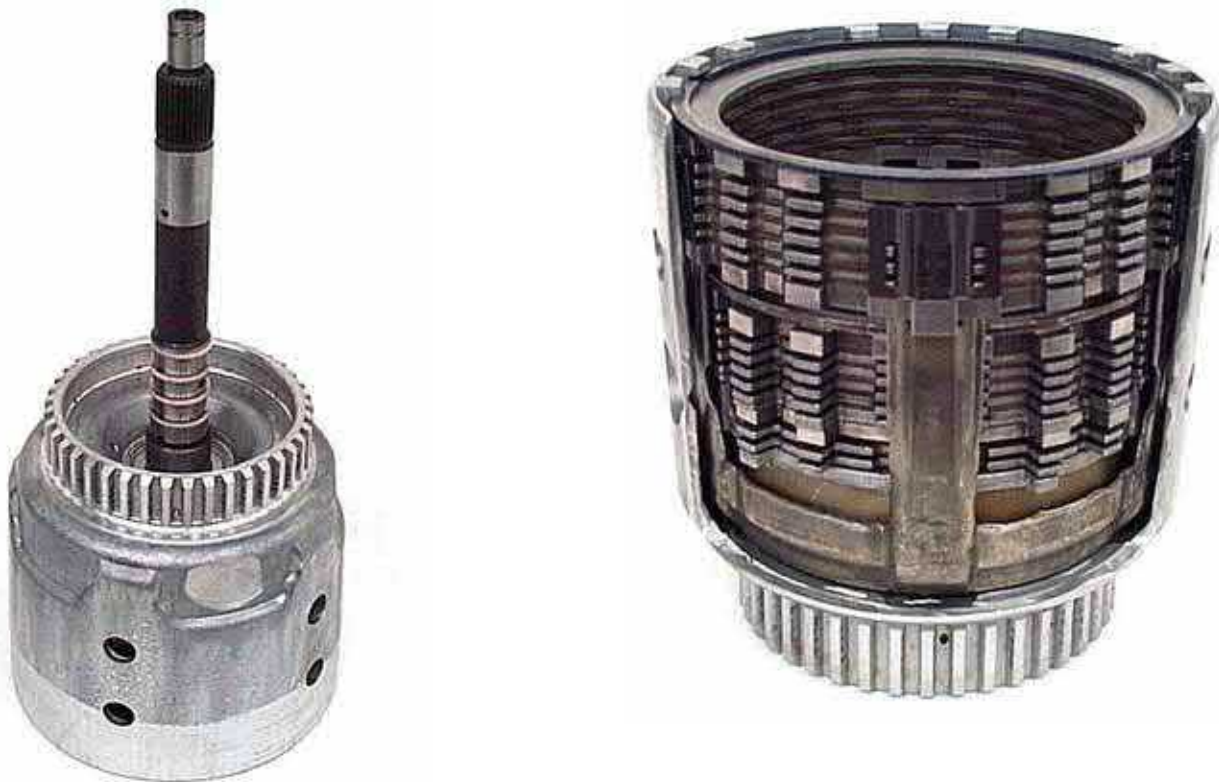
Condition: 4L60E applications setting slip DTC's may have problems with the 3-4 clutch. Upon inspection you may find the 3-4 clutches are burned.

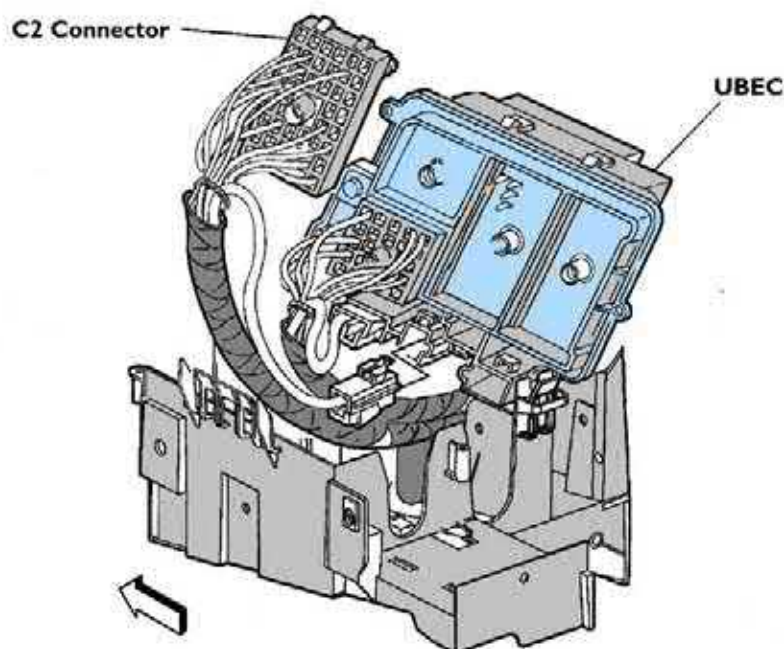
Always check circuit 1020 at the UBEC (Under hood Electrical Center) Connector C-2, terminal F-2 for a poor crimp condition. In many instances the terminal is crimped over the top of some of the wiring insulation leading to a poor connection. In most instances this condition is intermittent. Wiggle the wires at connector C-2 while monitoring the voltage on circuit 1020. If a terminal crimp issue is present replace the terminal using the special crimping pliers designed for the GM terminals.

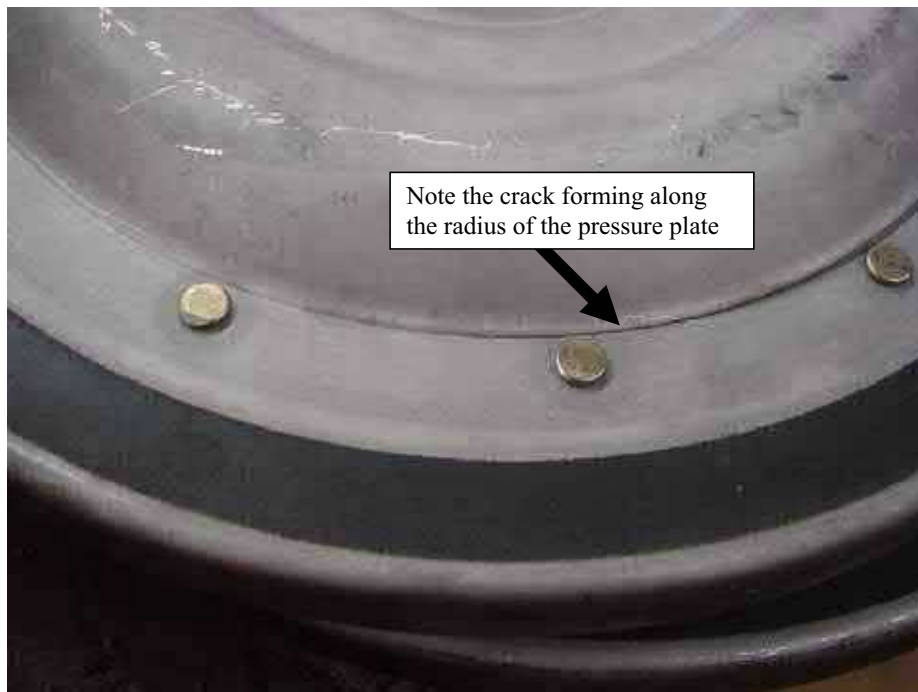
As with other applications several areas can cause the excessive slip condition. One of the most common causes on late model applications is cracks forming on the TCC apply plate. If the typical causes for the condition fail to address the root cause of the condition, replace the torque converter.

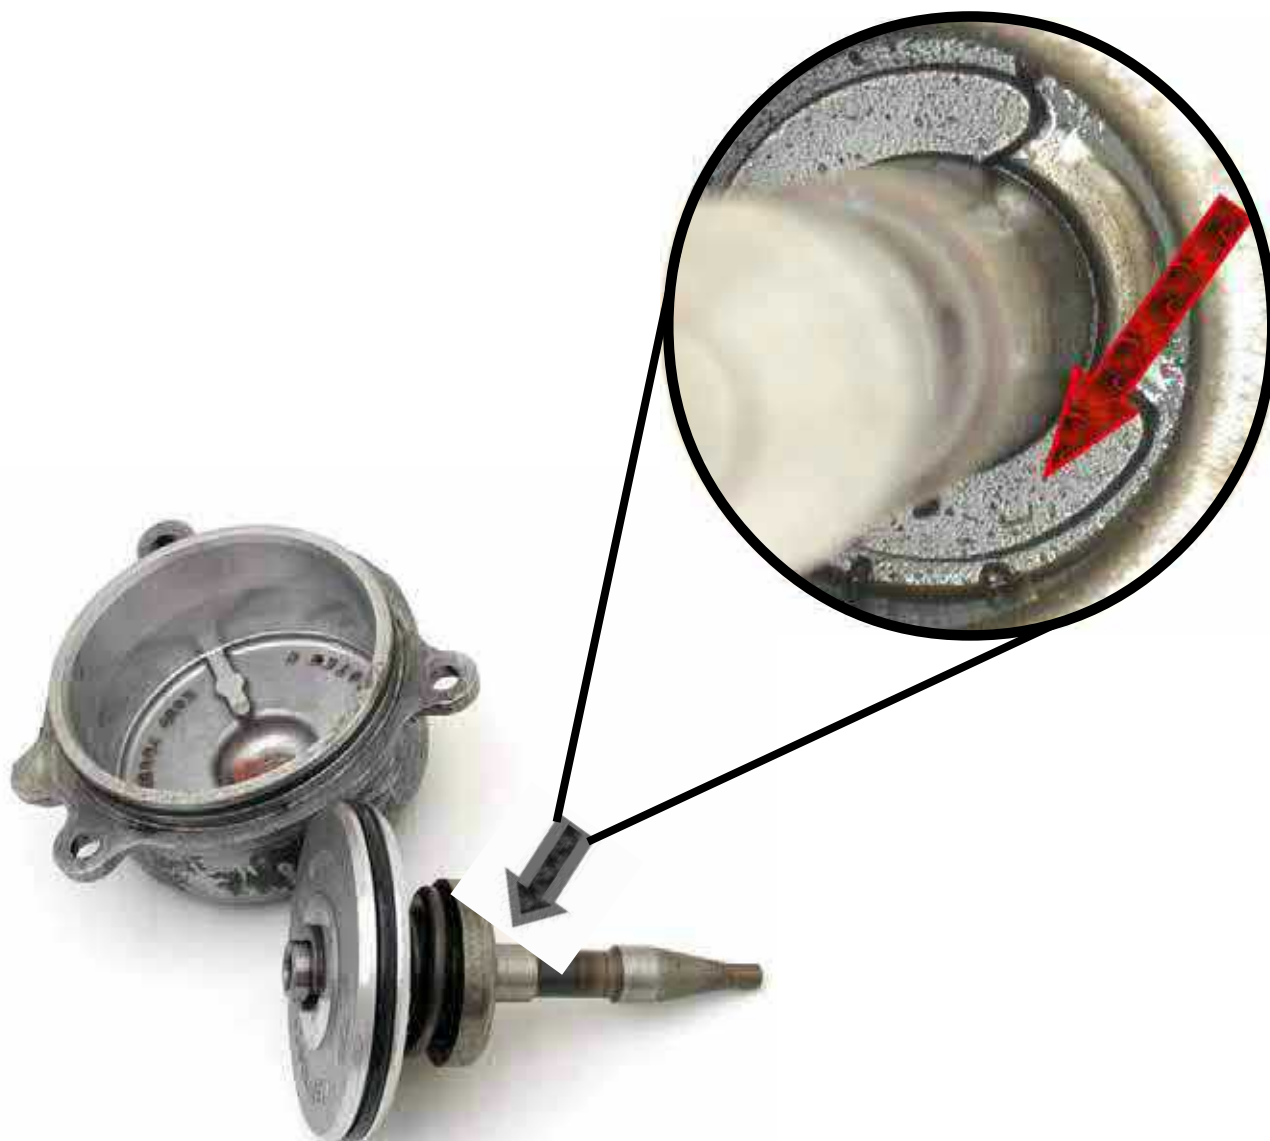
A no movement condition can be caused by the front clip breaking in the Low/Intermediate servo assembly.

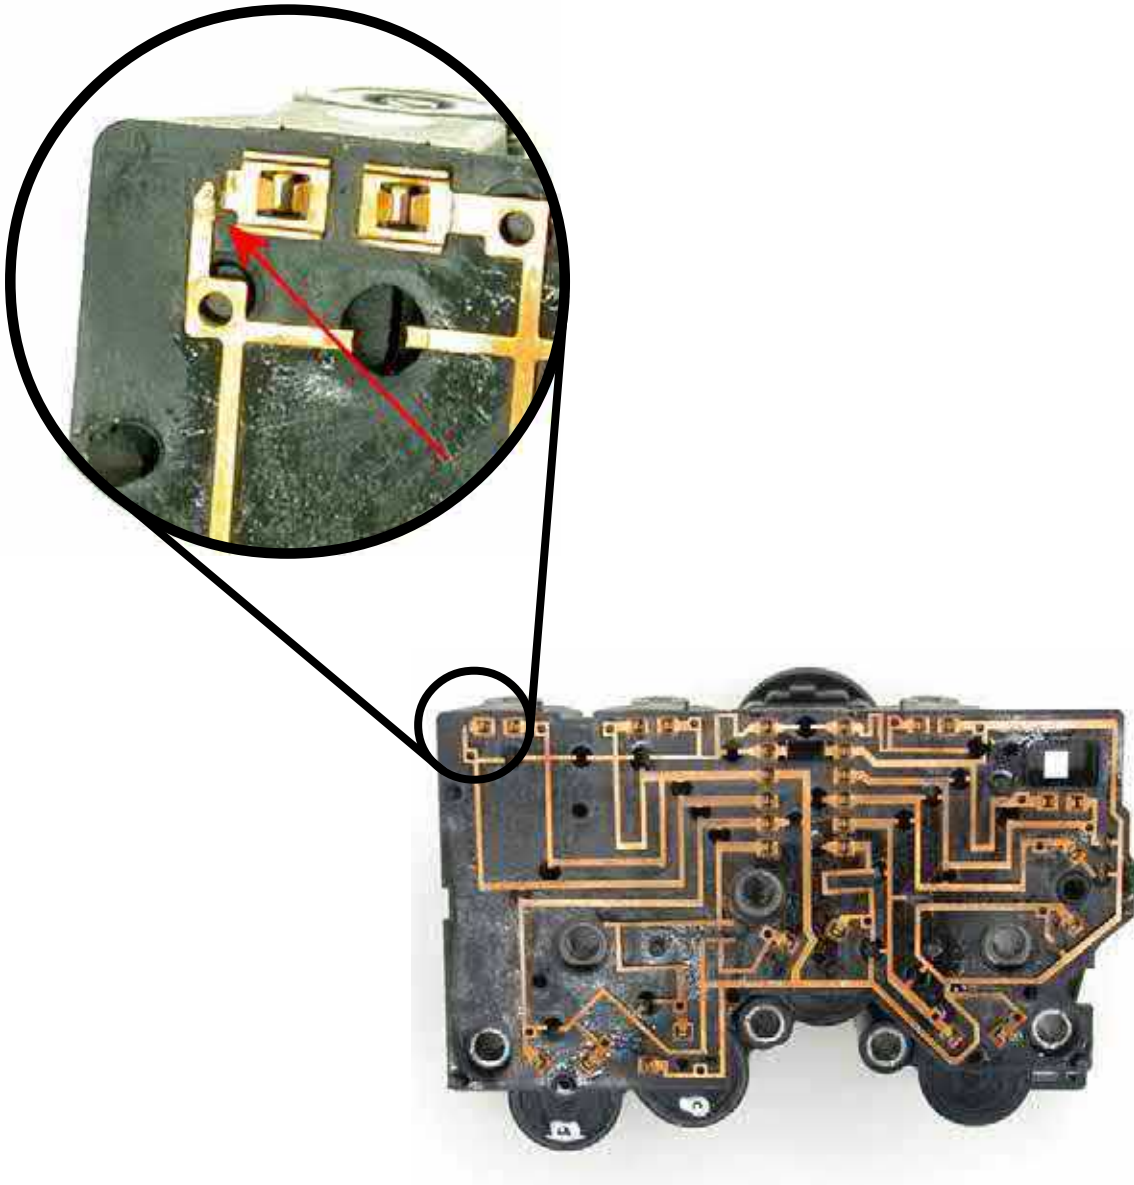
Multiple codes, with gears missing may be caused by a broken solenoid block circuit. This can be caused by the plastic housing rubbing on the circuit board.

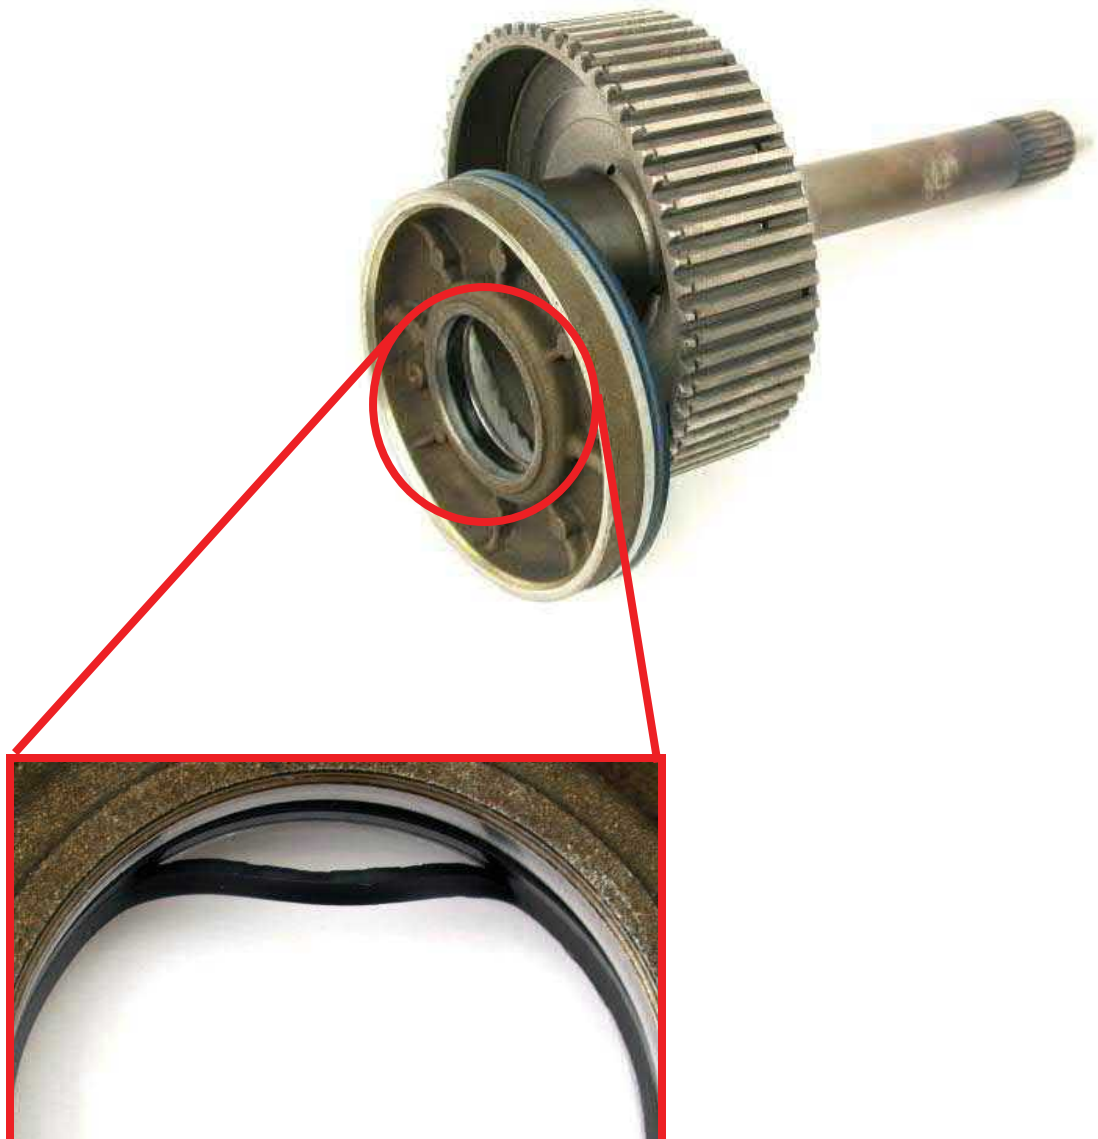
In some extreme cases during the winter months this seal can shrink and never apply.

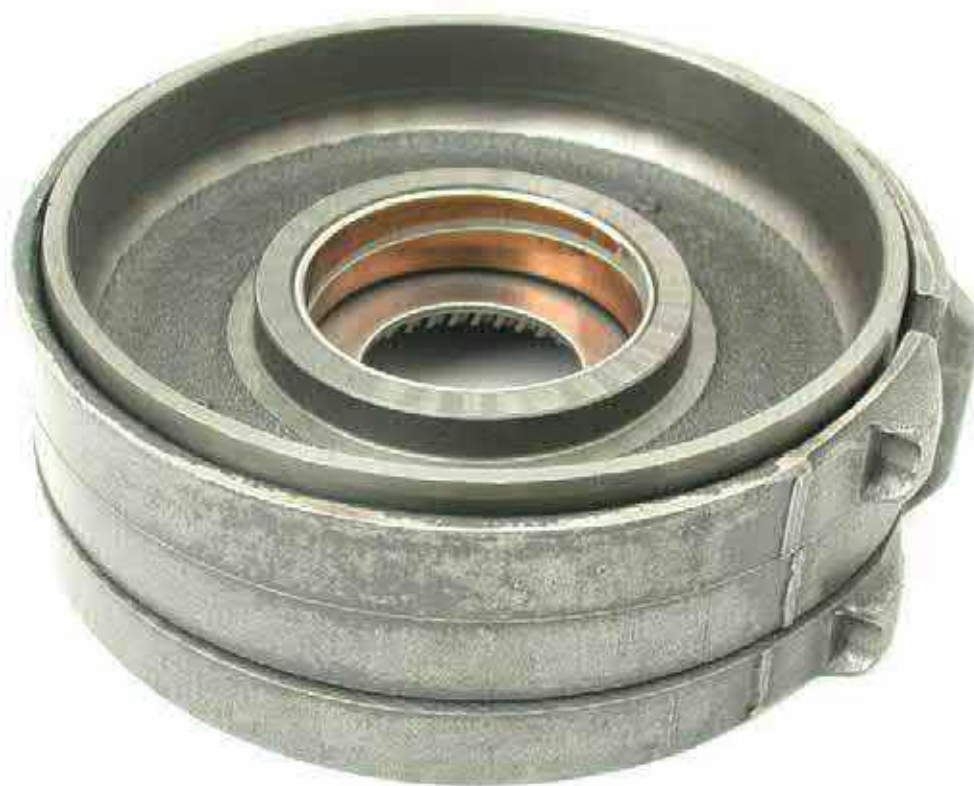
A common cause for the Band failure is the band being partially applied and dragging in 3rd or 4th gear. This is usually caused by insufficient servo release pressure, which can be the result of leaks in the 2nd clutch and/or 3rd clutch circuits. In this section we are going to review the servo release and related oil circuits, as well as what you need to check on every overhaul to prevent band failure.

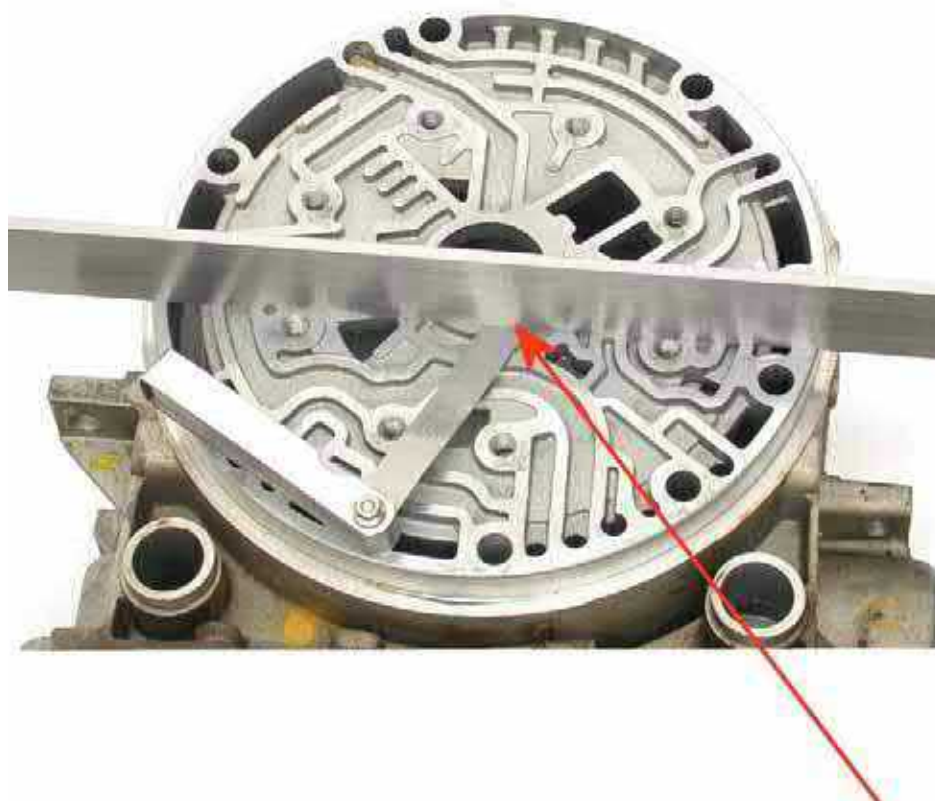
Always use a straight edge and a feeler gauge across the adapter case in several places to check it for possible warpage. The bolt holes are usually the high spots. You should not be able to fit a 0.0015" feeler gauge under the straight edge surface. If you can, your adapter case is warped.

Any gap under the straight edge should not exceed 0.0015"

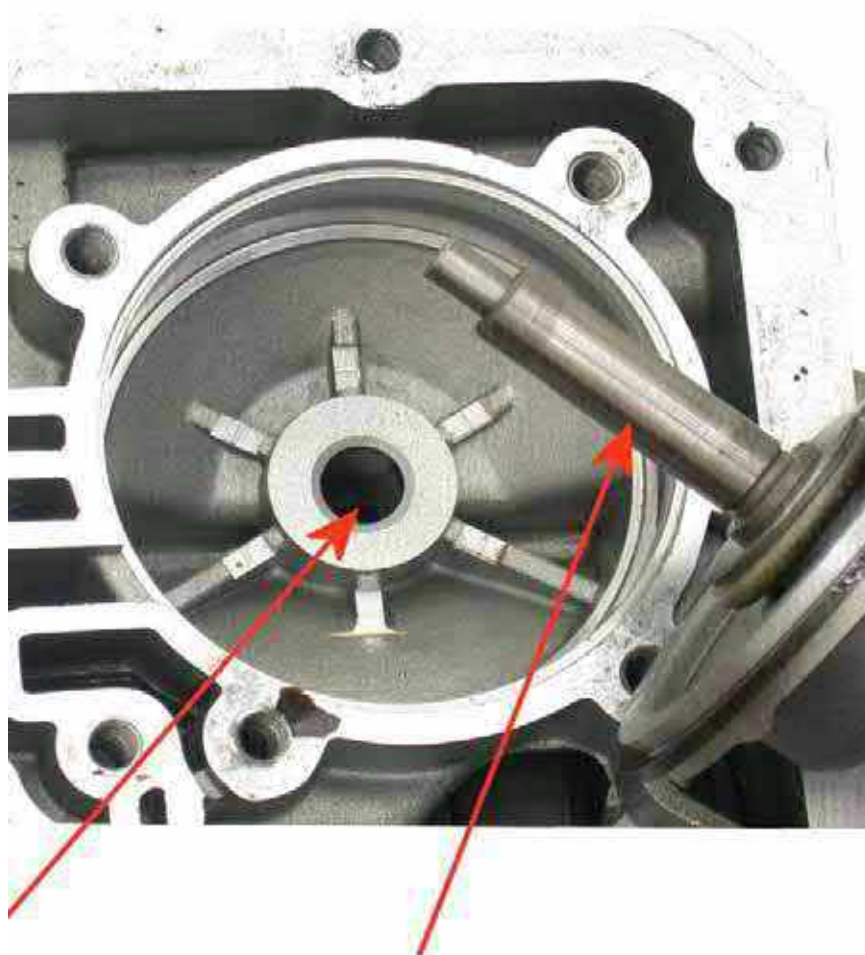
After removing the servo from the bore, check the inside area for wear.

Check for wear in these locations

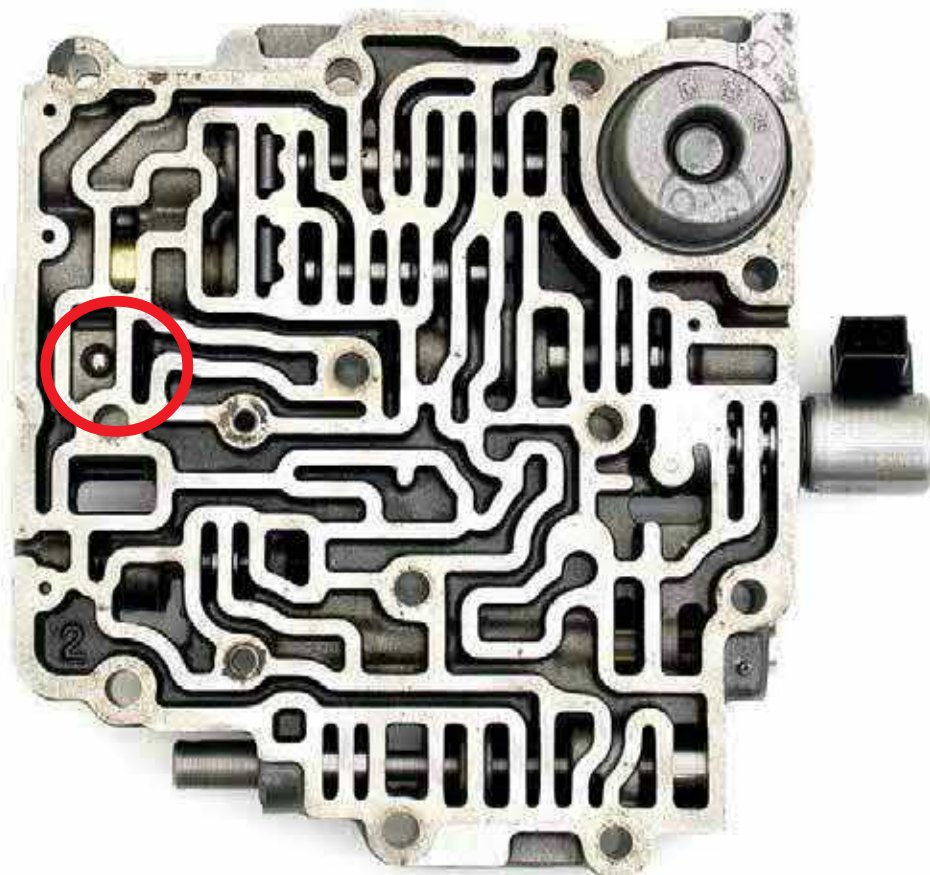
**3rd clutch
checkball**

A bindup condition in 4th gear may be caused by a missing or leaking 3rd clutch checkball. When this checkball is missing, 1-2 servo release pressure can leak in 4th gear causing the 1-2 band to apply.

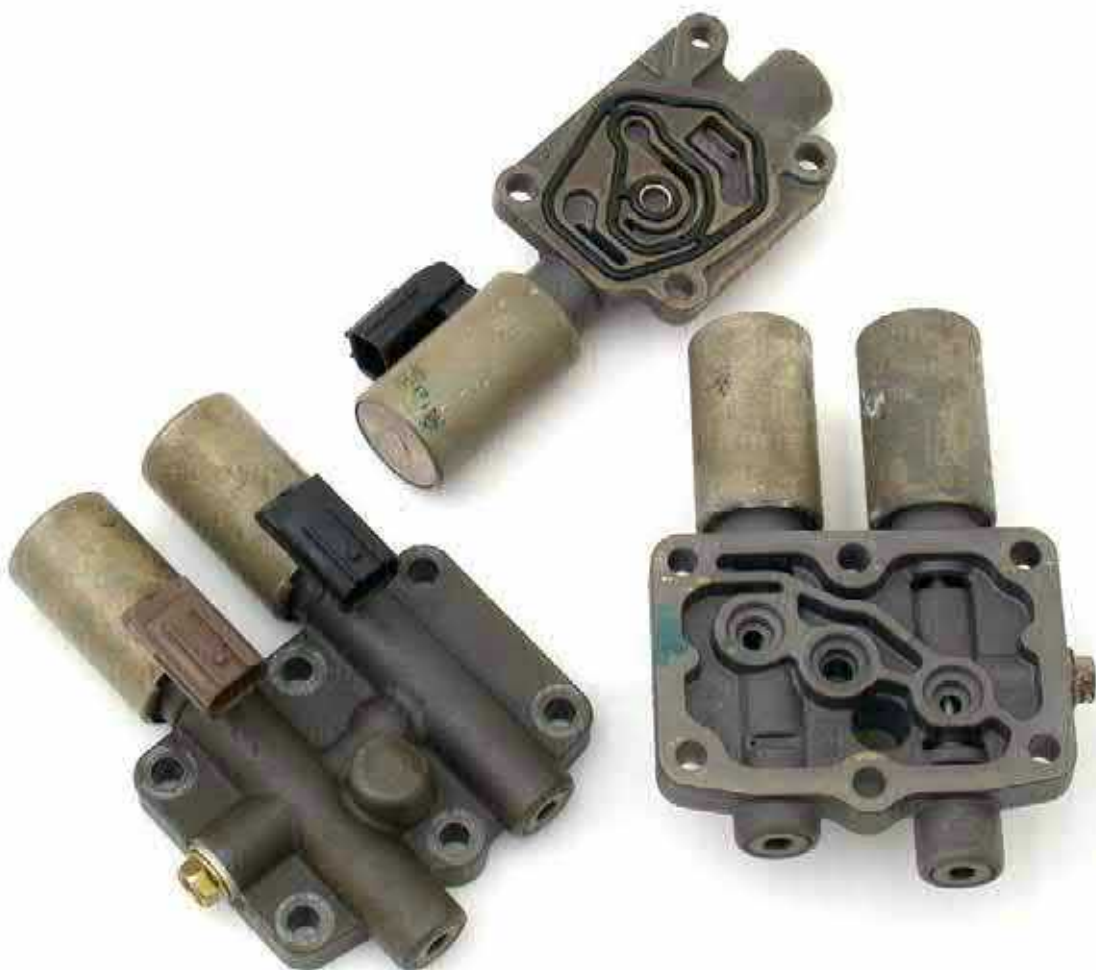
Many shift quality complaints including flares, harsh shifts, soft shifts, and engagement feel problems can be caused by contaminated CPC (Clutch Pressure Control) or Linear solenoids. Symptoms may be present only when cold. Normal flushing and cleaning of contaminated solenoids is usually not successful.

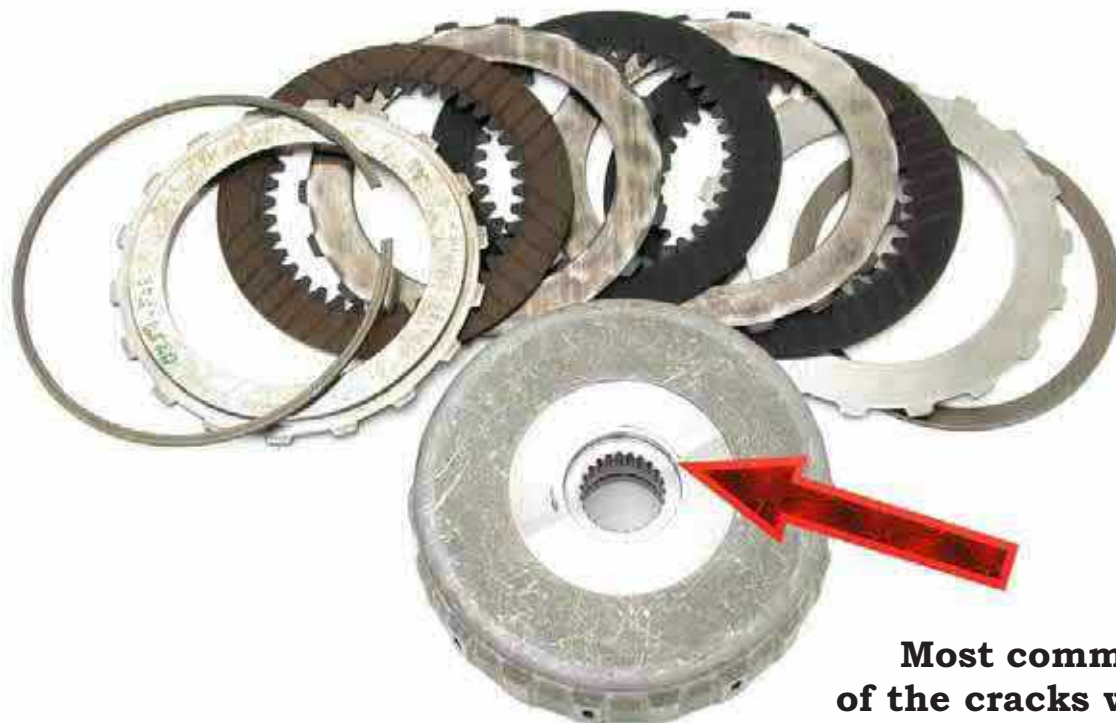
**Most common area
of the cracks will be
seen here.**

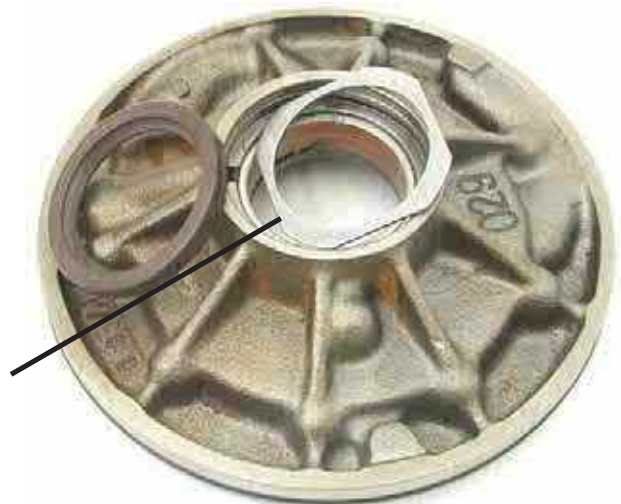
Possible front seal leak due to the oil deflector becoming loose and damaging the seal

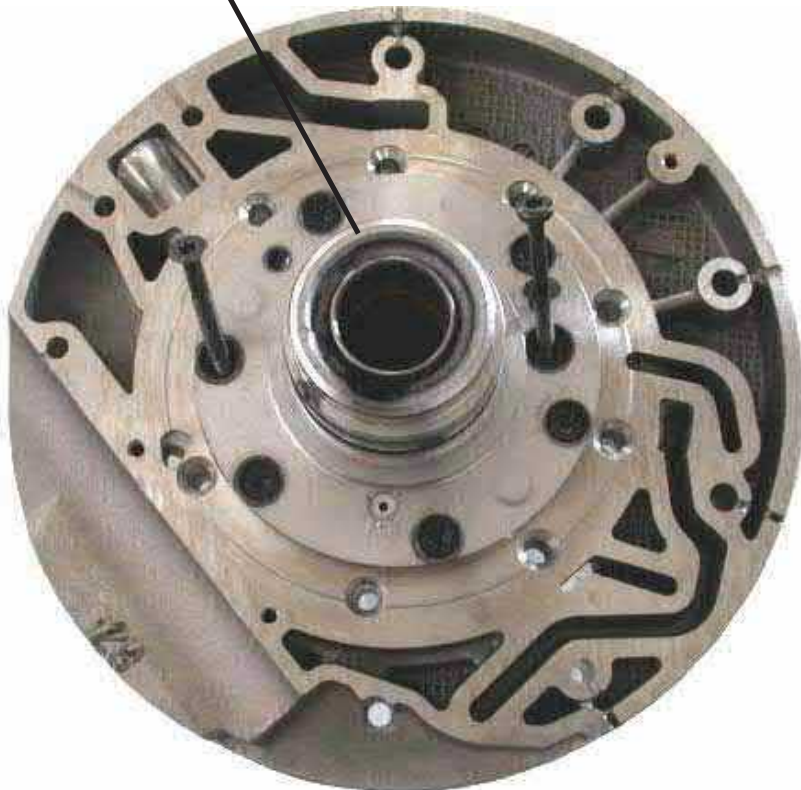
Look here for bushing wear.
