SolarEdge retrofit @ W1VLF Solar Array

SolarEdge retrofit W1VLF Solar Array

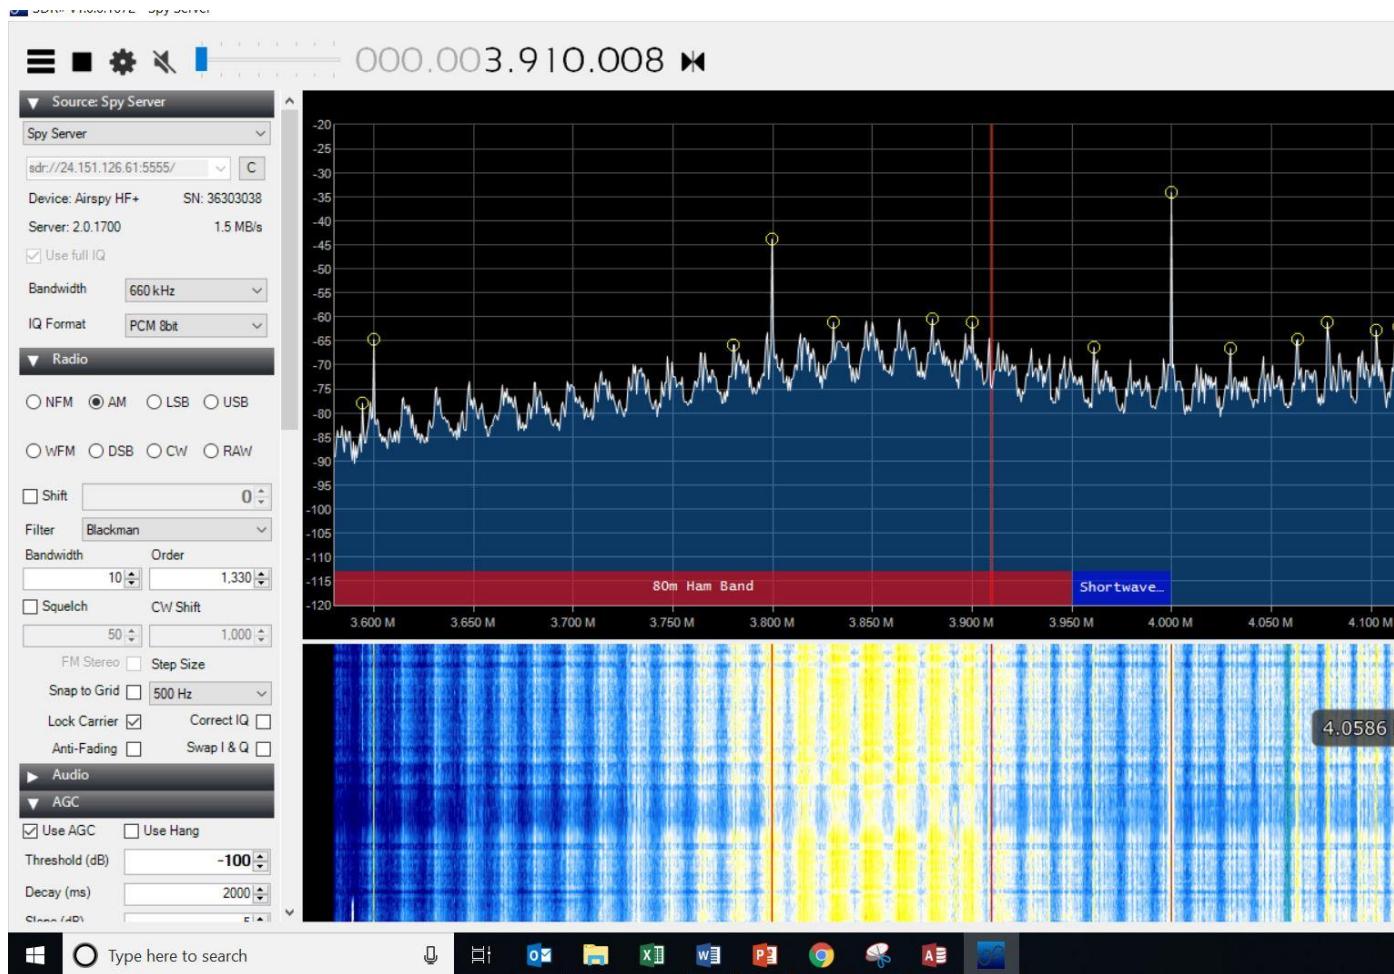
The 75 Meter band as seen @W1VLF. The antenna is a 160 Meter dipole fed with open wire feed. Screen capture was taken at 12 Noon. Note the strong carriers at 200 KHz intervals. Also note the digital noise “haystacks” at approx. 18 KHz intervals

1. The “Optimizer” is the source of the 200 KHz peaks. There is 1 optimizer per panel in the 27 Panel 6.25 KWhr solar array. The purpose of the optimizer is 2 fold. One it act as MPPT (Mean Power Point Transfer) device which constantly monitors the PV panel and loads it appropriately in order to extract maximum power output from the panel, based on light level, temperature, and other factors. It essentially a smart DC to DC converter.
2. The optimizer also performs the rapid shutdown function. Which is required by the NEC. Basically the DC from the PV panels must cease when either the AC inverter is disconnected, the DC disconnect is engaged. This done for safety reasons consider that in a 6.25 KW system running at 384 Volts to the inverter there is about 16 amps of current flowing. Rapid shut down insures the safety of firefighters, system technicians etc.

- All workers were using safety line tied off to designated anchor points on the system.
- Results are the 200 KHz noise spikes seen in the opening photo are completely eliminated. The noise haystacks every 18 KHz have also been eliminated.

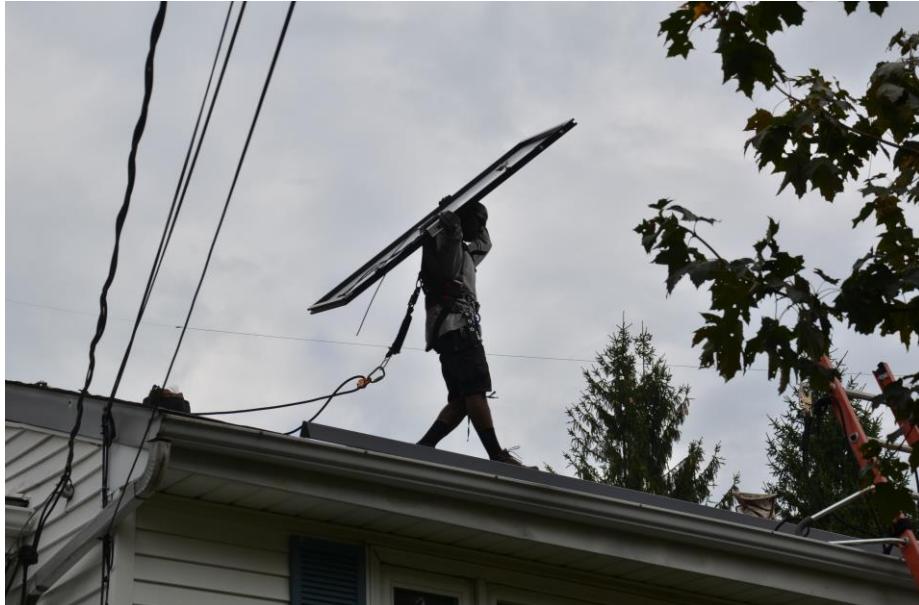
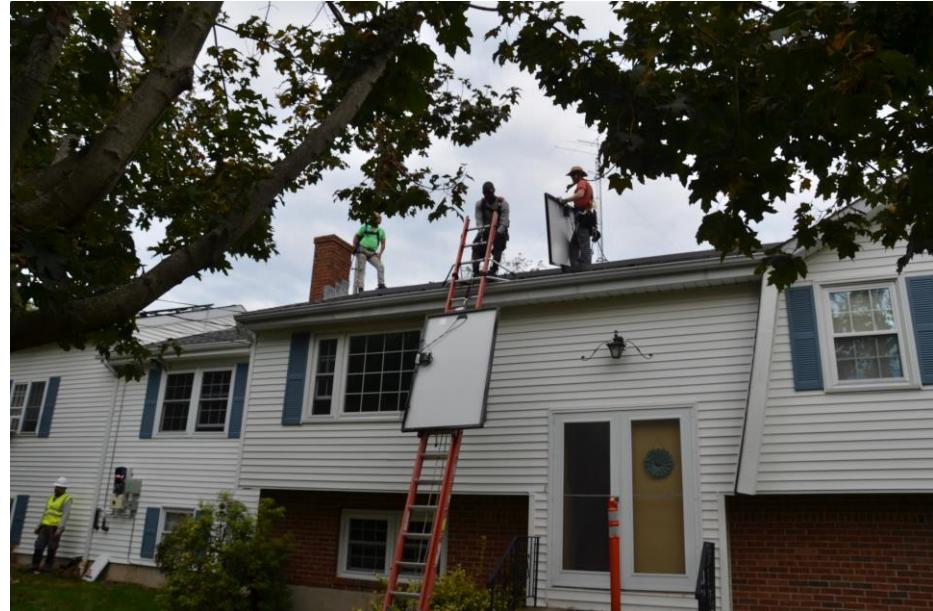
All 27 PV panels had to be disconnected, unbolted, lower to the ground and retrofitted with new optimizers

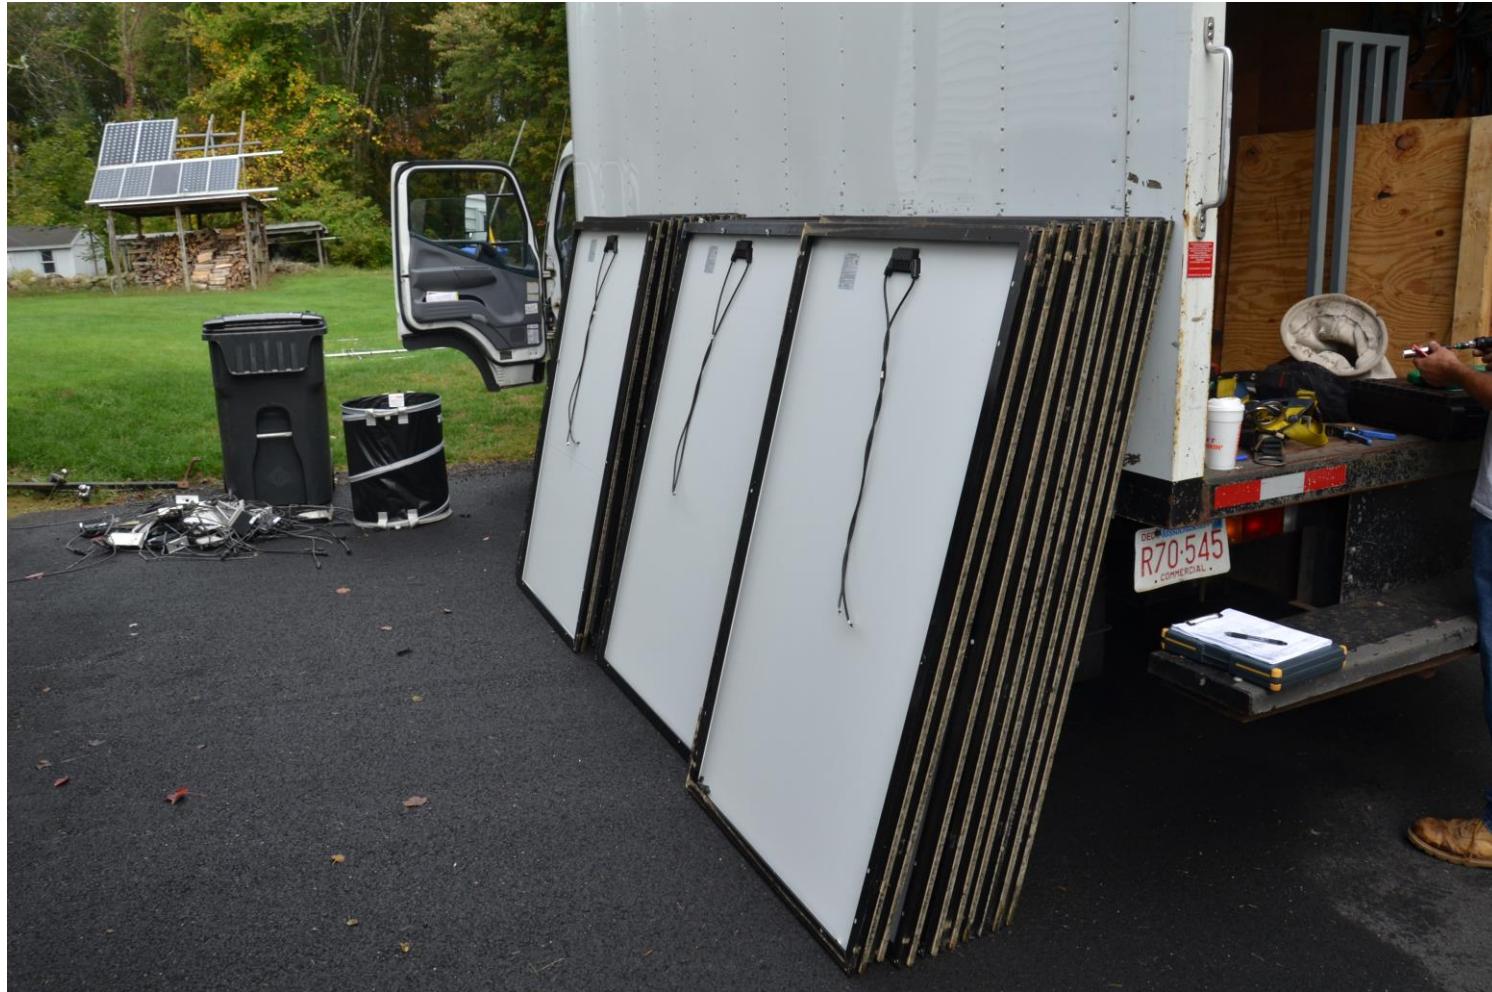
All 27 PV panels on the ground.

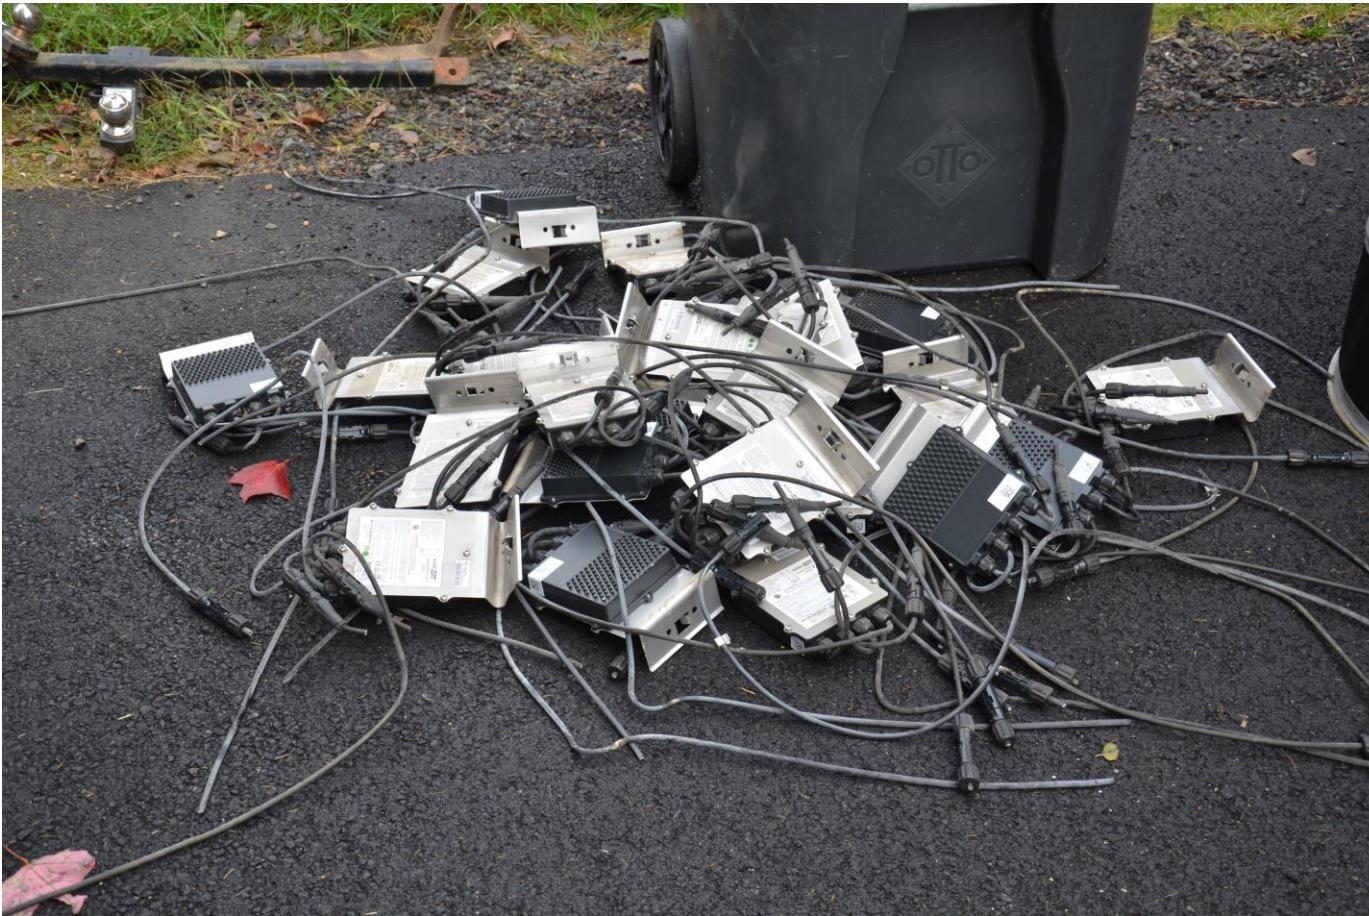
Discarded SolarEdge optimizers

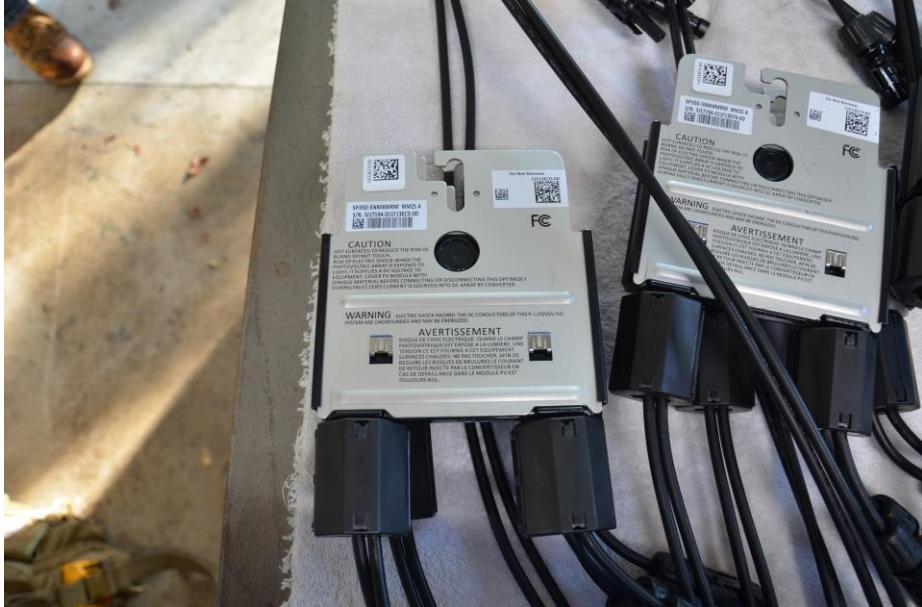
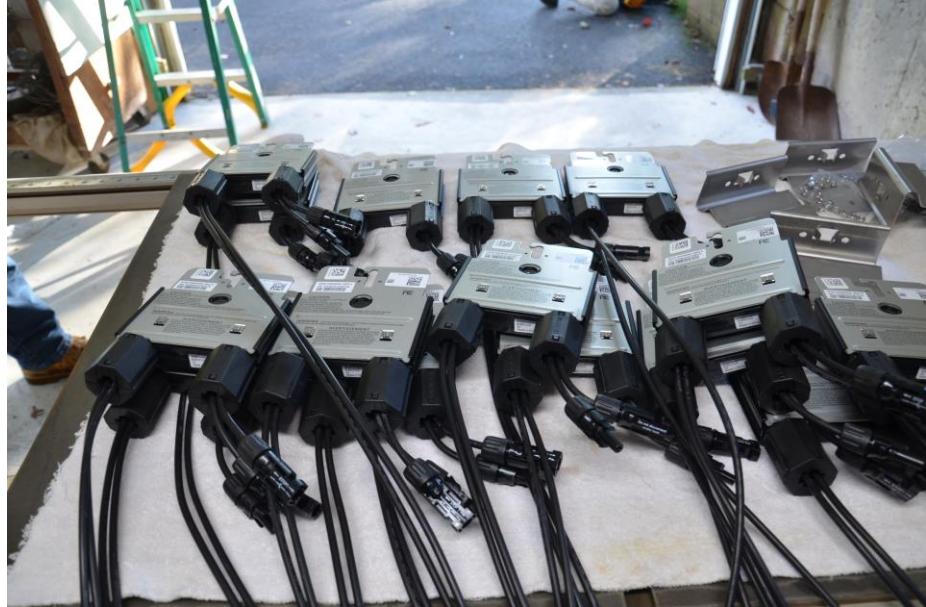
New “Spread Spectrum” SolarEdge optimizers fitted with Fair-Rite Mix 31 large snap on cores. Ready for installation onto the back of the PV panels

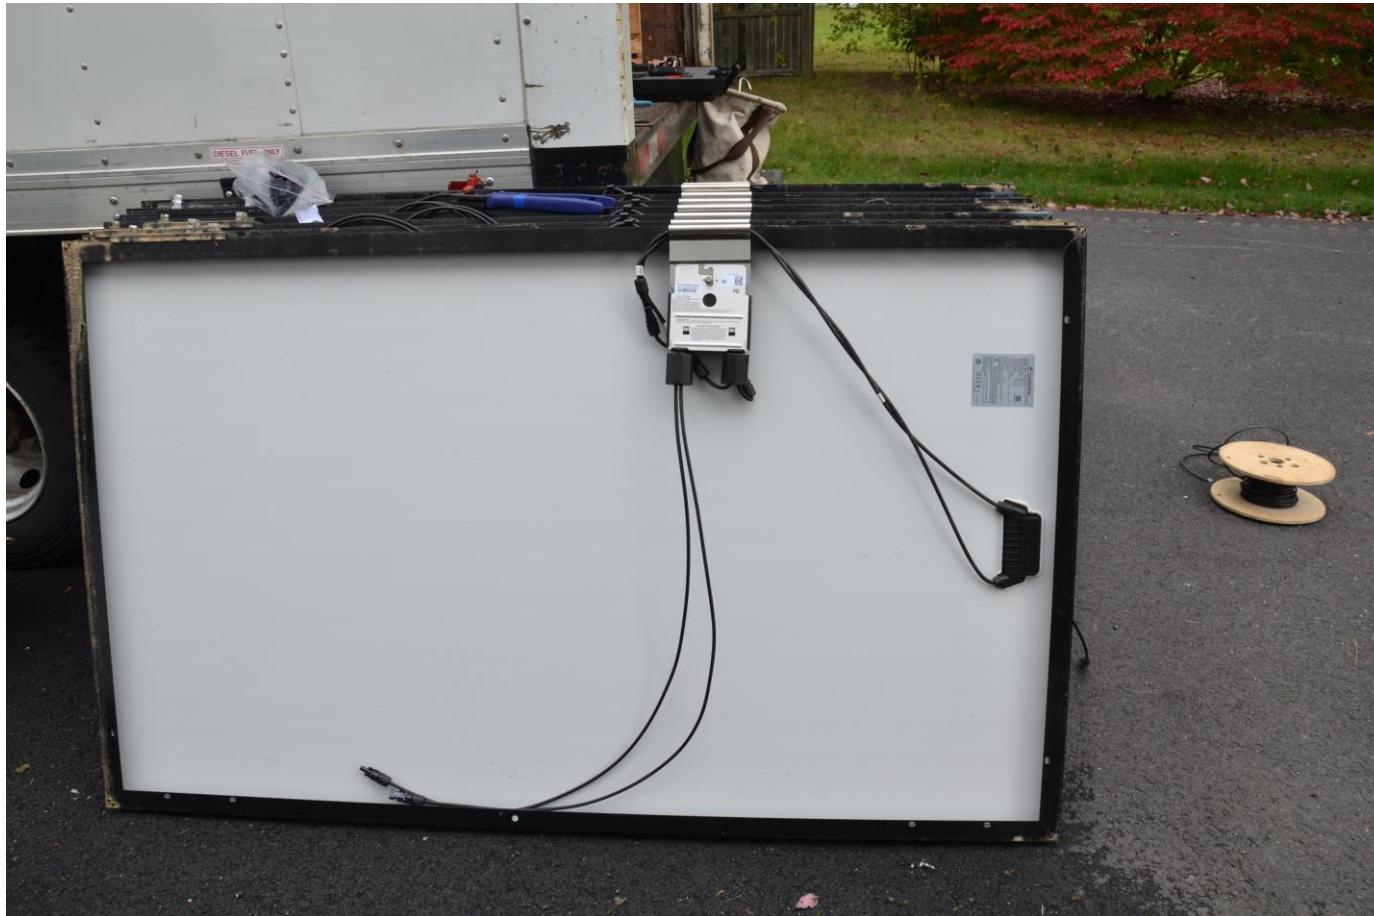
New "Spread Spectrum" SolarEdge optimizers fitted with Fair-Rite Mix 31 large snap on cores. Ready to be reinstalled on the roof. Note that the wires from the PV panel are twisted and have CMC's installed as well as the panel interconnect cables.

- Not shown is the PV panel interconnect cables being removed and replaced with new cables in a twisted pair configuration. Eliminating the loop configuration of the original installation. This required the use of several hundred feet on new interconnect cable and connectors
