INTRODUCTION THM 125C

Since the introduction of the THM 125 transaxle in model year 1980, there have been many major engineering changes. These changes have affected nearly every part used in the 125 and 125c.

This Update Handbook will explain each change, the parts affected by the change, any parts interchangeability problems created by the change. This Update Handbook will cover all of the changes from start of production up through and including model year 1987, along with common problems, and fixes, for the THM 125 transaxle.

Technical Service Information

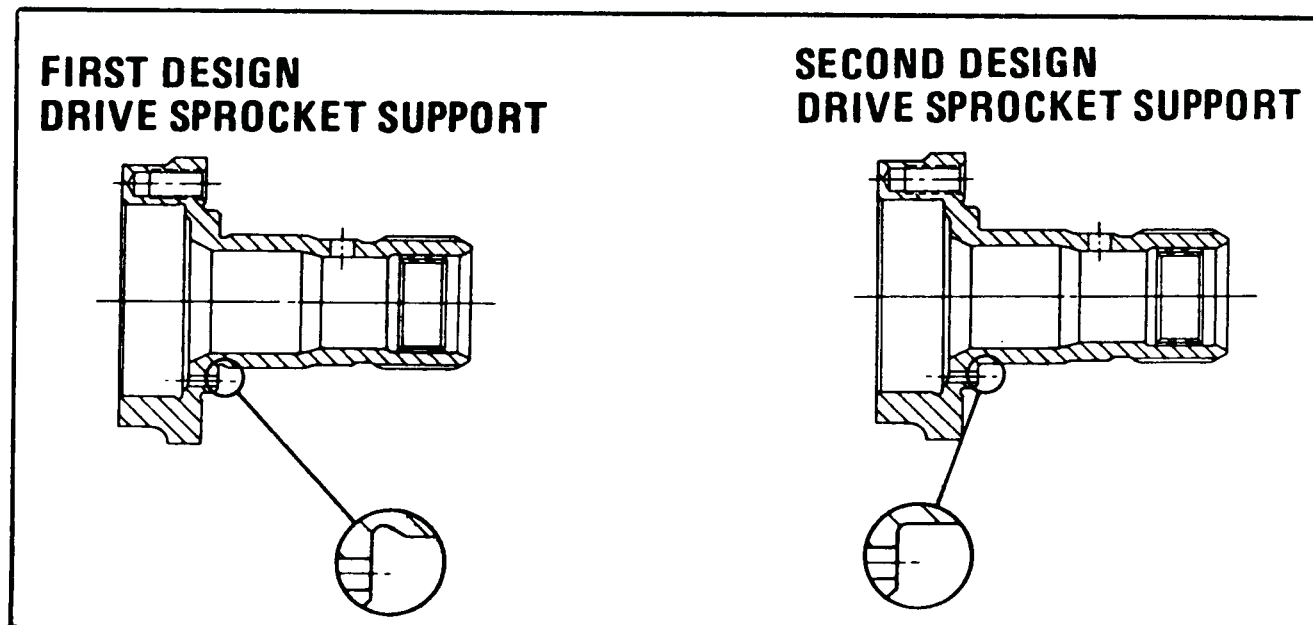
Figure 2

In mid-september, 1980, design changes on the drive sprocket support made it necessary to install the converter bushing $5/64$ " deeper inside of the converter hub.

For identification, the 1st design support has an undercut shaft and the 2nd design support has a radius shaft (See Figure 2).

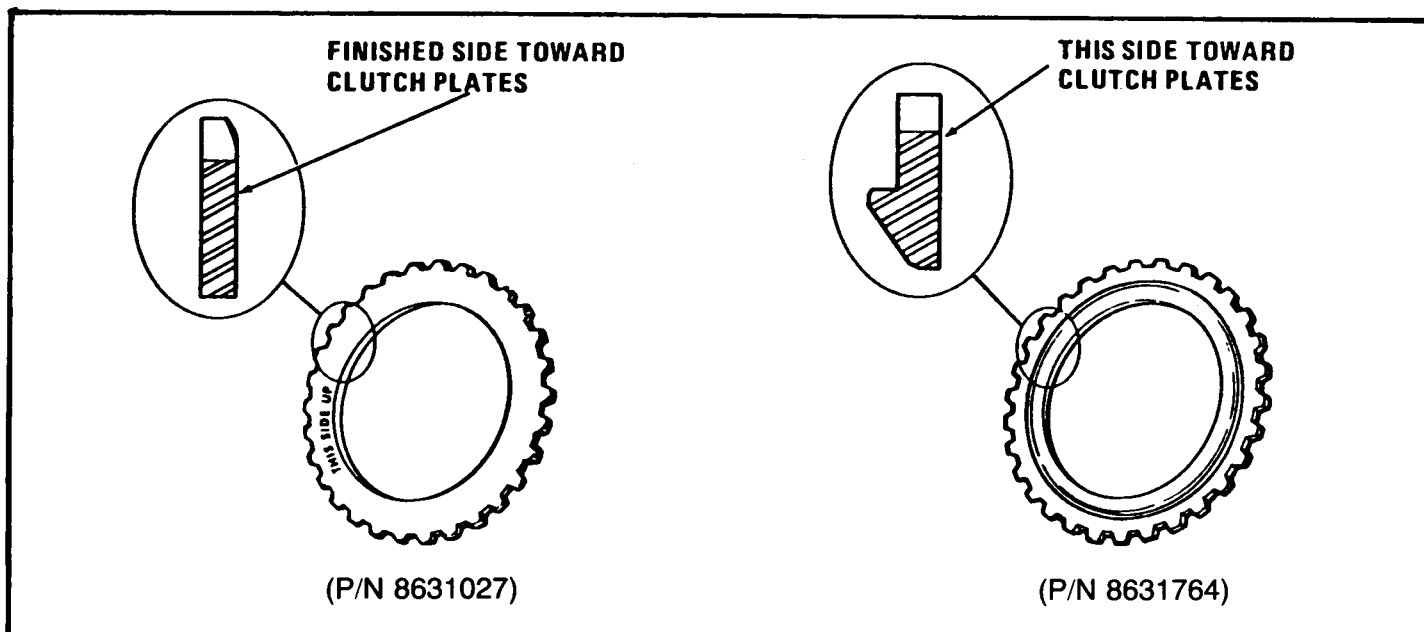
Figure 9

Beginning mid-July, 1981, a new design direct clutch backing plate was used on all THM 125 models (See Figure 9).

The new design backing plate has a raised side for identification, and a flat side, which when assembled, should face toward the clutch plates.

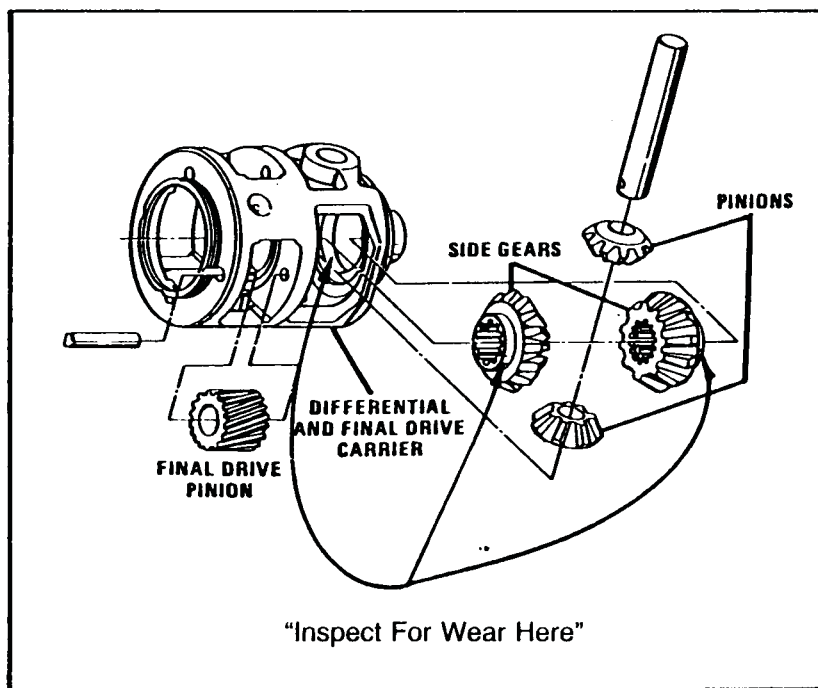
Figure 13

The extra lubrication was to help eliminate wear patterns in the final drive carrier and on the side gears (See Figure 13).

When the final drive carrier would wear it would first show up as an oil leak at the right hand axle seal. The final drive carrier was also later changed to a hardened surface (Identified by its blackened color), to help eliminate wear in this area.

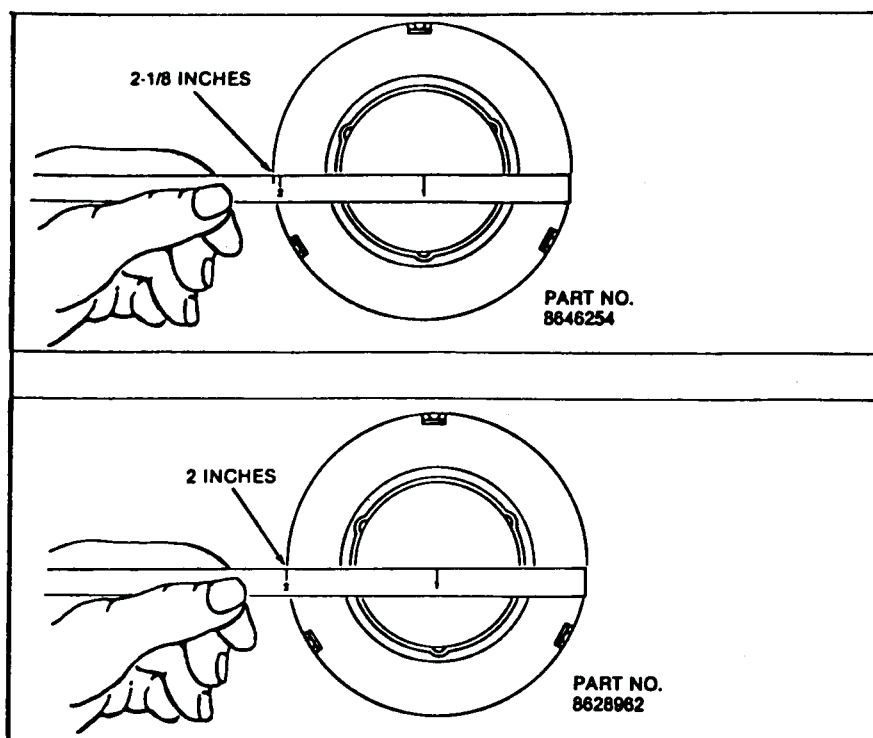
Figure 14

Beginning October, 1983, a new larger thrust bearing assembly (Final Drive Sun Gear to Differential Carrier) went into production in the 1984 model THM 125/125C transaxle, using the 2.84 final drive ratio.

The difference between the two thrust bearing assemblies is the outer diameter size. Also the final drive carrier bearing surface is machined larger to accept the larger outer diameter bearing. See figure 14 for comparison of the bearings.

The two thrust bearings are not interchangeable and damage to the final drive could result if the bearings are mixed.

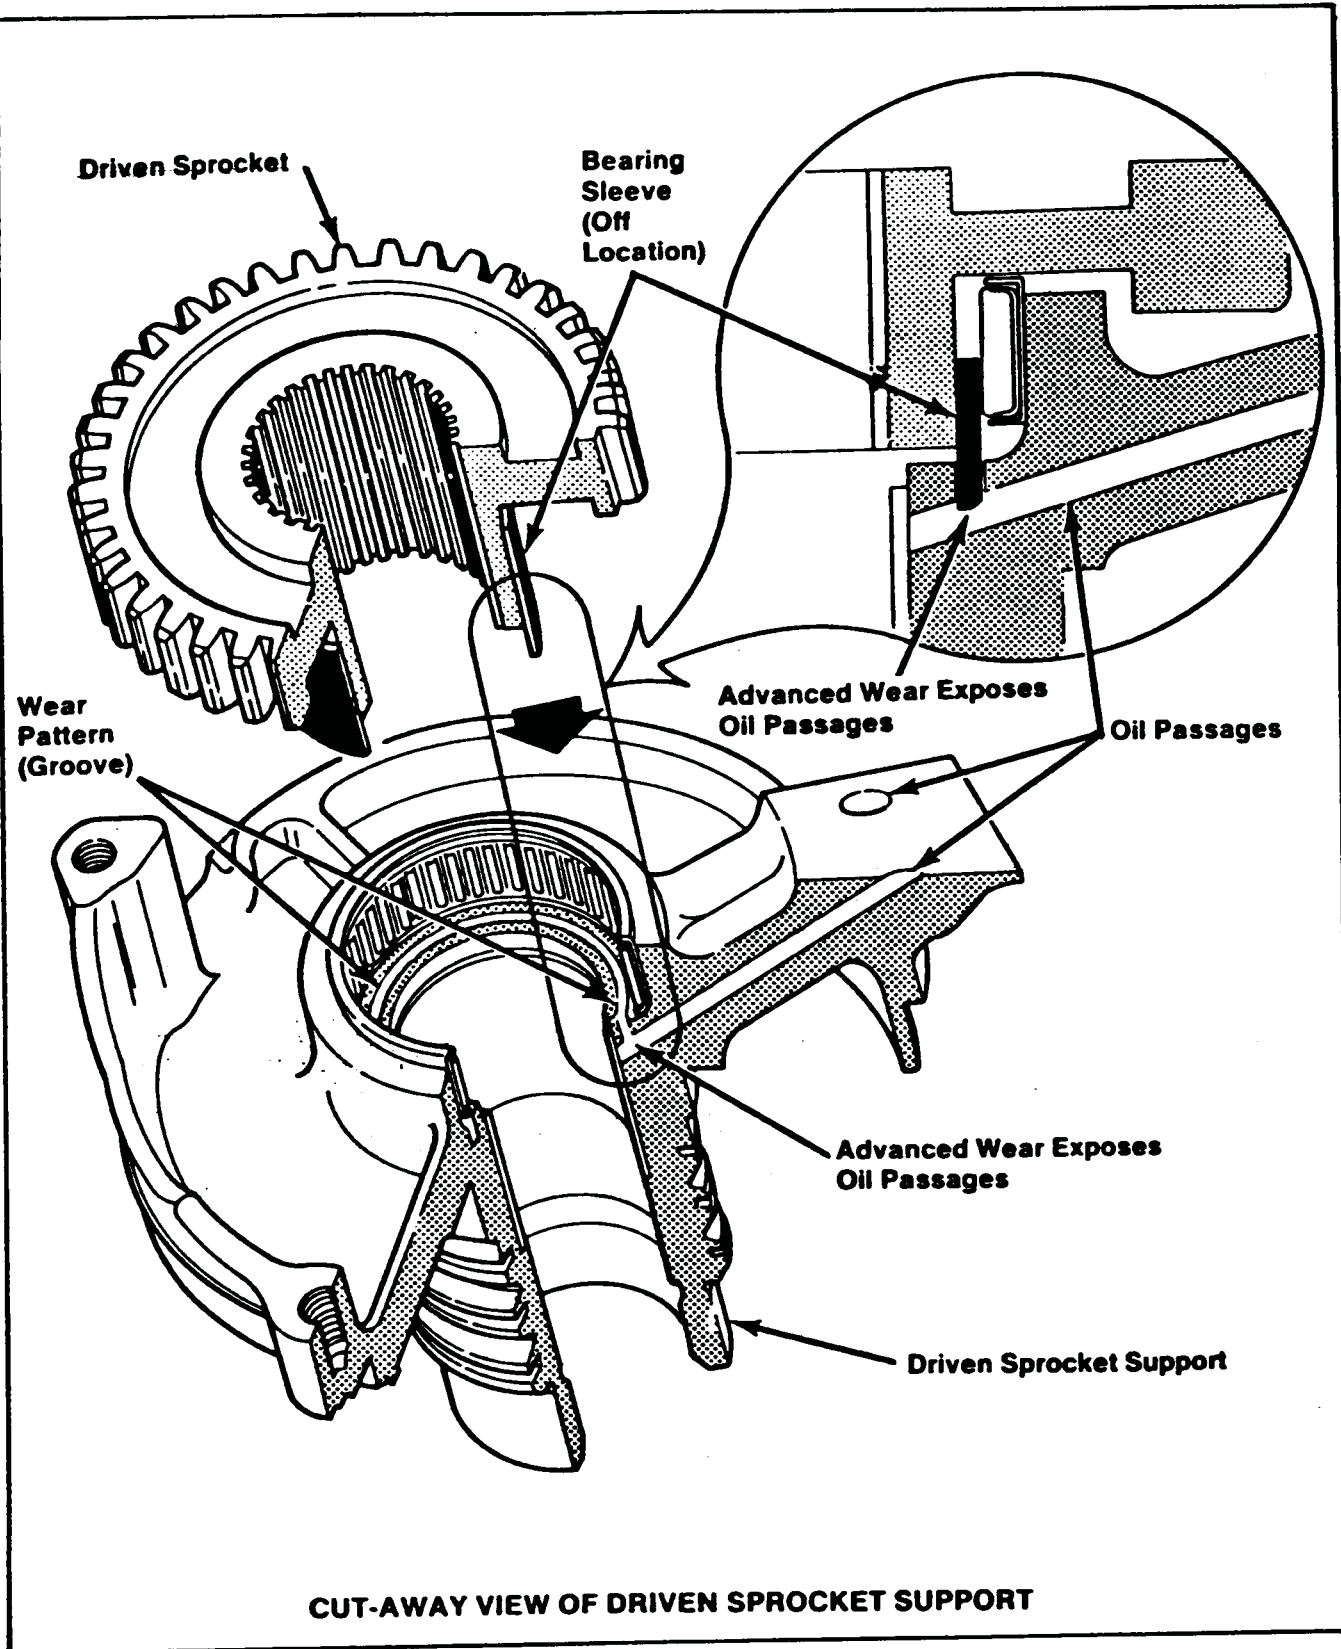
Figure 15

When diagnosing a THM 125 transaxle for lack of drive, slipping shifts, or erratic shifts, be sure to check the driven sprocket support for wear as shown in figure 15.

This wear pattern, if present, is caused by the bearing sleeve on the outside hub of the driven sprocket moving off and wearing into the driven sprocket support. As this wear condition reaches an advanced state the oil feed passages in the driven sprocket support are exposed, allowing an oil pressure leak.

The bearing sleeve on the driven sprocket may, after causing the indicated wear pattern (Groove), move back to the proper location and appear to be normal. Consequently, if this condition is present, be certain to check both the driven sprocket and driven sprocket support as shown in Figure 15.

CUT-AWAY VIEW OF DRIVEN SPROCKET SUPPORT

If the above condition exists, replace the driven sprocket, driven sprocket support, and any other affected parts. Be sure also to check the direct and forward clutch packs, as well as the intermediate band for wear.

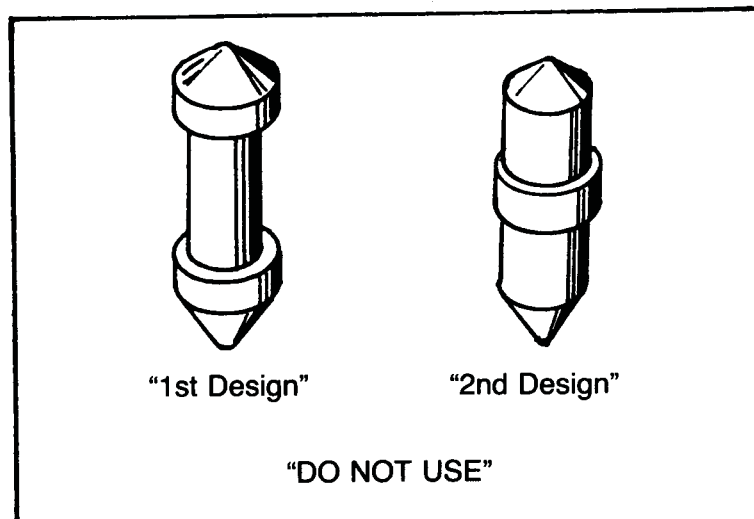
Figure 17

If this valve is leaking the result will be a burnt intermediate band and burnt direct clutch.

If you find a 3rd accumulator check valve like the ones shown in Figure 17, discard them and replace with the 3rd design (8643964).

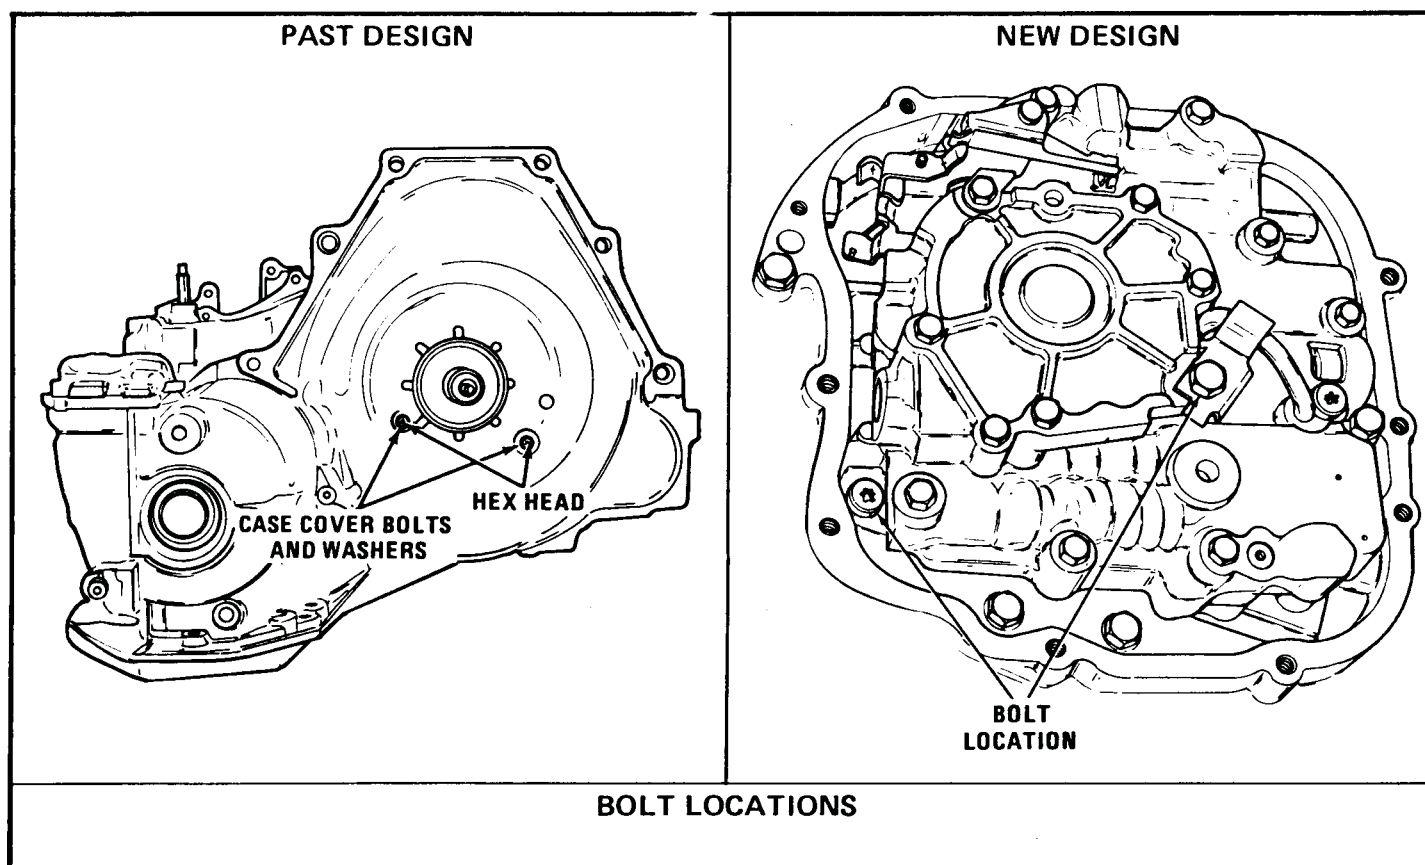
Figure 23

Beginning in late April, 1981, THM 125 transaxles were built with a new design case and case cover. This design change relocated the case to case cover bolts from inside the bell housing to the case cover area to eliminate a possible oil leak location. (Figure 23)

The new design parts and the past design parts are not interchangeable.
