## UPDATE HANDBOOK AODE, 4R70W, 4R70E, 4R75E

**AUTOMATIC TRANSMISSION SERVICE GROUP**  
**18639 S.W. 107 AVENUE**  
**MIAMI, FLORIDA 33157**  
**(305) 670-4161**

## AODE, 4R70W, 4R70E, 4R75E

*Printed  
October, 2006*

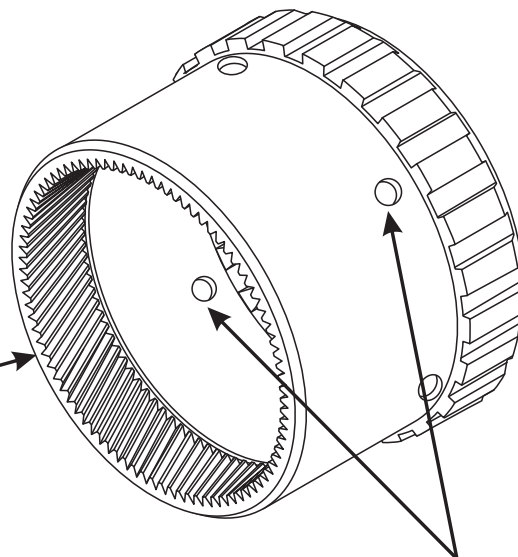
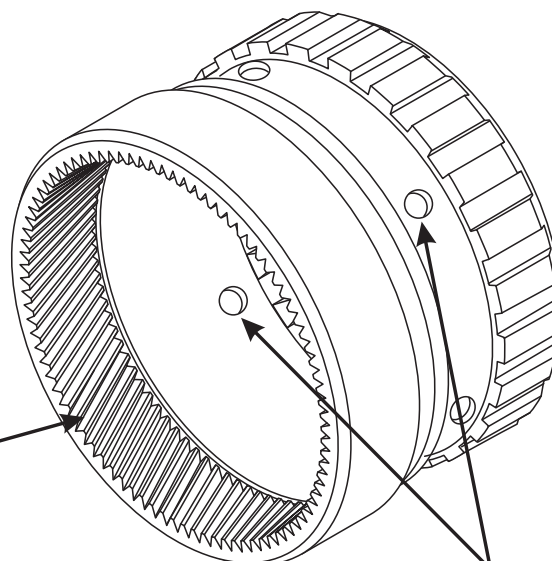
Figure 10

**CAUSE:** The cause may be, AOD internal ring gear that has no holes to trigger the output speed sensor has been installed by mistake.

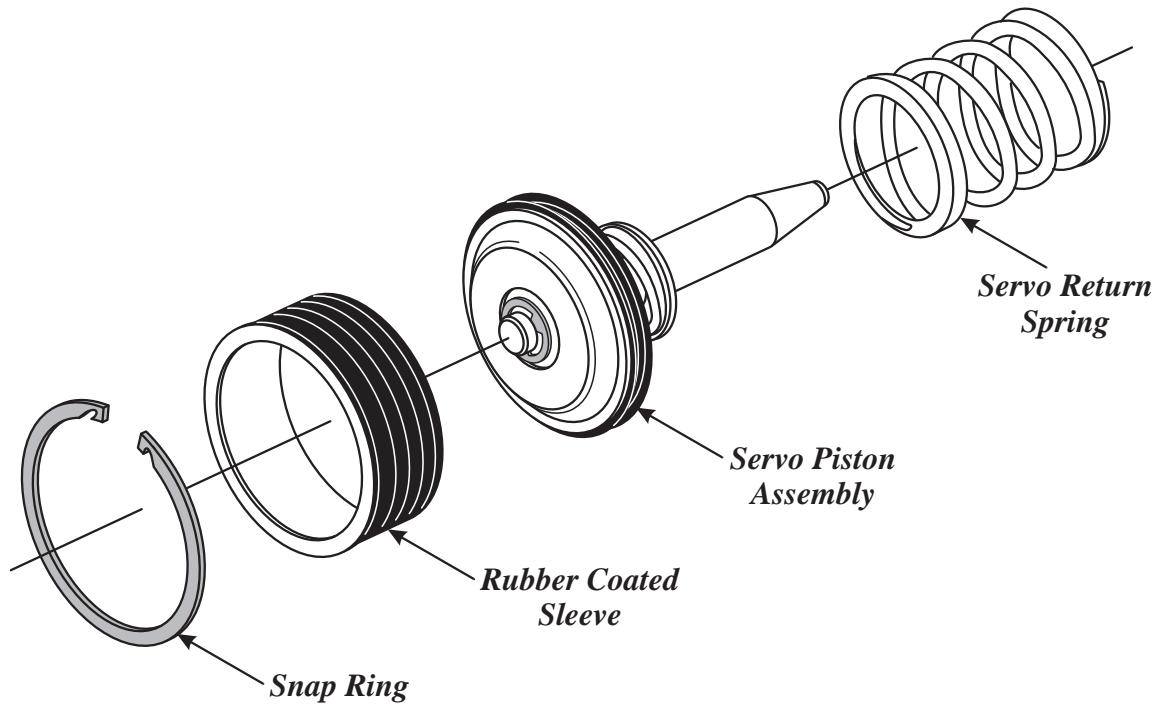
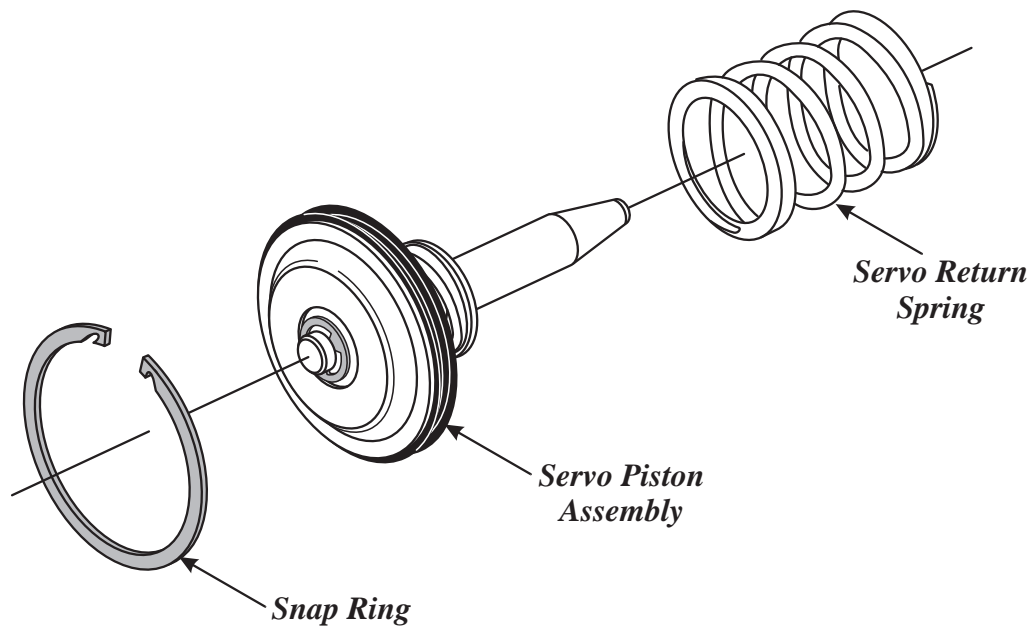
Figure 19

**CAUSE:** The cause may be, a mis-assembled Overdrive Servo Assembly, with the "Rubber Coated Sleeve" omitted. The 4R70W transmission is calibrated with a smaller diameter overdrive servo piston than is the AOD-E transmission. To retain a common case between the two transmissions, an additional "Rubber Coated Sleeve" is required on the 4R70W Overdrive Servo Assembly, as shown in Figure 19.

**CORRECTION:** Install the "Rubber Coated Sleeve" in the Overdrive Servo Assembly case bore, as shown in Figure 19. If your rubber coated sleeve is missing or lost, you **must** purchase the complete Overdrive Servo Assembly, available under part number F3LY-7H188-A. It is not available individually.  
Overdrive servo piston dimensions are shown in Figure 18, to identify the two different overdrive servo pistons.

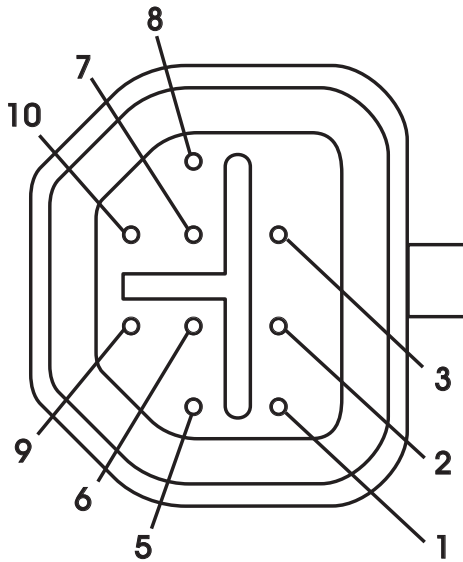
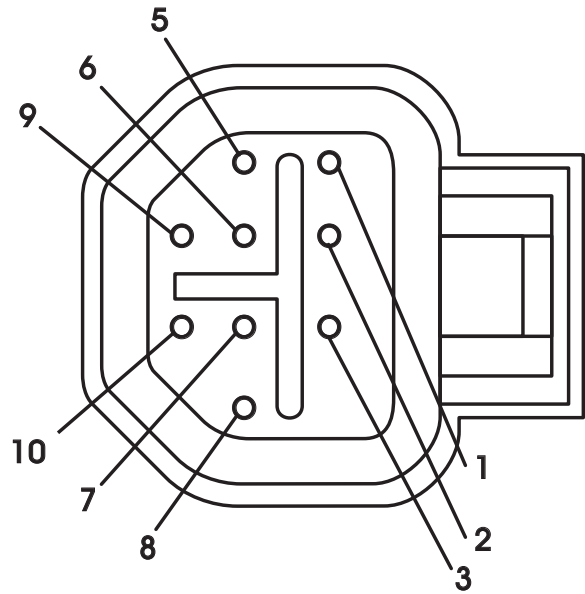
Figure 20

**CAUSE:** The cause may be, an incorrect Torque Converter Clutch (TCC) Solenoid, with low resistance (1.0 - 3.0 ohms), mistakenly installed in *some* 4R70W transmissions, as shown in Figure 20. The resistance should be 10-16 ohms on *some* models.

*Step 3:* *If* the valve body I.D. code is G2T, G3T, or G2U, *and* resistance on the TCC solenoid measures 1.0-3.0 ohms, *replace* the TCC Solenoid with OEM part number F5AZ-7G136-A. The resistance on these models should be 10-16 ohms.

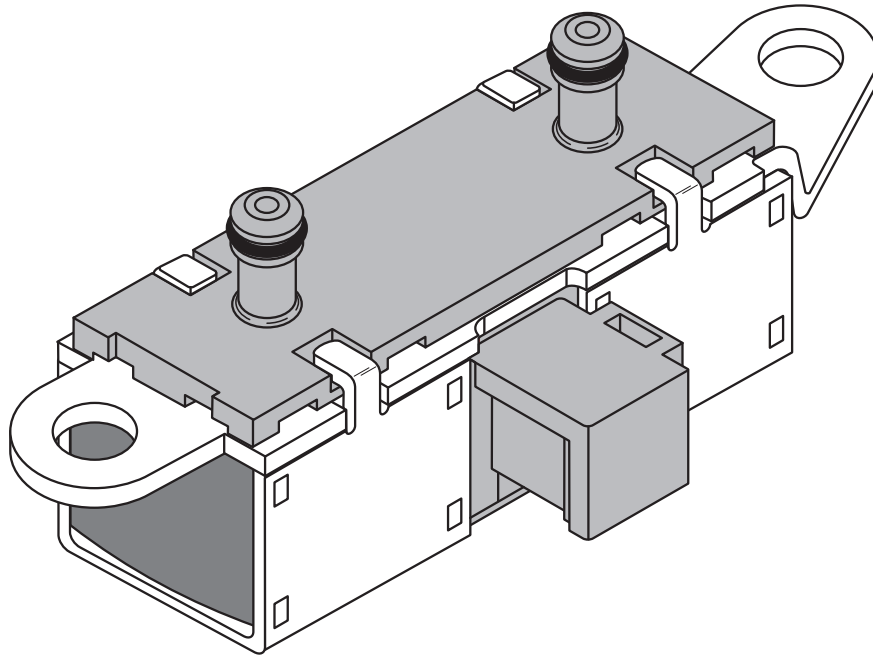
Figure 23

**CAUSE:** The cause may be, a partially clogged Shift Solenoid No. 2, which will stroke the 3-4 shift valve far enough to exhaust *some* of the forward clutch oil.

**CORRECTION:** Install two pressure gages to check line pressure and forward clutch pressure, as shown in Figure 22. With the transmission in Drive, both gages should read the same and should be approximately 55-75 PSI. If the forward clutch gage reads lower than the line pressure gage, ***and all internal parts are known to be good***, replace the Shift Solenoid Assembly with OEM part number F5AZ-7G484-A (See Figure 23).

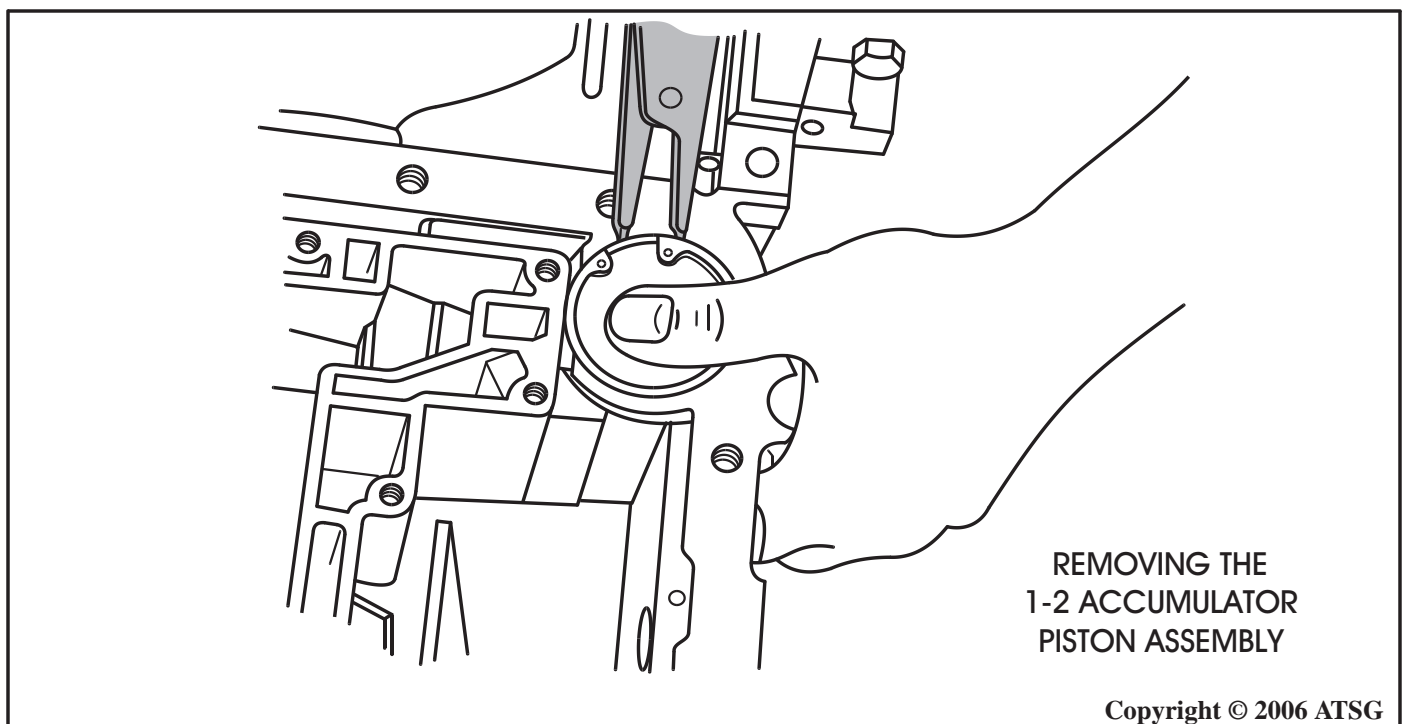
**CAUSE:** The cause may be, premature 1-2 accumulator seal wear, which also creates the case accumulator bore to become scuffed, which leads to the slipping condition and possible loss of intermediate clutches..

**CORRECTION:** Replace the cast aluminum 1-2 accumulator piston with a new design one piece stamped steel piston with molded rubber lip seals, and replace the top accumulator spring with the revised parts available from Ford Motor Co. Case replacement should not be necessary with the use of the revised stamped steel accumulator piston. Refer to Figure 27 to remove the piston assembly. Refer to Figure 28 for illustration of both design stack-ups, and to Figure 29 for a chart to install the proper revised springs into the proper model.

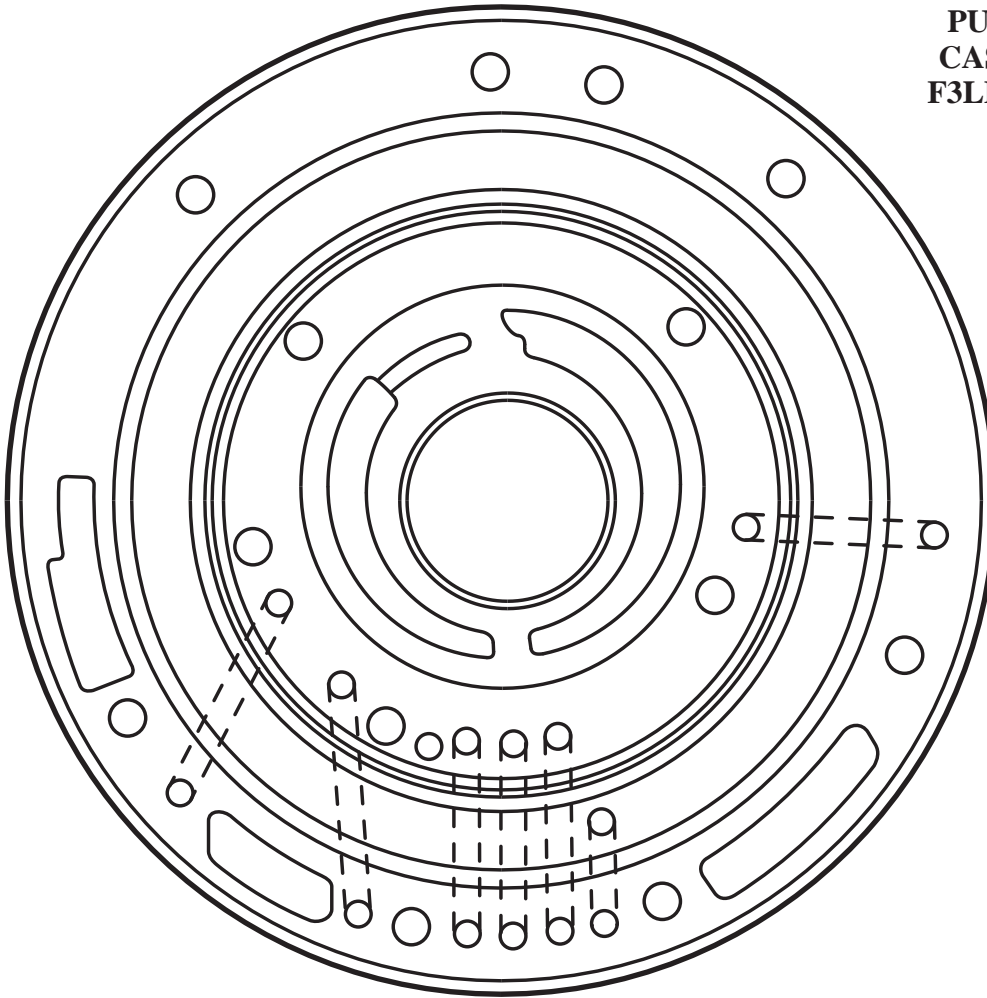
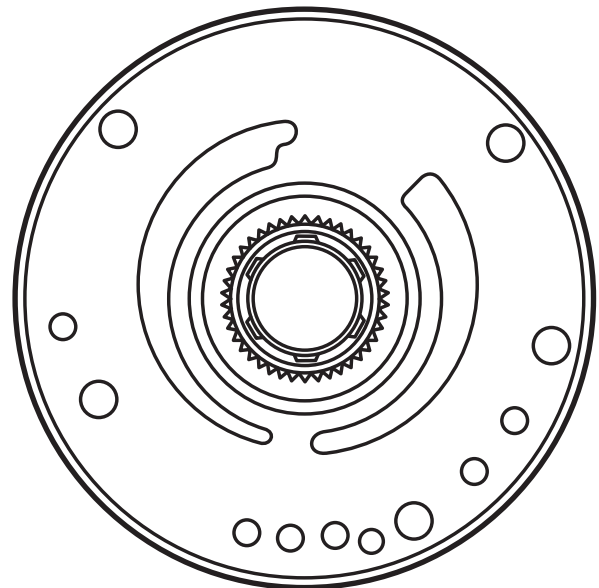
Figure 32

**CHANGE:** Beginning at the start of production for 1995 model vehicles equipped with the AODE/4R70W transmission, a new design oil pump was implemented with re-routed and enlarged pressure cavities (See Figures 32 and 33).

None of the parts listed above should be intermixed with one another. With the new design oil pump being so much more efficient than the previous design, it is **highly** recommended to use the new design pump assembly on **all** models of the AODE/4R70W transmission.

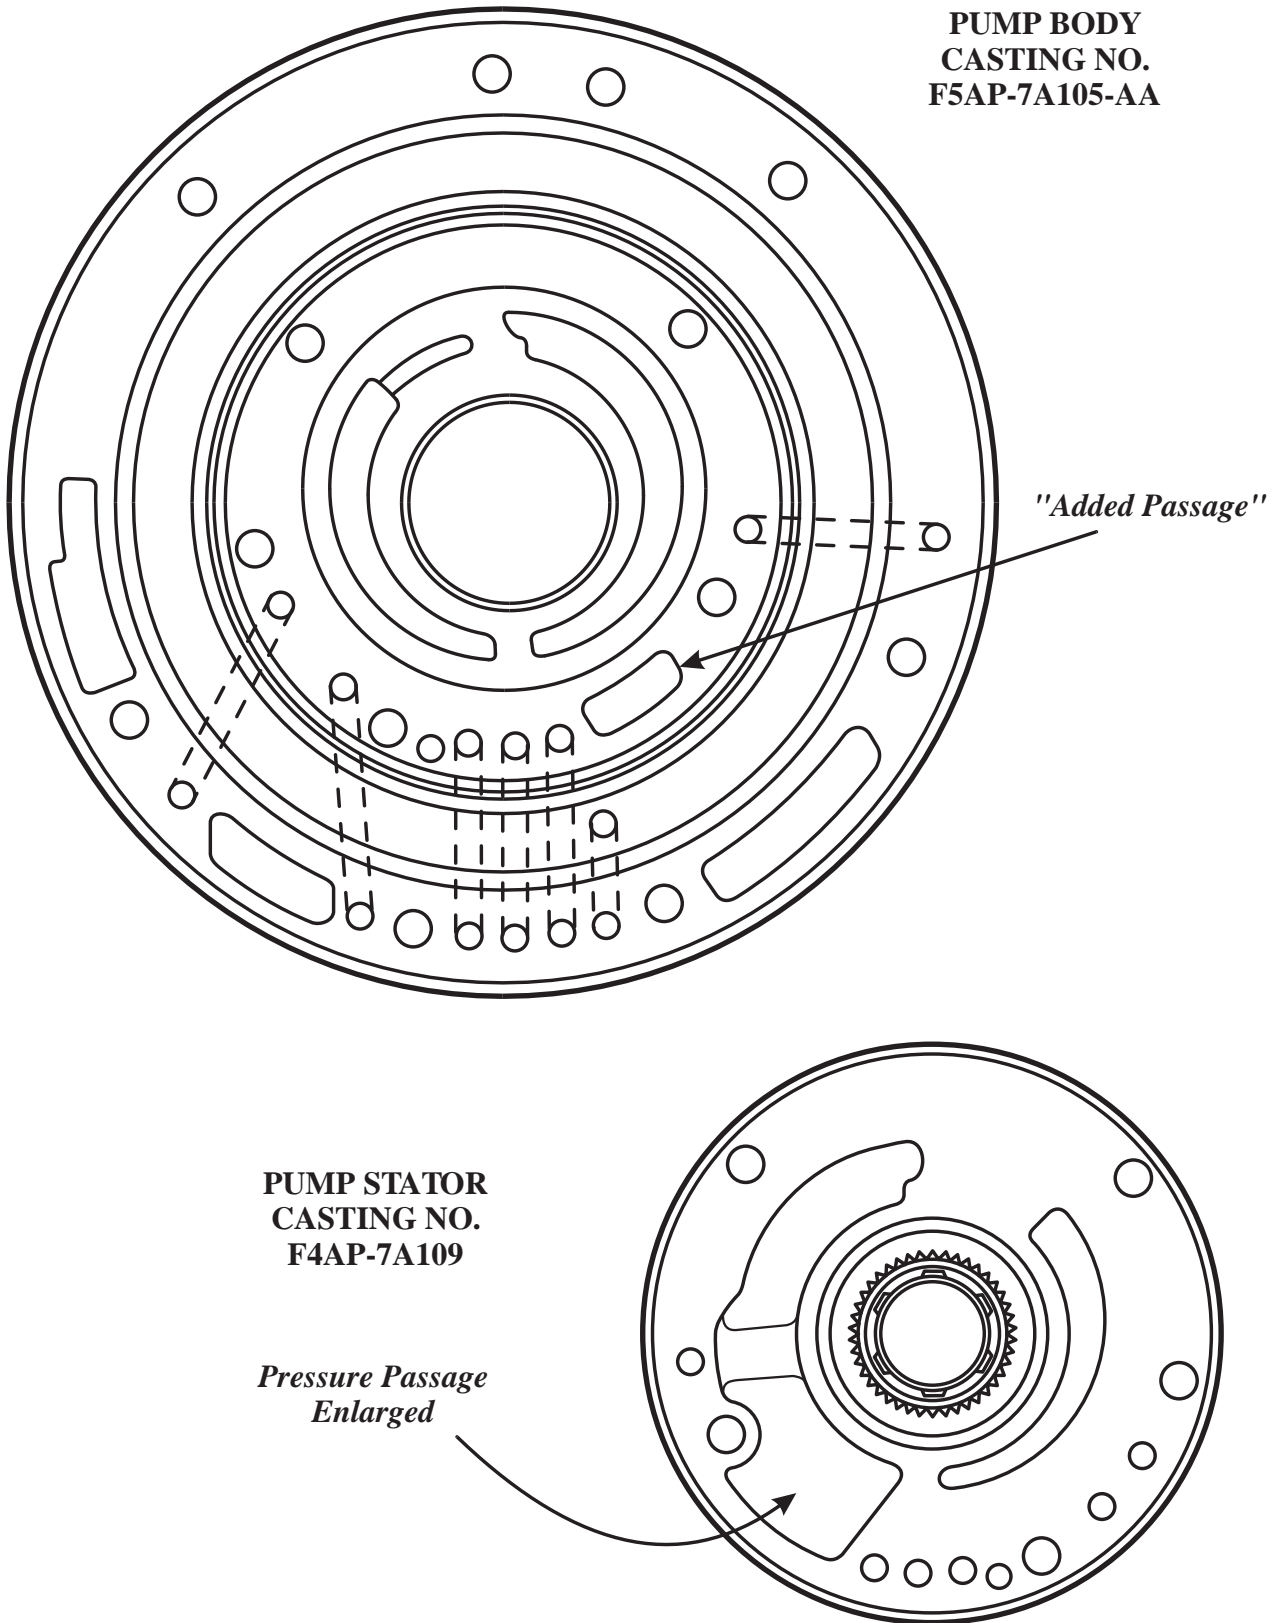
Figure 33

- (1) OIL PUMP BODY - Has an added pressure passage in pump body, shown in Figure 33, and is easily identified by casting number F5AP-7A105-AA located on the front side of pump body.
- (2) OIL PUMP STATOR - Has a much enlarged pressure passage in pump stator as illustrated in Figure 33, and is easily identified by casting number F4AP-7A109 located on back side of the pump stator.

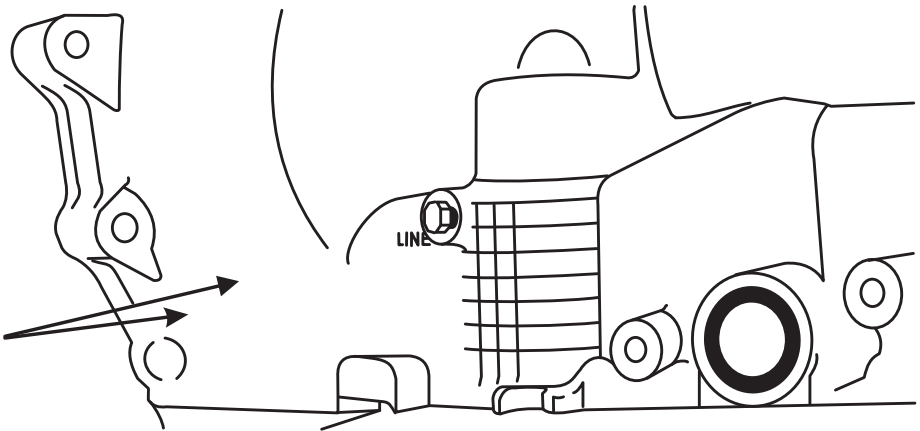
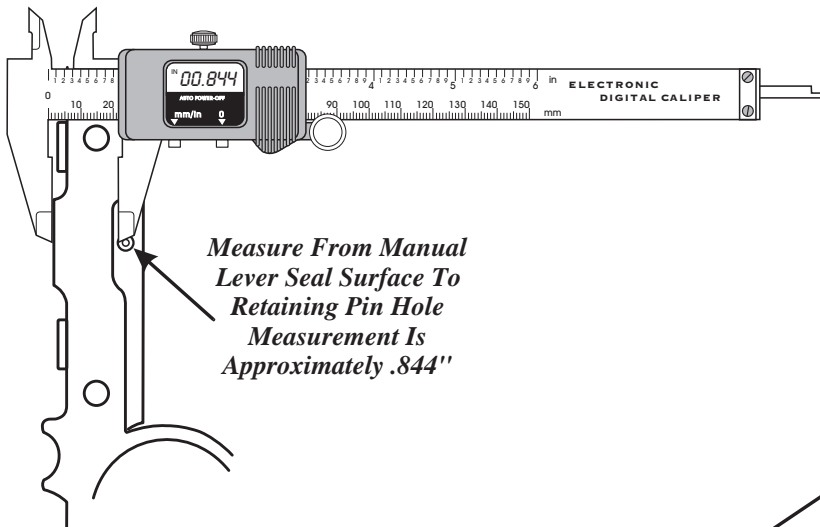
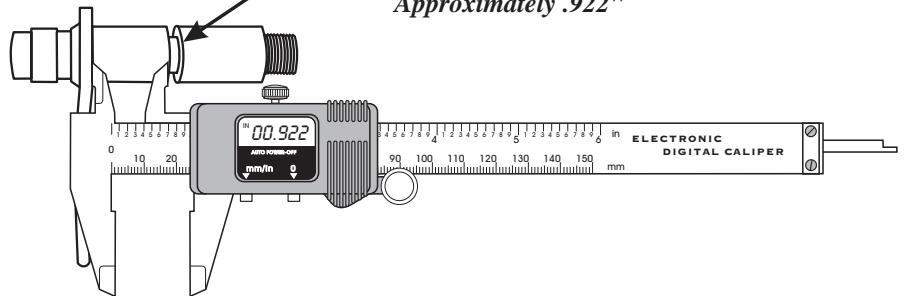
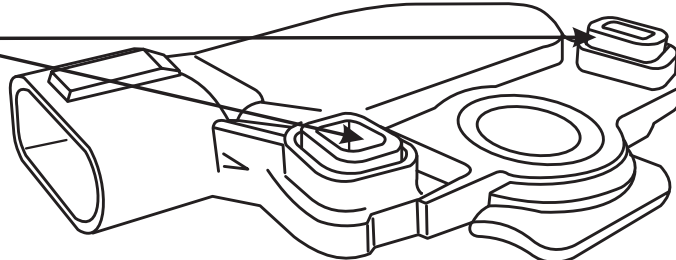
**CAUSE:** The AODE cases are different in thickness when measuring from the manual lever seal surface to the countersink in the manual lever retaining pin hole See Figure 44 and 45.

**Early Case** - The early case has None or One threaded boss on the lower left side of the case, as shown in Figure 44, and the measurement from the manual lever seal surface to the countersink in the manual lever retaining pin hole is approximately .844", which is also shown in Figure 44.

**Early Manual Shift Lever** - Measure from the back flange of shift lever to the first edge of the groove for the retaining pin, as shown in Figure 44. Early lever will measure approximately .922".

**Early MLPS** - Has the *short* torque limiters, as shown in Figure 44.

*NONE OR ONE  
DRILLED AND TAPPED  
BOSSES IN THIS AREA*

*Measure From Manual  
Lever Seal Surface To  
Retaining Pin Hole  
Measurement Is  
Approximately .844"*

*Measure From Manual  
Lever Surface To  
Retaining Pin Groove  
Measurement Is  
Approximately .922"*

*MLPS HAS SHORT  
TORQUE LIMITERS*

**CORRECTION:** It is *mandatory* that the proper parts be installed into the proper case, *as the parts listed above are not interchangeable.* Refer to Figure 44 for the early parts and to Figure 45 for the late parts.

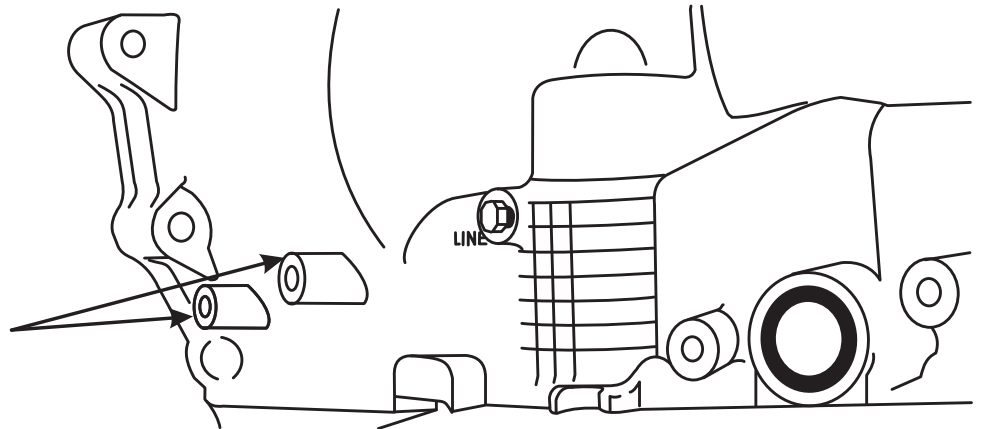
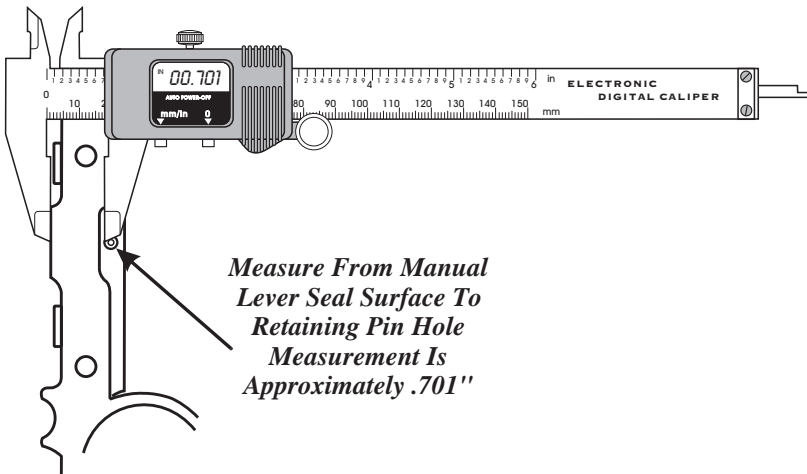
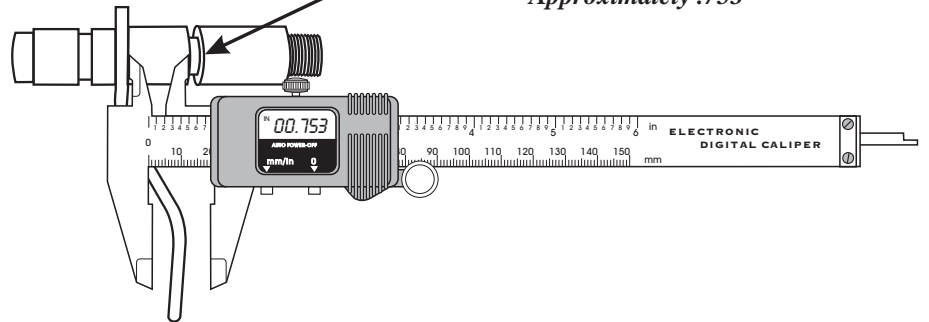
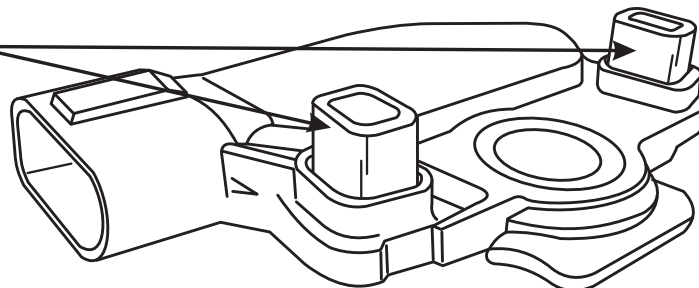
Figure 45

**Late Case** - The late case has Two threaded bosses on the lower left side of the case, as shown in Figure 45, and the measurement from the manual lever seal surface to the countersink in the manual lever retaining pin hole is approximately .701", which is also shown in Figure 45.

**Late Manual Shift Lever** - Measure from the back flange of shift lever to the first edge of the groove for the retaining pin, as shown in Figure 45. The Late lever will measure approximately .753".

**Late MLPS** - Has the *tall* torque limiters, as shown in Figure 45.

**TWO  
DRILLED AND TAPPED  
BOSSES IN THIS AREA**

*Measure From Manual  
Lever Seal Surface To  
Retaining Pin Hole  
Measurement Is  
Approximately .701"*

*Measure From Manual  
Lever Surface To  
Retaining Pin Groove  
Measurement Is  
Approximately .753"*

**MLPS HAS TALL  
TORQUE LIMITERS**

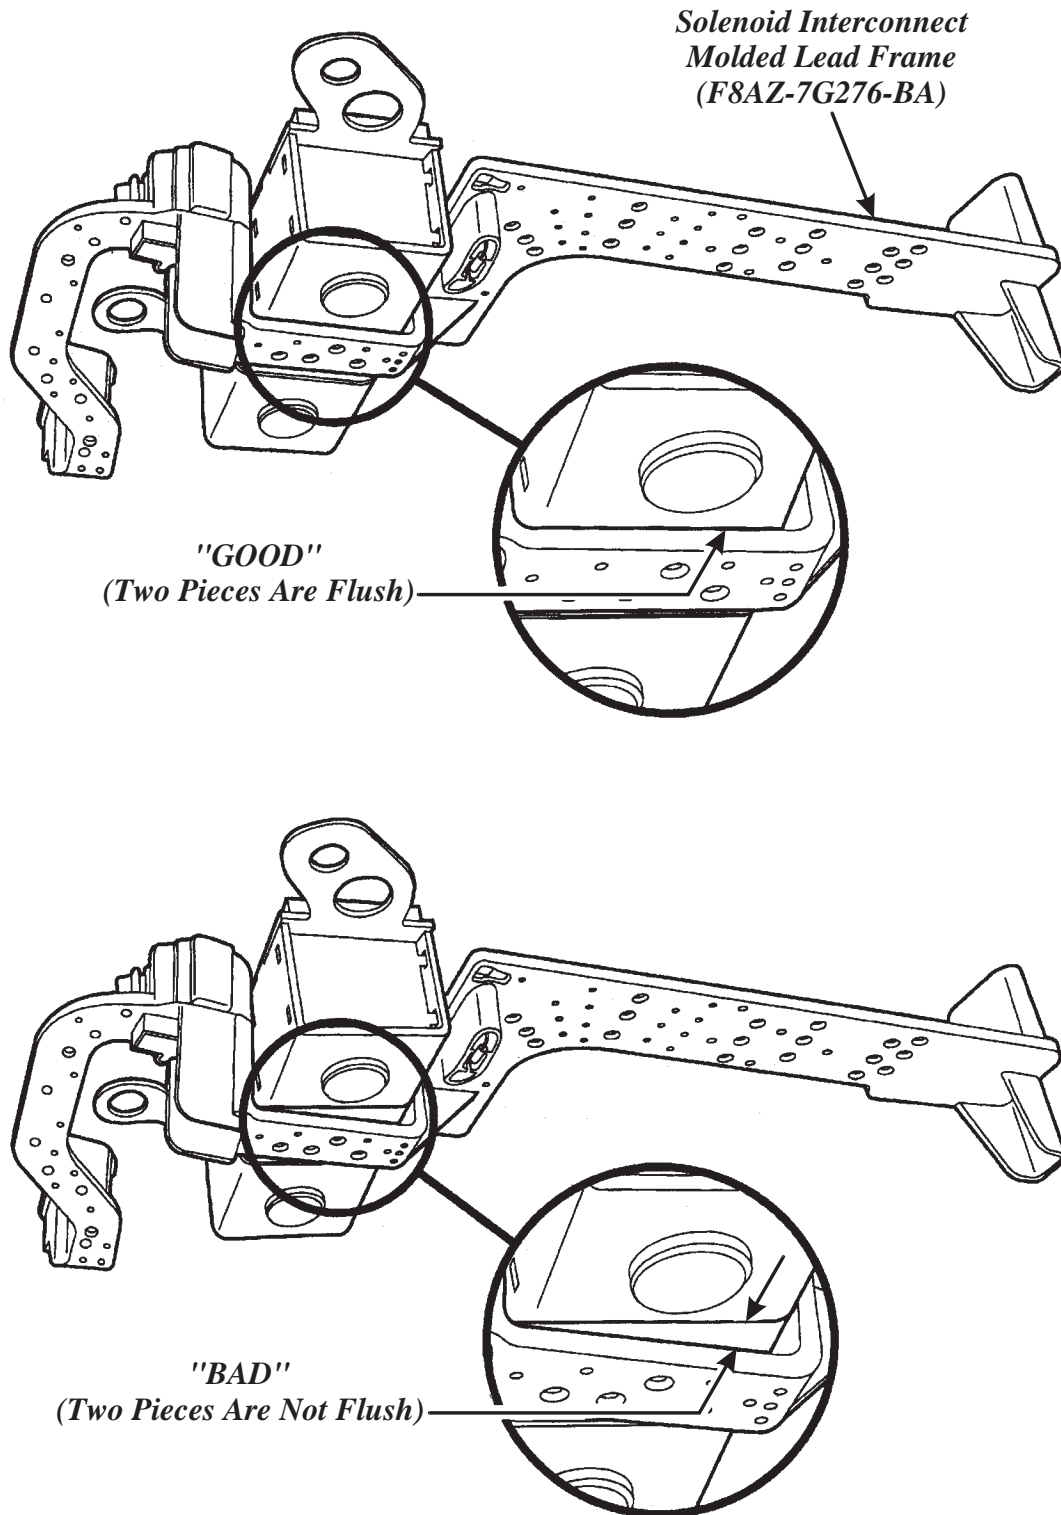
Figure 46

**CAUSE:** The cause may be, the solenoid interconnect molded lead frame not being fully seated on the solenoid pack or the bulkhead interconnect clips not being fully seated between the solenoid interconnect molded lead frame and bulkhead interconnect.

- (3) Verify that the solenoid interconnect molded lead frame is fully seated on all the solenoid connectors as shown in Figure 46. If the solenoid interconnect molded lead frame is fully seated, then gently remove the solenoid interconnect molded lead frame, valve body and the bulkhead interconnect.

- (5) Replace parts as necessary using the part numbers listed below and reassemble unit.

Bulkhead Interconnect (Case Connector) .....	F8AZ-7G276-AA
Solenoid Interconnect (Internal Molded Harness) .....	F8AZ-7G276-BA

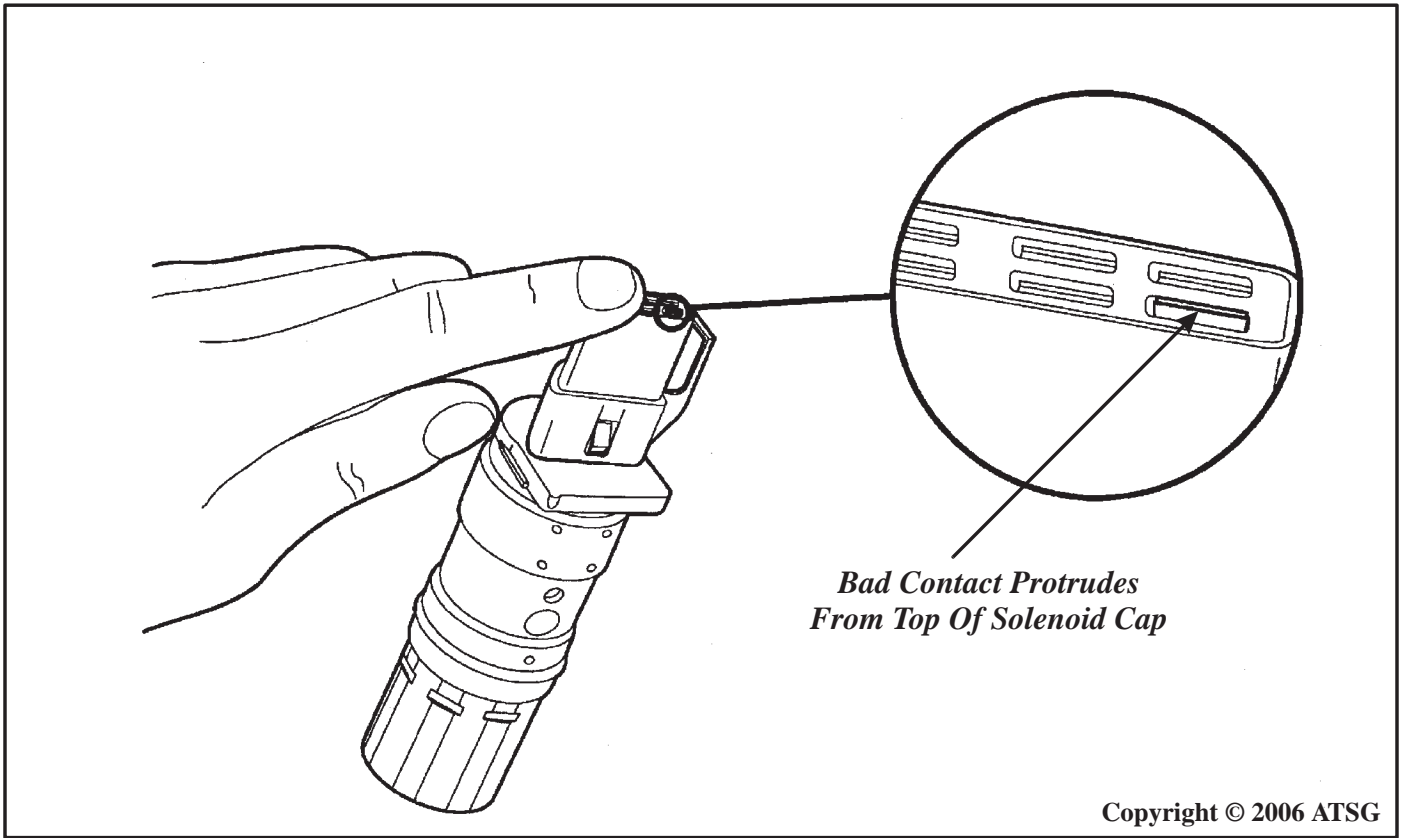
Figure 47

- (4) With the bulkhead interconnect removed, push down on the terminal cover and check to see if any of the terminals are slightly protruding above the plastic cover as shown in Figure 47. Gently pry off the terminal cover using a small screwdriver (See Figure 48). With the terminal cover off, inspect the bulkhead interconnect for spreading terminals as shown in Figure 49.

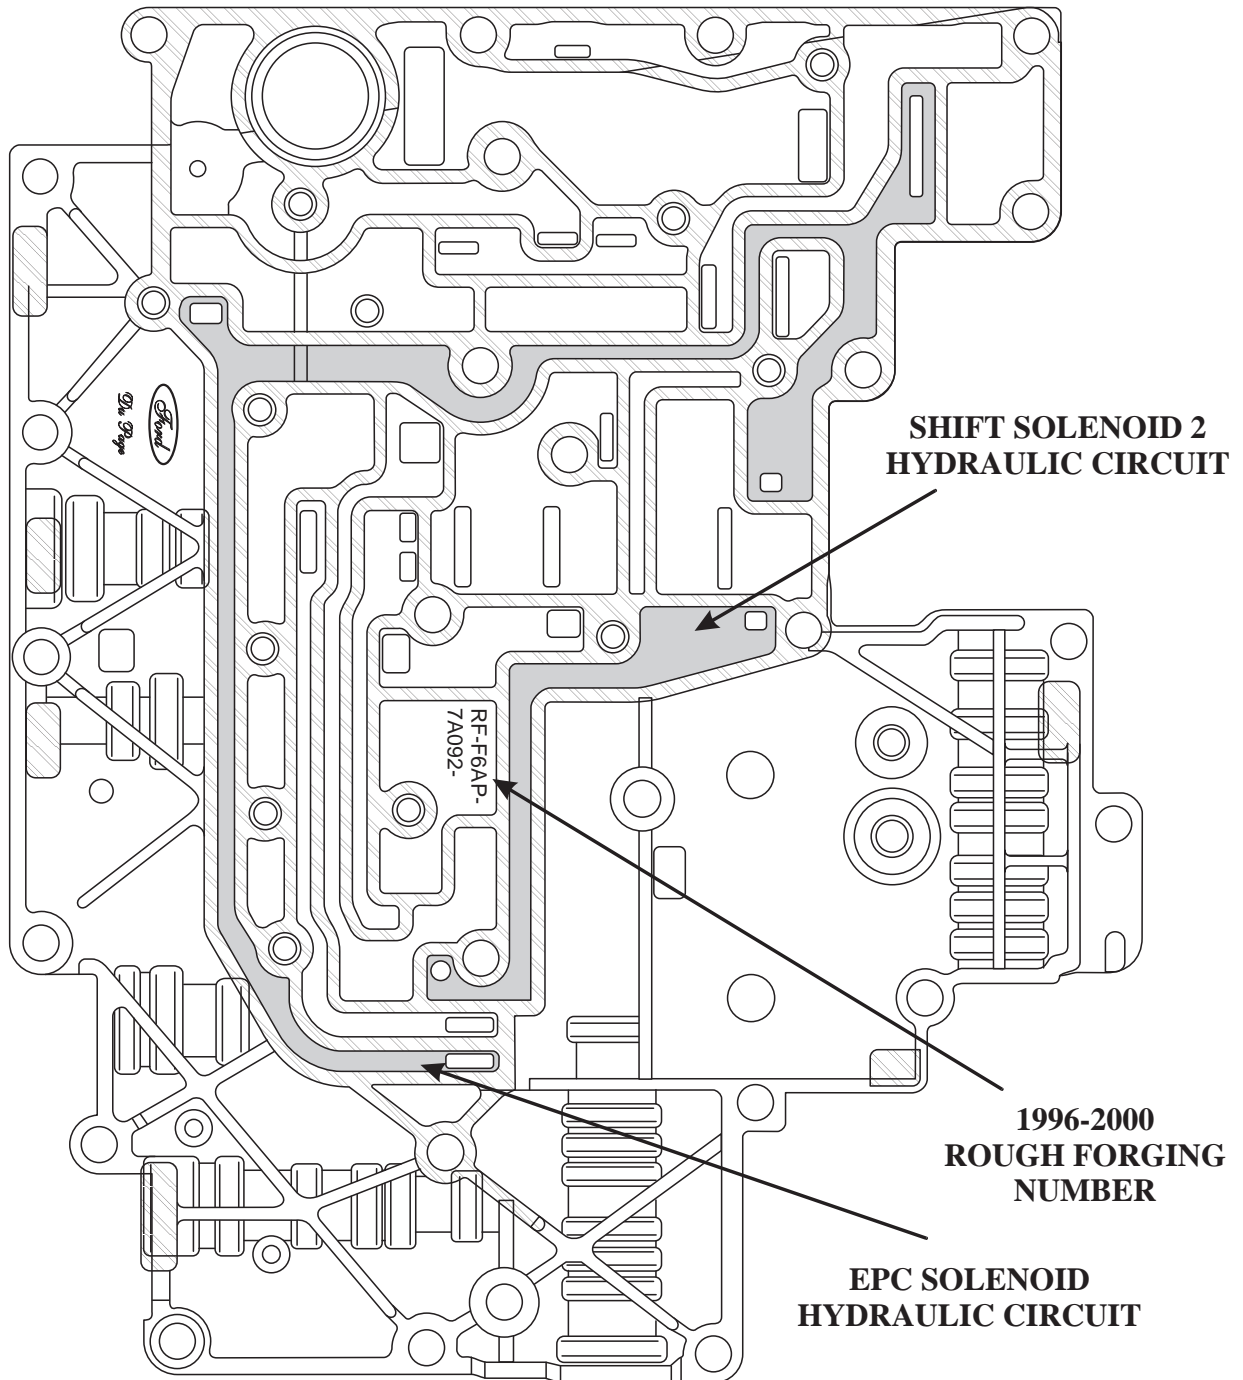
- (1) VALVE BODY CASTING (*Lower side*) - The Lower side of the valve body had casting changes to connect the 2-3 Backout Valve to the Shift Solenoid 2 hydraulic circuit, as shown in Figure 51. Figure 50 shows the previous design casting and identifies the EPC circuit that was connected to the 2-3 Backout Valve on the earlier models.

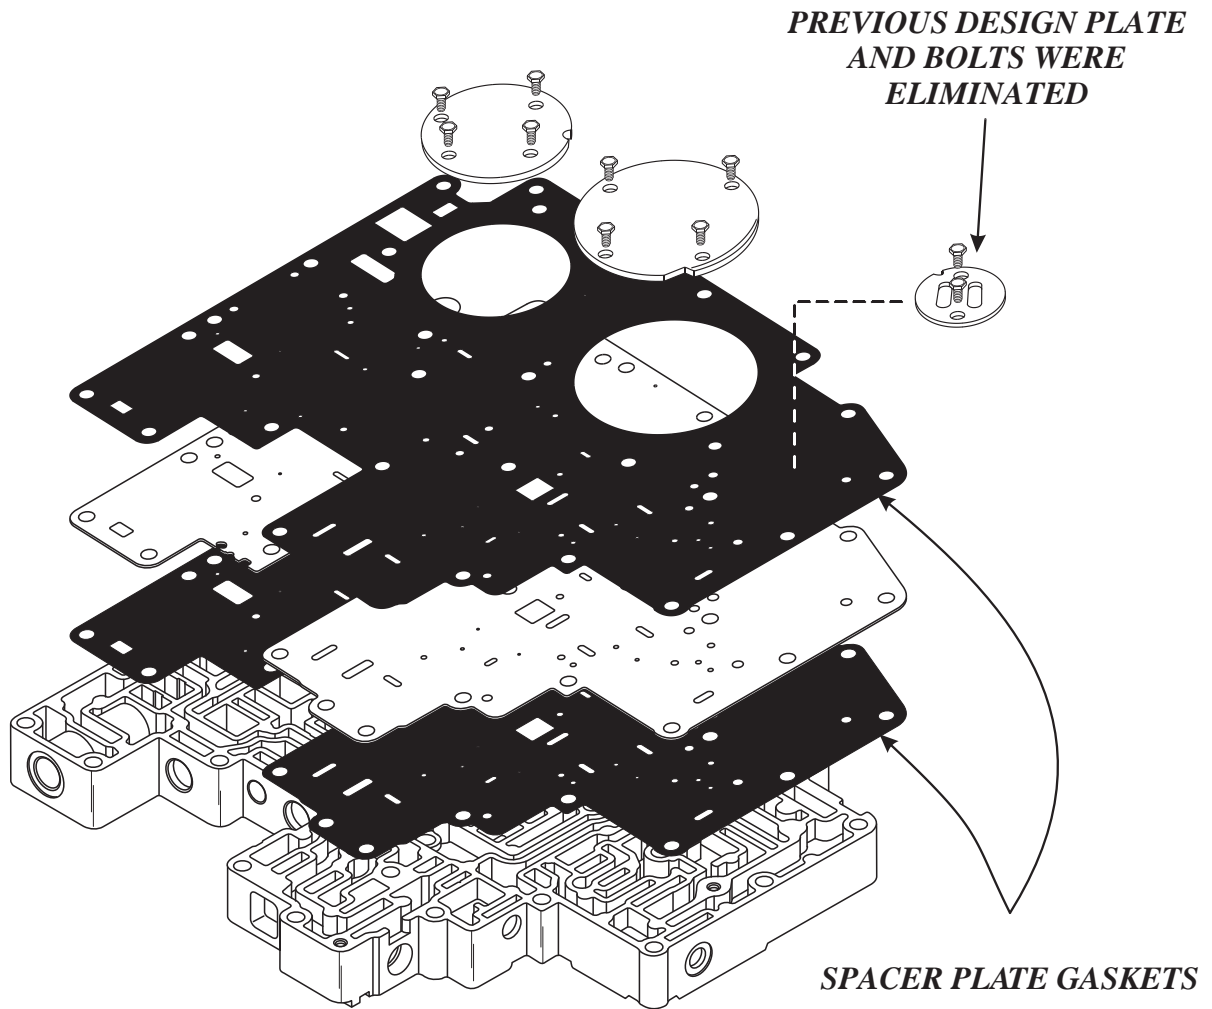
Figure 52

- (2) SPACER PLATE GASKETS - The 2001 and up design upper and lower spacer plate gaskets had numerous hole configuration changes, to accommodate the hydraulic changes with the valve body. The most obvious change is around the plate that was eliminated over the Direct Clutch Accumulator, as shown in Figure 52.

**SPACER PLATE GASKET TO CASE (FORD NUMBER) 1L3Z-7C155-AA**  
**SPACER PLATE GASKET TO VALVE BODY (FORD NUMBER) 1W7Z-7D100-AB**

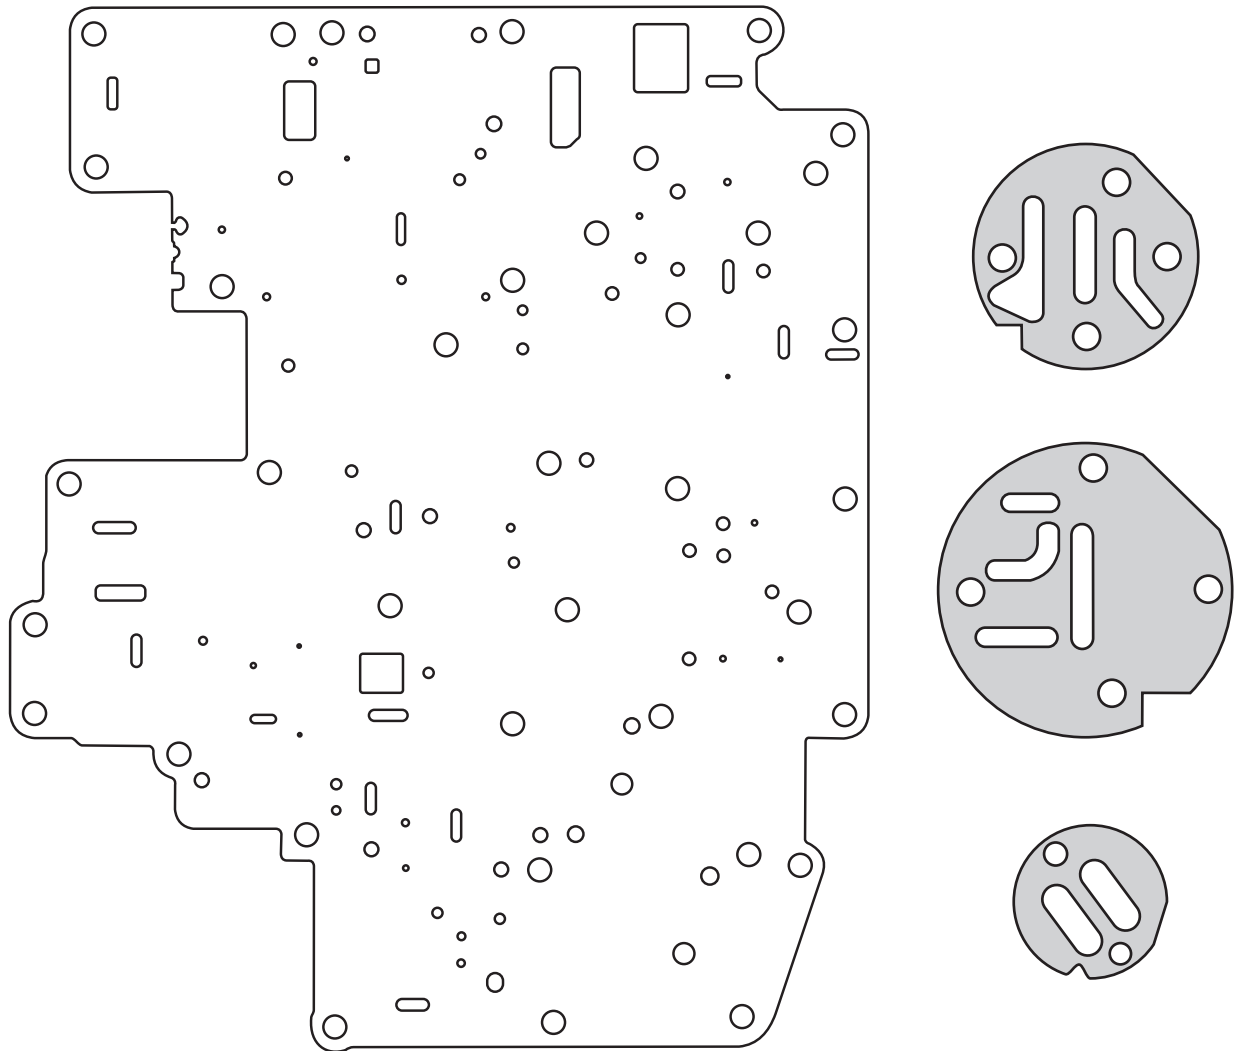
- (3) SPACER PLATE - The 2001 and up design spacer plate had hole changes to connect the added Overdrive Servo Regulator Valve Boost Valve and Sleeve to the EPC solenoid circuit, and to accommodate the changes in the 3-4 Capacity Modulator Valve. Figure 54 shows that a change also was made to the cover plate connecting the Forward Clutch Circuit to the 3-4 Capacity Modulator Valve. The bolt holes were removed from the Spacer plate along with the plate over the Direct Clutch Accumulator. Figure 53 shows a view of the previous design Spacer Plate.

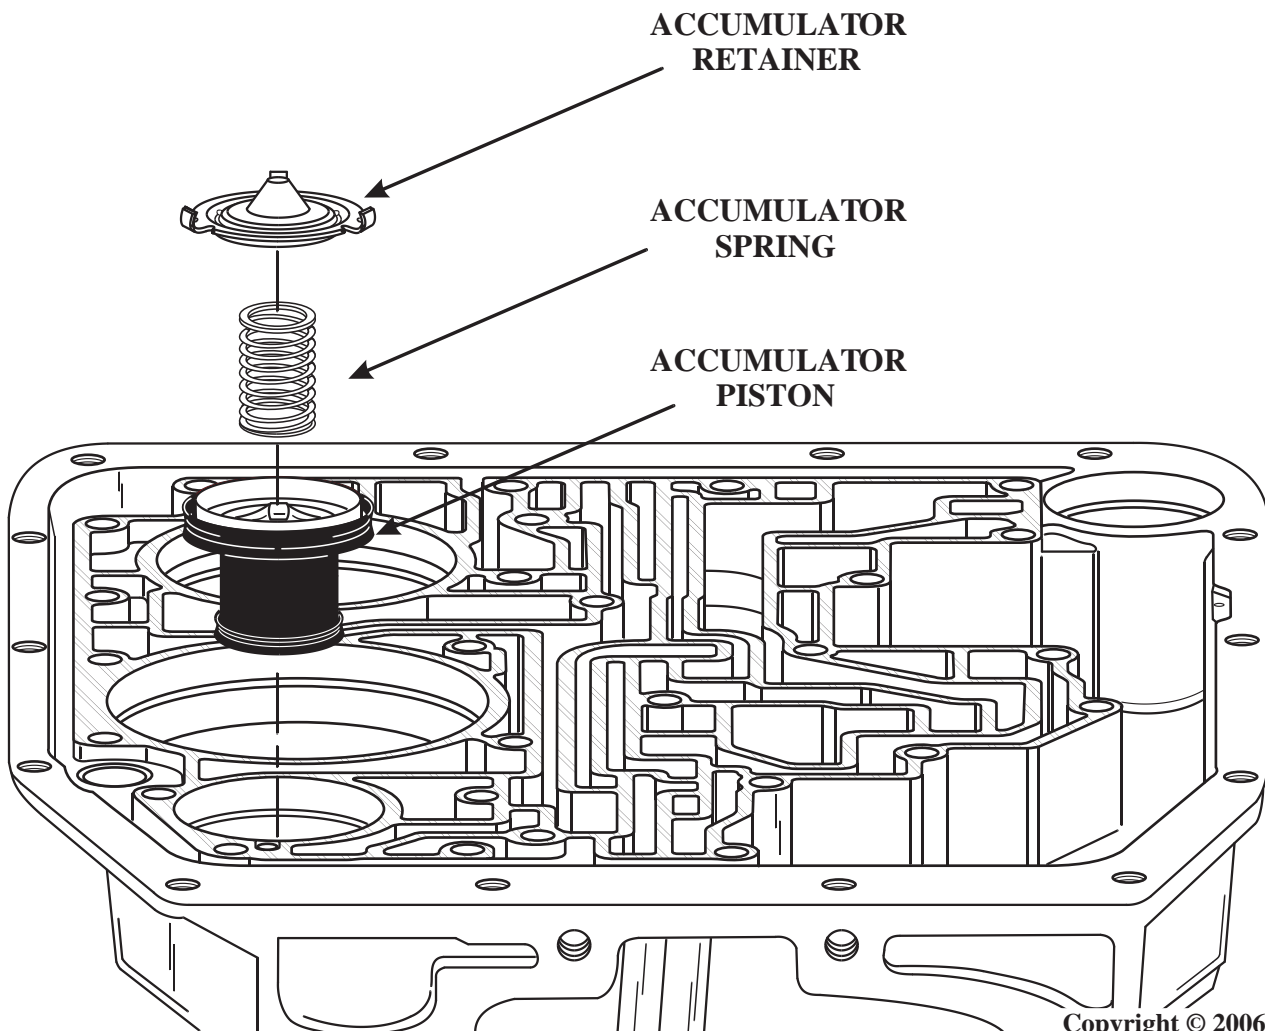
Figure 55

- (4) DIRECT CLUTCH ACCUMULATOR RETAINER - The retainer for the accumulator received a dimensional change to accommodate the elimination of the plate over the the Direct Clutch Accumulator, as shown in Figure 55.

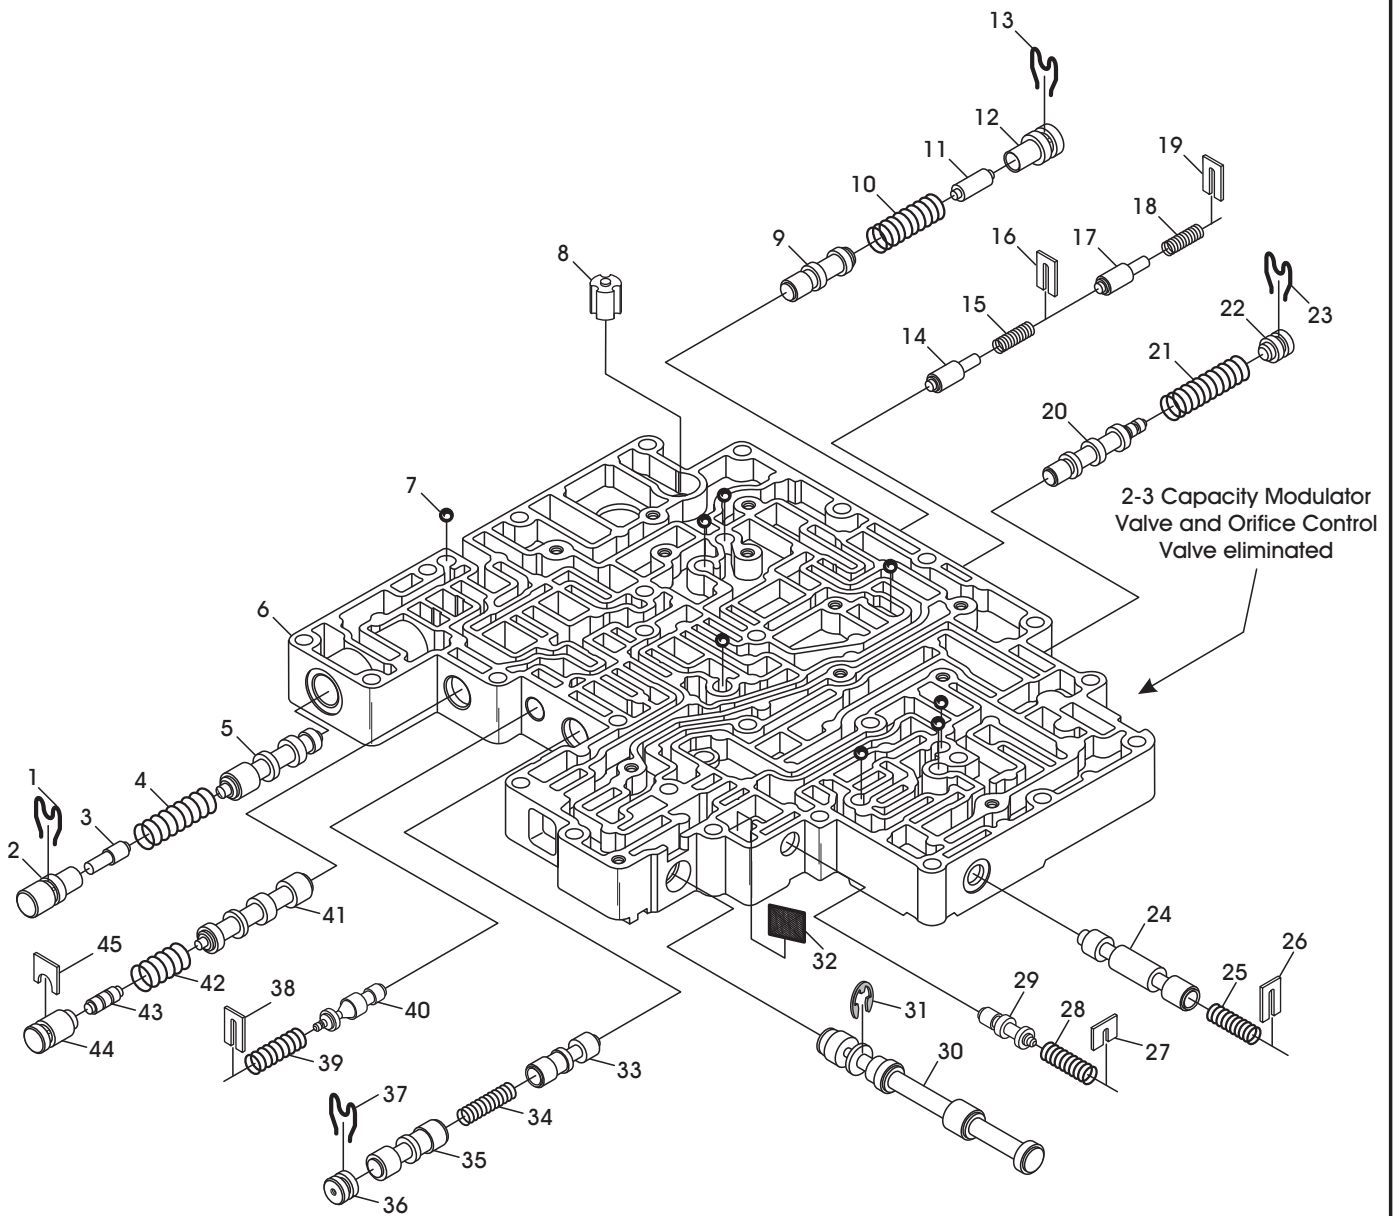
Figure 56

- (5) MAIN VALVE BODY - The main valve body received casting changes to accommodate the removal of the Orifice Control Valve and the 2-3 Capacity Modulator Valve, as shown in Figures 56, 57 and 58.
