## UPDATE HANDBOOK AODE, 4R70W, 4R70E, 4R75E

**AUTOMATIC TRANSMISSION SERVICE GROUP**  
**18639 S.W. 107 AVENUE**  
**MIAMI, FLORIDA 33157**  
**(305) 670-4161**

## AODE, 4R70W, 4R70E, 4R75E

*Printed  
October, 2006*

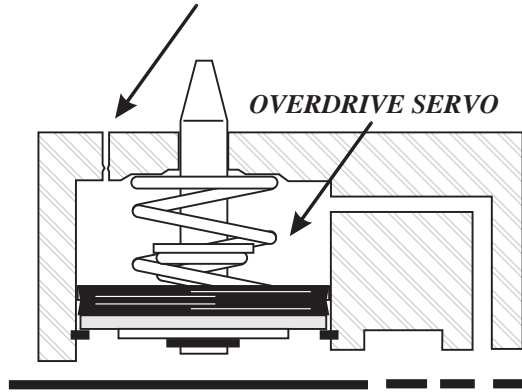
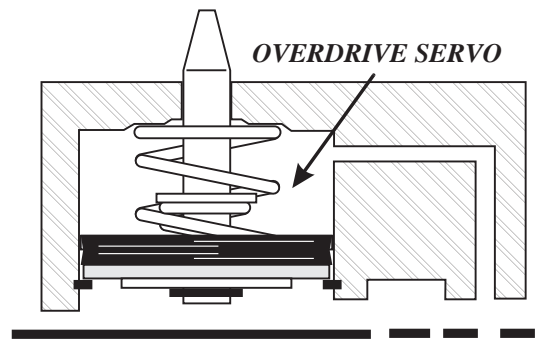
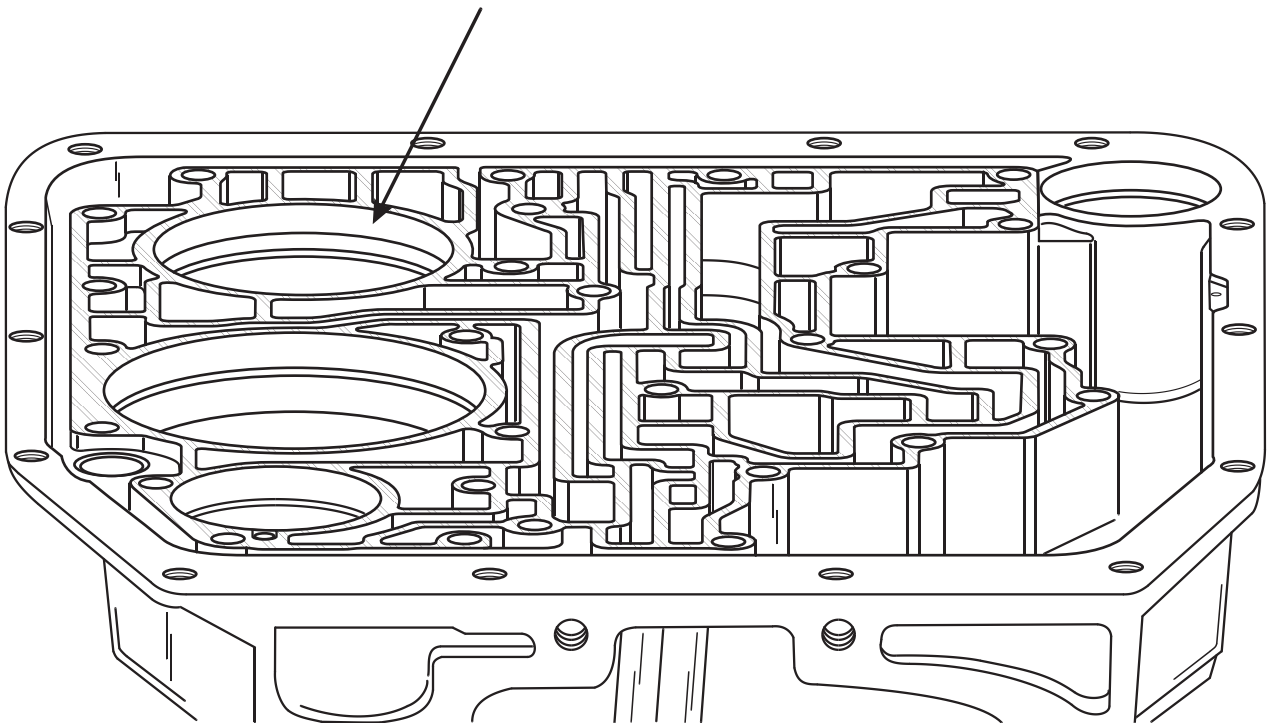
Figure 59

- (6) CASE - The Overdrive Servo Bleed orifice, as shown in Figure 59, was eliminated to accommodate the hydraulic circuit changes in the Overdrive Servo Regulator Valve. Refer to Figure 60 for a partial hydraulic circuit diagram identifying the 2001 and up hydraulic circuit.

**PREVIOUS DESIGN  
CASE "WITH" .020" BLEED ORIFICE**

**2001 & UP DESIGN  
CASE "WITHOUT" BLEED ORIFICE**

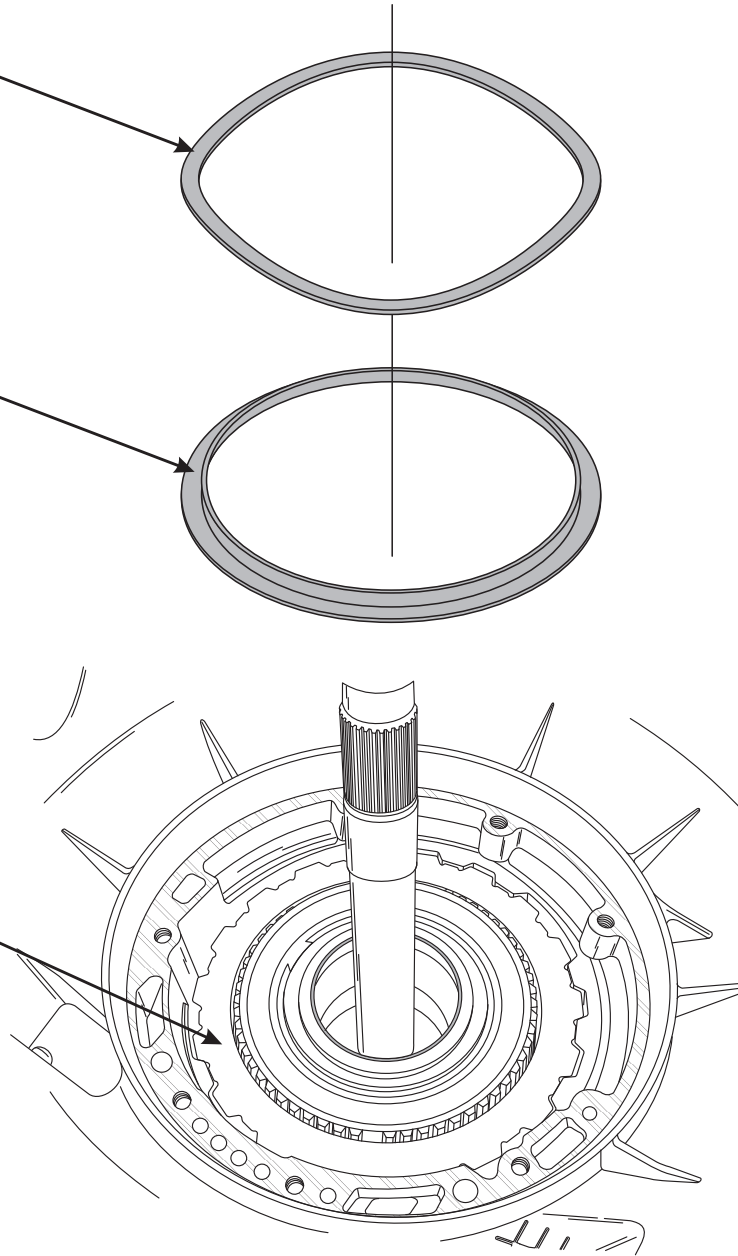
Figure 62

- (2) **INTERMEDIATE CLUTCH PISTON RETURN SPRING AND RETAINER**- A new design return spring and retainer was added and now installs into the case, as shown in Figure 62, to accommodate the new design level piston. Figure 63 shows cut-away views of both retainers.

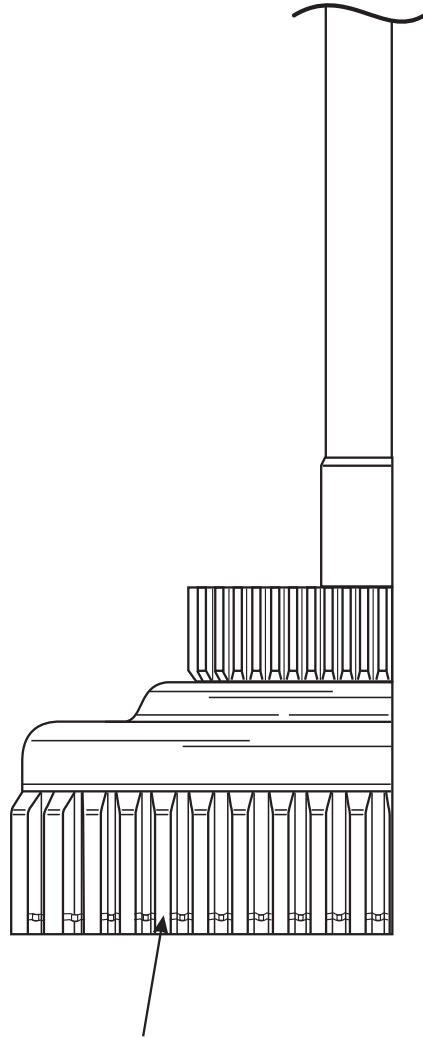
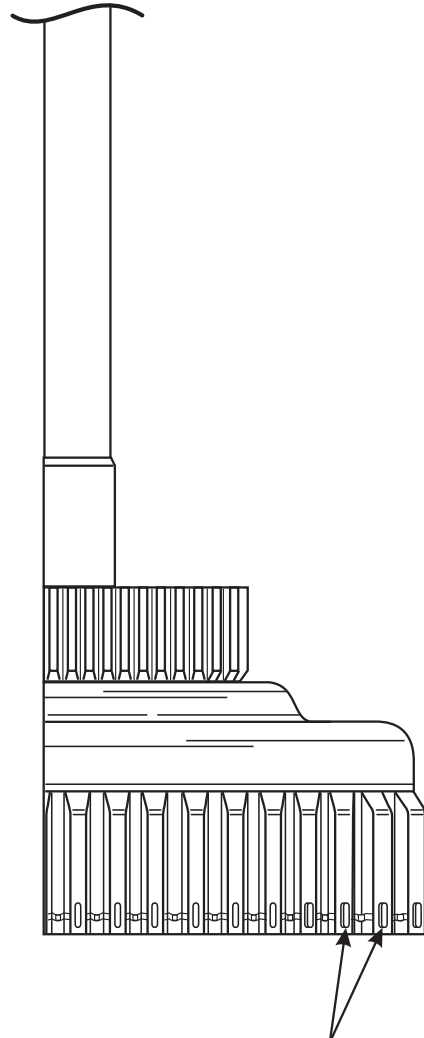
Figure 66

- (5) **FORWARD CLUTCH DRUM** - The Forward Clutch Drum had a stamping change to provide projections for the added Turbine Shaft Speed Sensor, as shown in Figure 66.

*NO PROJECTIONS*

*34 STAMPED PROJECTIONS  
ON THE OUTSIDE OF THE DRUM  
THAT THE ADDED TURBINE SENSOR  
READS FROM*

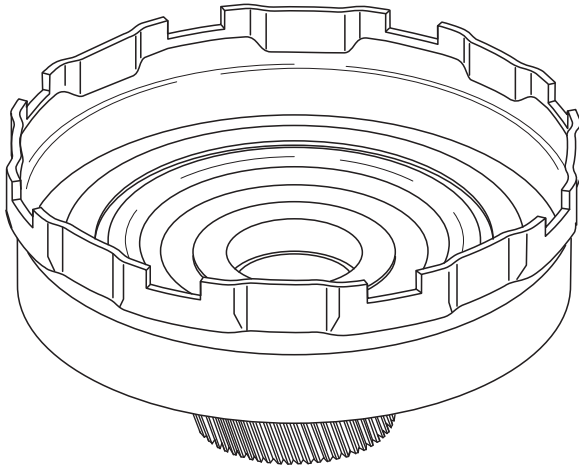
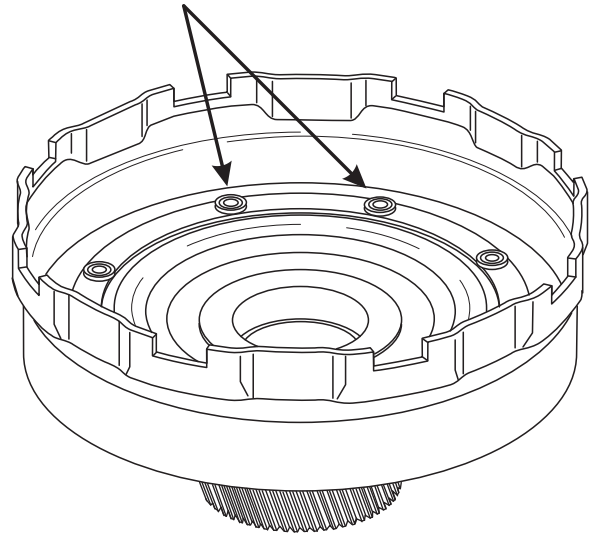
*New Sun Shell Is Now Riveted To The Sun Gear And Hub*

*The New Design Sun Shell is manufactured using a non-magnetic material, so the Turbine Sensor can read the stamped projections on the New Design Forward Drum.*

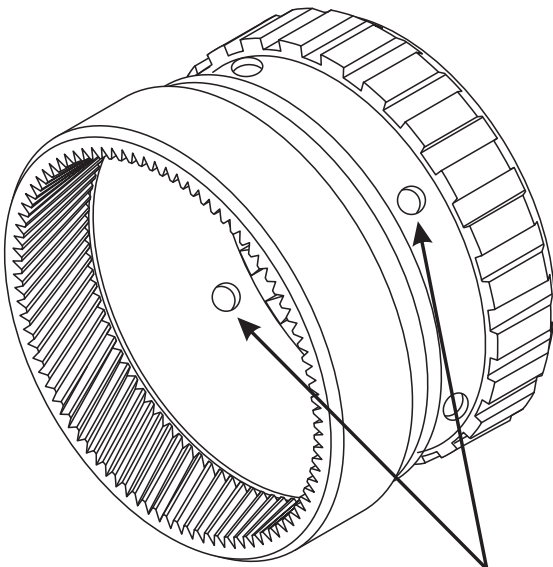
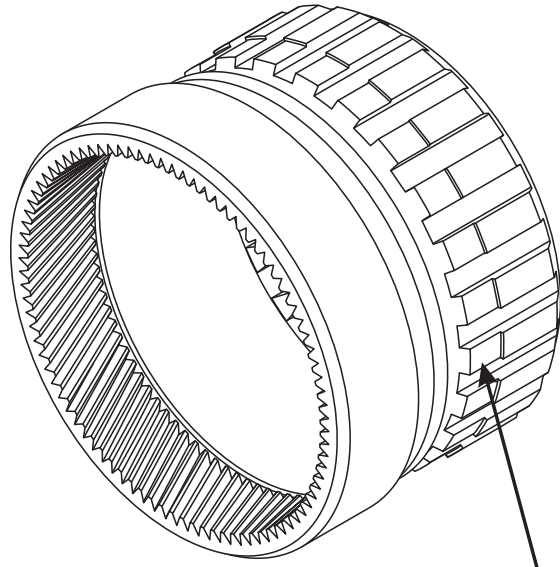
Figure 70

*Holes To Trigger  
Speed Sensor*

*Extended Lugs To Trigger  
Speed Sensor*

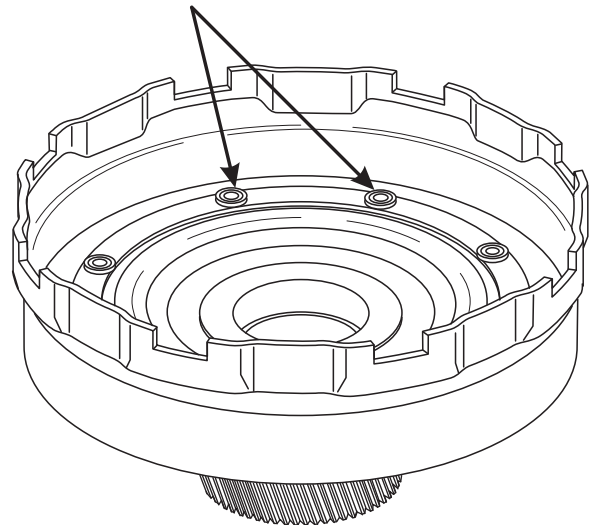
Figure 73

- (3) SUN GEAR AND SHELL ASSEMBLY - The new Sun Shell Assembly is easily identified by the new rivets that retain the sun shell to the sun gear, as shown in Figure 73. The new sun shell is manufactured from a different (non-ferrous) material than the previous shell. The new sun shell material is less magnetic than the previous sun shell.

**New Sun Shell Is Now Riveted**  
**To The Sun Gear And Hub**

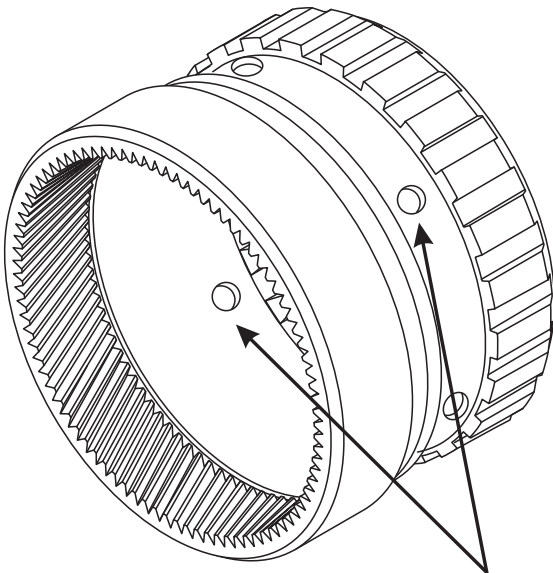
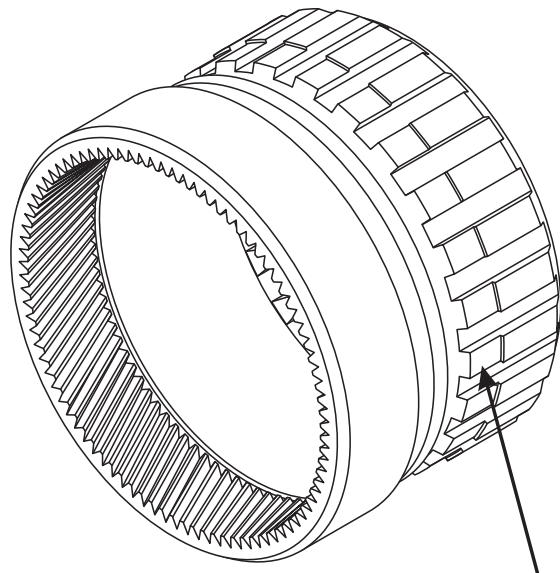
- (5) OUTPUT SPEED SENSOR - New design has a .100" **shorter** stem to accommodate the new design internal ring gear. Part numbers for all models are found in "Service Information".

*Holes To Trigger  
Speed Sensor*

*Extended Lugs To Trigger  
Speed Sensor*

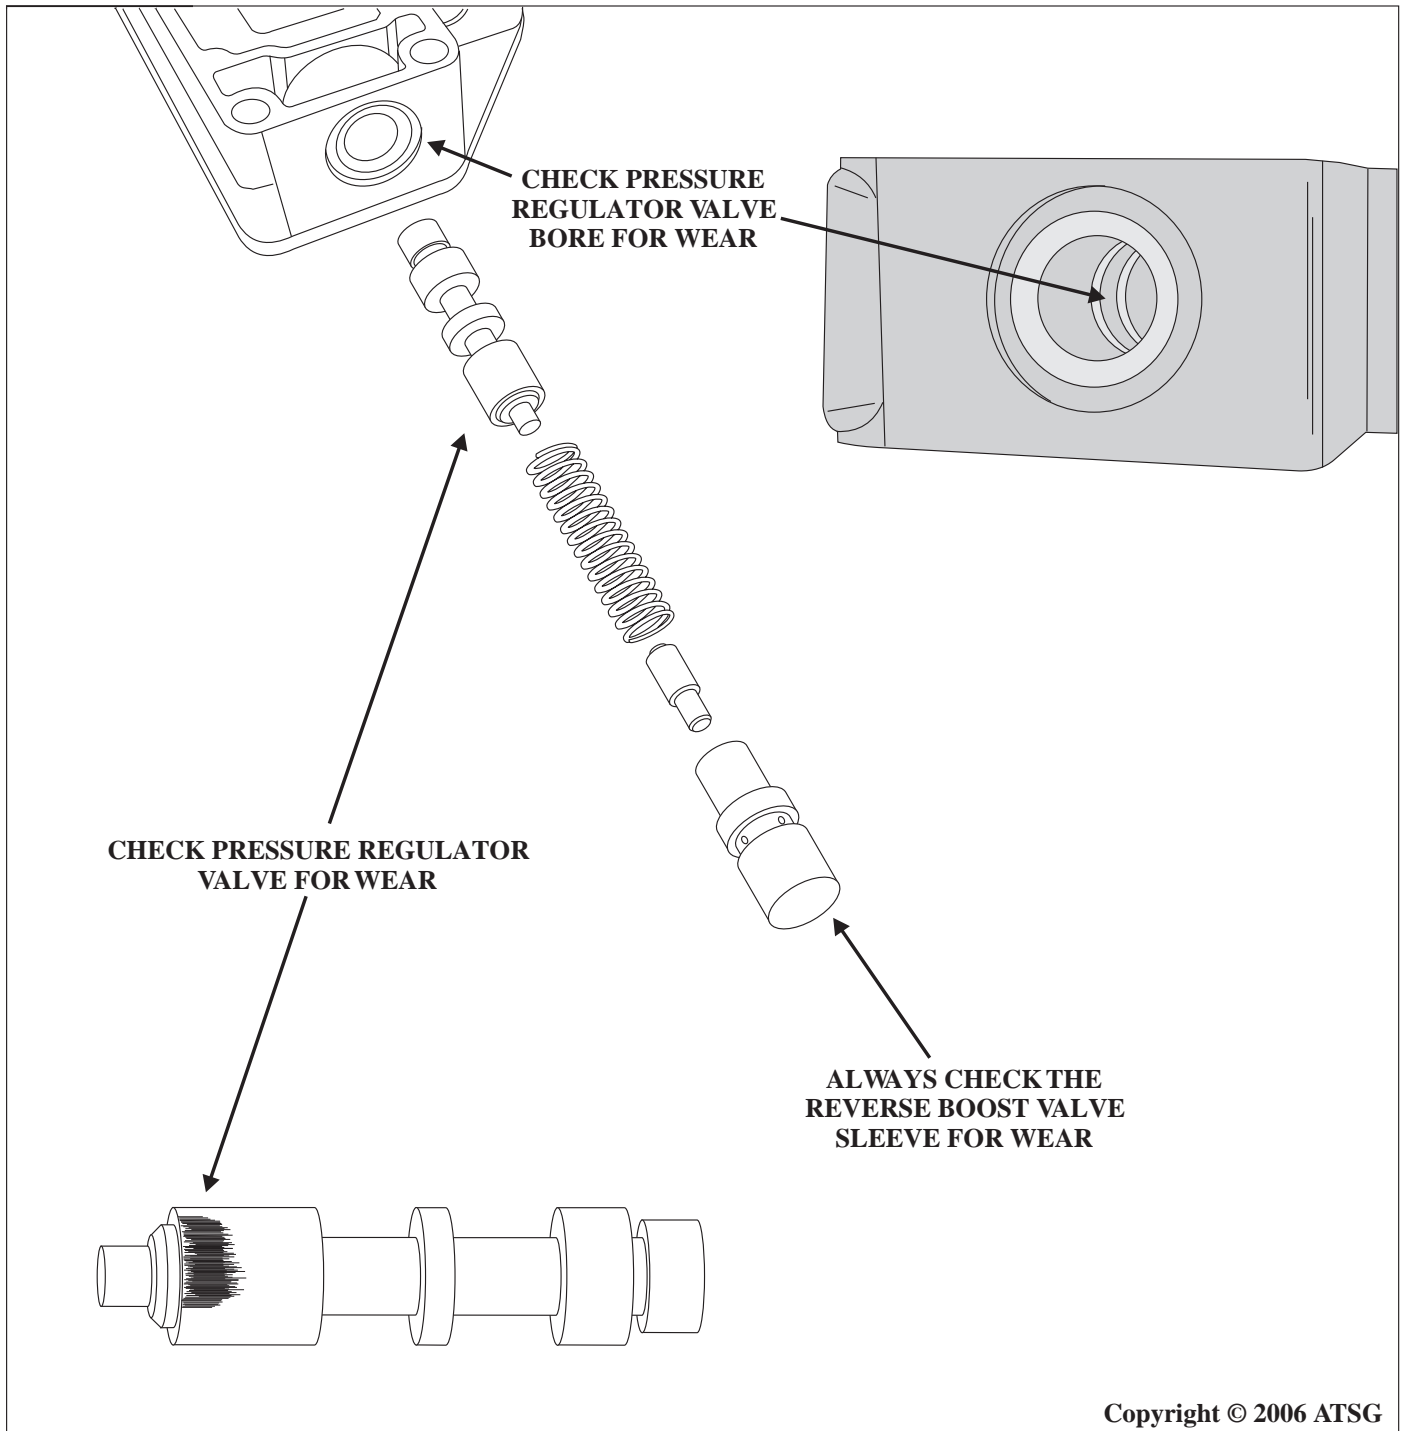
Figure 78

**CAUSE:** EPC pressure is routed to the Pressure Regulator Valve along side of a circuit that Ford identifies as the Boost Circuit. These oil passages can be identified in both the valve body and the case as seen in Figure 75 and 76. This is illustrated by the hydraulic schematic shown in Figure 77. This circuit is routed back to the inlet side of the pump. When the Pressure Regulator Valve or its bore is worn, (See Figure 78), EPC pressure is allowed to be sucked away by pump suction, (See Figure 79 and 80), preventing any line pressure rise from occurring when the throttle is opened.

**CORRECTION:** Always check the Pressure Regulator Valve and its bore for wear during the repair process. If it is worn use one of the repair kits that are available from Sonnax® to repair this condition, or, you must replace the valve body.

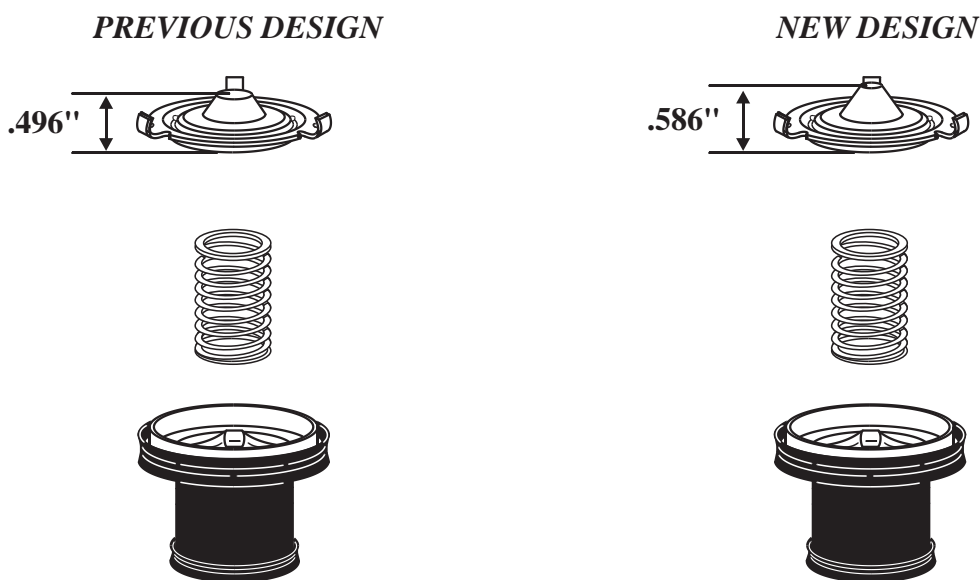
Figure 82

**CAUSE:** The cause may be, that a previous design 2-3 accumulator retainer was used, or the retainer was assembled upside down, when installing it into the case. **NOTE:** 2001 and up Valve Body assemblies, as shown in Figure 83, eliminated the small plate on the spacer plate side over the 2-3 accumulator retainer, which made a taller 2-3 accumulator retainer necessary for 2001 models, shown in Figure 82. When the early 2-3 accumulator retainer (shorter) is used, or if the retainer is installed upside down, the 2-3 accumulator piston may come out of its bore dumping Direct Clutch pressure to an exhaust. Refer to Figure 84 for a cutaway of the correct and incorrect assembly.

*New Design retainer is taller because of the elimination of the plate over the 2-3 accumulator line-up*

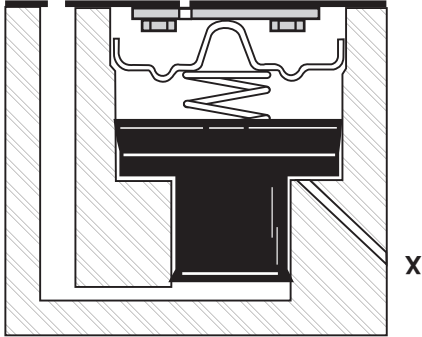
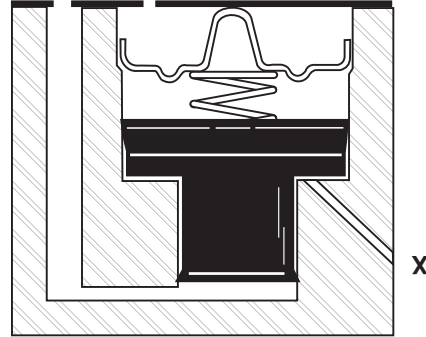
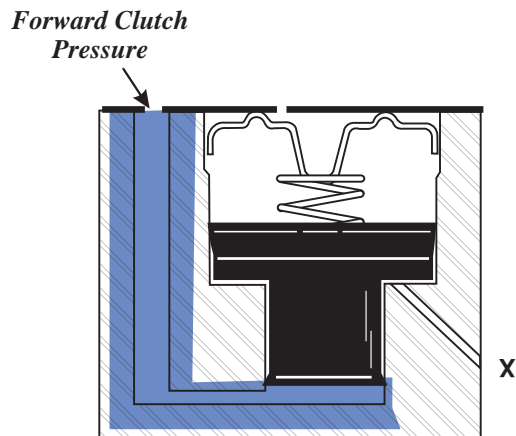
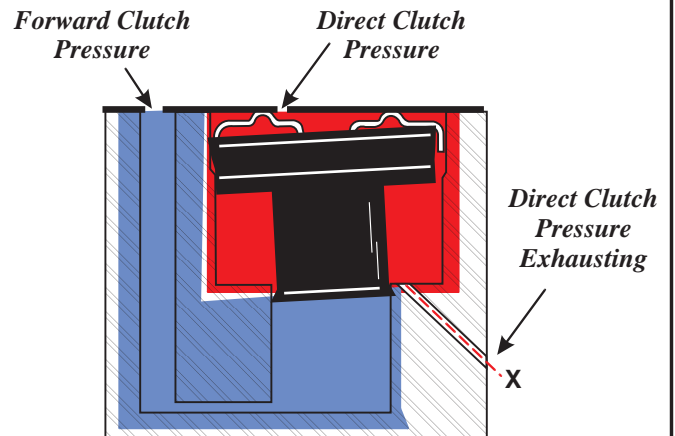
Figure 84

**Note:** When the 2-3 accumulator piston retainer is installed up-side down, as shown here, the accumulator piston may come out of it's case bore and connect the direct clutch to an exhaust.

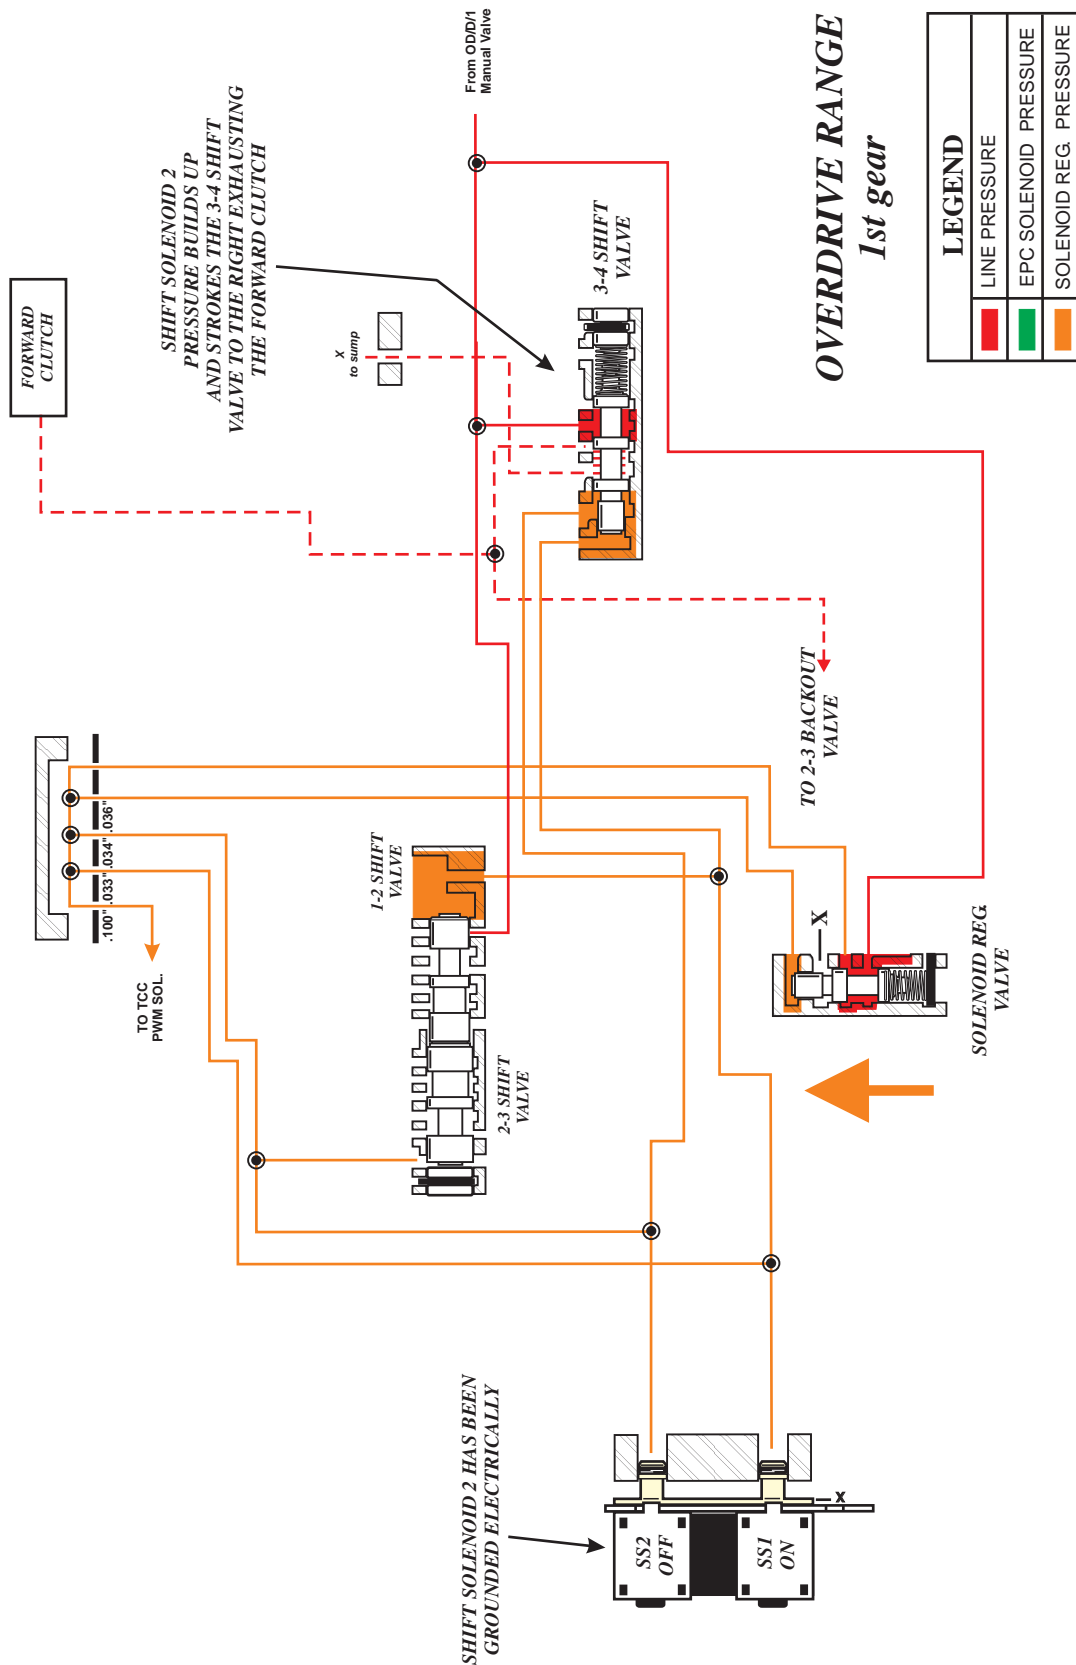
**CAUSE NO 1:** One cause for this condition may be that the PPL/ORG or VIO/ORG wire, which is model dependant, and controls Shift Solenoid 2, may have rubbed on the rear of the engine, causing the circuit to become grounded. When this occurs with the transmission in first gear, Shift Solenoid 2 closes and fluid pressure acts to stroke the 3-4 Shift Valve to the right, causing the Forward Clutch oil to exhaust through the 3-4 Shift Valve, creating the neutral condition. Refer to Figure 86 for hydraulic schematic. Diagnostic Trouble Code (DTC) P0755 may also be stored in memory.

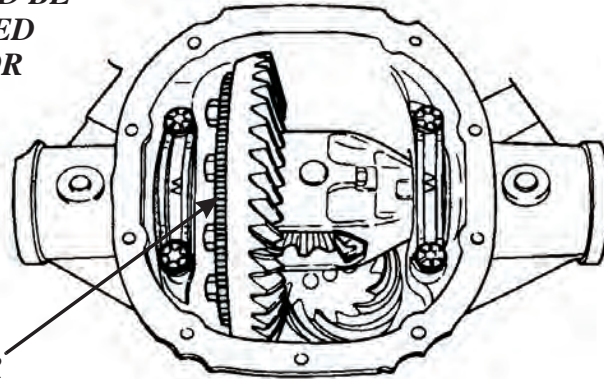
Figure 100

**EXCITER RING SHOULD BE  
TIGHT AND CENTERED  
WITH SPEED SENSOR**

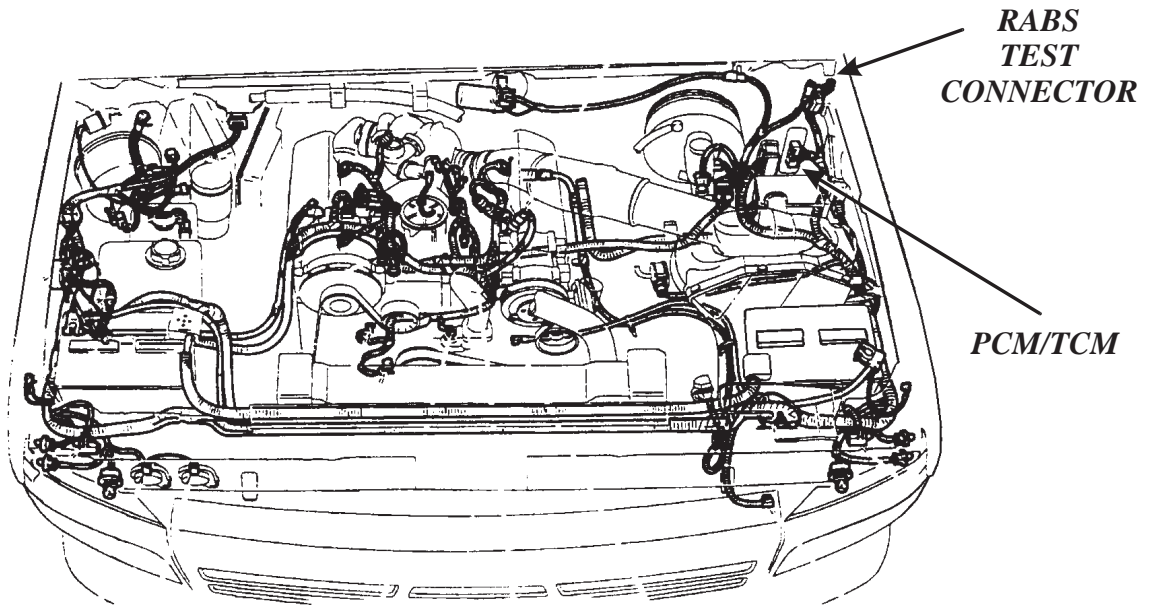
Figure 102

Locate the two wire RAB Sensor test connector (*Red with a pink tracer and light green with a black tracer*). For "F" series trucks it is located in the left rear corner of engine compartment (See Figure 102). For "E" series vans look behind the left side headlamp assembly (See Figure 103).

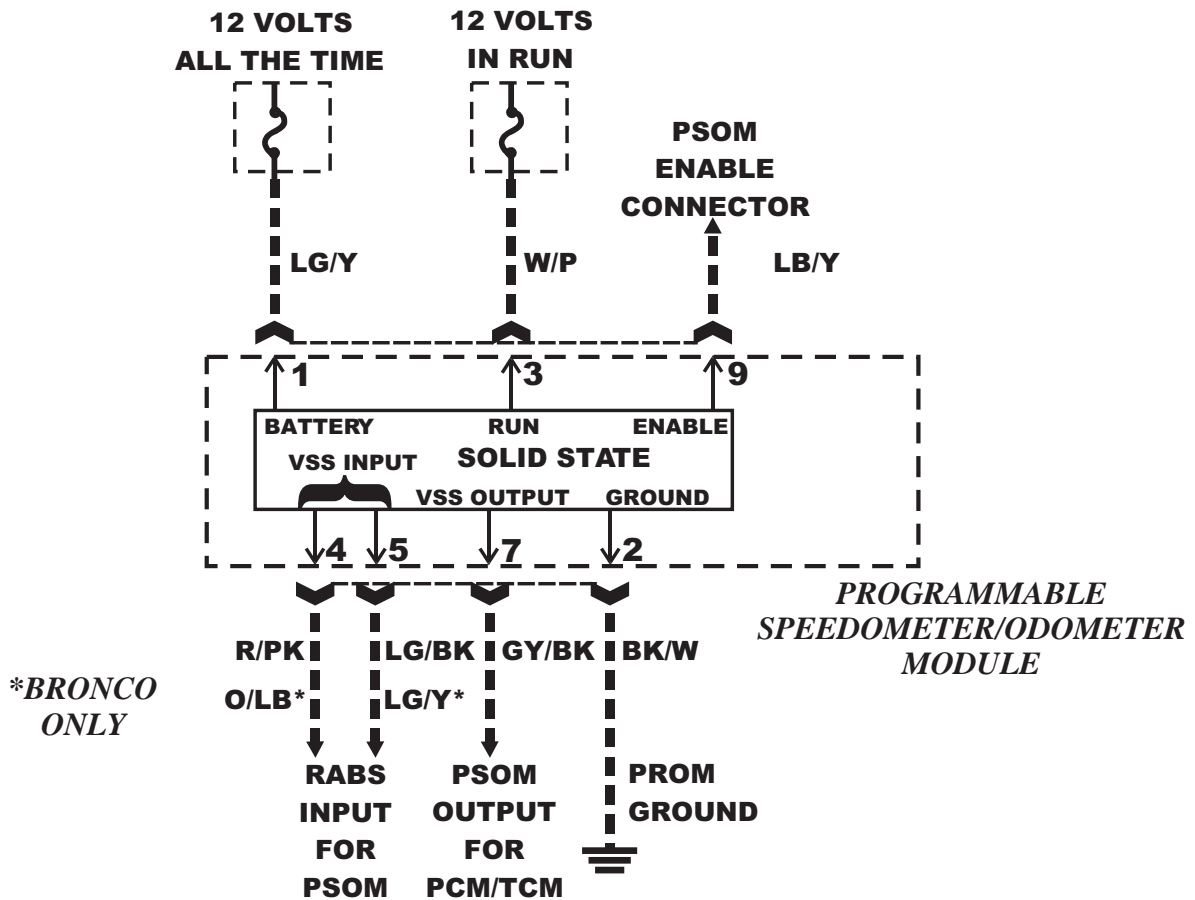
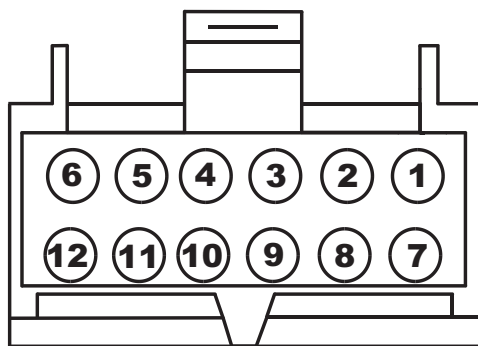
**STEP 3.** Remove the instrument cluster from the dash to gain access to the 12 pin PSOM connector as seen at the bottom of Figure 104. Refer to the schematic seen in Figure 104 for the following pin checks at the PSOM connector. **NOTE: If the dash panel has a dual tank fuel switch, it is necessary to remove the switch from the dash and allowing it to remain plugged into the harness. If this switch remains unplugged, the vehicle will not start.**

**STEP 4.** With the PSOM connector plugged into the cluster, set a multi-meter to DC volts and place the negative lead to a good known ground. With the positive lead, locate and probe a *light green wire with a yellow tracer* (circuit 54) at terminal 1 in the PSOM connector. This is keep alive power at all times and must have full battery voltage there even with the ignition off. If it does, move to Step 5. If it does not, inspect the number 8, (15) amp fuse in the under the dash fuse box for power. The fuse location can be seen in Figure 105. If the fuse is blown, replace it. If it blows again there is a short to ground in the LG/Y wire from the fuse to the PSOM connector and will need to be replaced. If there is power and the fuse is not blown, the LG/Y wire from the fuse to the PSOM connector is open, and will need to be replaced. If the number 8 fuse was not blown, and did not have power either, the 50 amp "S" maxi-fuse in the under hood fuse box should be checked and replaced if necessary (See Figure 106 for location). If the maxi-fuse is not blown, the *black wire with an orange tracer*, between the maxi-fuse and the under the hood fuse box may have been severed or there is an internal problem within the fuse box itself.

**STEP 5.** Keeping the multi-meter set to DC volts and the negative lead to a good known ground, locate and probe the *white wire with a purple tracer*, (circuit 269) at terminal 3 in the PSOM connector. System voltage must be observed when the ignition is on. If system voltage is there, continue on to Step 6. If it is not, inspect the number 18 (10) amp fuse for power (See Figure 105). If there is power and the fuse is not blown, the W/P wire is open and will need to be replaced. If the number 18 fuse was not blown and did not have power, the ignition switch, or the *grey wire with a yellow tracer* (circuit 687) from the switch to the fuse is faulty and will need to be replaced.

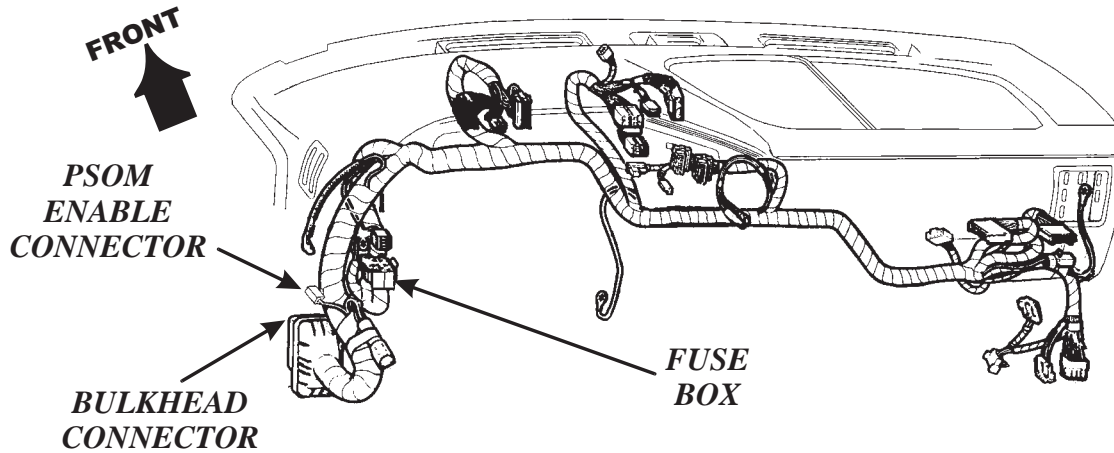
Figure 110

Locate the enable circuit 567 wire connector. This is a *light blue wire with a yellow tracer* coming from the PSOM connector pin 9 to a single connector. It is located under the left side of the dash, below the fuse box, near the bulkhead connector on "E" series vans as seen in Figure 110, and under the center of the dash below the glove box on "F" series trucks (See Figure 111). **NOTE: The letters PSOM should be printed on the enable connector. Once found, use the following procedures to reprogram the PSOM.**

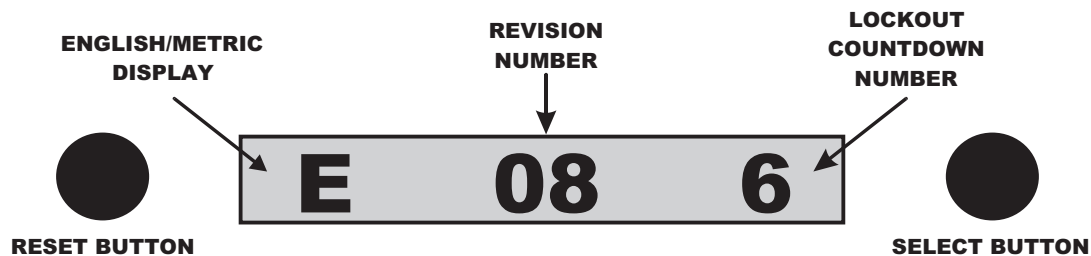
Figure 112

- (1) With the ignition in the "OFF" position, ground the enable connector with a jumper wire.
- (2) While pushing in on the trip odometer reset button (See Figure 112), turn ignition to the "ON" position.

**Do not start the engine.** Once in the ON position, release the trip odometer reset button.
- (3) At this time the speedometer needle should sweep across the face of the speedometer and back again. This sweep indicates that the PSOM has been put into the enable mode. Looking into the LCD odometer window, you should now see the English/Metric display, the revision level number and the lockout countdown number, which indicates how many times the PSOM can be reprogrammed (See Figure 112).

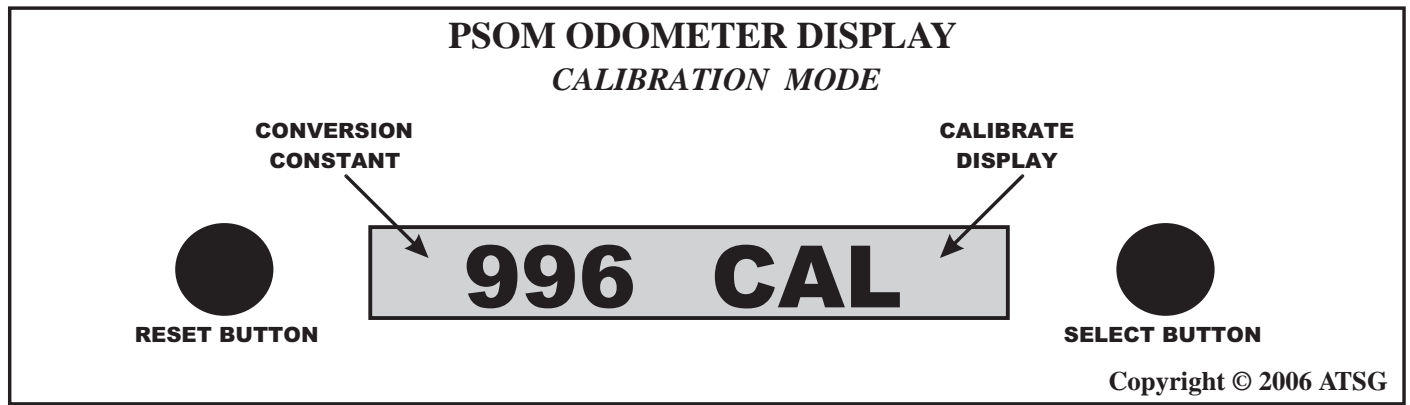
Figure 113

- (4) Press the odometer reset button once again. Now you will see inside of the odometer window, the **conversion constant** number without the decimal point, followed by the abbreviation "CAL". Refer to Figure 113.

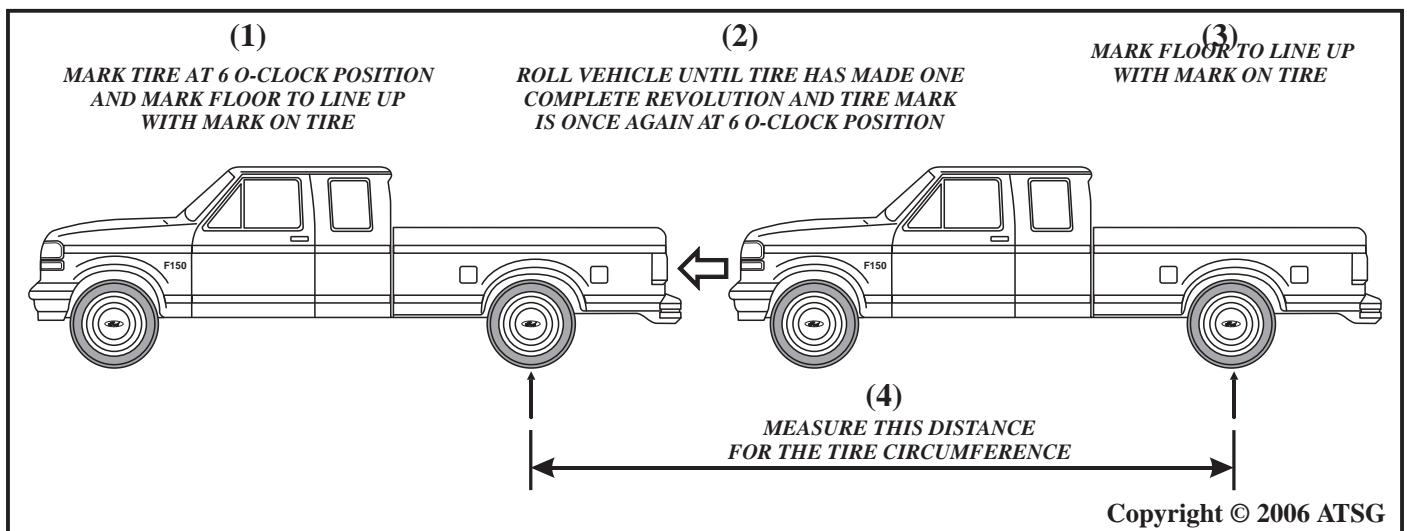
Figure 118

**Formula 4 in Figures 117 and 118 are used when tire size or gear ratios are questionable.**

**Special note: If the arrived numerical conversion constant is not one listed in the PSOM, then the tire size or differential gear ratio far exceeds OE tolerances prohibiting PSOM re-calibration.**
