AXOD/AXODE (AX4S) UPDATE HANDBOOK

AUTOMATIC TRANSMISSION SERVICE GROUP

INTRODUCTION

*Updated
October, 2002*

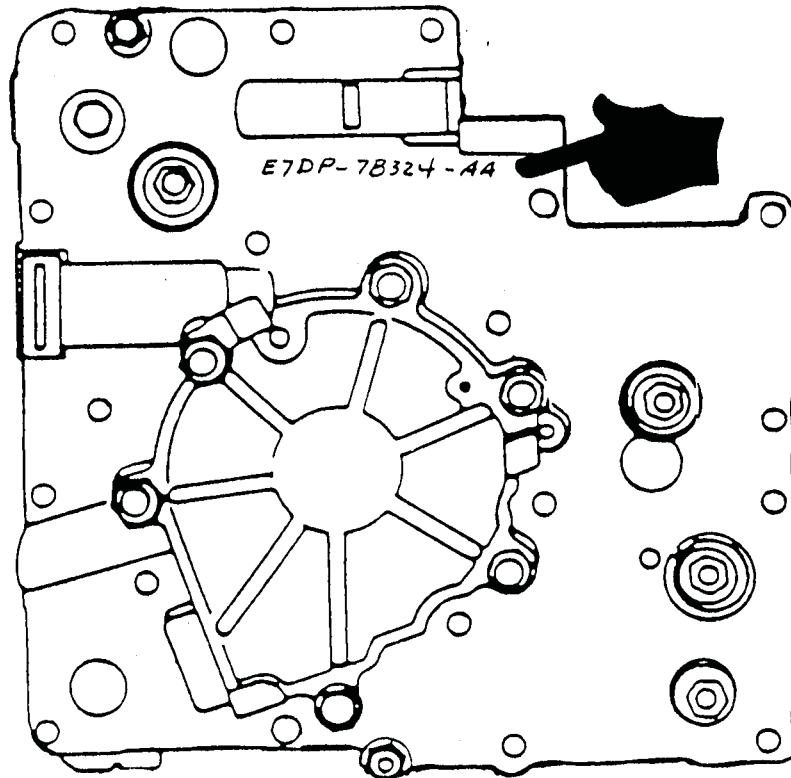
Figure 1

- (1) OIL PUMP CASTING - Must be identified by the casting number located on the pump as shown in Figure 1, and can be identified as follows:

OIL PUMP
CASTING NUMBER LOCATION

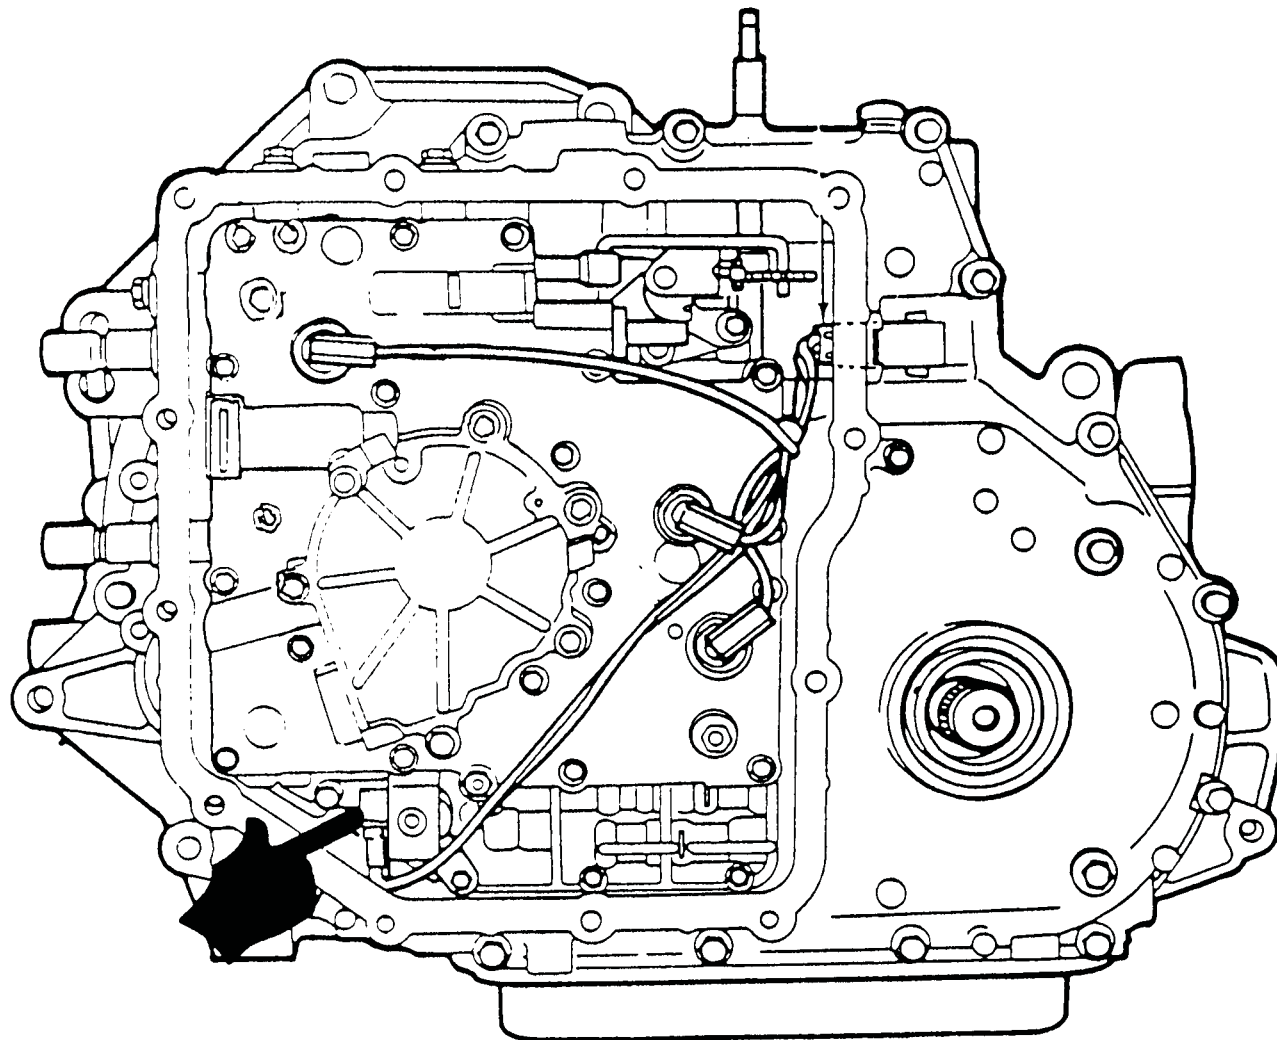
Figure 2

- (4) VALVE BODY CASTING - Must be identified by the casting number located beneath the lock-up solenoid as shown in Figure 2, and can be identified as follows:

VALVE BODY CASTING NUMBER
LOCATED UNDER LOCK-UP SOLENOID

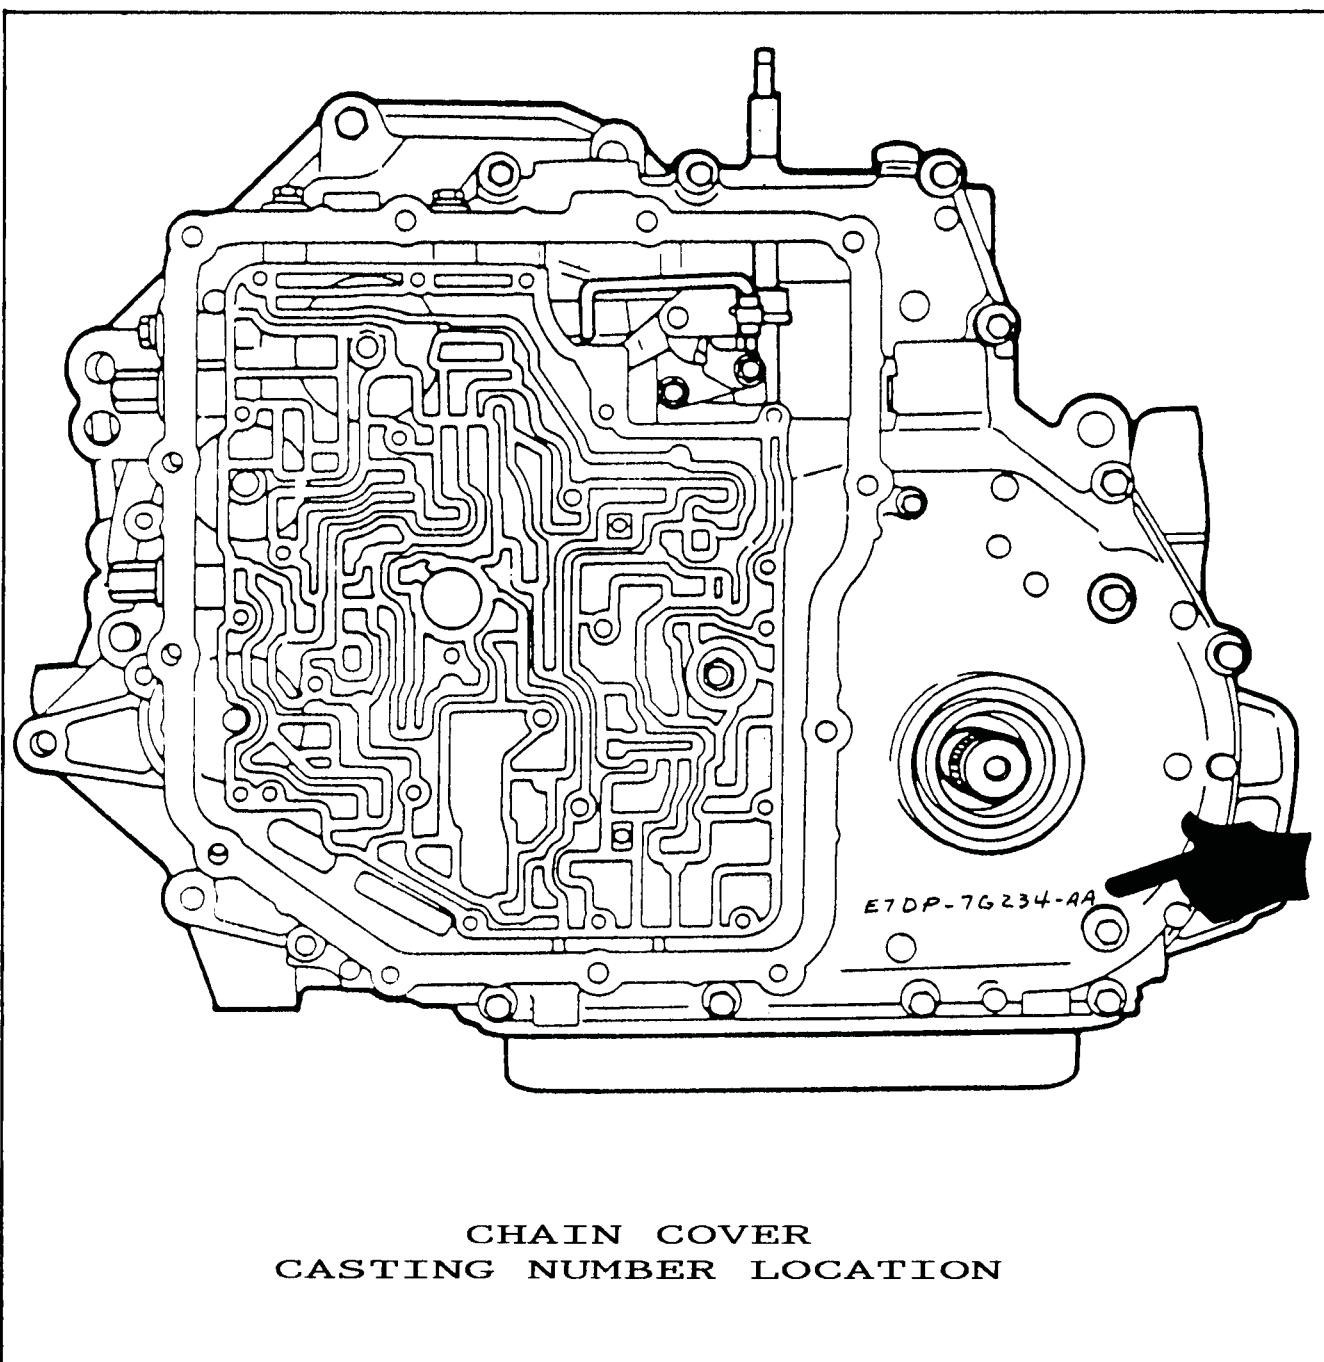
Figure 3

- (7) CHAIN COVER - Must be identified by the casting number located below the axle seal as shown in Figure 3, and can be identified as follows:
- E6SP-7G234-AA = 1986 Hydraulics Only.
 - E7DP-7G234-AA = 1987 Hydraulics Only.
 - E8DP-7G234-AA = 88/90 Hydraulics Only.
- (8) OIL PUMP CHECKBALL LOCATIONS - The 1986 through 1989 oil pumps have 9 checkballs, and locations are shown in Figure 16.
Some 1989 models and all 1990 model oil pumps have 10 checkballs, and locations are shown in Figure 17.

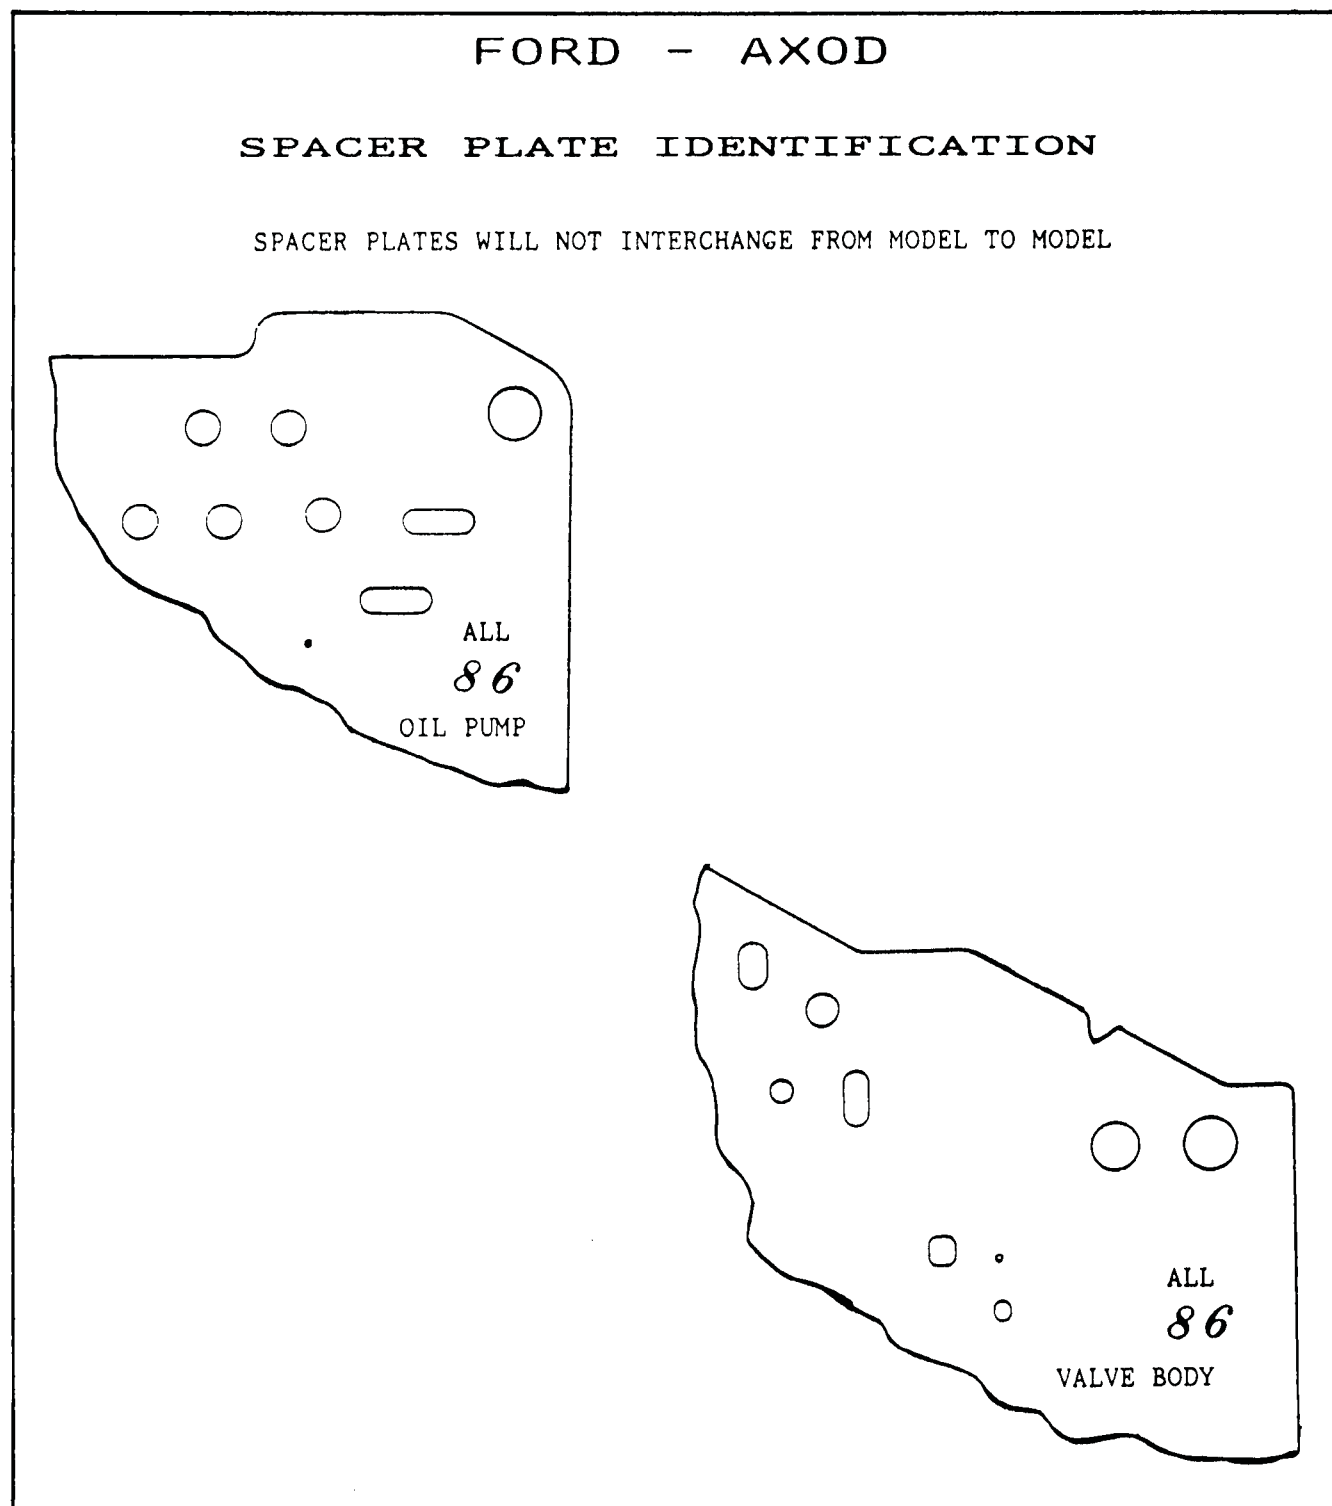
Figure 4

- (2) OIL PUMP SPACER PLATE - Must be identified by the "Notches" in the spacer plate as shown in Figures 4, 5, 6, and 7.

SPACER PLATES WILL NOT INTERCHANGE FROM MODEL TO MODEL

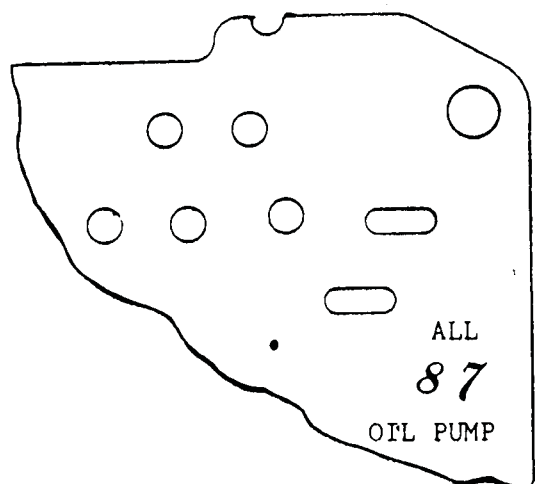
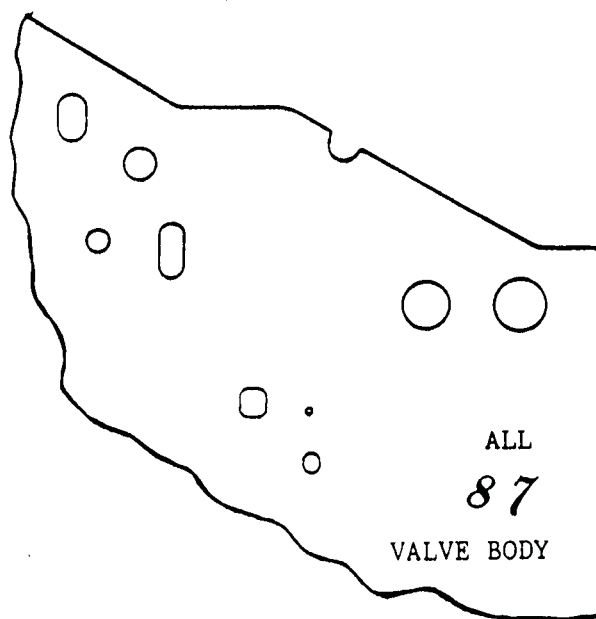
Figure 5

SPACER PLATES WILL NOT INTERCHANGE FROM MODEL TO MODEL

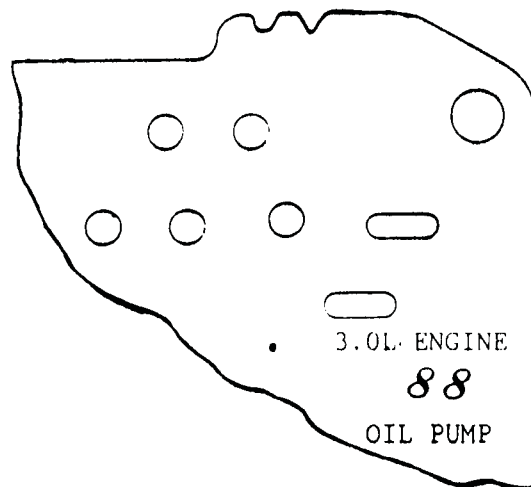
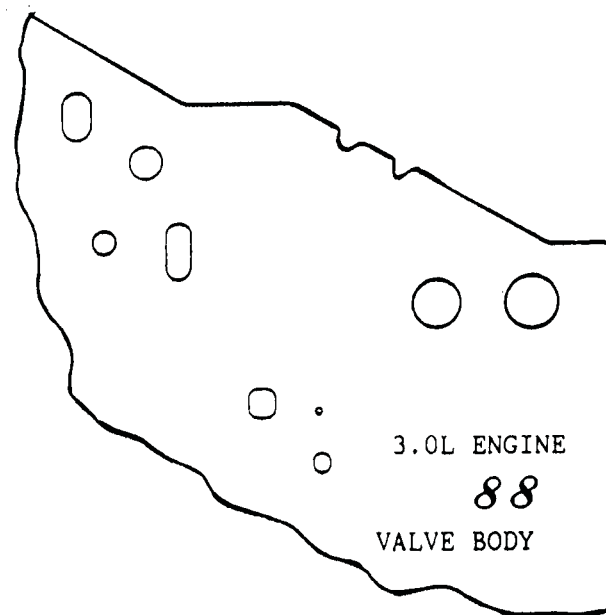
Figure 6

SPACER PLATES WILL NOT INTERCHANGE FROM MODEL TO MODEL

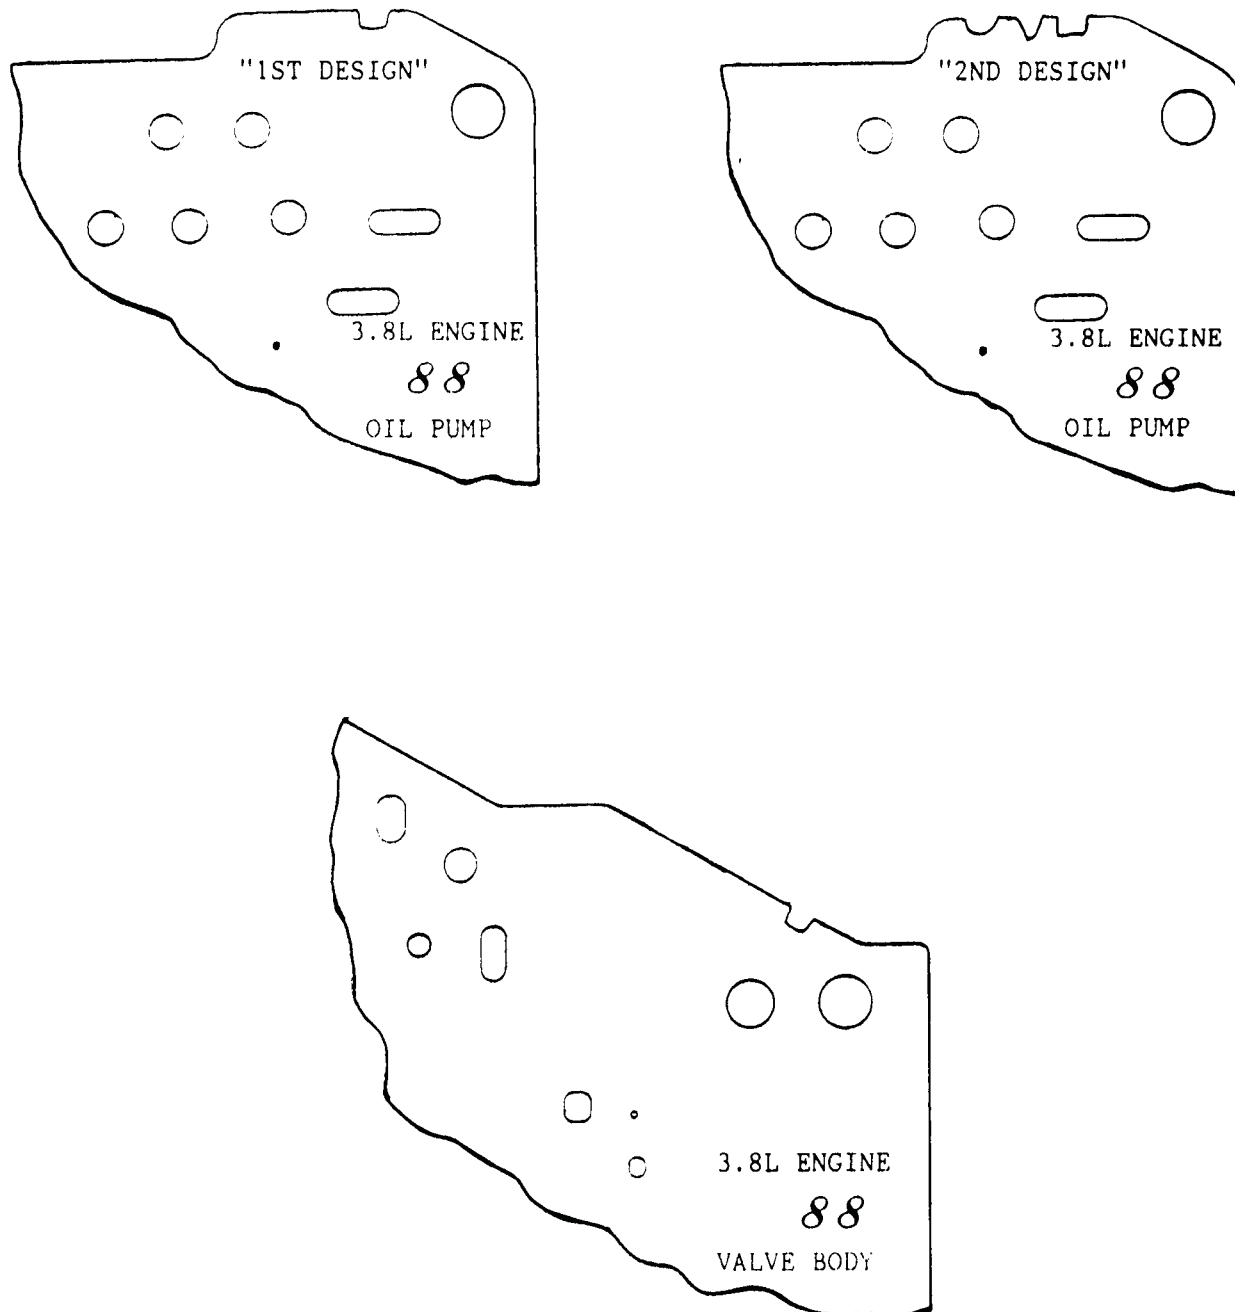
Figure 6A

SPACER PLATES WILL NOT INTERCHANGE FROM MODEL TO MODEL

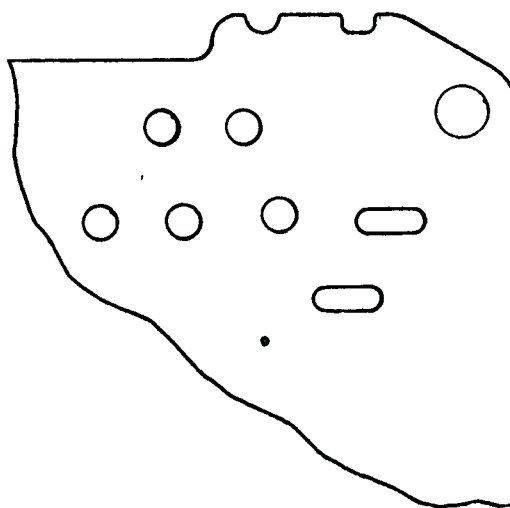
Figure 7

THIS SPACER PLATE FITS "ONLY" THE 10 CHECKBALL OIL PUMP.

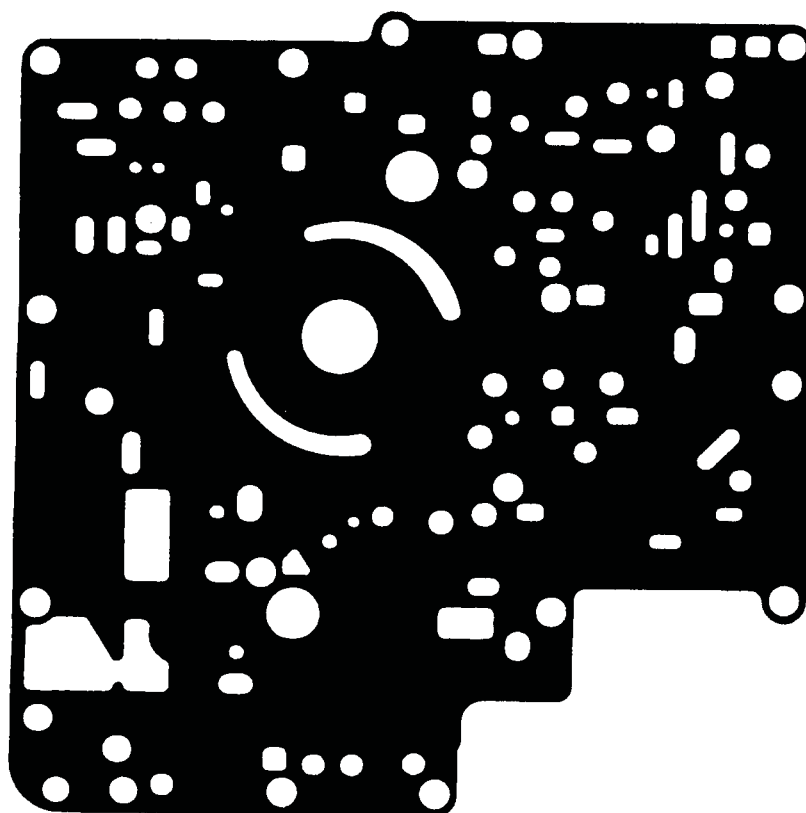
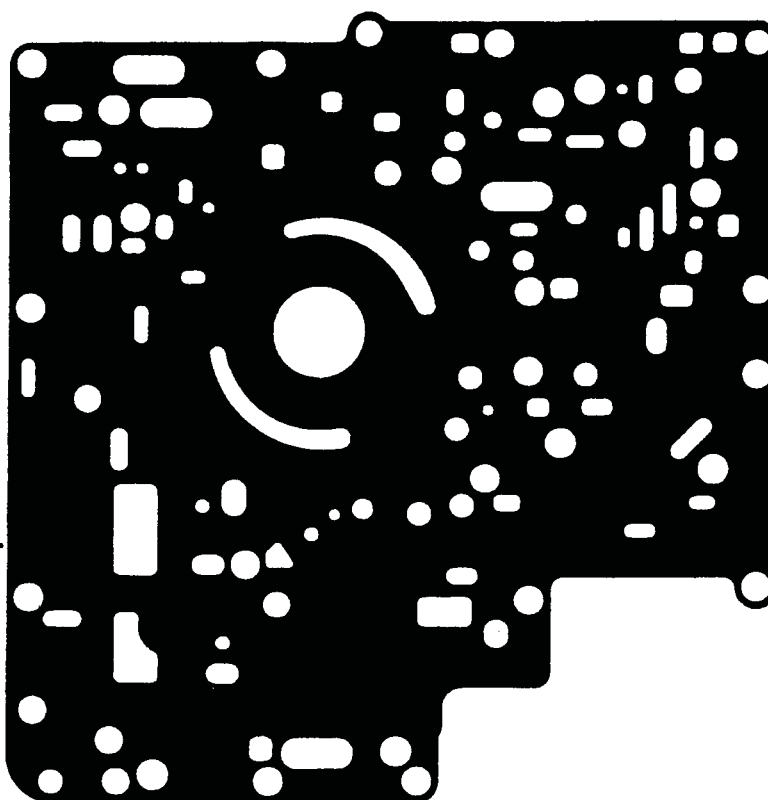
Figure 8

1986 PUMP SPACER PLATE
TO VALVE BODY.
E6DZ-7A136-A
(NO I.D. STRIPE)

1986 PUMP BODY TO
PUMP SPACER PLATE
E6DZ-7G331-A
(NO I.D. STRIPE)

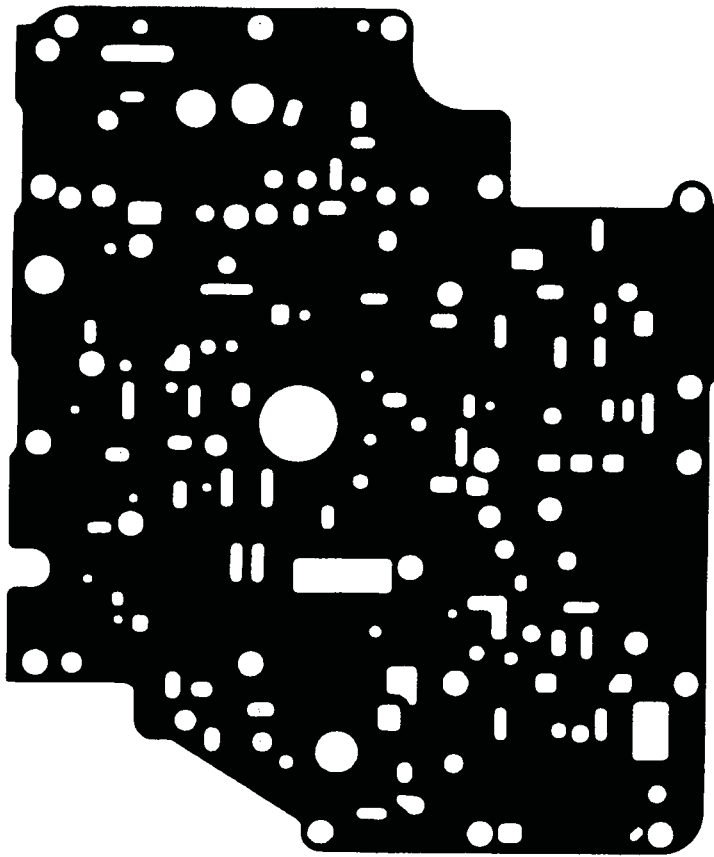
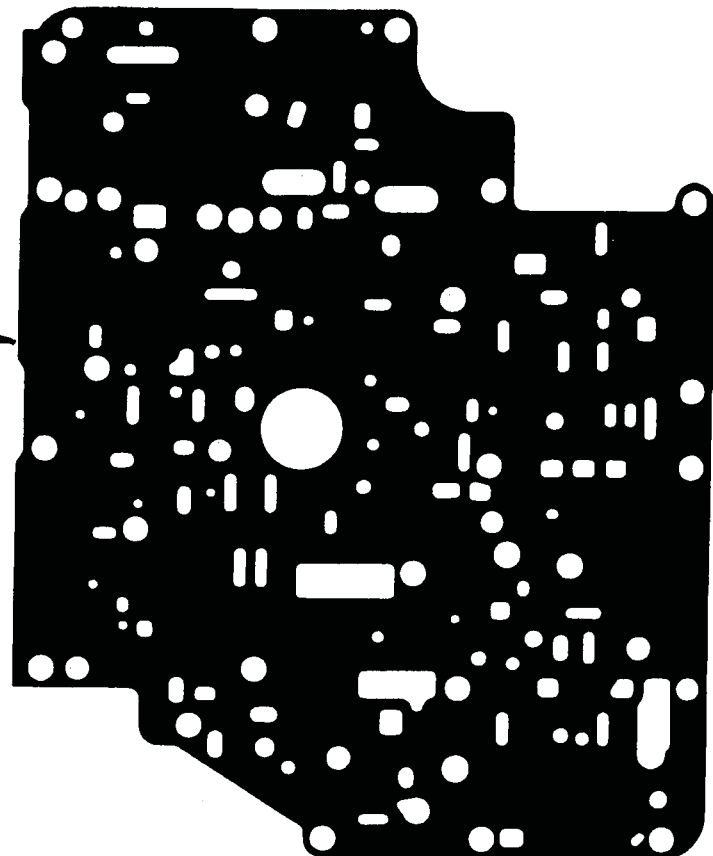
Figure 9

1986 VALVE BODY SPACER
PLATE TO CHAIN COVER
E6DZ-7C155-A
(NO I.D. STRIPE)

1986 VALVE BODY TO VALVE
BODY SPACER PLATE
E6DZ-7D100-A
(NO I.D. STRIPE)

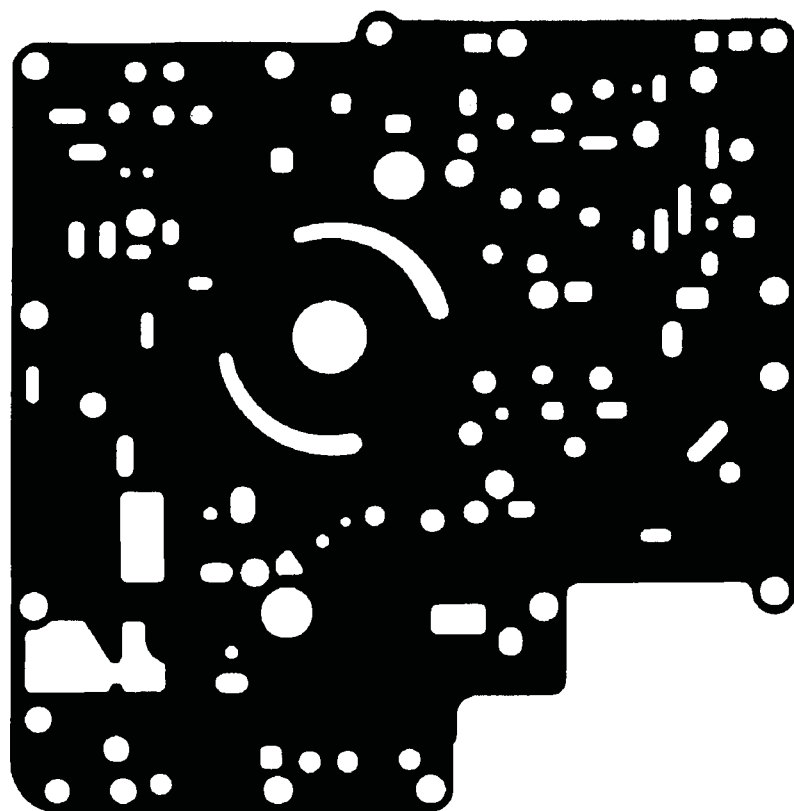
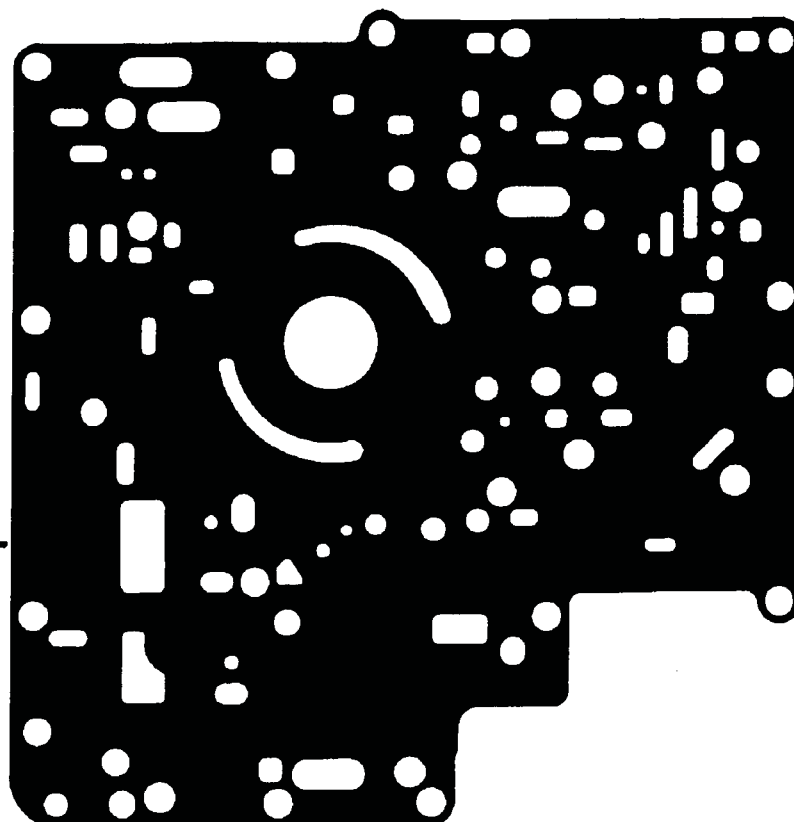
Figure 10
AUTOMATIC TRANSMISSION SERVICE GROUP
16

1987 PUMP SPACER PLATE
TO VALVE BODY
E7DZ-7A136-A
(WHITE I.D. STRIPE)

1987 PUMP BODY TO
PUMP SPACER PLATE
E7DZ-7G331-A
(WHITE I.D. STRIPE)

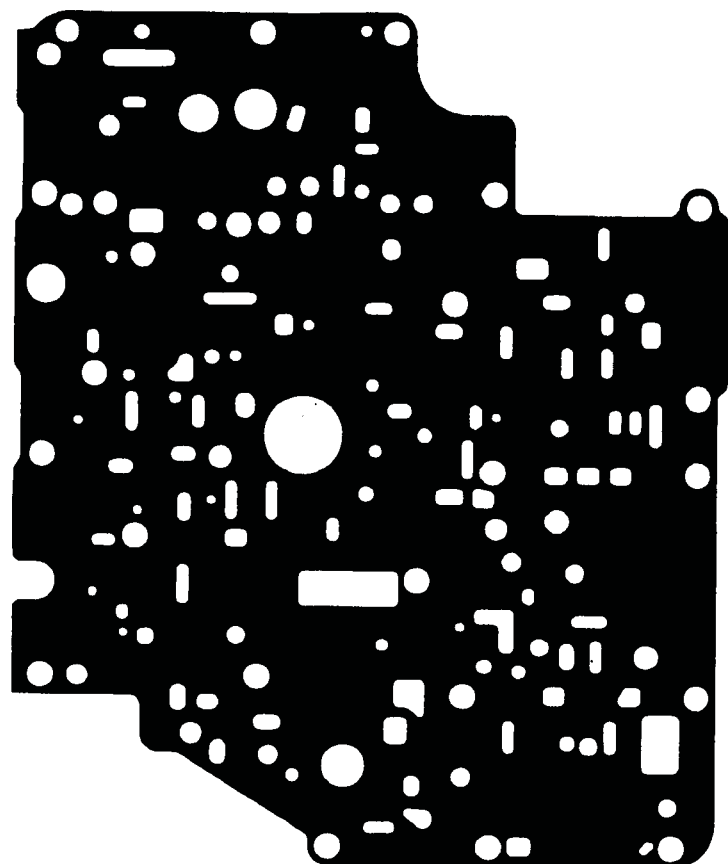
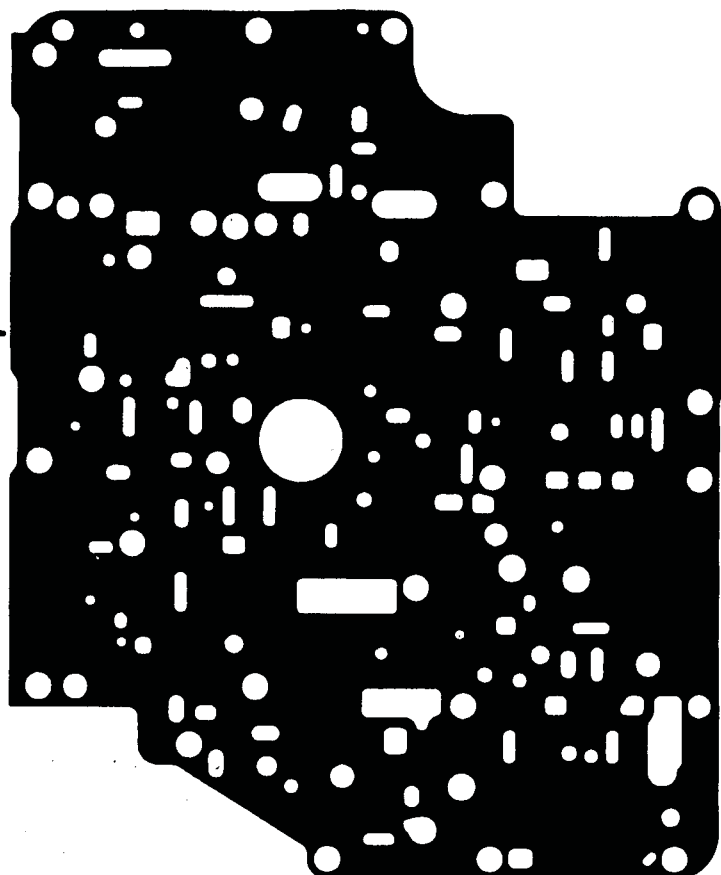
Figure 11
AUTOMATIC TRANSMISSION SERVICE GROUP

1987 VALVE BODY SPACER
PLATE TO CHAIN COVER
(E7DZ-7C155-A)
(WHITE I.D. STRIPE)

1987 VALVE BODY TO VALVE
BODY SPACER PLATE
E7DZ-7D100-A
(WHITE I.D. STRIPE)

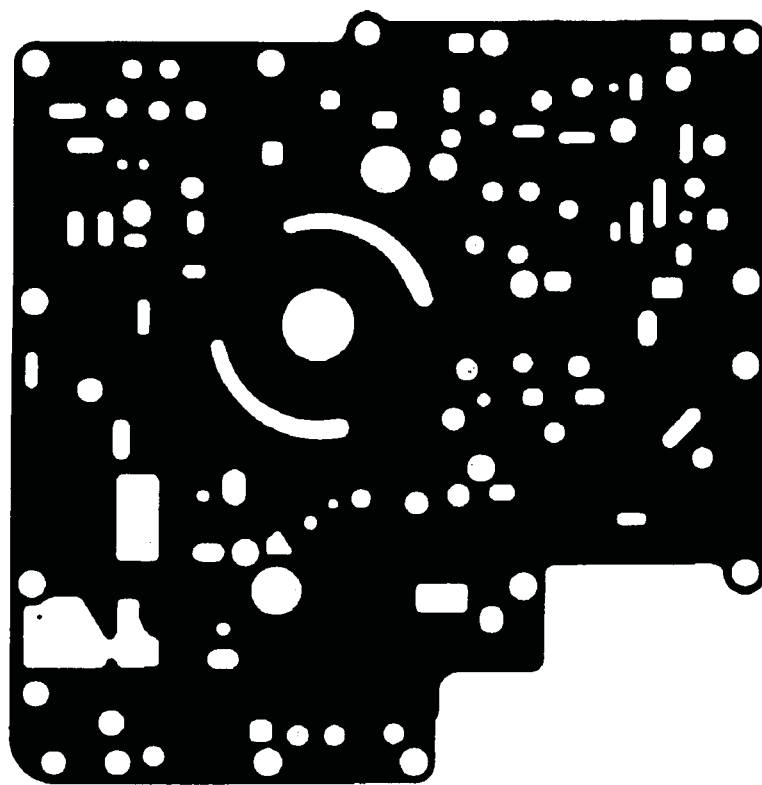
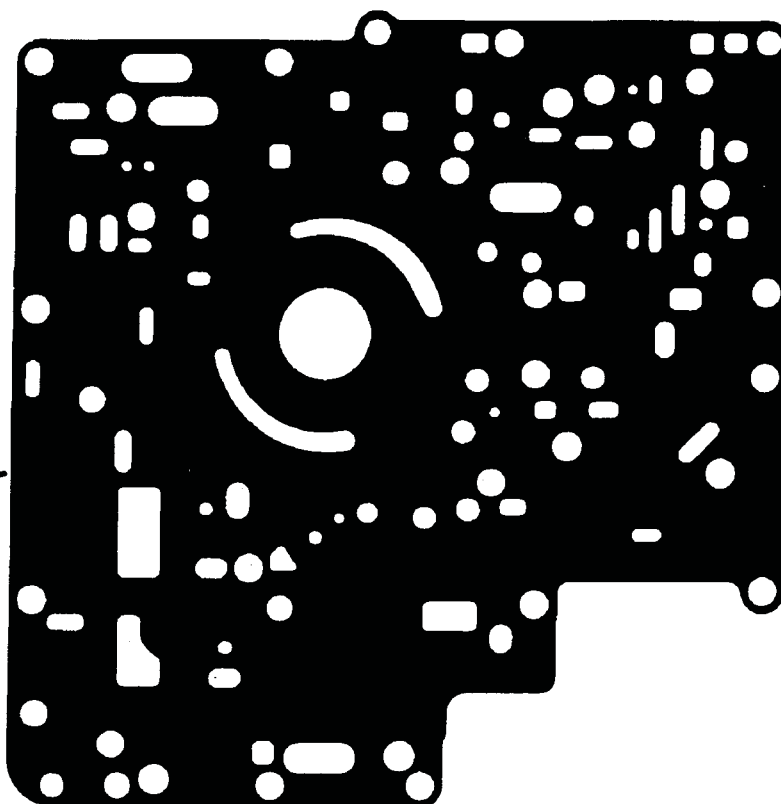
Figure 12
AUTOMATIC TRANSMISSION SERVICE GROUP

88/89 PUMP SPACER PLATE
TO VALVE BODY
E8DZ-7A136-A
(YELLOW I.D. STRIPE)

88/89 PUMP BODY TO
PUMP SPACER PLATE
E8DZ-7G331-A
(YELLOW I.D. STRIPE)

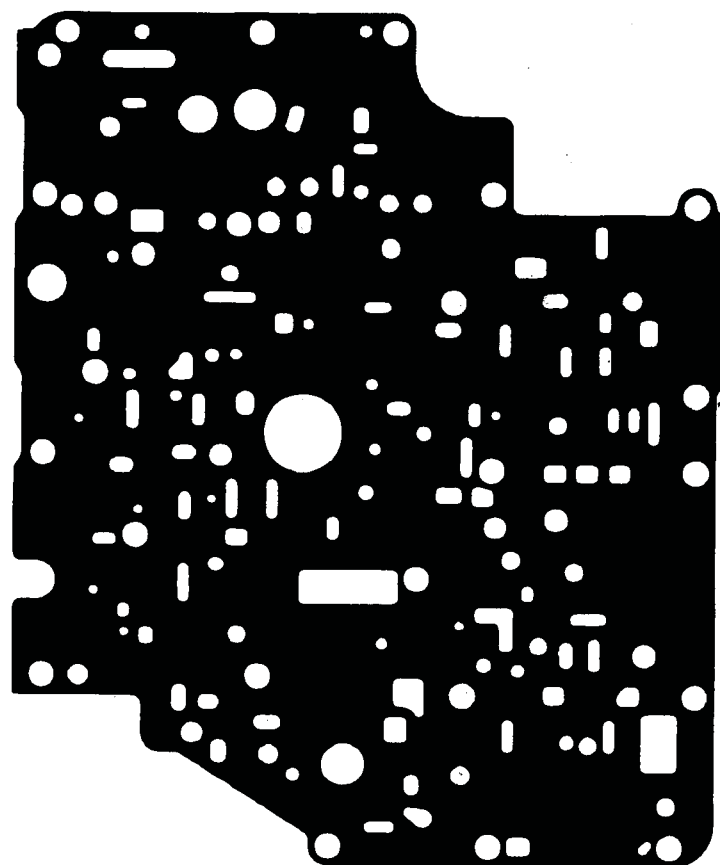
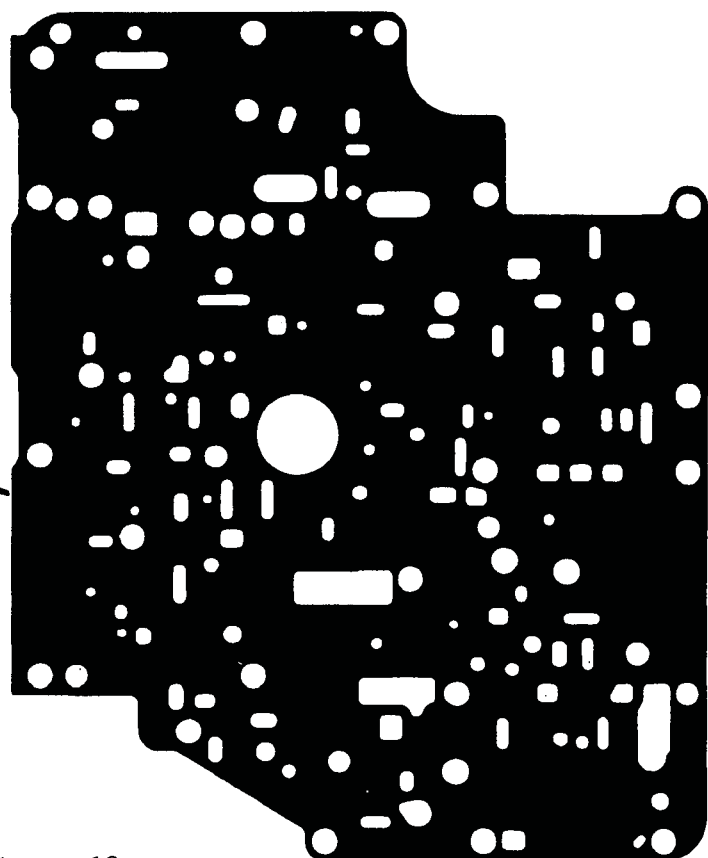
Figure 13
AUTOMATIC TRANSMISSION SERVICE GROUP

88/90 VALVE BODY SPACER
PLATE TO CHAIN COVER
E8DZ-7C155-A
(YELLOW I.D. STRIPE)

88/90 VALVE BODY TO VALVE
BODY SPACER PLATE
E8DZ-7D100-A
(YELLOW I.D. STRIPE)

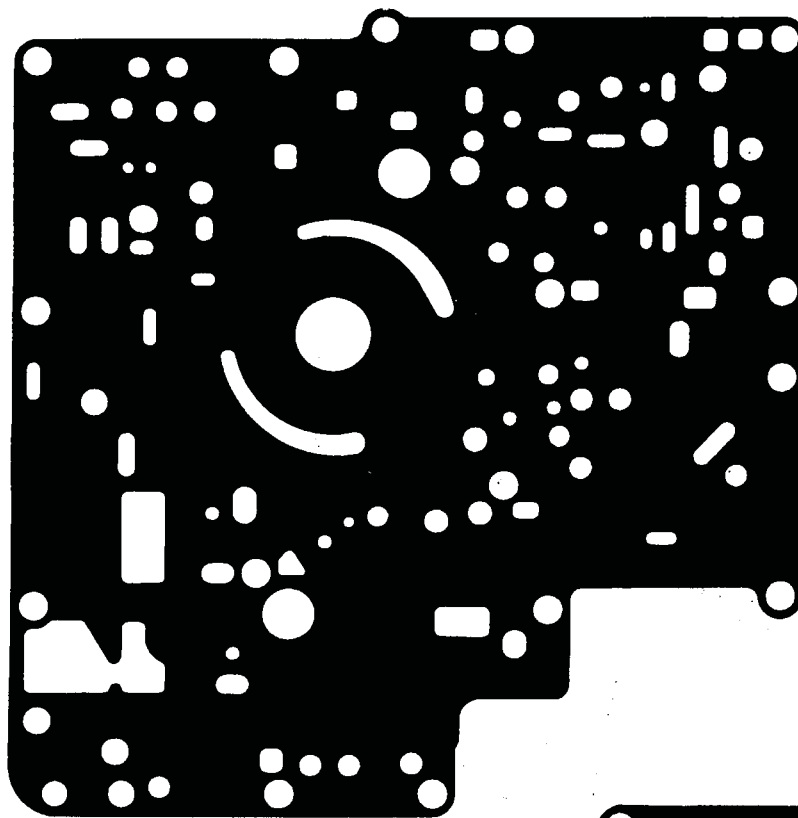
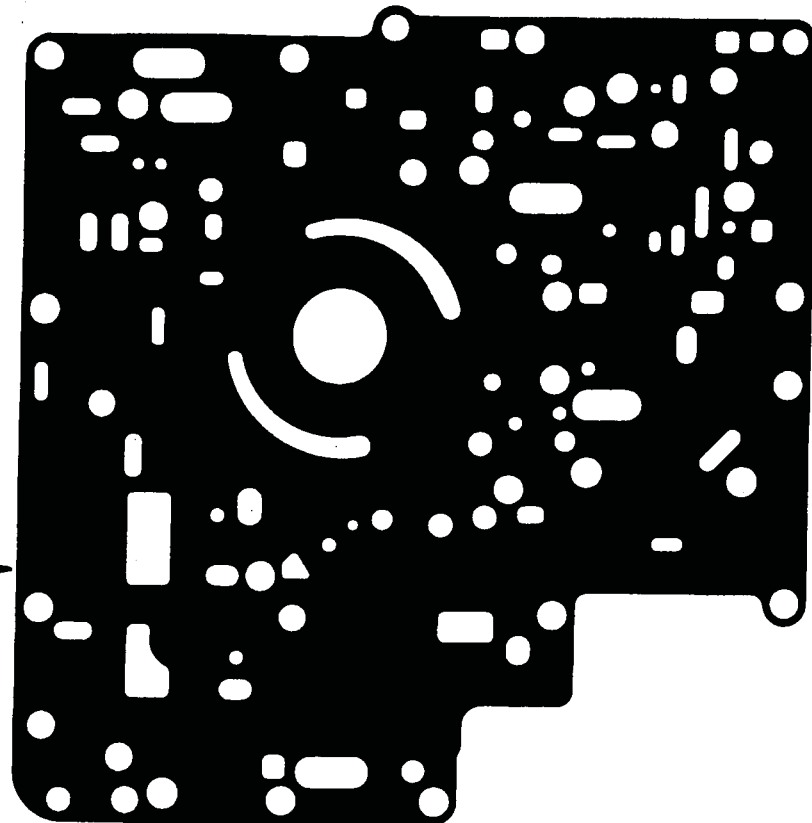
Figure 14

PUMP SPACER PLATE
TO VALVE BODY
E90Y-7A136-A
(BLUE I.D. STRIPE)

PUMP BODY TO
PUMP SPACER PLATE
E90Y-7G331-A
(BLUE I.D. STRIPE)

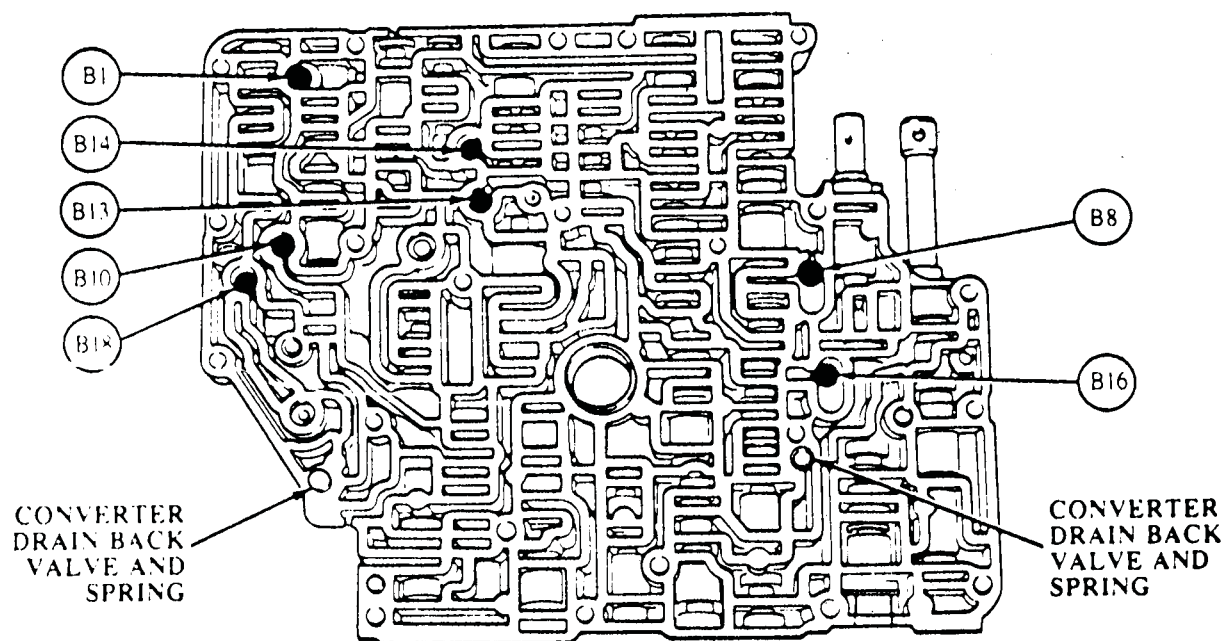
Figure 15

NOTE: Checkball locations in the valve body have remained the same for ALL model years and are shown in Figure 15.

VALVE BODY CHECKBALL LOCATIONS
(ALL MODELS)

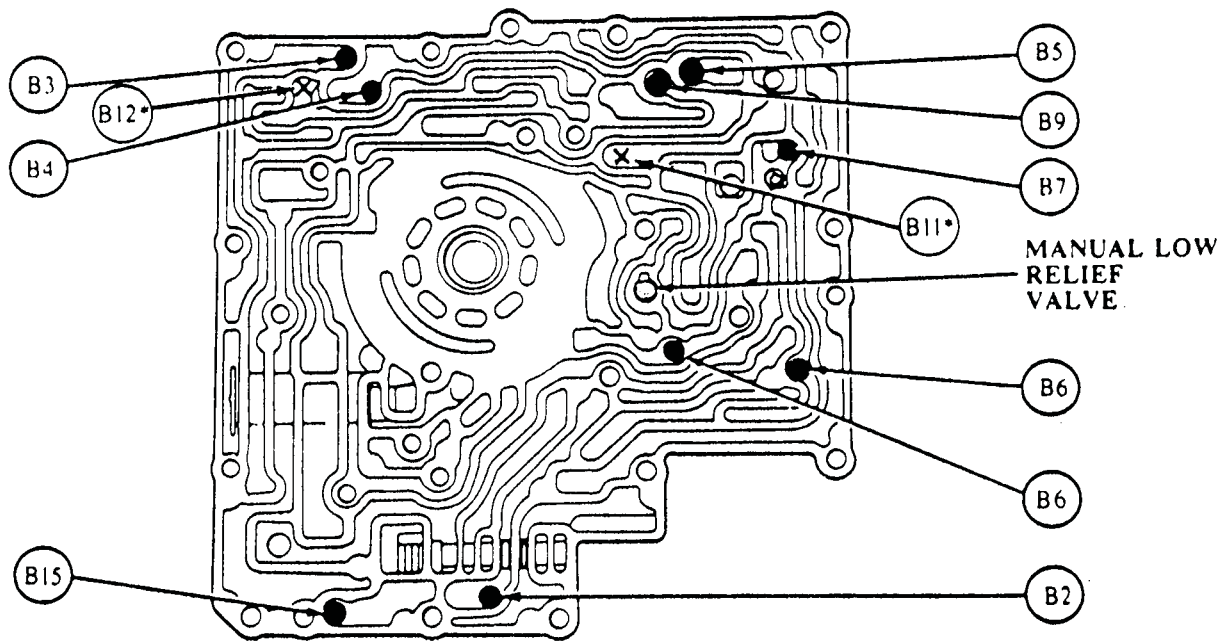
Figure 16

The 1986-1989 oil pumps have 9 checkballs, see Figure 16.

*Do not install ball check

NOTE: DO NOT INSTALL CHECKBALL IN LOCATIONS MARKED "X".

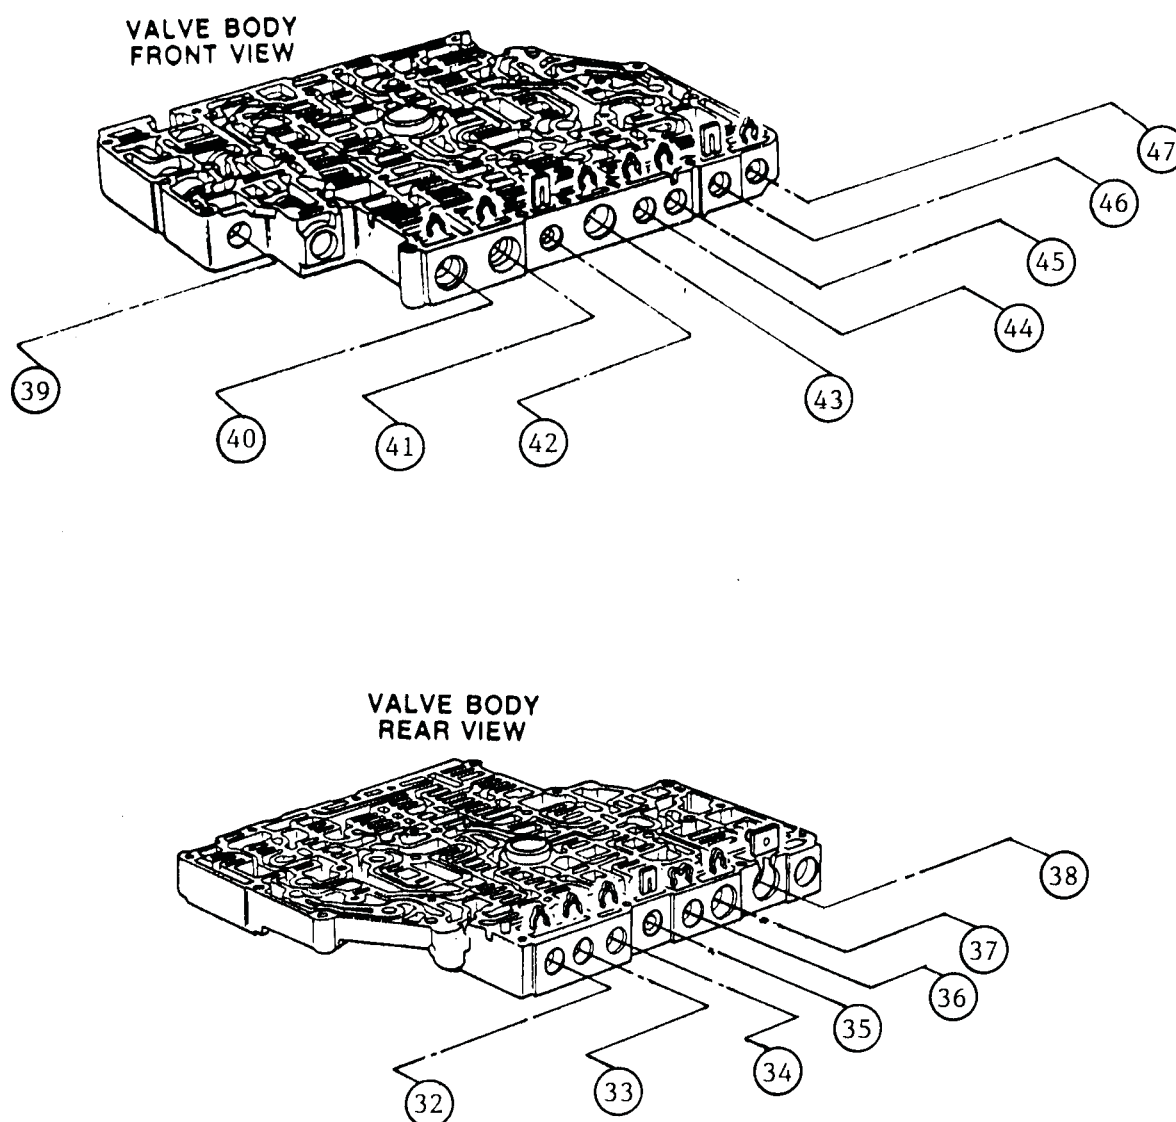
Figure 20

ON THIS PAGE WE HAVE ASSIGNED NUMBERS TO ALL OF THE VALVE BODY BORES AND RE-DRAWN THE VALVES AND SPRINGS IN THEIR PROPER LOCATIONS, WITH EACH VALVE ORIENTED PROPERLY, AND IDENTIFIED, AS SHOWN ON THE FOLLOWING PAGES. "ALL" OF THE MANUALS PRESENTLY IN PRINT ARE WRONG.

USE THIS MANUAL TO PROPERLY ASSEMBLE THE AXOD VALVE BODY.

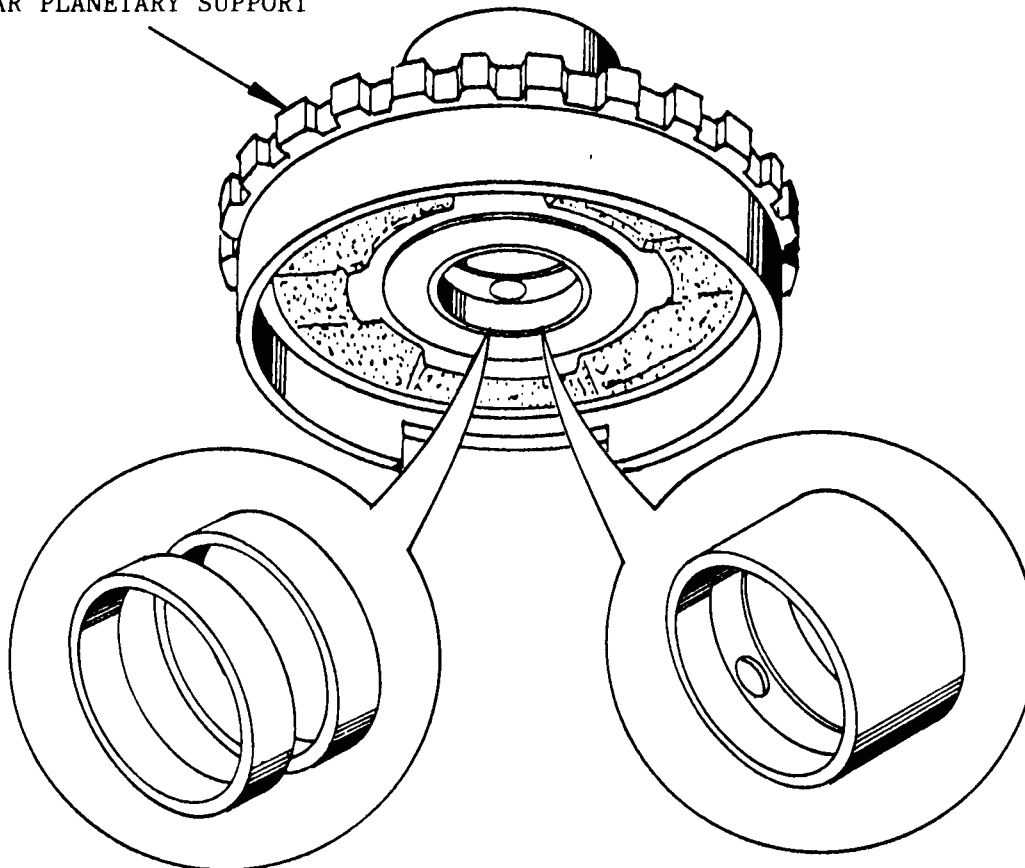
REAR PLANETARY SUPPORT

3. Inspect the bushings in the rear planetary support, as these bushings can move out of position and block the lube oil hole located in the support between them. The 1988 and later rear planetary support has a new design, wider, one piece bushing with a groove and lube hole in the center. This will provide more surface area to prevent the bushing from moving. Refer to Figure 29.
The later rear planetary support, with the 2nd design bushing, will retro fit back to ALL previous models and is highly recommended. The new design rear planetary support is available under OEM part number E6DZ-7A130-A.

1ST DESIGN

2 NARROW BUSHINGS

THE LATER REAR PLANETARY SUPPORT, WITH THE 2ND DESIGN BUSHING, WILL RETRO FIT BACK TO ALL MODELS AND IS HIGHLY RECOMMENDED.
