AXOD/AXODE (AX4S) UPDATE HANDBOOK

AUTOMATIC TRANSMISSION SERVICE GROUP

INTRODUCTION

*Updated
October, 2002*

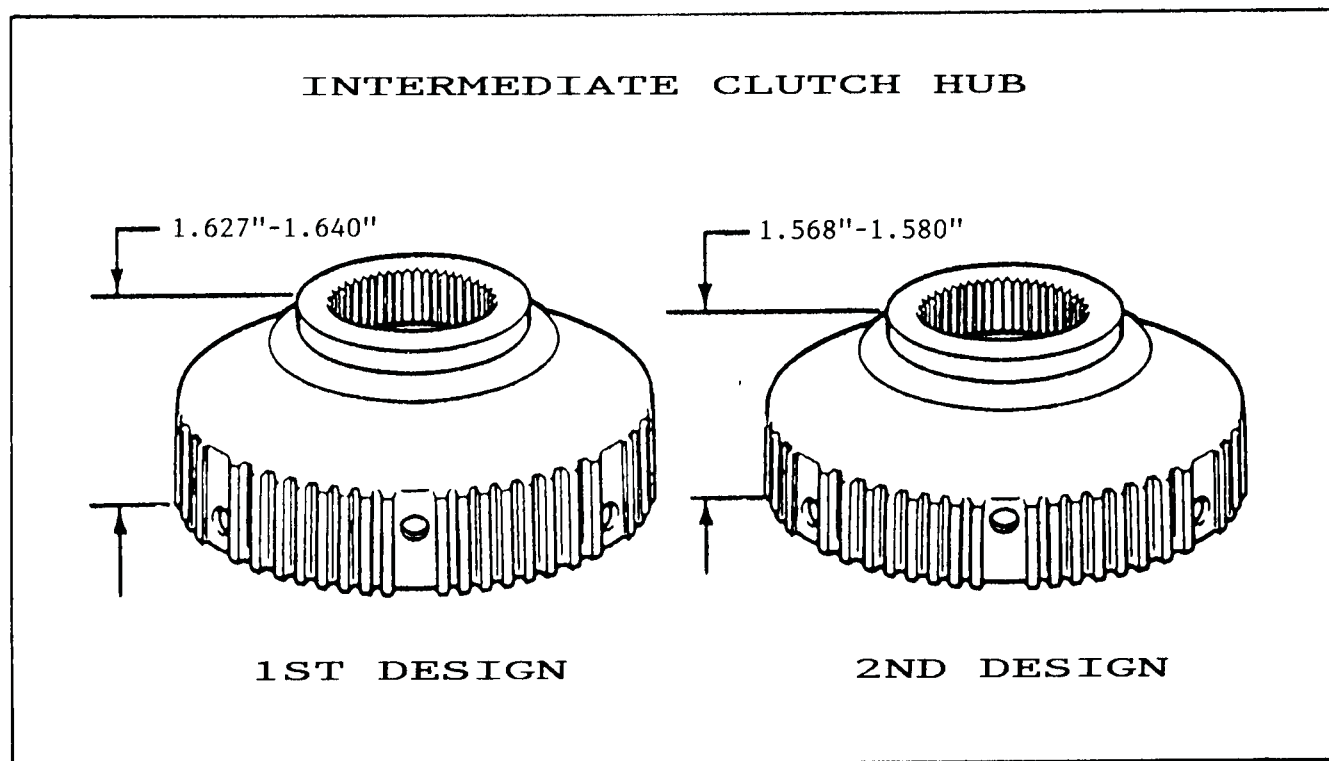
Figure 32

- (2) **INTERMEDIATE CLUTCH HUB** - Overall height was made shorter by approximately .060" with no identifying marks. The hub **MUST** be measured with a dial caliper or depth gage.
The 1st design hub will measure 1.627"-1.640", and the 2nd design hub will measure 1.568"-1.580" as shown in Figure 32.

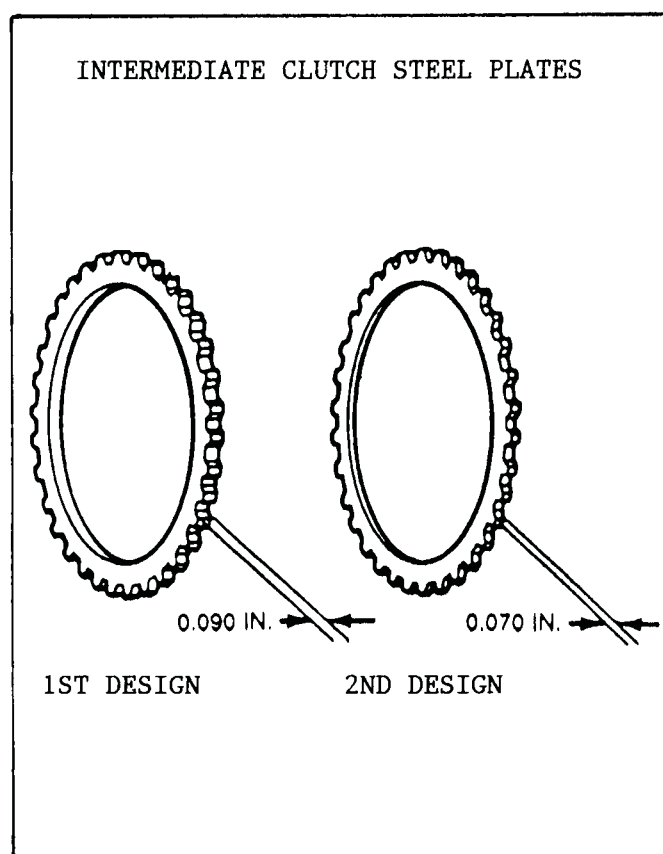
Figure 33

- (3) **INTERMEDIATE CLUTCH STEEL PLATES** - Thicknes was reduced by .020" to help accomodate the added wave plate on 3.8L models, or the added spacer plate on 3.0L models.
The 1st design steel plates are .090" thick, and the 2nd design steel plates are .070" thick as shown in Figure 33.

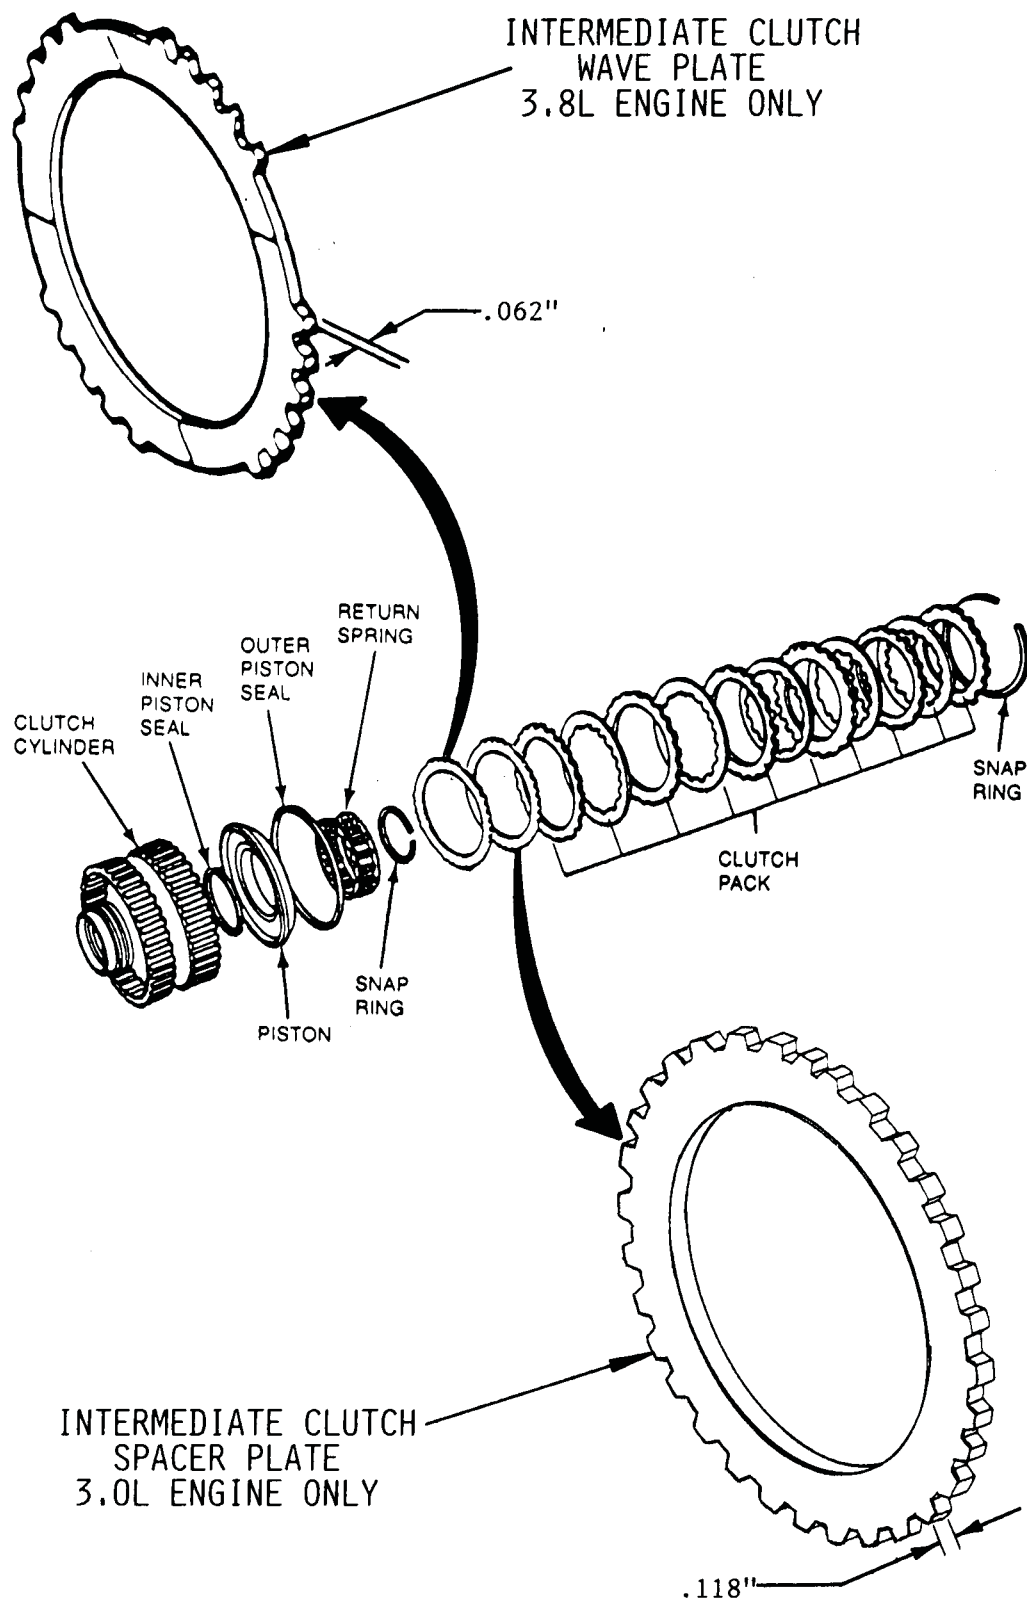
Figure 35

- (4) **INTERMEDIATE CLUTCH PRESSURE PLATE** - Thickness was reduced by .065" to help accomodate the added wave plate on 3.8L models, or the added spacer plate on 3.0L models.
The 1st design pressure plate is .190" thick, and the 2nd design pressure plate is .125" thick as shown in Figure 35.

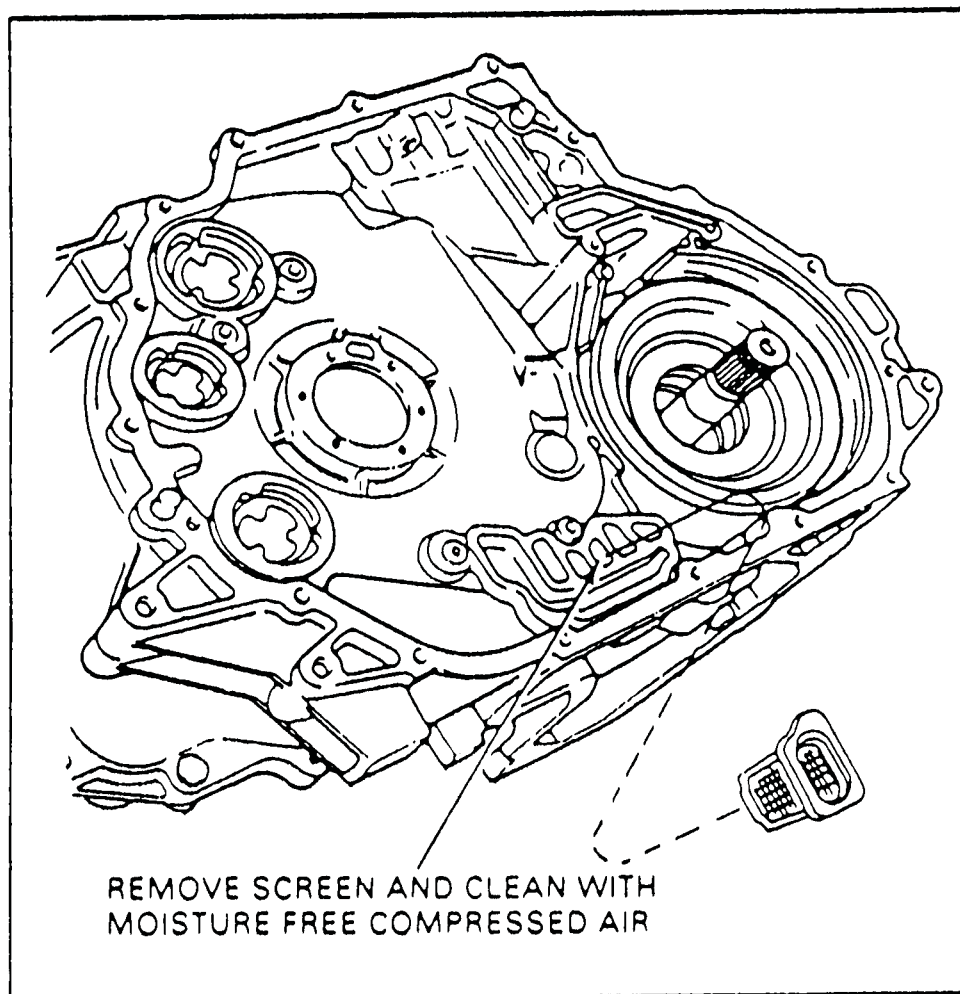
Figure 38

CHANGE: A new filter has been added to the 1989 AXOD 1-2 servo apply circuit as shown in Figure 38.

NOTE: A no forward condition could occur if the filter becomes contaminated.

New Filter E9DZ-7H162-A

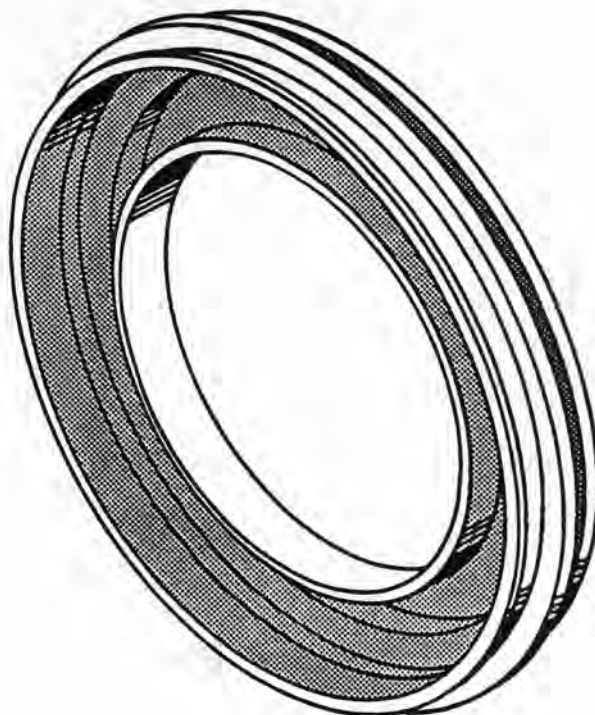
Figure 39

CHANGE: The Forward Clutch Piston material has now been changed to "Steel", instead of the previous design aluminum piston, as shown in Figure 39.

REASON: To eliminate cracks from occurring in the seal groove and greatly improve durability

- (1) FORWARD CLUTCH PISTON - Now manufactured out of steel, instead of aluminum, and there are no dimensional changes on the piston (See Figure 39).

Forward Clutch Piston (All Except "SHO" Models)	F4DZ-7A262-A
Forward Clutch Piston (3.2L "SHO" Models Only)	F4DZ-7A262-B

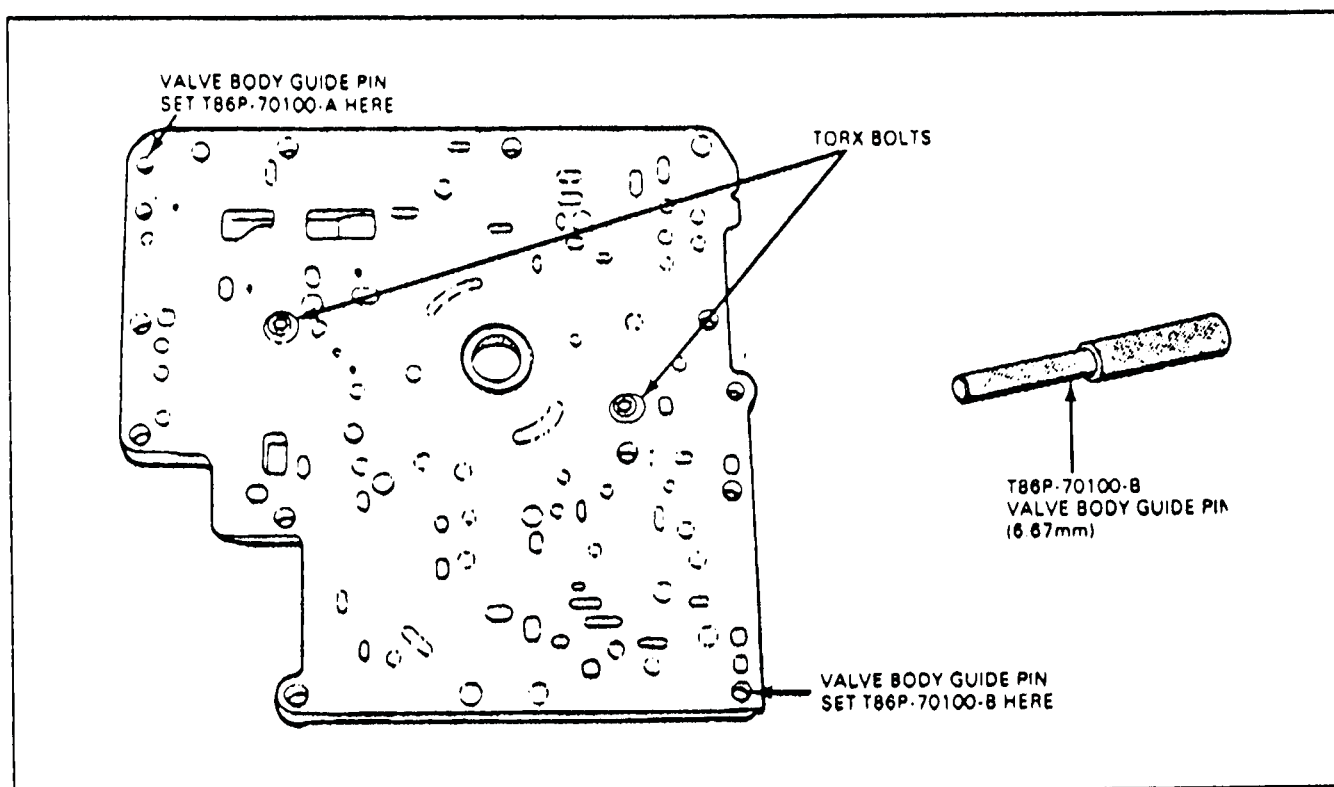
Figure 44

Proper alignment of the oil pump and the valve body are mandatory to prevent premature wear of the oil pump drive shaft and the bearing assembly located in the pump housing. When re-assembling the valve body and oil pump, use the guide pins to assure proper alignment.

1. Position the spacer plate on the pump housing, using a new gasket.
2. Insert valve body guide pin T86P-70100-A (.271" Diameter) and valve body guide pin T86P-70100-B (.262" Diameter), as shown in Figure 44.
3. Install two "Torx" bolts and torque to 7 to 9 ft.lb.
4. Remove both guide pins.
5. Position the spacer plate on the valve body using a new gasket.
6. Insert two valve body guide pins T86P-70100-A (.271" Diameter, as shown in Figure 45.
7. Install two "Torx" bolts and torque to 7 to 9 ft.lb.
8. Position the oil pump on the valve body using a new gasket.
9. Insert pump body guide pin T86P-70370-A and valve body guide pin T86P-70100-C which is .245" in Diameter.
10. Install two valve body to oil pump retaining bolts and torque to 7 to 9 ft.lb.

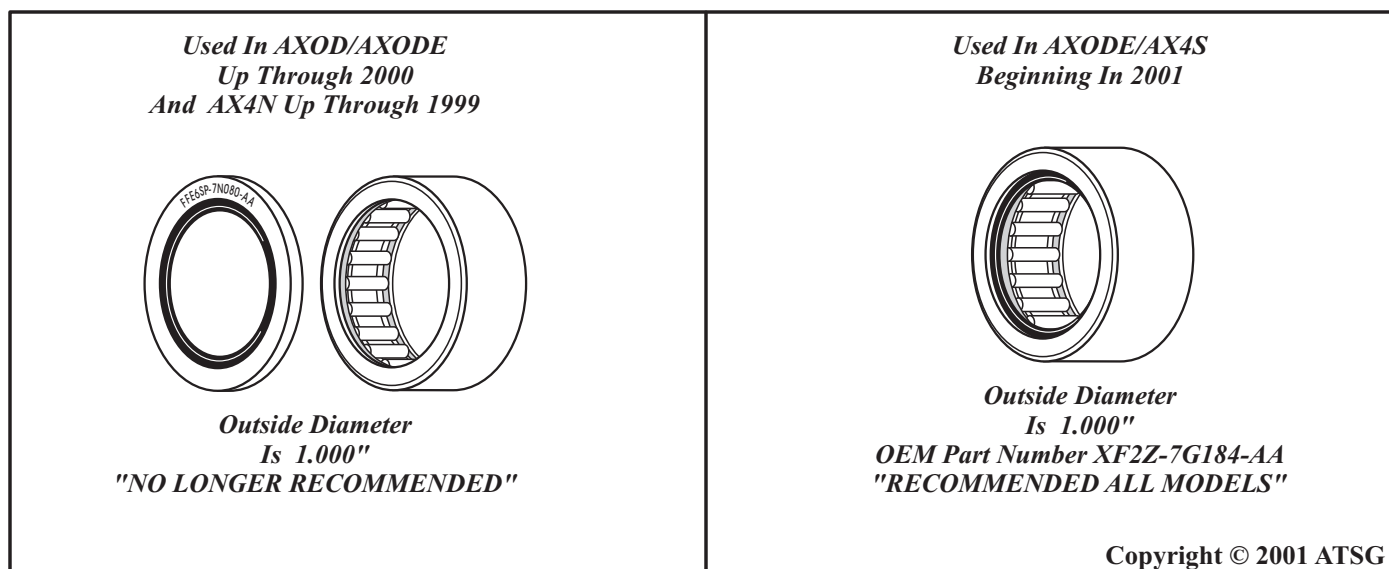
Figure 47

CHANGE: Beginning at the start of production for 2001 on all AX4S transaxles, Ford Motor Company introduced a new design pump bearing that includes an integrated seal, as shown in Figure 47. When this new design bearing and seal assembly went into production, it was installed with the ***seal on the valve body side of the pump instead of the rotor side.***

REASON: Greatly reduced pump bearing, pump rotor and vane ring failure, for much improved durability and reliability.

Pump Bearing With Integral Seal XF2Z-7G184-AA

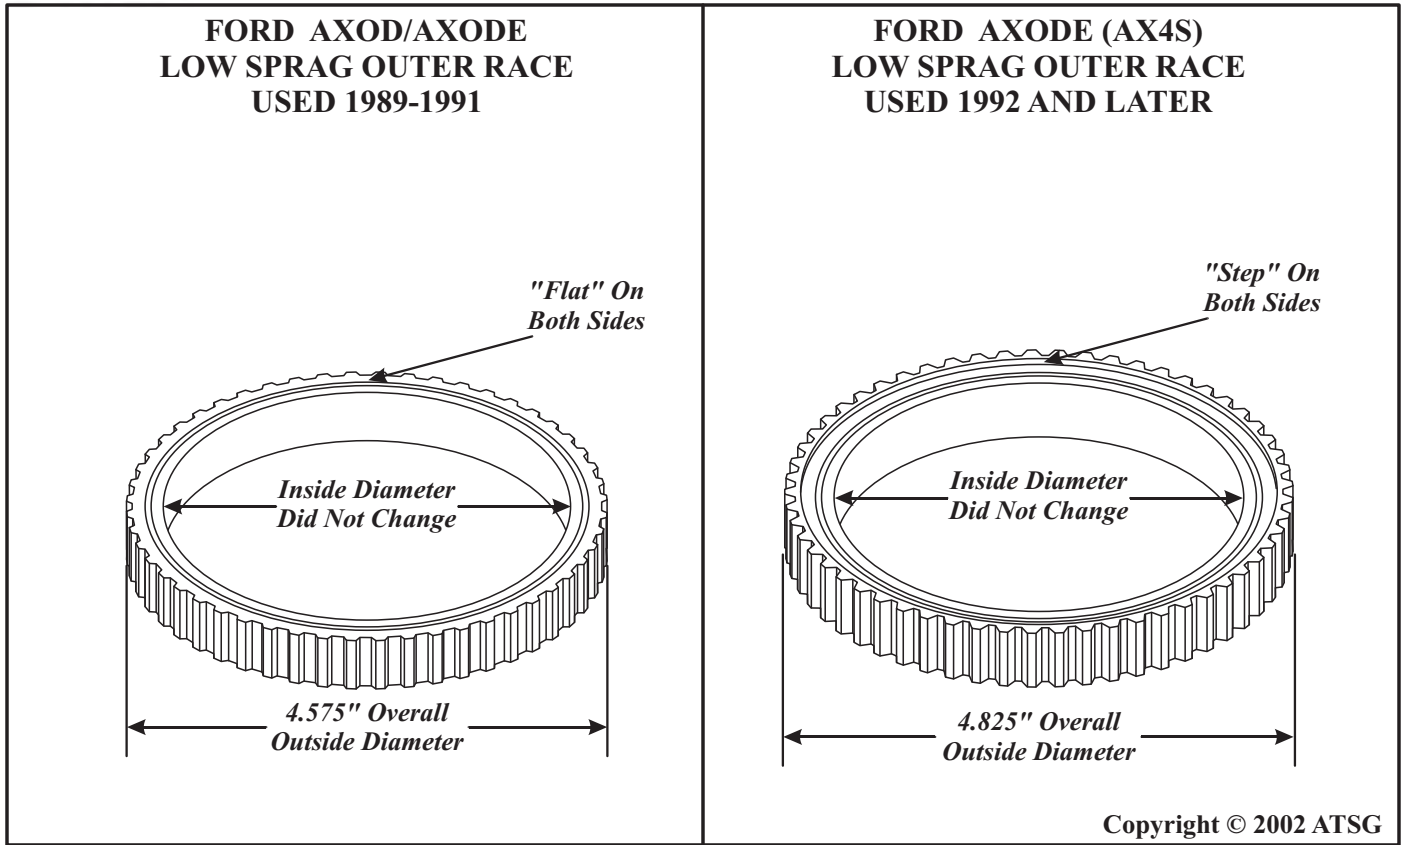
Figure 57

- (1) **LOW SPRAG OUTER RACE** - The outer diameter of the race was increased from 4.575" to 4.825", and the width of the race was increased from .600" to .725", as shown in Figure 57. *The Inside Diameter of the sprag race Did Not Change.*

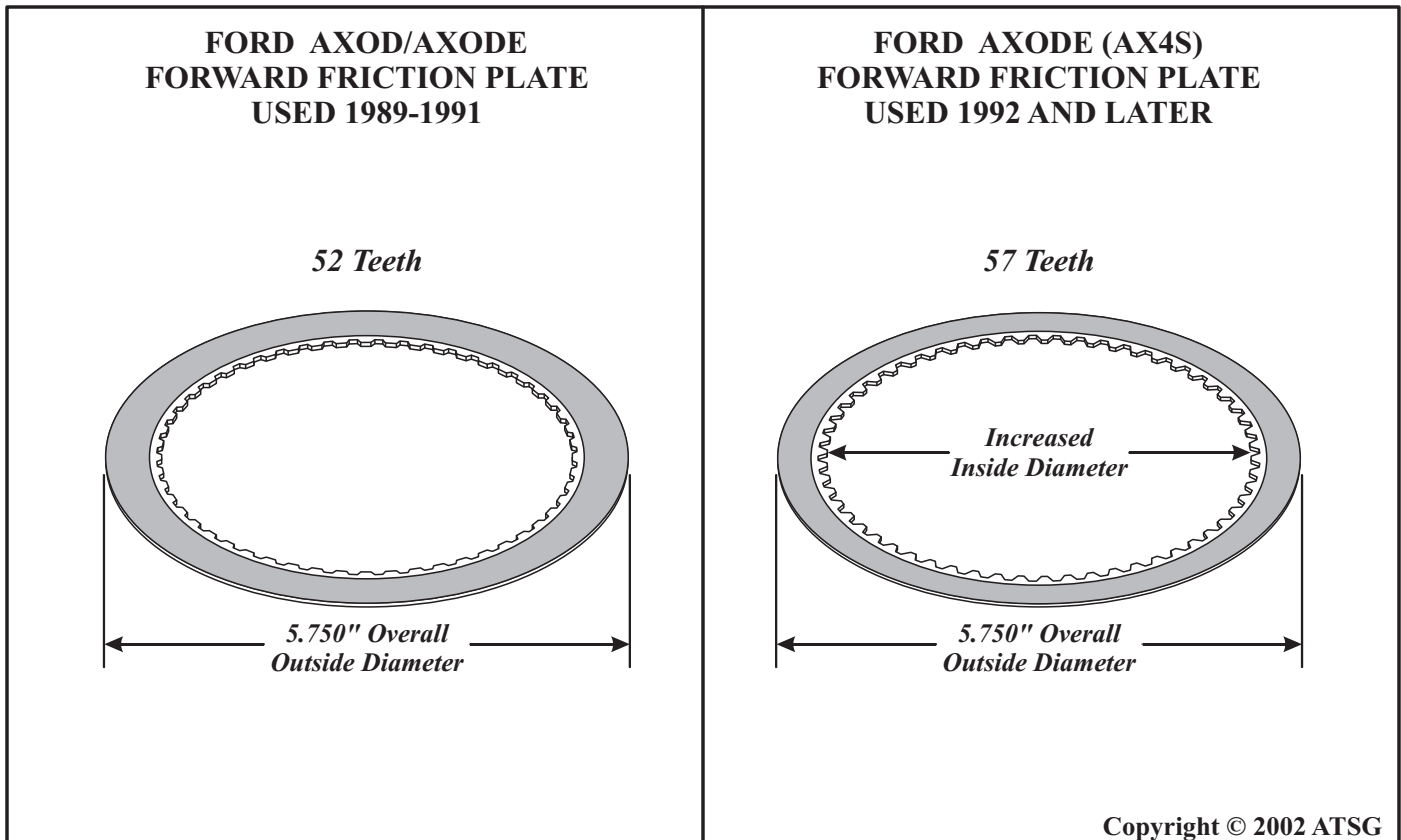
Figure 58

- (2) **FORWARD CLUTCH FRICTION PLATES** - Have an increased amount of teeth to 57 Teeth from the previous 52 Teeth, to accommodate the increased diameter of the sprag outer race, as shown in Figure 58.

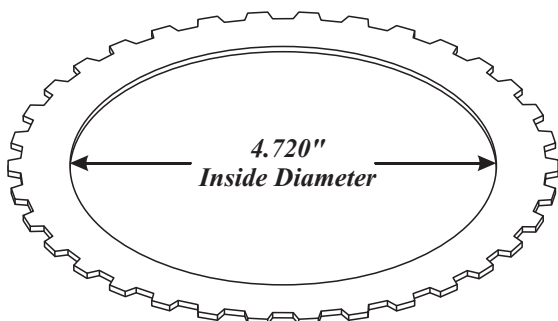
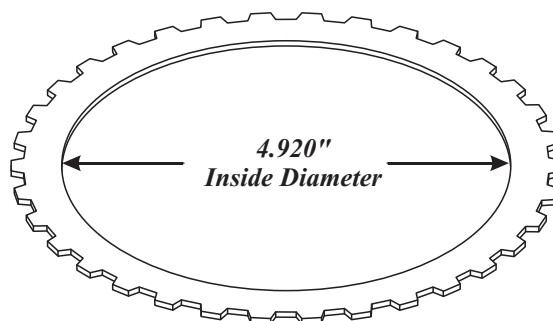
Figure 59

- (3) **FORWARD CLUTCH STEEL PLATES** - Have an increased inside diameter to 4.920" from the previous 4.720", to accommodate the increased diameter of the sprag outer race, as shown in Figure 59.

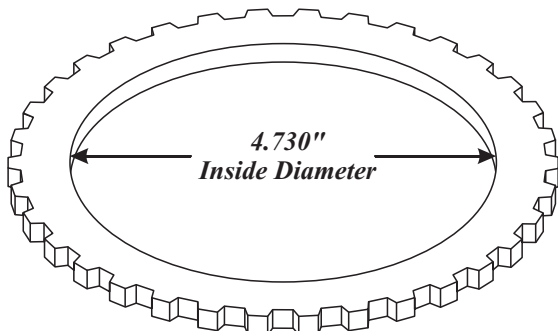
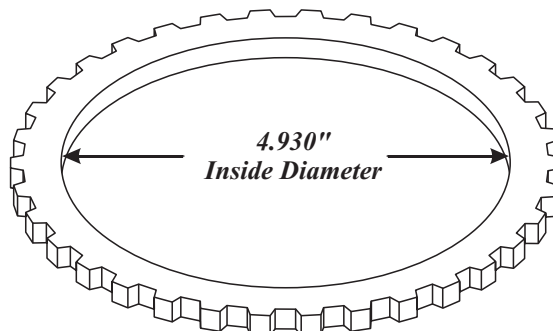
Figure 60

- (4) **FORWARD CLUTCH PRESSURE PLATE** - Has an increased inside diameter to 4.930" from the previous 4.730", to accommodate the increased diameter of the sprag outer race, as shown in Figure 60.

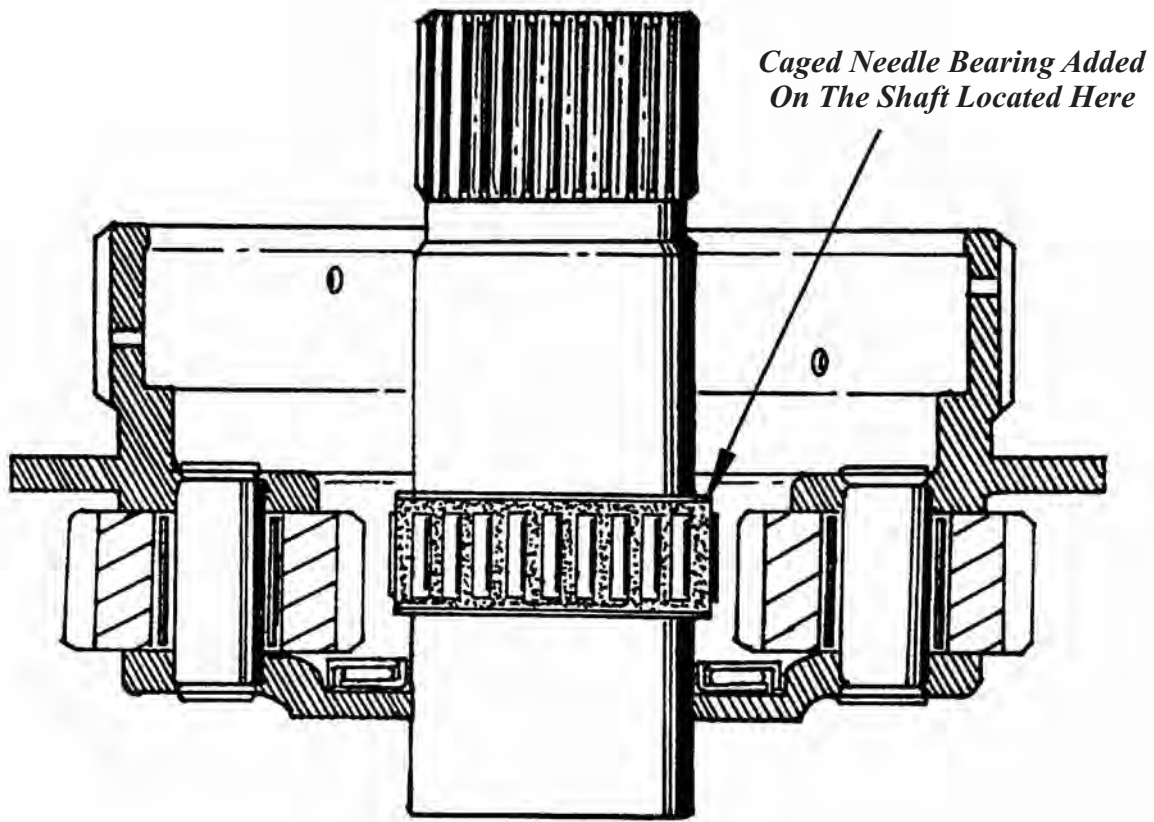
Figure 62

- (1) INPUT PLANETARY CARRIER - New caged needle Bearing added to the shaft on the Input Planetary Carrier, as shown in Figure 62.
- (2) SUN GEAR AND SHELL ASSEMBLY - Single bushing is now located in front of the lube holes in the sun gear, and the area behind is now machined to accommodate the new caged needle bearing, as shown in Figure 63.

When you order an Input Planetary Carrier and/or a Sun Gear and Shell assembly from OEM, they will automatically supercede to the new service package part number F4DZ-7A398-A, which includes both of the new design parts listed above.

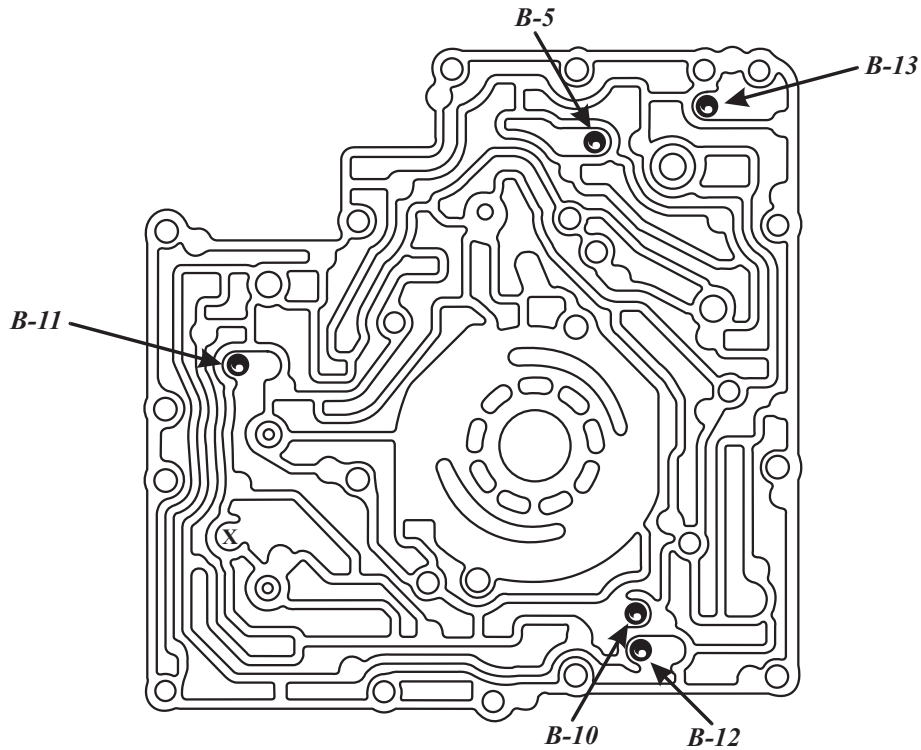
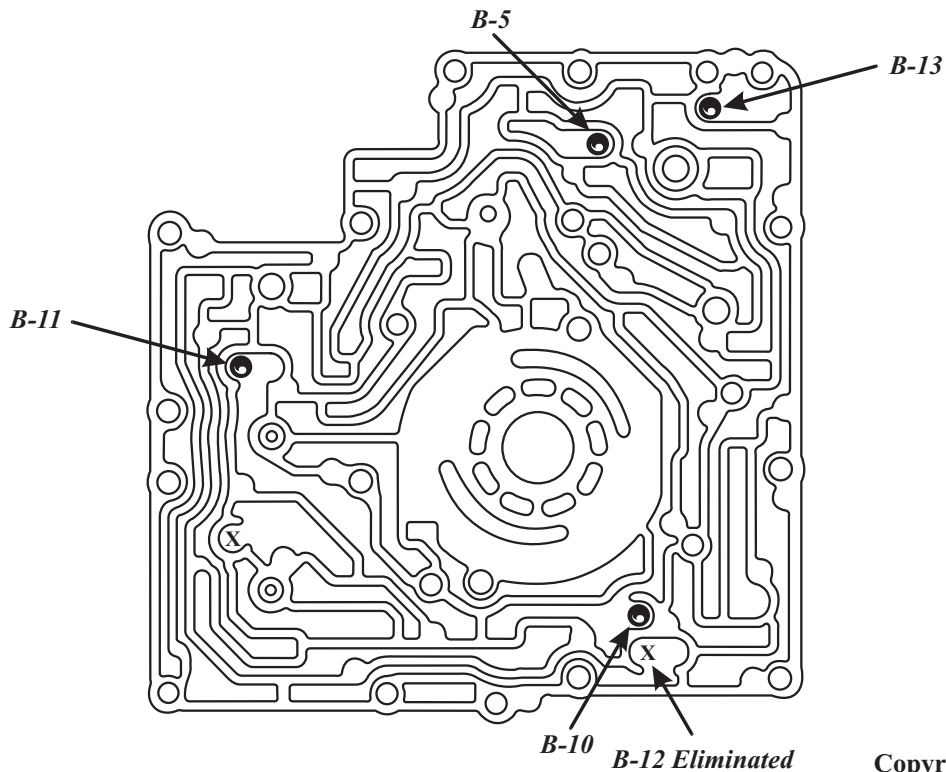
Figure 65

"Early" 1991 Only - Uses 5 checkballs in the locations shown in Figure 65. Use chart above to determine Early or Late transaxle by serial number.

"Late" 1991 Only - Uses 4 checkballs in the locations shown in Figure 65. Use chart above to determine Early or Late transaxle by serial number.

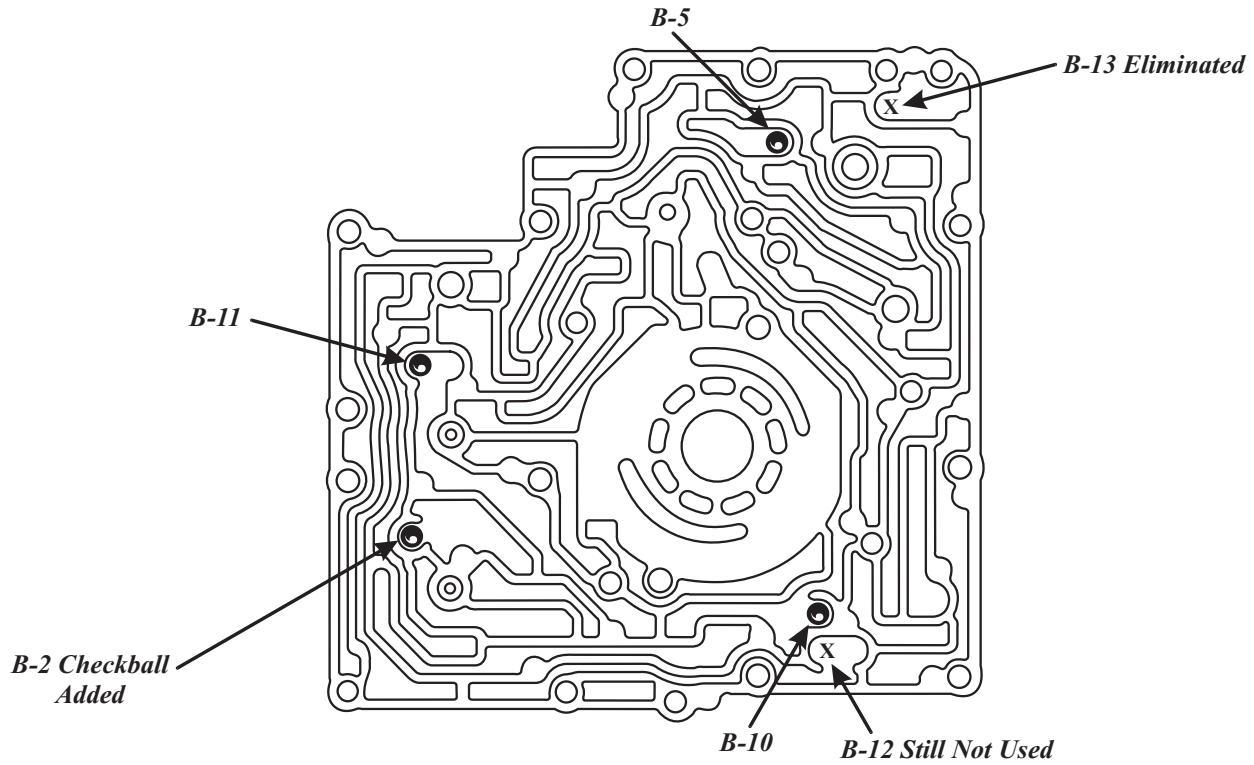
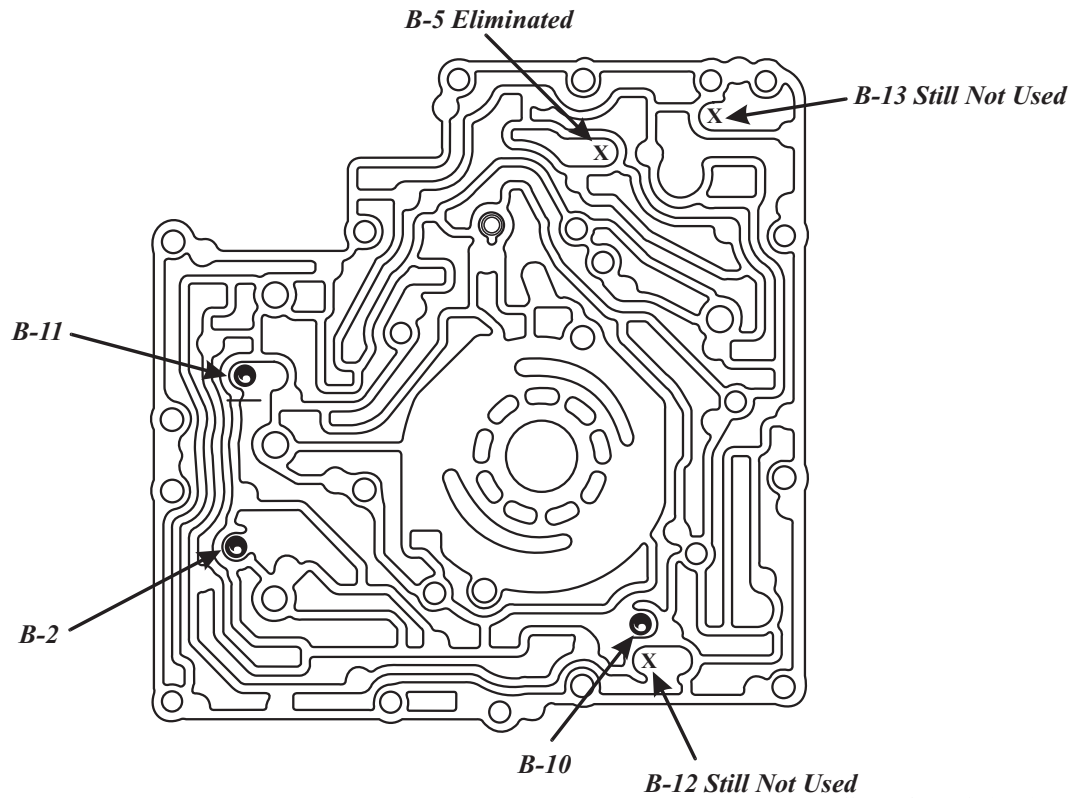
Figure 66

1992-1998 Only - Uses 4 checkballs but in different locations, as shown in Figure 66. B-13 checkball was eliminated and B-2 checkball was added.

1999-2002 Only - Uses 3 checkballs in the locations shown in Figure 66. B-5 checkball was eliminated.

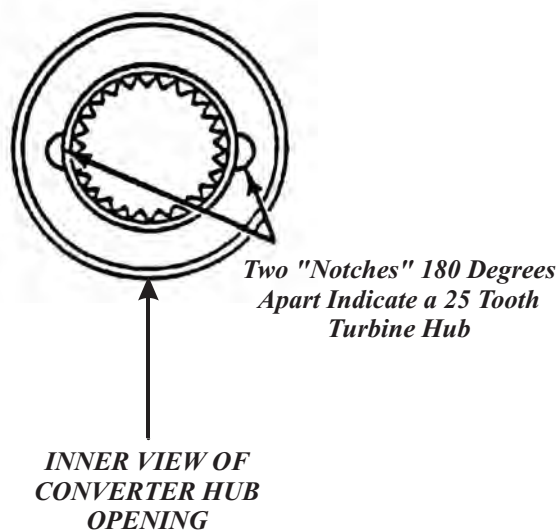
- (1) **TORQUE CONVERTER** - Converter turbine splines changed from 23 splines to 25 splines. To identify this change, the converter "Stamp Code" was changed. Refer to the chart found in Figure 67 for identification, if the converter has not been rebuilt.
- (2) **TURBINE SHAFT** - Splines changed from 23 splines to 25 splines. Count the number of splines on turbine shaft for positive identification.

CAUTION: *It is possible to install a 25 Spline converter onto a 23 Spline turbine shaft. If this occurs, the vehicle will have a "No Movement" condition and after the engine is started will usually twist off the stator shaft (Drive Sprocket Support).*

If replacement of either torque converter and/or turbine shaft is necessary, ensure that equal number of splines exist on the mating parts.

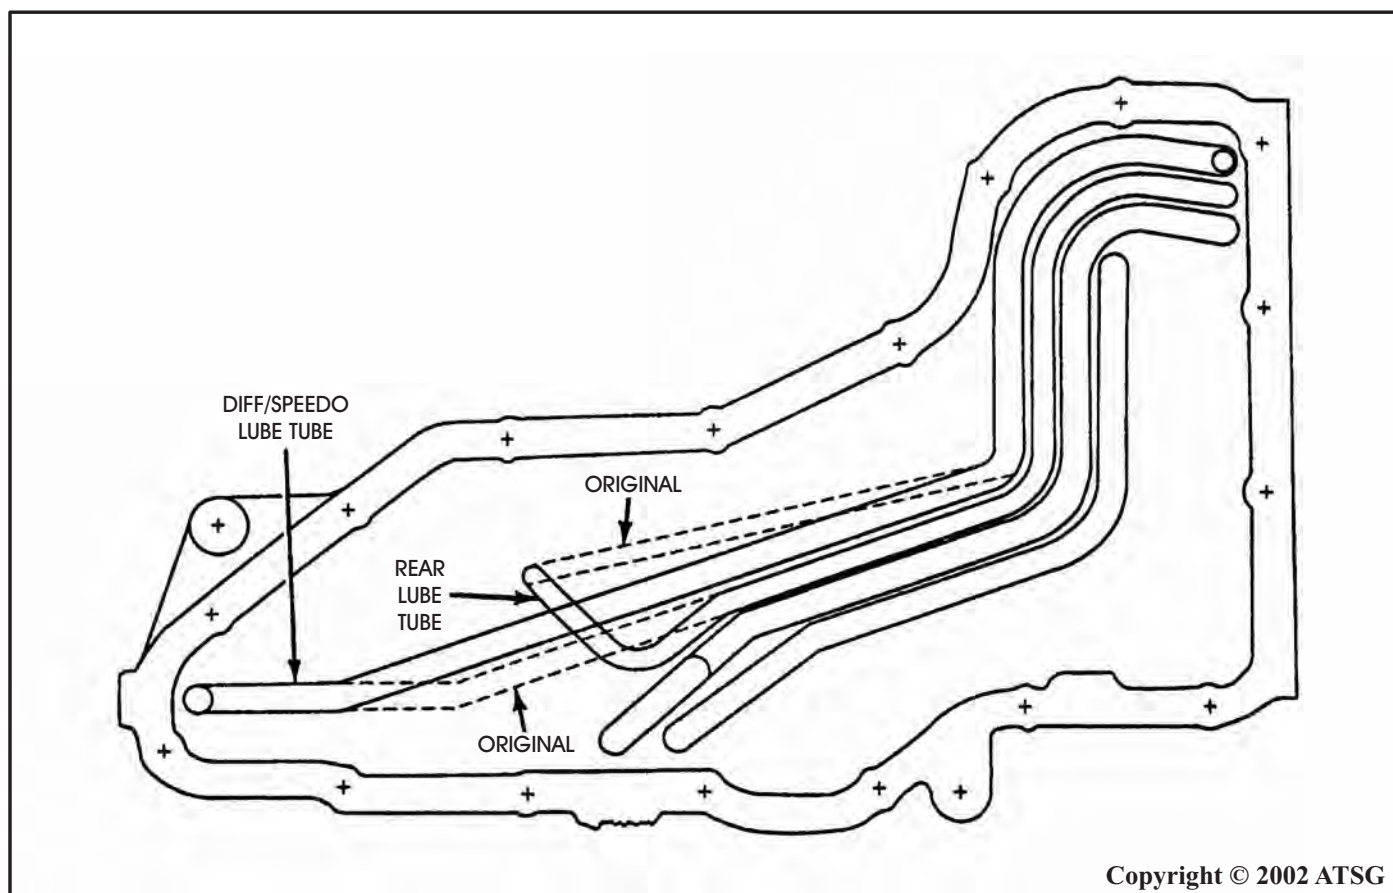
Figure 83

COMPLAINT: Front planetary and gear train failure with no visible root cause.

CAUSE: The cause may be, a limited volume of lube oil to the front planetary due to hydraulic control system demands.

CORRECTION: Install a new design "Cross-over" rear lube tube and a new design Differential/Speedo lube tube, that will increase the volume of lube oil to the front planetary system, as shown in Figure 83. This requires the rear lube tube to "Cross-over" the differential and speedo lube tube, as shown in Figure 83.

Crossover Rear Lube Tube	F2DZ-7G084-A
Differential/Speedo Lube Tube	F2DZ-7G086-A

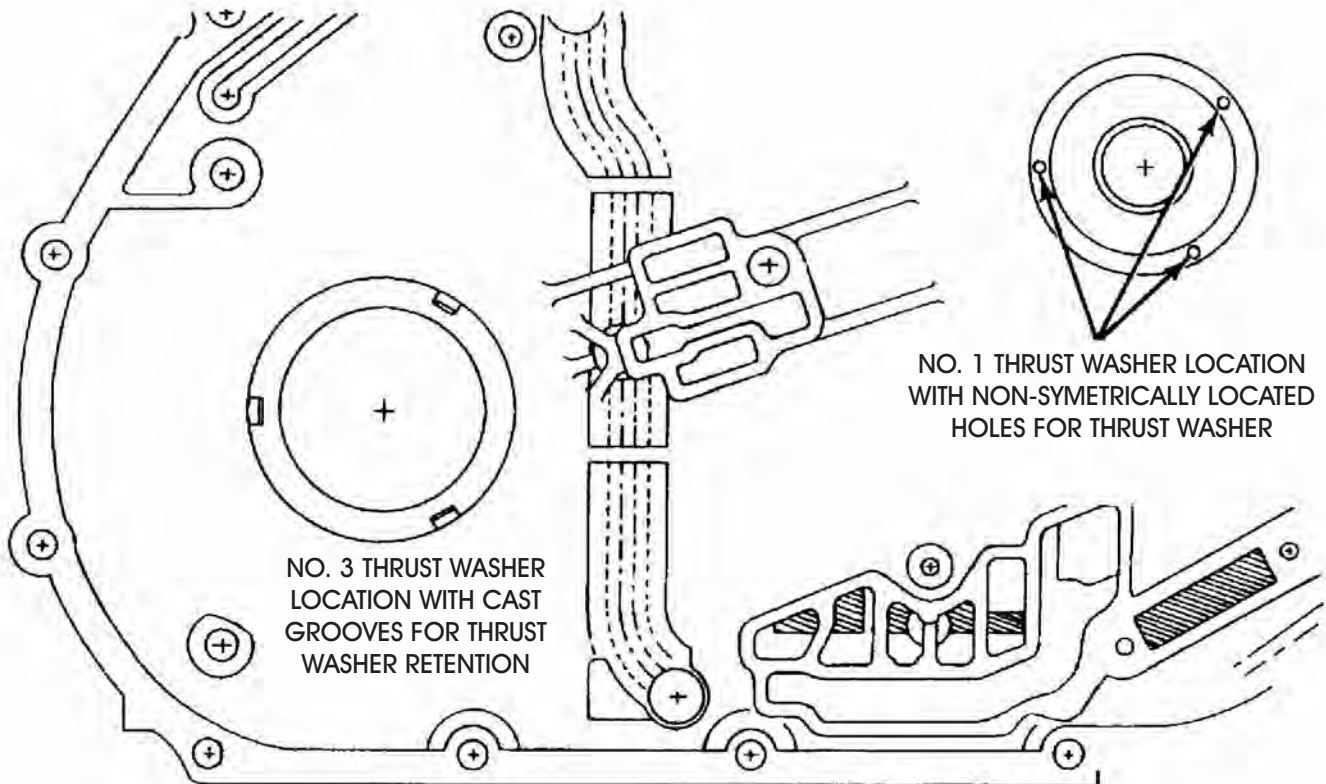
Figure 85

- (3) **CHAIN COVER** - New design will accept either the previous bronze No. 3 thrust washer with the tangs on outside diameter, or the new design Black plastic No. 3 thrust washer with the 3 symmetrically located tabs, as shown in Figure 86.
The previous design Chain Cover will accept **only** the bronze No. 3 thrust washer with the tangs on the outside diameter, as shown in Figure 85.
The new design Chain Cover will accept **only** the new design No. 1 thrust washer with 3 symmetrically located tabs, as shown in Figure 86.
The previous design Chain Cover will accept **only** the previous design No. 1 thrust washer with 3 non-symmetrically located tabs, as shown in Figure 85.

REQUIRES THE PLASTIC NO. 1
THRUST WASHER WITH TABS THAT
ARE NON-SYMETRICALLY LOCATED
PART NUMBER E6DZ-7G099-A

If replacement of the number 1 and/or the number 3 thrust washer becomes necessary, inspect the chain cover in the thrust washer tab areas to determine the correct thrust washers required. Refer to Figures 85 and 86.

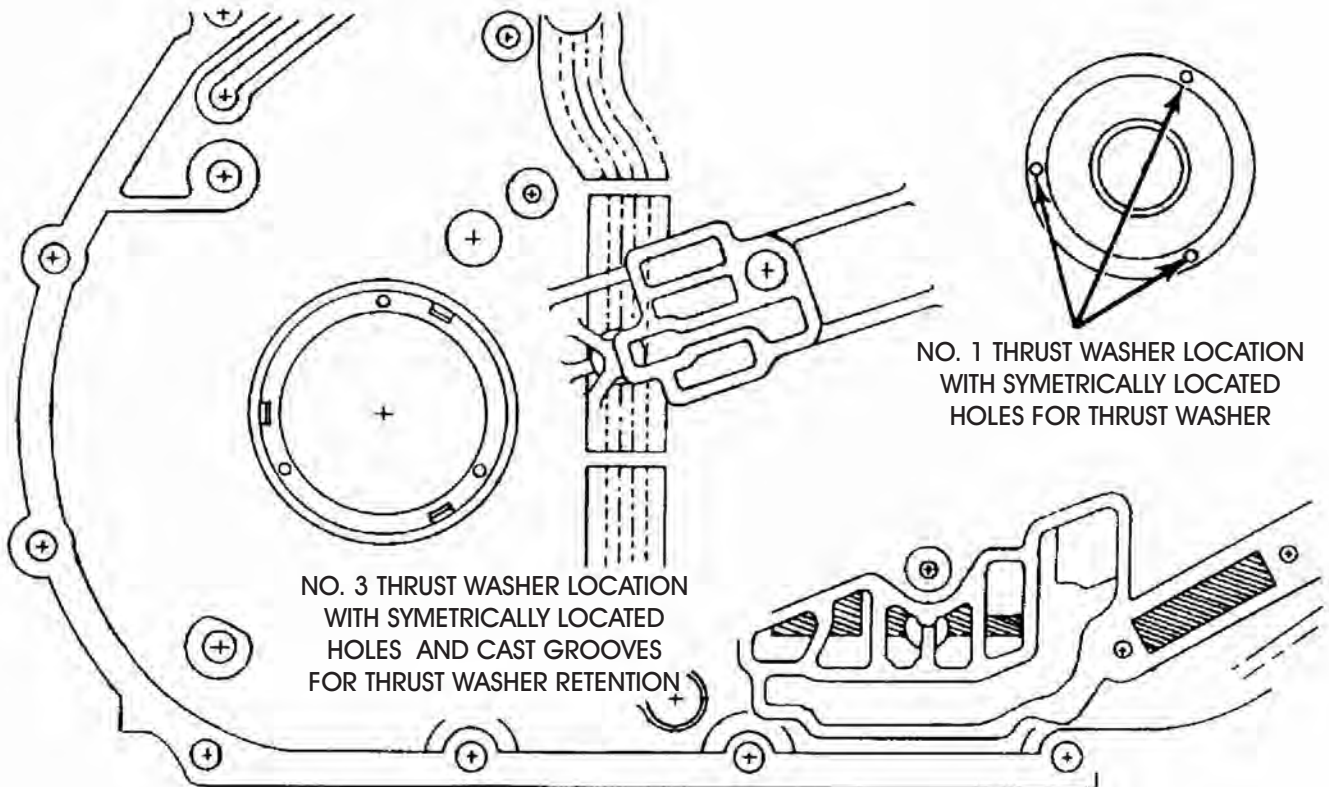
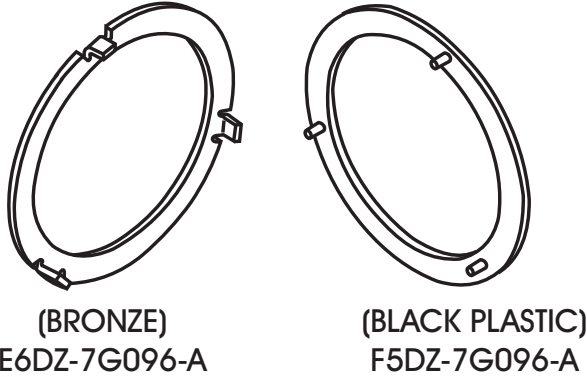
Figure 86

CHAIN COVER AND THRUST WASHERS OCTOBER 13, 1995 AND BEYOND

REQUIRES THE PLASTIC NO. 1
THRUST WASHER WITH TABS THAT
ARE SYMETRICALLY LOCATED
PART NUMBER F5DZ-7G099-A

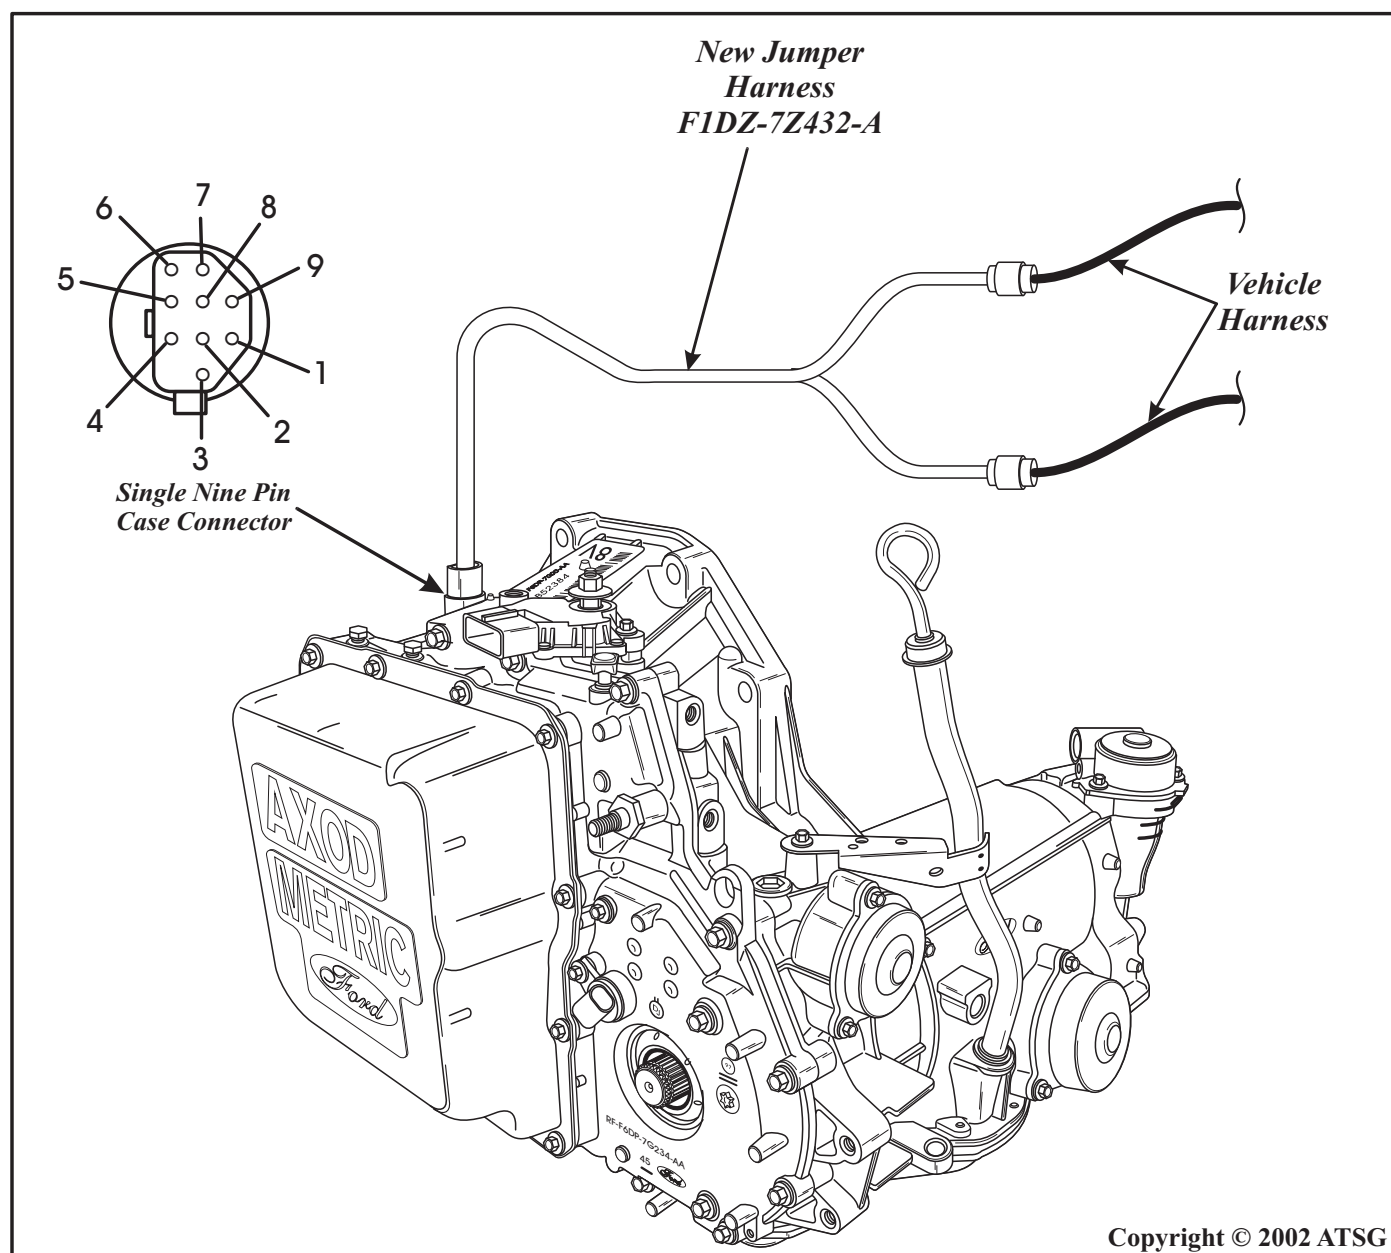
Figure 89

If service requires replacement of the chain cover on a 1991 or 1992 AXODE transaxle, it must be replaced with a 1993 design level AXODE chain cover assembly kit. The 1993-Up design level chain cover has only one nine pin external electrical connector located at the top of the transaxle as shown in Figure 89, and the previous side connector, as shown in Figure 88, has been eliminated. This requires a new "Y" harness, which is included in the service package "Kit", to make it compatible with 91-92 vehicles. The new design "Y" harness is also illustrated in Figure 89.

AXODE Chain Cover Assembly Kit F1DZ-7G188-B
AXODE Jumper "Y" Harness F1DZ-7Z432-A

Note: Chain Cover Assembly "Kit" includes Chain Cover, New Internal Harness, New Jumper Harness, Eight Tie Wraps and Instruction Sheet.
