AXOD/AXODE (AX4S) UPDATE HANDBOOK

AUTOMATIC TRANSMISSION SERVICE GROUP

INTRODUCTION

*Updated
October, 2002*

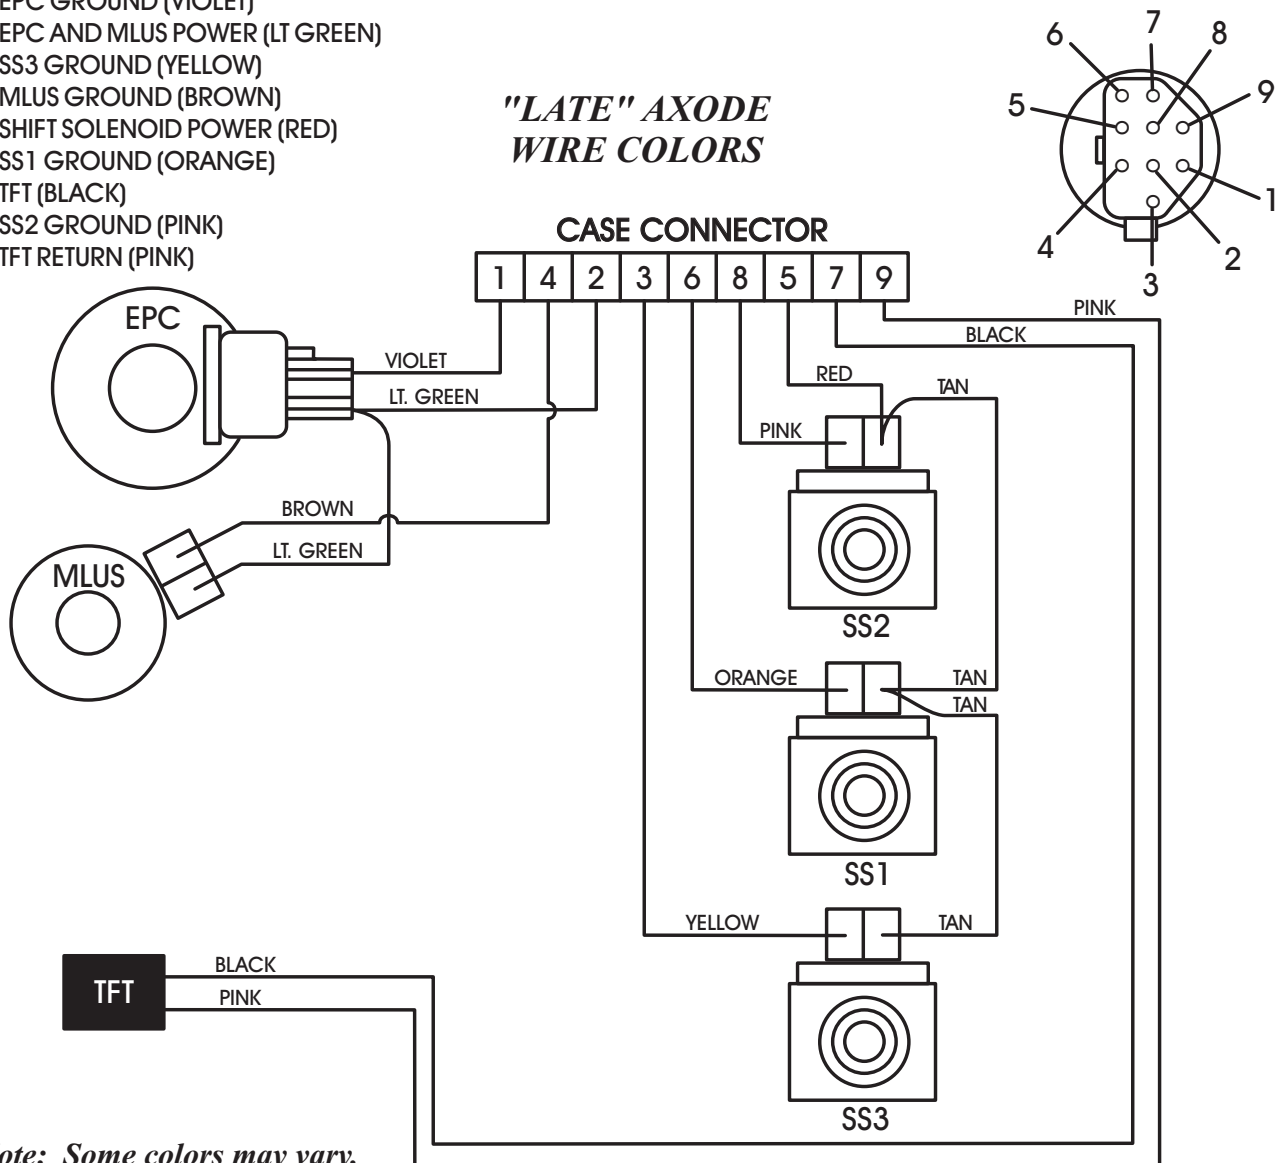
"LATE" AXODE WIRE COLORS

COMPLAINT: *After rebuild*, harsh shifts (High Line) and/or a "Clicking" or cycling noise may be heard from the side cover area, that is usually accompanied by an ON/OFF bind-up sensation that coincides with the "Clicking" noise. These symptoms may be accompanied with Diagnostic Trouble Code (DTC) 652 (MLUS Shorted or Open Circuit), DTC 624 (EPC Circuit Failure), and/or one Shift Solenoid DTC 621, 622, or 624.

CAUSE: The cause may be, solenoid wire connectors installed on the wrong solenoids.

NOTE: The internal wire harness normally is secured by wire-ties which would prevent improper connection of solenoids, however, not all wire harnesses have the wire ties necessary to prevent this problem and the chart must be used.

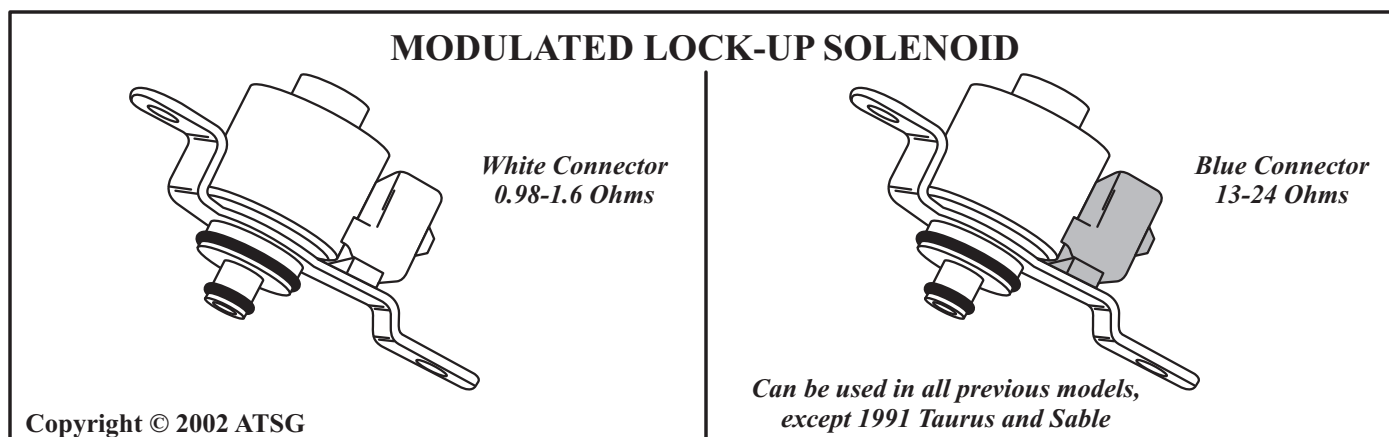
Figure 92

- MODULATED LOCK-UP SOLENOID - The new design MLUS is round, like the previous (1) design solenoid, but has a **blue** connector instead of the previous white, and a resistance value of **13-24 Ohms**, instead of the previous 0.98-1.6 Ohms resistance (See Figure 92).

The O.E. Manufacturer first advised not to interchange the solenoids, but has since backed off of that statement, as the only MLUS now available is the new design with the blue connector and higher resistance. ATSG has seen **no problems** with installing the new design MLUS on the previous model transaxles, **except** 1991 Taurus and Sable which are non-modulated models. Use the chart in Figure 93 to check the resistance of the MLUS through the case connector to determine which solenoid is in the transaxle.

Modulated TCC Solenoid with Blue Connector.....	F7OZ-7G136-AA
Modulated TCC Solenoid with White Connector.....	F3DZ-7G136-AA
AX4S Transaxle Shift Solenoids	F1DZ-7G484-A
AX4N Transaxle Shift Solenoids	F3DZ-7G484-AA

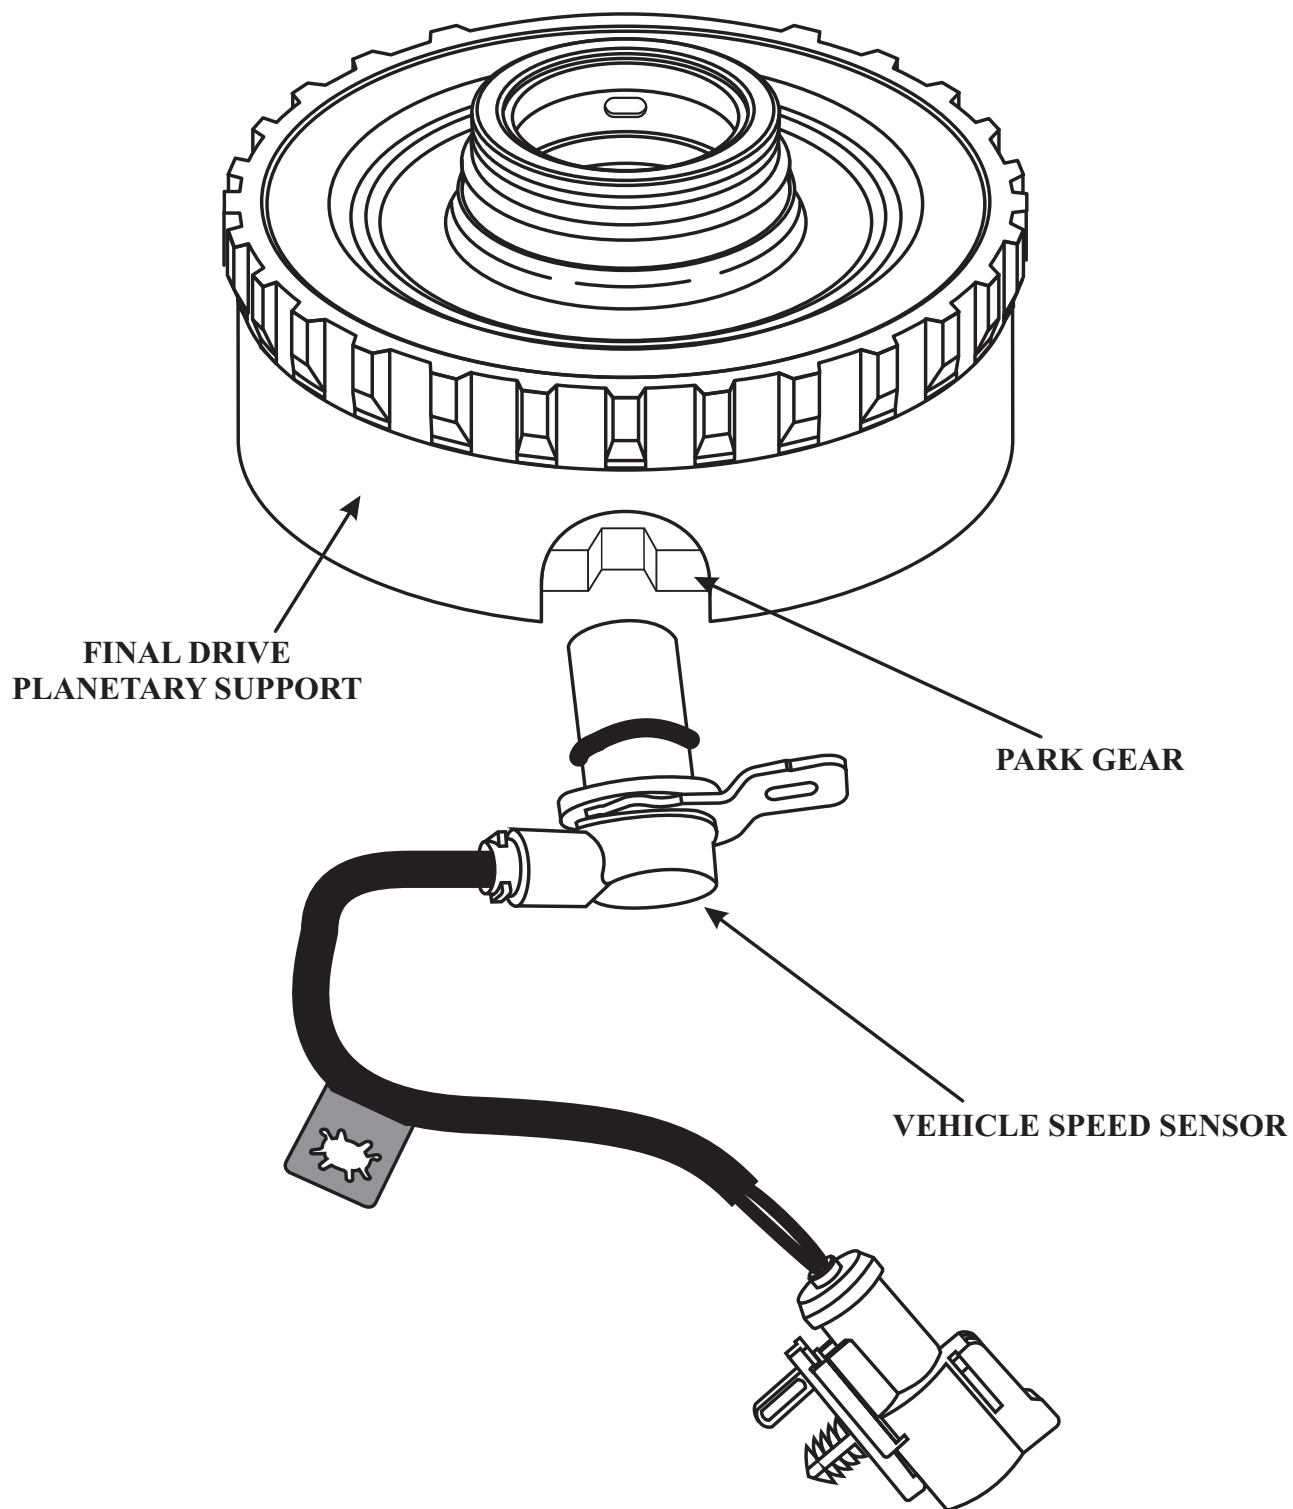
Figure 94

CHANGE: The gear driven vehicle speed sensor that has been in use in the AX4S and the AX4N since their inception will be replaced, as a running change during the 1999 model year beginning with the AX4S, and at the start of production for the 2000 model year for the AX4N, with a permanent magnet speed sensor. The PM Generator will be mounted in the barrel of the case and will be using the park gear teeth as an exciter wheel.

REASON: The possibility of the VSS drive or driven gear "apple coring" will be eliminated as well as the intermittent loss of vehicle speed signal due to the speed sensor sub harness damage that would occur as a result of exhaust system heat transferral.

- (1) TRANSAXLE CASE - Changed to accommodate mounting the new design speed sensor so that it is in line with the planetary support and the park gear.
- (2) FINAL DRIVE SUPPORT - Changed to accommodate mounting the new design speed sensor and now has a "*cut out*" for the speed sensor to look through at the park gear, as shown in Figure 94.

AX4S Vehicle Speed Sensor.....	XF2Z-7H103-AA
AX4N Vehicle Speed Sensor.....	YF1Z-7H103-AA

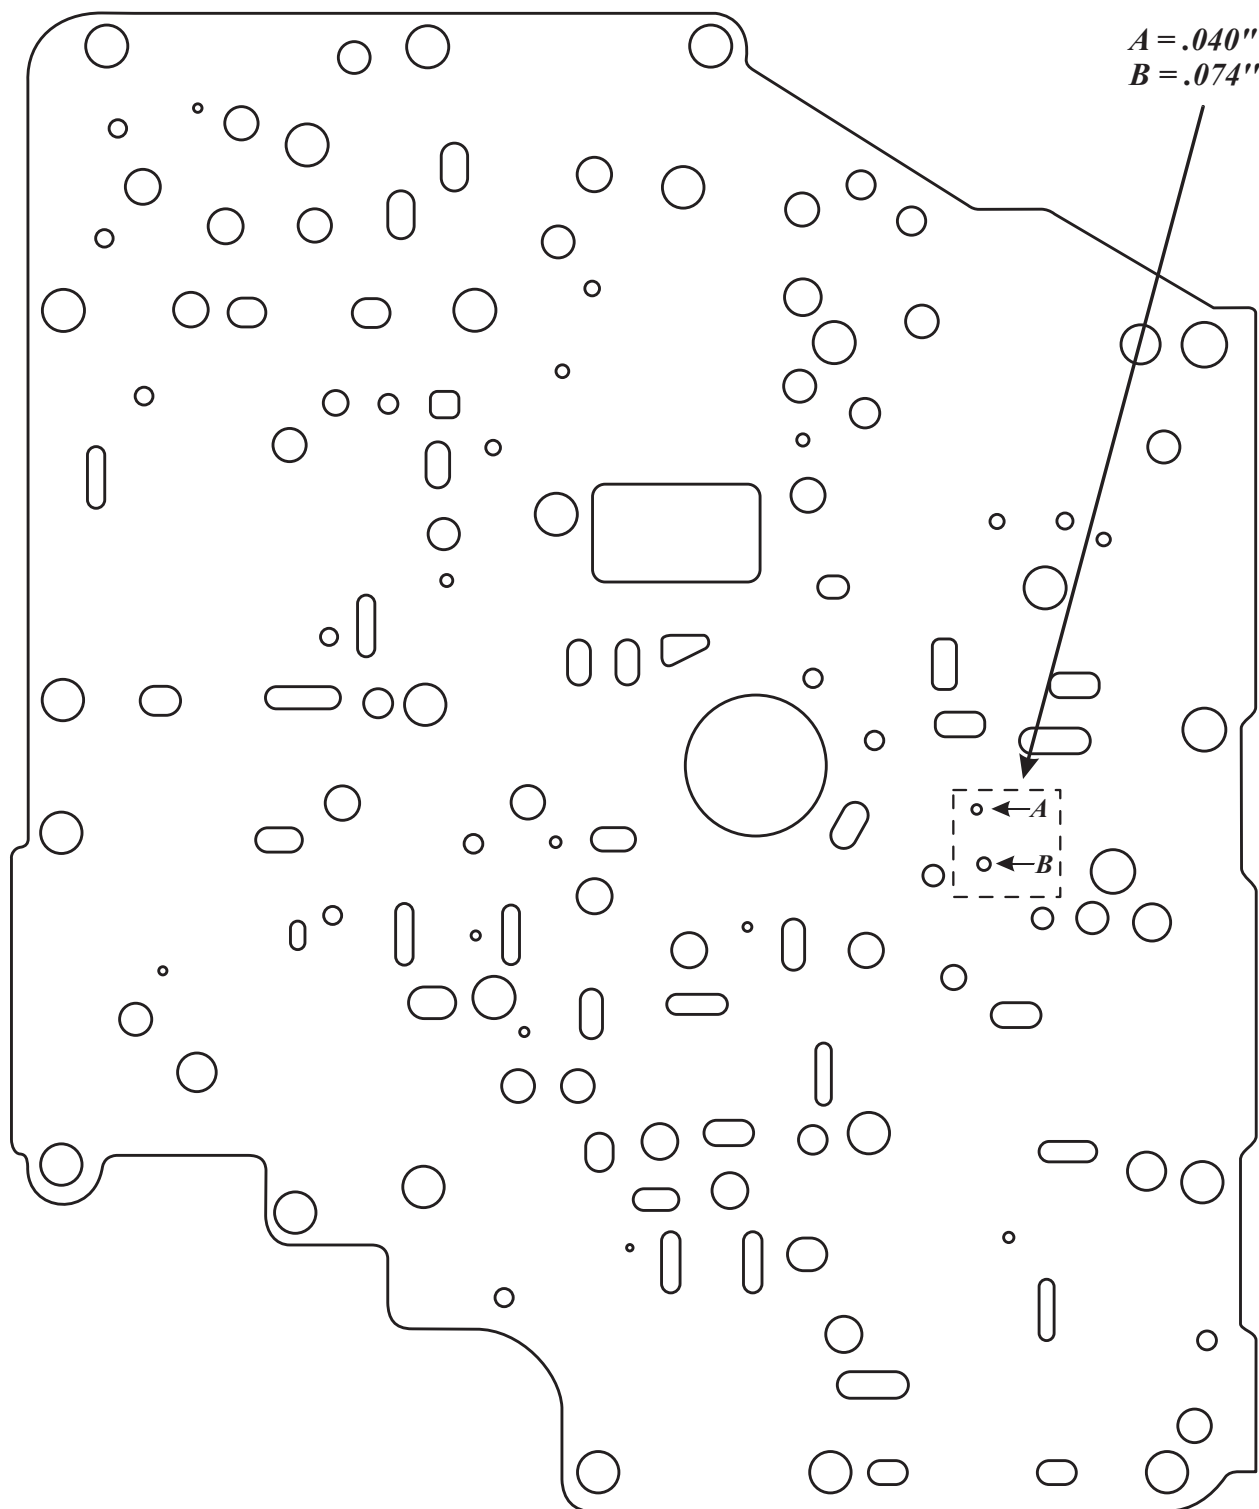
CAUSE: The cause may be, a valve body spacer plate designed for the Taurus, Sable, Continental passenger car family, has been installed on a Windstar Van, creating a harsh 1-2 upshift. If the Windstar Van valve body spacer plate, is installed on the Taurus, Sable, Continental family of vehicles, the result will be a soft or flared 1-2 upshift. ***Obviously these two spacer plates are different.*** Refer to Figures 101 and 102, using the two holes over the 1-2 capacity modulator valve area, for identification.

CORRECTION: Install the proper valve body spacer plate for the Ford family that you happen to be servicing at this time. Refer to the illustration in Figure 101 to identify the valve body spacer plate for the Windstar Van. Refer to the illustration in Figure 102 to identify the valve body spacer plate for the Taurus, Sable and Continental family.

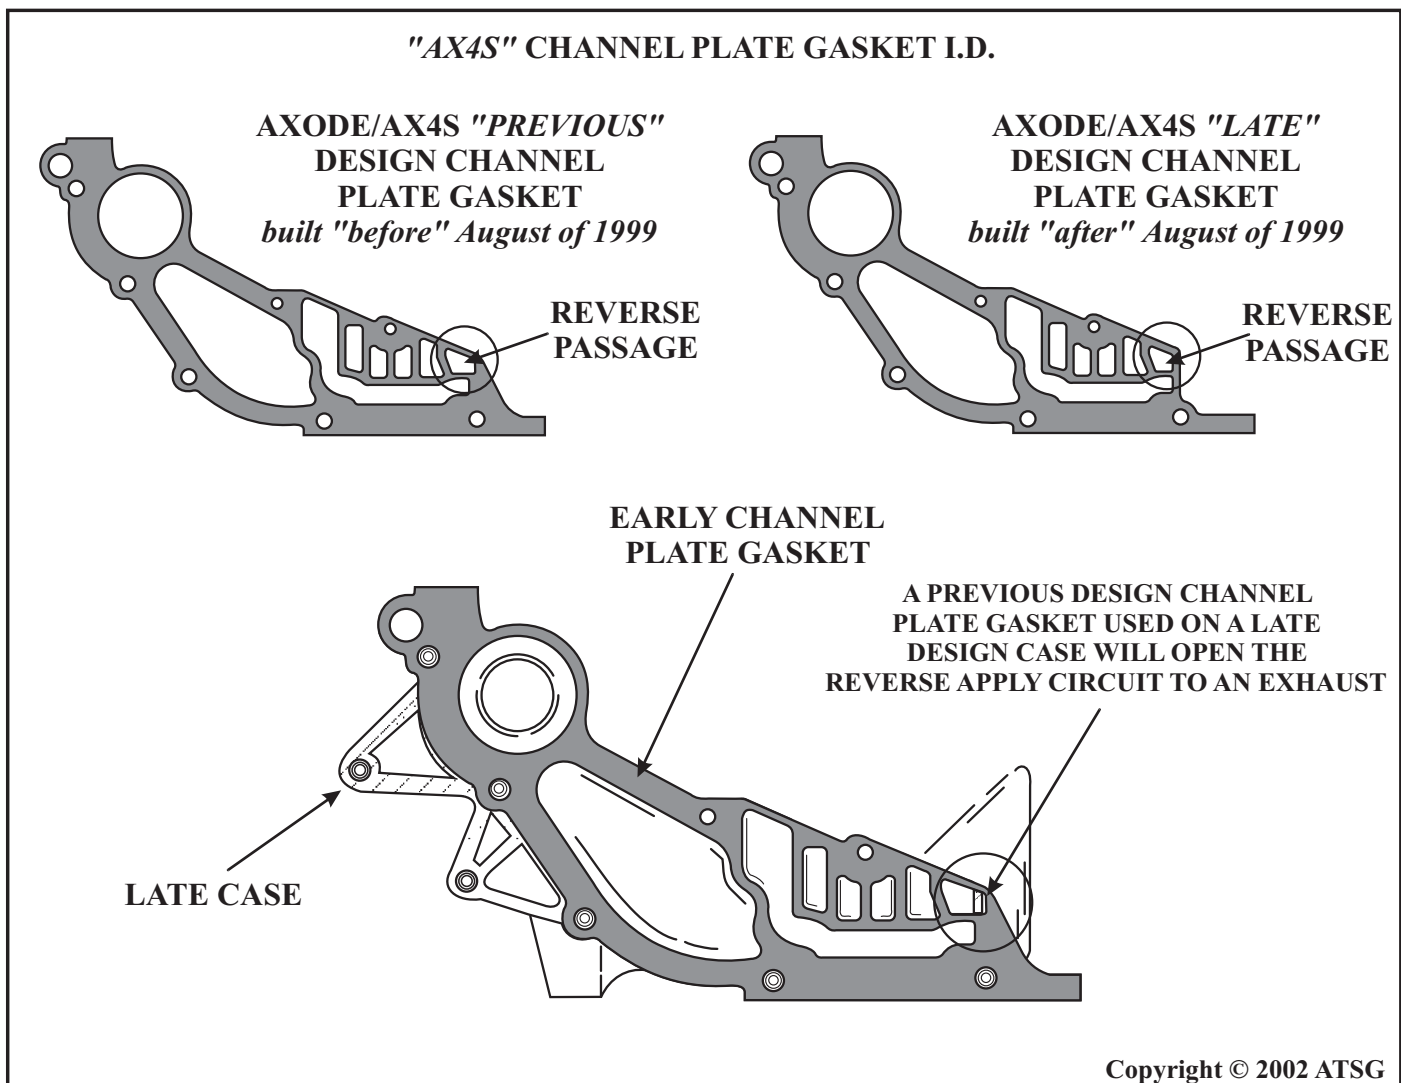
CAUSE: The cause may be, that the *Previous Design* Channel Plate Gasket, was used on a *Late Design* case as shown in Figure 103. When this happens, Reverse apply pressure will be exhausted back into the case because of the gasket hanging over the case casting.

CORRECTION: AX4S-Refer to Figure 103 to identify the correct Channel Plate Gasket for the application of vehicle you are working on.
AX4N-Refer to Figure 104 to identify the correct Channel Plate Gasket for the application of vehicle you are working on.
