FORD 4R100 "UPDATE HANDBOOK"

FORD 4R100 PRELIMINARY INFORMATION

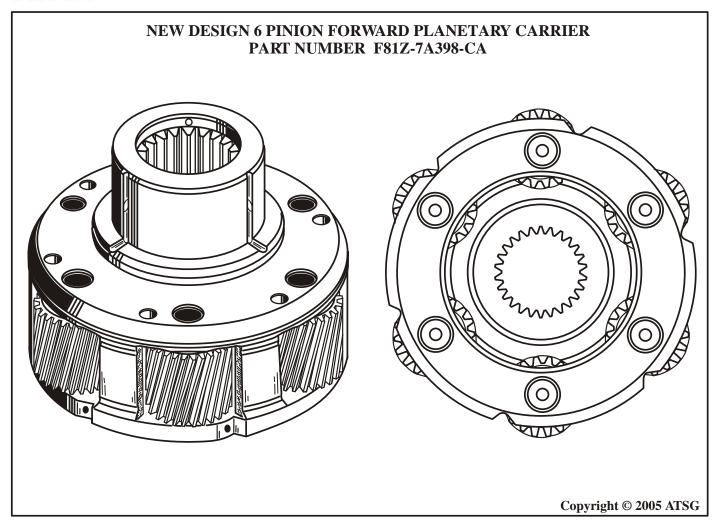
Figure 47

CHANGE: Beginning at the start of production for all 1998 model E4OD transmissions, *some models* will be equipped with a new design 6 pinion forward planetary carrier (See Figure 47), and a new design 6 pinion reverse planetary carrier (See Figure 48).

- (1) FORWARD PLANETARY CARRIER Now has 6 pinions instead of the previous 4 pinions for increased torque carrying capacity and increased durability (See Figure 47).
- (2) REVERSE PLANETARY CARRIER Now has 6 pinions instead of the previous 4 pinions for increased torque carrying capacity and increased durability (See Figure 48).

The new design forward planetary carrier *will back service all models* of the E4OD, but it *does require* the latest design forward ring gear hub and bearing assembly, as there are no holes for the previous design thrust washer (See Figure 47).

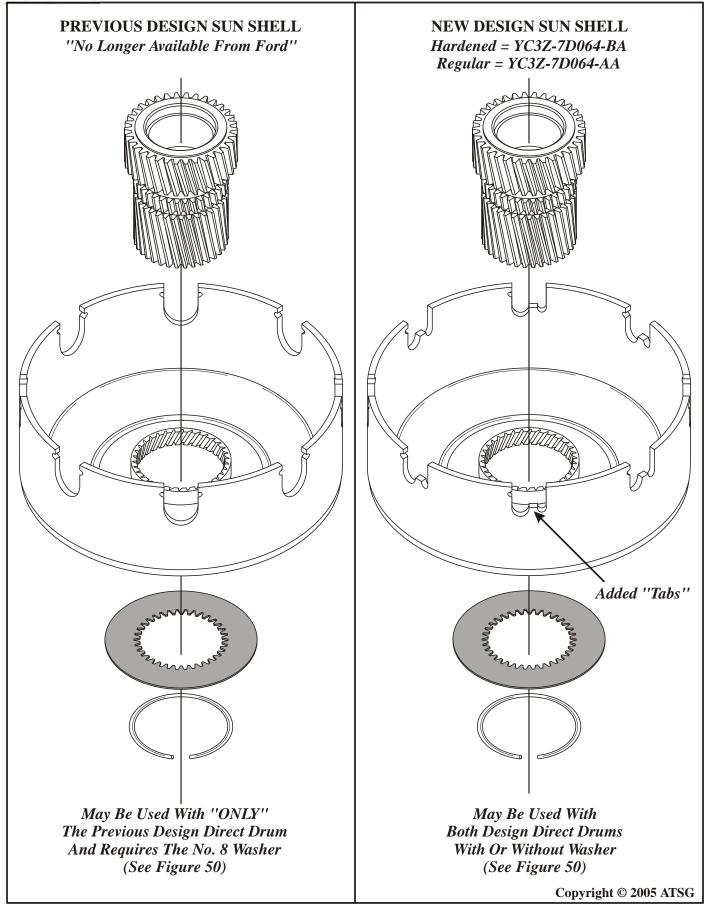
Figure 49

CHANGE: There is now a new design Sun Shell with "Tabs" added to the center of the sun shell slots, as shown in Figure 49, implemented by Ford Motor Co. as a running change, during the 2000 model year. This change eliminated the need for the number 8 thrust washer between the forward and direct drums.

- (1) INPUT SUN SHELL New design have "Tabs" added to the center of the sun shell slots, as shown in Figure 49, which now support the direct drum for the required clearance between the direct and forward clutch housings, and allows elimination of the number 8 thrust washer, as shown in Figure 50.
- (2) DIRECT CLUTCH HOUSING Manufactured "Without" slots in the center hub, as they were no longer needed to accept the number 8 thrust washer tabs. Both design direct drums are illustrated in Figure 50, and cut-away in Figure 51.
- (3) NUMBER 8 THRUST WASHER Eliminated (See Figure 50 and 51).

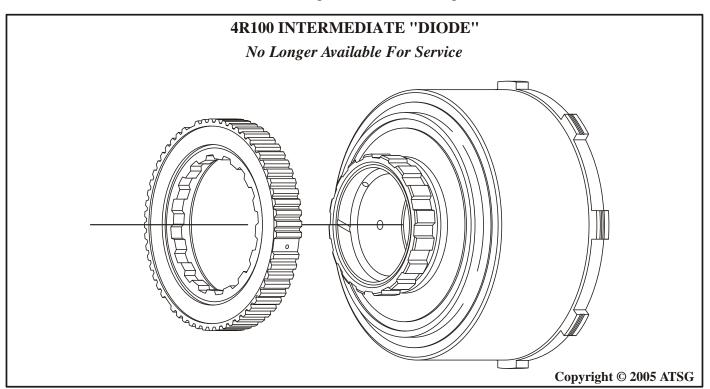
Figure 52

premature failure of the newly introduced Intermediate "Diode" Freewheel device that was

installed in model year 2001 and illustrated in Figure 52.

Direct Clutch Housing, 2nd Design (Without 4 Tab Washer)	
Direct Clutch Housing, 1st Design (With 4 Tab Washer)	F81Z-7D044-BA
Sun Shell, Hardened, 2nd Design	
Sun Shell, Regular, 2nd Design	YC3Z-7D064-BA
Direct to Forward Drum 4 Tab Thrust Washer	E9TZ-7C096-A
Direct Drum to Outer Sprag Race Thrust Washer	E9TZ-7G401-A
Intermediate Sprag Assembly	E9TZ-7A089-B
Intermediate Friction Plates (Special 50 Tooth, 3 Required)	1C3Z-7B164-BA

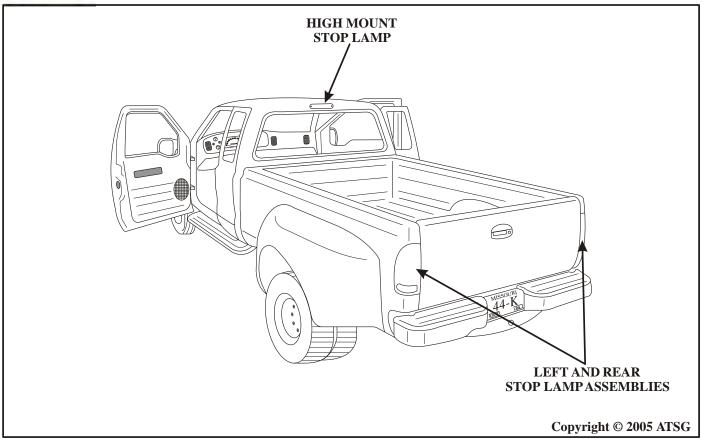
Figure 65

- CAUSE NO. 1: One cause for this condition may be that one or more of the vehicle brake light bulbs, including the High Mount brake light may be burned out, or have a damaged filament (See Figure 65). When this condition is present, the PCM will detect an open in the brake lamp circuit, and due to a pull-up resistor in the PCM, will output voltage from PCM terminal 92 to the brake on-off switch (See Figure 66). As a result, the Torque Converter Clutch will not be applied at less than 30 percent throttle.

Replace any burned out brake lamp bulbs, including the High Mount brake lamp bulb, as shown in Figure 65. It is also important to note, that a bad ground for the rear lamp assembly, has also been known to cause the identical symptom. Refer to Figure 69 for the rear lamp assemblies ground location.

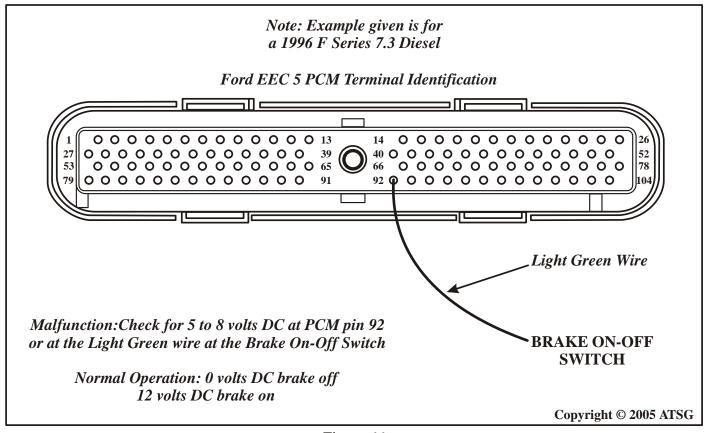
Figure 66

Prior to any part replacement or modifications, it would be recommended to check for a 5 to 8 volt DC signal coming out of the PCM at terminal 92 using a volt meter set to read DC voltage. Voltage may also be checked at the Light Green wire located at the back of the Brake On-Off Switch. *Note: The example given is for a 1996 F-Series 7.3 Diesel.* This test will help to confirm that a circuit fault has been detected by the PCM. Refer to Figure 66. *Normal operation will be 0 volts DC, brake off, and 12 volts DC, brake on.*

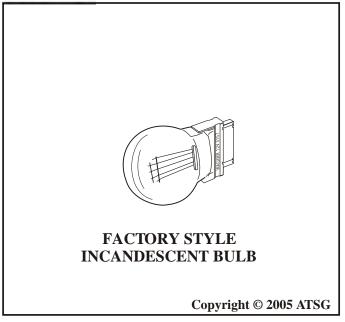
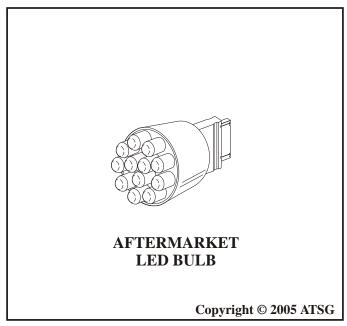
Figure 67 Figure 68

- CAUSE NO. 2: Recently there has been an increase in the popularity of replacing the stock incandescent brake lamp bulbs, with aftermarket LED lamp assemblies. Refer to Figures 67 and 68. The main advantages of switching to LED lamp assemblies is that there are no fragile filaments to burn out or break, which means that the LED lamp assemblies may possibly last for the entire life of the vehicle, and LED lamps consume much less energy than the stock incandescent bulbs. Due to the low power consumption, the PCM *may* view this reduced current draw as being a burned out bulb, resulting in a no Torque Converter Clutch apply at less than 30 percent throttle.

The 6 ohm, 50 watt Load Resistors are available from the suppliers of the LED bulb assemblies. Two examples are "superbrightleds.com" and "digikey.com". Cost of the resistor is approximately five dollars U.S.
