A4LD UPDATE HANDBOOK INDEX

FORD A4LD

"UPDATE HANDBOOK"

Since the start of production in 1985, the FORD A4LD transmission has received many major engineering design changes. These design level changes have affected nearly every part used in the A4LD transmission.

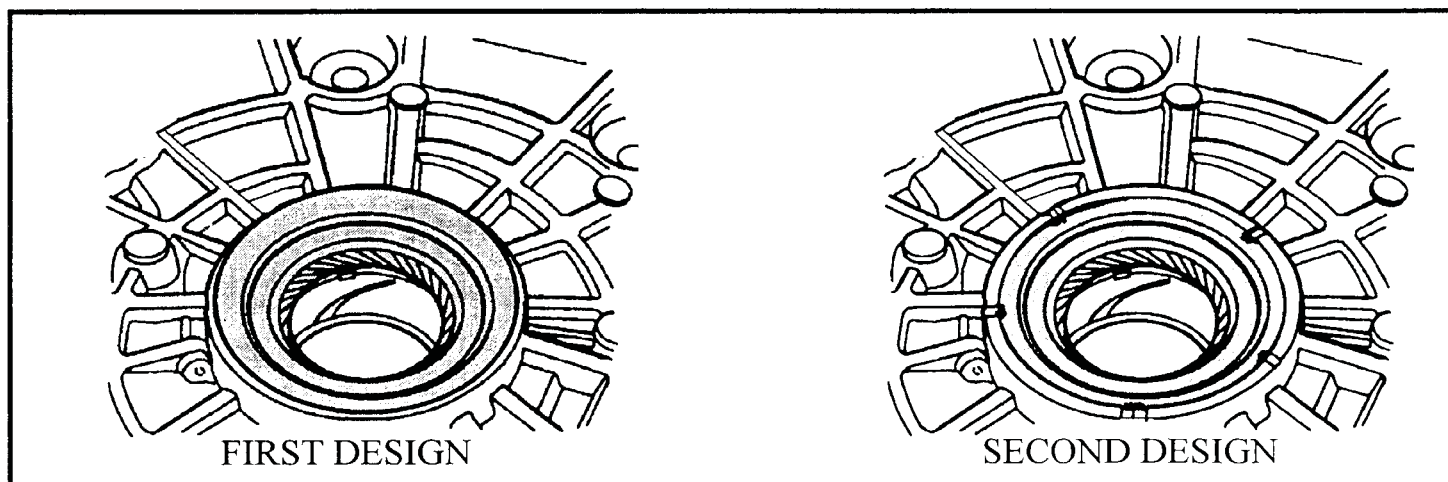
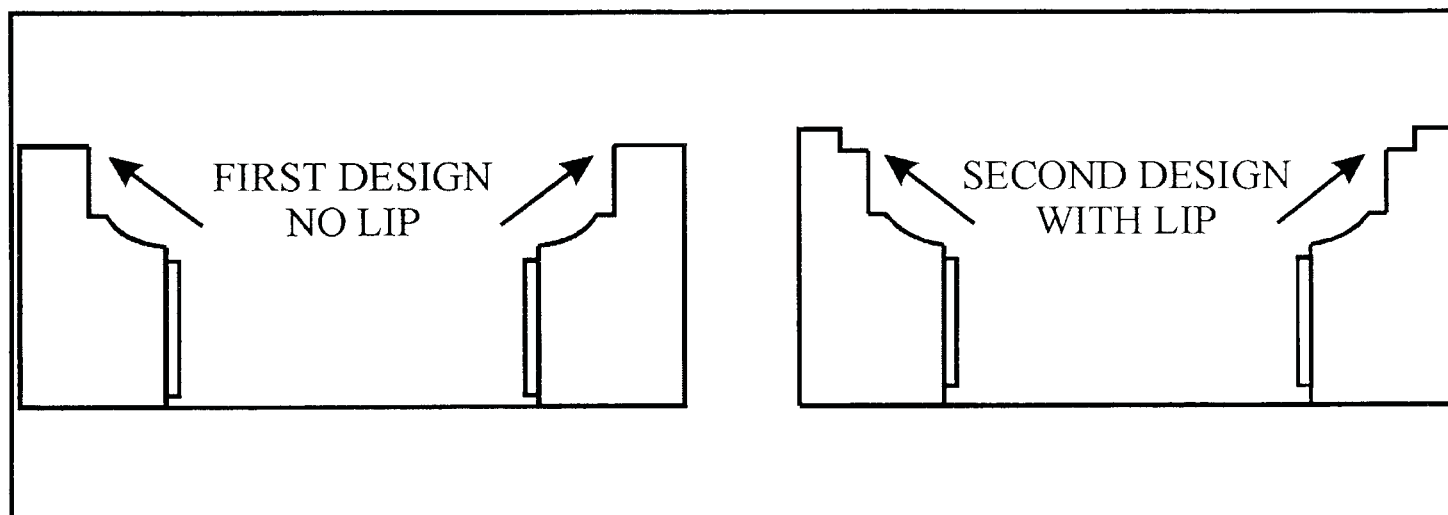
Figure 5

BELL HOUSING - A machined lip was added at the front seal bore to allow the front seal to be staked in place (Refer to Figures 5 & 6).

As long as the engine bolt pattern is the same (See Figures 1 thru 4), bell housings will interchange. However, using an early style bell housing without the lip is not recommended.

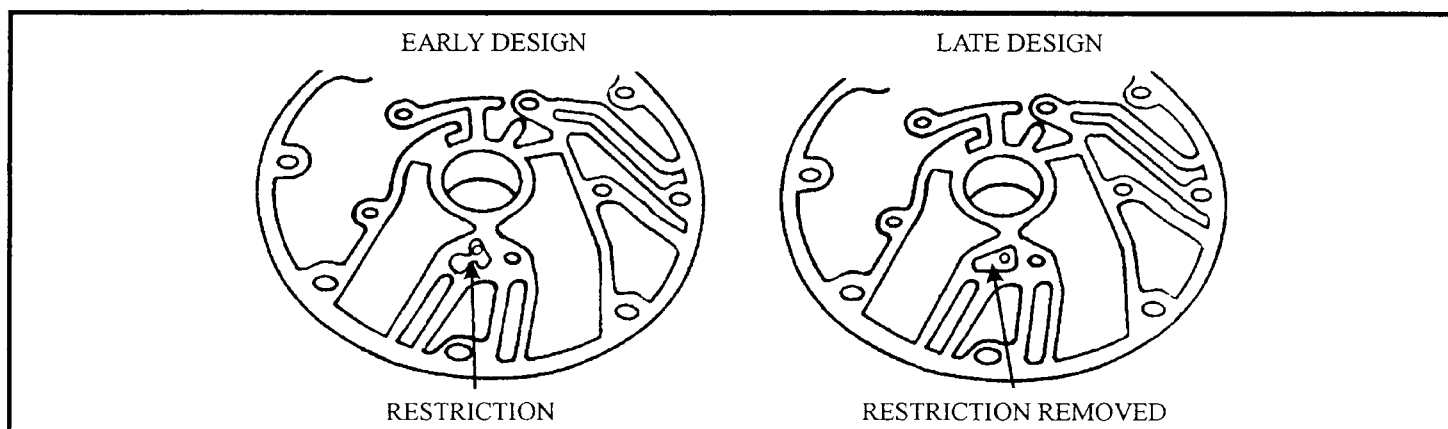
Figure 7

BELL HOUSING - Converter drain back passage area was enlarged for better flow to the drain back hole in the pump body (Refer to Figure 7). It is not necessary to replace the bell housing to cure this problem. Using a rotary file, or die grinder, remove material to allow "full flow" to the drain back hole (Refer to Figure 7). Also enlarge the existing drain back hole in both the bell housing and the pump body to 1/4" (Refer to Figure 8).

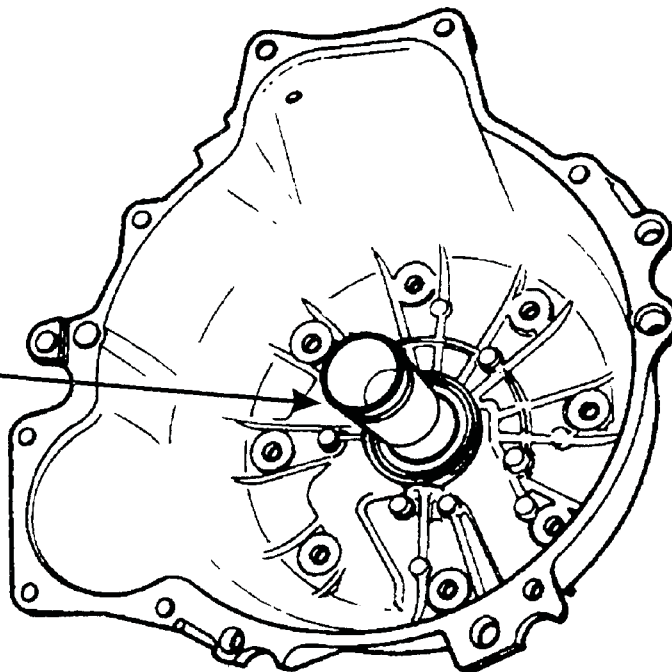
Figure 10

When assembling the pump body to the bell housing, a pump alignment tool must be used (Refer to Figure 10). Using the torque converter, will not produce proper pump alignment. If an alignment tool is not used, several problems may occur, such as:

- (1) PUMP GEARS BREAKING
- (2) PUMP WHINE
- (3) IRREGULAR BUSHING WEAR
- (4) IRREGULAR CONVERTER HUB WEAR
- (5) FRONT SEAL LEAK OR BLOW OUT

Another concern that may be attributed to the above listed problems, is replacement of the front pump bushing in the bell housing. At the factory, Ford puts an oversized bushing in the bell housing and then bores the bushing to the proper size, and establish the centerline. When a new bushing is installed, (possibly off center) pump alignment may not be possible. Ford Motor Company recommends using a new bell housing if bushing replacement is necessary. Aftermarket exchange bell housings with line bored bushings are also available.

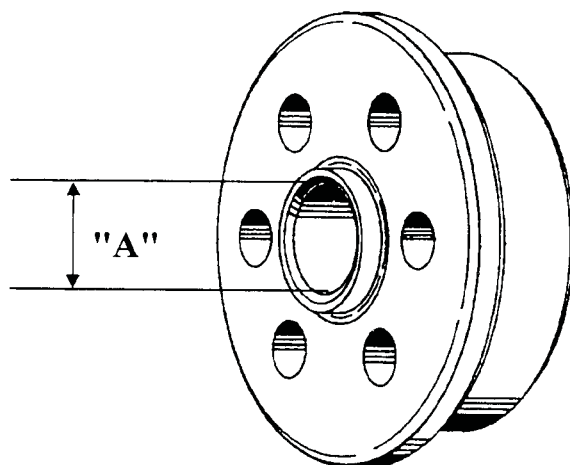
COMPLAINT: Continuous leaks from the front pump seal area, possibly premature bushing wear and/or wear on the torque converter hub seal area, and in extreme cases may exhibit premature front pump gear breakage. The complaint may be any or all of the above, depending on the extent of the wear.

CAUSE: The cause may be a "Crankshaft to Flywheel Spacer" worn in the area that supports the converter pilot hub allowing a mis-alignment of the torque converter to the pump, on models equipped with 2.8, 2.9 and 4.0 liter engines.

DIMENSION "A" SHOULD BE .750" ON NEW O.E. SPACER

CORRECTION: Inspect the "Crankshaft to Flywheel Spacer" for abnormal wear and replace as necessary. Refer to Dimension "A" in Figure 11 to measure the spacer. Dimension "A" on a new spacer is .750", and the OEM part number is D4ZZ-6434-A.

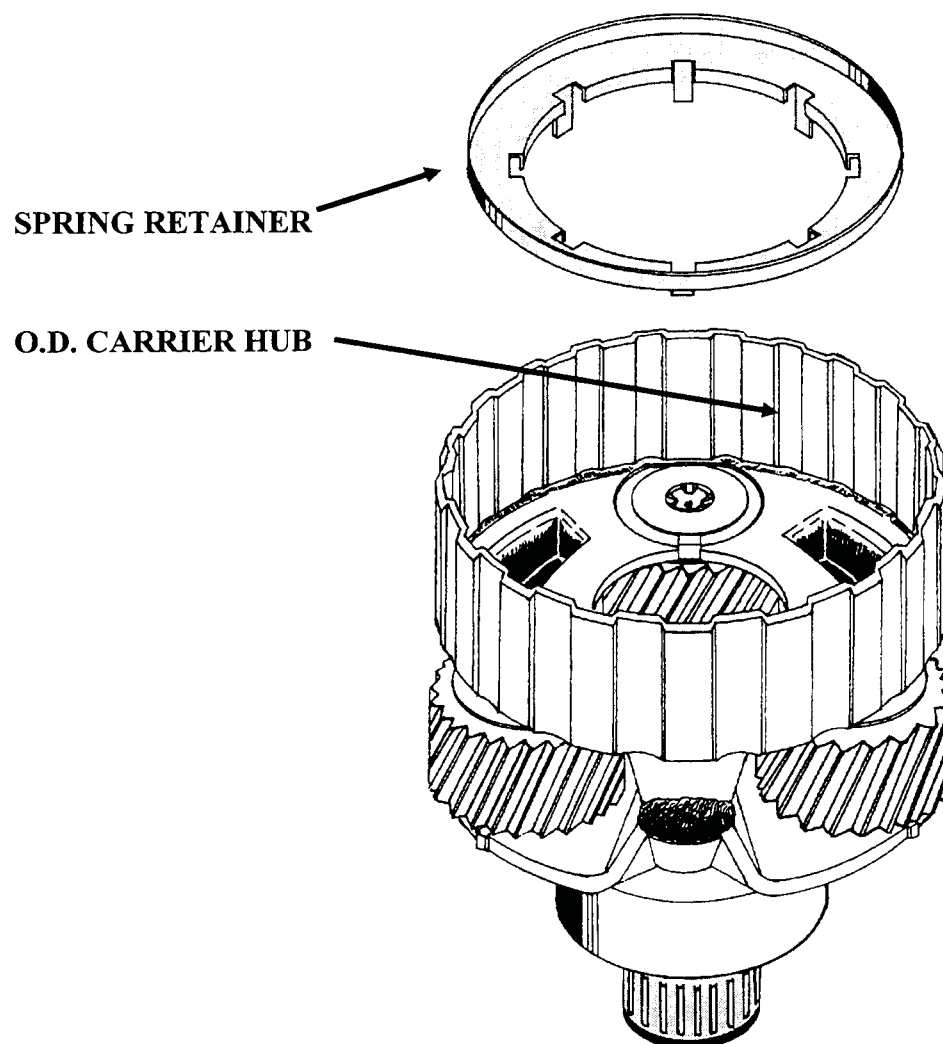
Figure 16

- A. Poorly supported overdrive planetary carrier, allowing the inside diameter of the hub on the overdrive carrier to contact, and turn in a twisting motion, the overrun clutch spring retainer. This will destroy the retainer and return springs in a very short period of time (See Figure 16). NOTE: The dimension between the outside diameter of the overrun clutch spring retainer, and the inside diameter of the overdrive carrier hub, is critical. (See Figure 16).
- B. Bent or improperly installed overrun clutch spring retainer will also drastically affect the clearance between the retainer and the carrier hub.

- CORRECTION:**
- A. Inspect and replace the following, as necessary;
 - 1. Turbine shaft bushings in the pump stator for wear and/or damage.
 - 2. Turbine shaft splines (Overdrive Carrier End) for wear and/or damage.

- 3. Turbine shaft splines in overdrive planetary carrier, for wear and/or damage. Ensure a "snug" fit when installing the turbine shaft into the overdrive carrier.

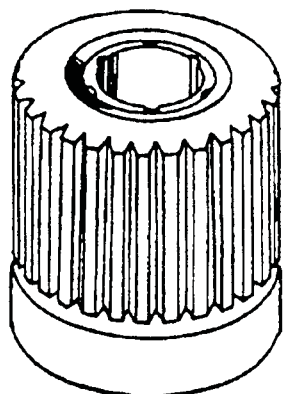
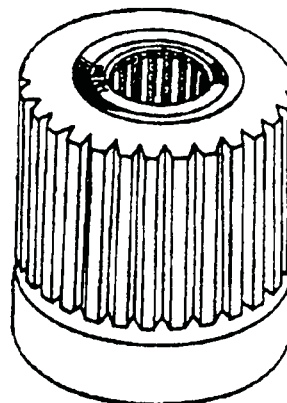
Figure 17

- 4. Bushing in the front end of the output shaft for wear and/or damage. This will support the forward clutch drum and the overdrive center shaft. Replace this bushing on All units during rebuild (See Figure 17).
NOTE: In later applications a caged needle bearing is used in this location. Inspect and replace as necessary (See Figure 17).

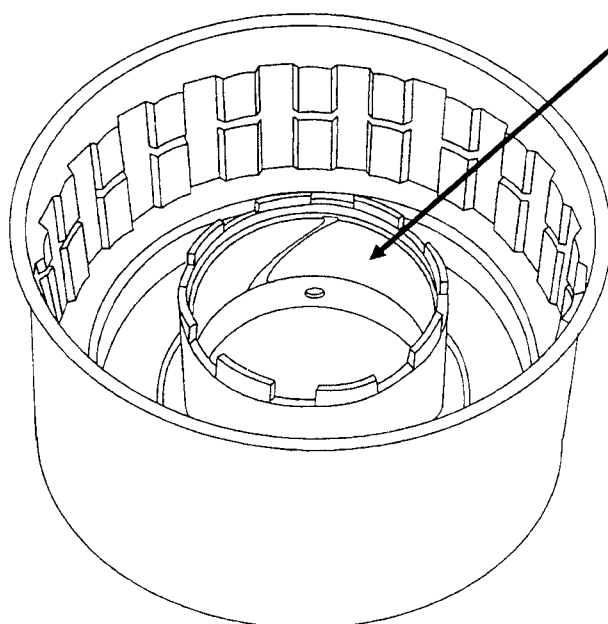
Figure 18

- 5. Overrun clutch housing bushing for wear and/or damage (See Figure 18).
 - B. Ensure that the overrun clutch spring retainer is supported evenly, using an outer pump gear, when compressing the return springs to avoid ANY distortion. This is critical, and is easily distorted with any uneven pressure.

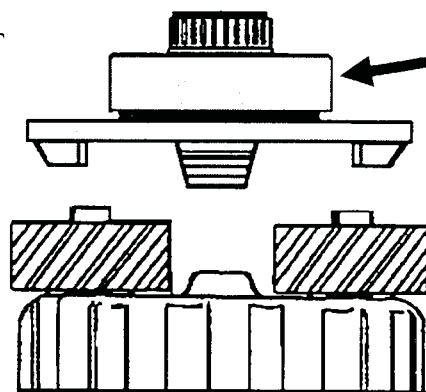
Figure 20

THIS REAR SECTION OF THE
PLANETARY IS A PRECISION
MACHINED, ONE PIECE, CASE
HARDENED ASSEMBLY

CORRECTION: Replace the overdrive carrier. Remanufactured "HEAVY DUTY" planetary carriers are available from aftermarket suppliers (See Figure 20).

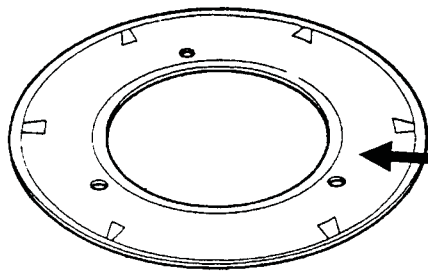
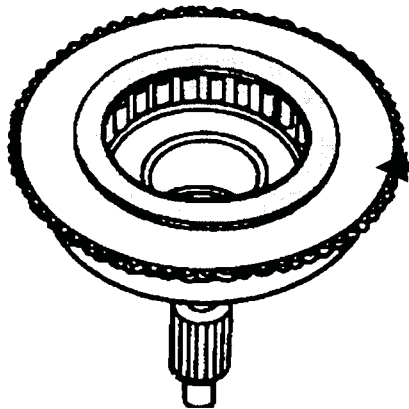
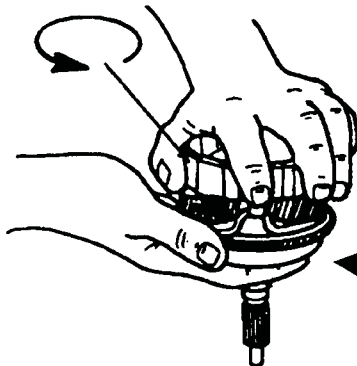
CAUSE: The cause may be the overdrive sprag in backwards or not holding (See Figure 21).

THE O.D. SPRAG RETAINING WASHER MUST BE INSTALLED SO THE RAISED INSIDE DIAMETER FACES THE O.D. CARRIER

INSTALL THE OVERDRIVE SPRAG WITH THE LIP UP

PLANETARY ASSEMBLY MUST ROTATE COUNTER CLOCKWISE AND LOCK CLOCKWISE

CORRECTION: Replace the overdrive sprag, and inspect the inner and outer sprag races for wear or damage.

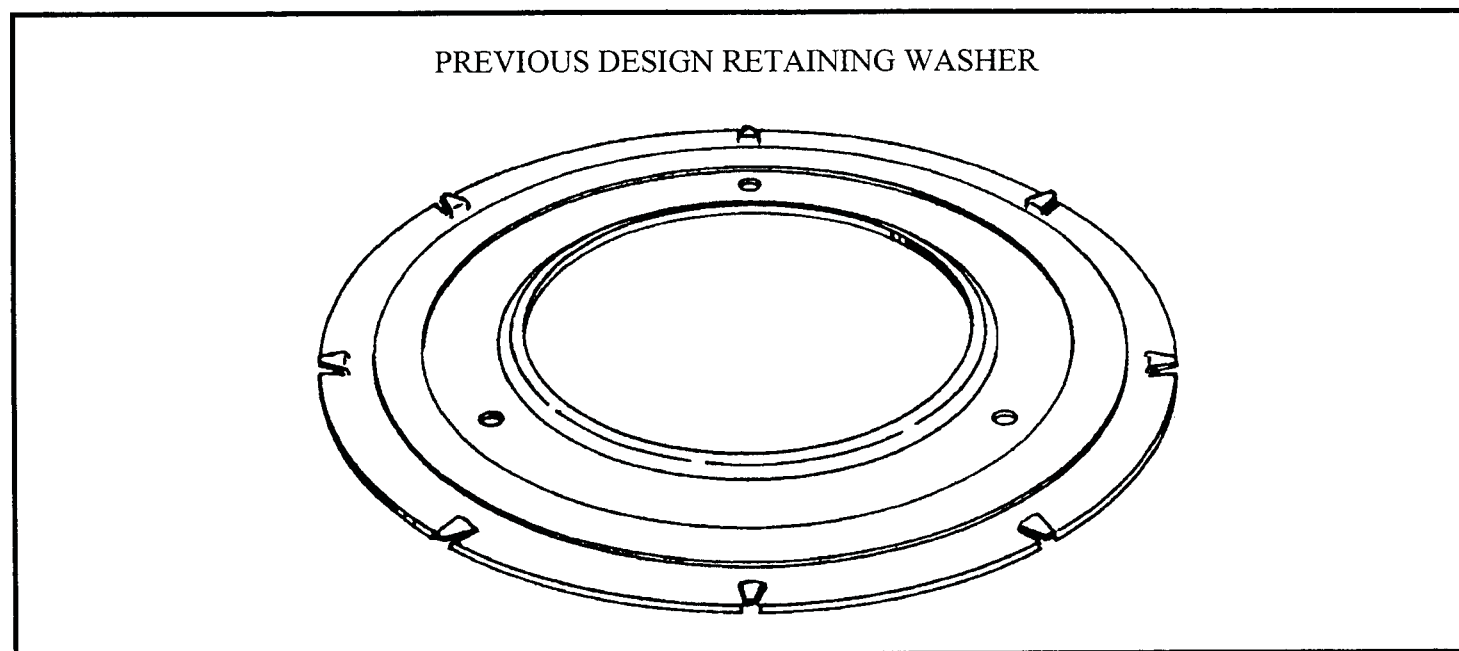
- (1) OVERDRIVE SPRAG ASSEMBLY - Previous design steel caged sprag must be used, as the plastic caged sprag is no longer serviced, which requires the use of the previous design ring gear and the previous retaining washer (See Figure 22).
- (2) OVERDRIVE RING GEAR - Previous design ring gear must be used to accommodate the steel caged sprag and retaining washer that must be used. Measure the overdrive ring gear, as shown in Figure 23, to ensure you have the proper one.
- (3) RETAINING WASHER - Previous design retaining washer shown in Figure 22 must be used to accommodate the previous design overdrive ring gear.

Overdrive Sprag Assembly (Previous Design)	E5TZ-7A089-A
Overdrive Ring Gear (Previous Design)	E5TZ-7A153-A
Retaining Washer (Previous Design)	E7TZ-7L339-A

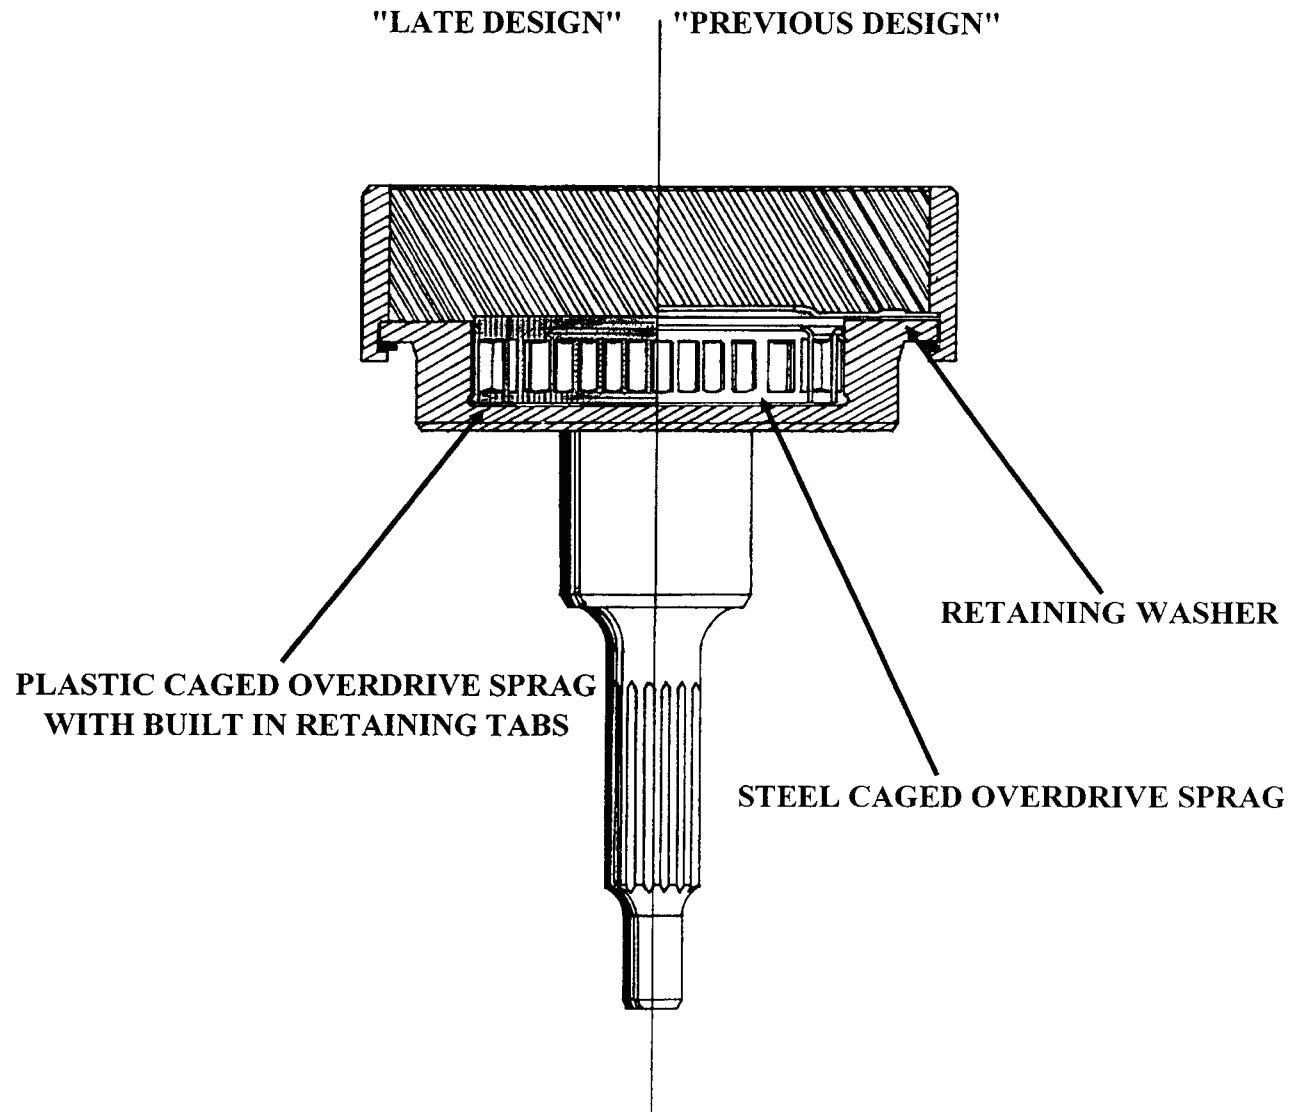
Figure 24

CHANGE: Vehicles equipped with A4LD transmissions built after June 9, 1992 contain a plastic caged overdrive sprag assembly that is no longer serviced. The previous design steel caged sprag and all related parts must be used for service (See Figure 24).

REASON: Ford Motor Co. felt that the plastic caged overdrive sprag assembly could be damaged upon disassembly from the overdrive center shaft.

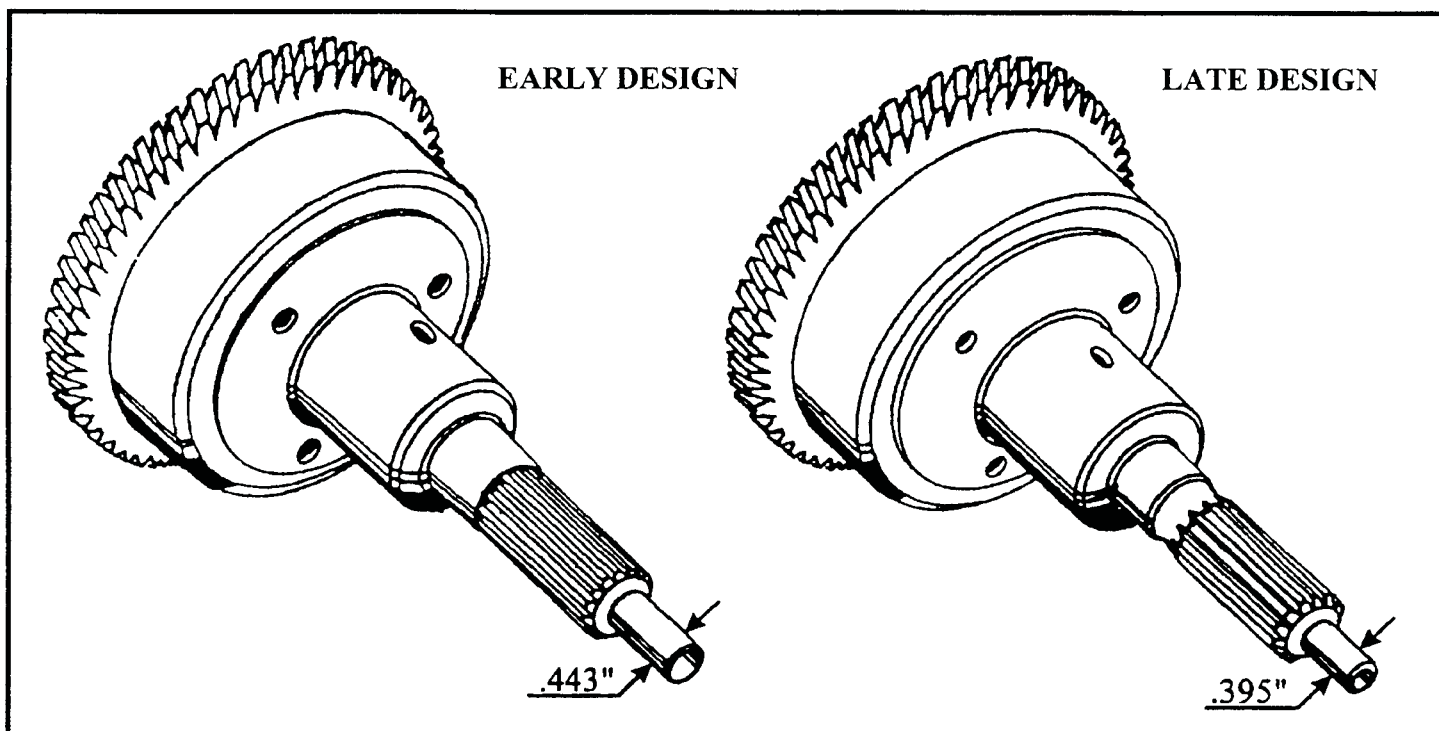
Figure 25

- (1) O.D. CENTER SHAFT - The diameter of the pilot on the shaft was machined .048" smaller than the previous design, to accommodate the bearing added to the output shaft. The new design pilot diameter is .395", and the previous design pilot diameter is .443". (See Figure 25)
- (2) OUTPUT SHAFT - Previous design bushing was replaced by a caged needle bearing. (See Figure 26). The caged needle bearing is not serviced separately from Ford Motor Co.

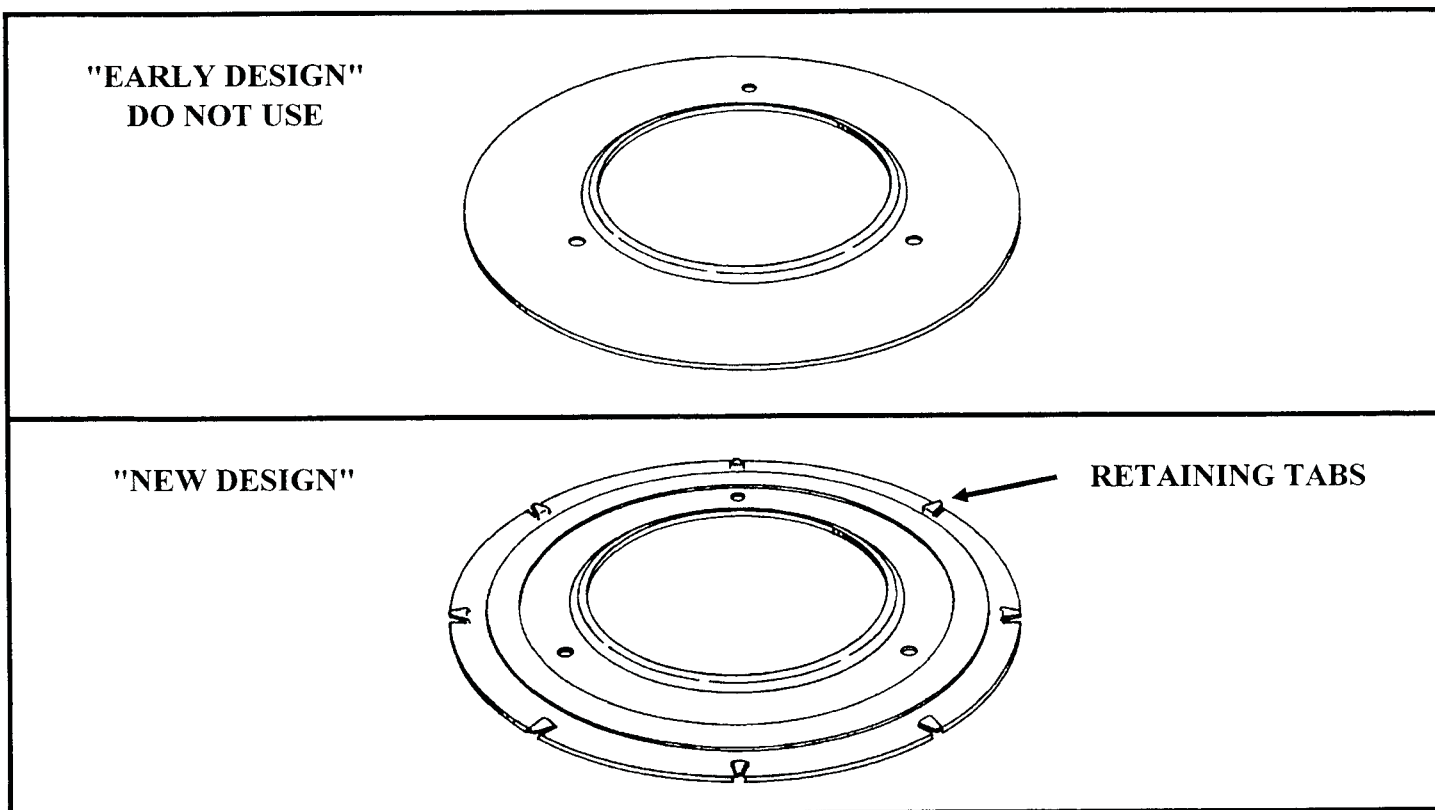
Figure 27

- (1) OVERDRIVE SPRAG RETAINING WASHER - The new design retaining washer increased in overall diameter and has retaining tabs stamped into it to prevent the washer from rotating in the overdrive ring gear. (See Figure 27).

Retaining Washer (New Design).....E7TZ-7L339-A

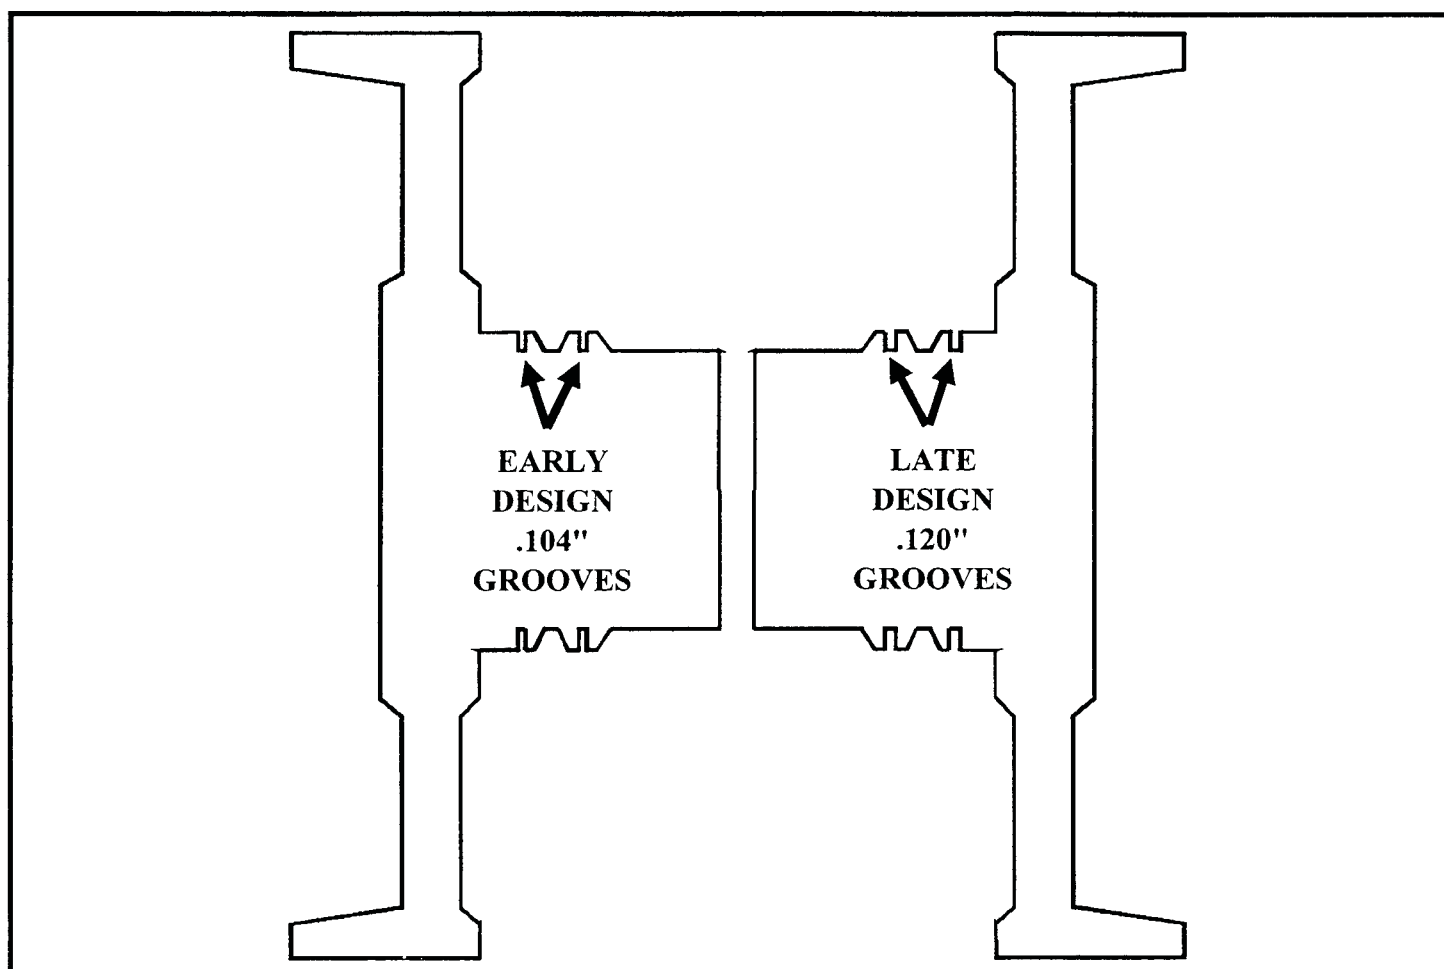
Figure 29

(1) **CENTER SUPPORT** - The sealing ring grooves were widened from .104" to .120"
(See Figure 29).

The center supports are interchangeable, however, you must use the correct size rings for the center support you are using.

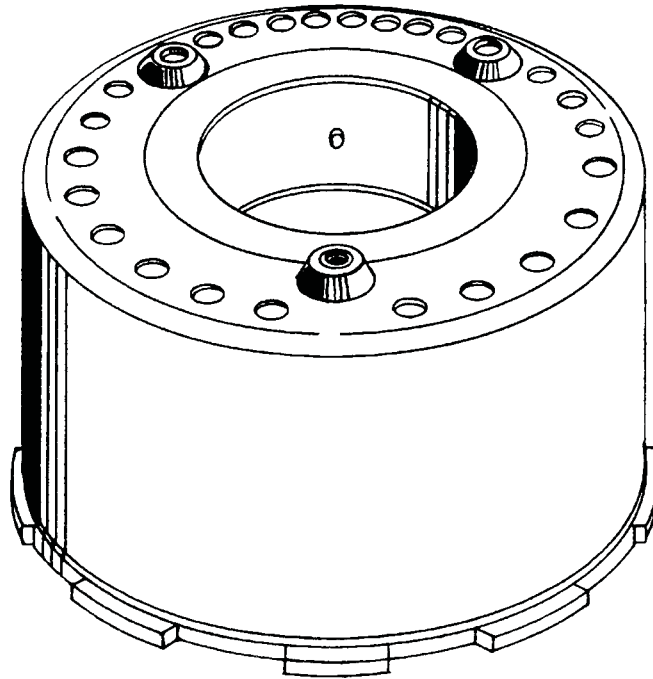
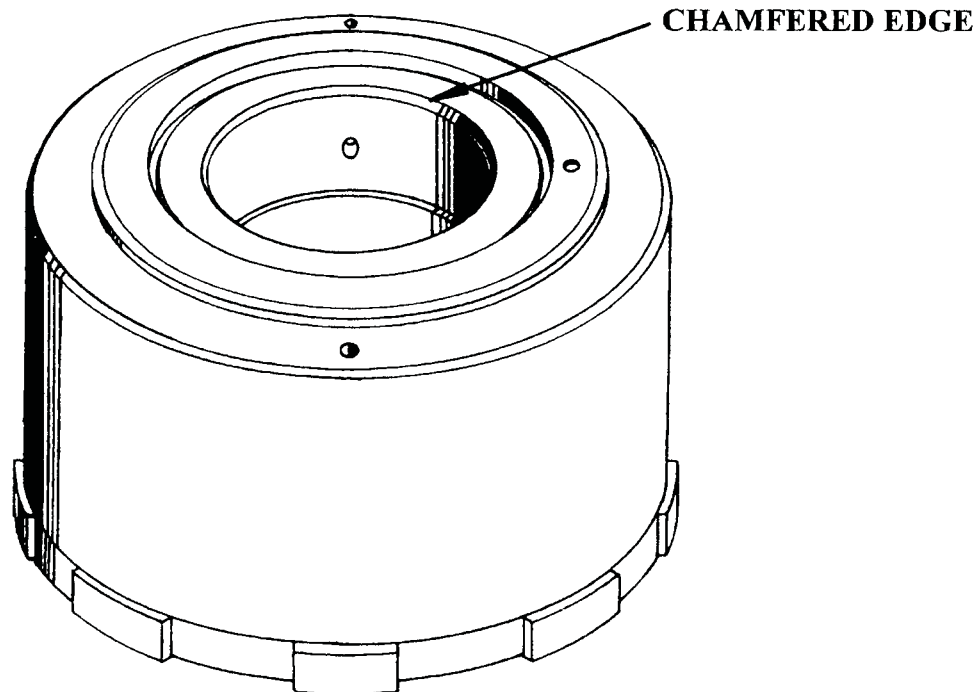
Figure 30

(1) **DIRECT CLUTCH DRUM - 1st Change:** Was changed from a stamped steel drum to a cast drum, and the sealing ring bore area was chamfered for ease of assembly (See Figure 30).
2nd Change: The "Lug" area where the direct clutch drum engages the sun gear shell, was machined approximately .200" thinner, and a .050" deep groove was machined into the drum to accommodate the added retaining tabs on the "Snap Shell" (See Figure 31). This now allows the sun shell and the direct drum to "Snap" together for easier assembly (See Figure 32). This change also allows the elimination of the number 4 thrust washer, located between the direct clutch drum and center support.

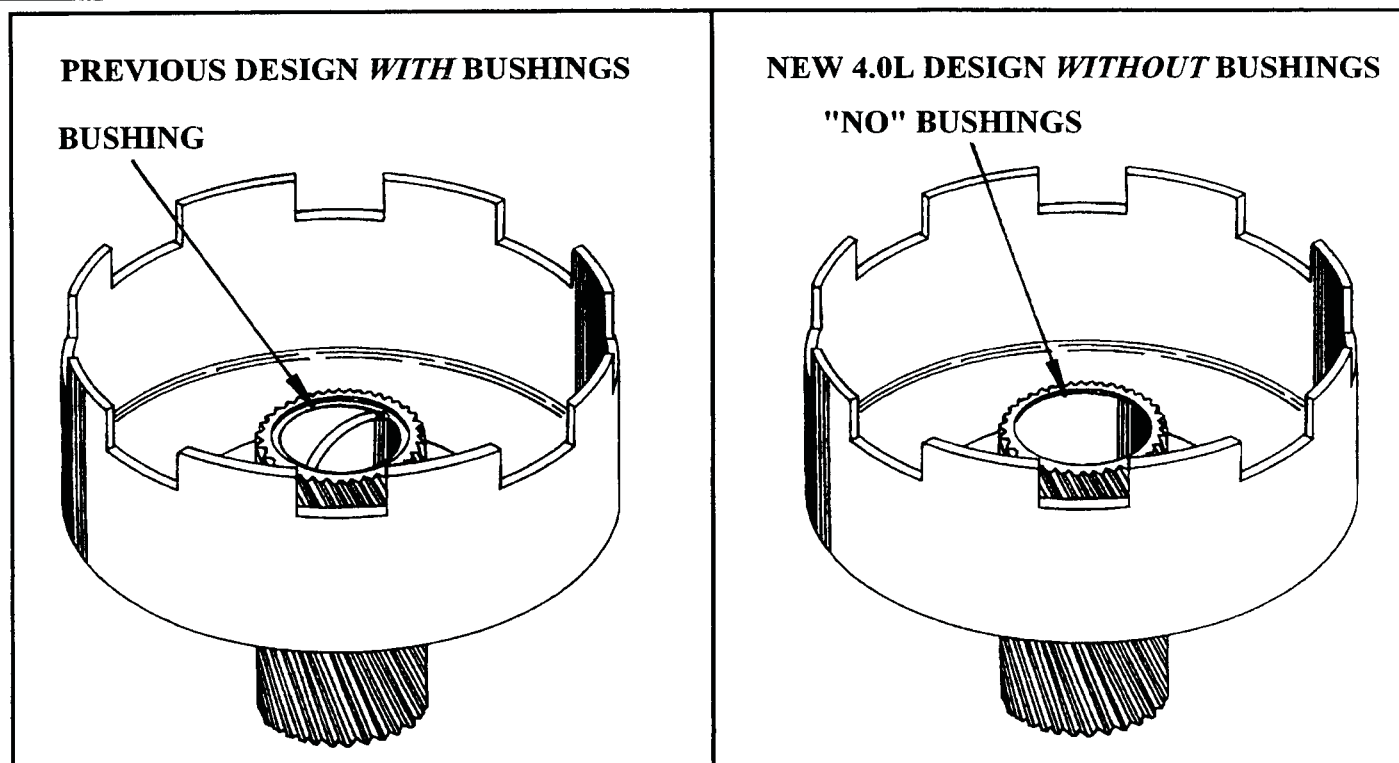
Figure 33

(2) **SUN GEAR** - Both bushings, inside the sun gear, were eliminated to allow full lubrication flow to the front planetary (See Figure 33).

- (1) The new design sun gear **WITHOUT** bushings **WILL** retro-fit back to all previous models (See Figure 33).
- (2) The previous design sun gear **WITH** the bushings **CANNOT** be used forward into the 4.0L models (See Figure 33).

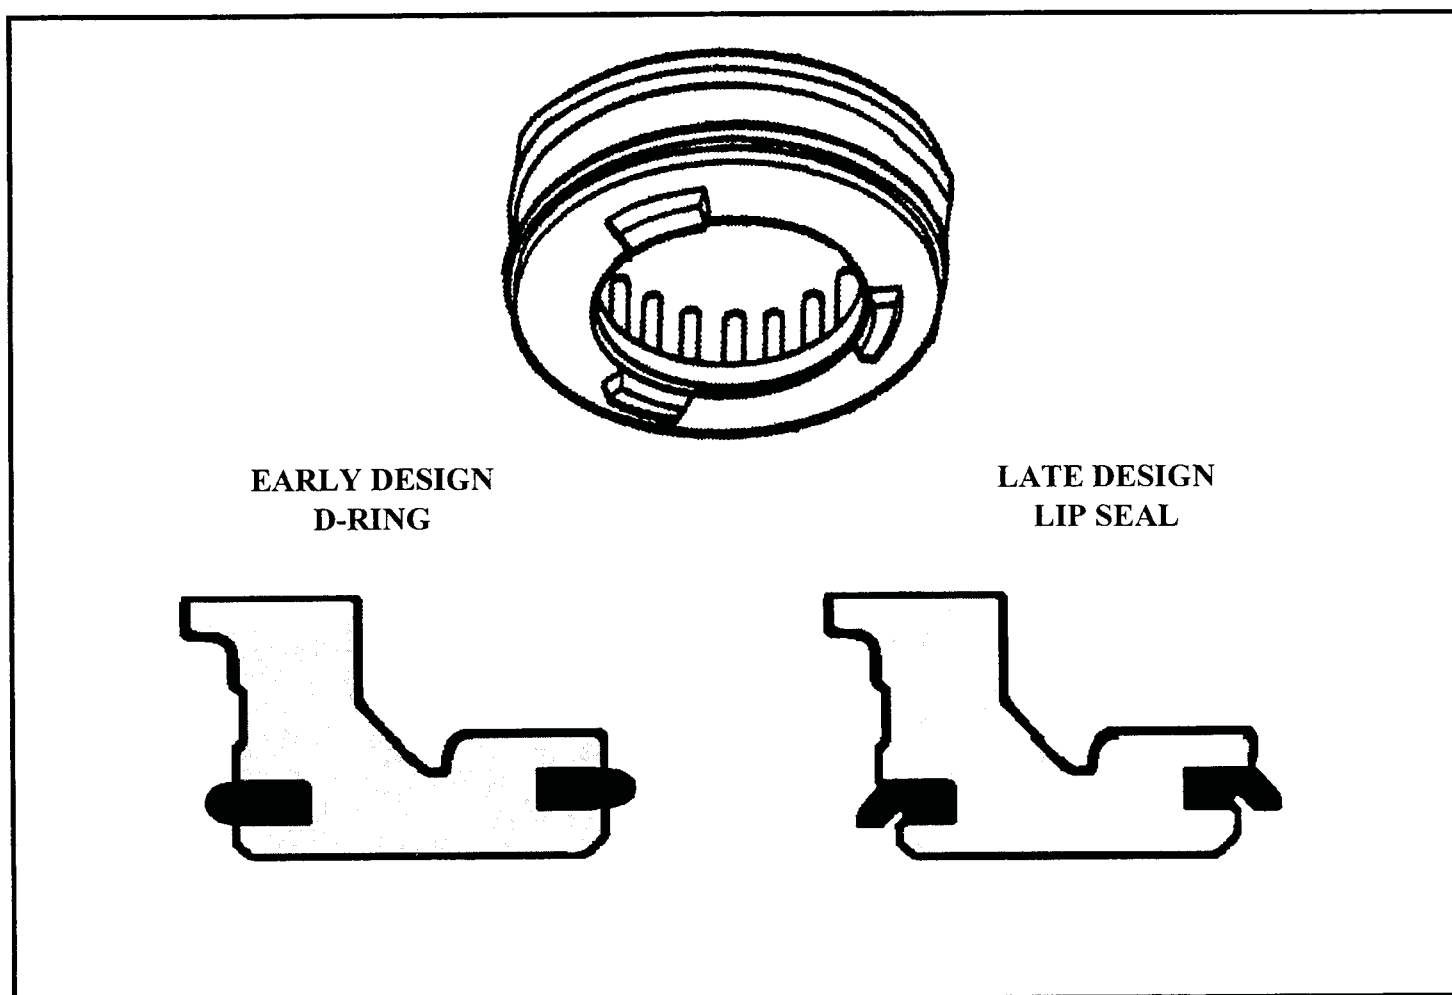
Figure 40

CHANGE: Both the overrun clutch and direct clutch piston seals were changed in 1987 from "D"-ring seals to lip seals (See Figure 40).

Although the early design "D"-ring & piston will interchange, we recommend using the later design lip seal, which requires changing the piston.

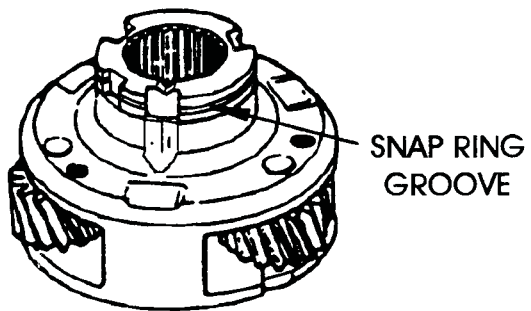
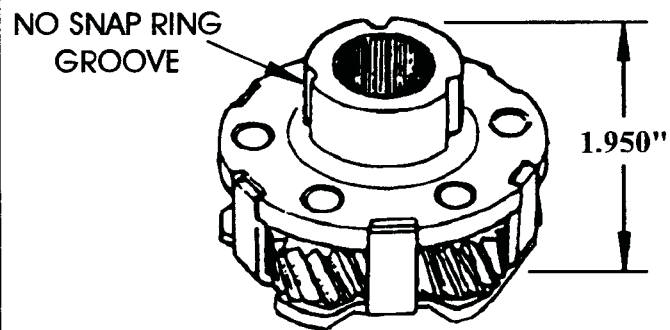
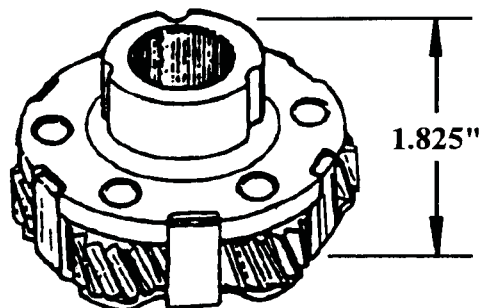
Figure 41

CHANGE: Sometime in model year 1987, the 1st design **3 pinion aluminum** front planetary carrier was replaced with a revised **4 pinion steel** front planetary carrier (See Figures 41 and 43). In model year 1990, on 4.0L engine models only, the steel front planetary carrier was once again revised to a **6 pinion steel** carrier (See Figures 41 and 43). These changes have affected many of the related parts and created confusion for many rebuilders.

- (1) **FRONT PLANETARY CARRIER** - The 1st design **3 pinion aluminum** carrier was eliminated and replaced with a revised **4 pinion steel** carrier. The snap ring groove and the snap ring that previously retained the carrier into the ring gear were eliminated (See Figure 41). In 1990 the steel carrier was once again upgraded with a **6 pinion steel** carrier, for 4.0L engine models only. The 6 pinion steel carrier was also shortened in overall height, by approximately .125", to accommodate a new design number 6 (3 piece) thrust bearing (See Figures 41 & 43). **NOTE:** The 1st Design 3 pinion aluminum and 2nd Design 4 pinion steel front carriers are no longer serviced by Ford Motor Co. They are now upgraded to the latest 3rd Design 6 pinion steel front planetary system, which comes as a service package and includes all necessary hubs and washers to make it compatible.

- (1) The **1st Design 3 pinion aluminum** front planetary carrier system, as shown in Figure 43, is recommended for nothing larger than 2.3L engine models. The 1st Design 3 pinion aluminum front planetary carrier is no longer serviced by Ford Motor Co. It now upgrades to the latest 3rd Design 6 pinion steel front planetary carrier system, which comes as a service package and includes all necessary hubs and washers to make it compatible, and is available under OEM part number F0TZ-7A398-E.

- (2) The **2nd Design 4 pinion steel** front planetary carrier system, as shown in Figure 43, with the 1.580" inside diameter ring gear hub, the number 7 thrust bearing, the number 6 "Top Hat" thrust washer **WILL** retro-fit back on all models, except 4.0L engine models, but all parts listed above must be used as an assembly (See Figure 43). The 2nd Design 4 pinion steel front planetary carrier is no longer serviced by Ford Motor Co. It now upgrades to the latest 3rd Design 6 pinion steel front planetary carrier system, which comes as a service package and includes all necessary hubs and washers to make it compatible, and is available under OEM part number F0TZ-7A398-E.

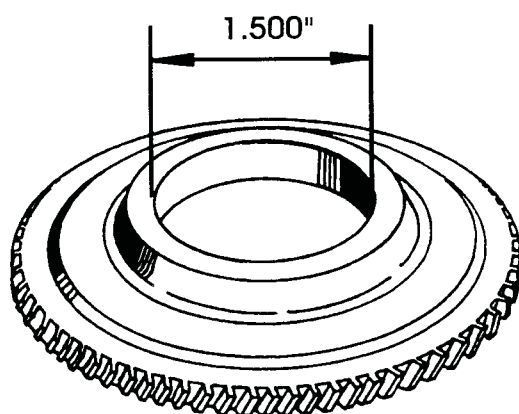
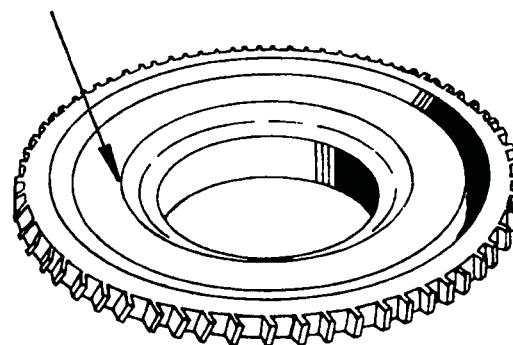
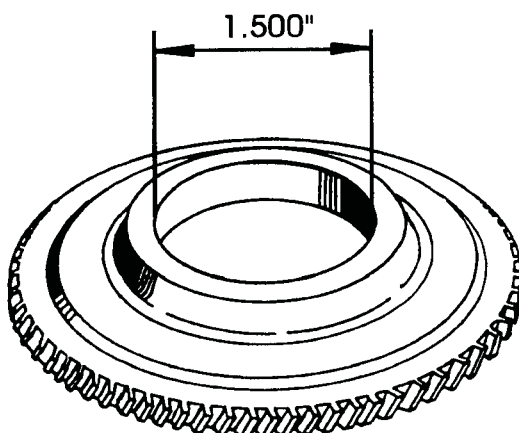
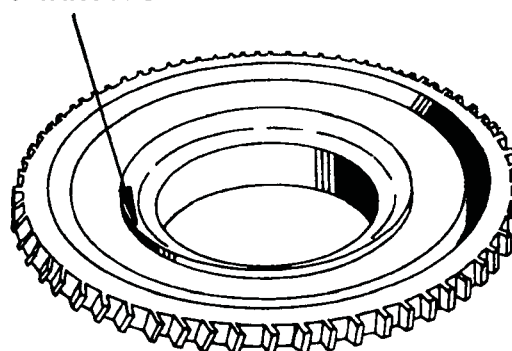
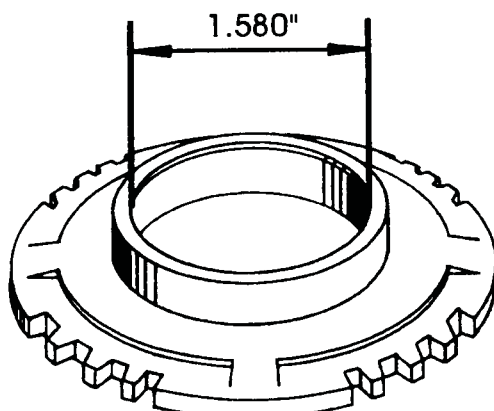
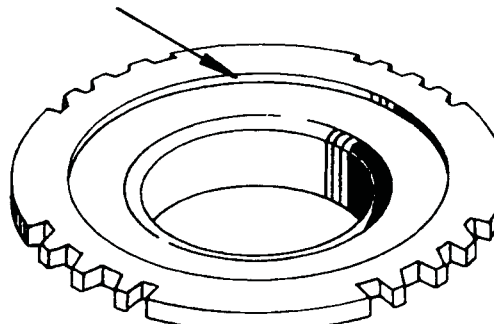
Figure 42
AUTOMATIC TRANSMISSION SERVICE GROUP

- (2) **FORWARD RING GEAR HUB** - The 1st Design forward ring gear hub uses a number 7 thrust washer as shown in Figure 43. On the 2nd Design ring gear hub, a recess was machined to accommodate an added number 7 thrust bearing, that replaced the number 7 thrust washer. Refer to Figures 42 and 43. Both 1st and 2nd design ring gear hubs inside diameter measure 1.500", as shown in Figure 42. On the 3rd Design ring gear hub the inside diameter was machined approximately .080" larger to accommodate a new design number 6 "Top Hat" thrust washer (See Figure 43). The inside diameter on the 3rd Design ring gear hub measures 1.580", as shown in Figure 42.

- (4) **NUMBER 7 THRUST WASHER** - Sometime in 1986, the number 7 thrust washer was eliminated, and replaced with a number 7 thrust bearing as shown in Figure 43. This change required the machined recess in the ring gear hub, to make room for the thrust bearing, as shown in Figure 42. The number 7 thrust bearing is still used through current production (See Figure 43).

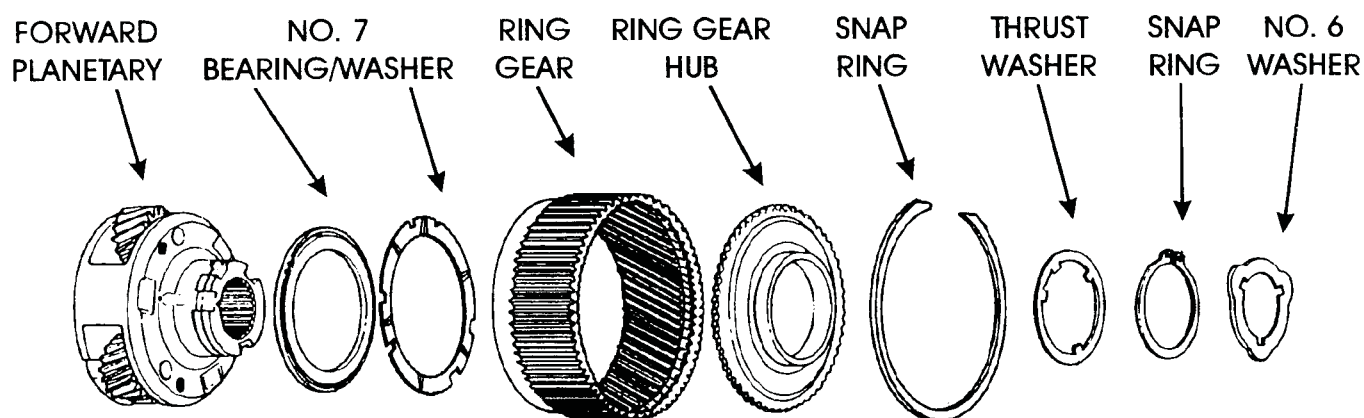
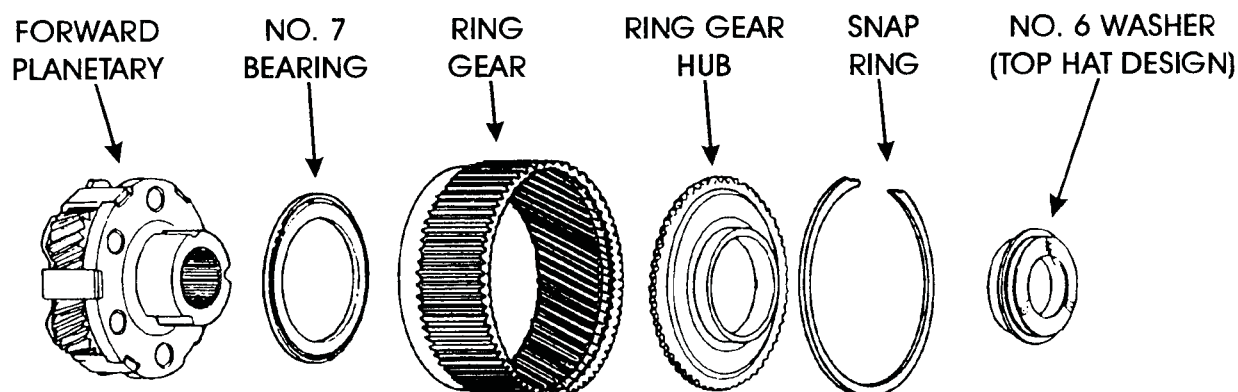
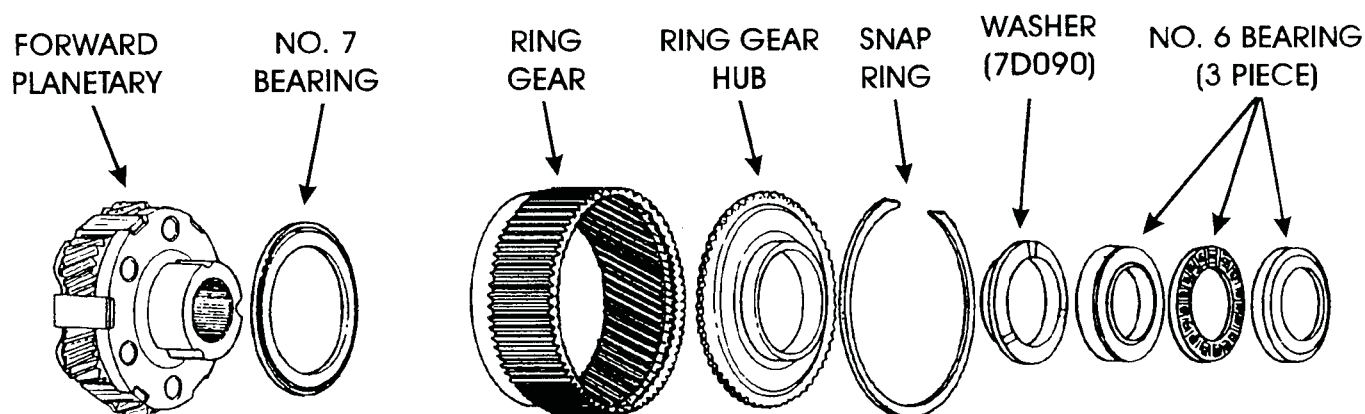
Figure 43

- (3) **NUMBER 6 THRUST WASHER** - Was changed from a 3 tab thrust washer to a "Top Hat" design thrust washer in 1987 (See Figure 43). This change is what required the larger inside diameter on the ring gear hub. Beginning in 1990, on 4.0L engine models, the number 6 "Top Hat" thrust washer was replaced with a new number 6 (3 Piece) thrust bearing, as shown in Figure 43. Notice also the added washer (7D090), that must be used with the 3 piece bearing design (See Figure 43). This is what required the carrier to be machined shorter. The 3 piece thrust bearing has now been changed to a normal "Torrington" (Snap Together) type bearing and replaces the 3 piece design without any other changes.

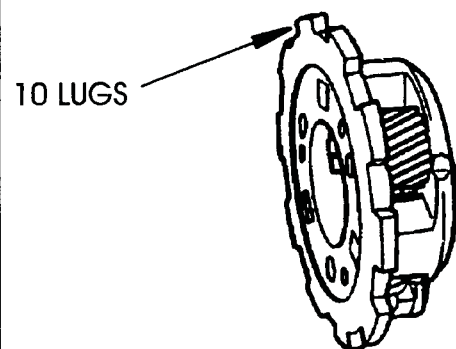
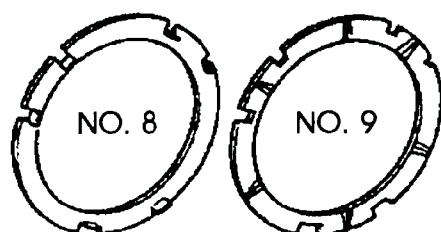
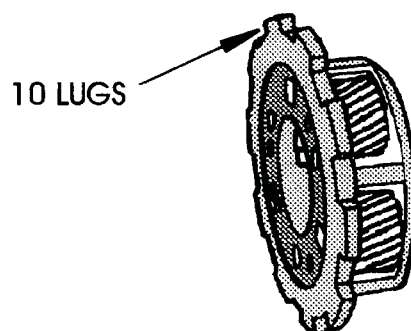
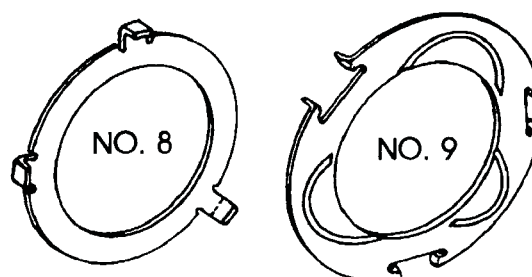
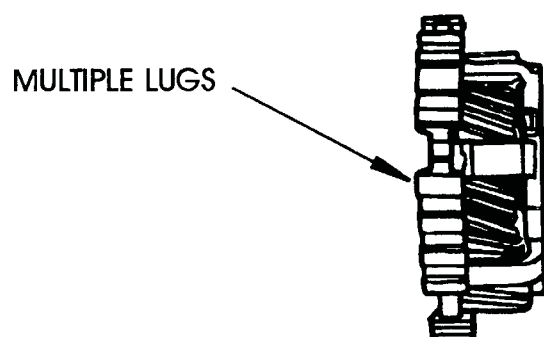
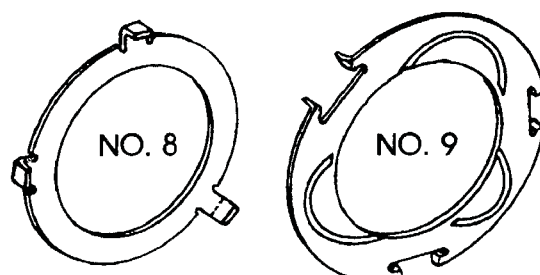
Figure 45
AUTOMATIC TRANSMISSION SERVICE GROUP

CHANGE: Sometime in model year 1987, the 1st design *3 pinion aluminum* rear planetary carrier was replaced with a 2nd design *4 pinion steel* rear planetary carrier (See Figure 45). In model year 1990, on 4.0L engine models only, the 4 pinion steel carrier was once again revised to a *6 pinion steel* rear planetary carrier (See Figure 45). Included in this change were changes in the internal lubrication circuit. These changes have affected many of the related parts and created confusion for many rebuilders.

- (1) **REAR PLANETARY CARRIER** - The 1st design *3pinion aluminum* rear carrier was eliminated and replaced with a 2nd design *4 pinion steel* rear carrier, as shown in Figure 45. Both 1st and 2nd design rear carriers have 10 lugs where it lugs into the reverse drum, as shown in Figure 45. The 1st design 3 pinion aluminum rear carrier is no longer serviced by Ford Motor Co, and automatically supercedes to the 4 pinion steel rear carrier. It is available as a service package under OEM part number E7SZ-7D006-C, which includes the number 8 and number 9 thrust washers, to make it compatible. Beginning in 1990, on 4.0L engine models only, Ford introduced a 3rd design *6 pinion steel* rear carrier, which has multiple lugs where it lugs into the reverse drum (See Figure 45).
