A4LD UPDATE HANDBOOK INDEX

FORD A4LD

"UPDATE HANDBOOK"

Since the start of production in 1985, the FORD A4LD transmission has received many major engineering design changes. These design level changes have affected nearly every part used in the A4LD transmission.

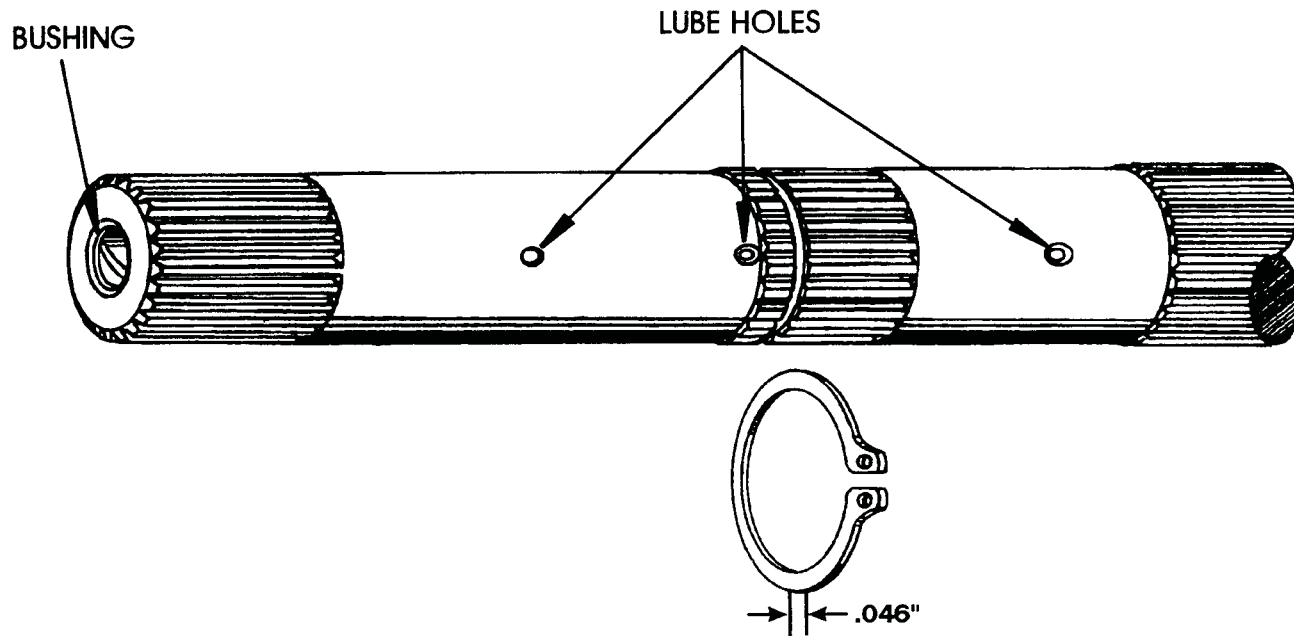
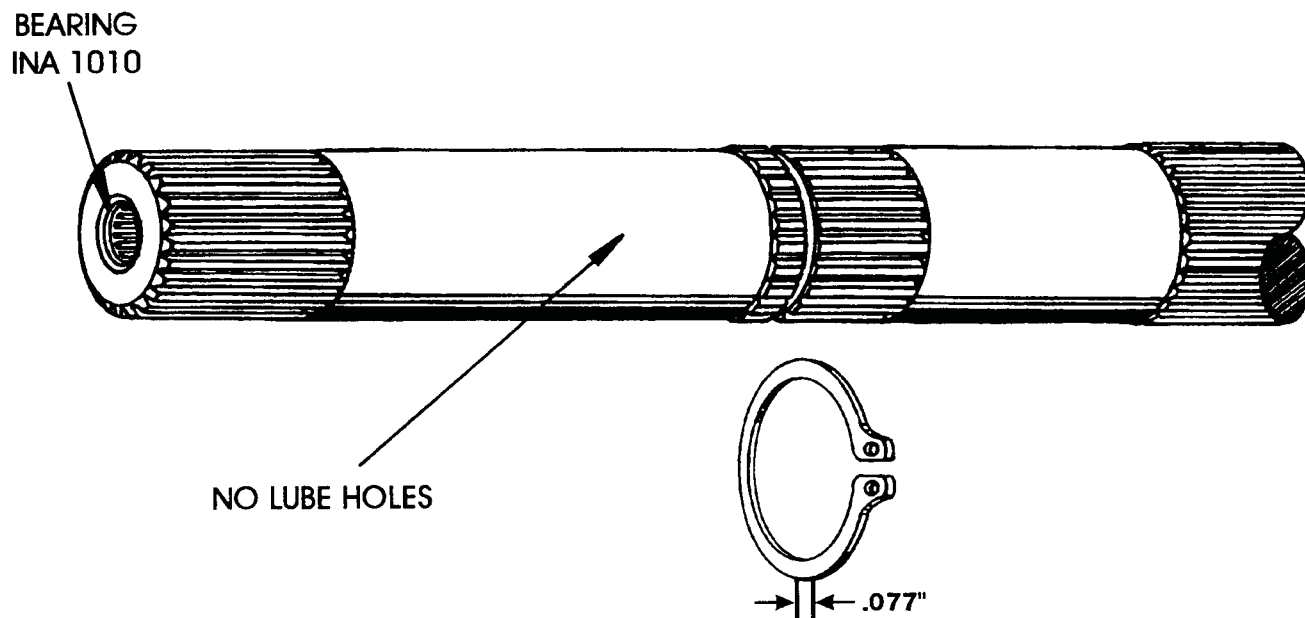
Figure 48

- (8) OUTPUT SHAFT - The Output Shaft was revised in three areas:
- The front output shaft bushing was replaced with a caged needle bearing (See Figure 48).

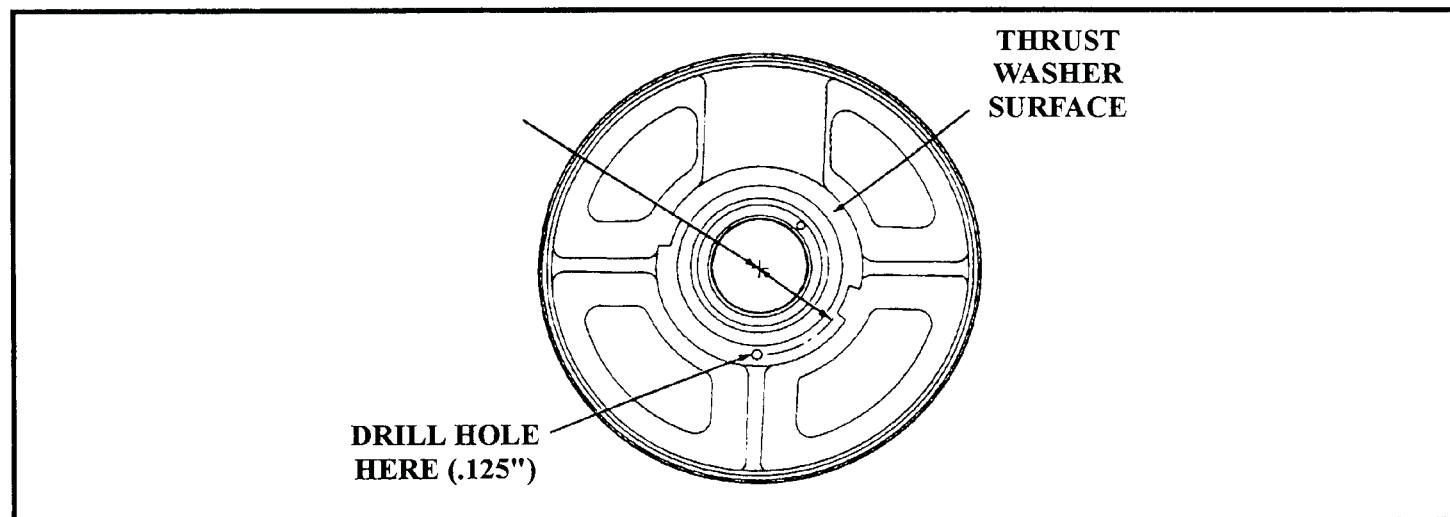
To perform the endplay check, fabricate a depth gauge fixture from a spare center support. A 1/8" inch hole must be drilled through the thrust washer surface of the center support. See Figure 56 for proper drilling location. This allows the depth micrometer access to the area between the thrust washer surface and the intermediate brake drum. Remove the rubber sealing rings from the spare center support to allow easy insertion into the drum.

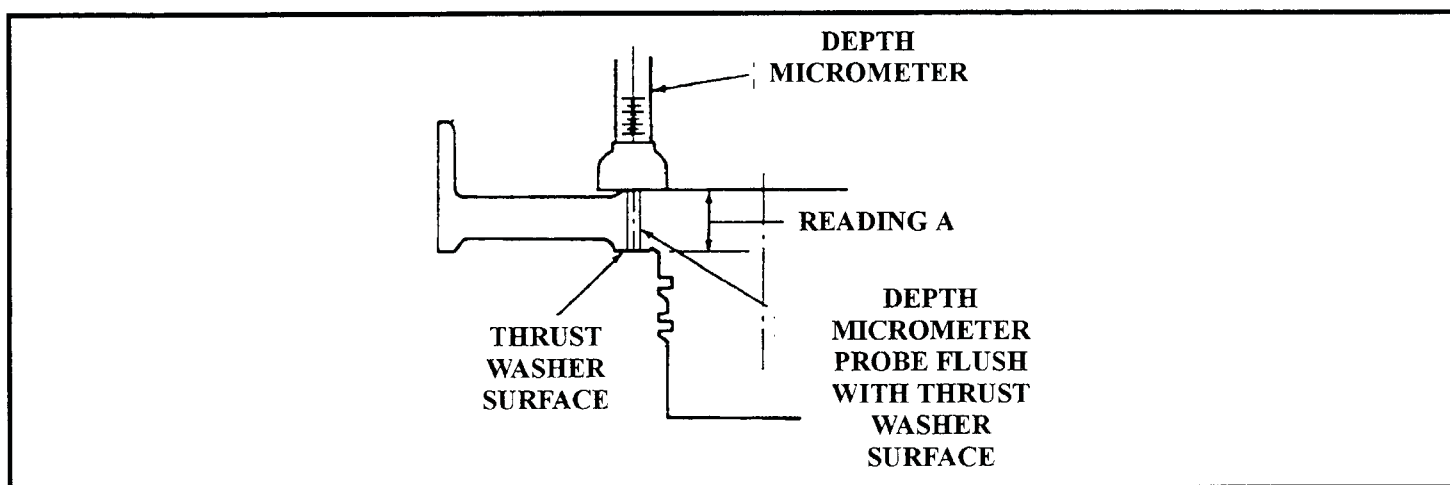
Figure 57

- (1) Place micrometer over drilled hole in the fabricated depth gauge fixture. Extend micrometer probe until it is flush with the thrust washer surface (See Figure 57). Record the measurement. This is reading A.

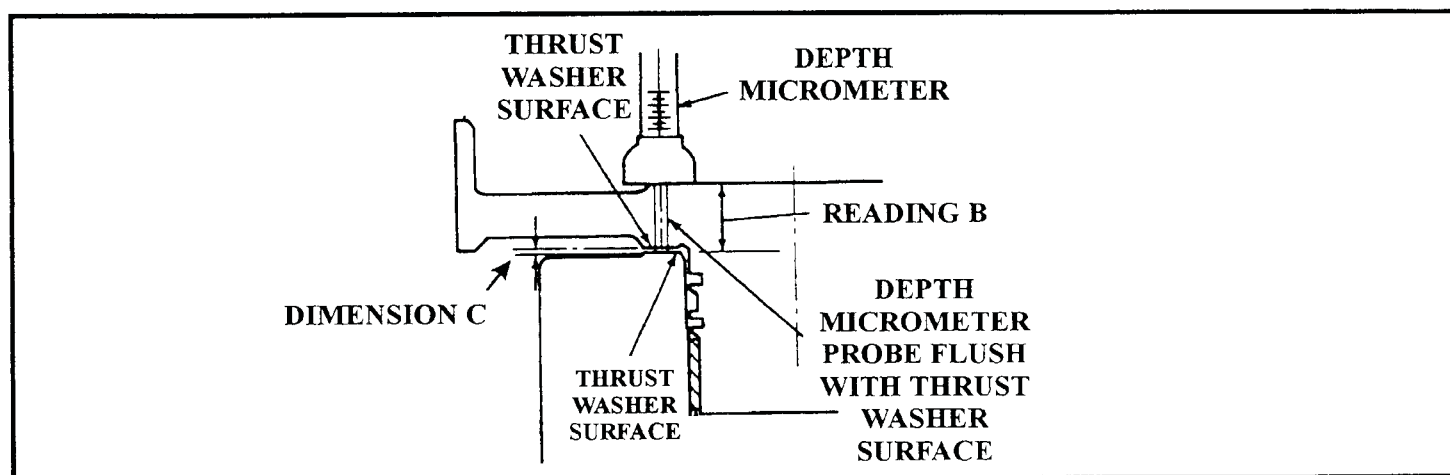
Figure 58

- (3) Place the micrometer over the drilled hole in the fixture. Extend the probe until it contacts the thrust washer surface of the direct clutch drum (See Figure 58). This is reading B.

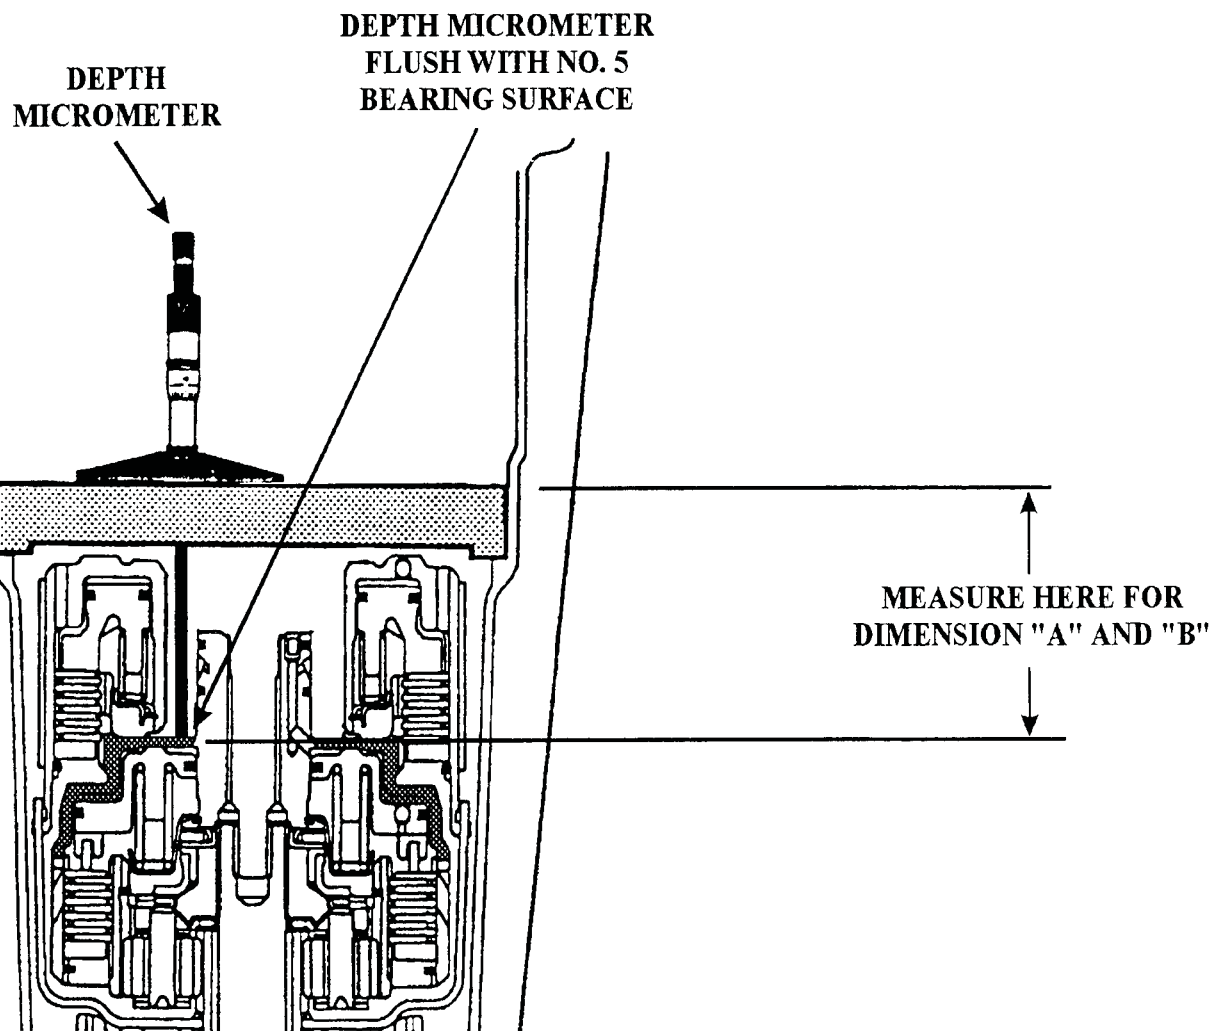
Figure 59

*The center support fixture used on previous models, will not work on "Snap" shell design models. To perform the rear endplay check on these models you **must** use a gauging bar (T93T-77003-AH), as shown in Figure 59, and using the following procedure:*

- (1) Place Gauging Bar (T93T-77003-AH) on case shoulder, as shown in Figure 59, and set the depth micrometer on top of gauging bar as shown in Figure 59.

- (2) Extend gauging bar probe until it contacts number 5 thrust bearing surface of the forward clutch drum, as shown in Figure 59. ***Number 5 (Selective) thrust bearing is removed for this check.***

- (3) Remove the depth micrometer and record this reading as Dimension "A".
- (4) Move the depth micrometer to the opposite side of the gauging bar (180 degrees). Extend gauging bar probe until it contacts number 5 thrust bearing surface of the forward clutch drum, as shown in Figure 59.

- (7) Using Dimension "C" in the chart provided below, choose the proper selective number 5 thrust bearing, which will now provide you with the proper end play of .004"-.024".

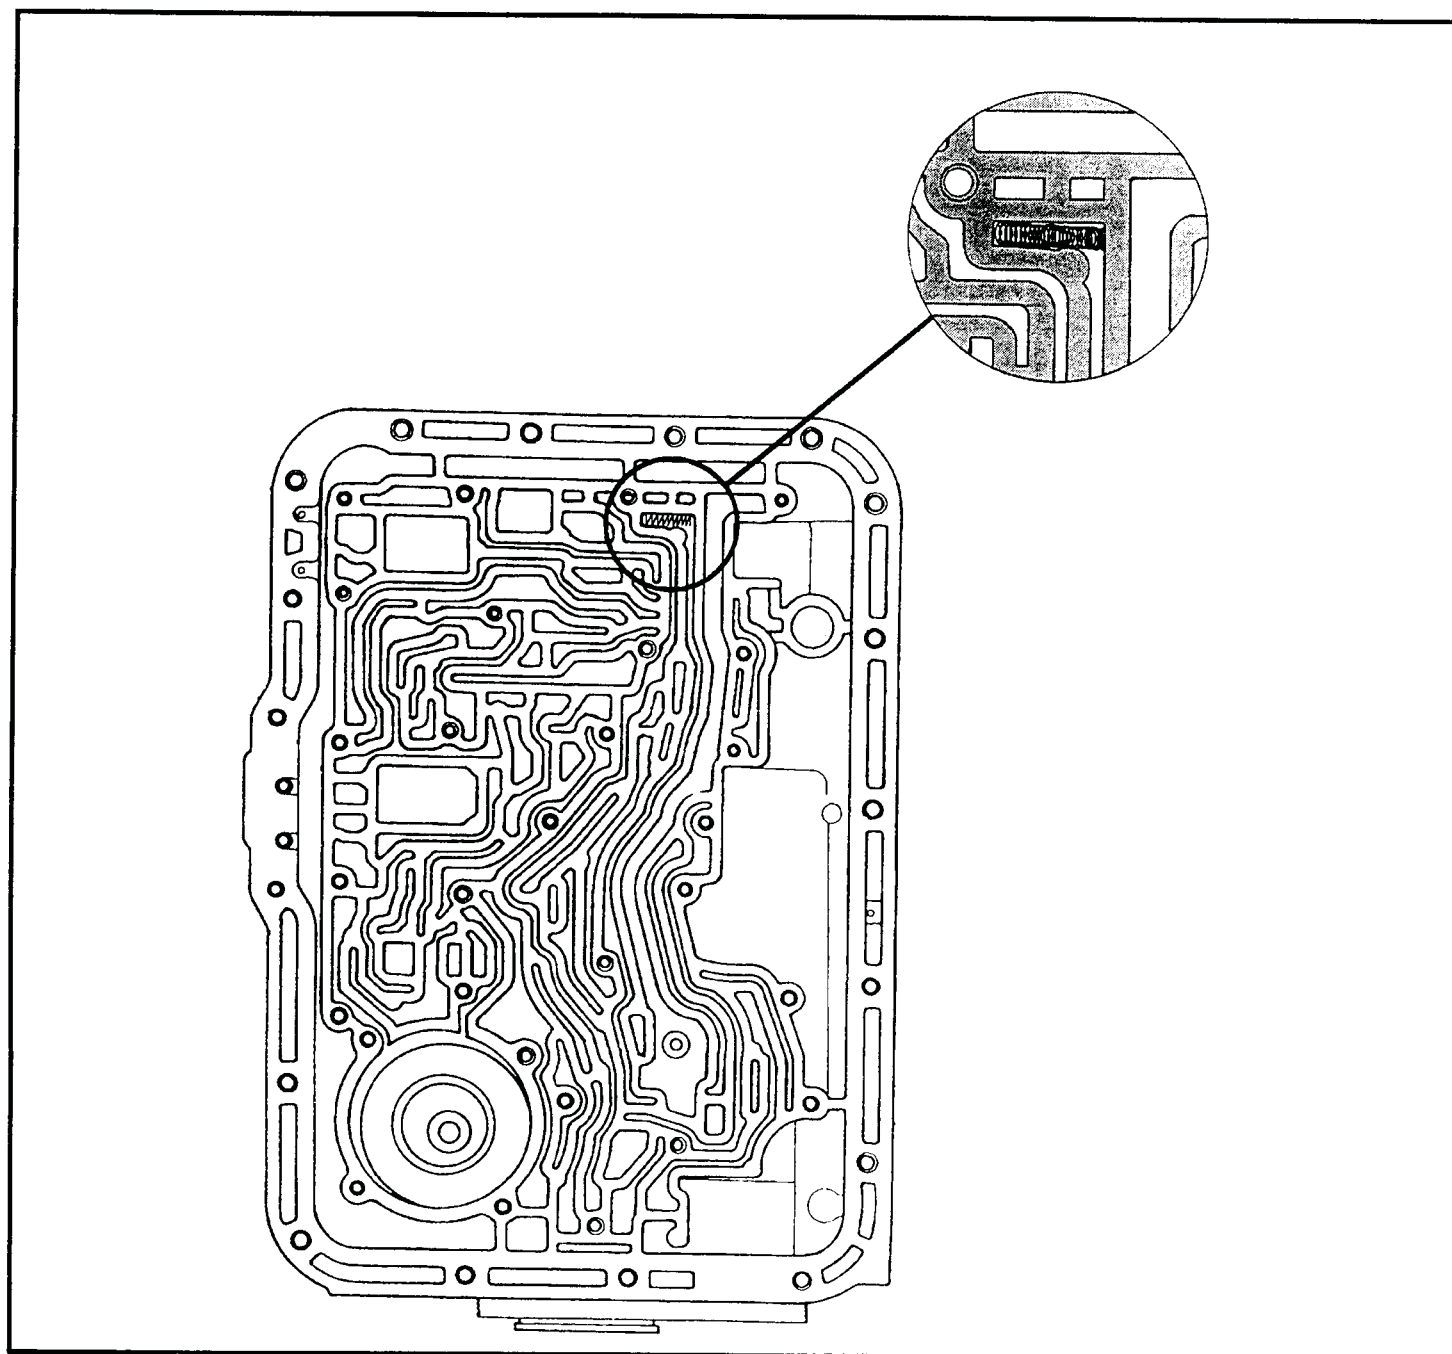
Figure 61

A spring was installed in the transmission case worm track to trap large machining chips and reduce engine stall complaints created by a stuck converter lock up valve in the valve body (See Figure 61).

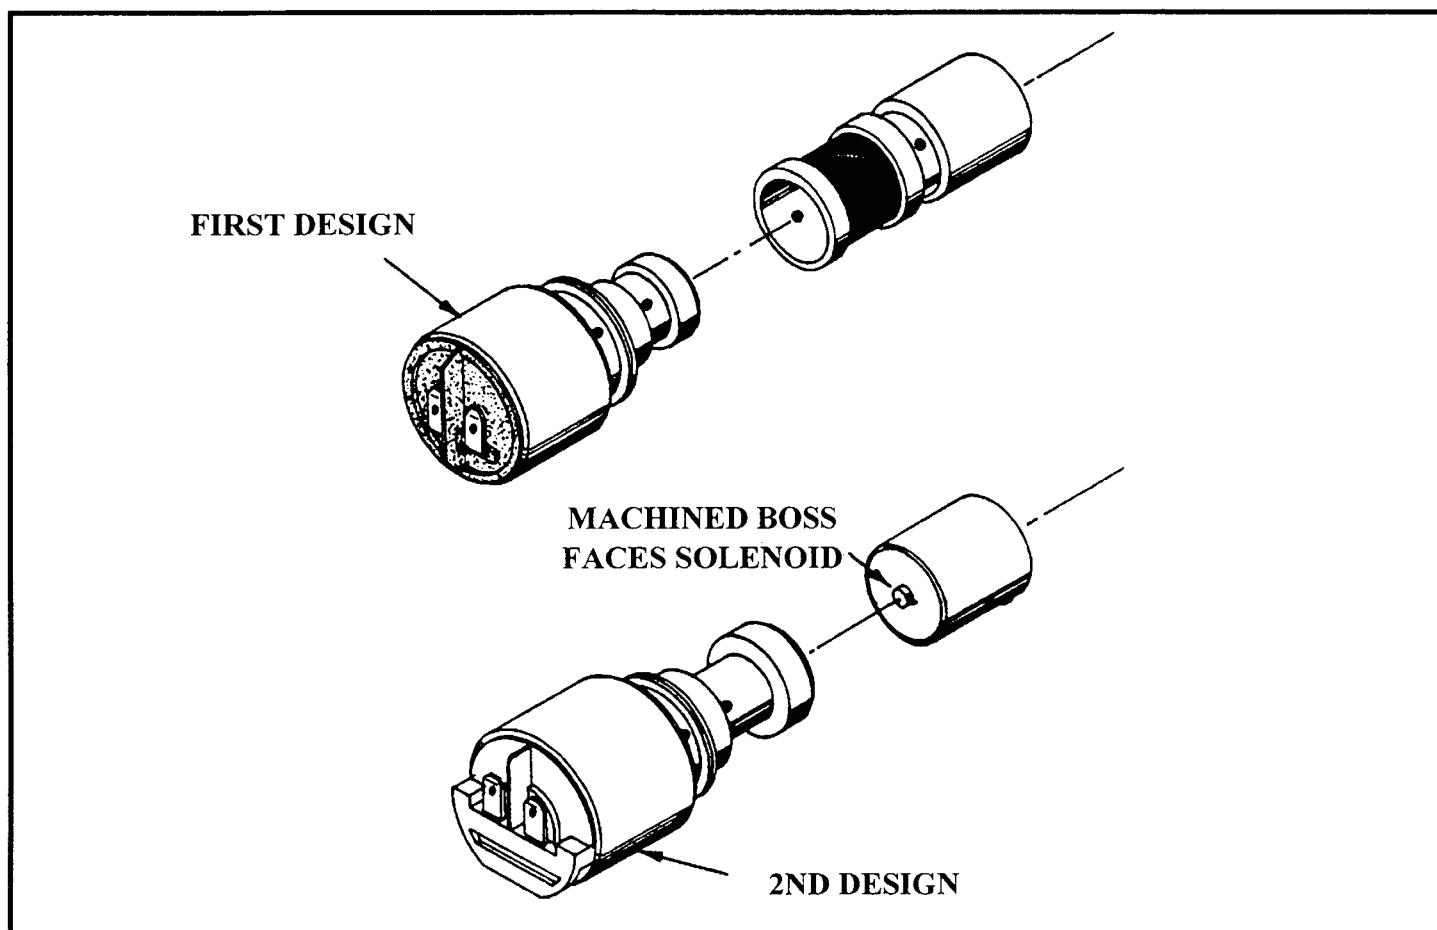
Figure 66

3-4 SHIFT SOLENOID - The 2nd design 3-4 shift solenoid eliminates the screen, has dimensional changes on the solenoid itself, and includes a new plug with a boss machined on one end. The plug must be installed with the machined boss facing the solenoid as shown in Figure 66.

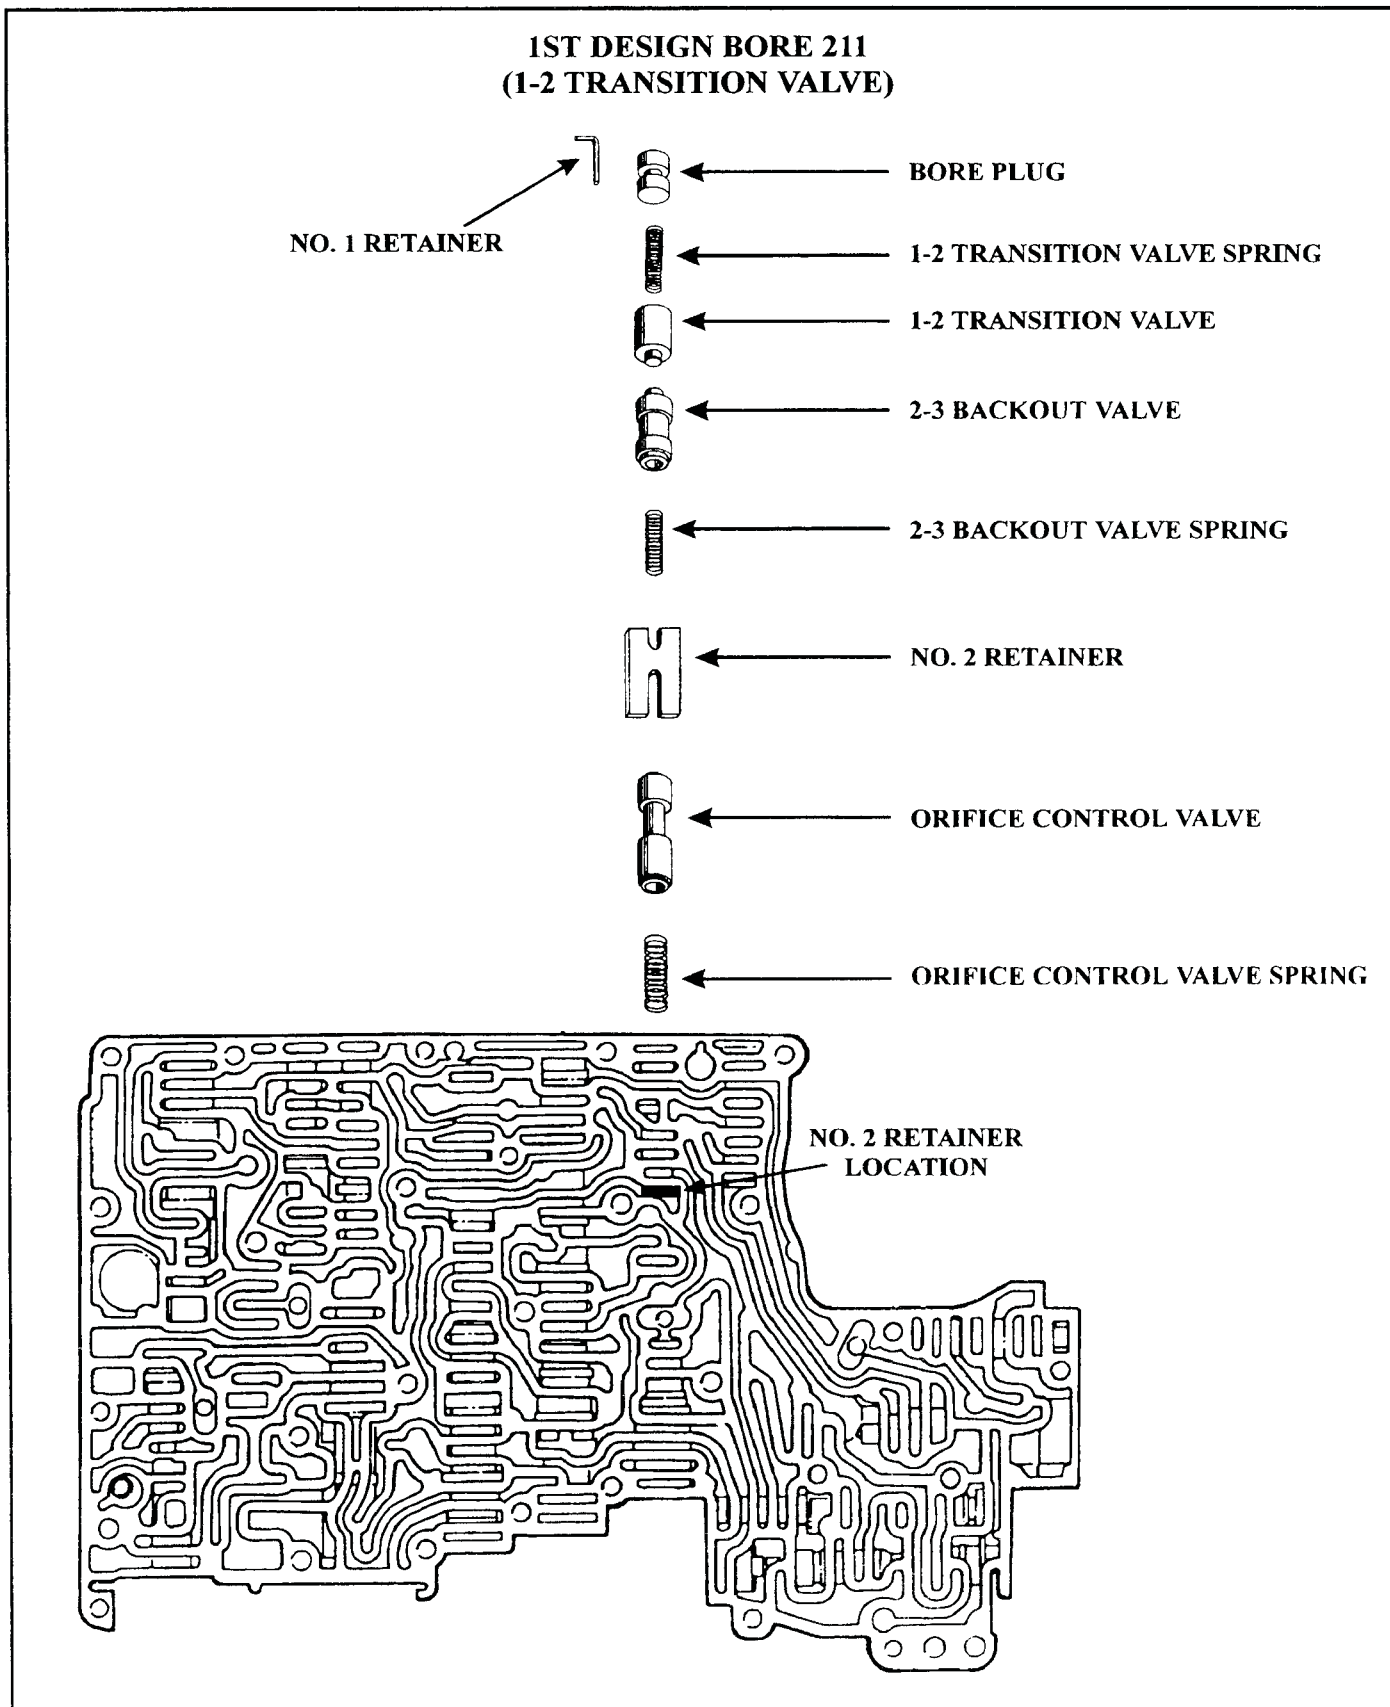
Figure 67

CAUSE: Mis-matching of the valve body and spacer plates. Not all will interchange.

This bore contains the 1-2 Transition Valve and is located as shown in Figure 67. Notice the location of the No. 2 retainer in valve body is also shown in Figure 67. Figure 68 shows the "Large Hole" spacer plate that is required on the valve body with the 1st design bore 211. Figure 68 also identifies the holes that were eliminated on the two solenoid valve bodies.

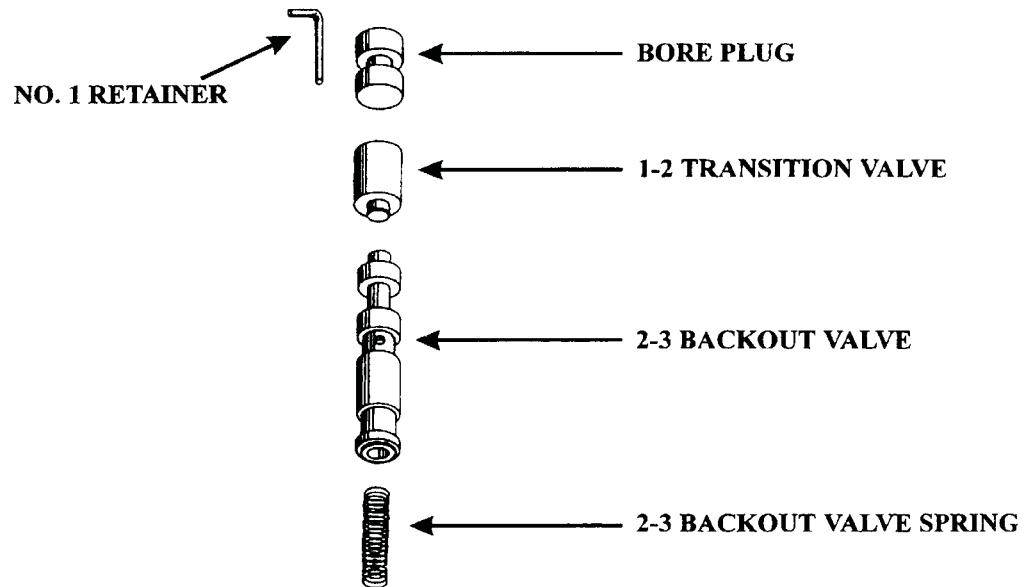
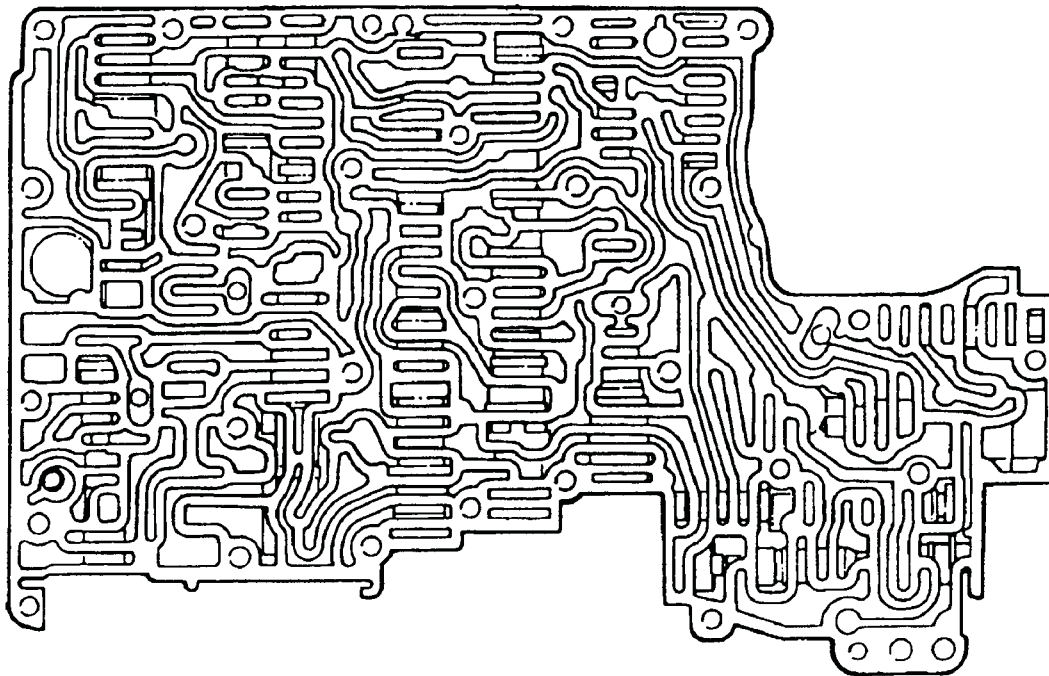
Figure 69

The 2nd design valve train has eliminated two springs and incorporated two spool valves into one, as shown in Figure 69. Figure 70 shows the "Small Hole" spacer plate that is required with the 2nd design line-up in bore 211.

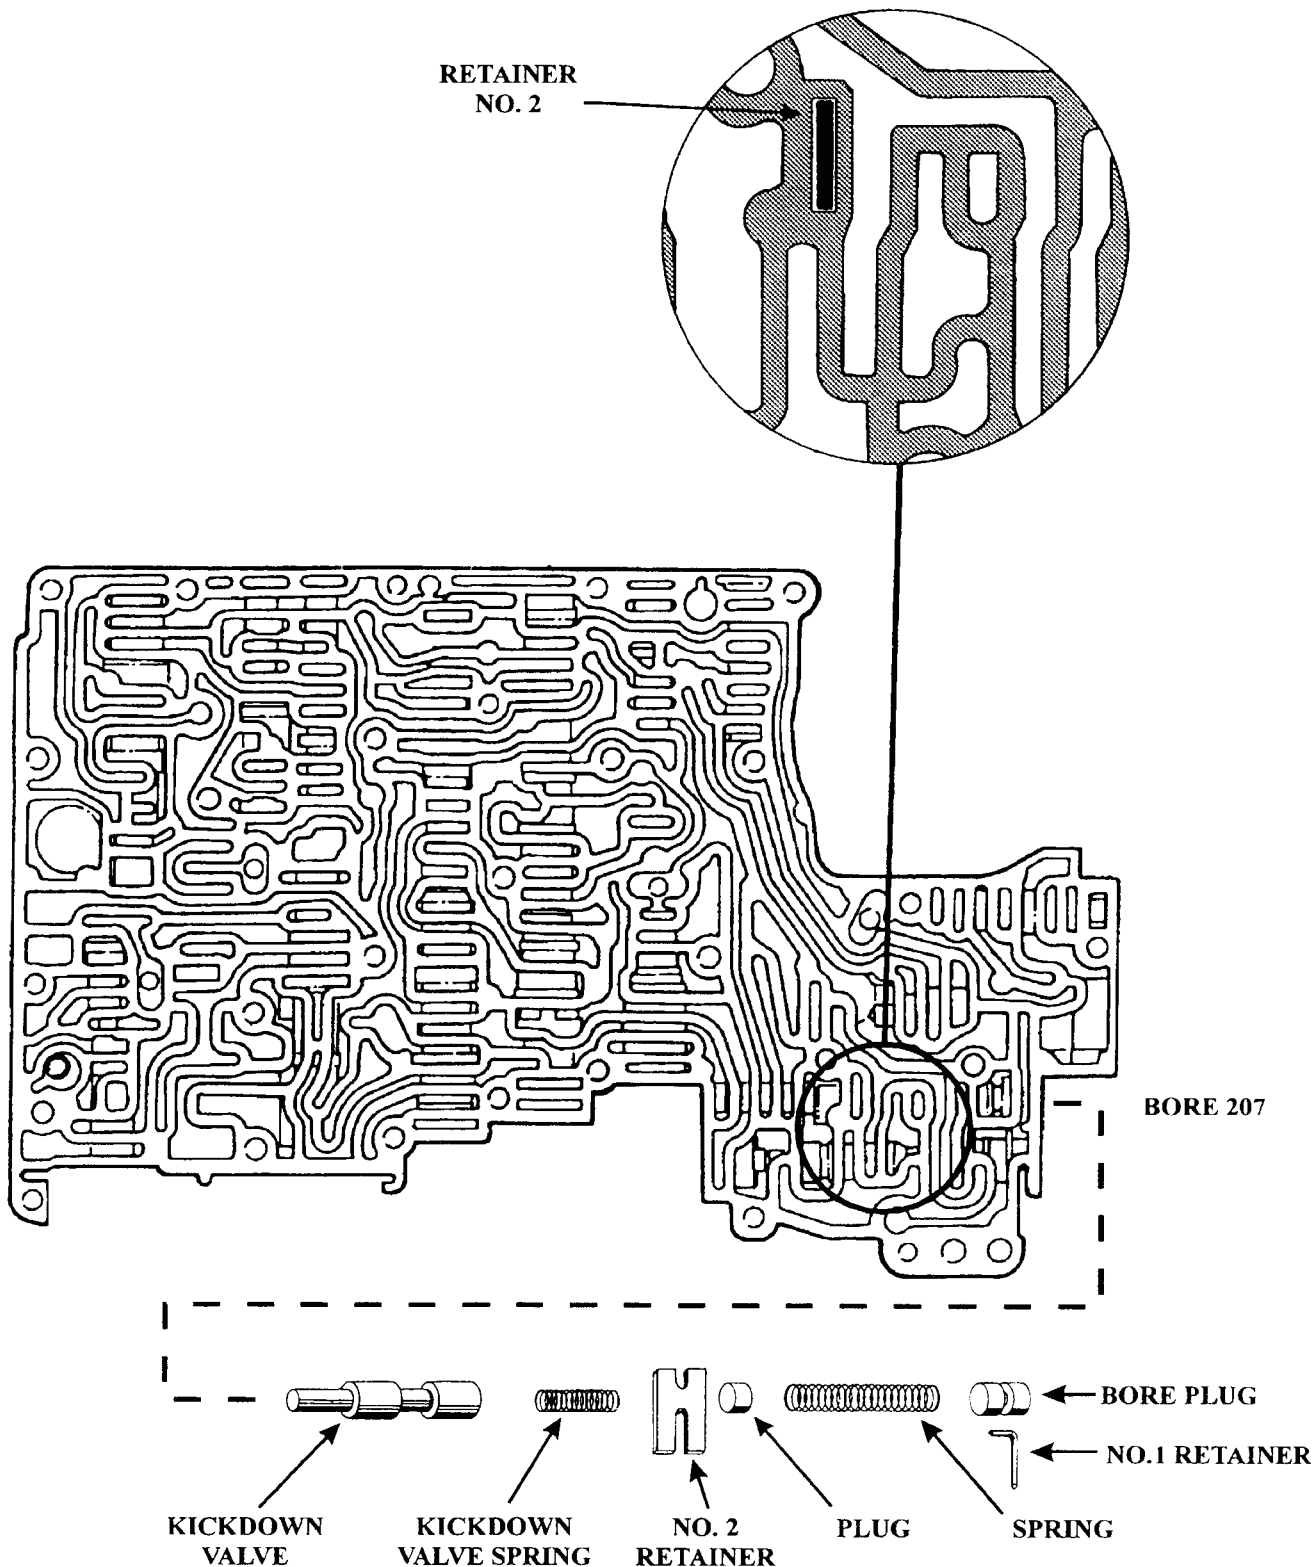
Figure 71 shows the correct line-up for this bore, and the No. 2 retainer location in the valve body casting. Figure 72 shows the "Slot" in the spacer plate that is required for the 1st design bore 207, "Without" reverse engagement valve.

Note: Valve body castings are also different in the worm track area, when it comes to bore 207. Compare the inset in Figure 71 to the inset in Figure 73, and you will see the difference in the passages, which **will not** allow you to install reverse engagement valve into a 1st design valve body casting.

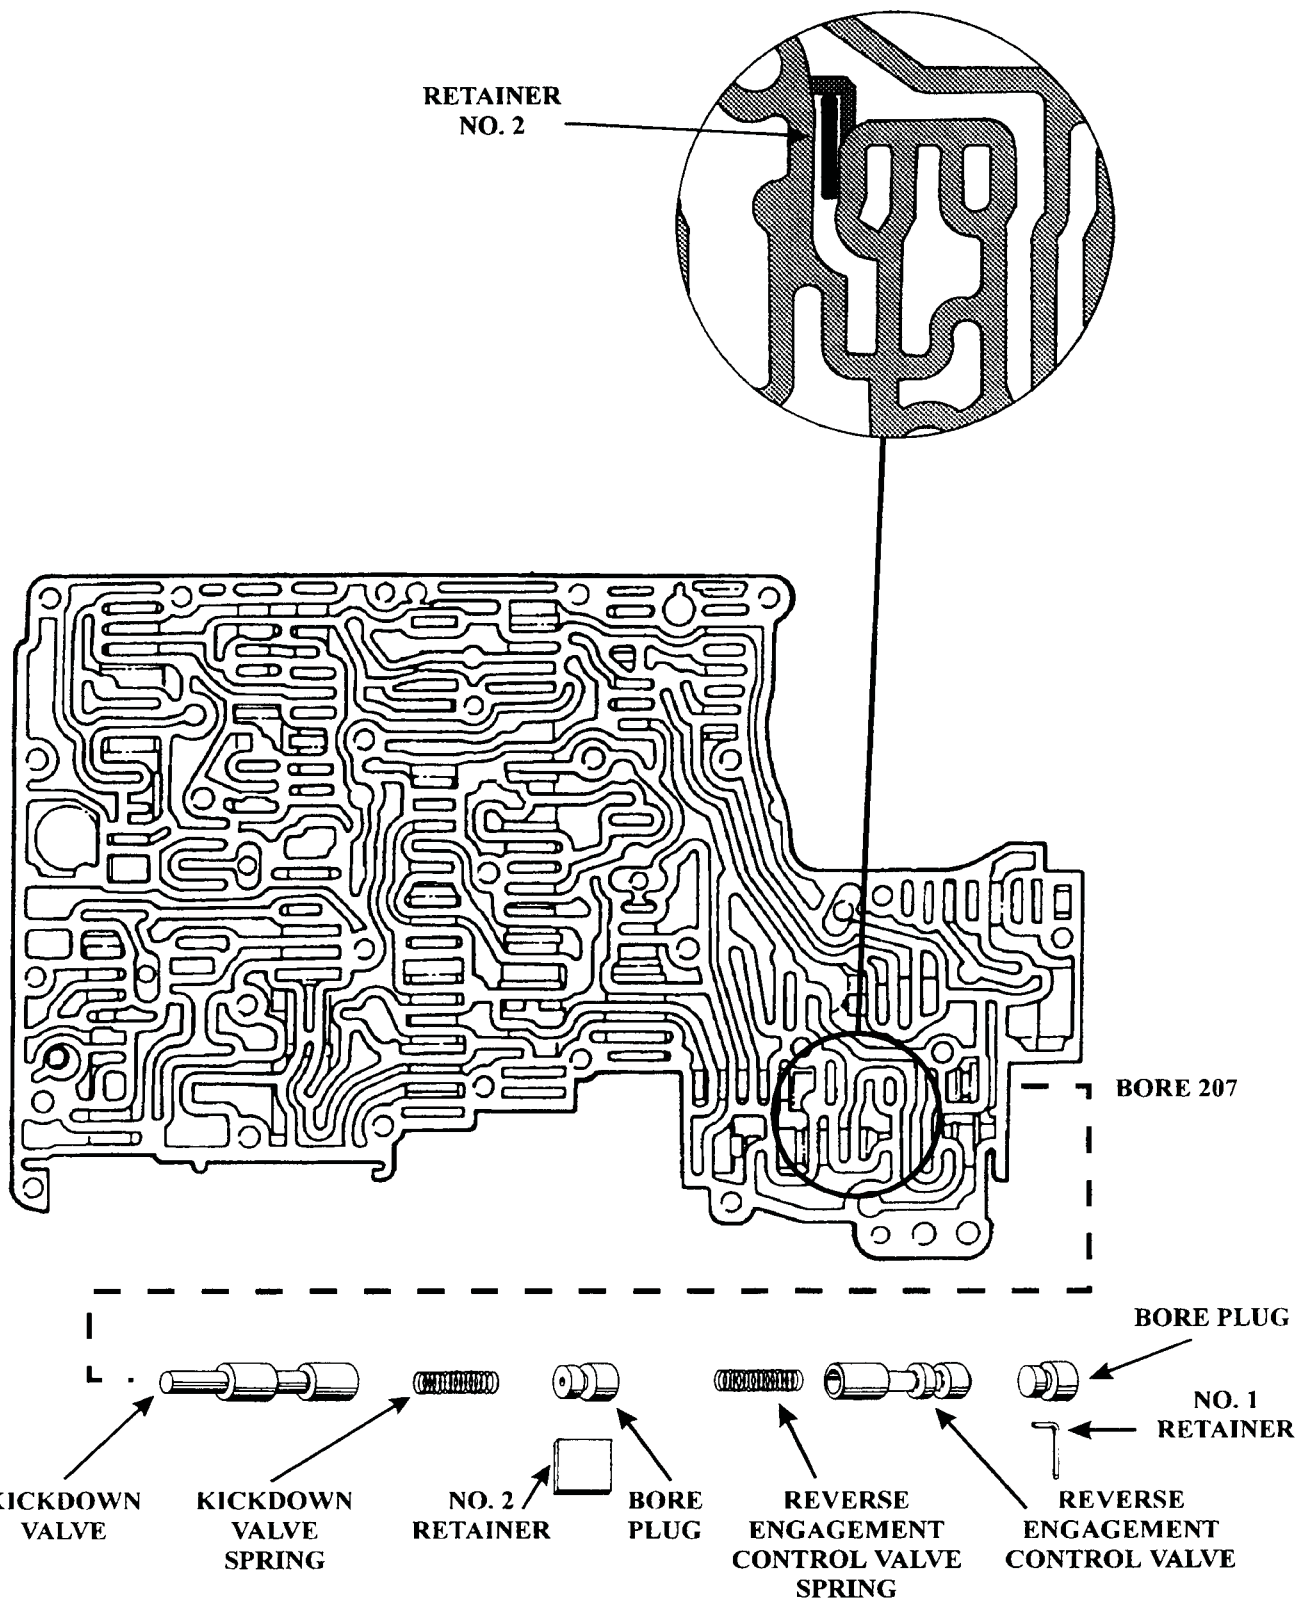
Figure 73

This is when the reverse engagement control valve was added to bore 207, as shown in Figure 73, and also shows the location of the No. 2 retainer in the valve body casting and the direction of the bore plugs. Figure 74 shows the "3 Hole" spacer plate that is required on valve bodies containing the reverse engagement control valve.

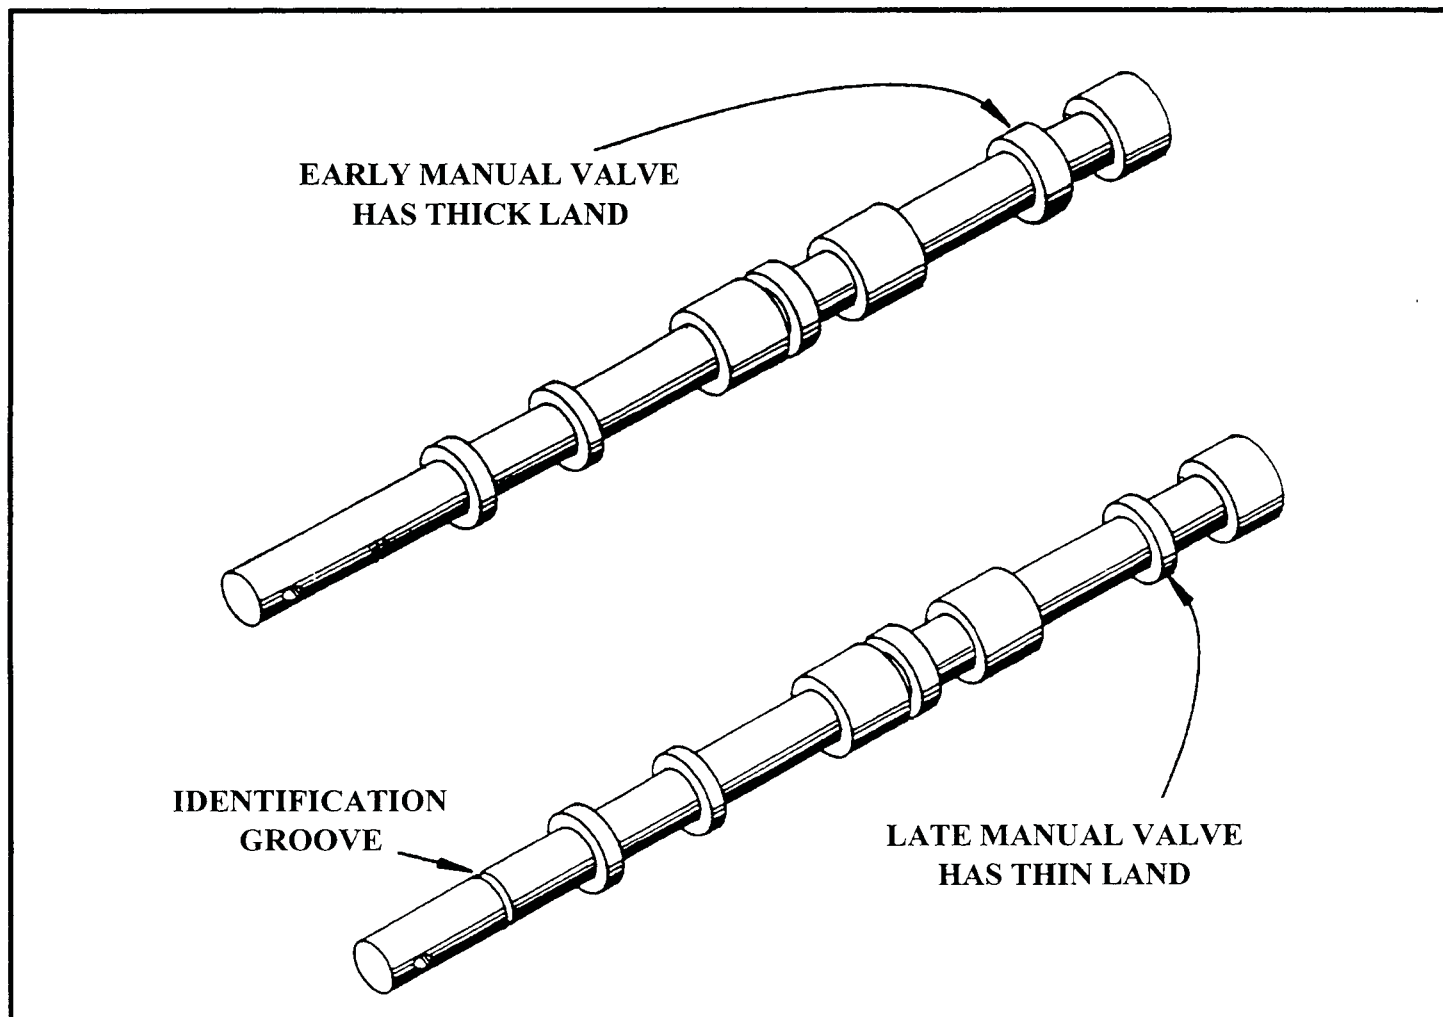
Figure 76

MANUAL VALVE - The 2nd design manual valve has a thinner land on it as shown in Figure 76, and is identified by a groove just behind the manual valve link hole.

The 2nd design manual valve will retro fit to all models and is highly recommended.

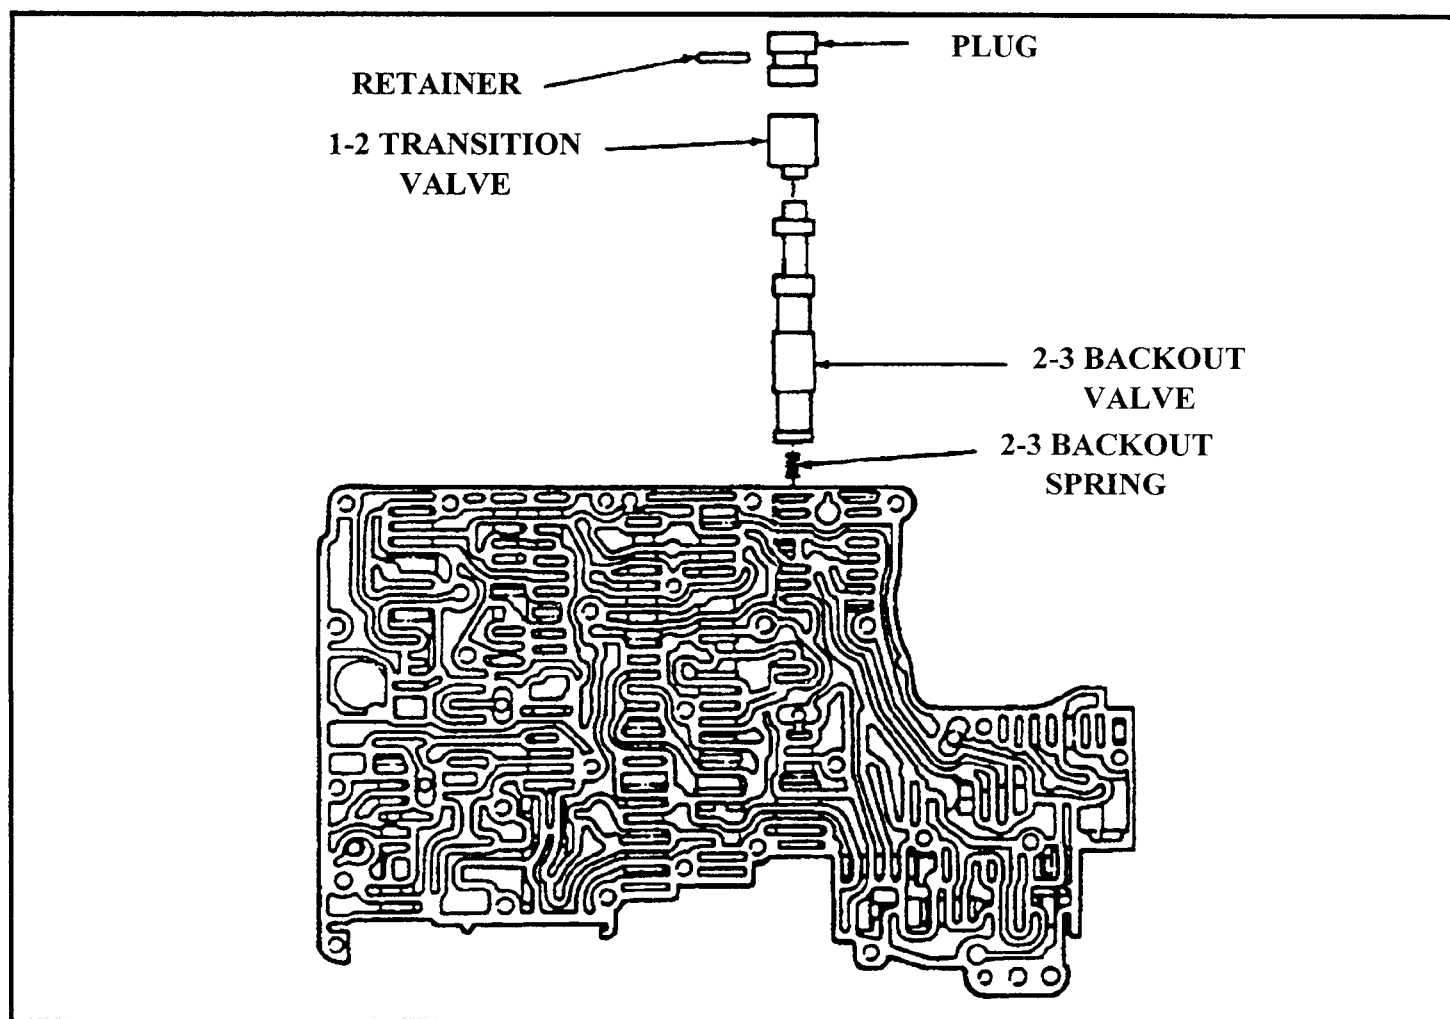
COMPLAINT: Some 1990-92 transmissions may exhibit a harsh 2-3 backout upshift under certain conditions. This may be better described as being harsh when releasing the accelerator pedal during the 2-3 upshift. This condition is most evident when operating the vehicle at high altitudes.

CAUSE: This is caused by the incorrect calibration of the 2-3 backout valve spring in the valve body.

CORRECTION: A new 2-3 backout valve spring is available from Ford that has a revised calibration. It is light blue in color. See Figure 77 for proper bore identification and spring location.

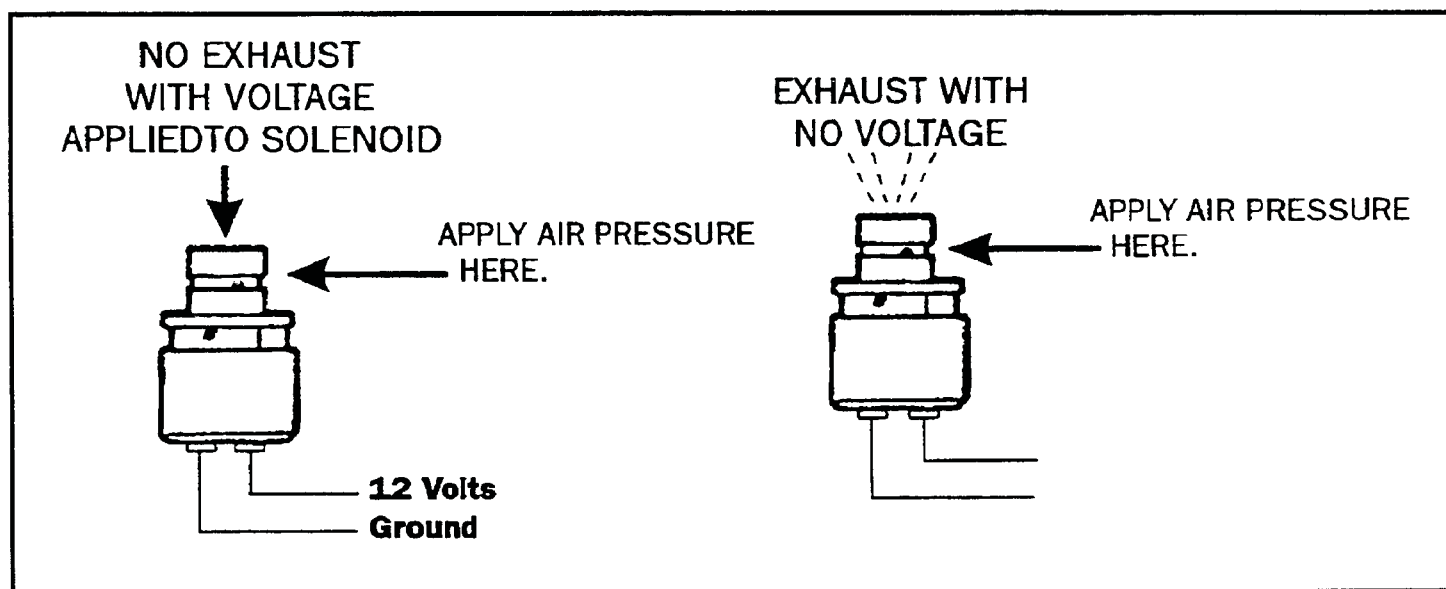
Figure 78

- CAUSE:**
- (1) The lock-up solenoid may not have been correctly bench checked during overhaul or when failure is suspected. This is due to confusion in printed material regarding air test procedures and ohms check procedures.
 - (2) The converter clutch shuttle spring is broken or collapsed
 - (3) The converter clutch TV modulator spring is not strong enough to shut off line pressure to the converter clutch shuttle valve during coastdown.

- (1) The proper air test procedure is shown in Figure 78. You must use no more than 70psi. when checking the lock-up solenoid or else the results will not be valid. Ohms check the solenoid across the two terminals. There should be 25 - 40 ohms of resistance across both terminals but no continuity to the solenoid body.
