A4LD UPDATE HANDBOOK INDEX

FORD A4LD

"UPDATE HANDBOOK"

Since the start of production in 1985, the FORD A4LD transmission has received many major engineering design changes. These design level changes have affected nearly every part used in the A4LD transmission.

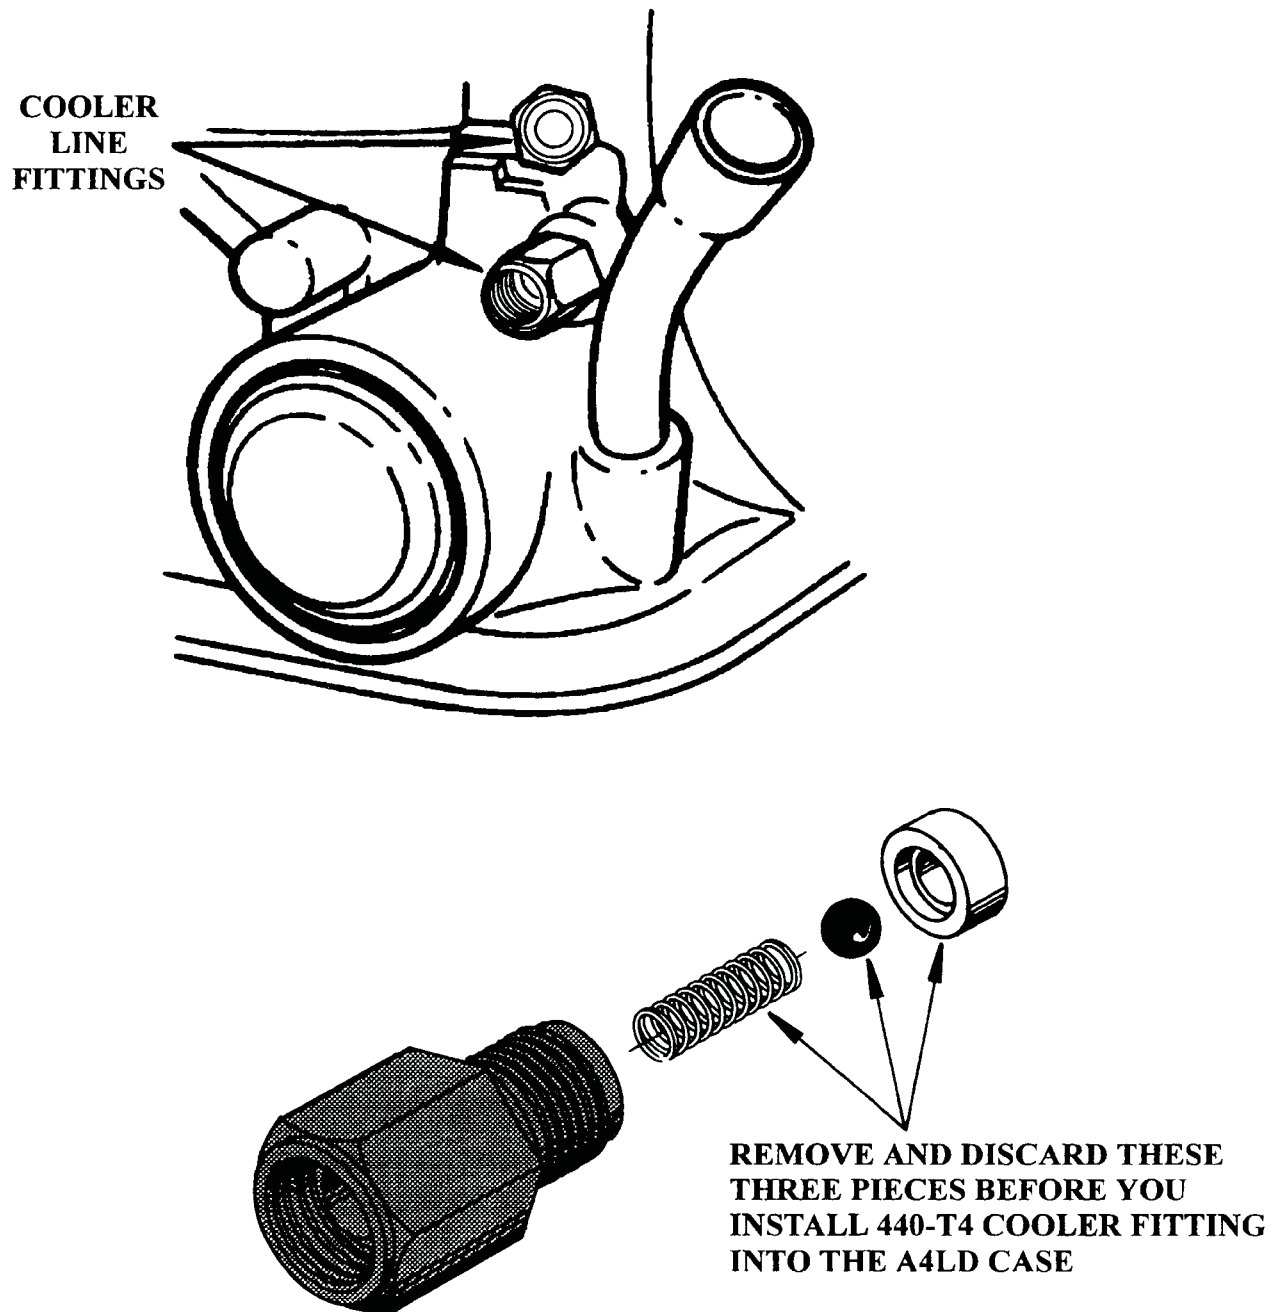
Figure 103

There are currently two different size cooler line fittings for the A4LD case. The cases for the small fittings (1/8" Pipe Thread) are no longer serviced by Ford Motor Co. There are adapters available from Ford, for installing the small cooler line fittings into a large thread case, and are available under OEM part number E7TZ-7D273-B.

However, the large black cooler line fitting from the THM 440-T4 transaxle will also fit in the A4LD large thread case, **but you must remove and discard the ball and spring from the 440 fitting.** (See Figure 103).
