FORD E4OD "UPDATE HANDBOOK"

*Updated
April, 2004*

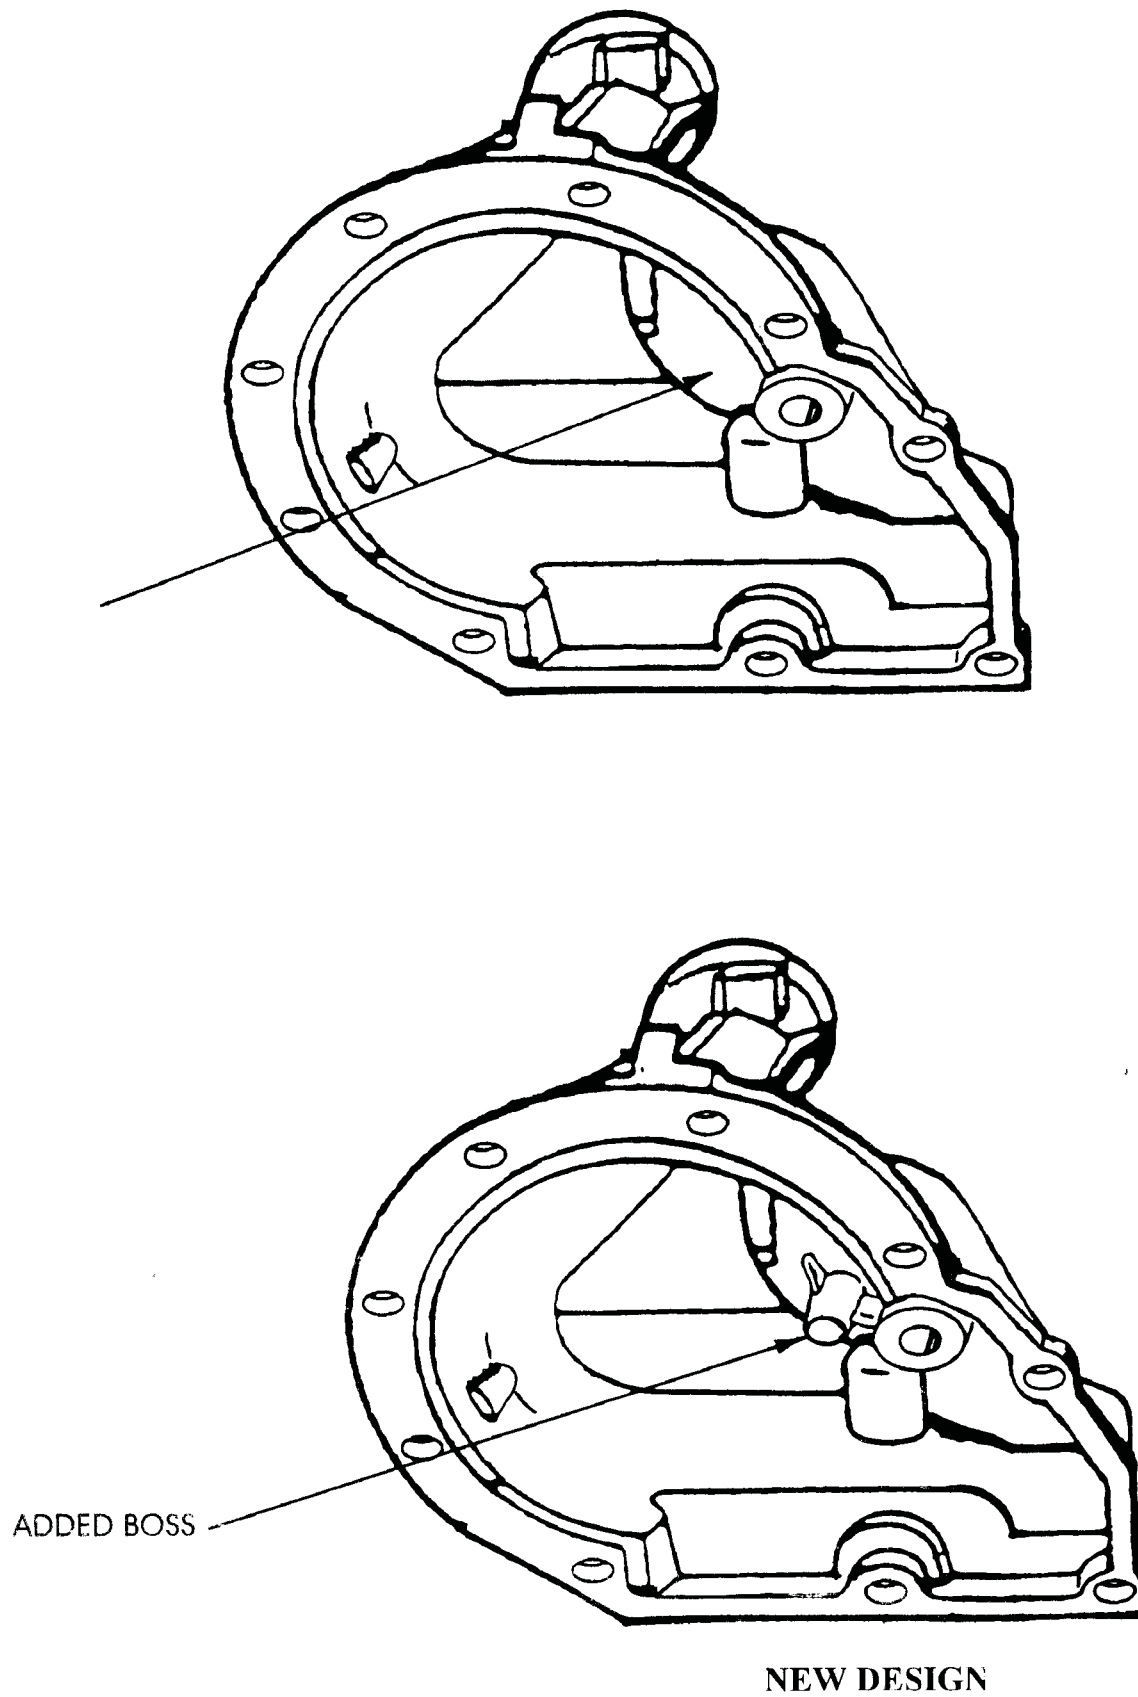
Figure 24
AUTOMATIC TRANSMISSION SERVICE GROUP

CAUSE: The cause may be a broken snap ring on the output shaft, allowing the parking gear to move rearward, and then the parking pawl cannot engage into the parking gear. Refer to Figure 22.

CORRECTION: There is now available a new service package, under OEM part number F0TZ-7A040-A, that includes a new design extension housing with a new "Boss" cast into it to prevent the parking gear from moving rearward in case the snap ring breaks (See Figure 24). The service package also includes a new "*high strength*" snap ring, and a snap ring installation aid, as shown in Figure 25.

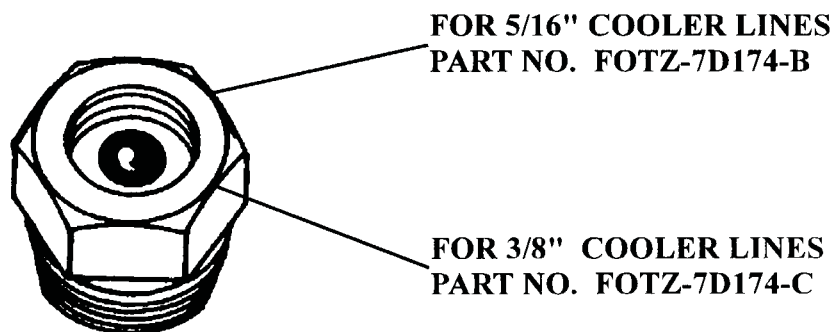
Figure 31

TRANSMISSION CASE COOLER LINE FITTING THAT INCORPORATES CHECK VALVE

In-Line Check Valve Service Package	FOTZ-7D174-A
Cooler Fitting For 5/16" Cooler Lines (Late 90-Up)	FOTZ-7D174-B
Cooler Fitting For 3/8" Cooler Lines (Late 90-Up)	FOTZ-7D174-C

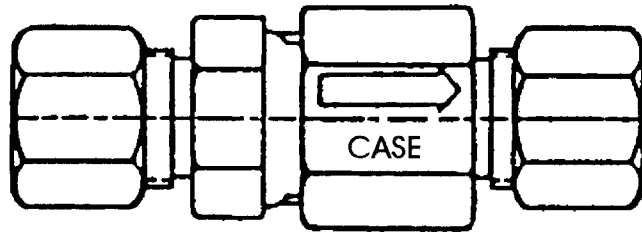
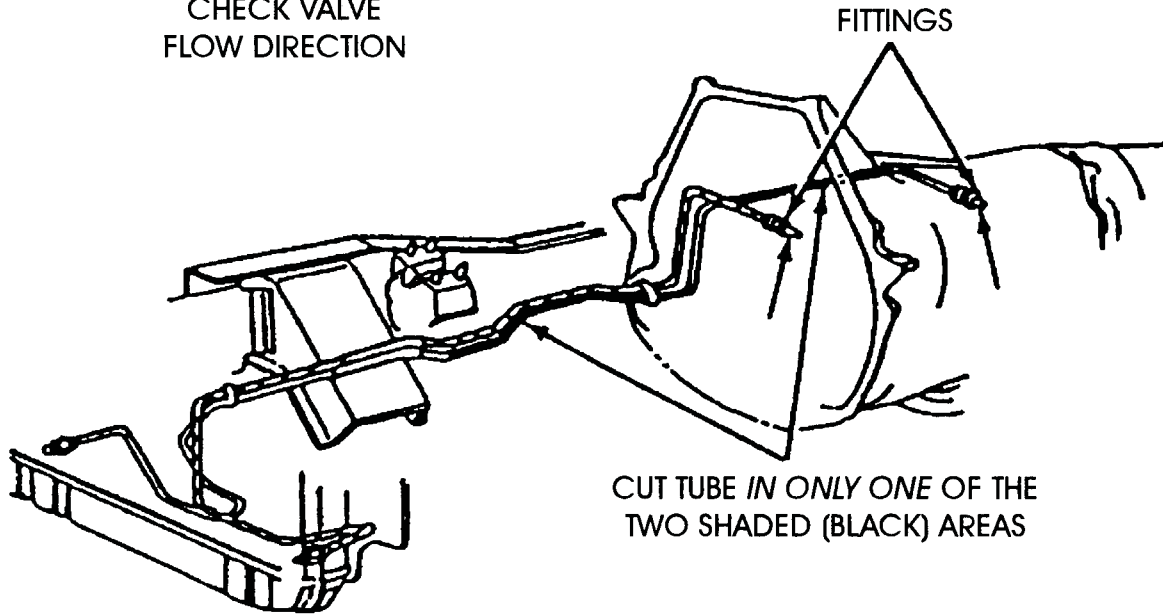
"IN-LINE" COOLER CHECK VALVE FOR SERVICE PART NUMBER FOTZ-7D174-A

CHECK VALVE
FLOW DIRECTION

CUT TUBE IN ONLY ONE OF THE
TWO SHADED (BLACK) AREAS

INSTALL IN-LINE CHECK VALVE
IN COOLER LINE GOING TO REAR
TRANSMISSION CASE FITTING IN THE
DIRECTION OF ARROW SHOWN ABOVE

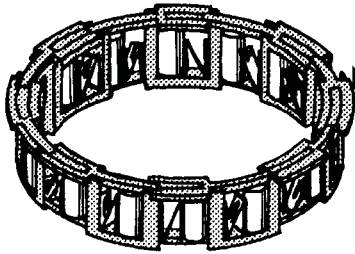
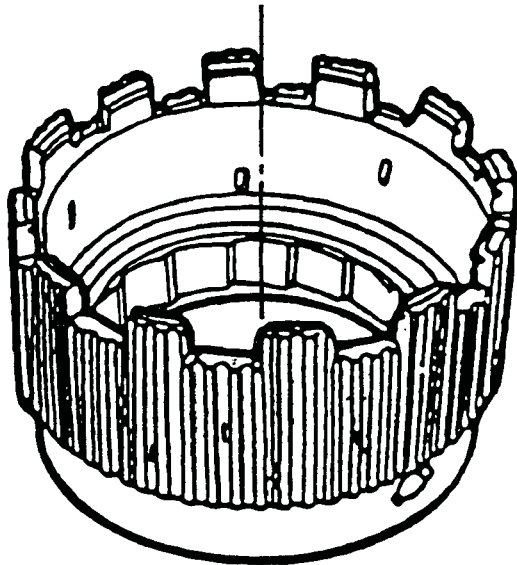
***"INCORRECTLY"
INSTALLED***

NOTE TABS ON
TOP OUTER EDGE

CAUTION

IF THE ROLLER CLUTCH IS INSTALLED IN
THIS DIRECTION, THE REVERSE HUB WILL
FREEWHEEL IN BOTH DIRECTIONS.

- (1) Remove the upper snap ring, brass bushing, roller clutch assembly, and the lower snap ring, as shown in Figure 35. **Discard all parts removed!**
- (2) Install the New Plastic Cage Low Roller Clutch Assembly through the **rear** side of the Reverse Clutch Hub, with the tabs on the rear edge. Seat the Low Roller Clutch into the Reverse Clutch Hub, and rotate clockwise to seat rollers and lock tabs in place. Refer to Figure 36 for proper installation.

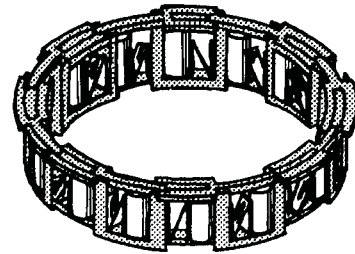
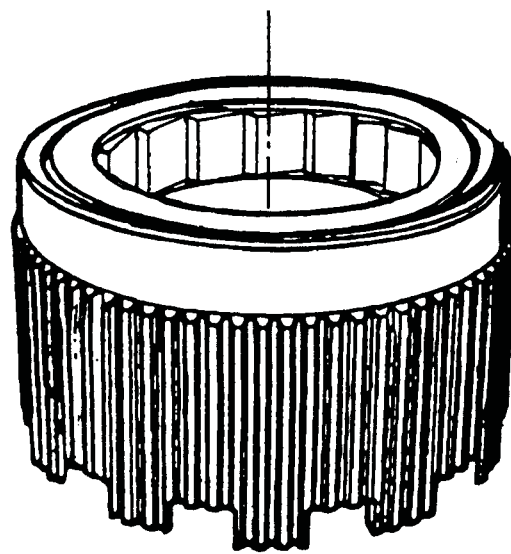
Figure 36

***"CORRECT"
INSTALLATION***

NOTE TABS ON
TOP OUTER EDGE

DISCARD BOTH SNAP RINGS. THEY ARE NOT
USED WITH THE PLASTIC ROLLER CLUTCH

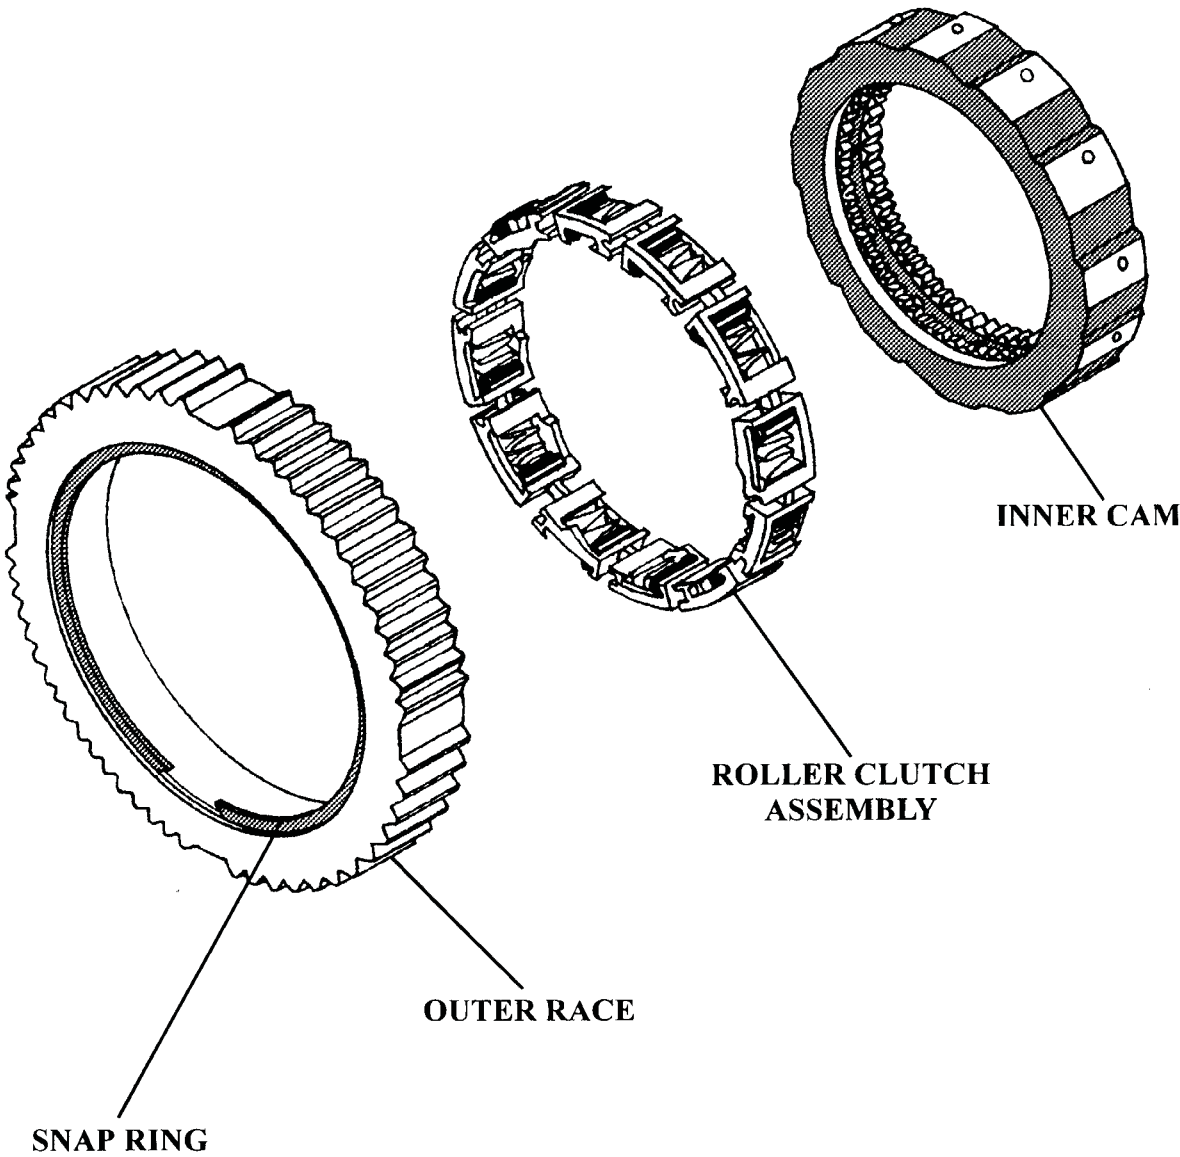
Figure 37

**OVERDRIVE ROLLER CLUTCH ASSEMBLY
PART NUMBER F5TZ-7A089-A**

The previous design Overdrive Sprag (E9TZ-7A089-A) **is no longer available**. The previous part number will now supercede to one of the part numbers listed below under "Service Information", as there is one number for F-Super Duty and Motorhomes and another number for all others. The new design "Overdrive Roller Clutch Service Kit" will retro-fit back on **all** previous models (See Figure 37).

Overdrive Roller Clutch Service Kit, (All Except Super Duty and Motorhome) F5TZ-7A089-A
Overdrive Roller Clutch Service Kit, (7.5L F-Super Duty and Motorhome) F4TZ-7A089-A

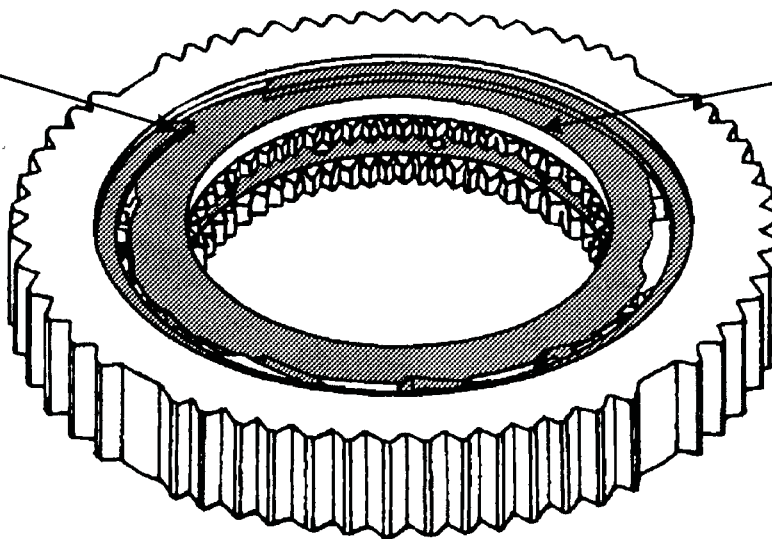
Figure 41

ROTATE THE OUTER RACE CLOCKWISE UNTIL FULLY SEATED

SNAP RING
FACING UP

UNDERCUT
FACING UP

"INNER RACE MUST FREEWHEEL COUNTERCLOCKWISE"

- (1) Place the new inner cam on a flat work surface with the "Undercut" on the inside diameter facing **up**, as shown in Figure 38.
- (2) Install the overdrive roller clutch assembly over the inner cam, **with the 9 locking tabs on the inner diameter facing down, and the three upper locking tabs facing up**, as shown in Figure 38.
- (3) Push the overdrive roller clutch assembly all the way down, as shown in Figure 39.
- (4) Install the snap ring into the groove in the outer race, as shown in Figure 40.
- (5) Install the outer race assembly over the overdrive roller clutch, by holding the inner cam and rotating the outer race in a clockwise direction, until fully seated, as shown in Figure 41.

NOTE: *With the outer race snap ring facing up, and the inner cam "undercut" facing up, the inner cam should freewheel in a counter-clockwise direction and lock clockwise, while holding the outer race. Refer to Figure 41.*

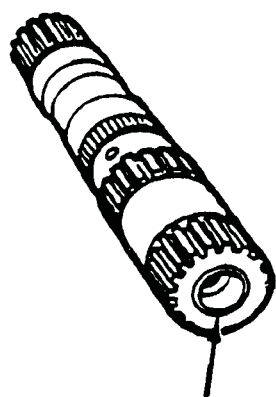
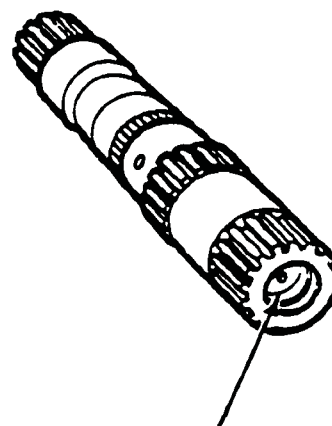
THE ORIFICE CUP PLUG MUST BE
INSTALLED BELOW THIS SURFACE

REMOVE THE
ORIGINAL BUSHING

INSTALL THE ORIFICE CUP
PLUG FROM THE SERVICE KIT

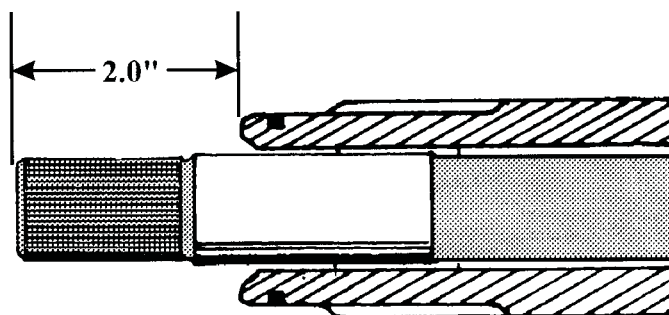
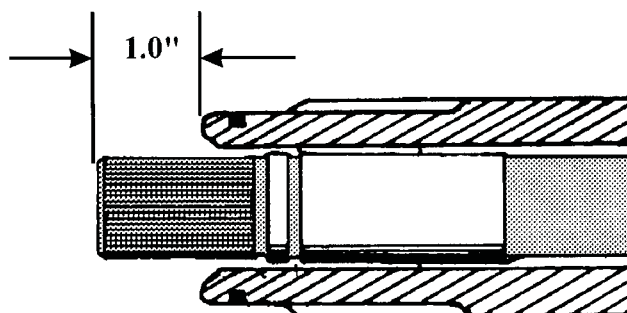
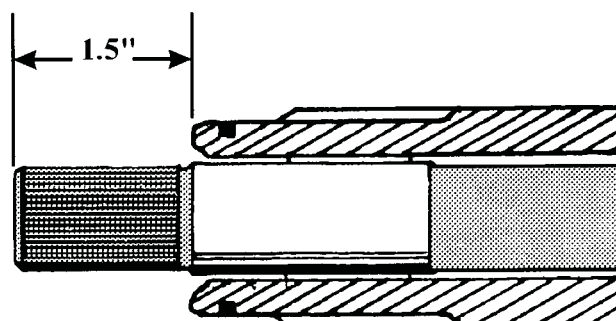
Figure 49

"INCORRECT"

PREVIOUS (LONG) INPUT SHAFT USED
WITH NEW DESIGN OVERDRIVE CARRIER

NEW DESIGN (SHORT) INPUT SHAFT USED
WITH PREVIOUS DESIGN OVERDRIVE CARRIER

"CORRECT USAGE"

THE INPUT SHAFT MUST EXTEND 1.5" PAST THE END OF THE PUMP STATOR
IF THE CORRECT INPUT SHAFT AND OVERDRIVE CARRIER WERE USED

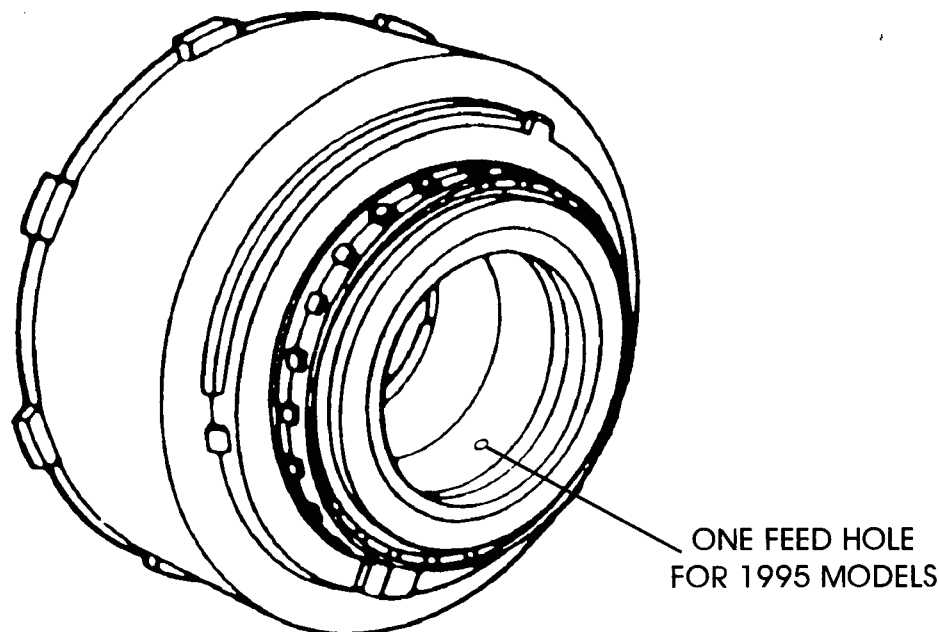
Figure 51

CHANGE: Beginning at the start of production for the 1995 model year, all E4OD transmissions were built with a revised Direct Clutch Housing (Intermediate Brake Drum) as shown in Figure 51.

- (1) DIRECT CLUTCH HOUSING - 1995 models now have only **one** direct clutch apply pressure feed hole, instead of the **two** feed holes found in previous models (See Figure 51).

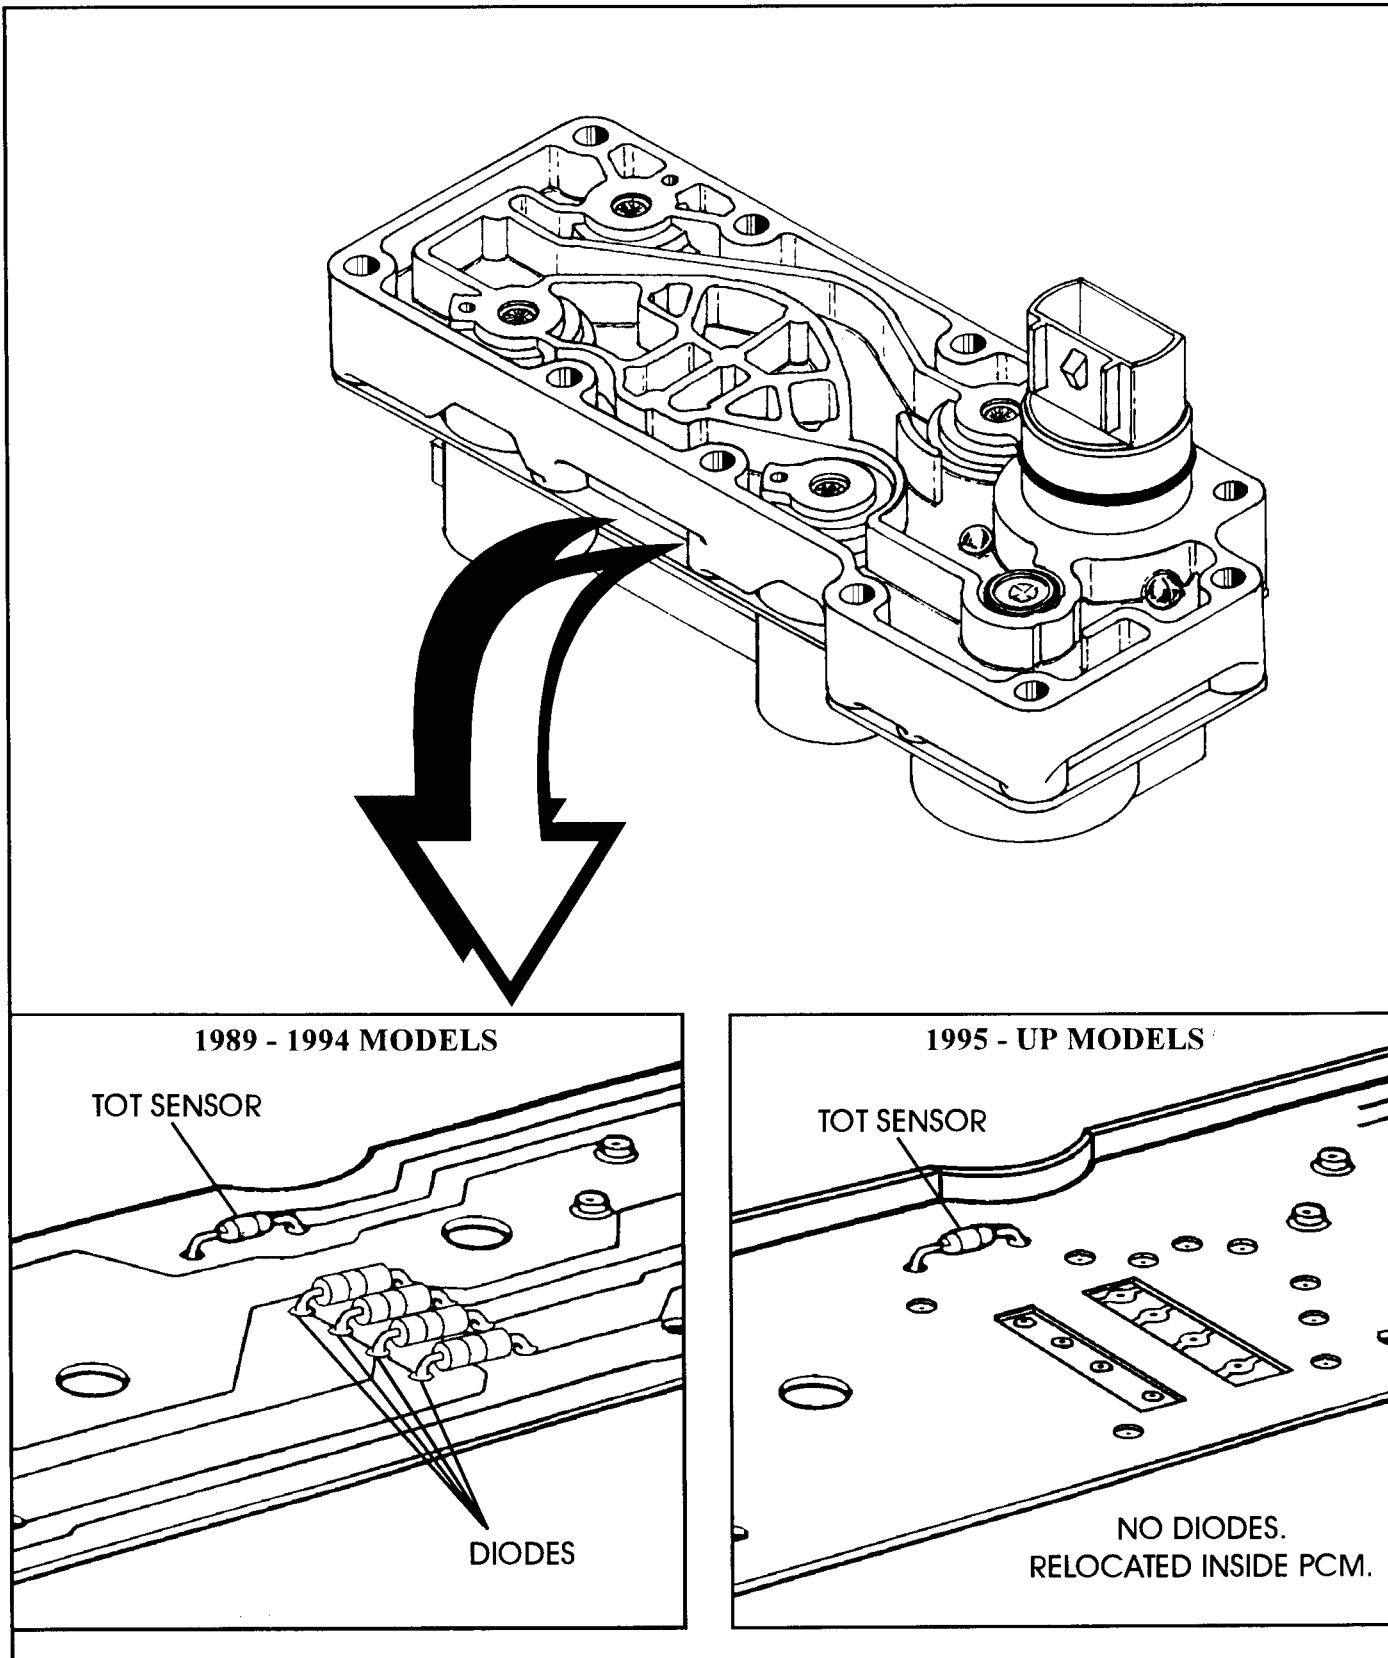
Figure 54

CHANGE: Beginning at the start of production for 1995, all models of the E4OD transmission were produced using a new design solenoid pack, that will not interchange with previous models, as the internal diodes have been eliminated and put into the PCM (See Figure 54)

They will not interchange because in 1995 models the diodes for the solenoids were moved out of the solenoid pack and placed into the PCM (See Figure 54).

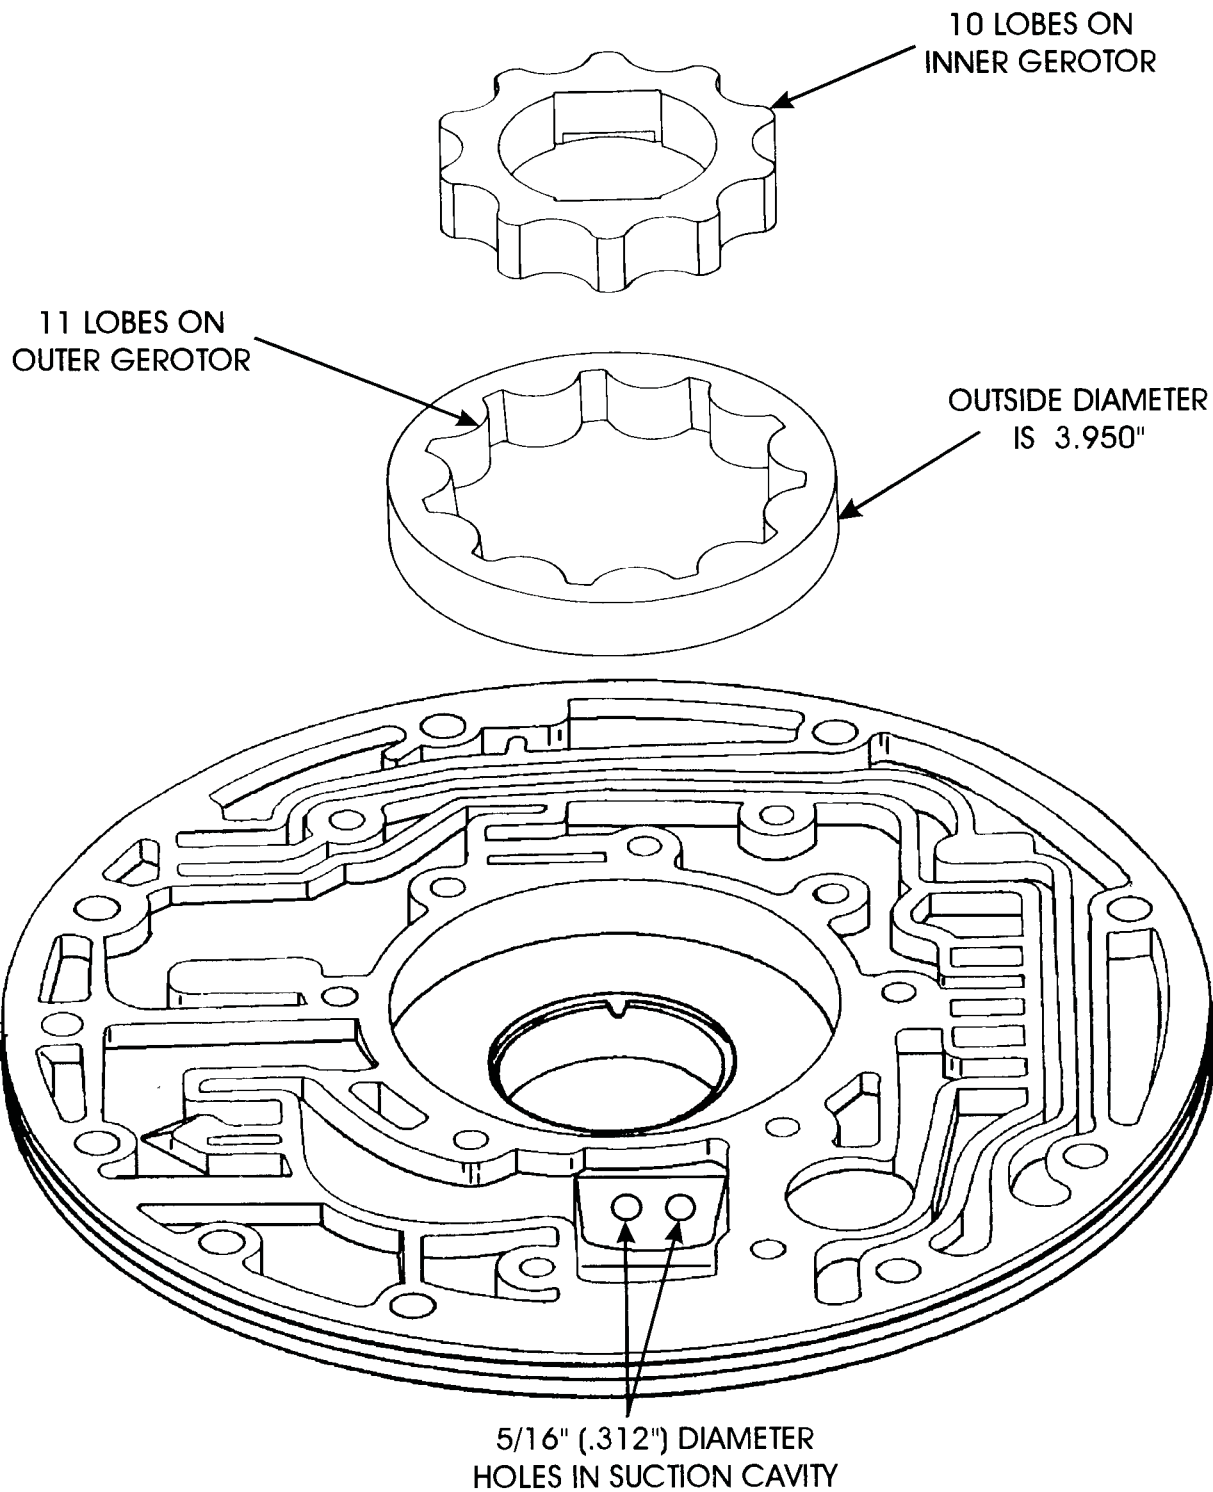
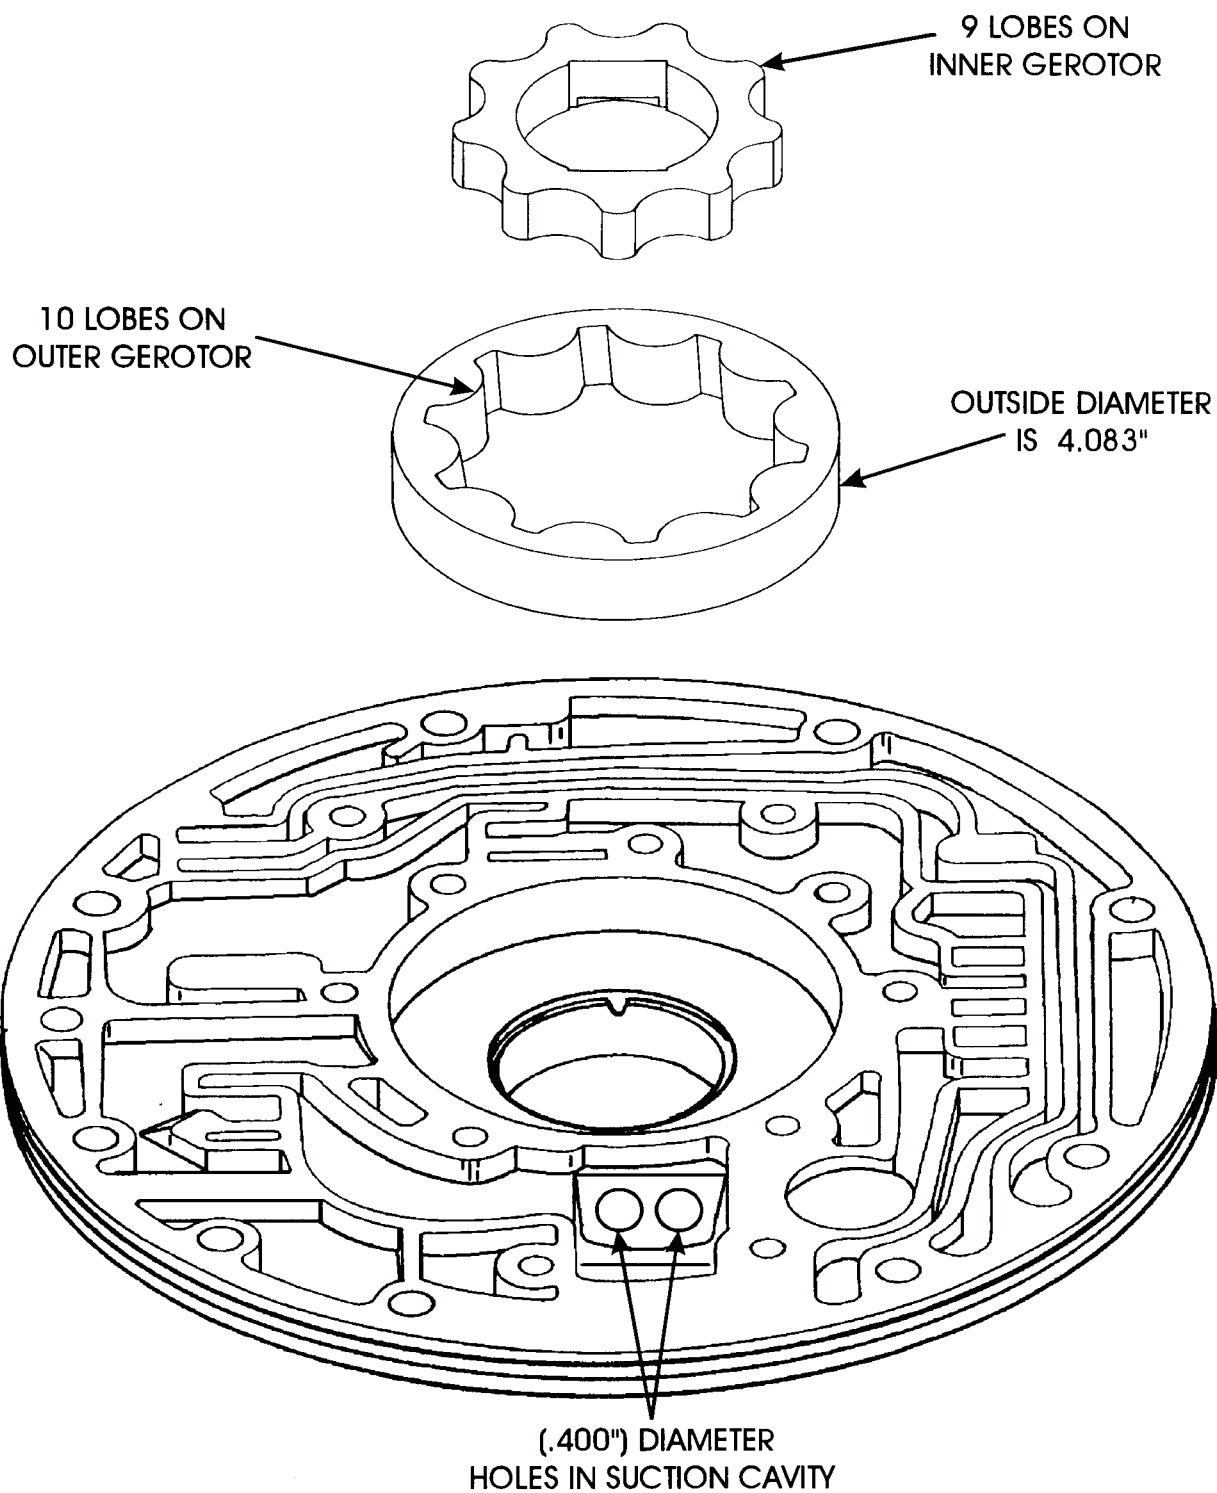
- (1) **FRONT PUMP BODY** - Gerotor bore has an increased diameter to accommodate the new design level outer gerotor. Previous outer gerotor diameter was 3.950" and the new design level outer gerotor diameter is 4.083". Refer to Figures 55 and 56. Also, the two holes in the suction cavity were increased from .312" to .400", as shown in Figures 55 and 56.
Another way to identify the new pump body is with the "Rough Forging Number" F5TP-7A105-AA, and is found on the front seal side of the pump body.
All of the oil passages in the new design Front Pump Body remained the same as previous years and are identified in Figure 58.

- (2) **OUTER GEROTOR** - The lobes on the Outer Gerotor changed from the previous 11 lobes to 10 lobes on the new design, to accommodate the changes on the inner gerotor. The diameter of the Outer Gerotor also changed from 3.950" to 4.083". Refer to Figures 55 and 56.
The changes on both the inner and outer gerotor increased the cavity between the gerotors for increased pump volume, as shown in Figure 57.

- (1) The new design level Front Pump Assembly will retro-fit back to all previous models, when used as an assembly, and is recommended for all rebuilds. The new design Front Pump Assembly is available under OEM part number F5TZ-7A103-A.
- (2) *The new design level and previous design level gerotors will not interchange in any way.*

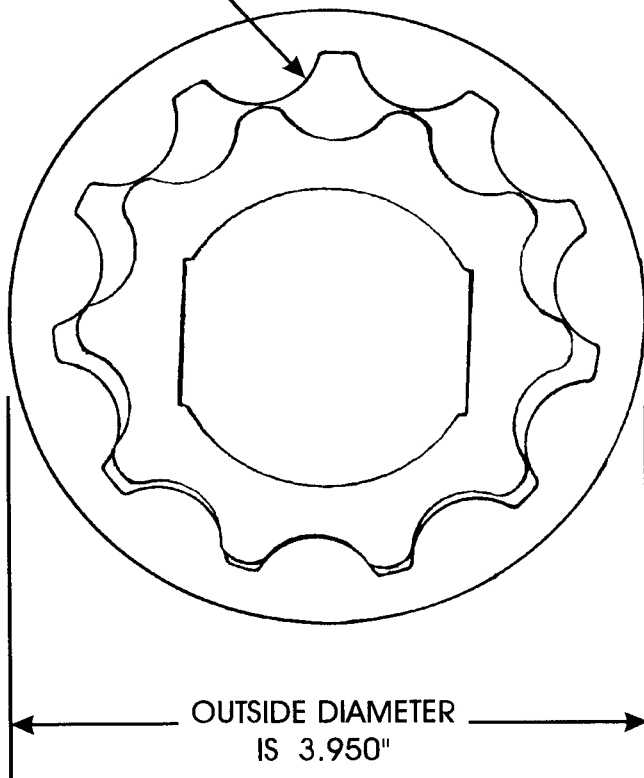
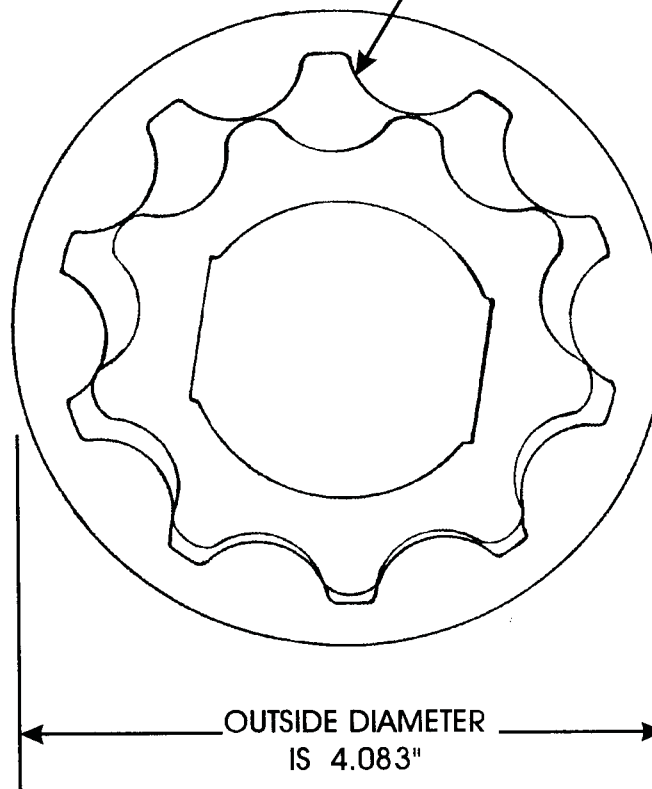
Figure 57

10 LOBES ON INNER GEAR
11 LOBES ON OUTER GEAR

SMALLER CAVITY THAN
NEW DESIGN PUMP

9 LOBES ON INNER GEAR
10 LOBES ON OUTER GEAR

LARGER CAVITY BETWEEN GEARS
FOR INCREASED PUMP VOLUME

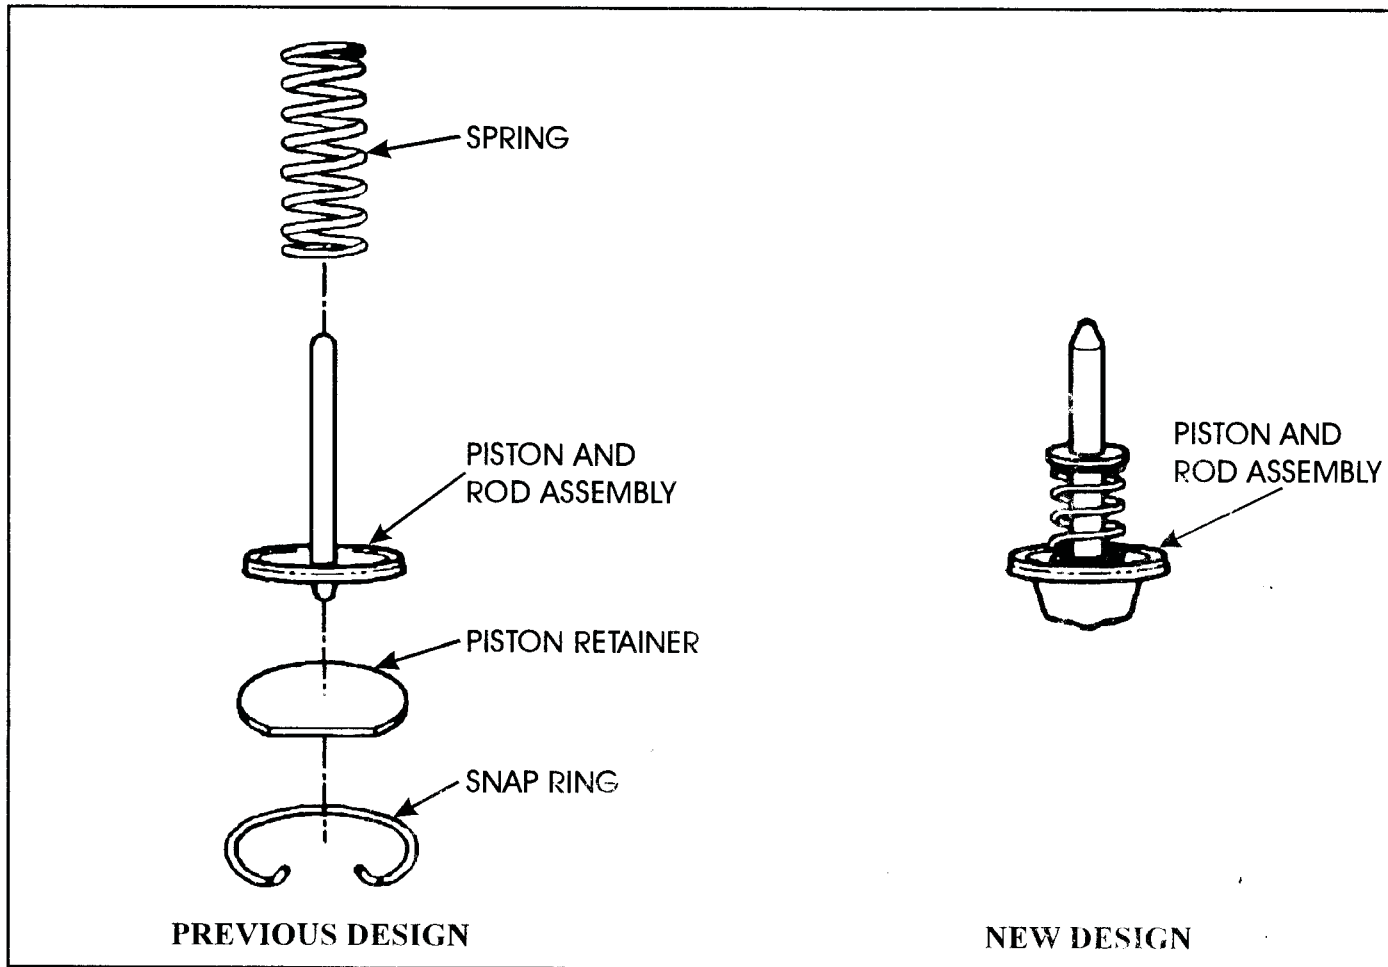
Figure 61

CHANGE: Beginning on August 8, 1995, all 1996 model E4OD transmissions were produced with a new design Intermediate Band Apply Servo Assembly (See Figure 61).

- (1) INTERMEDIATE SERVO PISTON - Total change in design, as shown in Figure 61.
- (2) SERVO PISTON RETAINER - Eliminated, as shown in Figure 61.
- (3) RETAINING SNAP RING - Eliminated, as shown in Figure 61.
- (4) TRANSMISSION CASE - Snap ring groove in the case piston bore was eliminated, as it was no longer need (See Figure 62).

Intermediate Servo Piston Assembly (New Design) F6TZ-7D021-A

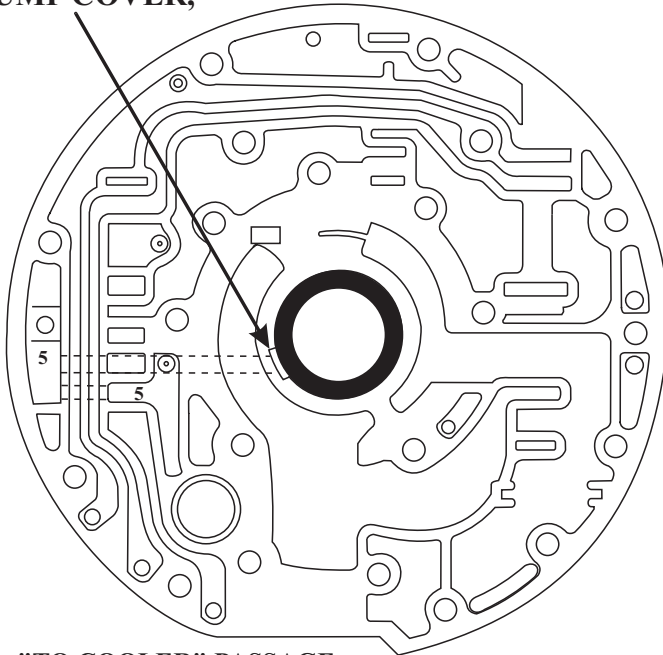
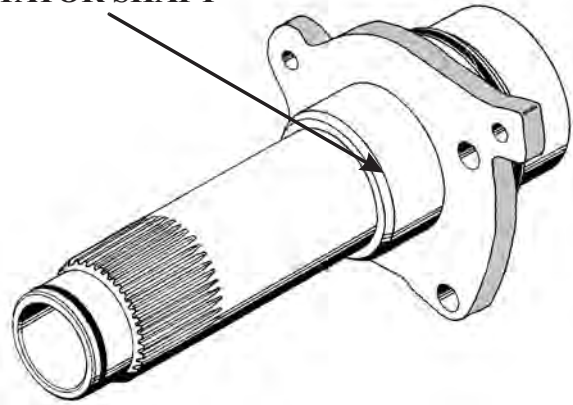
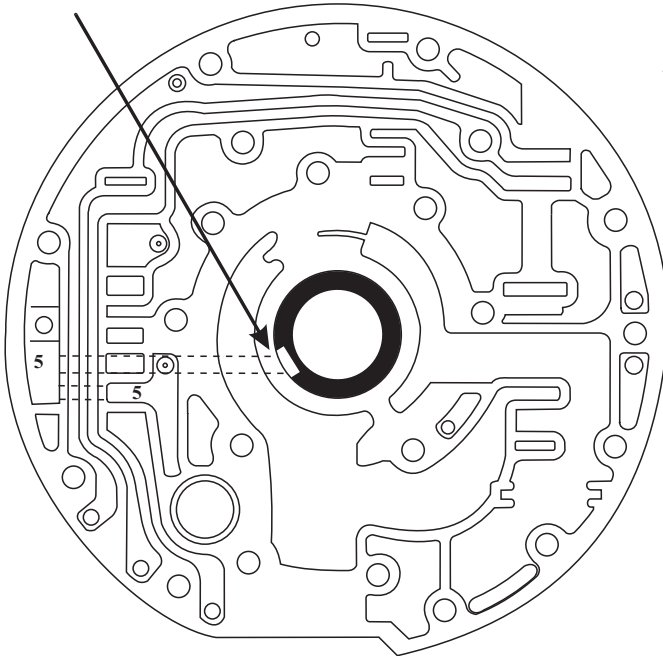
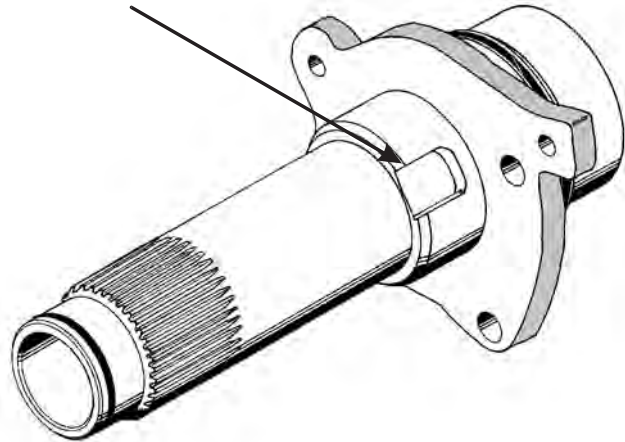
Figure 67
AUTOMATIC TRANSMISSION SERVICE GROUP

If you install a 89-94 stator shaft *without notch*, into a 95-96 pump cover *without notch* -- You will create a *totally blocked "To Cooler" passage* in the pump cover. Refer to Figure 67.

**89-94 PUMP STATOR (WITHOUT NOTCH)
IN 89-94 PUMP COVER (WITH NOTCH)**

**NOTCH IN
PUMP COVER,**

**NO NOTCH IN
STATOR SHAFT**

"CORRECT" ASSEMBLY

**95-96 PUMP STATOR (WITH NOTCH)
IN 95-96 PUMP COVER (WITHOUT NOTCH)**

**NO NOTCH IN
PUMP COVER,**

**WITH NOTCH IN
STATOR SHAFT**

89-94 Model pump cover *with notch*, **MUST** be used with the stator shaft *without notch*. Refer to Figure 67.

95-96 Model pump cover *without notch*, **MUST** be used with the stator shaft *with notch*. Refer to Figure 67.

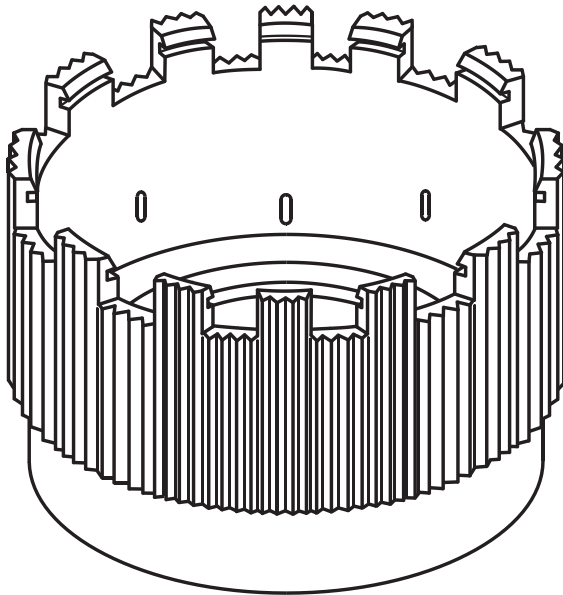
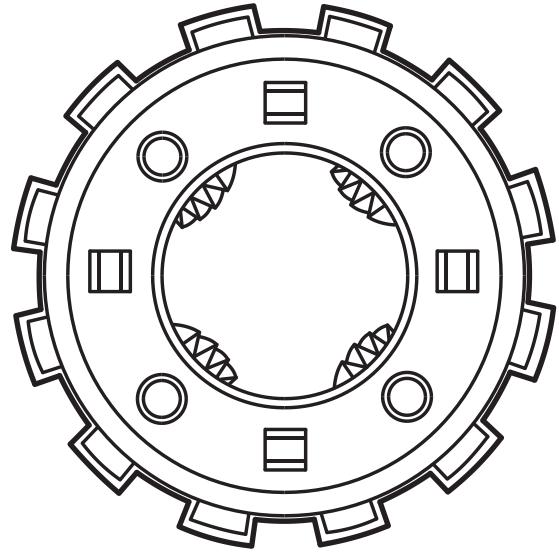
Figure 73

- (5) REAR PLANETARY CARRIER - New design level has narrow teeth on the outside diameter instead of the previous wide teeth, to accommodate the new design reverse clutch hub. Refer to Figures 73 and 74.

1989-1996 DESIGN LEVEL REVERSE CLUTCH HUB AND REAR PLANET ASSEMBLY

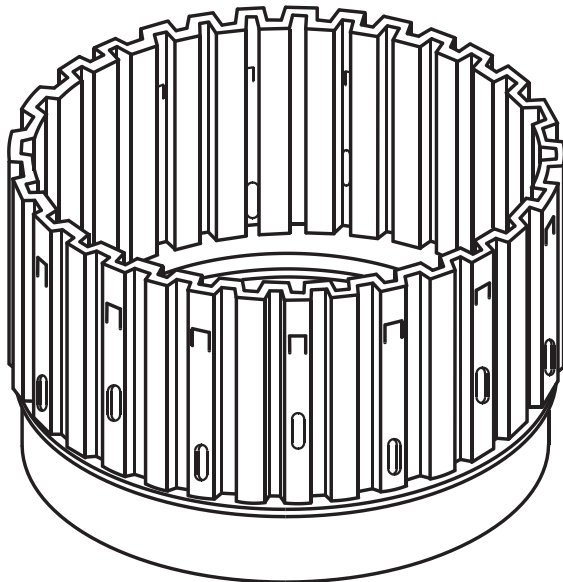
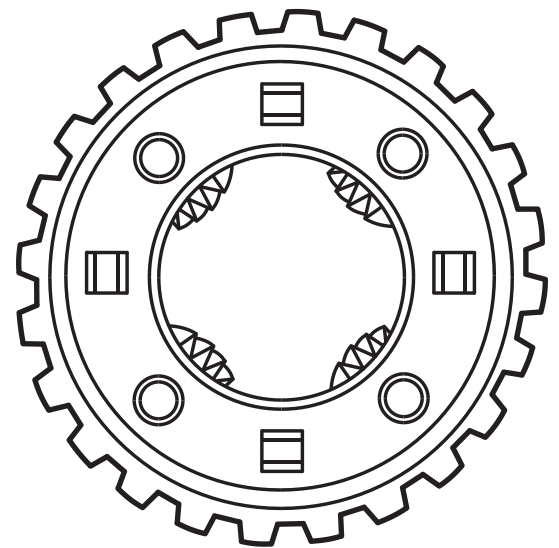
Figure 74

1997-UP DESIGN LEVEL REVERSE CLUTCH HUB AND REAR PLANET ASSEMBLY

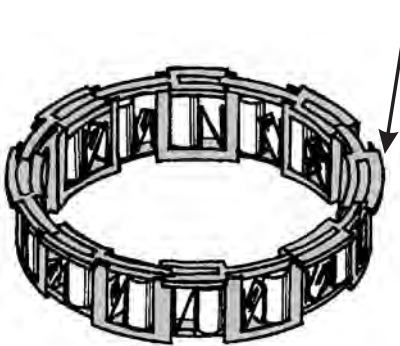
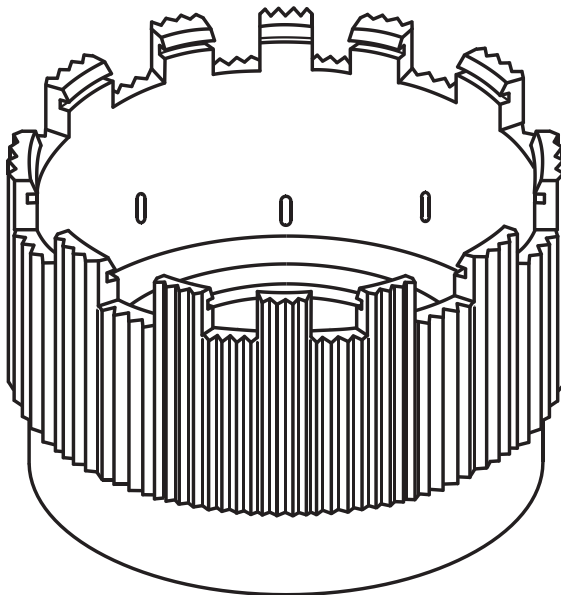
"INCORRECTLY" INSTALLED

*NOTE TABS ON
TOP OUTER EDGE*

CAUTION

IF THE ROLLER CLUTCH IS INSTALLED IN THIS DIRECTION, THE REVERSE HUB WILL FREEWHEEL IN BOTH DIRECTIONS.

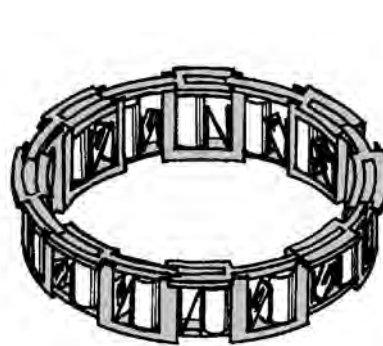
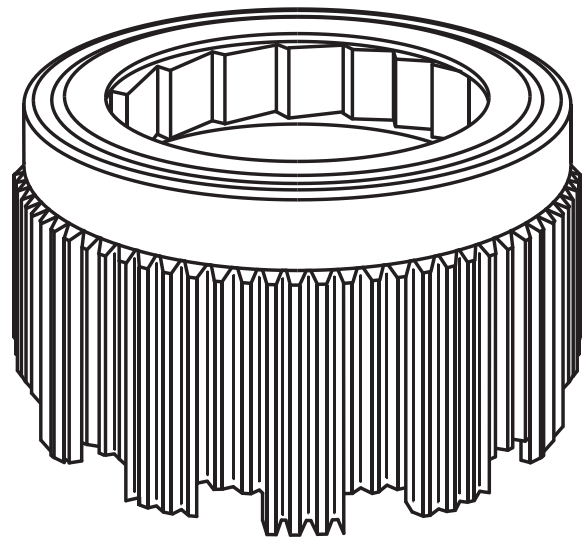
"CORRECT" INSTALLATION

*NOTE TABS ON
TOP OUTER EDGE*

DISCARD BOTH SNAP RINGS. THEY ARE NOT USED WITH THE PLASTIC ROLLER CLUTCH

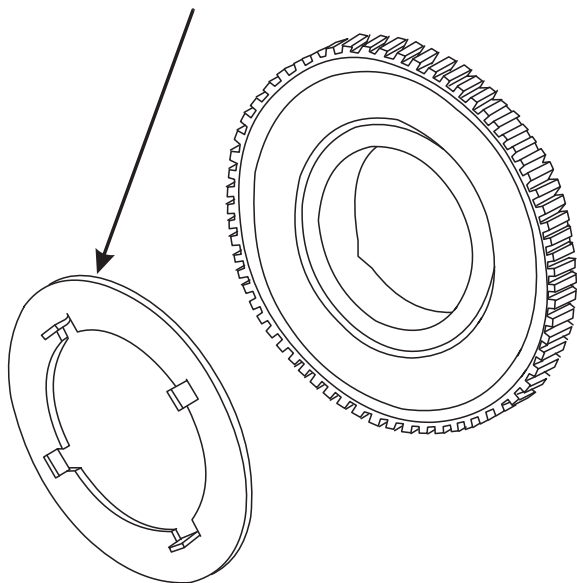
EARLY FORWARD CLUTCH RING GEAR HUB

1989-1996 THRUST WASHER
PART NUMBER E9TZ-7A166-A
(No Longer Available From Ford)

1989-1996 RING GEAR HUB
.030" FROM WASHER SURFACE TO EDGE AS SHOWN,
AND *REQUIRES* THRUST WASHER SHOWN ABOVE.
(NO LONGER AVAILABLE FROM FORD)

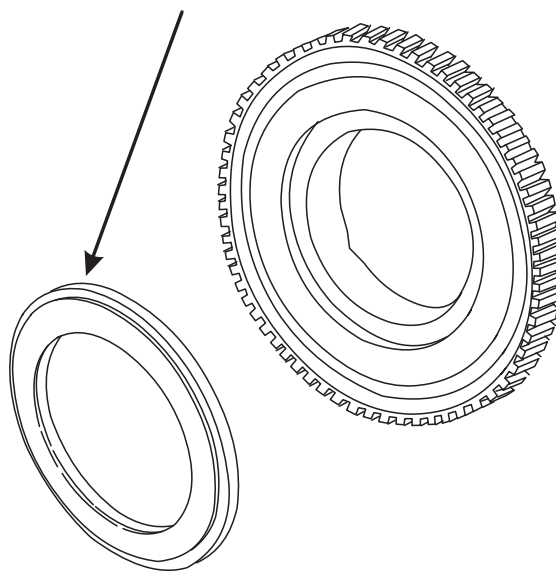
Figure 76

- (1) RING GEAR HUB - Now cut deeper on the side that goes against the forward planetary carrier by .100", to accommodate the new design bearing that replaced the thrust washer. Refer to Figure 76.
- (2) THRUST BEARING - Replaces the previous four tang thrust washer for improved durability. Refer to Figure 76.
- (3) FORWARD PLANETARY - Thrust washer slots have been eliminated, as shown in Figure 77, and there is an updated part number from Ford Motor Company, that is shown in Service Information below.

- (2) New design Thrust Bearing must be used only with the new design Ring Gear Hub. It cannot be used on any previous models (See Figure 76).
- (3) There is also a new part number for the Forward Planetary Carrier, with no dimensional changes, and will retro-fit back on all previous models, but, ***some*** of the new part number carriers will not be cut to accept the four tang thrust washer. In that case you will have to install the new thrust bearing, which means you will also have to replace the ring gear hub with the new design level (See Figure 77).

LATE FORWARD CLUTCH RING GEAR HUB

1997-UP THRUST BEARING
PART NUMBER F81Z-7A166-AA
(Now Available From Ford)

1997-UP RING GEAR HUB
.130" FROM WASHER SURFACE TO EDGE AS SHOWN,
AND *REQUIRES* THRUST BEARING SHOWN ABOVE.
RING GEAR HUB PART NUMBER F7TZ-7B067-AB.

When ordering the Forward Clutch Ring Gear Hub from Ford Motor Co, it will automatically supercede to the newest Service Package part number F7TZ-7B067-AB, and will come with the new design thrust bearing. When used together these parts will retro-fit back to 1989.
