FORD E4OD "UPDATE HANDBOOK"

*Updated
April, 2004*

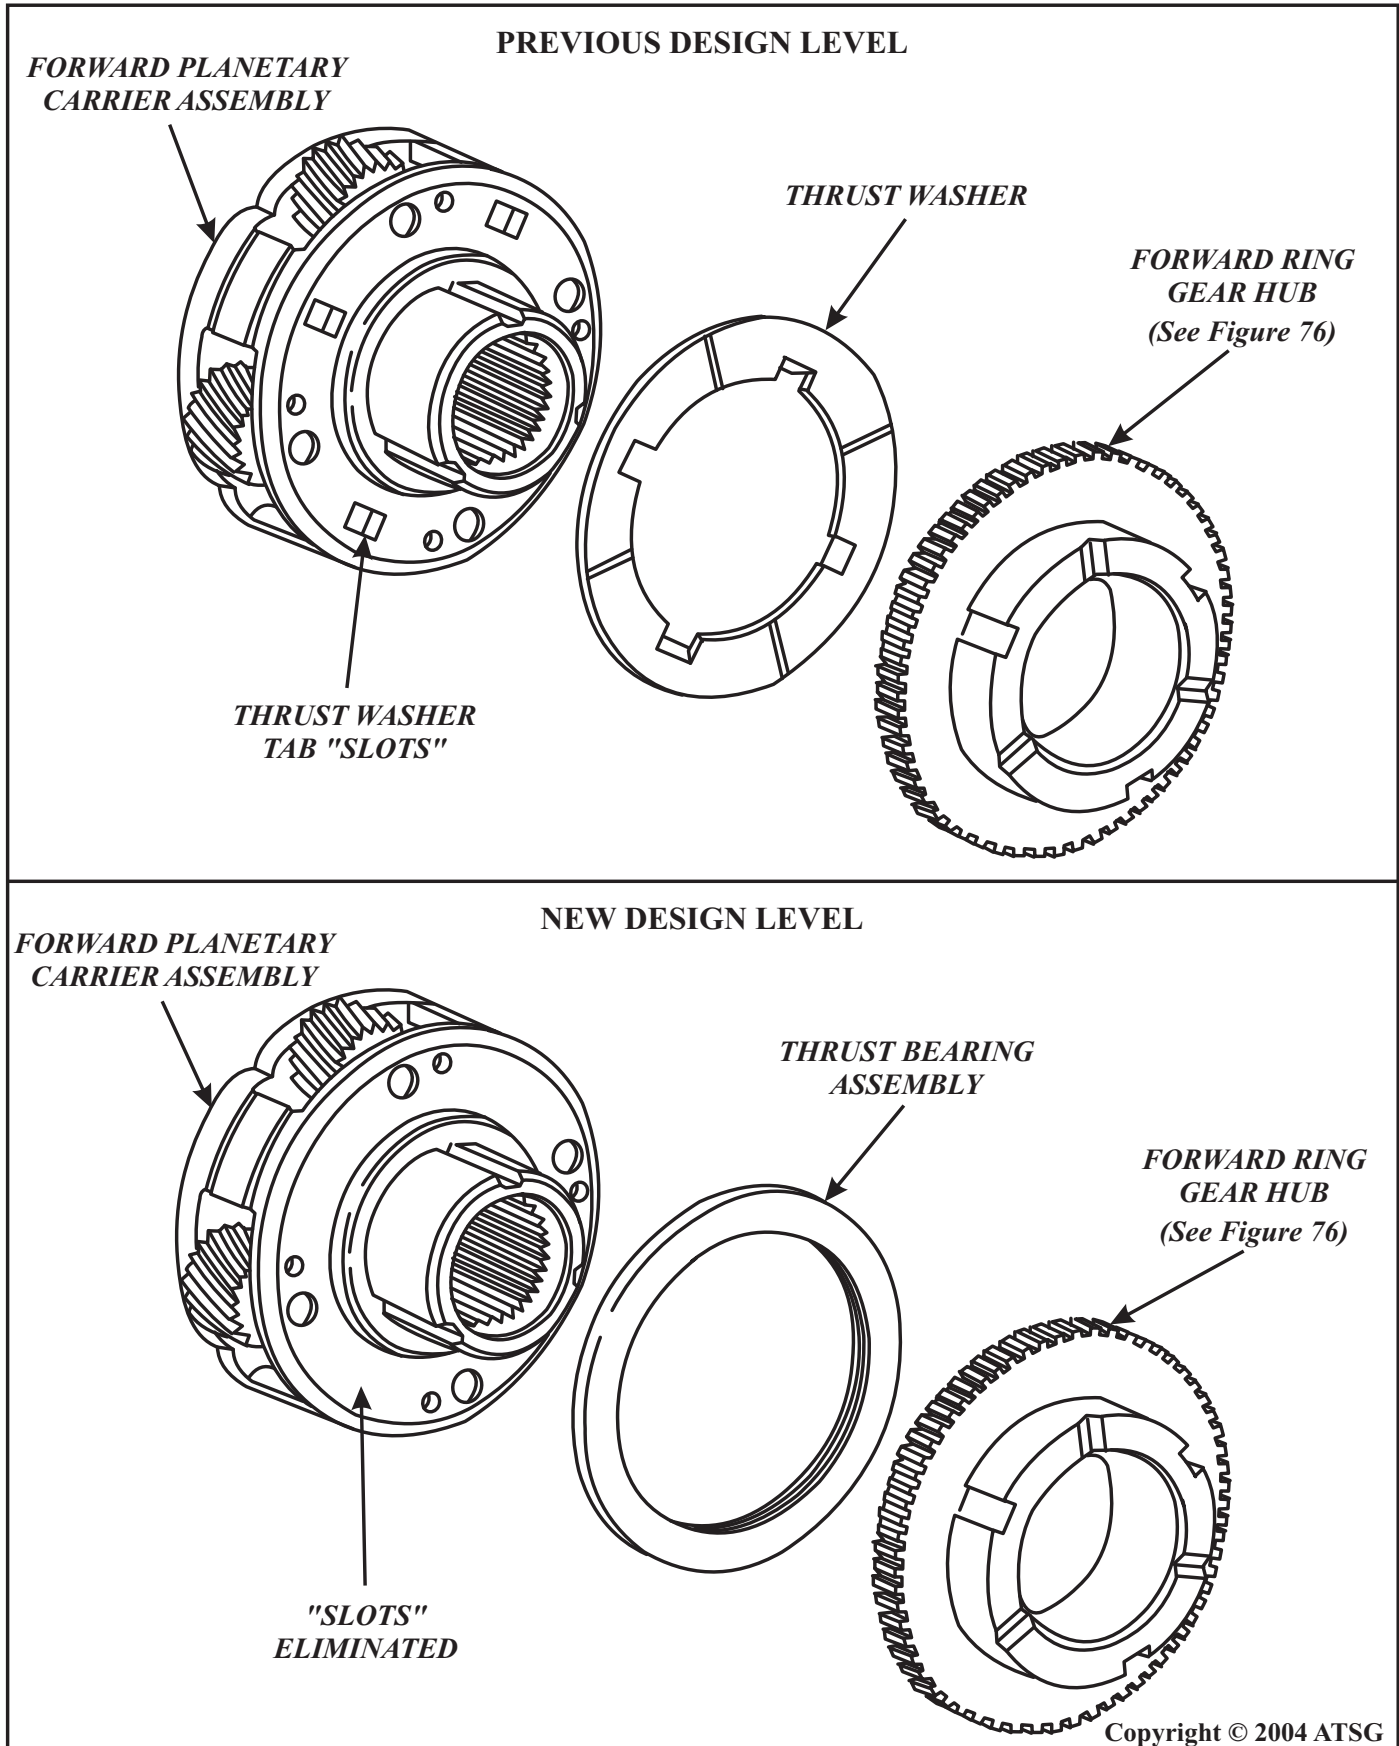
Figure 77
AUTOMATIC TRANSMISSION SERVICE GROUP

CHANGE: Beginning at the start of production for the 1997 model year, Ford Motor Company introduced a new design Forward Clutch Ring Gear Hub, to accommodate a new thrust bearing, that replaces the thrust washer on the forward planetary carrier, and a new design Forward Planetary Carrier that eliminates the thrust washer tab slots (See Figures 76 and 77).

- (2) New design Thrust Bearing must be used only with the new design Ring Gear Hub. It cannot be used on any previous models (See Figure 76).
- (3) There is also a new part number for the Forward Planetary Carrier, with no dimensional changes, and will retro-fit back on all previous models, but, ***some*** of the new part number carriers will not be cut to accept the four tang thrust washer. In that case you will have to install the new thrust bearing, which means you will also have to replace the ring gear hub with the new design level (See Figure 77).

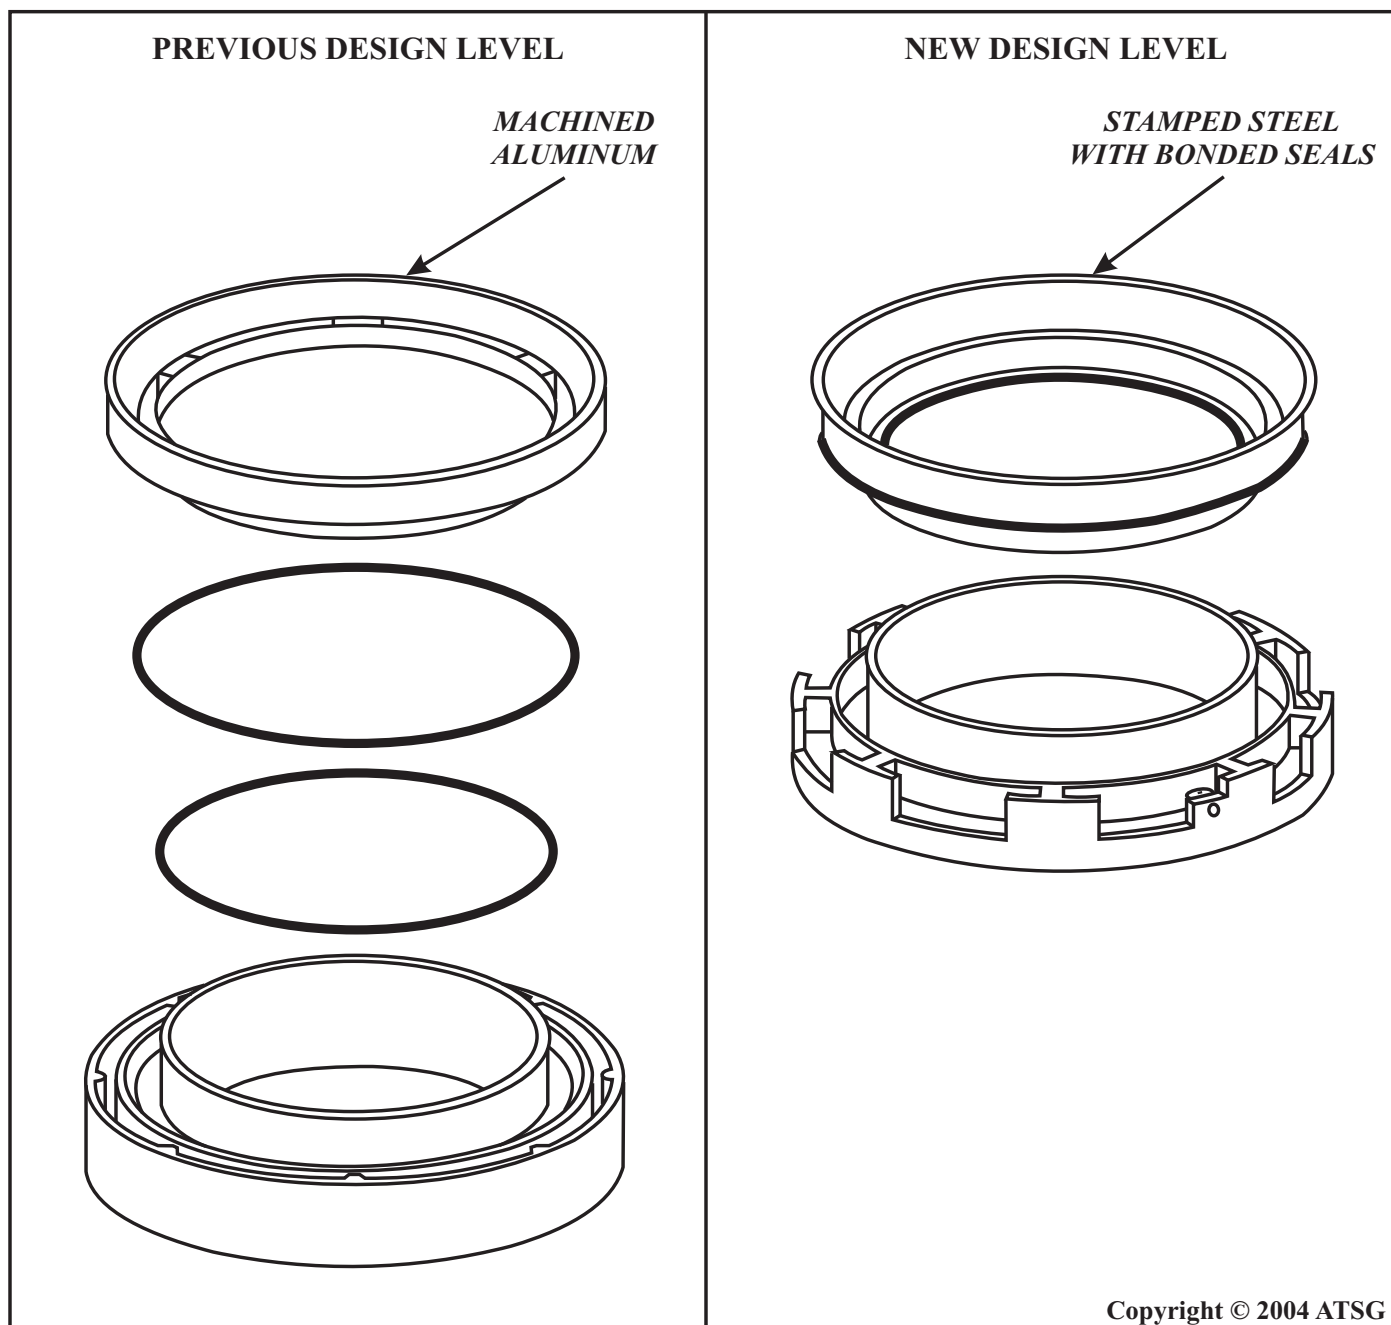
Figure 78

CHANGE: Some 1996-1997 vehicles equipped with the E4OD transmission were built with a new design level overdrive clutch piston, with the seals bonded to the piston (See Figure 78).

- (1) OVERDRIVE PISTON - Now stamped steel with moulded rubber inner and outer seals on the piston assembly, instead of the previous machined aluminum, as shown in Figure 78.
- (2) OVERDRIVE/INTERMEDIATE CLUTCH CYLINDER - Major casting changes to clutch cylinder, to accommodate the new design level bonded piston, as shown in Figure 78.

Note: *Until the new design level parts are fully stocked, the current service parts must be used to replace the new design level parts, if it becomes necessary to replace either the new design bonded seal piston or new design cylinder.*

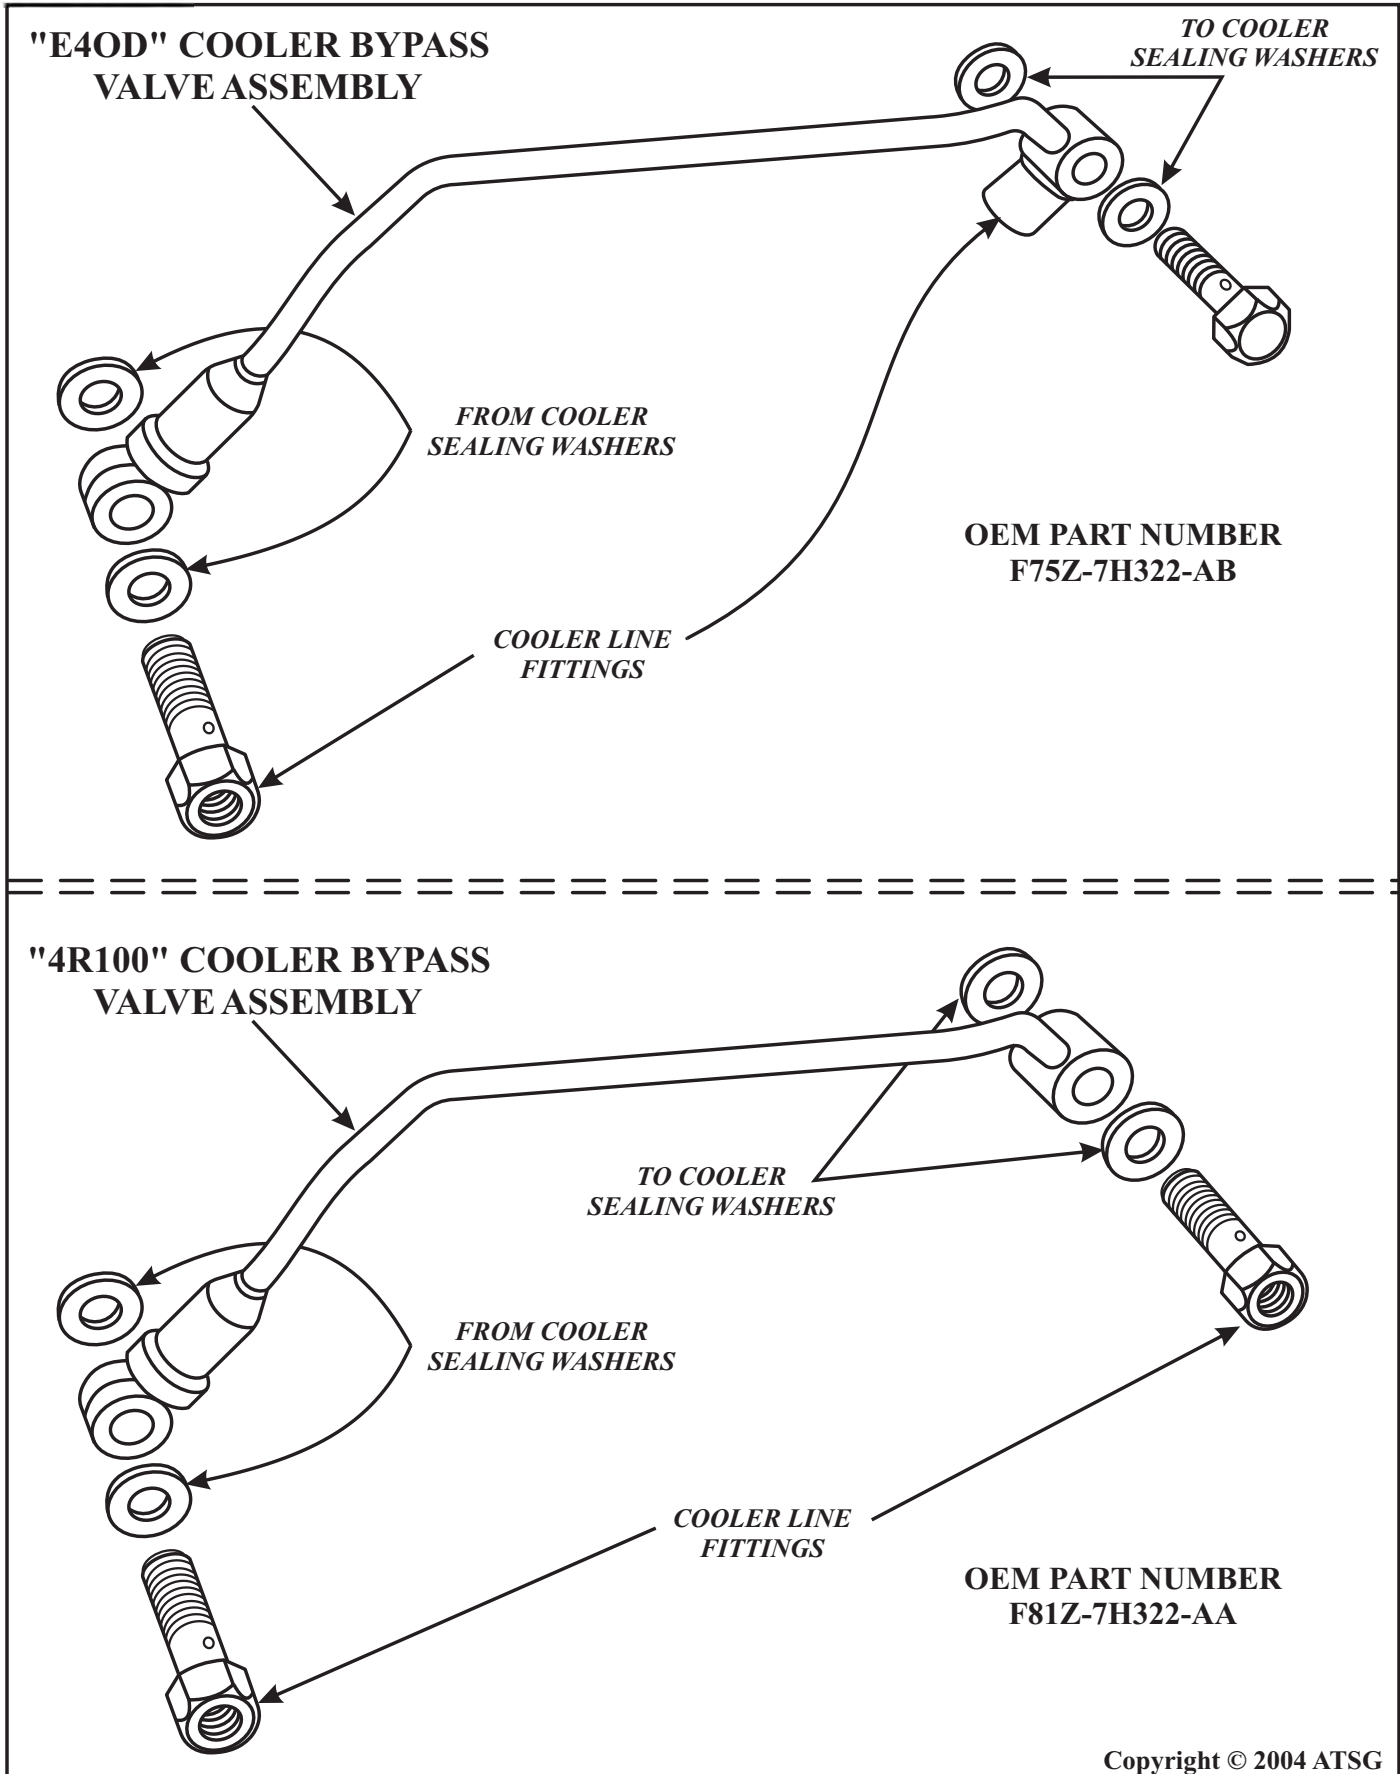
Figure 79

CHANGE: Some 1997 Econoline, Expedition, F-150 Trucks and F-250 Trucks have been equipped with a Cooler Bypass Valve Assembly that requires sealing washers on both the "To Cooler" end and "From Cooler" end of the bypass valve assembly, as shown in Figure 79.

- (1) COOLER BYPASS VALVE ASSEMBLY - Added between the cooler line fittings in the case, to increase lube flow during cold weather operation (See Figure 79).
- (2) CASE FITTINGS - Requires special case fittings to retain the "Banjo" ends of the cooler bypass valve assembly into the transmission case (See Figure 79).
- (3) SEALING WASHERS - Requires sealing washers on both of the "Banjo" ends of the cooler bypass valve to seal properly (See Figure 79).

The new design Cooler Bypass Valve Assembly will retro-fit back to all previous models, and we would recommend the 4R100 style bypass valve assembly, as shown in Figure 79, because you do not have to bend the existing cooler line to get it hooked up.

If a removed Cooler Bypass Valve has an "O" ring installed, remove the "O" ring prior to re-installing the assembly. The "O" rings are only used to hold the sealing washers in place for shipping purposes. If the entire Cooler Bypass Valve requires replacement, be sure to remove the shipping caps and "O" rings prior to installation.

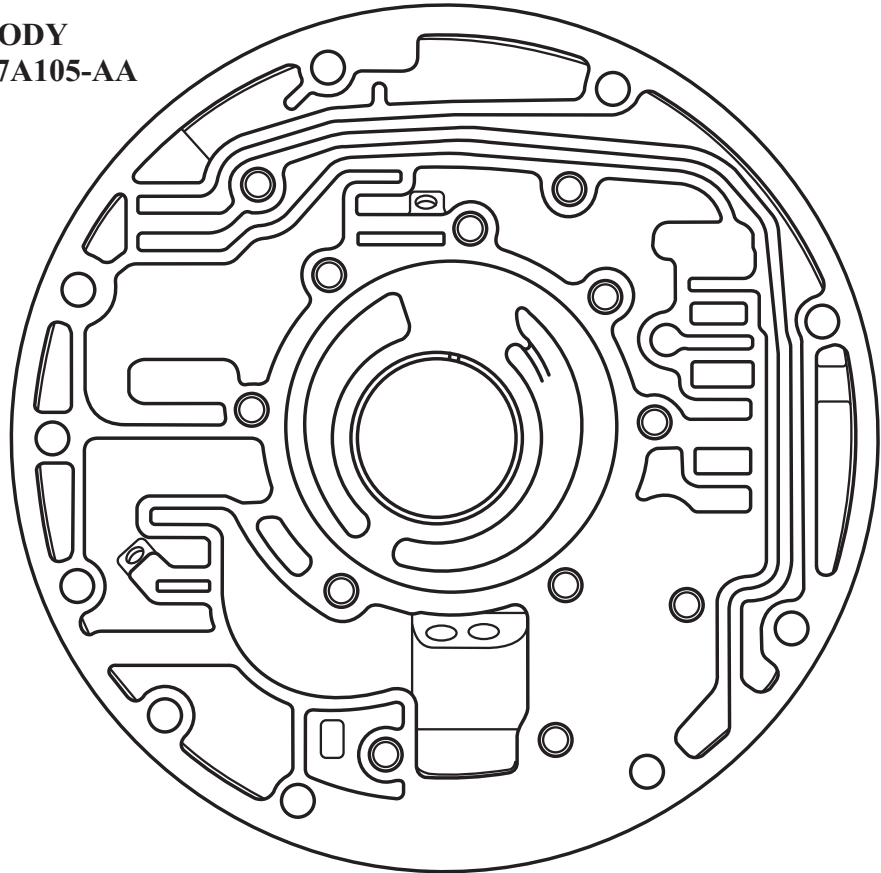
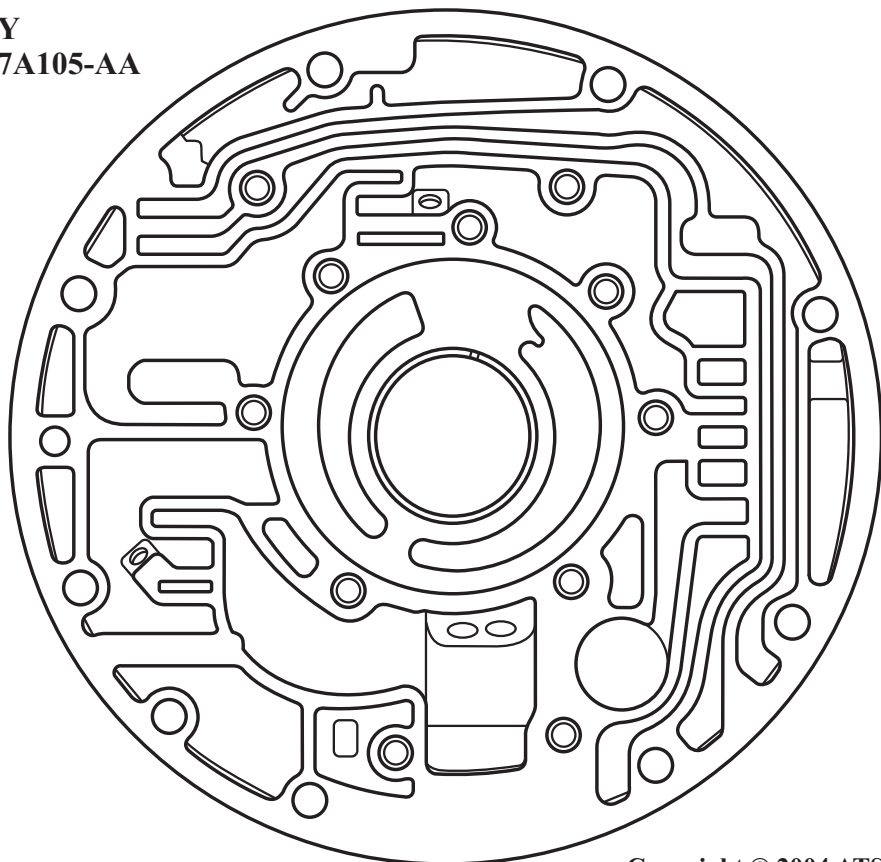
Figure 83

- (1) OIL PUMP BODY - Now has different worm tracks to accommodate the new pump cover assembly and is identified by the rough forging number RF-F81P-7A105-AA, and is cast into the pump body in the location shown in Figure 82. The worm track side of the new pump body and the previous pump body are shown in Figure 83.

**1998 E4OD/4R100 PUMP BODY
CASTING NUMBER RF-F81P-7A105-AA
WORM TRACK SIDE**

**1995 E4OD PUMP BODY
CASTING NUMBER RF-F5TP-7A105-AA
WORM TRACK SIDE**

This new Oil Pump Assembly will retro-fit back to previous models, as long as you have the proper valve line-up in the converter clutch control valve bore. The pump halves **cannot** be inter-mixed because of the major worm track differences. All other parts listed above are model dependent and **great care must be used** when parts replacement is necessary.

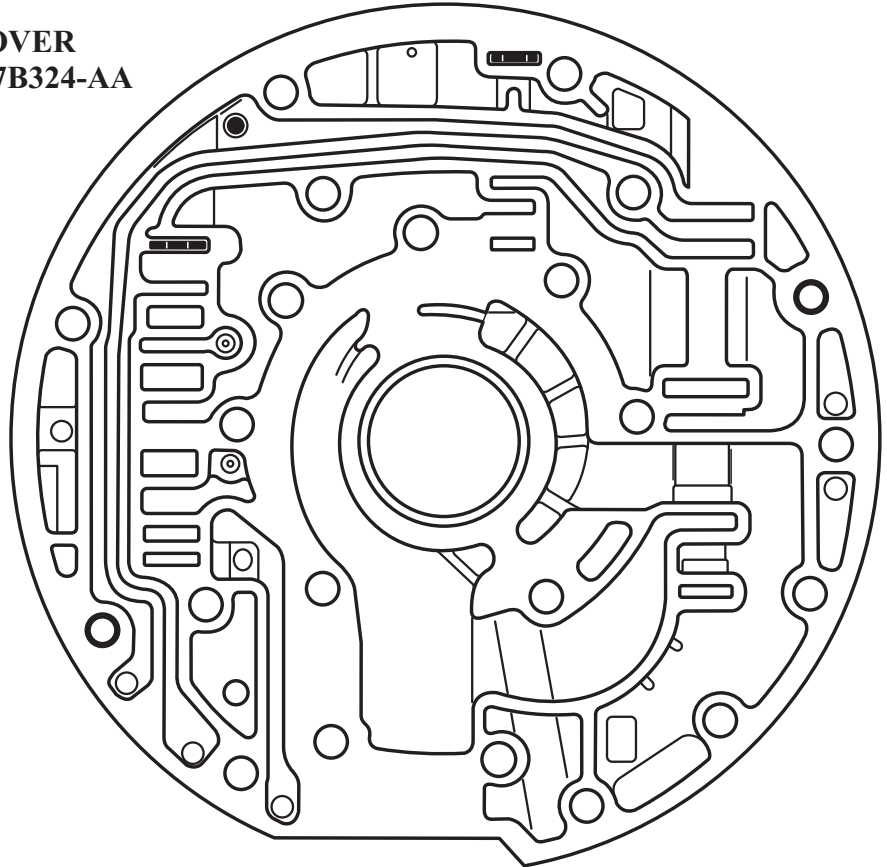
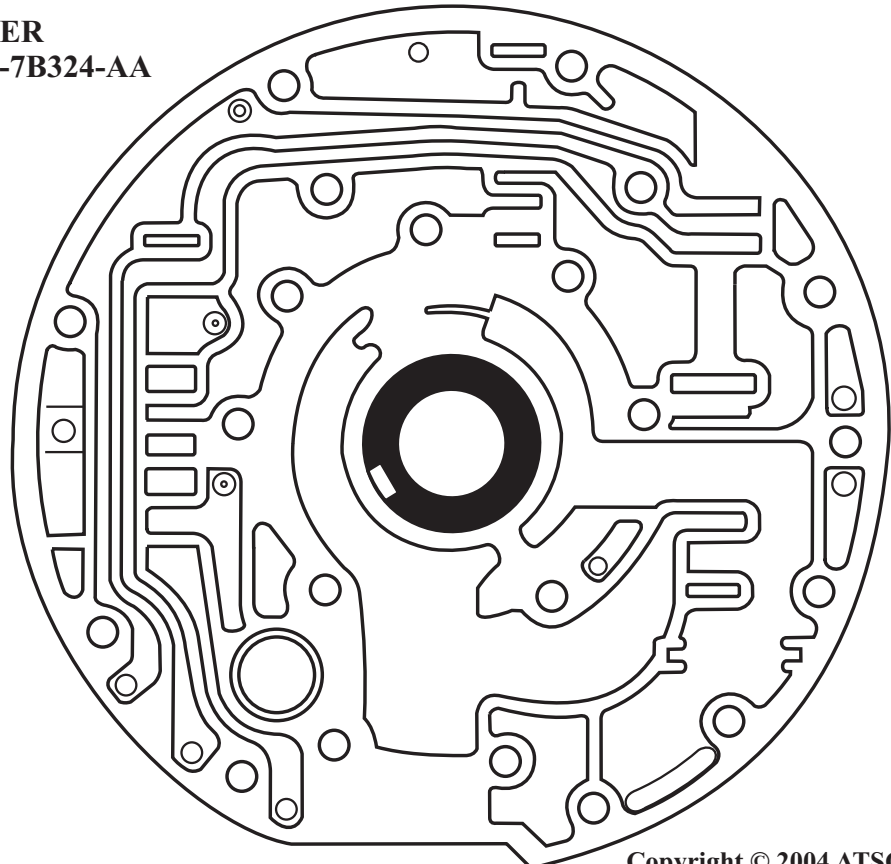
Figure 84
AUTOMATIC TRANSMISSION SERVICE GROUP
105

- (2) OIL PUMP COVER - Now has different worm tracks to accommodate two different styles of converter clutch valve line-ups, and has one added bolt to clamp the pump halves together. The worm track side of the new pump cover and the previous pump cover are illustrated in Figure 84, and casting number on new pump cover is RF-F81P-7B324-AA for identification.

1998 E4OD/4R100 PUMP COVER
CASTING NUMBER RF-F81P-7B324-AA

1995 E4OD PUMP COVER
CASTING NUMBER RF-F5TP-7B324-AA

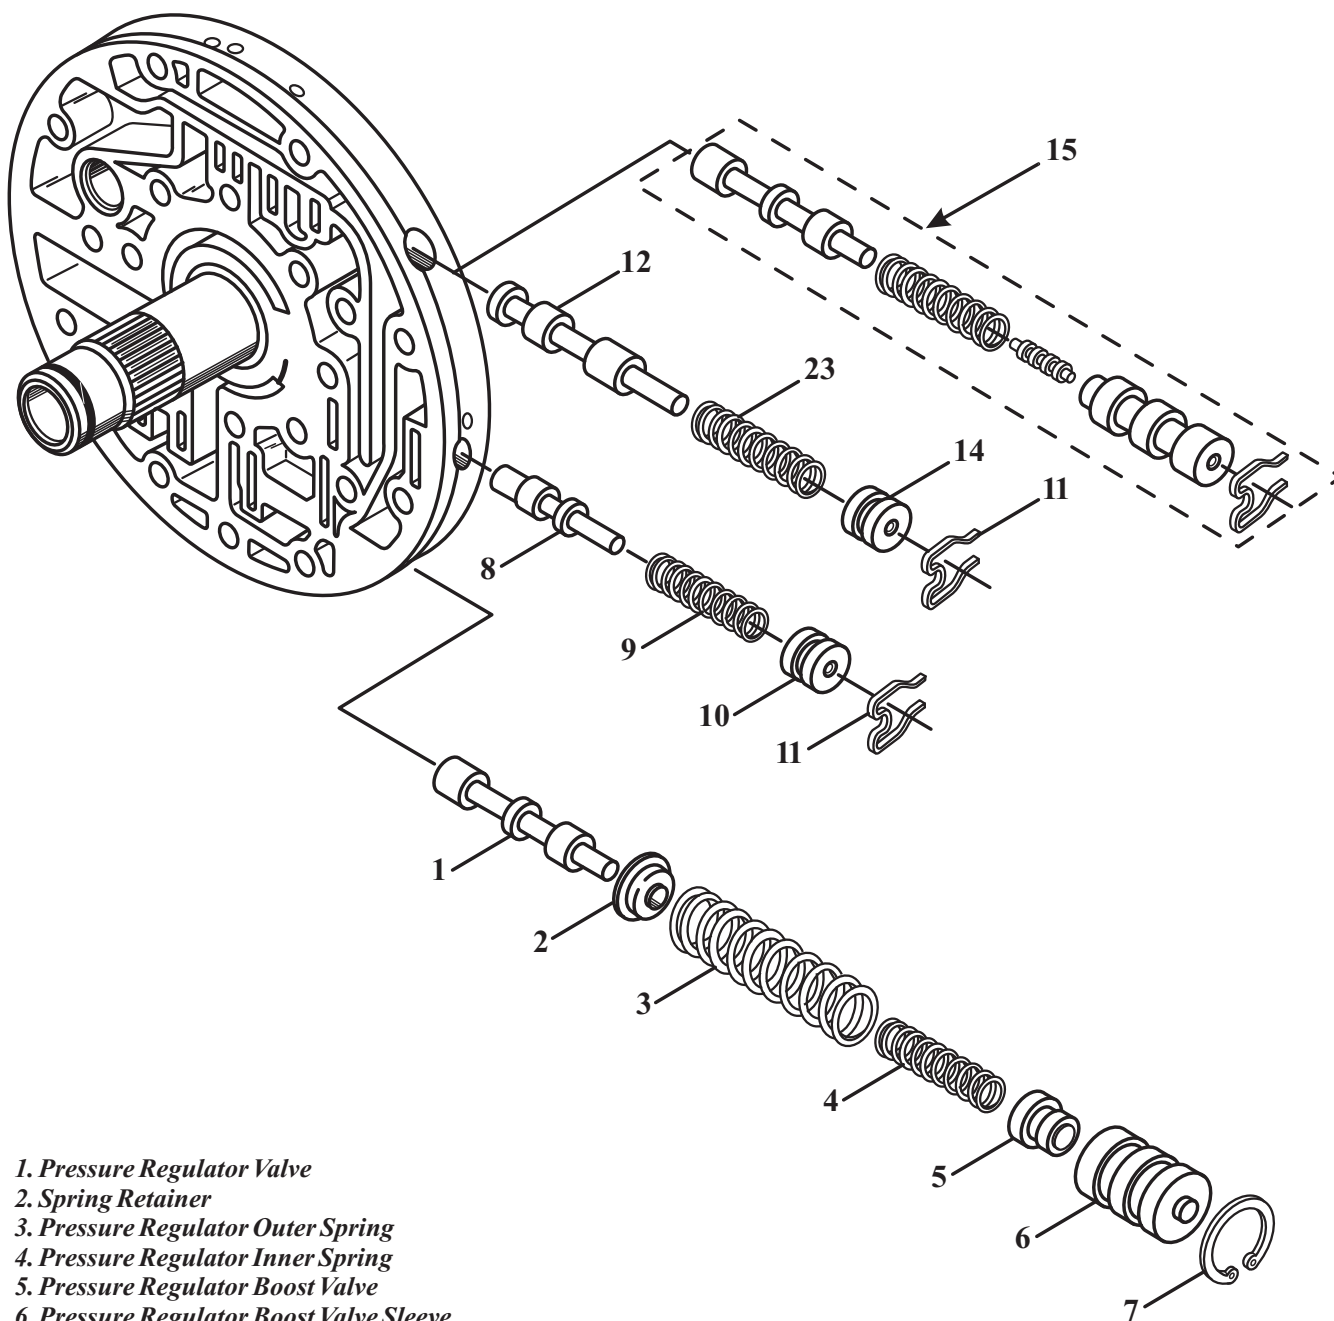
Figure 85

- (3) TCC LINE-UP - There are now two different Converter Clutch Control Valve Line-Ups in the oil pump cover depending on whether it is gasoline or diesel engine. Both of these valve line-ups are illustrated in Figure 85.

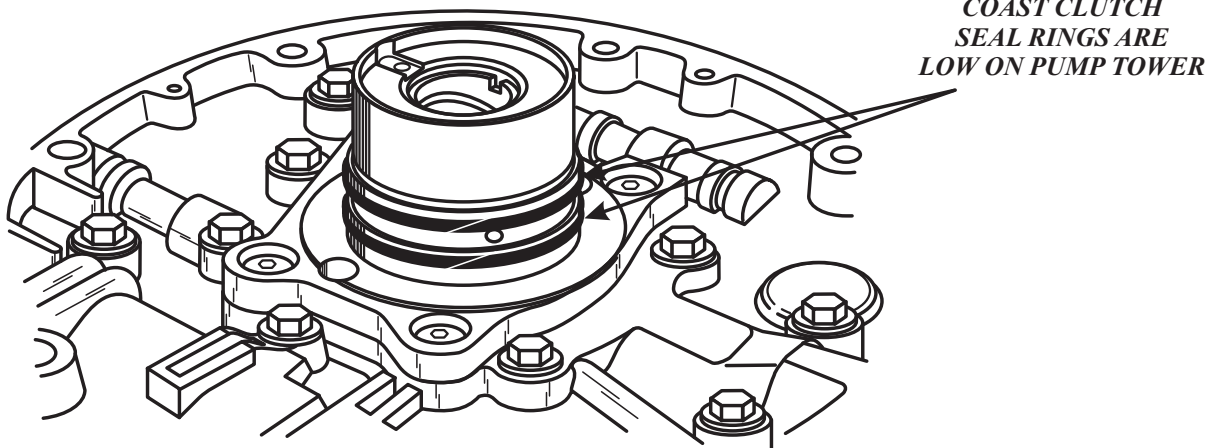
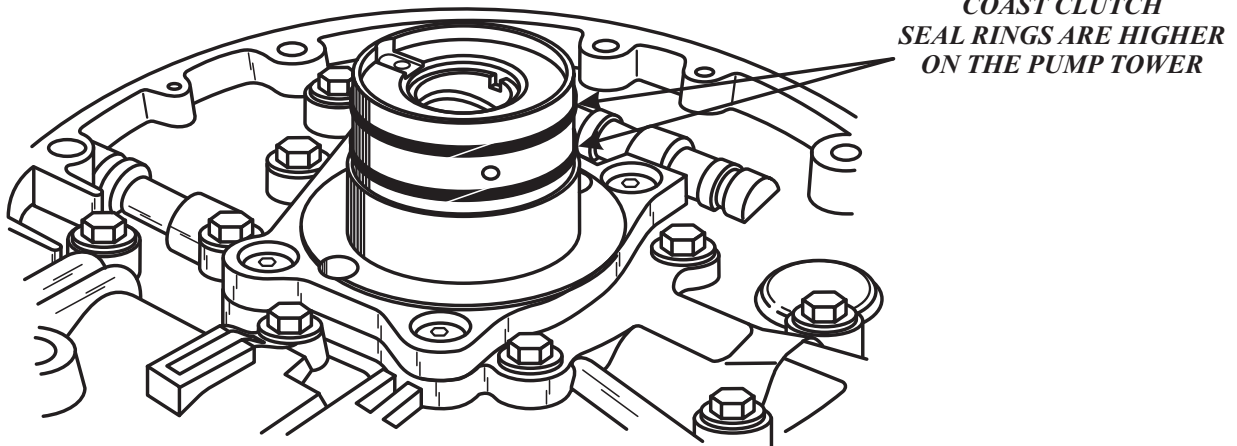
Figure 86

- (4) STATOR SHAFT ASSEMBLY - There are now two different Stator Shaft Assemblies with different sealing ring configurations, to accommodate the new coast clutch housing, as illustrated in Figure 86, and are model dependent.

**USED WITH THE "CAST IRON" COAST CLUTCH DRUM
WITH 5.4L AND 6.8L "WITHOUT" PTO OPTION**

**USED WITH THE "STAMPED STEEL" COAST CLUTCH DRUM
WITH 5.4L AND 6.8L "WITHOUT" PTO OPTION**

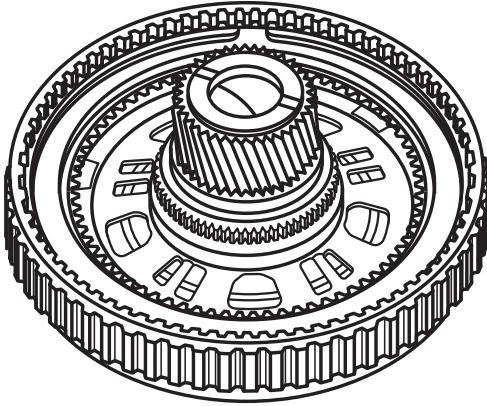
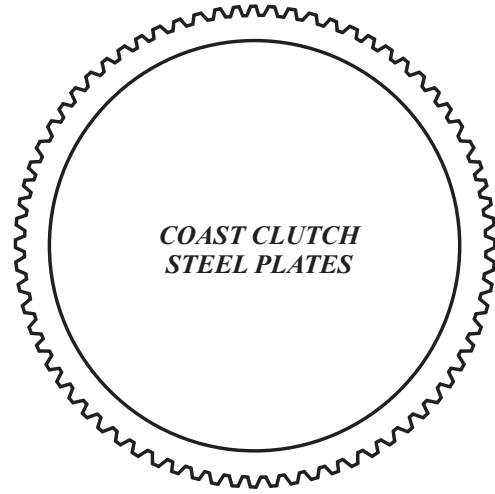
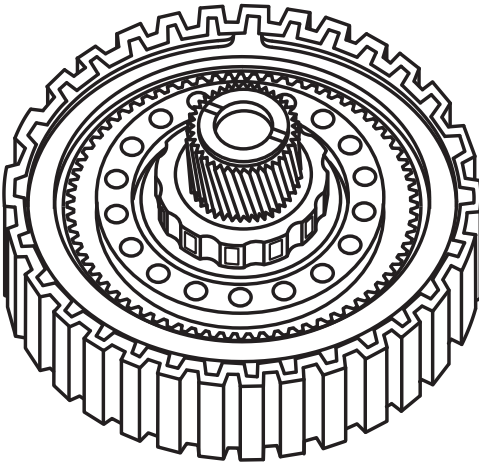
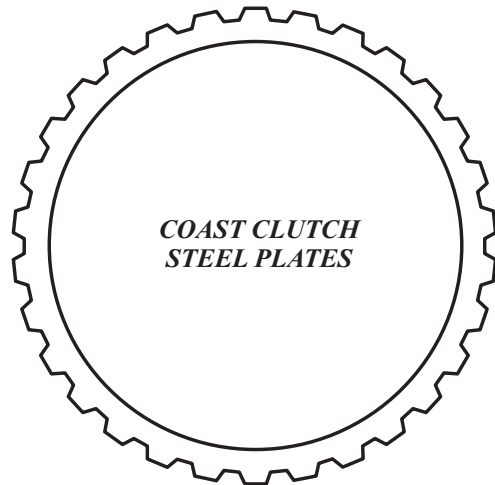
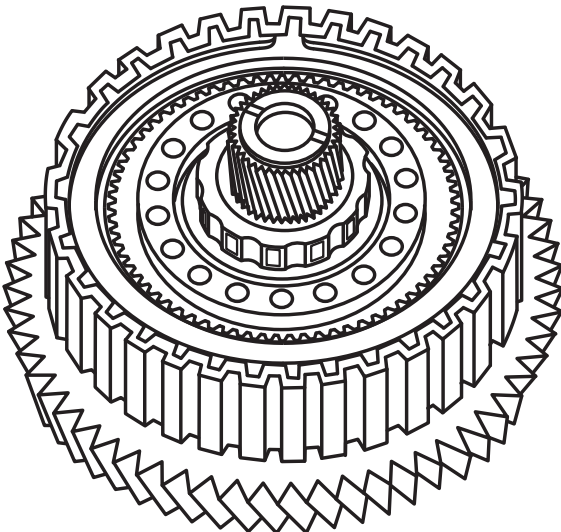
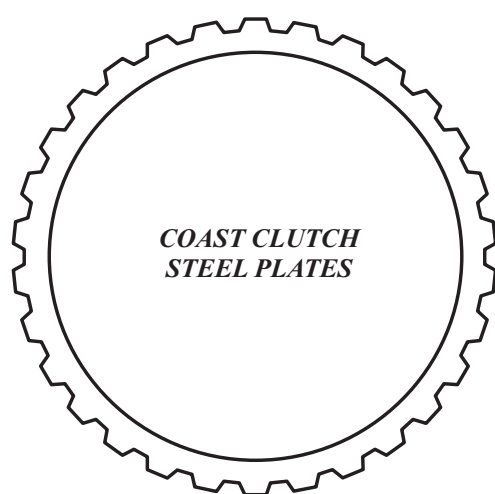
Figure 87

- (5) COAST CLUTCH HOUSING - There is now a "stamped Steel" coast clutch housing that may or may not have a PTO gear pressed onto the housing, that is used in addition to the previous cast iron coast clutch housing, depending on the model and engine size, and is illustrated in Figure 87. This also changes the coast clutch steel plates and the fourth clutch friction plates, as shown in Figures 87 and 88.

**"CAST IRON" COAST CLUTCH DRUM USED
WITH 5.4L AND 6.8L "WITHOUT" PTO OPTION**

**"STAMPED STEEL" COAST CLUTCH DRUM USED
WITH 5.4L AND 6.8L "WITHOUT" PTO OPTION**

**"STAMPED STEEL" COAST CLUTCH DRUM USED
WITH 6.8L AND 7.3L "WITH" PTO OPTION**

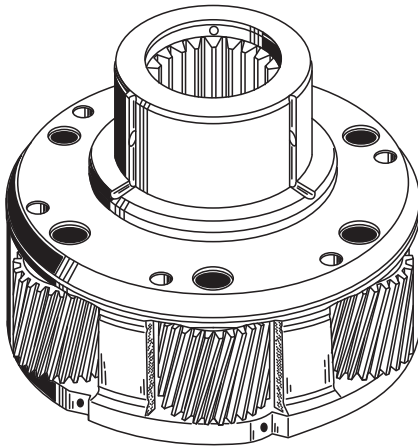
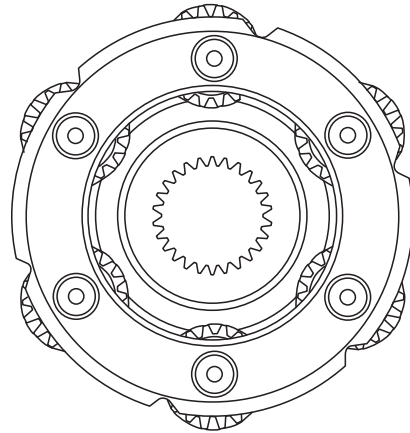
Figure 89

- (1) FORWARD PLANETARY CARRIER - Now has 6 pinions instead of the previous 4 pinions for increased torque carrying capacity and increased durability (See Figure 89).
- (2) REVERSE PLANETARY CARRIER - Now has 6 pinions instead of the previous 4 pinions for increased torque carrying capacity and increased durability (See Figure 89).

NEW DESIGN 6 PINION FORWARD PLANETARY CARRIER PART NUMBER F81Z-7A398-CA

The new design forward planetary carrier *will back service all models* of the E4OD, but it *does require* the latest design forward ring gear hub and bearing assembly, as there are no holes for the previous design thrust washer (See Figure 89).

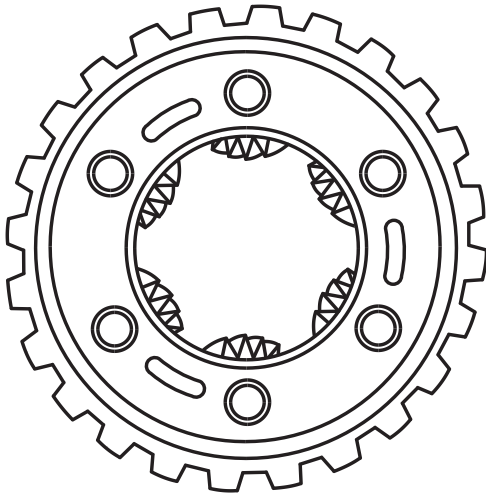
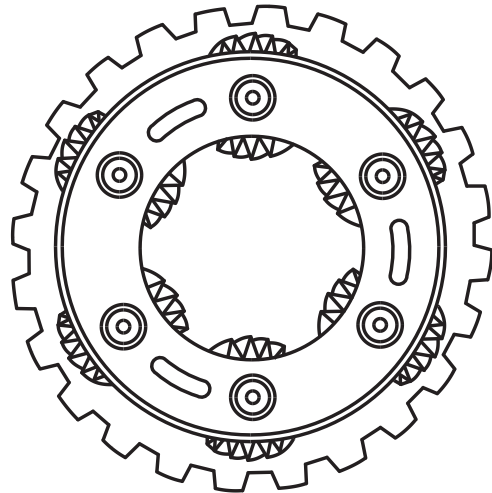
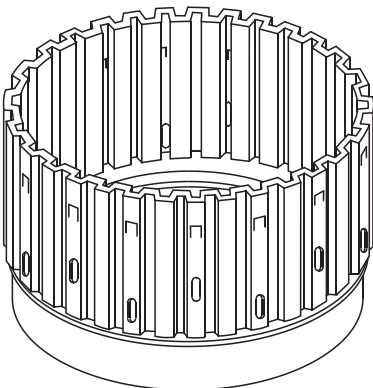
NEW DESIGN 6 PINION REVERSE PLANETARY CARRIER PART NUMBER F81Z-7D006-AA

**REQUIRES 1997-UP DESIGN LEVEL
REVERSE CLUTCH HUB ASSEMBLY**

**REQUIRES 3 TANG THRUST WASHERS
ON BOTH SIDES OF REAR CARRIER
PART NUMBER F0TZ-7A166-D**

The new design reverse planetary carrier *will back service all models* of the E4OD, but it *does require* the latest design reverse clutch hub and three tang thrust washer for both sides, as shown in Figure 89.

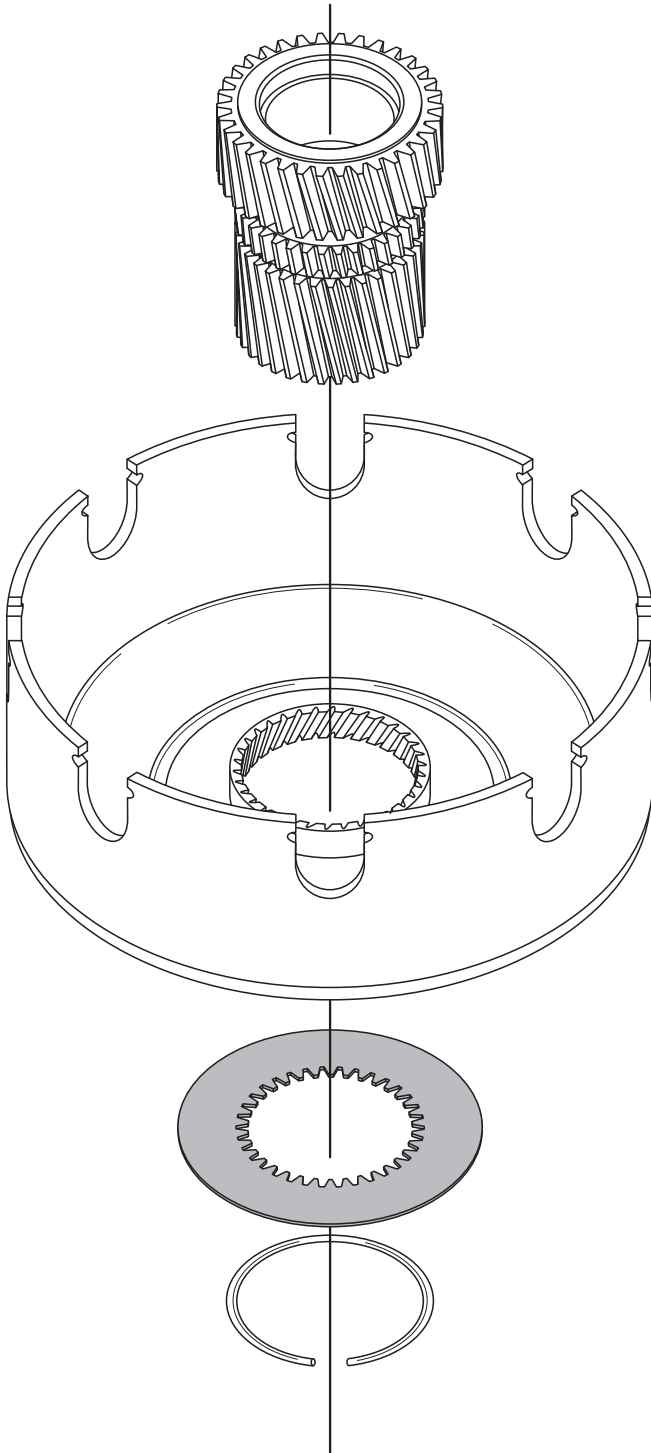
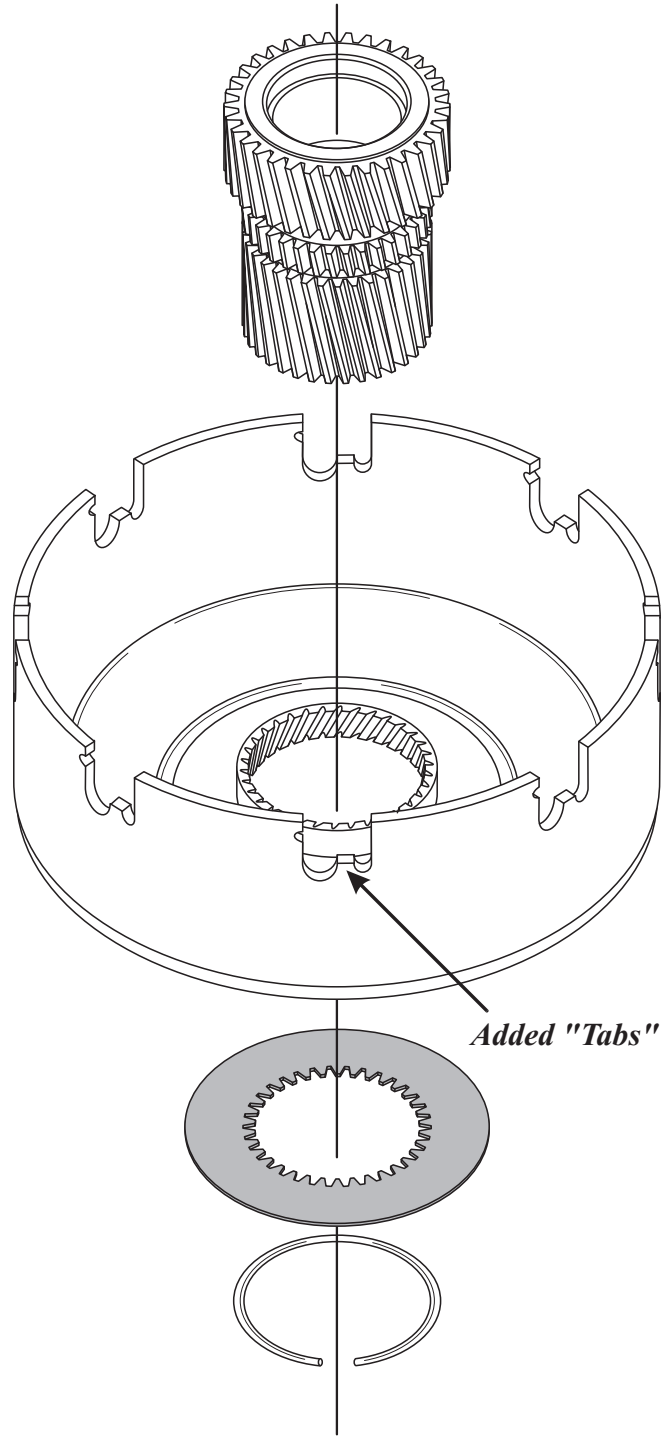
Figure 90

CHANGE: There is now a new design Sun Shell with "Tabs" added to the center of the sun shell slots, as shown in Figure 90, implemented by Ford Motor Co. as a running change, during the 2000 model year. This change eliminated the need for the number 8 thrust washer between the forward and direct drums.

PREVIOUS DESIGN SUN SHELL *"No Longer Available From Ford"*

*May Be Used With "ONLY"
The Previous Design Direct Drum
And Requires The No. 8 Washer
(See Figure 91)*

NEW DESIGN SUN SHELL *Hardened = YC3Z-7D064-BA Regular = YC3Z-7D064-AA*

*May Be Used With
Both Design Direct Drums
With Or Without Washer
(See Figure 91)*

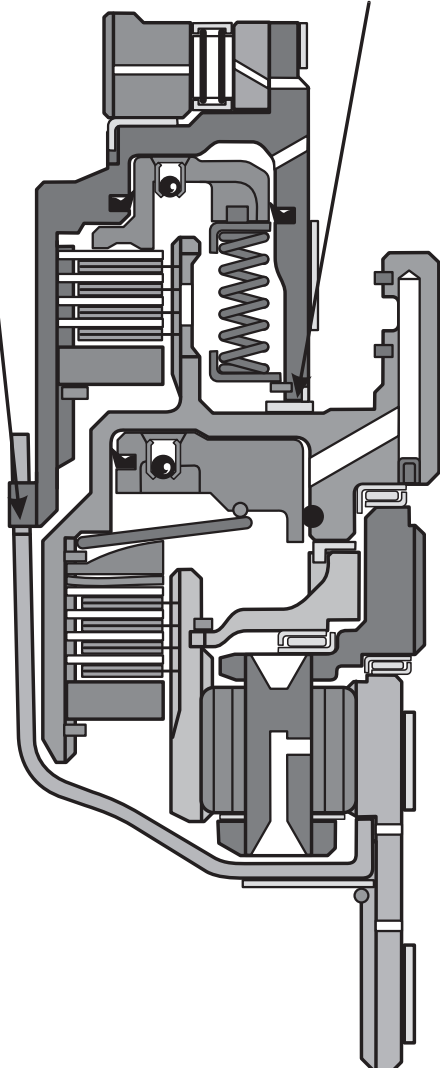
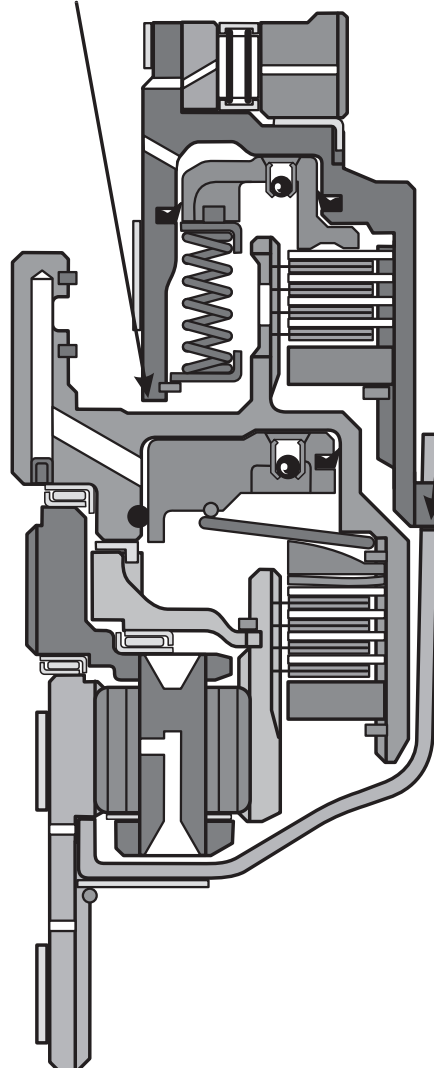
**PREVIOUS DESIGN DIRECT CLUTCH
DRUM "WITH" SLOTS FOR THE
NUMBER 8 THRUST WASHER
AND PREVIOUS SUNSHELL**

*When Direct Clutch Housing
Is Not Supported Here,*

*The Number 8 Thrust
Washer Is Required*

**NEW DESIGN DIRECT CLUTCH
DRUM "WITHOUT" SLOTS FOR THE
NUMBER 8 THRUST WASHER
AND NEW SUNSHELL**

*When Direct Clutch Housing
Is Supported By The "Added"
Raised Tabs Here,*

*The Number 8 Thrust
Washer Is Not Required*

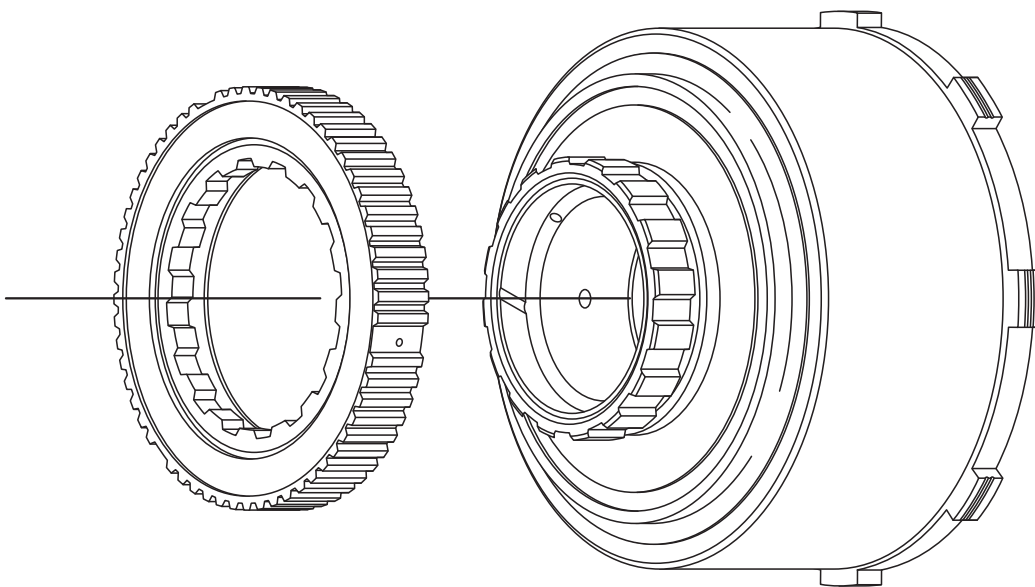
Figure 93

COMPLAINT: Some Ford Motor Company vehicles equipped with the 4R100 transmission may exhibit premature failure of the newly introduced Intermediate "Diode" Freewheel device that was installed in model year 2001 and illustrated in Figure 93.

CAUSE: The cause may be, more than expected load factors.

4R100 INTERMEDIATE "DIODE"

No Longer Available For Service

CORRECTION: The Intermediate "Diode" is ***no longer serviced*** by Ford Motor Company. The part number now supercedes to all of the previous design level parts, which include the direct clutch housing, intermediate sprag assembly, outer race to direct drum thrust washer, and the intermediate friction plates. All of the previous design level parts are illustrated in Figure 94, with the OEM part numbers. The intermediate frictions must be replaced because the tooth count on the outer race between the diode and the sprag are different.

Special Note: ATSG recommends replacing the Intermediate "Diode" during service, even if it has not yet failed, to protect yourself from possible future failures.

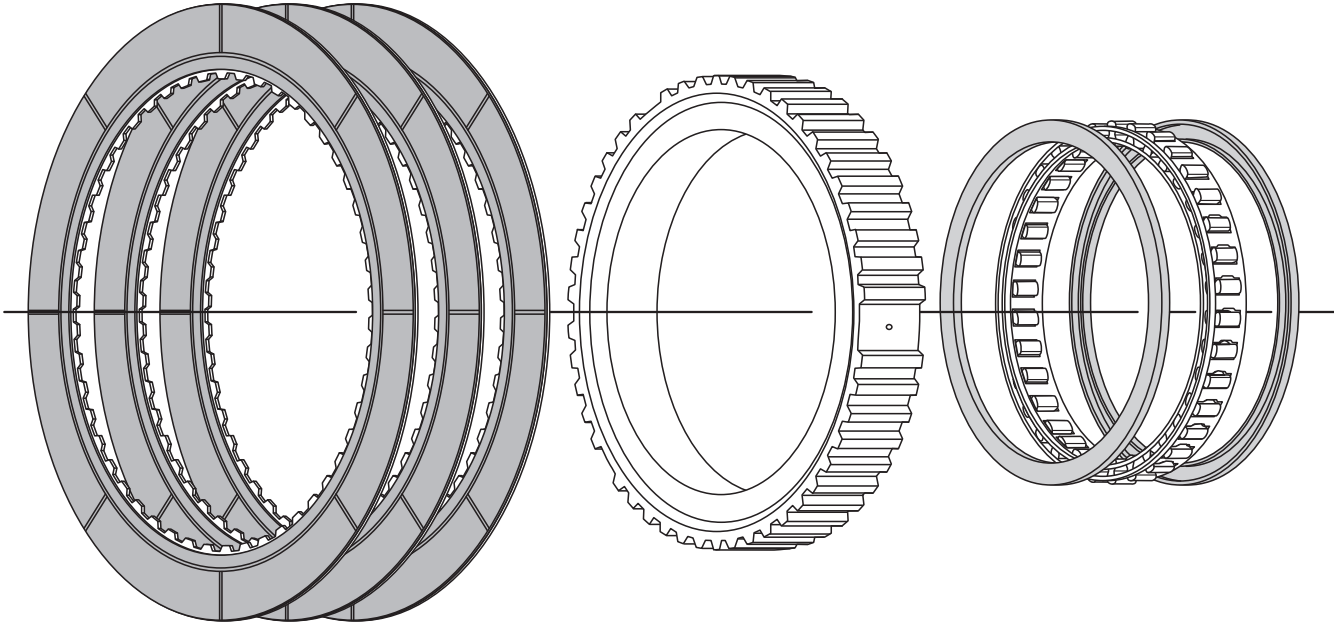
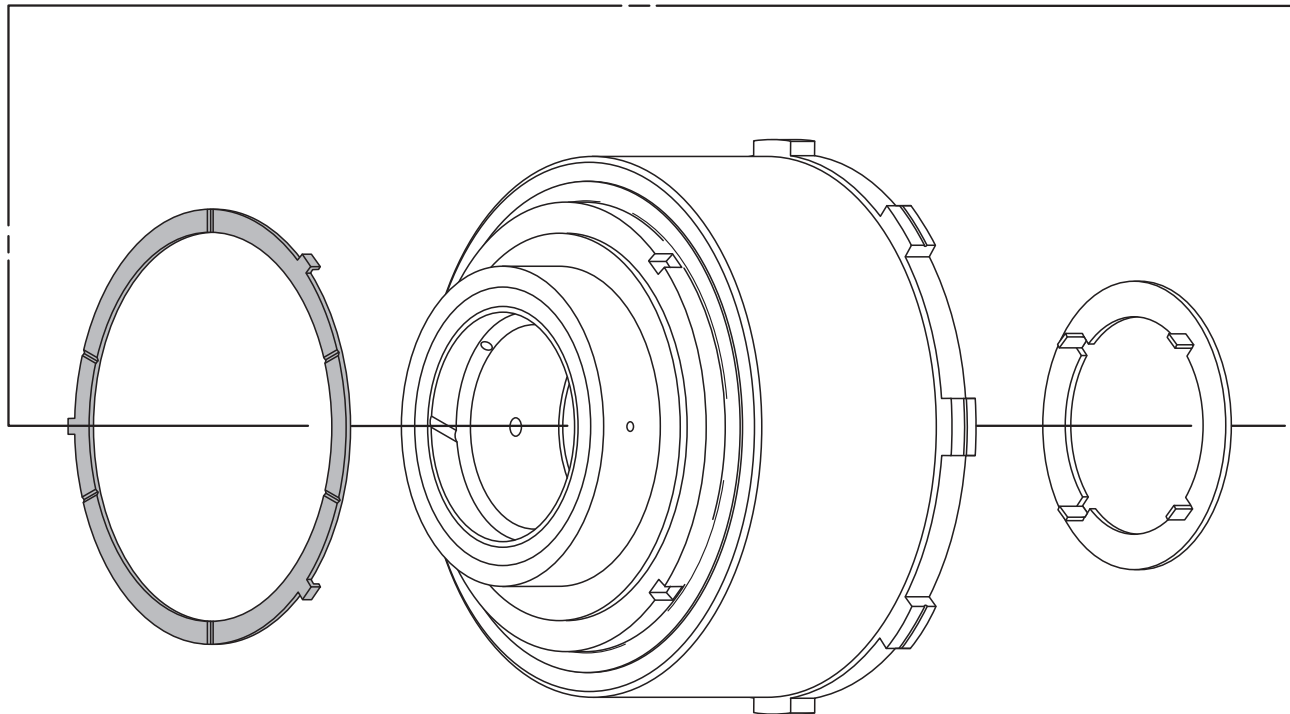
PARTS NEEDED TO REPLACE INTERMEDIATE DIODE

Intermediate Friction Plates
Part Number 1C3Z-7B164-BA
(Or Raybestos Plates OK)
(3 Required)

Intermediate Sprag Assembly
Part Number E9TZ-7A089-B
