FORD E4OD "UPDATE HANDBOOK"

*Updated
April, 2004*

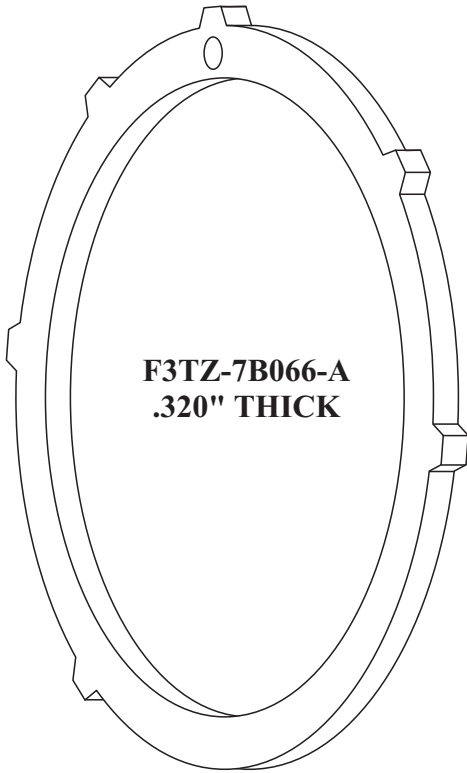
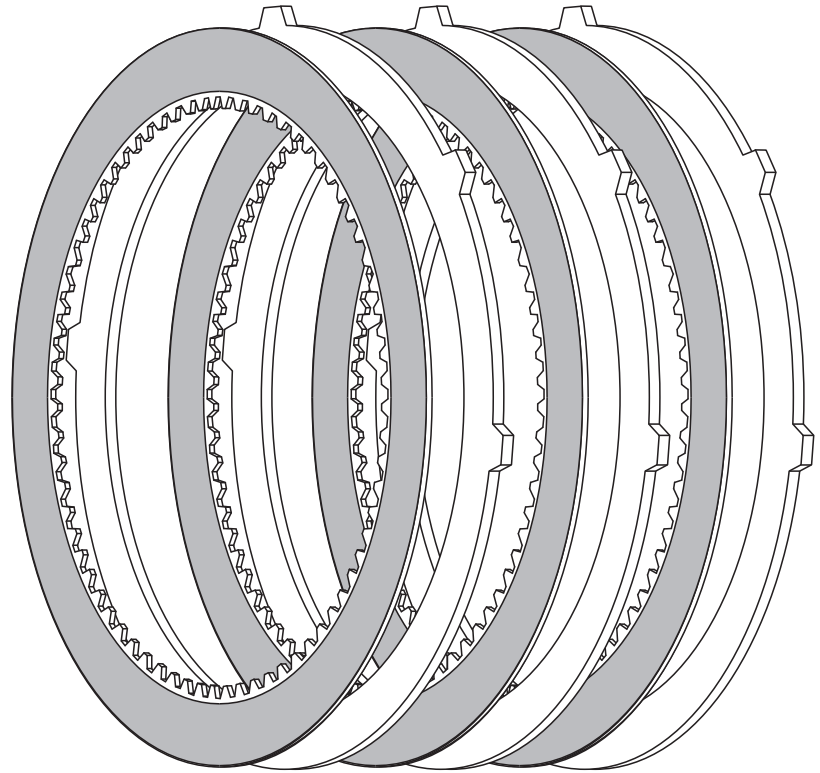
COMPLAINT: Some vehicles equipped with the E4OD transmission may exhibit premature failure of the overdrive clutches, especially heavier loaded vehicles.

CAUSE: The cause may be, not enough clutch capacity for the overdrive clutch.

E4OD 3 PLATE OVERDRIVE CLUTCH STACK-UP

CORRECTION: Install 3 clutches in the overdrive clutch pack by purchasing a thinner, .320" thick backing plate, to replace the previous .490" thick backing plate. The 3 clutch backing plate is available under OEM part number F3TZ-7B066-A. Refer to Figure 95 for both the 2 clutch and 3 clutch stack-ups.

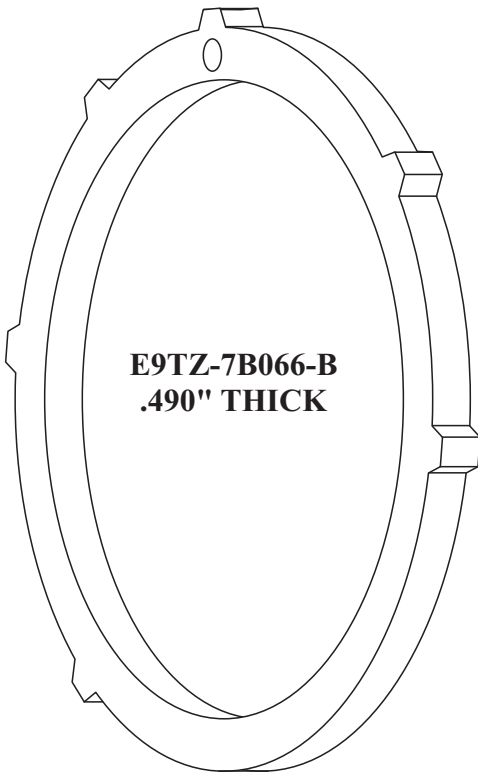
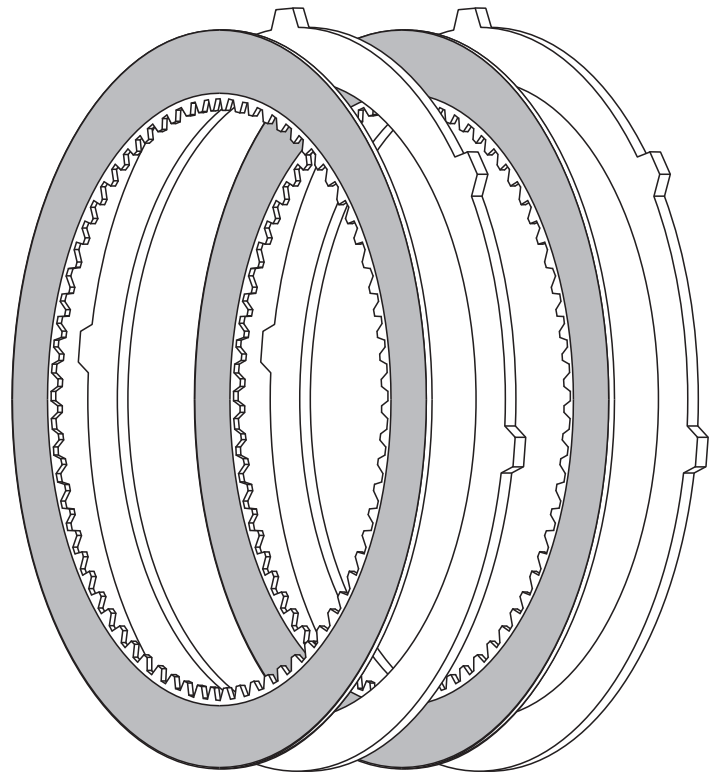
E4OD 2 PLATE OVERDRIVE CLUTCH STACK-UP
