**AUTOMATIC TRANSMISSION SERVICE GROUP**

## INTRODUCTION

Since the introduction of the THM 440-T4 Transaxle in April, 1984, there have been many major engineering design changes. These changes have affected nearly every part used in the THM 440-T4. This Update Handbook will explain each change, the parts affected by the change, and any parts interchangeability problems created by the change.

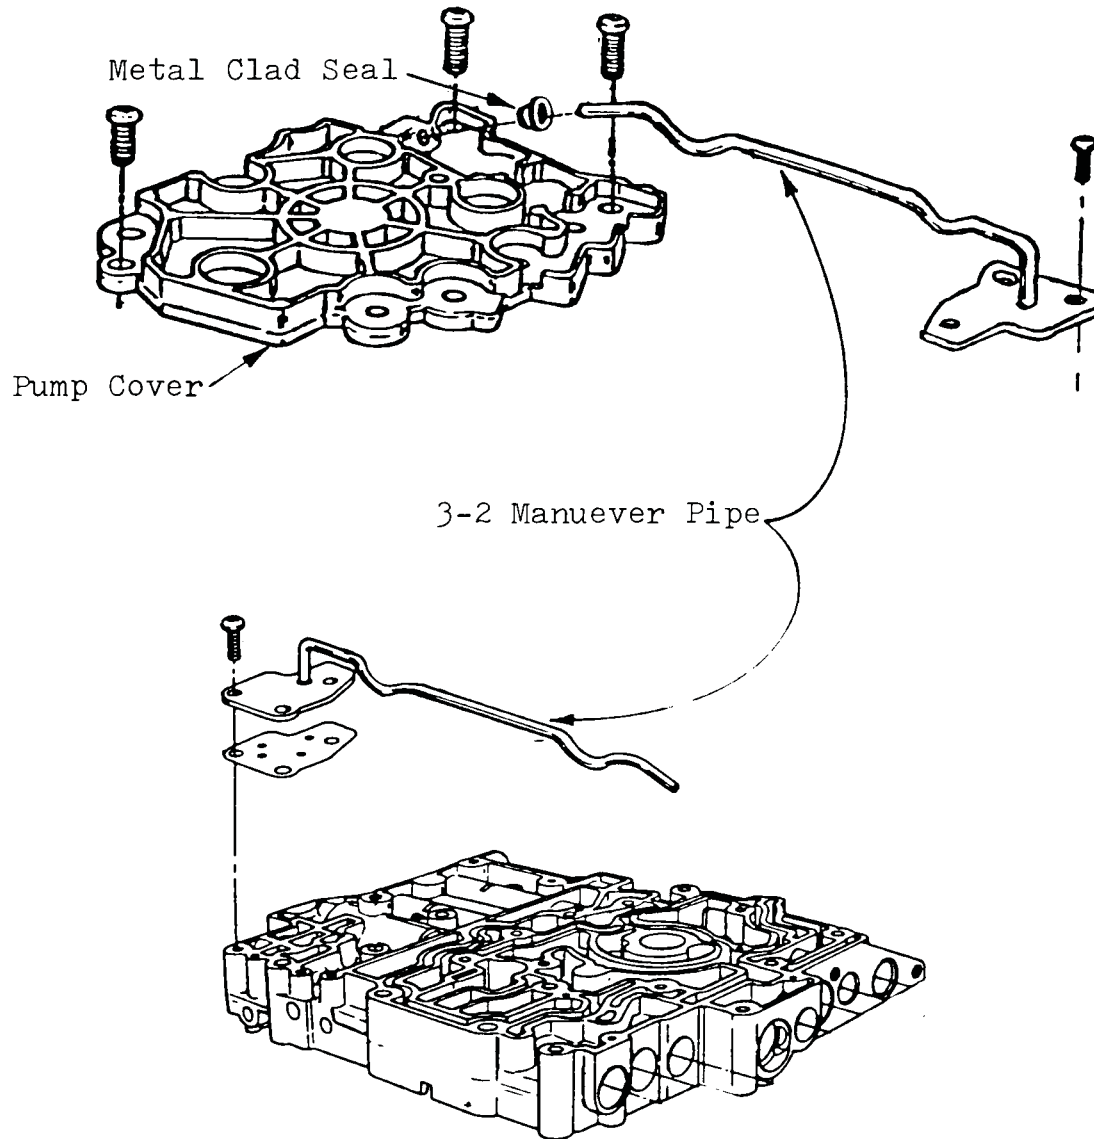
Figure 6

Some 1987 440-T4 transaxles built between November 26, 1986 (Julian Date 330) and January 12, 1987 (Julian Date 012), may exhibit a slip or no drive condition as a result of low line pressure.

This condition may be caused by the pump slide binding on excessive casting flash when the slide is in the low pressure position.

If pressures do not vary with vacuum signal changes, inspect for pump slide bind by removing the oil pump cover and slide springs. If present, excessive flash will cause the slide to bind when the cover is on and torqued.

If flash is present you will have to replace the oil pump assembly, or use a Dremel Tool with a carbide bit and remove flash from 87 model to match contour of 86 model (See Figure 7).

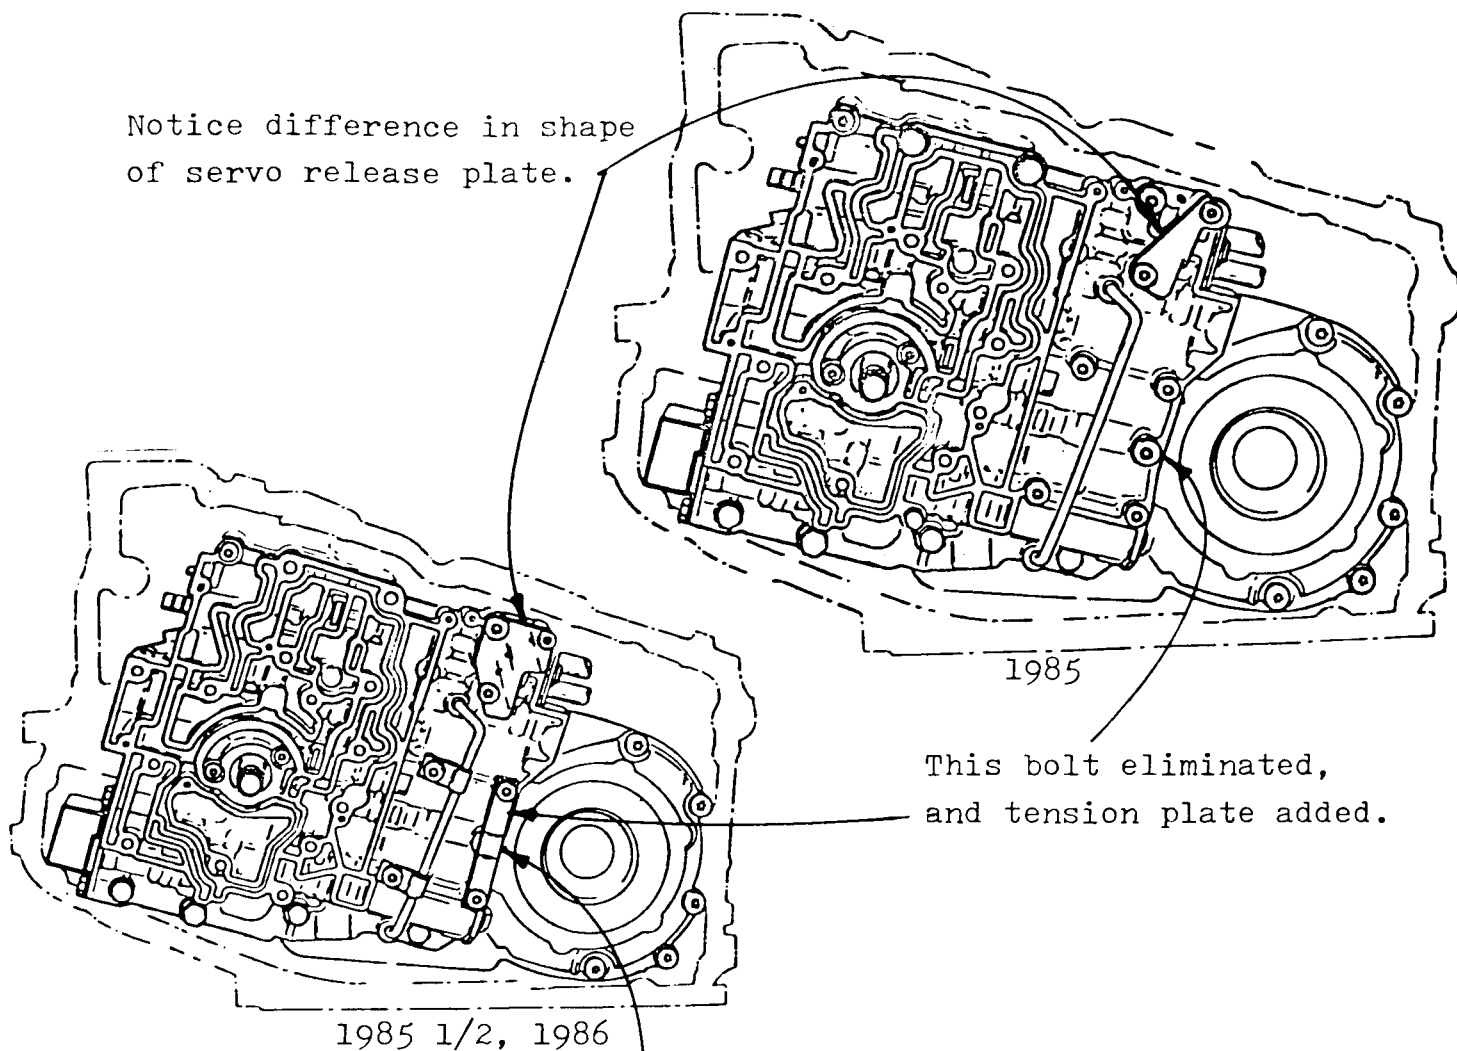
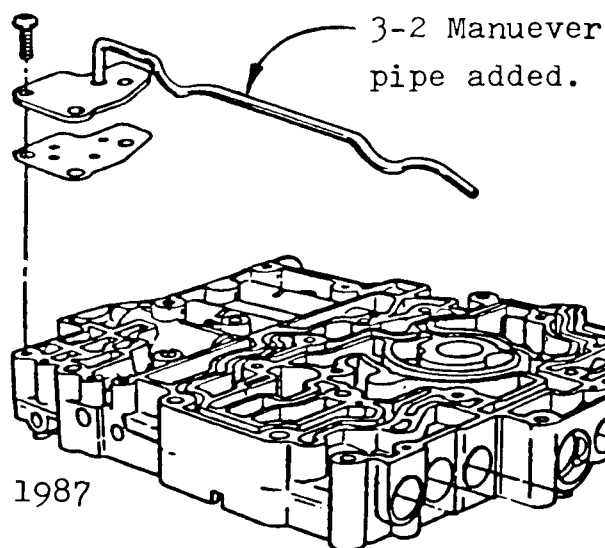
Figure 8

1985	Identification:	Notice difference in shape of 1-2 servo release plate. Also extra bolt in valve body (See Figure 8).
	Interchangeability:	NOT INTERCHANGEABLE.
85 1/2, 86	Identification:	Notice difference in shape of 1-2 servo release plate (See Figure 8). Extra bolt eliminated in valve body to make room for the addition of 3-2 TV bias valve in valve body (See Fig. 9). Special bolt added under valve body in channel plate, and addition of tension plate (See Figure 8).
	Reason:	Improved 3-2 downshift.
	Interchangeability:	Not Compatible with 1985. Will interchange with 86 models, as long as calibration requirements are met.
1987	Identification:	Addition of 3-2 maneuver pipe (See Figure 8).
	Reason:	Further improved 3-2 downshift.
	Interchangeability:	Not compatible with 1985. Will interchange with 85 1/2 and 86 models, as long as calibration requirements are met.

Notice difference in shape of servo release plate.

Special bolt goes here, under valve body.

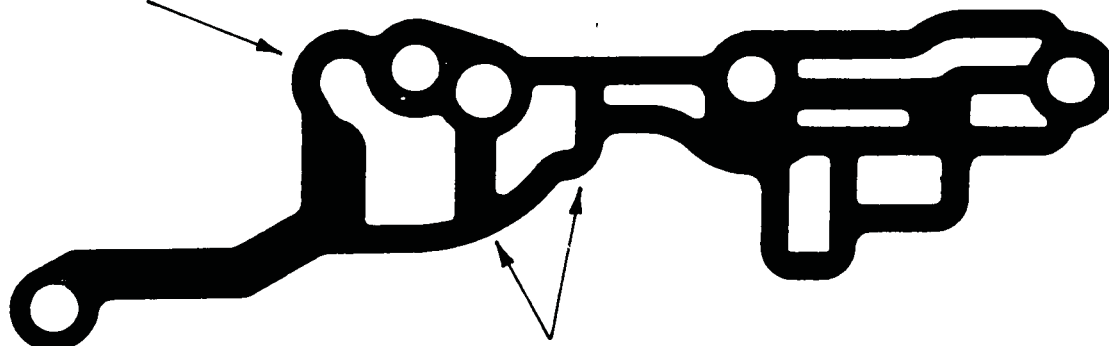
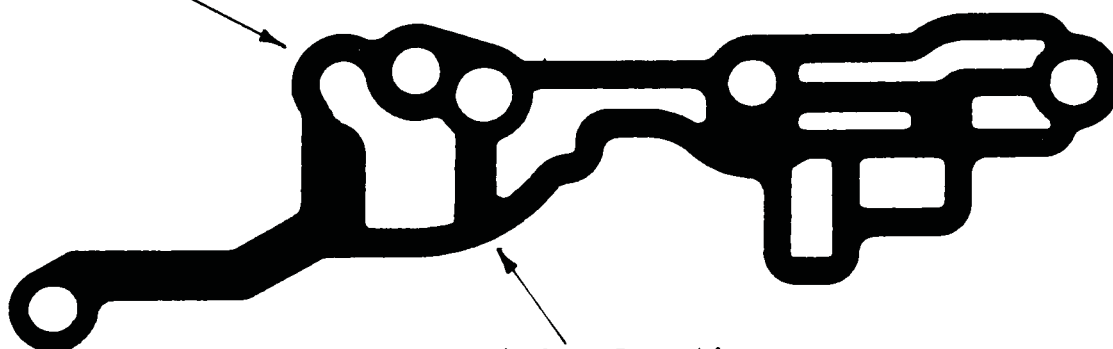
Figure 19

- 1) The upper channel plate gasket was changed to match movement of the dam in the channel plate (See Figure 19).

If the second design gasket (See Figure 10), is used on the 1985 channel plate (Figure 17), it allows PRN oil to enter the reverse servo feed circuit and applies the reverse band. The end result will be, that the transaxle will be in reverse and park at the same time because we also have the input clutch on in park in the 440-T4.

Has Dam At Both Locations.  
(Will Work On Either Channel Plate)

Has Dam At One Location.  
(Will Work Only On 1985 1/2 And Up)

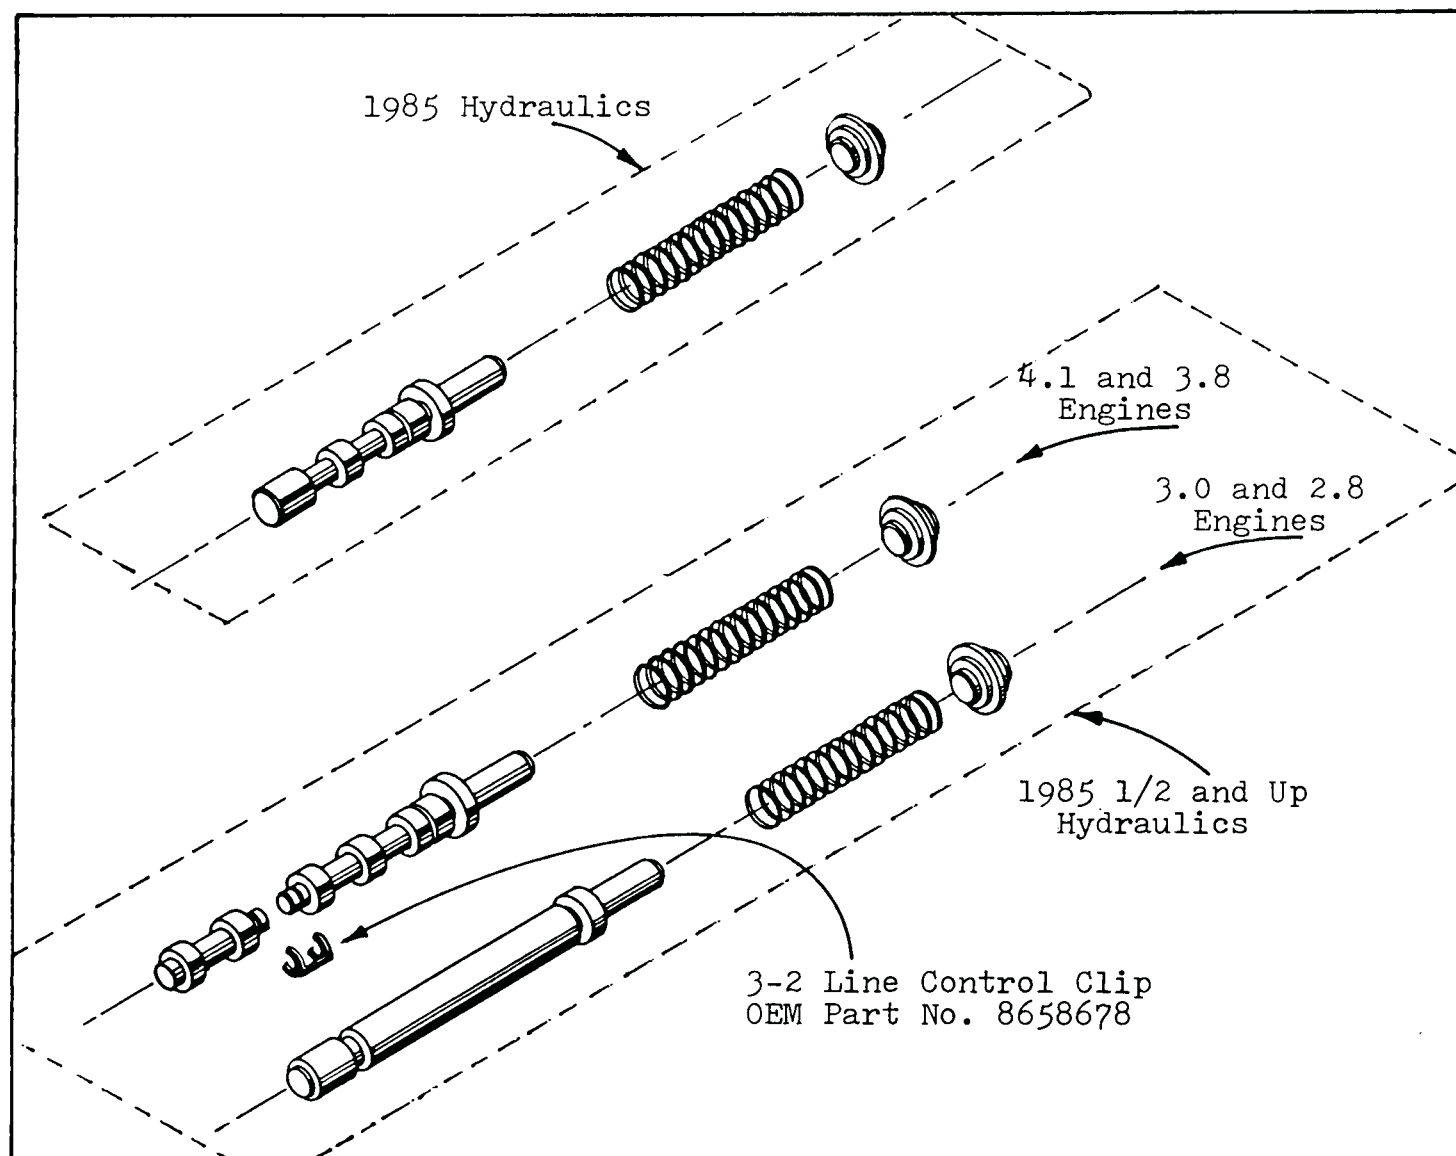
Figure 21

- 2) The 3-2 line control valve located in the channel plate (See Figure 20 For Location), was changed from a single valve, to a two piece valve (See Figure 21). The 2 piece is connected together with a small clip that has a bad habit of breaking, and will create no 3-2 downshift.

Also notice (See Figure 21) that there are 2 line ups for the 85 1/2 and up models. The 2 piece 3-2 line control valve is used on 4.1 Cadillac, and 3.8 Buick engines. The "Plug" that is also shown (Figure 21), is used on 3.0 Buick, and 2.8 Chevrolet engines.

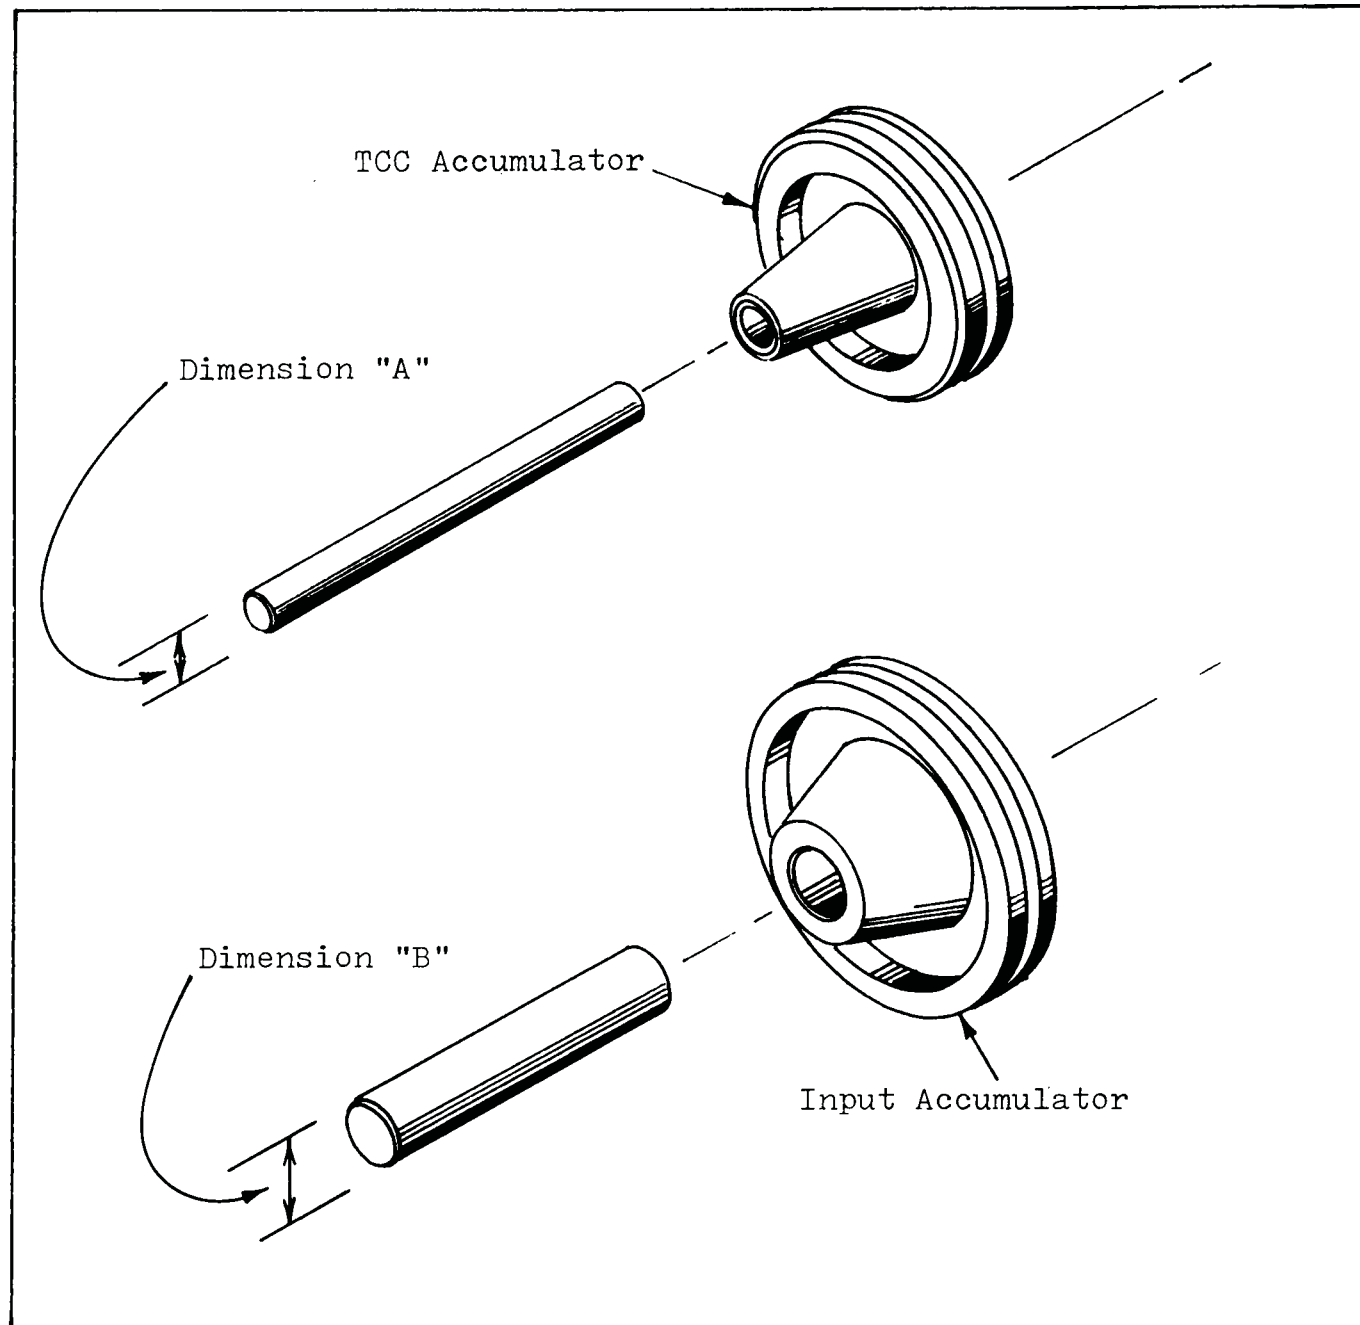
Figure 23

In mid 1985 the dimensions of both the TCC accumulator pin and piston, and the input accumulator pin and piston changed. We have included the dimensions of both early and late for identification purposes. (See Figure 23).

EARLY .309 Inches  
LATE .314 Inches

When the TCC accumulator pin is worn, or mismatched, TCC shudder is the result.

When the input accumulator pin is worn, or mismatched, input clutch durability is drastically reduced.

Obviously you would not be able to install the late pin into the early piston, but you could go the other way very easily. Make sure you measure these pins and "Always" up-date to the larger 2nd design.

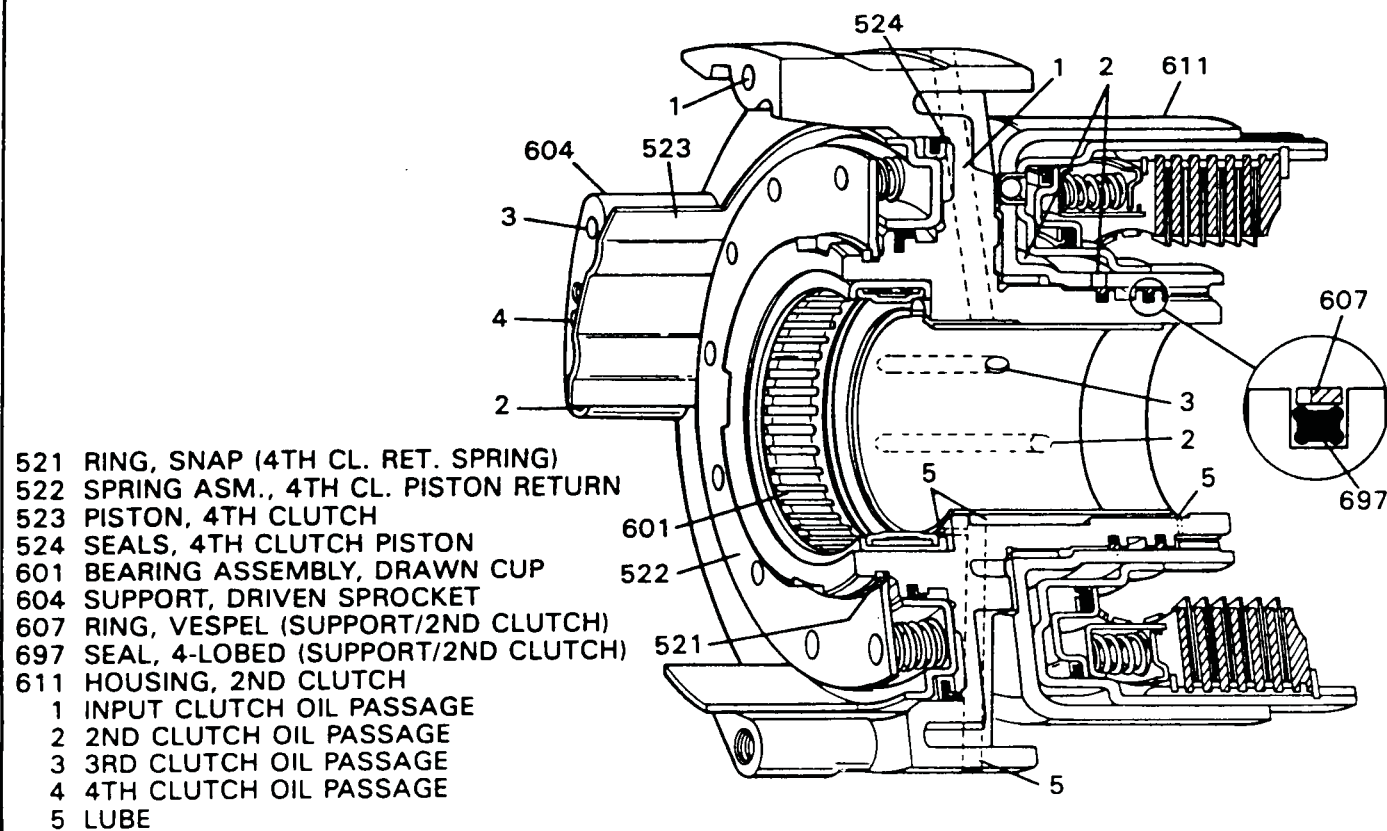
Figure 36

This change, also initiated in the 1987 models, related to 2nd clutch durability and was on the driven sprocket support. The 84-86 models have large steel, hook joint, sealing rings to feed the 2nd clutch. In 1987 models the steel rings were replaced with "Vespel" (Plastic), step joint, sealing rings, that have tabs on them to prevent them from spinning in the driven sprocket support (See Figure 37). This made it necessary to machine slots in the driven sprocket support, to accept the tabs on the "Vespel" rings. There is also a special 4 lobe ring that goes in the ring groove under the "Vespel" ring, and acts as an expander for the "Vespel" sealing rings (See Figure 36).

- 1) Driven Sprocket Support ----- 8662523
- 2) "Vespel" Sealing Ring ----- 8662330
- 3) 4 Lobe Ring (Expander) ----- 8662329

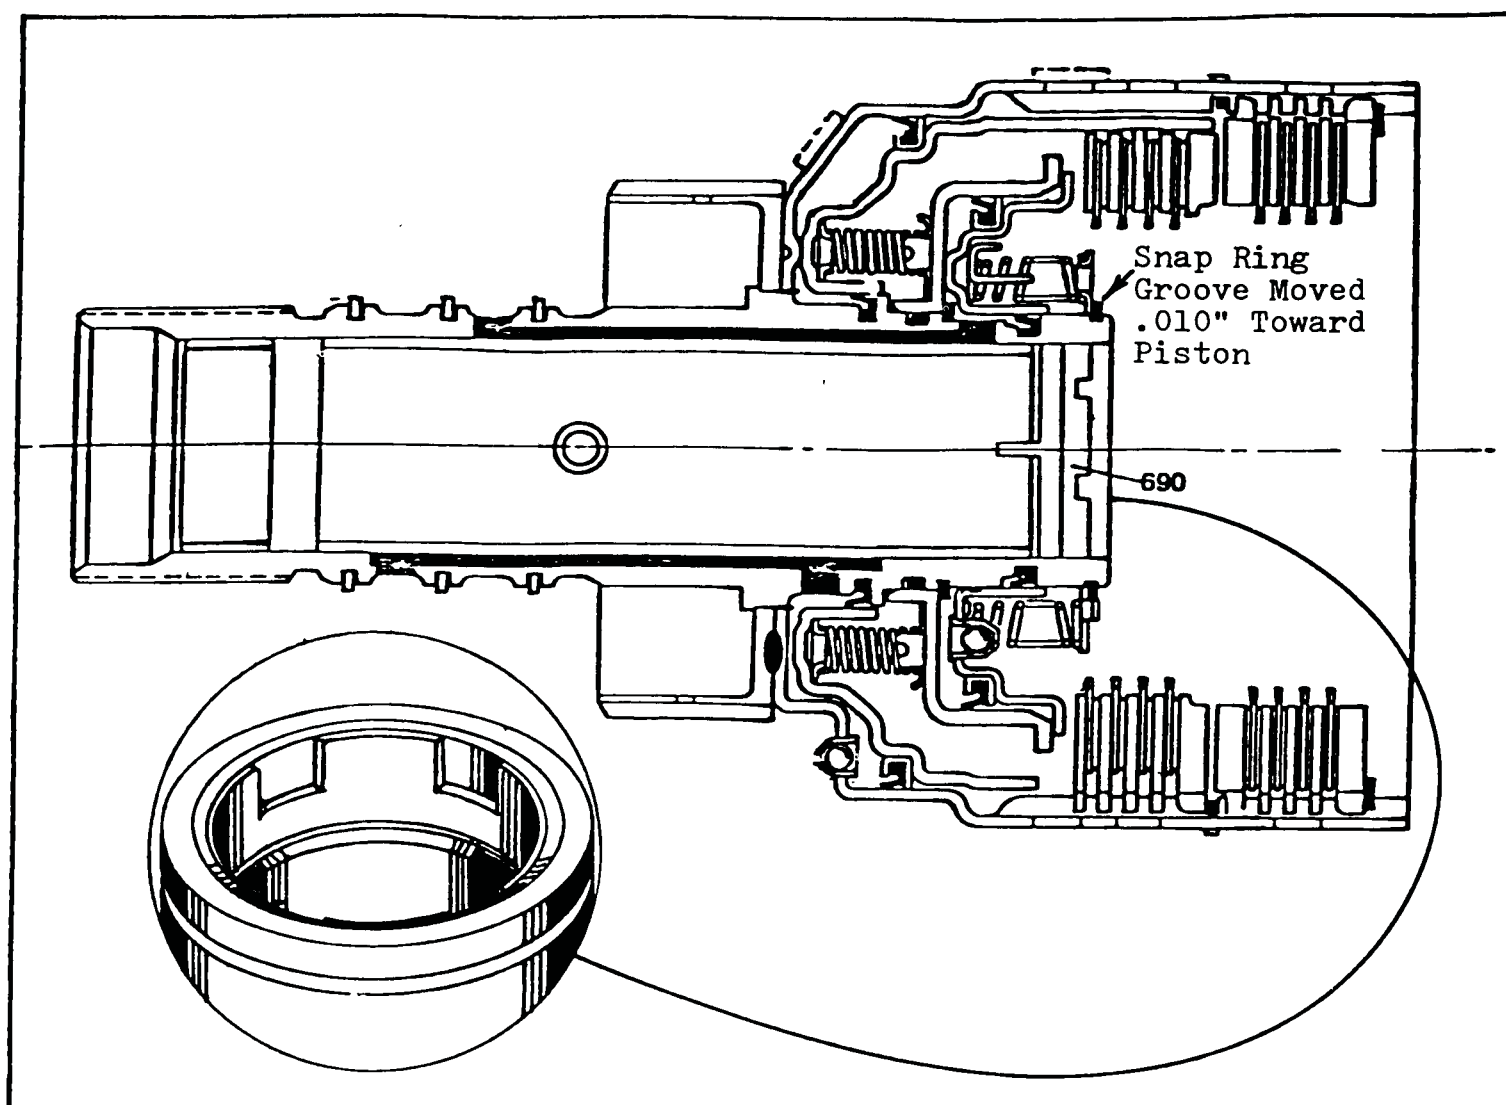
Figure 42

NOTE: If new input housing is purchased, be sure to remove (690) sleeve from old input housing and reinstall in the new input housing, as it does not come with the new input housing (See Inset, Figure 42).

This (690) sleeve has notches in it to accept the tangs of the "Top Hat" washer to prevent the washer from spinning in the housing (See Inset, Figure 42).

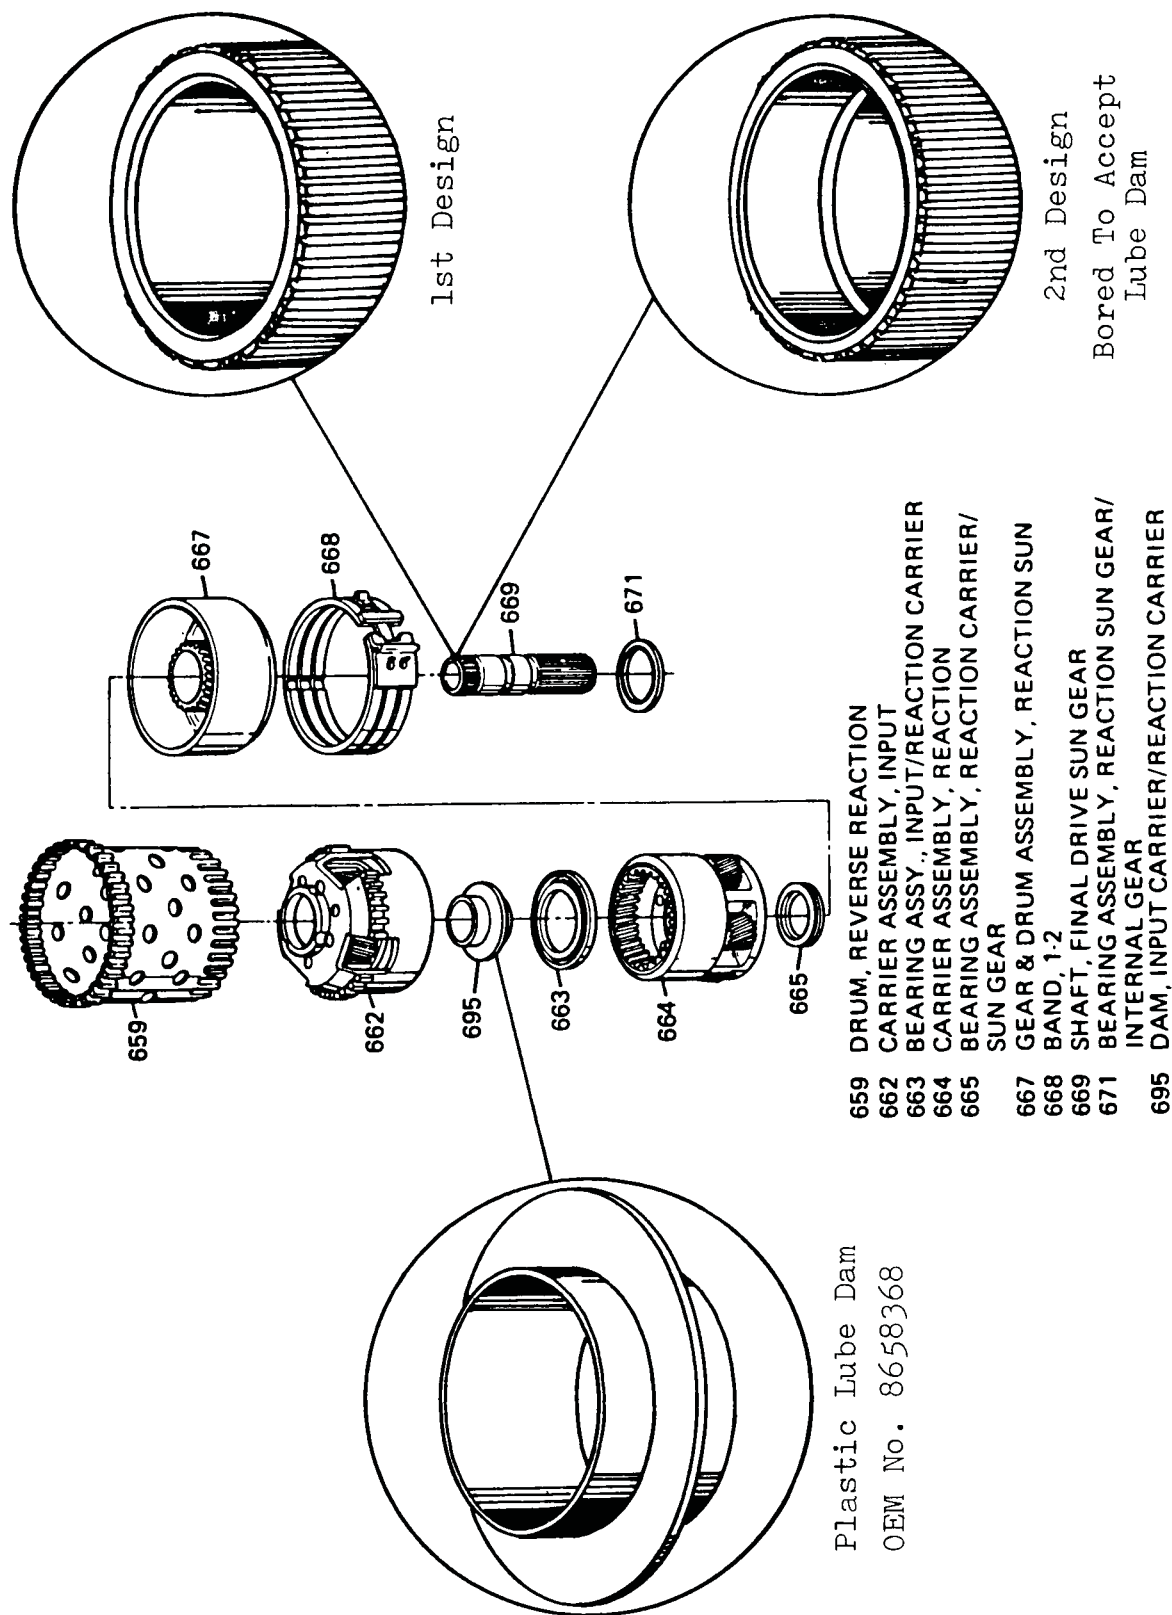
Figure 44

Change: Addition of plastic lube dam (695) between carriers.  
(See Figure 44).

- 1) Input Carrier(662) (Figure 44) - Bored larger on inside diameter to accept added lube dam.
- 2) Output Shaft(565) (Figure 45) - Machined shoulder on output shaft to accept added lube dam (See Inset, Figure 45).
- 3) Final Drive Sun Gear Shaft(669) (Figure 44) - Inside diameter bored larger on one end to accept added lube dam. (See Inset, Figure 44).

You can use input carrier, output shaft, or final drive sun gear shaft, in any configuration that you want to (Mix and Match), AS LONG AS THE INPUT CARRIER IS NOT BORED FOR THE LUBE DAM. If the input carrier is bored for the lube dam, you MUST use the lube dam. If you use the lube dam, you MUST use the 2nd design output shaft, and the 2nd design final drive sun gear shaft (See Figures 44 and 45).

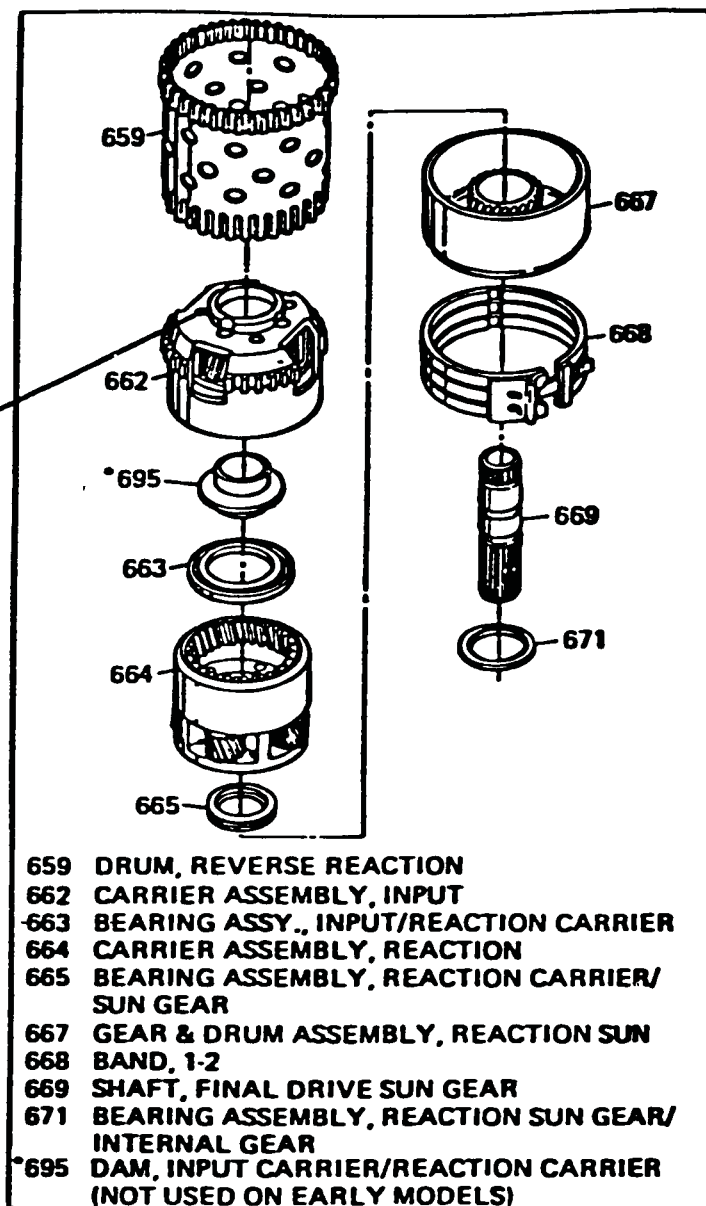
Figure 46

CAUTION: The input carrier must be replaced or modified as per specifications in Figure 46. If not replaced or modified, an interference will result and damage to the transaxle. The lip protruding on top of the input carrier must be machined to meet the dimension shown in Figure 46. Extra care must be used in the machining process, as the torrington bearing will not come out of the input carrier.

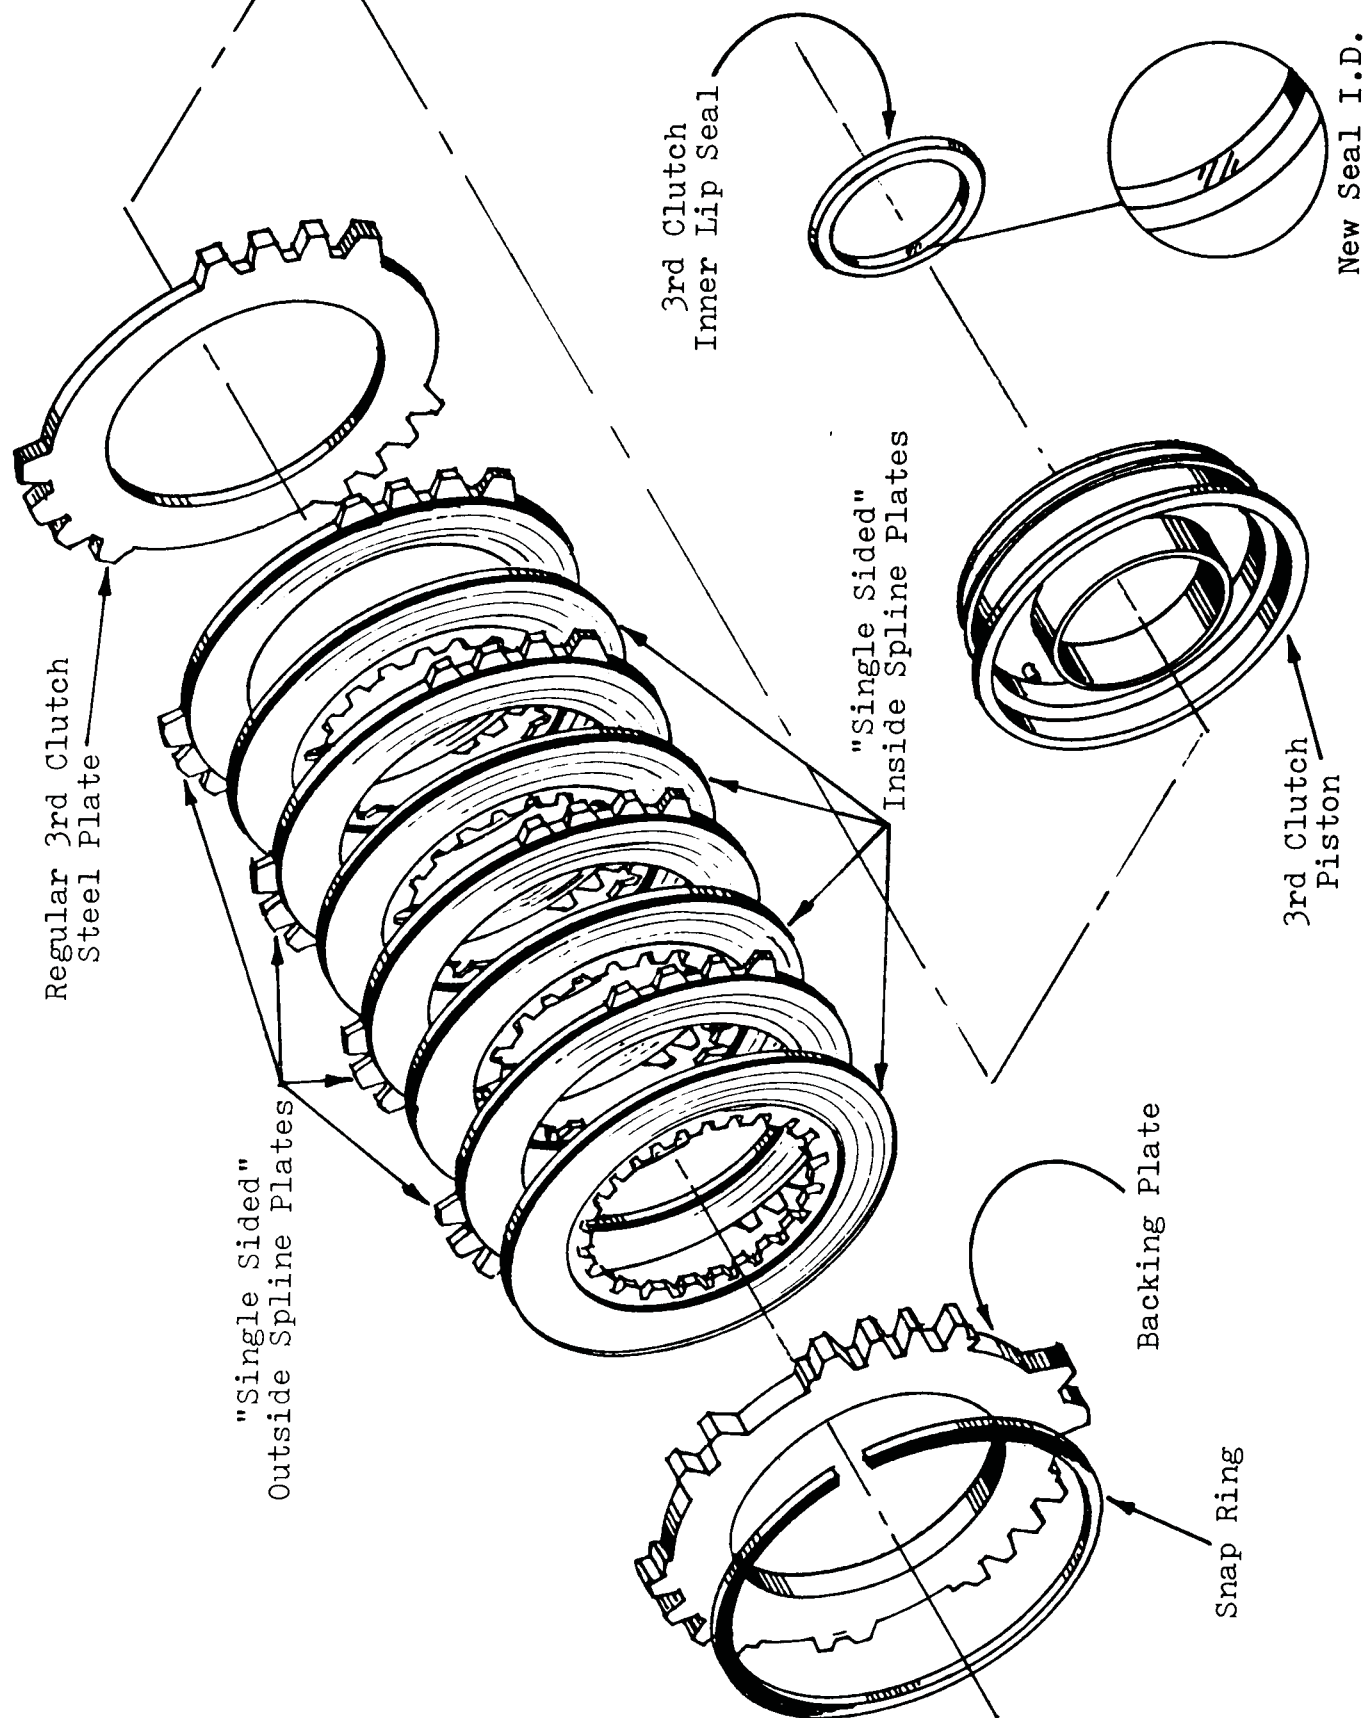
Figure 51

Will retro fit backwards, and is recommended. New OEM Part No. is 8662673 on the new 3rd clutch lip seal. For positive identification of the new seal, check for hash marks on inside diameter of lip seal (See Inset, Figure 51). For difference in profile compare Inset "A" and "B" in Figure 52.

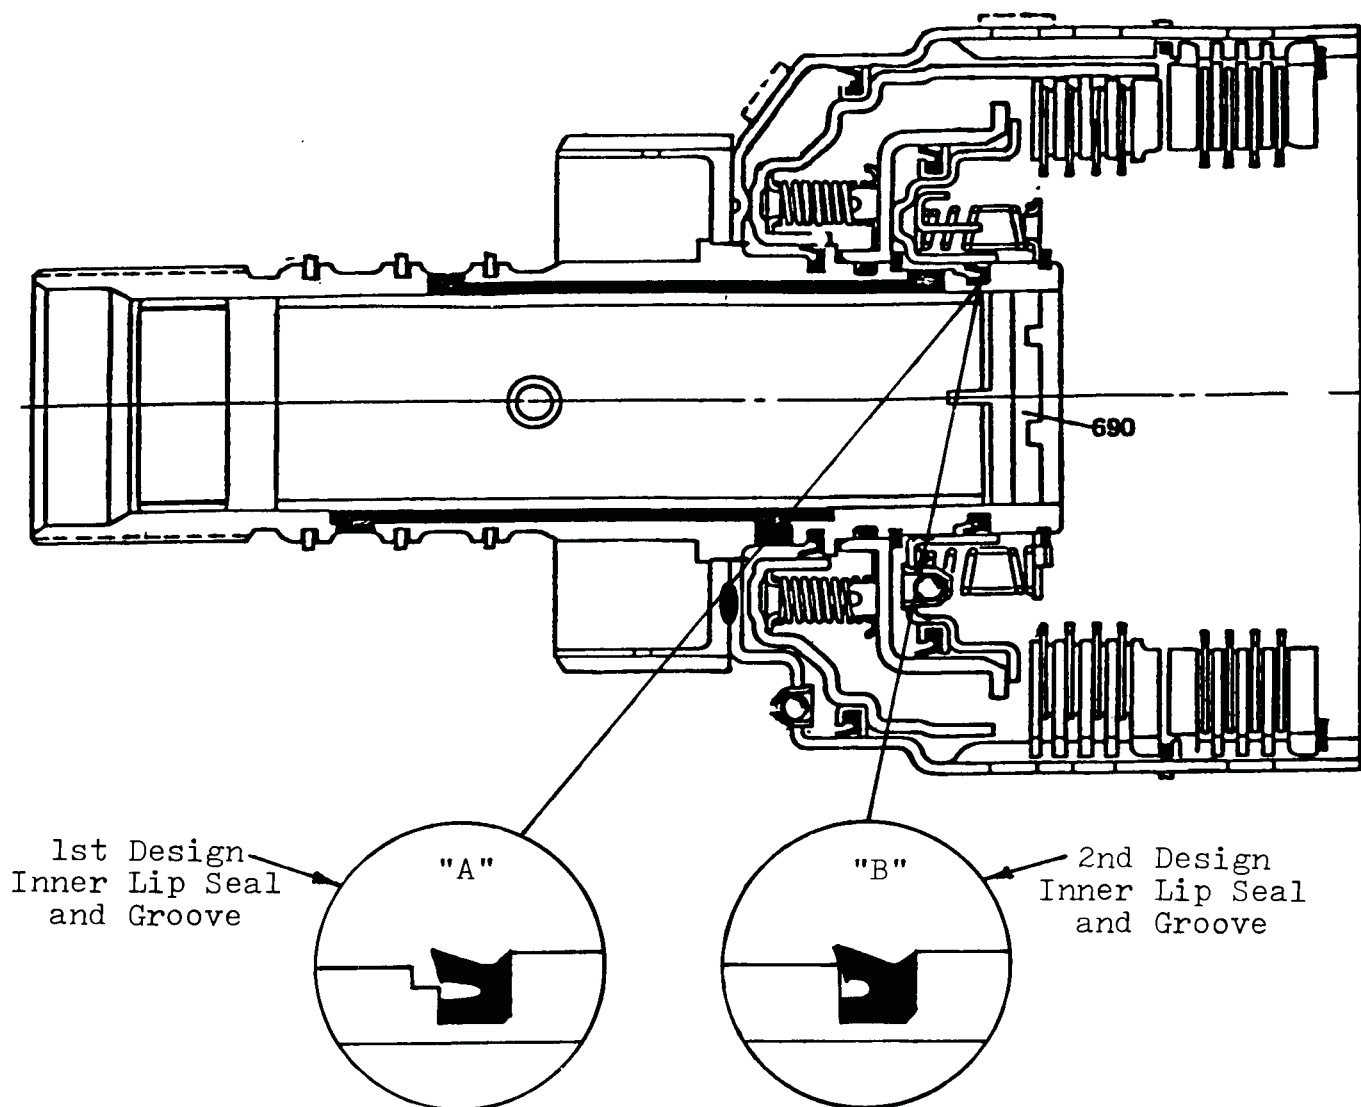
Figure 52

- 1) 3rd Clutch Inner Lip Seal - Thicker profile to help prevent seal from rolling (See Inset, Figure 52).

- 1) Input/3rd Clutch Housing - One machining process eliminated in groove for the 3rd clutch inner lip seal, which provided more support for the lip seal to prevent it from rolling.  
(Compare Inset "A" and "B", Figure 52).

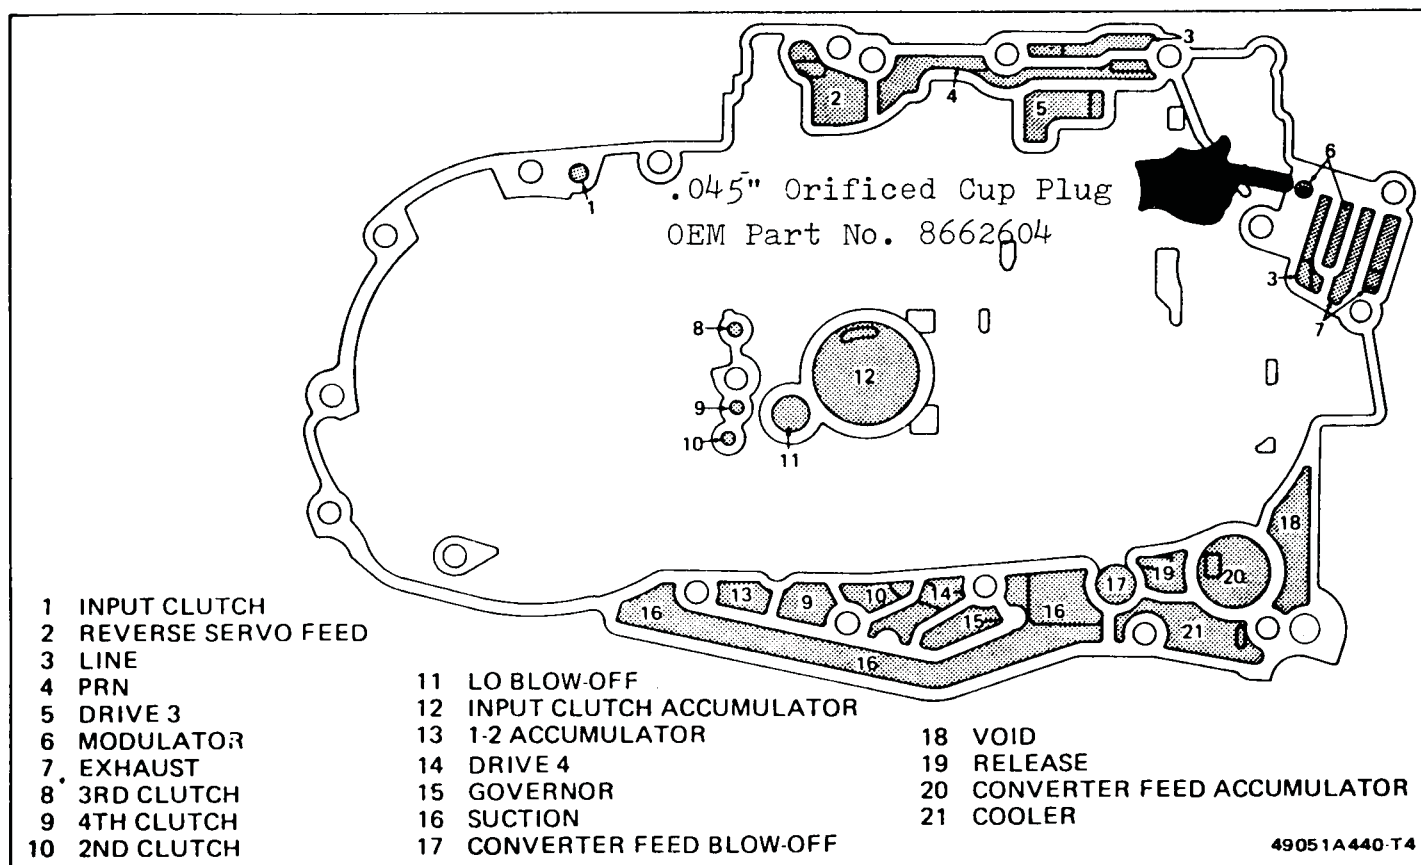
Figure 53

- 1) Vacuum Modulator - Late design has plunger sticking out of modulator (See Figures 54 and 55).
- 2) Modulator Valve - Redesigned to be compatable with "Plunger" style modulator. (Stem Removed--See Figures 54 and 55).
- 3) Channel Plate - Orificed cup plug added to channel plate to stabilize modulator valve action (See Figure 53).

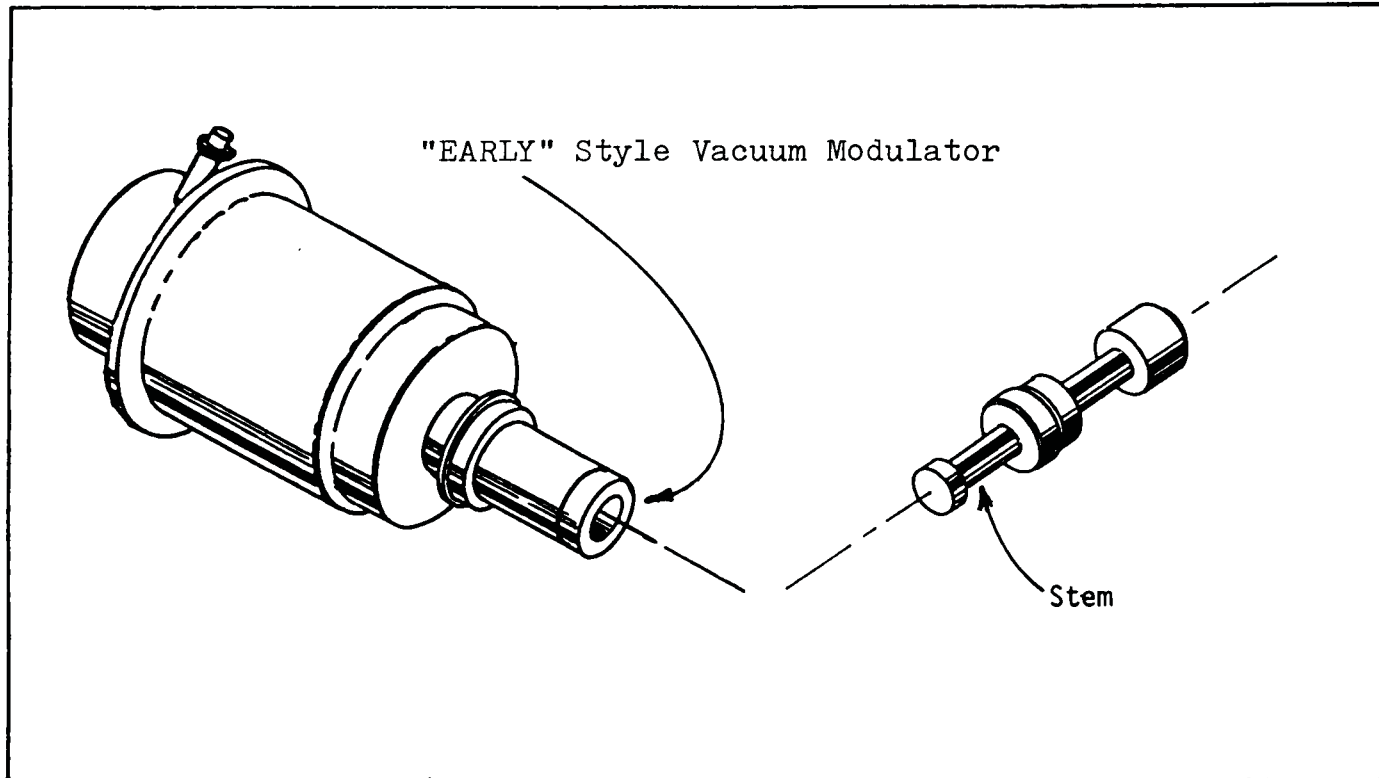
Figure 54

Change: Modulator redesigned on the end that goes into transaxle.  
(Compare Figures 54 and 55). Occured Approx. July, 1986.

**CAUTION:** Be certain, if changing modulators, that you have compatable parts together. You cannot install the late style modulator on top of the early style valve, but you can go the other way very easily.

If you install the early style modulator on top of the late style valve, you lose all modulator boost, and clutch damage will occur in about 15 minutes of normal vehicle operation.

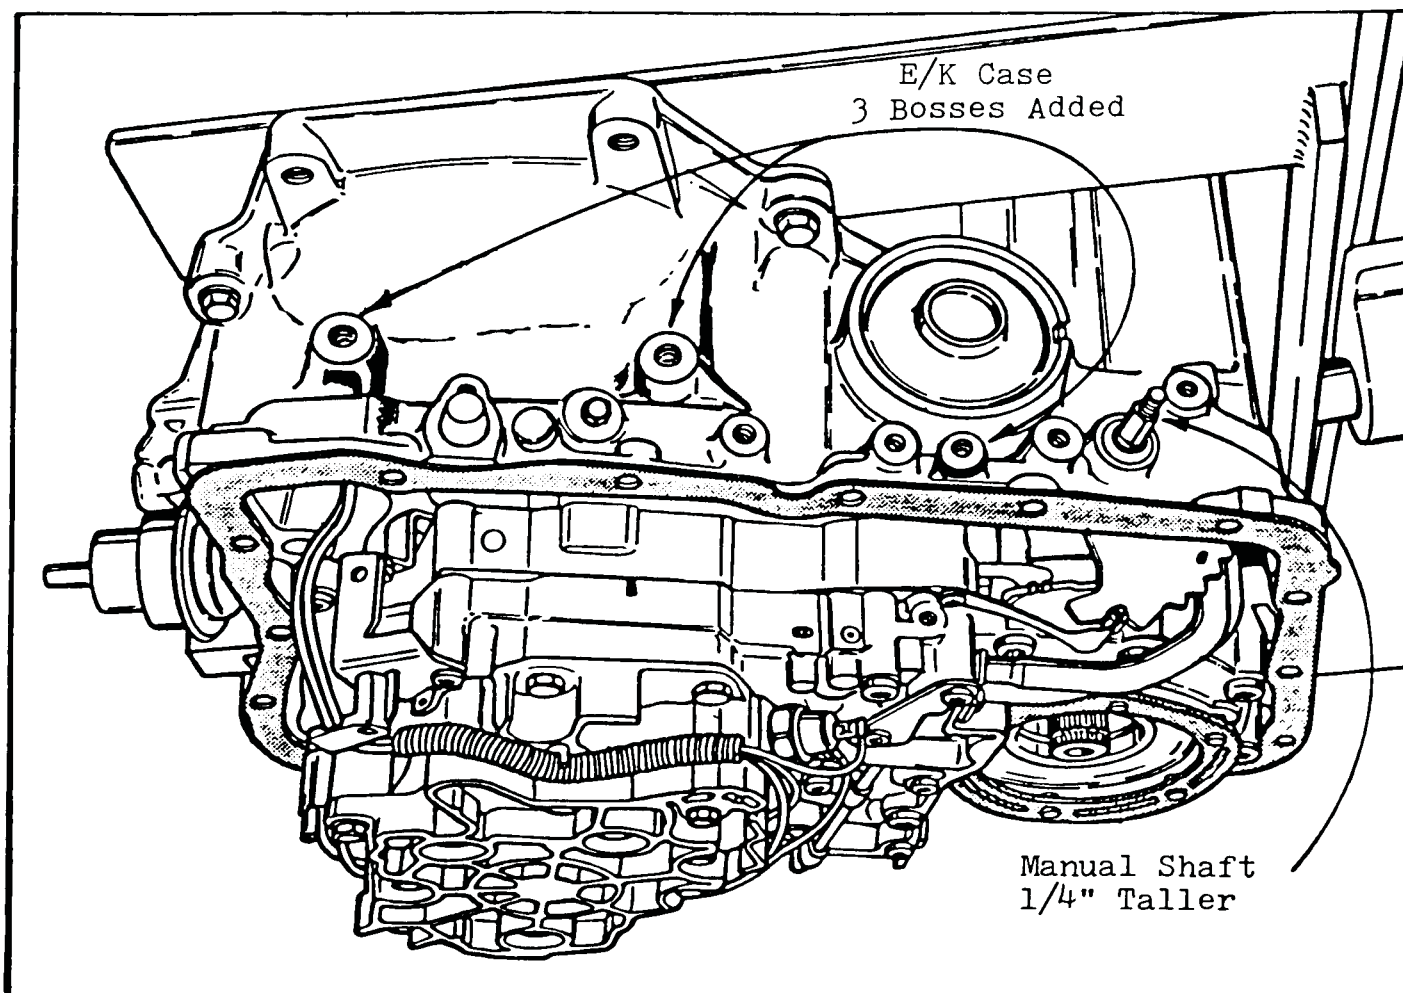
Figure 56

**Change:** Transaxle Case Assembly - 3 bosses added to transaxle case assembly (See Figures 56 and 57).

- 1) Transaxle Case - 3 bosses added to the case assembly (See Figures 56 and 57). The larger bosses on top of the case are for mounting purposes in the "E" and "K" bodies only. The smaller boss is for fuel line bracket in the "E" and "K" bodies only (See Figure 56). We can immediately see why it is called the E/K case.
- 2) Manual Shaft - The manual shaft is 1/4" longer on the E/K cars only.
