**AUTOMATIC TRANSMISSION SERVICE GROUP**

## INTRODUCTION

Since the introduction of the THM 440-T4 Transaxle in April, 1984, there have been many major engineering design changes. These changes have affected nearly every part used in the THM 440-T4. This Update Handbook will explain each change, the parts affected by the change, and any parts interchangeability problems created by the change.

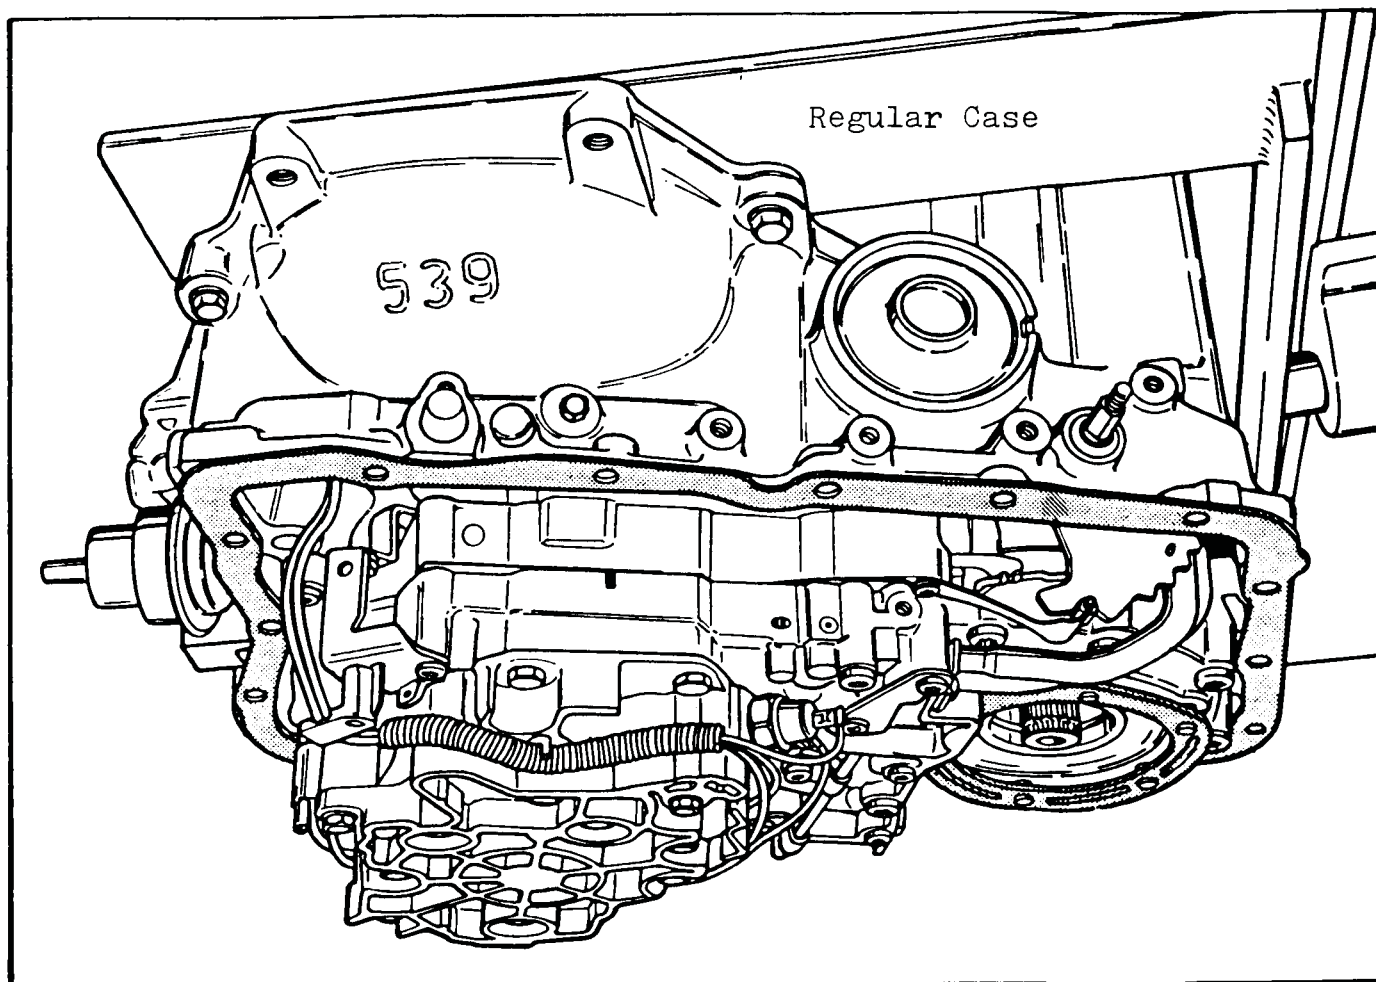
Figure 57

**Change:** Transaxle Case Assembly - 3 bosses added to transaxle case assembly (See Figures 56 and 57).

- 1) Transaxle Case - 3 bosses added to the case assembly (See Figures 56 and 57). The larger bosses on top of the case are for mounting purposes in the "E" and "K" bodies only. The smaller boss is for fuel line bracket in the "E" and "K" bodies only (See Figure 56). We can immediately see why it is called the E/K case.
- 2) Manual Shaft - The manual shaft is 1/4" longer on the E/K cars only.

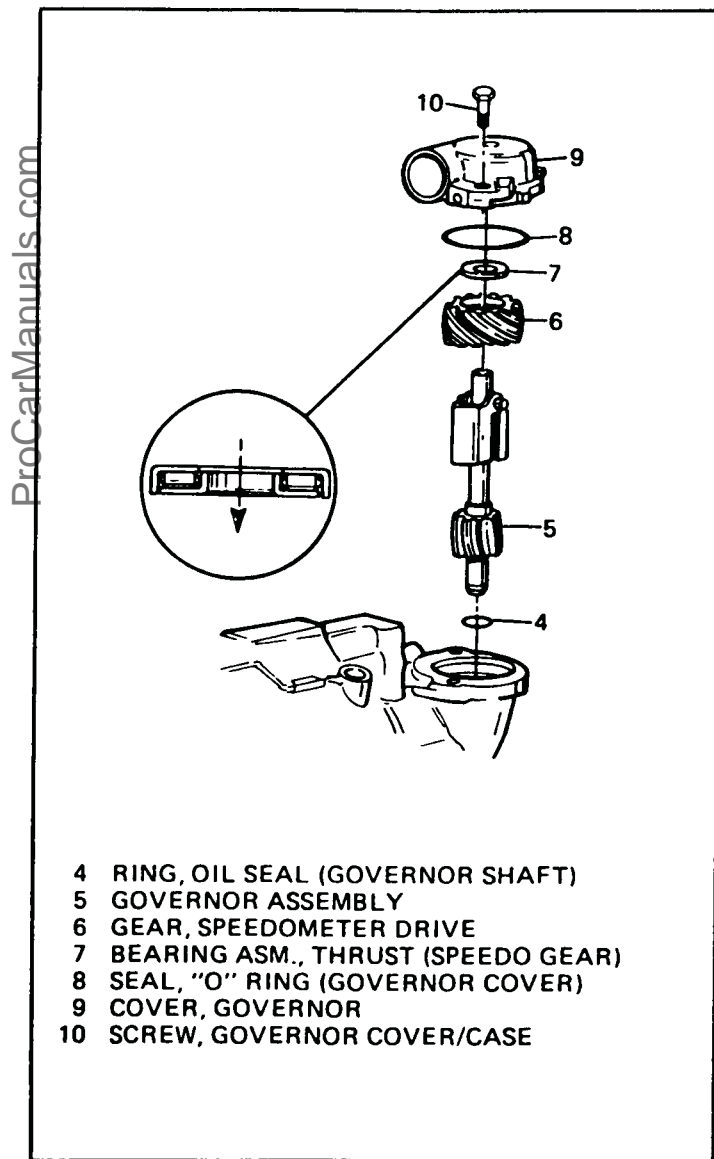
Figure 58

- 1) Governor Cover - Redesigned and speed sensor added to governor cover (See Figures 58 and 59).
- 2) Speedometer Gear - Replaced by 14 tooth rotor (11 Tooth on Allante) That is pressed on governor shaft (See Figure 59).

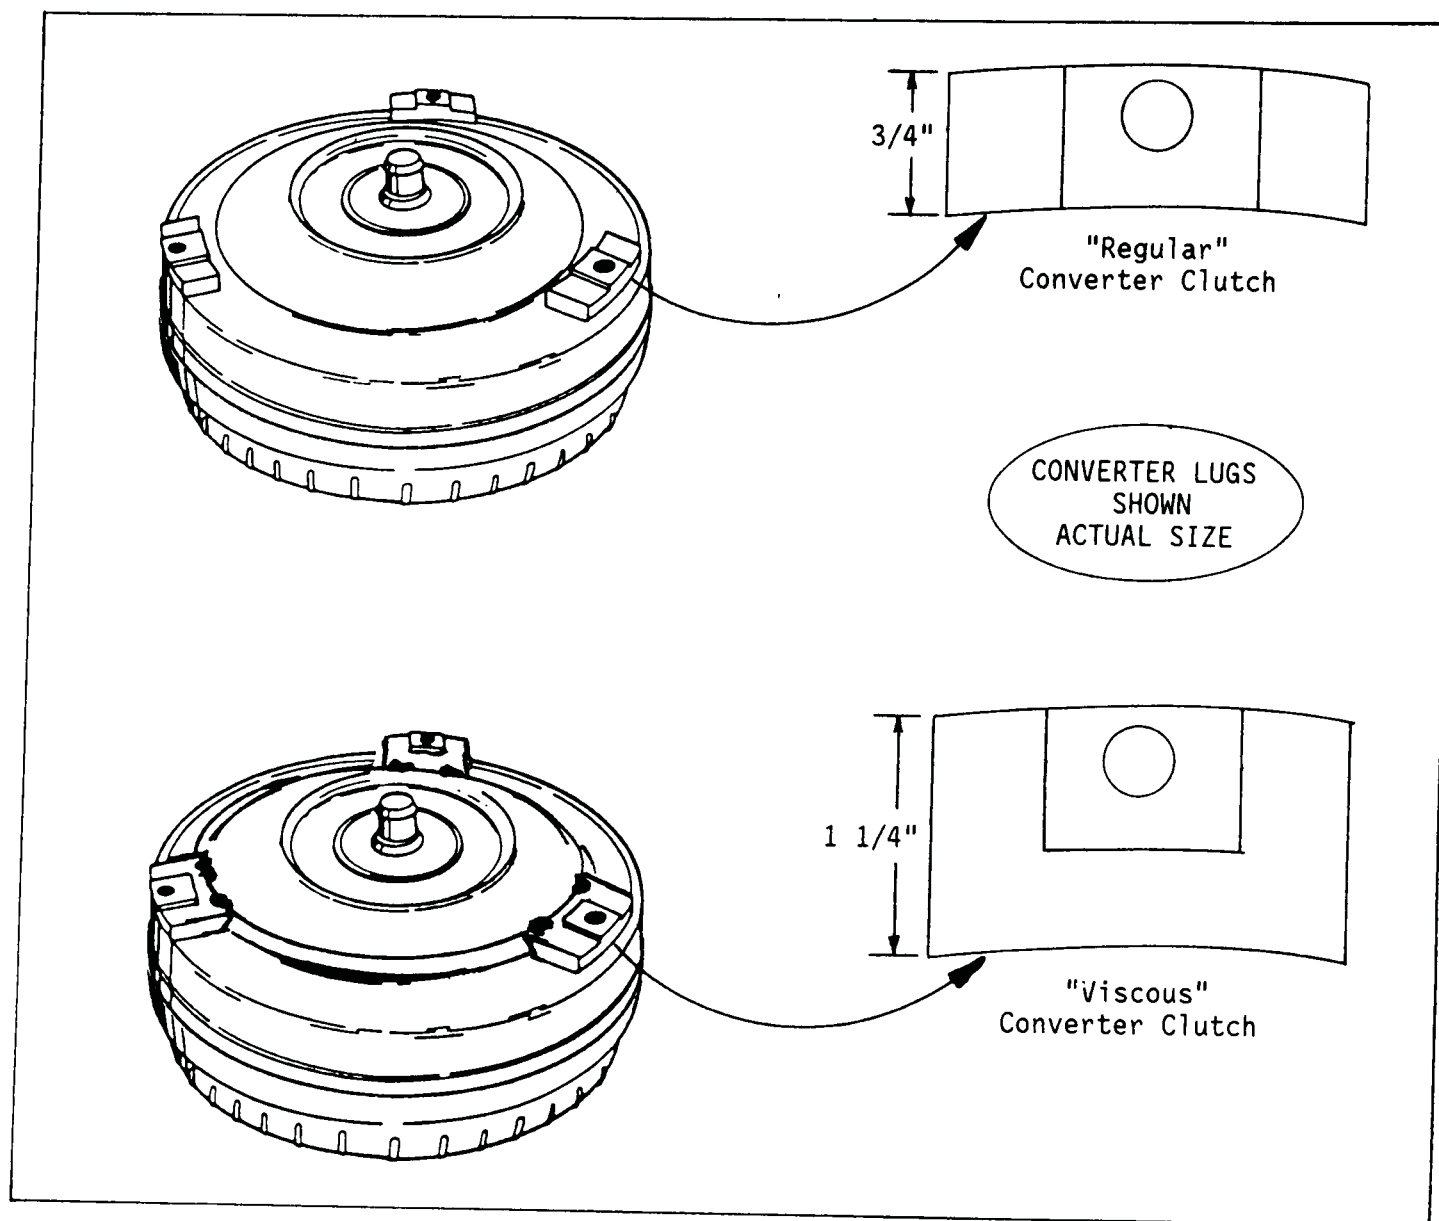
Figure 60

Identification of the "VISCOUS" converter from the "REGULAR" converter, can be done very easily externally. Notice the difference in the size of the converter drive lugs (see Figure 60). The profile of the converter covers are also different, but takes a closer look to detect, than do the drive lugs.

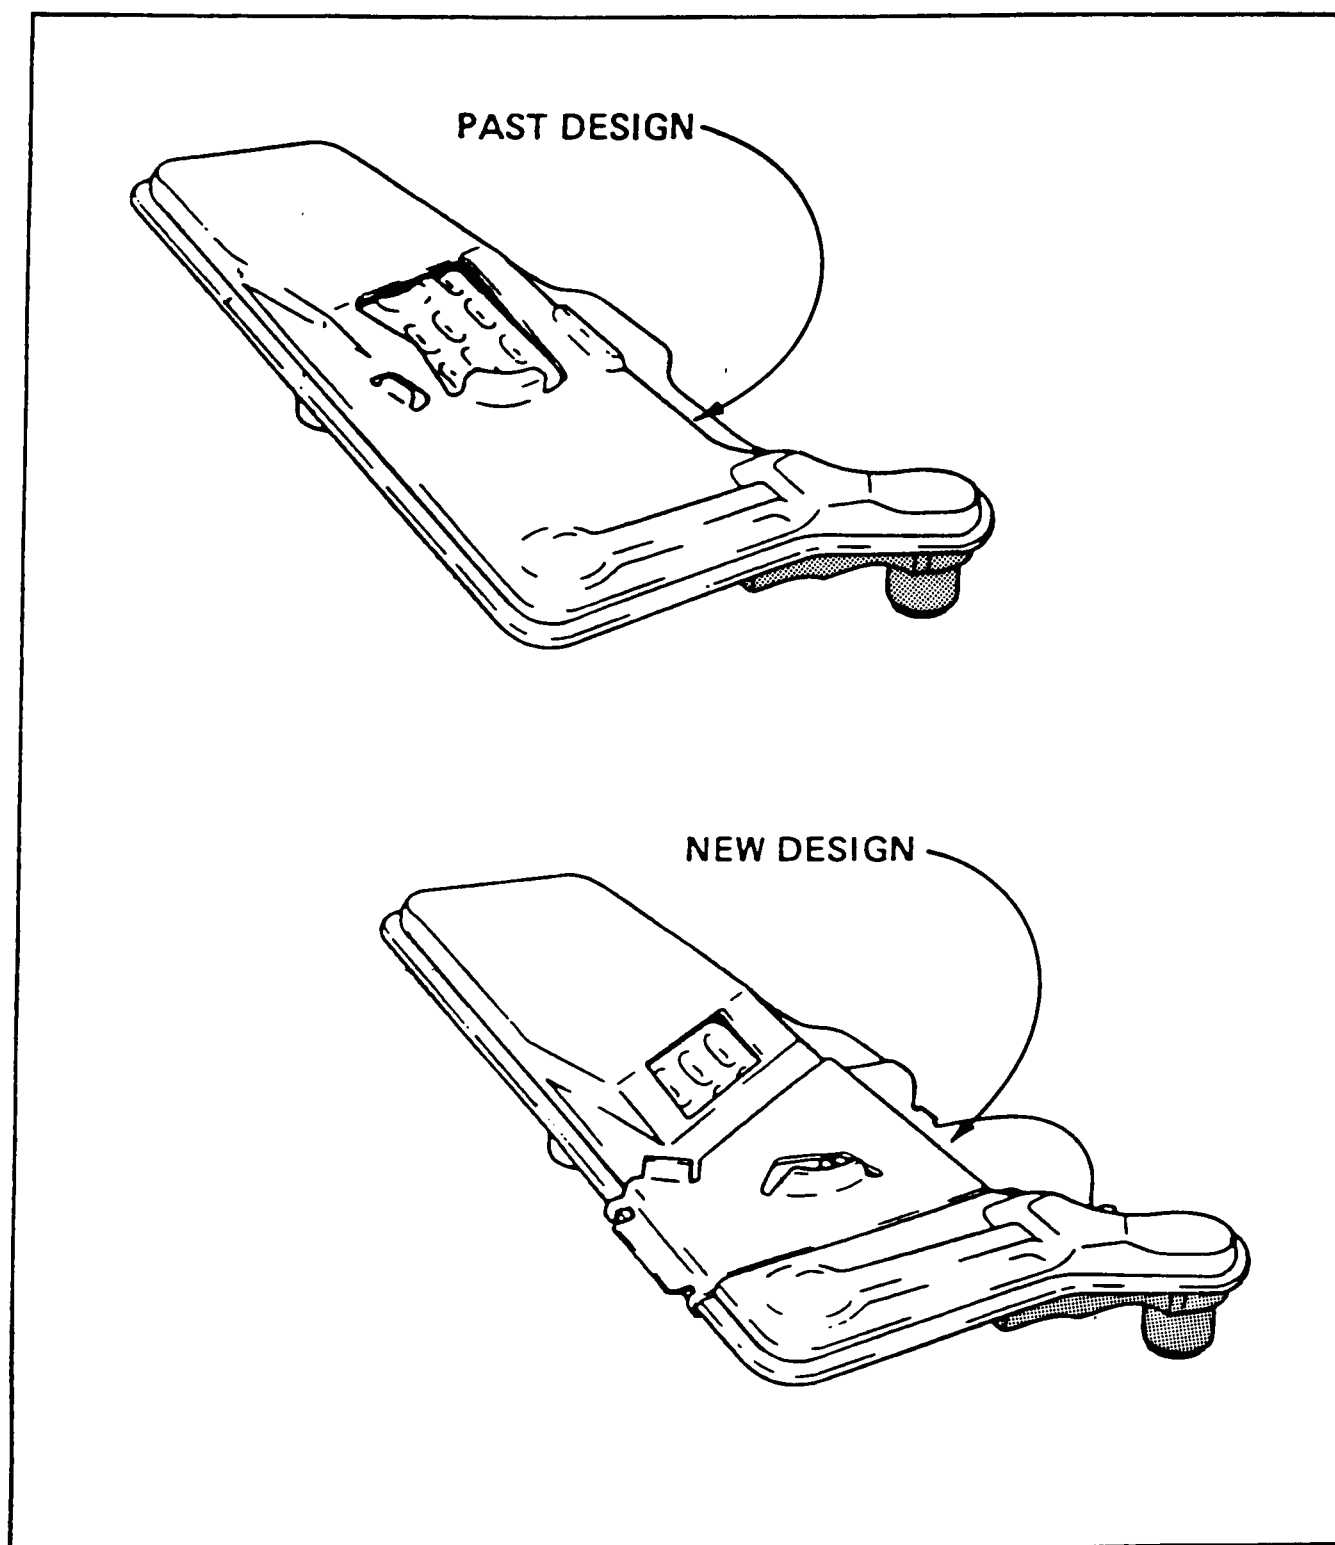
Figure 68

CHANGE: Oil Filter Assembly - Added baffles to oil filter and revised inlet (See Figure 68).

Additional baffles were installed on the new design filter and the inlet was revised (See Figure 68). Starting April 6, 1987 (Julien Date 096), all THM 440-T4 transaxles were built using the new design filter with the new inlet and baffle design.

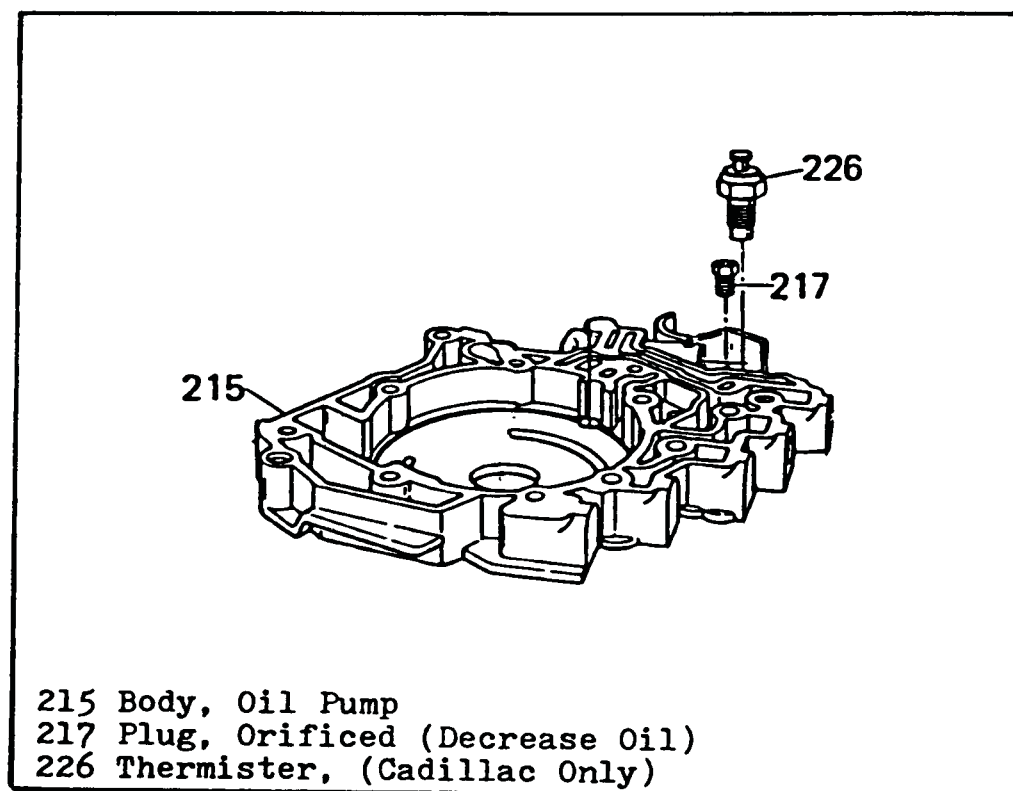
Figure 72

**CHANGE:** Thermister located in oil pump housing moved into cooler line (See Figures 72 & 74). Temperature switch in channel plate was also eliminated (See Figure 73).

- (1) Thermister - Removed from pump housing (See Figure 72).
- (2) Temperature Switch - Eliminated (See Figure 73).
- (3) Cooler Line - Temperature Sensor added (See Figure 74).
- (4) Case Connector - "E" terminal that normally carried the thermister wire is now empty (See Figure 75).
- (5) Vehicle Wiring Harness.

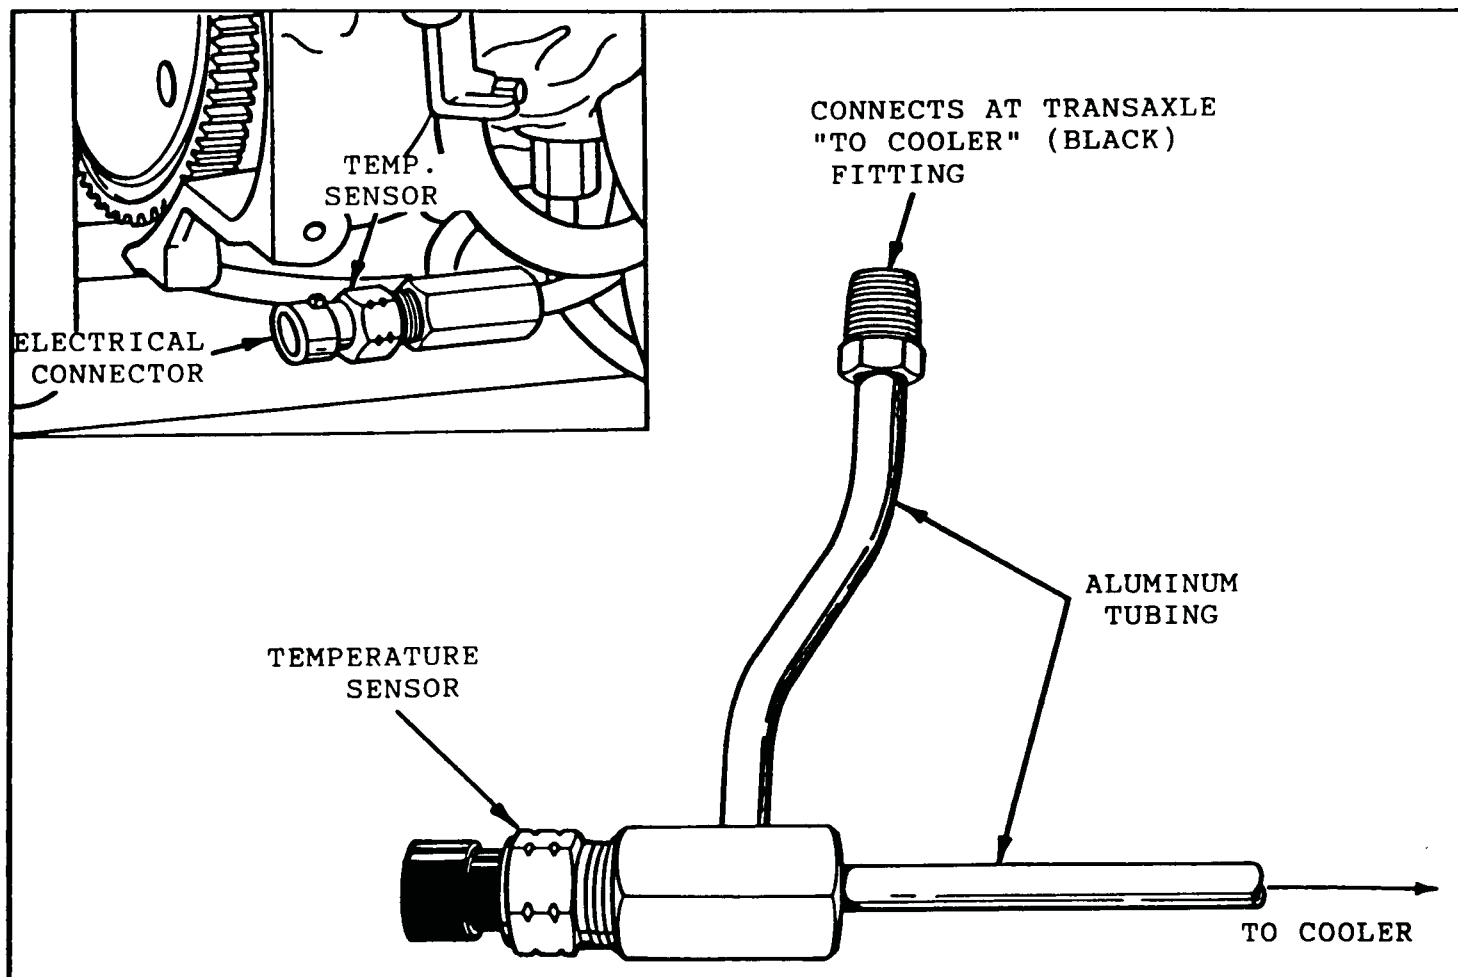
Figure 74

**NOTE:** SOME EARLY 1988 CADILLAC MODELS MAY HAVE "NO" COOLER FLOW CREATED BY NEW TEMPERATURE SENSOR IN COOLER LINE. CHECK COOLER FLOW ON "ALL" 1988 CADILLAC MODELS AND REPLACE COOLER LINE ASSEMBLY WITH OEM PART NUMBER 25036979 IF NECESSARY.

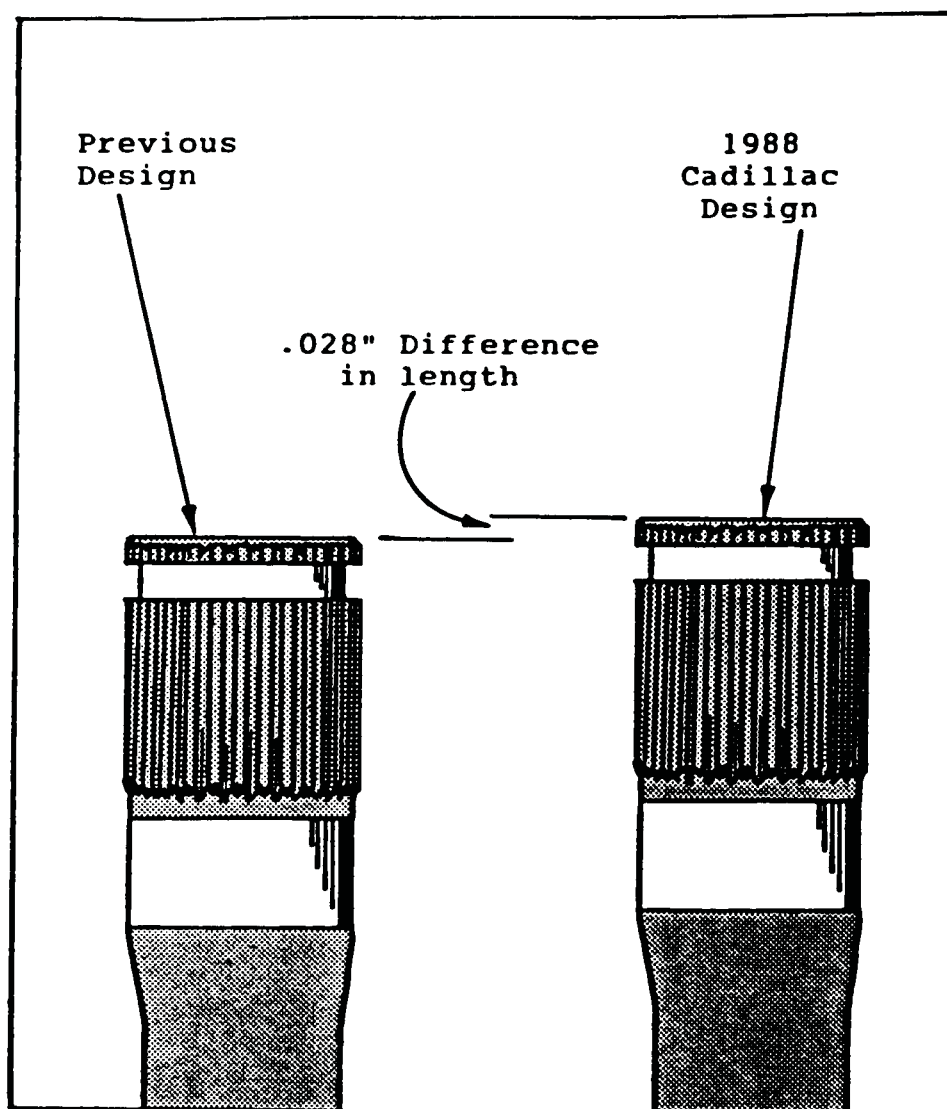
Figure 80

- (1) Differential Side Gears - Revised dimension (Thicker), and they have 16 teeth instead of previous 15.
- (2) Differential Pinion Gears - Revised dimension, and have 10 teeth instead of previous 11.
- (3) Side Gear Thrust Washers - Revised dimension.
- (4) Pinion Gear Thrust Washers - Revised dimension.
- (5) Differential Housing - Revised dimensions (Internal), to accept new side gears and new pinion gears.
- (6) Differential Pinion Shaft - Black in color to identify the new design final drive assembly (See Figure 79). Also is a smaller diameter.
- (7) Output Shaft - Longer (.028"), so that it will extend through the thicker side gears, to get "C" clip installed. The longer output shaft can be identified by green paint on the end of the shaft opposite the "C" clip end (See Figure 80).

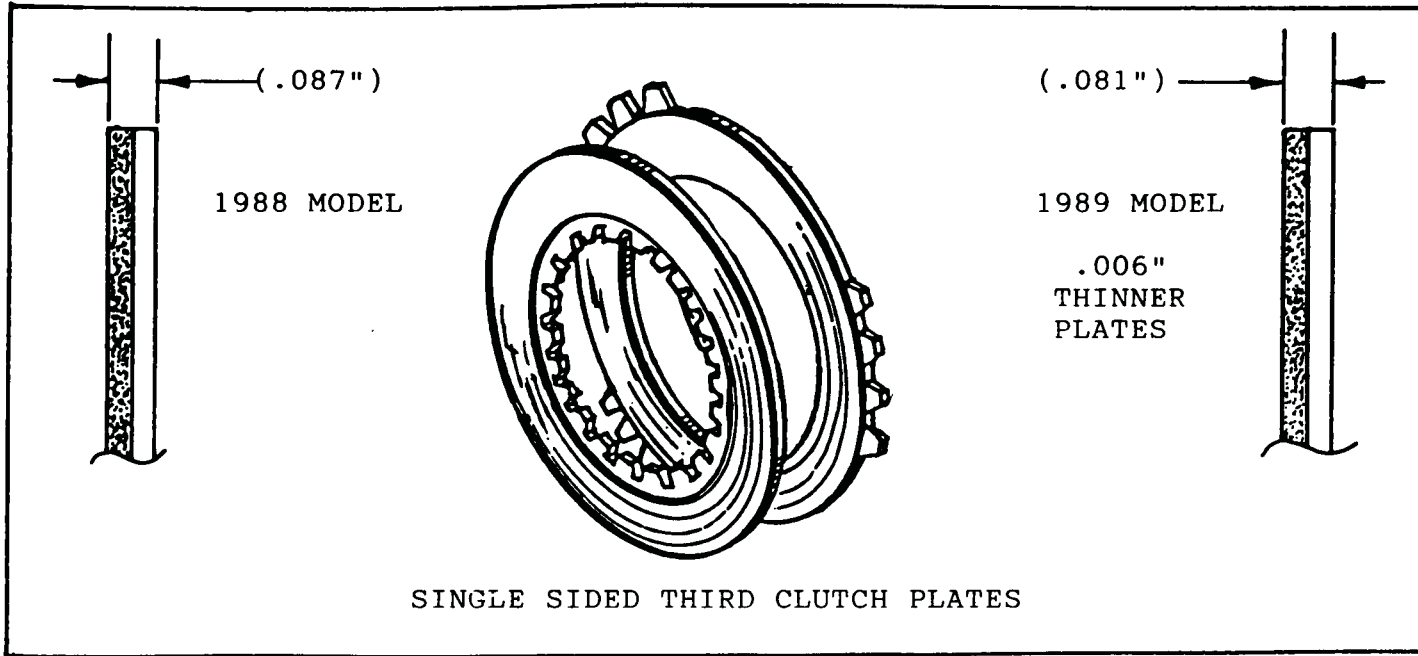
Figure 82

- (1) Single Sided 3rd Clutch Plates - Both inside and outside spline plates are .006" thinner for 89, to make room for the two additional plates (See Figure 82).

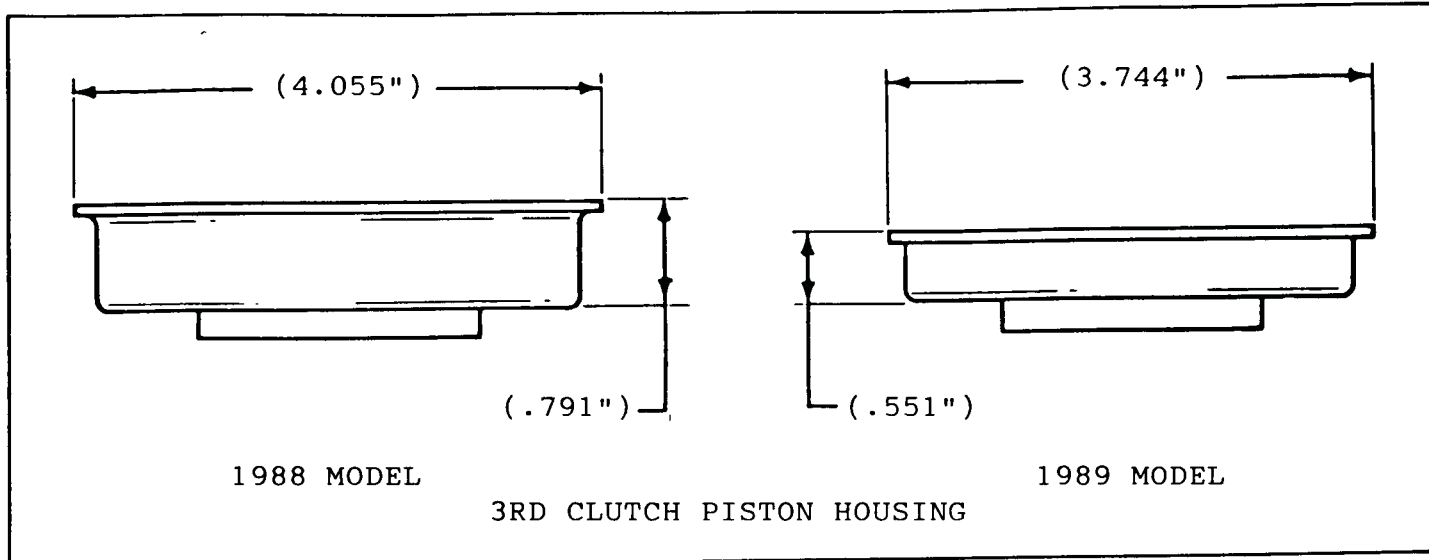
Figure 83

- (2) 3rd Clutch Piston Housing - Was decreased in overall size for calibration considerations (See Figure 83).
- (3) 3rd Clutch Piston - The 3rd clutch piston outer seal is now moulded to the 3rd clutch piston (See Figure 84).

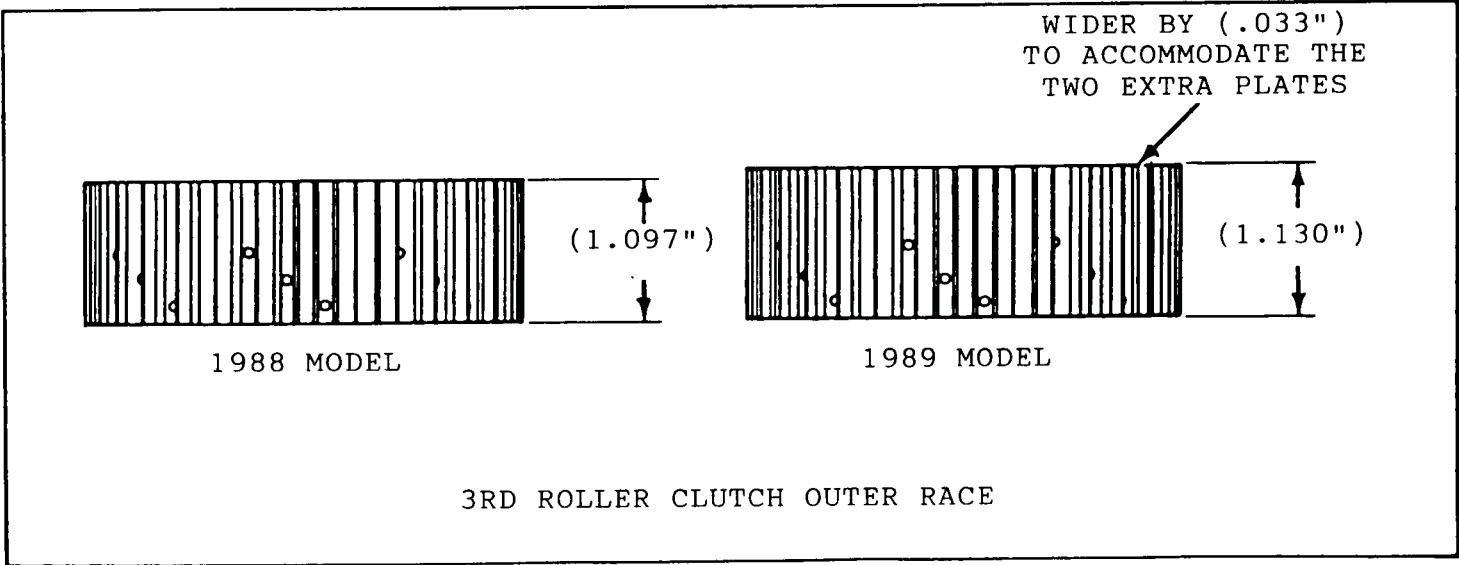
Figure 85

- (4) Input Clutch Piston - The cutouts in the piston for the 3rd clutch plates are .250" deeper to accomodate the additional two clutch plates in the 3rd clutch pack (See Figure 85).

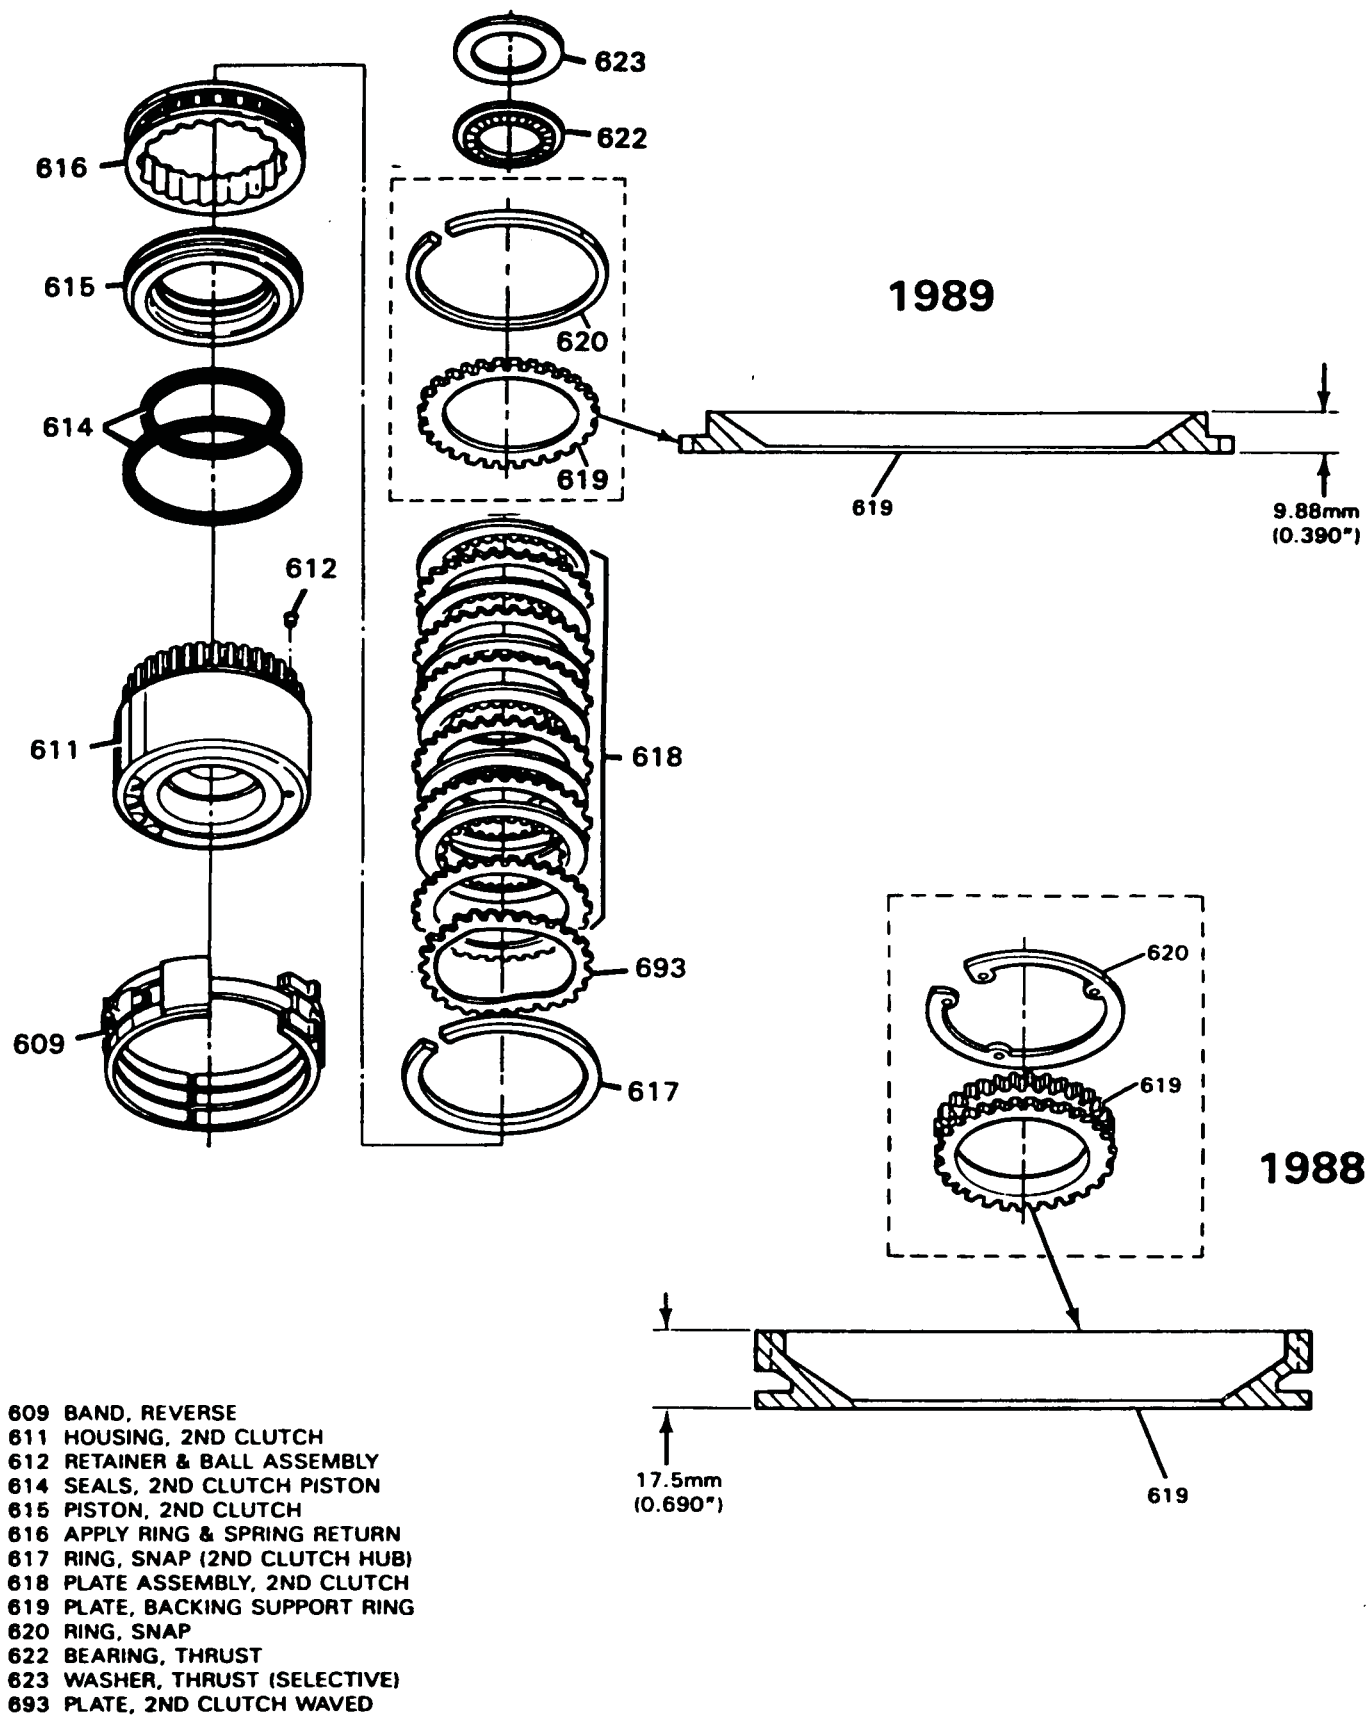
Figure 88  
89

CHANGE: 2nd Clutch Backing Plate was redesigned (See Figure 88).

- (1) 2nd Clutch Backing Plate - "Windows" in backing plate are eliminated which makes the backing plate less prone to warpage. Also notice (See Figure 88) that the support ring has been eliminated from the backing plate and is no longer used, because "Engine Torque Management" was added as an ECM function. This was one of the reasons for the addition of the 2nd clutch switch in 1988.
- (2) 2nd Clutch Backing Plate Snap Ring - The new snap ring is only half as wide as the previous models and must be used with the third design backing plate.

2nd Clutch Backing Plate (3rd Design).....8668566  
2nd Clutch Snap Ring (3rd Design).....8668567

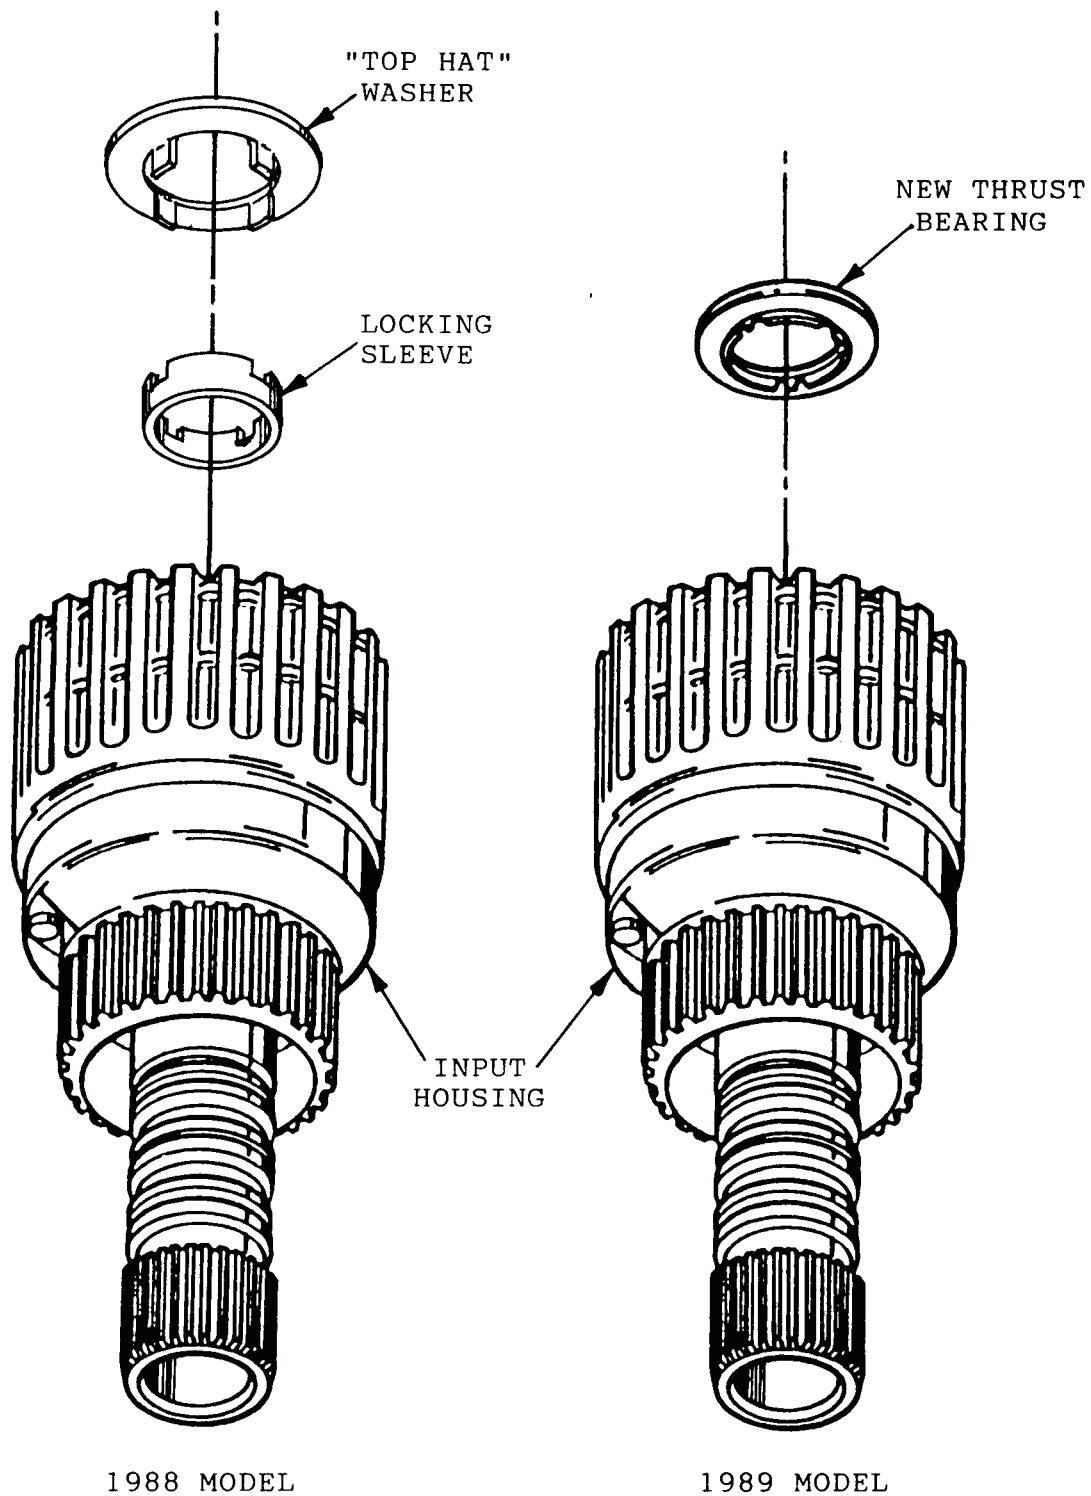
Figure 89

**CHANGE:** A new Thrust Bearing Assembly replaces the "Top Hat" Thrust Washer and Lock Up Sleeve in the input housing. (See Figure 89). The new bearing and related parts went into production on all 1989 models on November 28, 1988 (Julian Date 333).

Thrust Bearing Assembly (New Design).....8668422  
3rd Roller Clutch Complete (New Design).....8657046  
Service Package.....8662970  
Contains the following;  
1. New design Input Housing.  
2. New design Thrust Bearing Assembly.  
3. New design 3rd Roller Clutch Complete.  
4. Instruction Sheet.

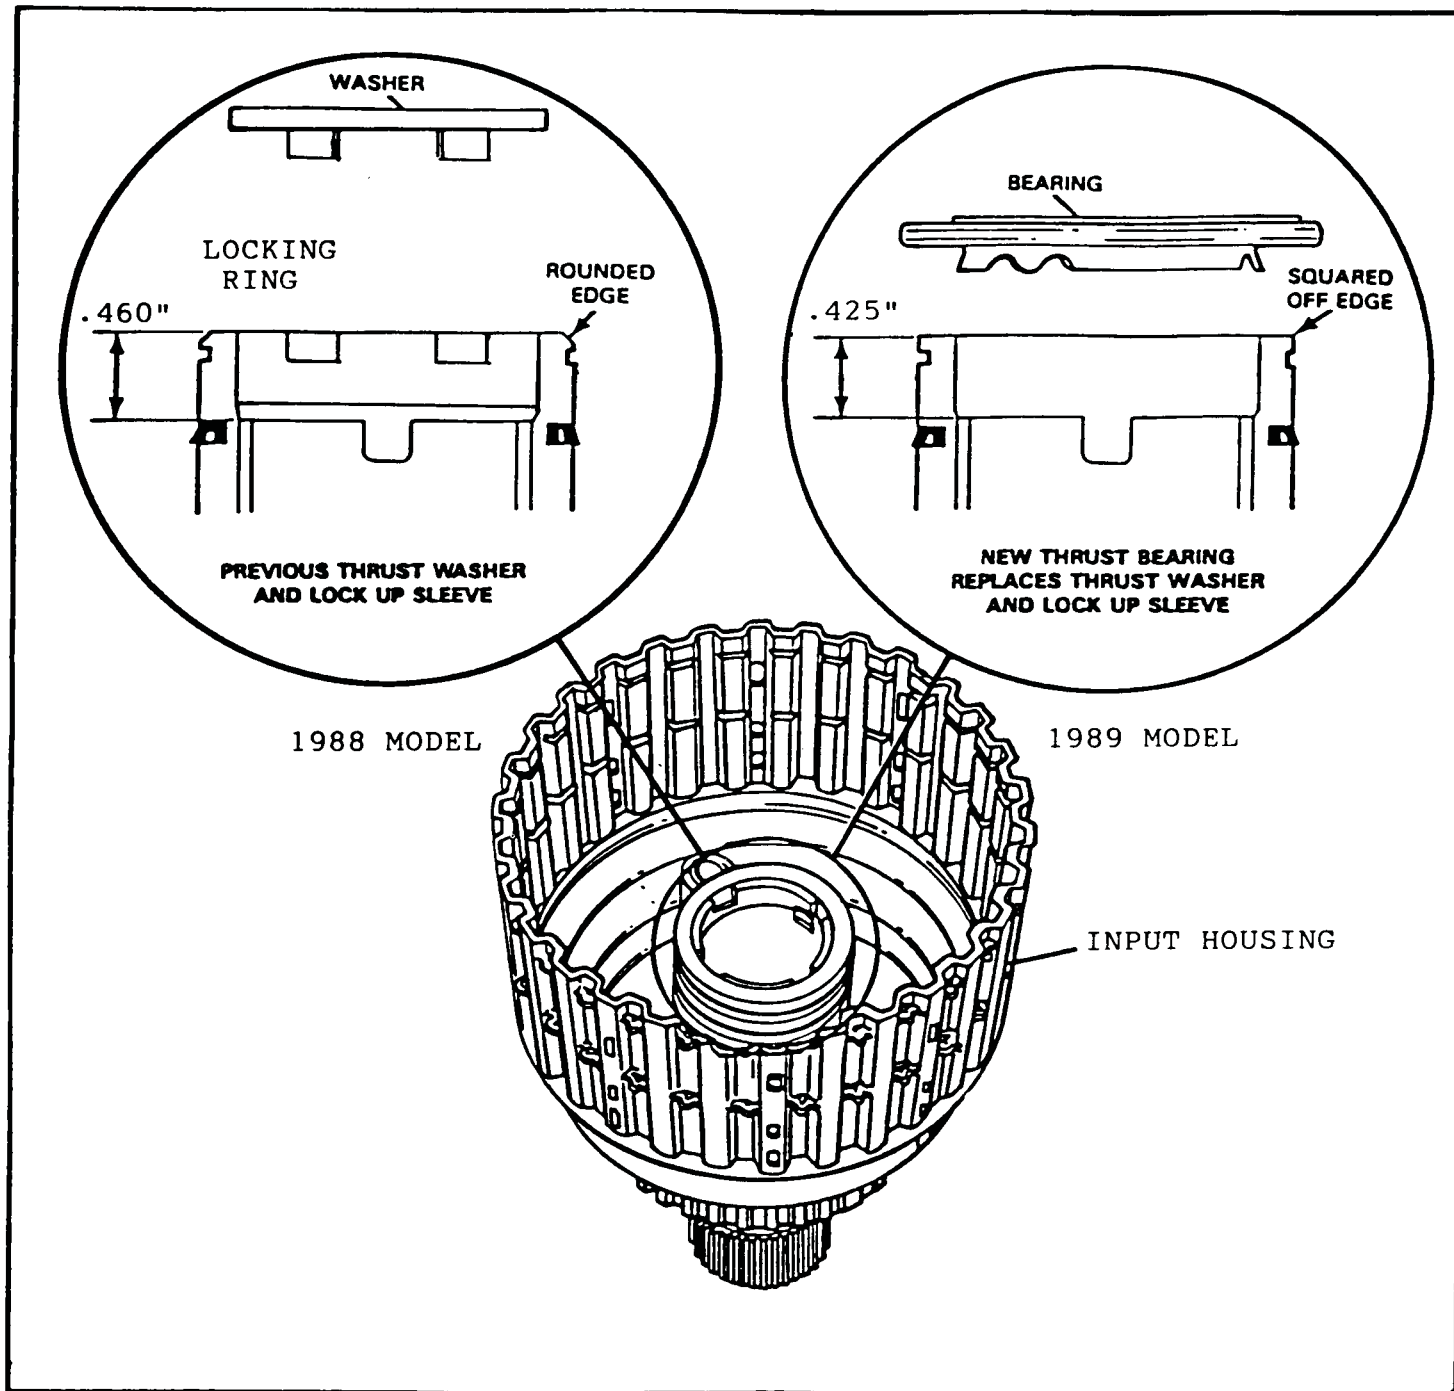
Figure 90

- (1) Input Housing - Surface on the input housing where the new bearing assembly rides, has been reduced by .035" to accommodate the increased thickness of the new bearing (See Figure 90).
- (2) "Top Hat" Thrust Washer - Eliminated (See Figure 90).
- (3) Lock Up Sleeve - The lock up sleeve is no longer needed and has been eliminated (See Figure 90).
- (4) 3rd Roller Clutch Lube Dam - The inside diameter has been increased by .256" to accommodate the larger diameter new bearing, and the lip on the lube dam eliminated for increased lube flow to the 3rd roller assembly (See Figure 91).
- (5) 3rd Roller Clutch Inner Race - Has been machined .040" thinner to accommodate the increased thickness of the new bearing assembly (See Figure 91).

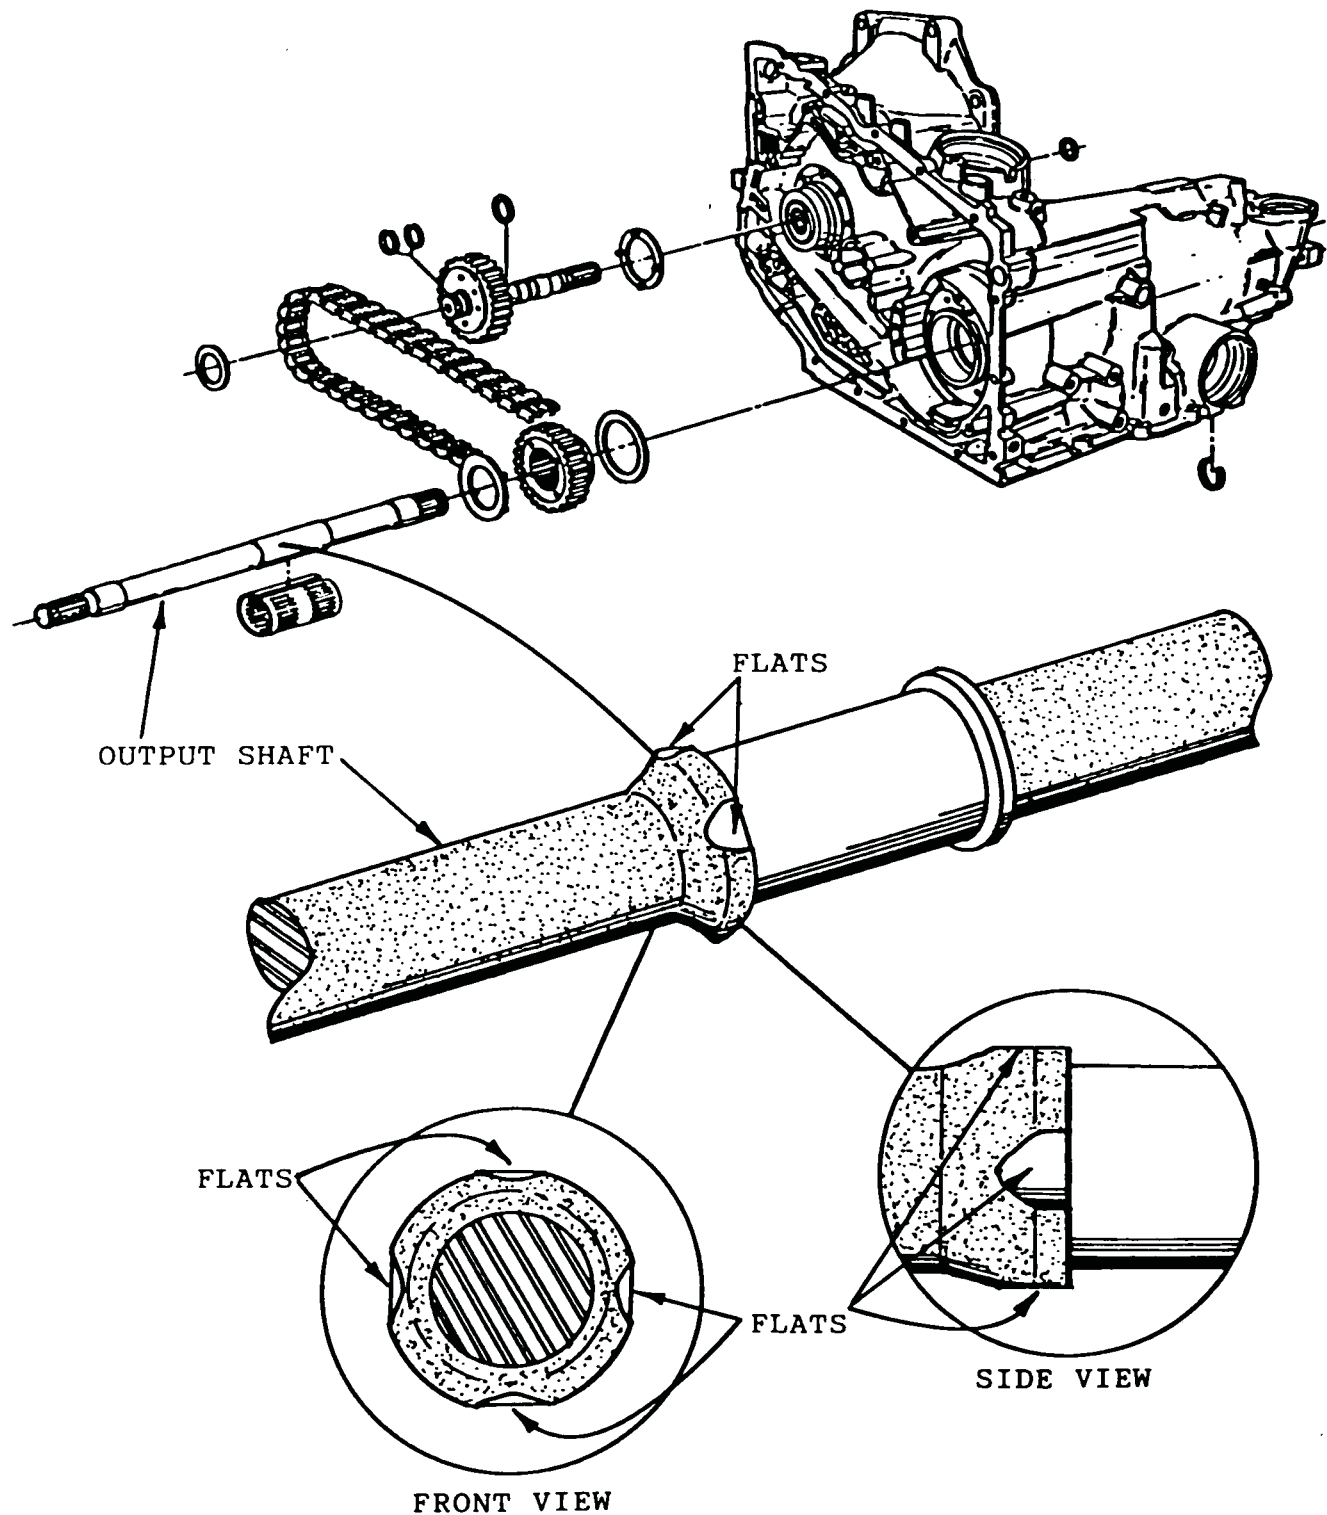
Figure 92

### 3RD ROLLER CLUTCH AND INPUT SPRAG FAILURE

- COMPLAINT: Repeated failure of the 3rd Roller Clutch and/or the Input Sprag Assembly.
- CAUSE: Lack of lube oil to 3rd Roller Clutch and Input Sprag.
- CORRECTION: Modification as follows, of the parts indicated, will increase lube flow to both the 3rd Roller Clutch and the Input Sprag.

1. MODIFY OUTPUT SHAFT:  
Grind four (4) flats on the Output Shaft at the front of the bearing in the locations shown in Figure 92.
  2. MODIFY OUTPUT SHAFT BEARING:  
Remove individual needle bearings as shown in Figure 93 in three equally spaced locations around the bearing, to provide three "Troughs" for additional lube oil to flow. Removing the needles does not impair the durability of the bearing assembly.

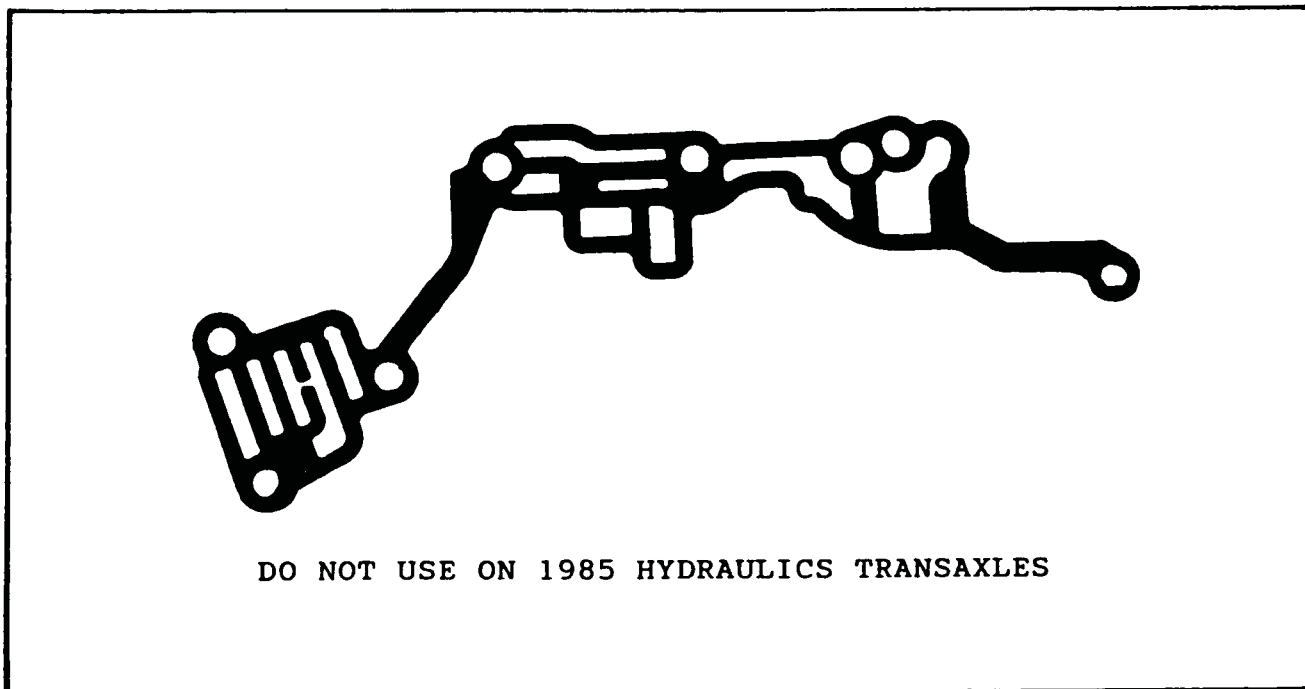
Figure 95

**CHANGE:** Upper Channel Plate Gasket (See Figure 95).

- (1) Upper Channel Plate Gasket - The Upper Channel Plate Gasket and Modulator Port Gasket are now connected together as one gasket (See Figure 95).

The new design Upper Channel Plate Gasket will most likely "Not Appear" in aftermarket gasket sets, as the previous design gaskets will work fine.
