**AUTOMATIC TRANSMISSION SERVICE GROUP**

## INTRODUCTION

Since the introduction of the THM 440-T4 Transaxle in April, 1984, there have been many major engineering design changes. These changes have affected nearly every part used in the THM 440-T4. This Update Handbook will explain each change, the parts affected by the change, and any parts interchangeability problems created by the change.

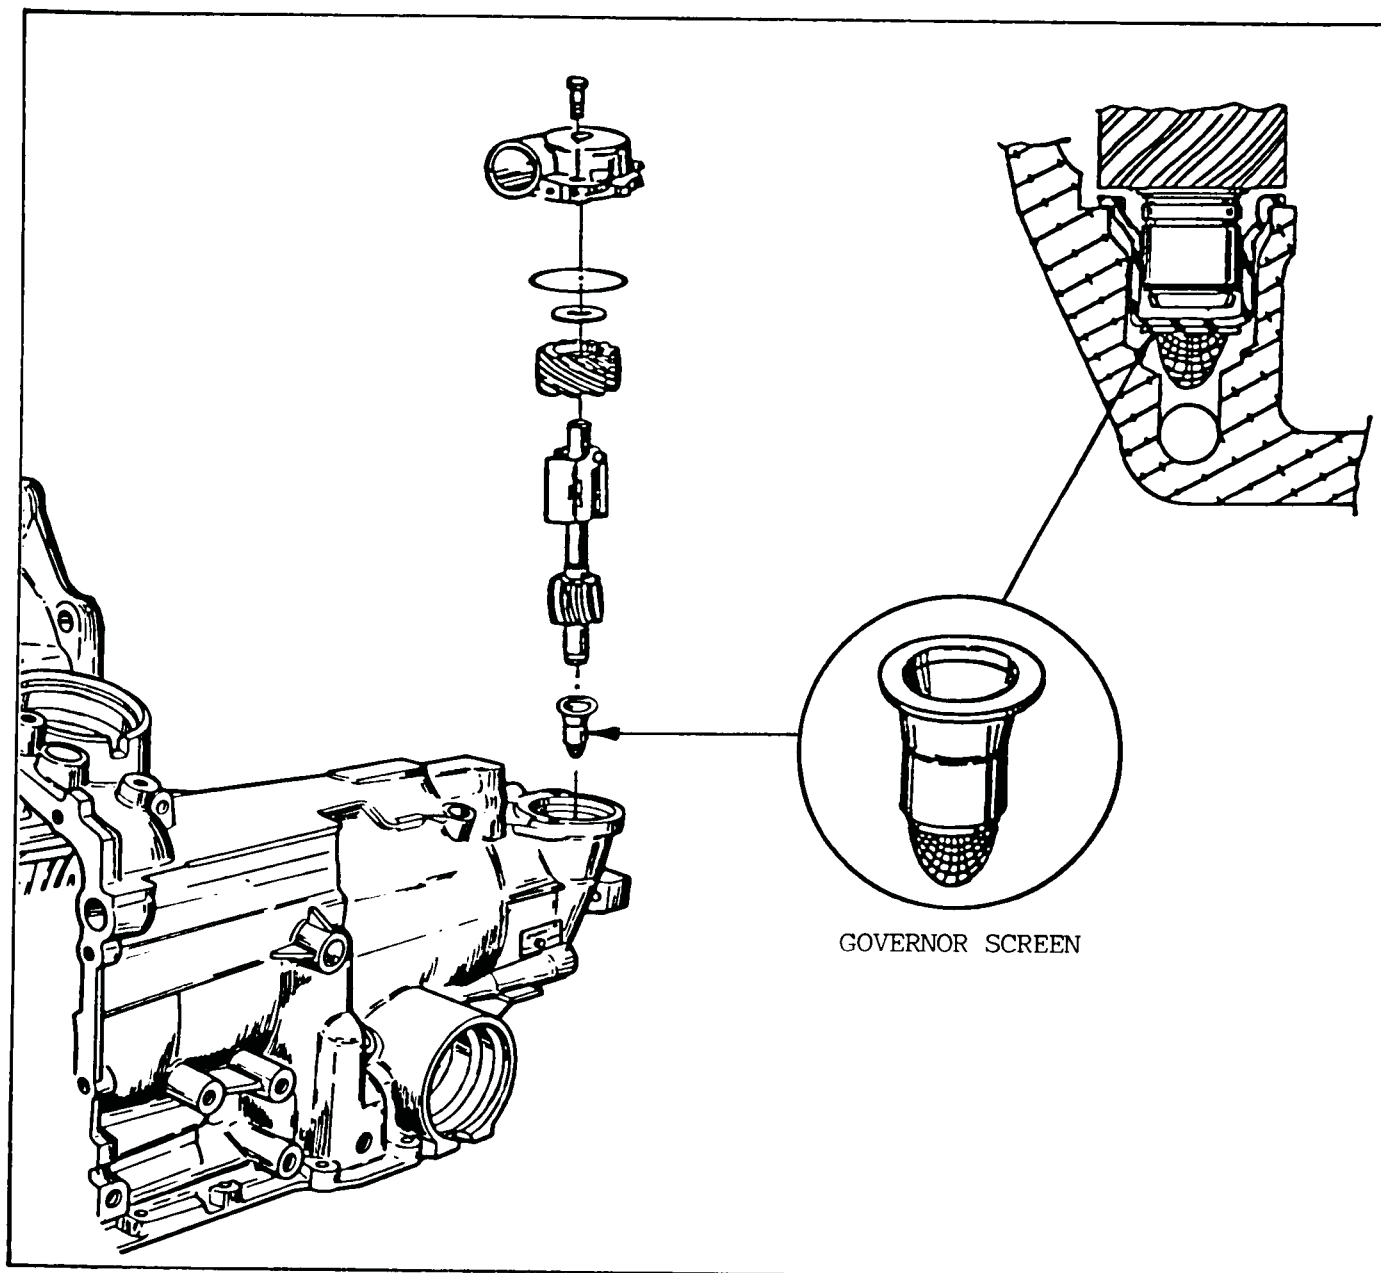
Figure 96

The governor screen was added in 1989 to the governor sleeve in the case, to minimize the possibility of sediment entering the governor assembly and preventing the governor balls from seating properly. (See Figure 96).

A machining change was necessary in the case to make room for the new governor screen, thus it will not retro fit to previous models.
