AUTOMATIC TRANSMISSION SERVICE GROUP

"VOLUME II"

INTRODUCTION

THM 440-T4 (4T60)

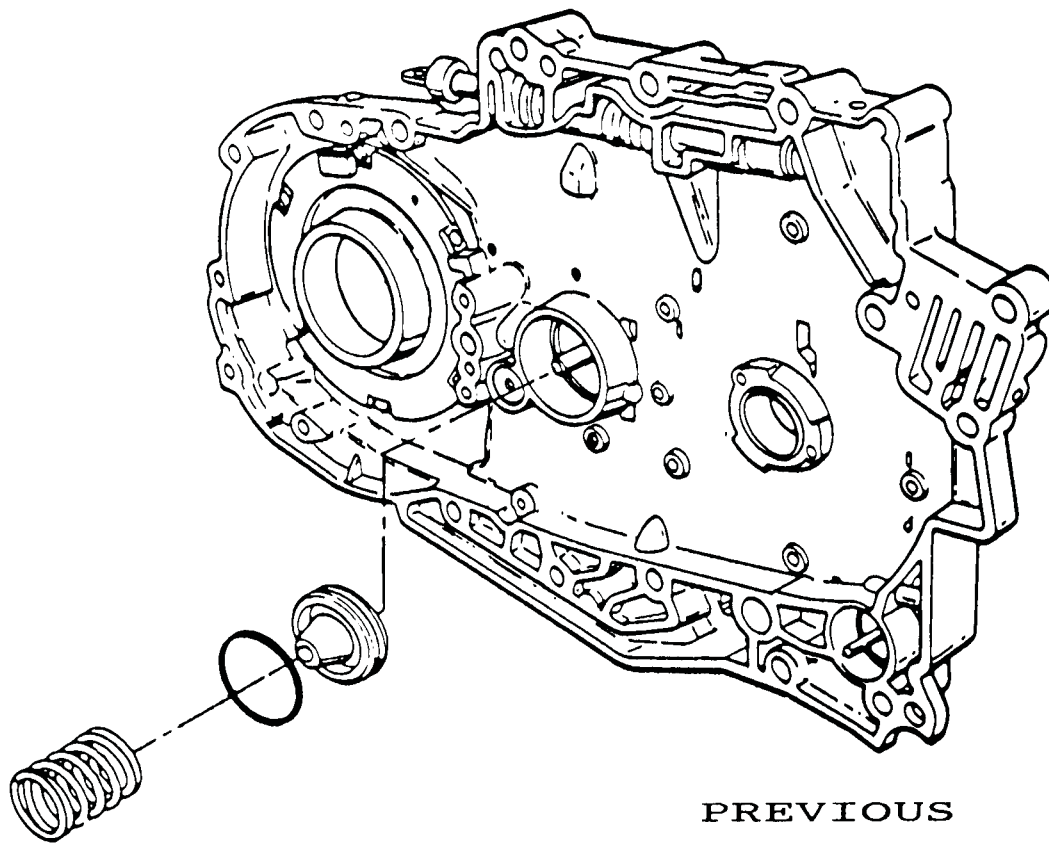
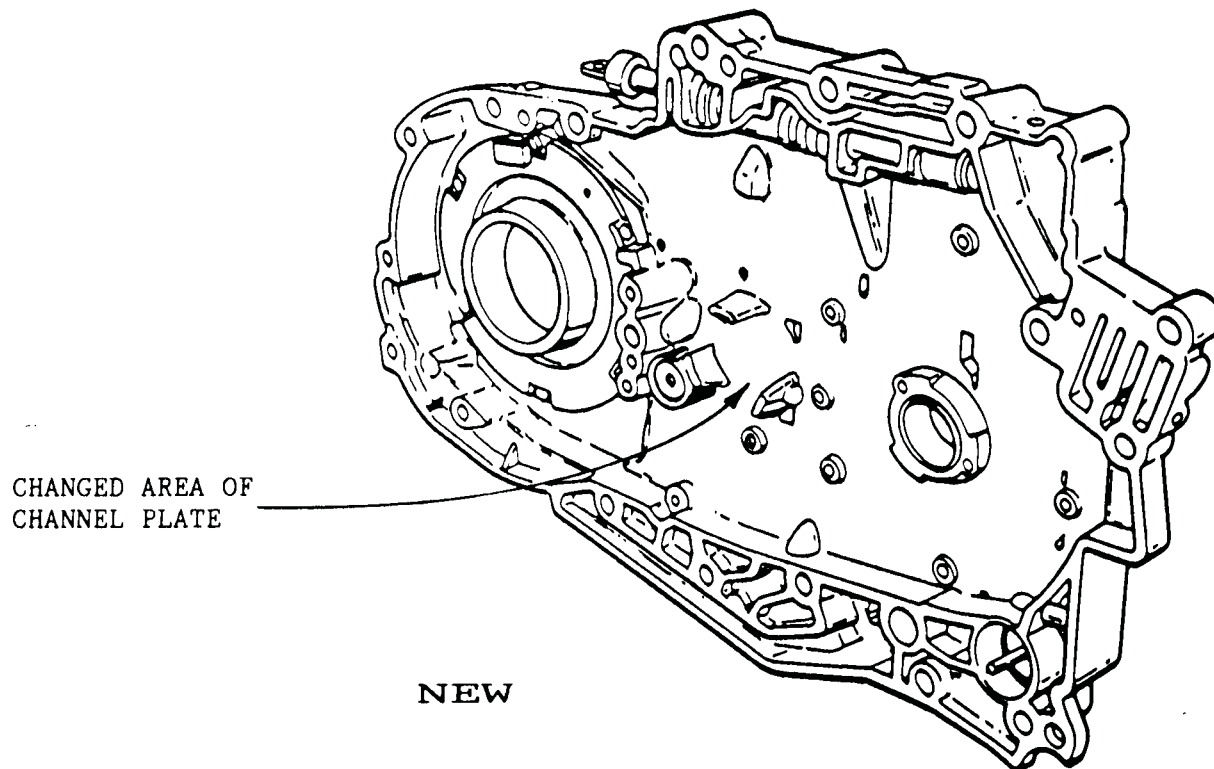
Figure 19

CHANGE: The Input Clutch Accumulator has been eliminated from the channel plate (See Figure 19).

- (1) CHANNEL PLATE - The input clutch accumulator piston, piston pin, and accumulator spring have been eliminated from the channel plate, which of course changes the channel plate casting (See Figure 19).
- (2) INPUT HOUSING - Top snap ring groove moves .060" closer to the top of the input housing, to accomodate the added wave plate (See Figure 20).
- (3) INPUT CLUTCH STEEL PLATES - The steel plates are .027" thinner to help accomodate the added wave plate (See Figure 21). The new steel plates are .049" thick, and the old steel plates are .076" thick (Figure 21).
- (4) INPUT CLUTCH "STACK-UP" - The input clutch stack has also been revised to accomodate the new changes. Refer to Figure 21 for proper assembly of the new input clutches.

NOT RECOMMENDED TO INTERCHANGE WITH PREVIOUS MODELS.

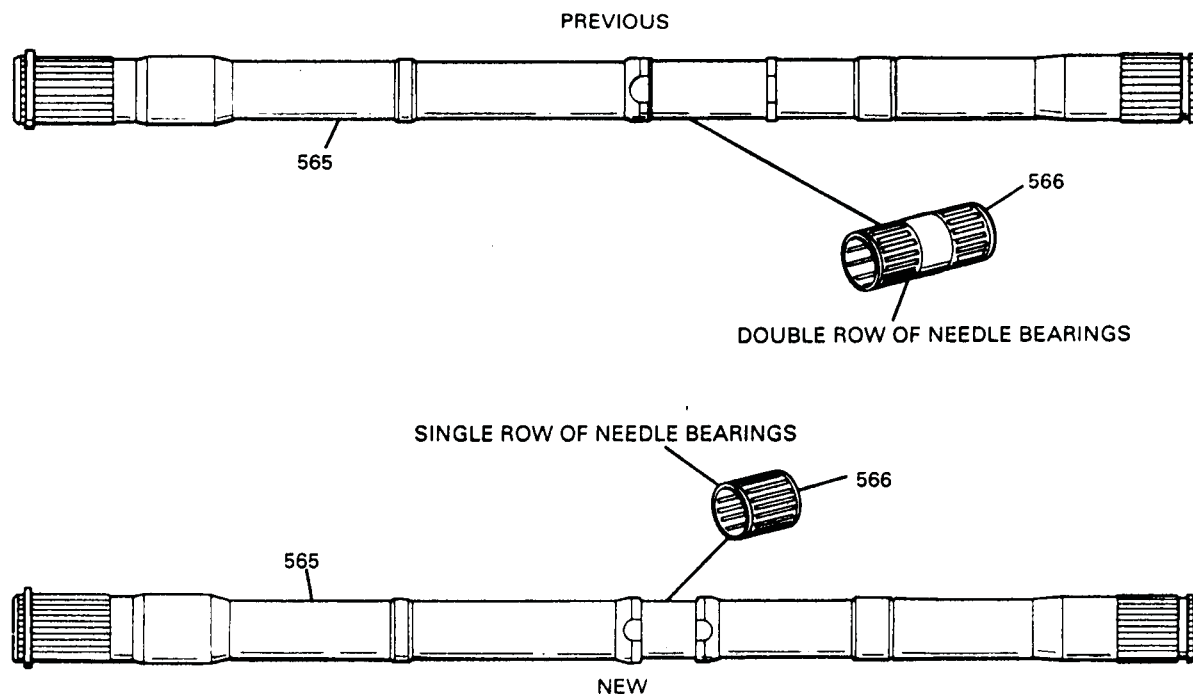
Figure 22

- (1) **OUTPUT SHAFT/BEARING** - The new bearing has a single row of needle bearings instead of a double row, and the output shaft is machined different to accomodate the new bearing (See Figure 22). This change will improve lube oil flow to the 3rd roller clutch and input sprag.
- (2) **3RD ROLLER CLUTCH ASSEMBLY** - The new 3rd roller clutch outer race has four (4) less lube holes than previous models. The four lube oil holes are in line with the very end of the rollers (See Figure 23). Elimination of these four holes helps keep the rollers from "Skewing" (Running at an Angle), thus generating less heat.

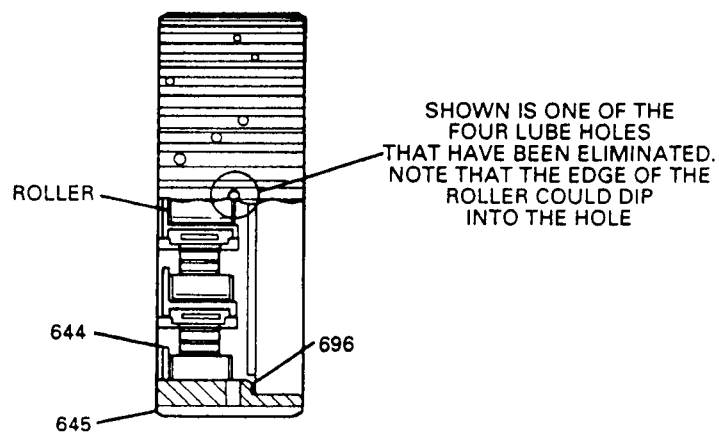
Figure 23

CHANGE: There is now a new Output Shaft/Bearing Assembly, and a new style (5th Design) 3rd Roller Clutch Assembly (See Figures 22 and 23). Beginning on December 11, 1989 (Julian Date 345) all 1990 model 440-T4 transaxles were built with the new 3rd Roller Clutch Assembly, and the new Output Shaft/Bearing Assembly went into production on January 25, 1990 (Julian Date 025).

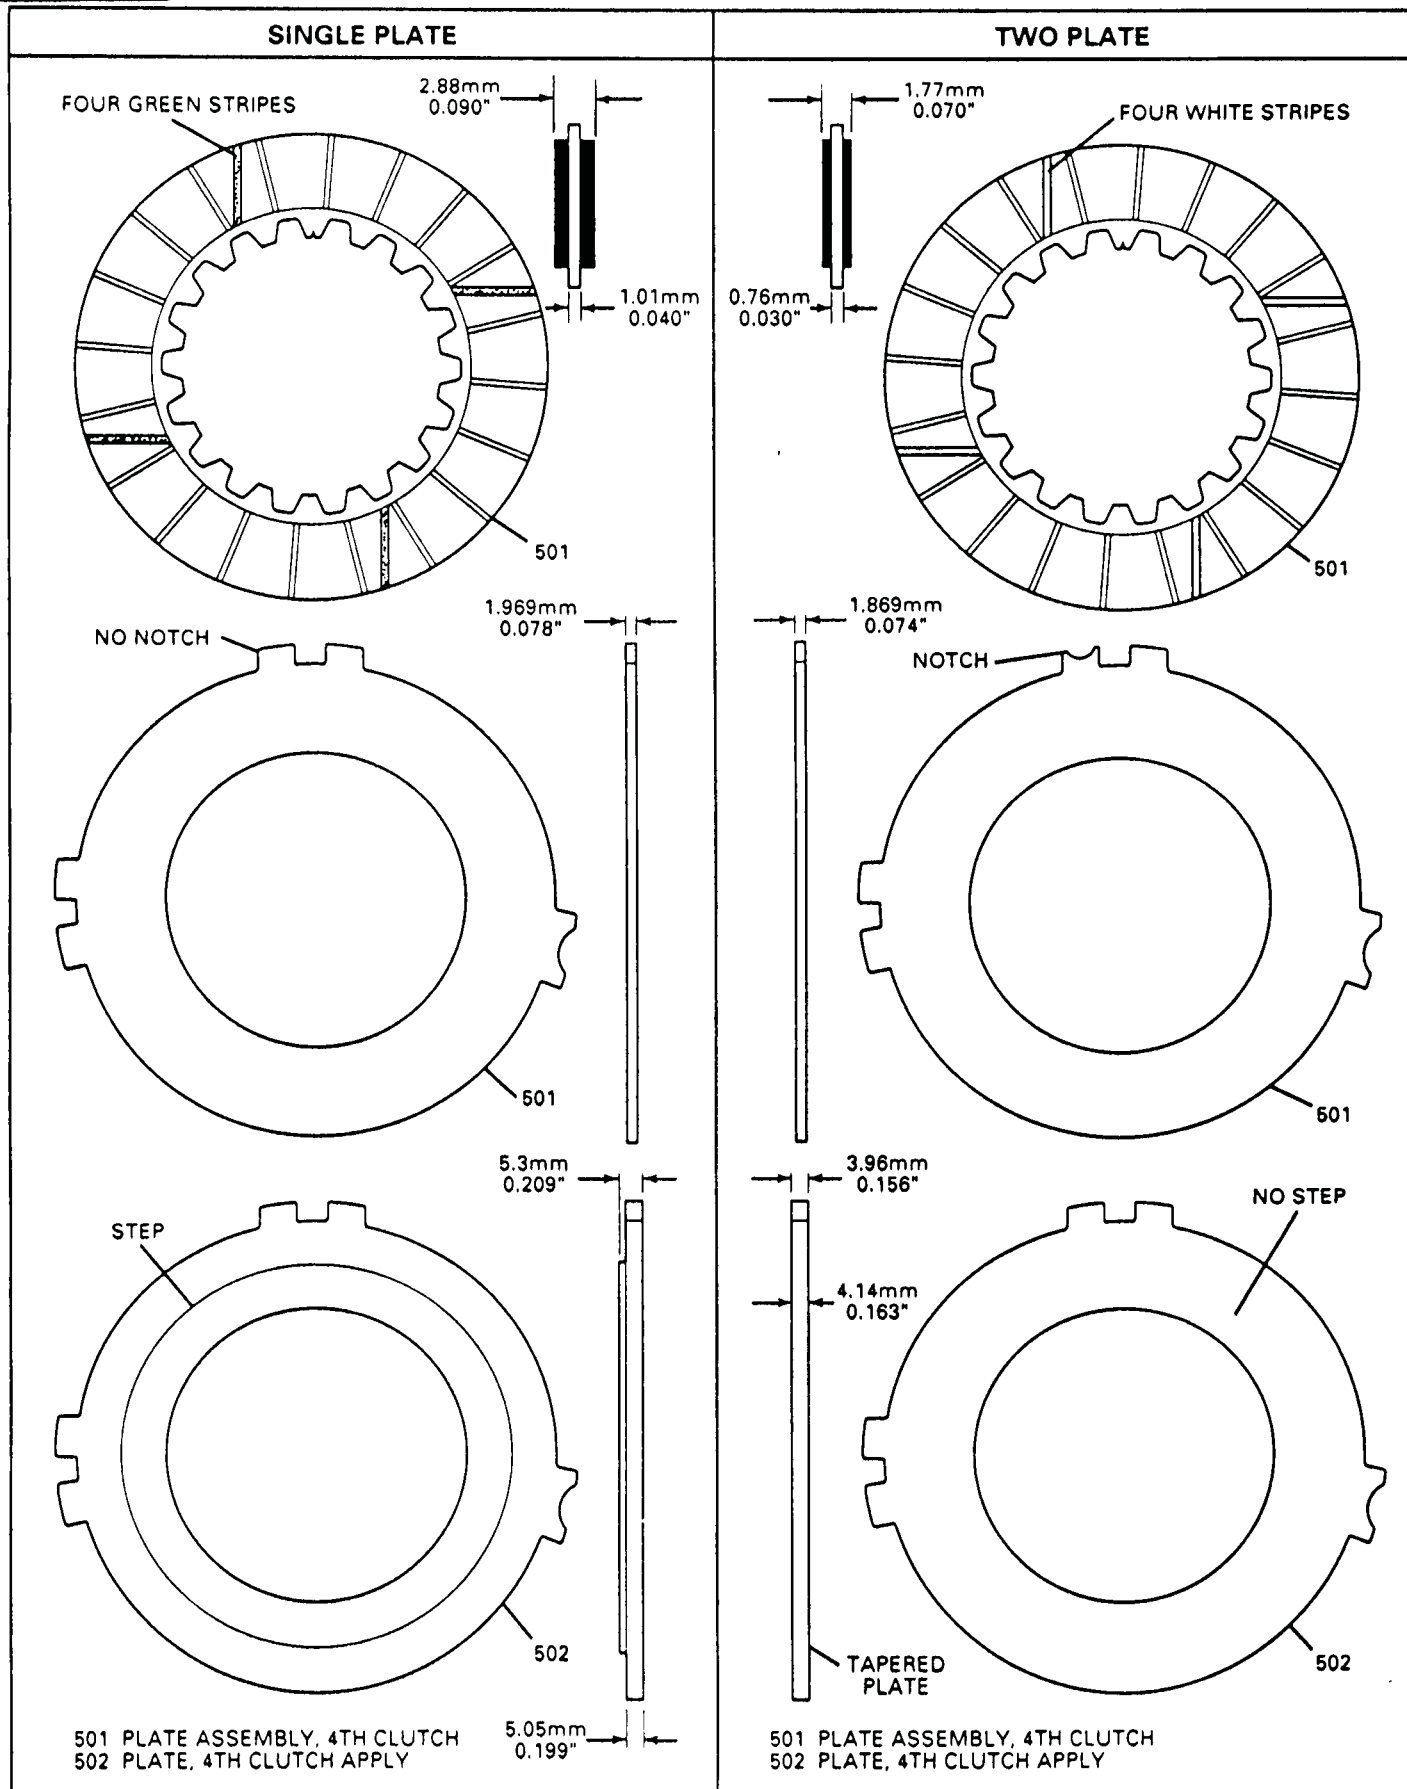
Figure 33

CHANGE: A new "Two Plate" 4th clutch assembly was used to replace the Single Plate 4th clutch assembly for SOME MODELS ONLY on the 1990 THM 440-T4 transaxles (See Figure 33).

- (1) 4TH CLUTCH LINED PLATES - Were made thinner by .020" than the previous lined plate, and can be identified by the four WHITE stripes, while the single plate lined plate has four GREEN stripes (See Figure 33). The Single Plate 4th Clutch is .090" thick, and the new "Two Plate" 4th Clutch plates are .070" thick.
- (2) 4TH CLUTCH STEEL PLATES - Were made thinner by .004" than the previous plates, and can be identified by a "Notch" cut into one of the tabs (See Figure 33). The single plate 4th clutch steels are .078" thick, and the new "Two Plate" steels are .074" thick.
- (3) 4TH CLUTCH APPLY PLATE - Was machined thinner than the previous apply plate, and the step was removed. Refer to Figure 33.
