THM 4L60-E/4L65-E "UPDATE HANDBOOK"

INTRODUCTION

THM 4L60-E/4L65-E

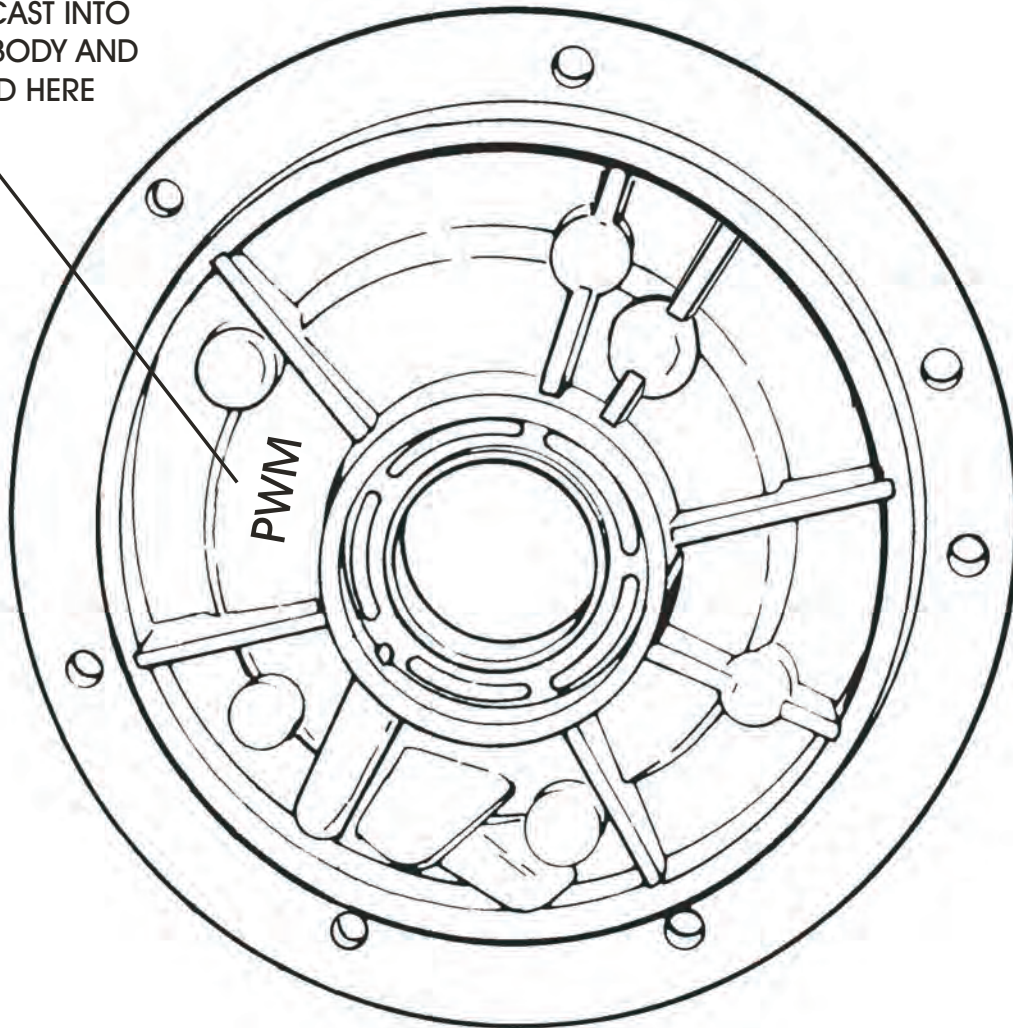
Figure 4

1995 "PWM" PUMP BODY IDENTIFICATION

"PWM" IS CAST INTO
THE PUMP BODY AND
LOCATED HERE

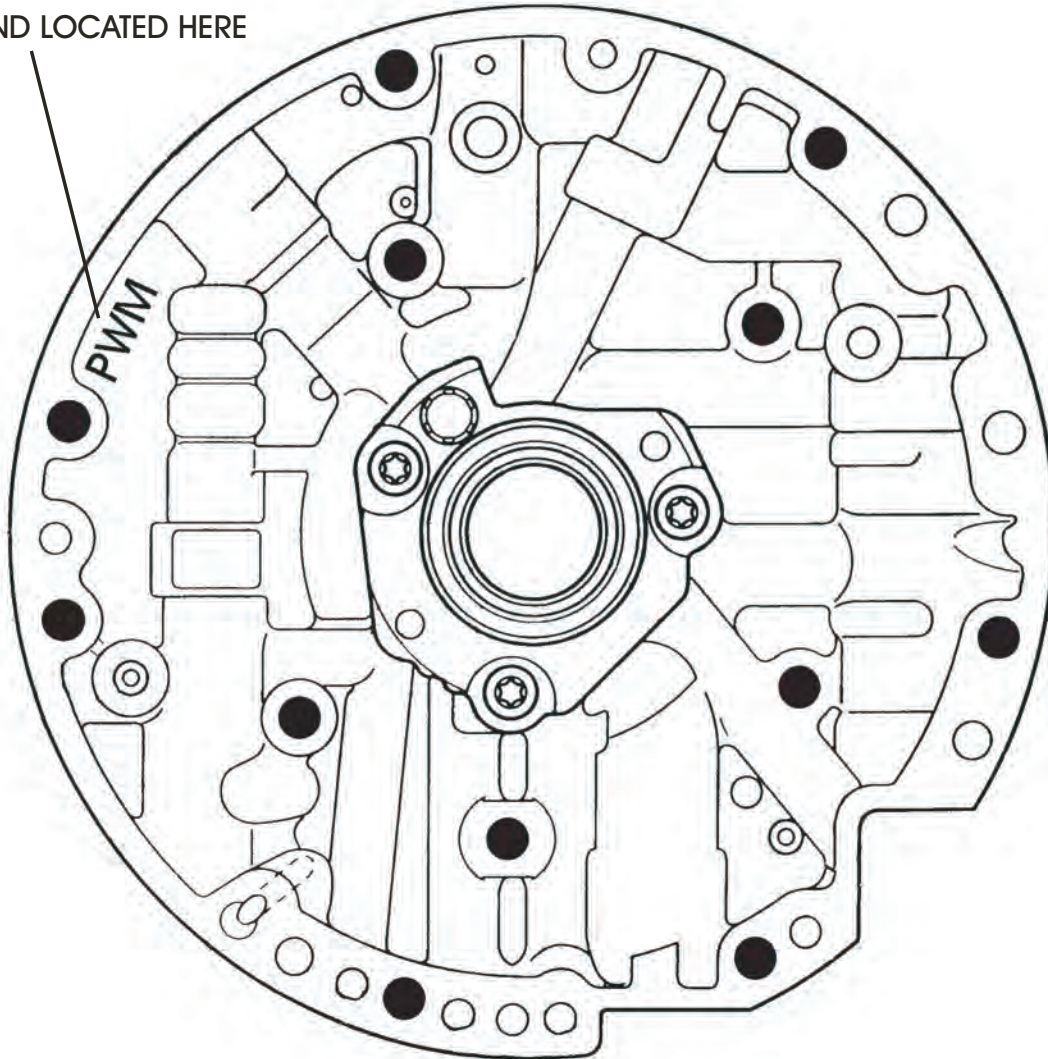
Figure 6

1995-1996 "PWM" PUMP COVER IDENTIFICATION

"PWM" CAST INTO THE PUMP
COVER AND LOCATED HERE

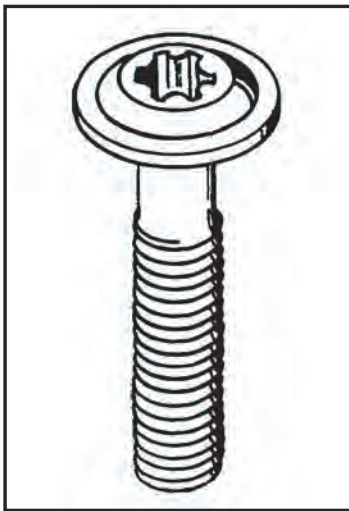
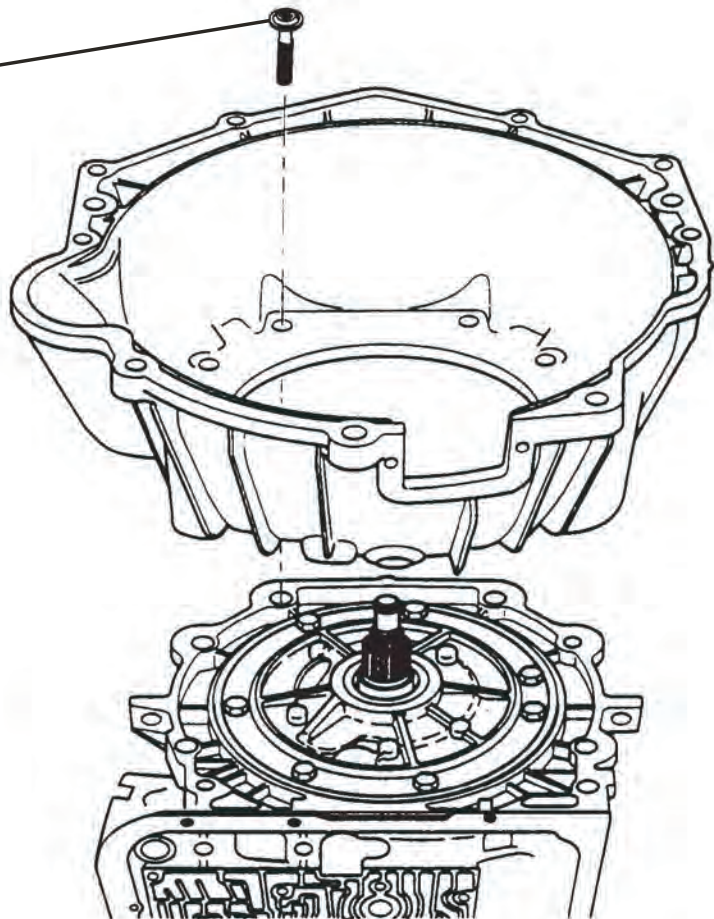
Figure 1

**USE "TORX-PLUS 50-IP" BIT ONLY
ON BELLHOUSING BOLTS**

**"TORX PLUS 50-IP"
OK TO USE**

**50 TORX BIT
DO NOT USE**

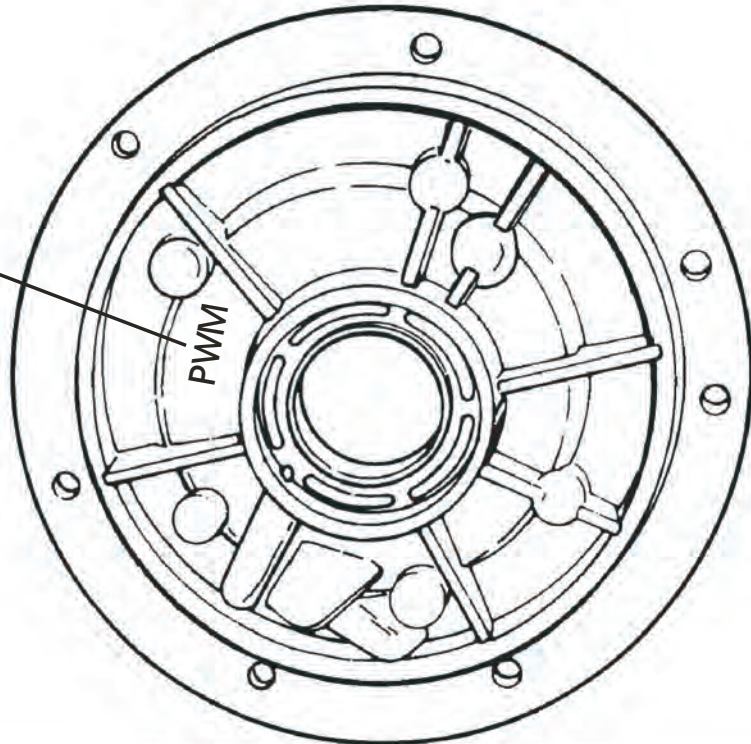
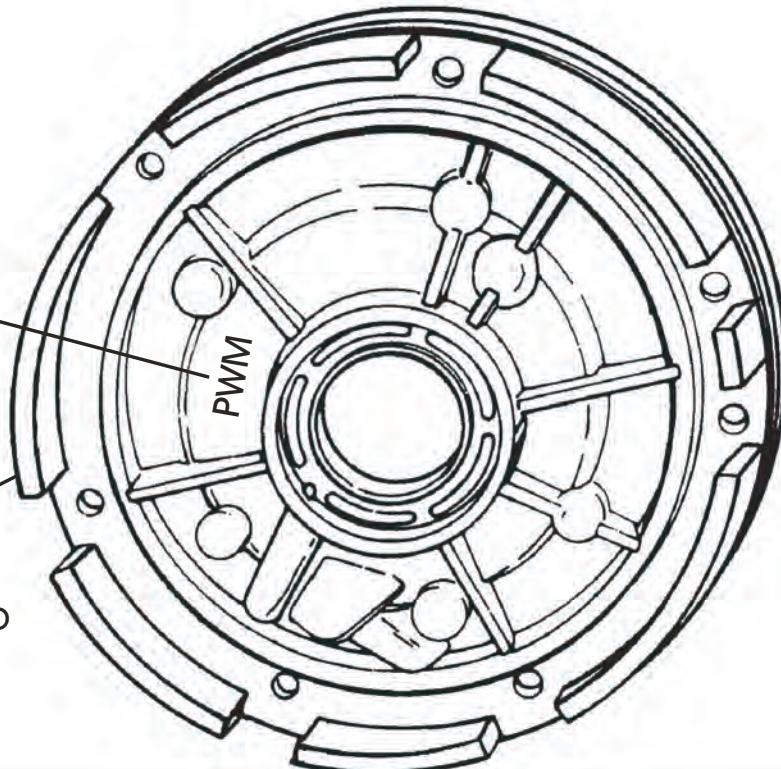
Figure 2

All of the parts listed above are unique to the 1996 model 2-piece case. However, the pump body with the added machined ring, will be found in some 1995 models, and will back service to 1995 models *only*. It cannot be used in 93-94 models because of worm track cavity differences that occurred in 1995.

1995-1996 "PWM" PUMP BODY FOR REGULAR CASE

"PWM" CAST INTO PUMP BODY
AND LOCATED HERE

1996 "PWM" PUMP BODY FOR BOLT-ON BELL HOUSING

ADDED MATERIAL AND MACHINED
TO CENTER THE BELLHOUSING

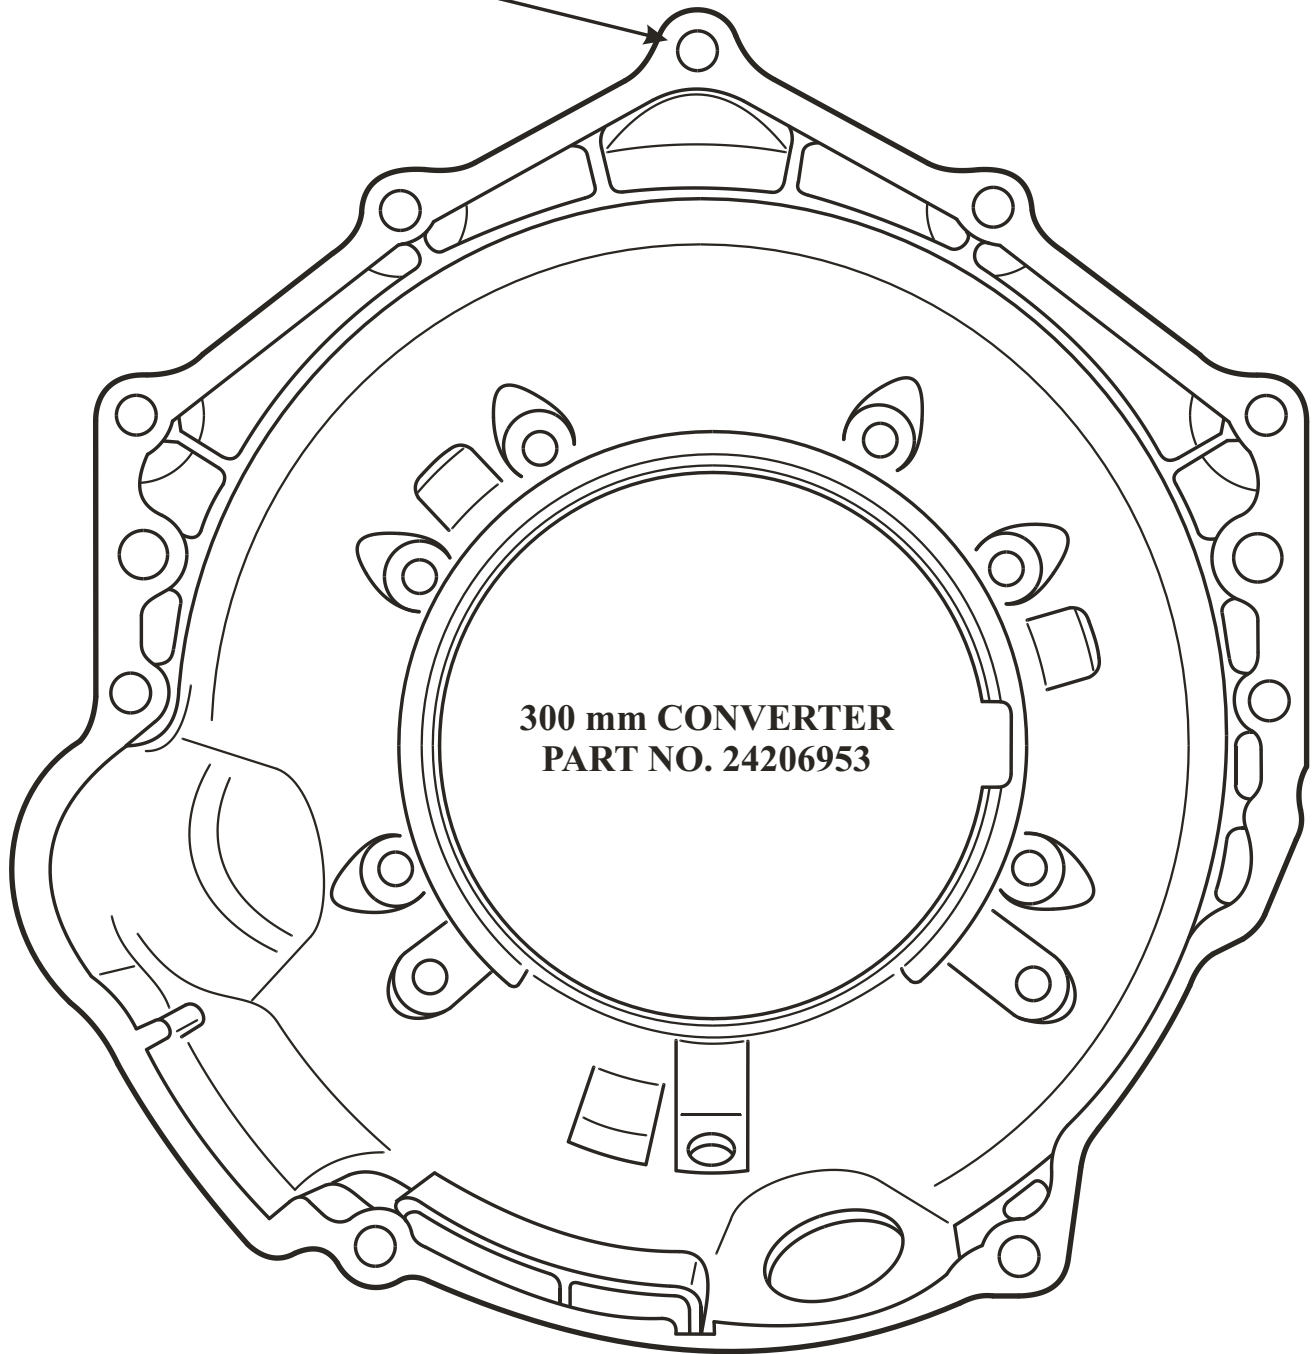
Figure 1

**ADDED BOLT HOLE AND
IS APPROX. 1/4" DEEPER**

**300 mm CONVERTER
PART NO. 24206953**

This style bellhousing and the 300mm torque converter also require a new design turbine shaft and stator shaft that are approximately 1/4" longer than other models.

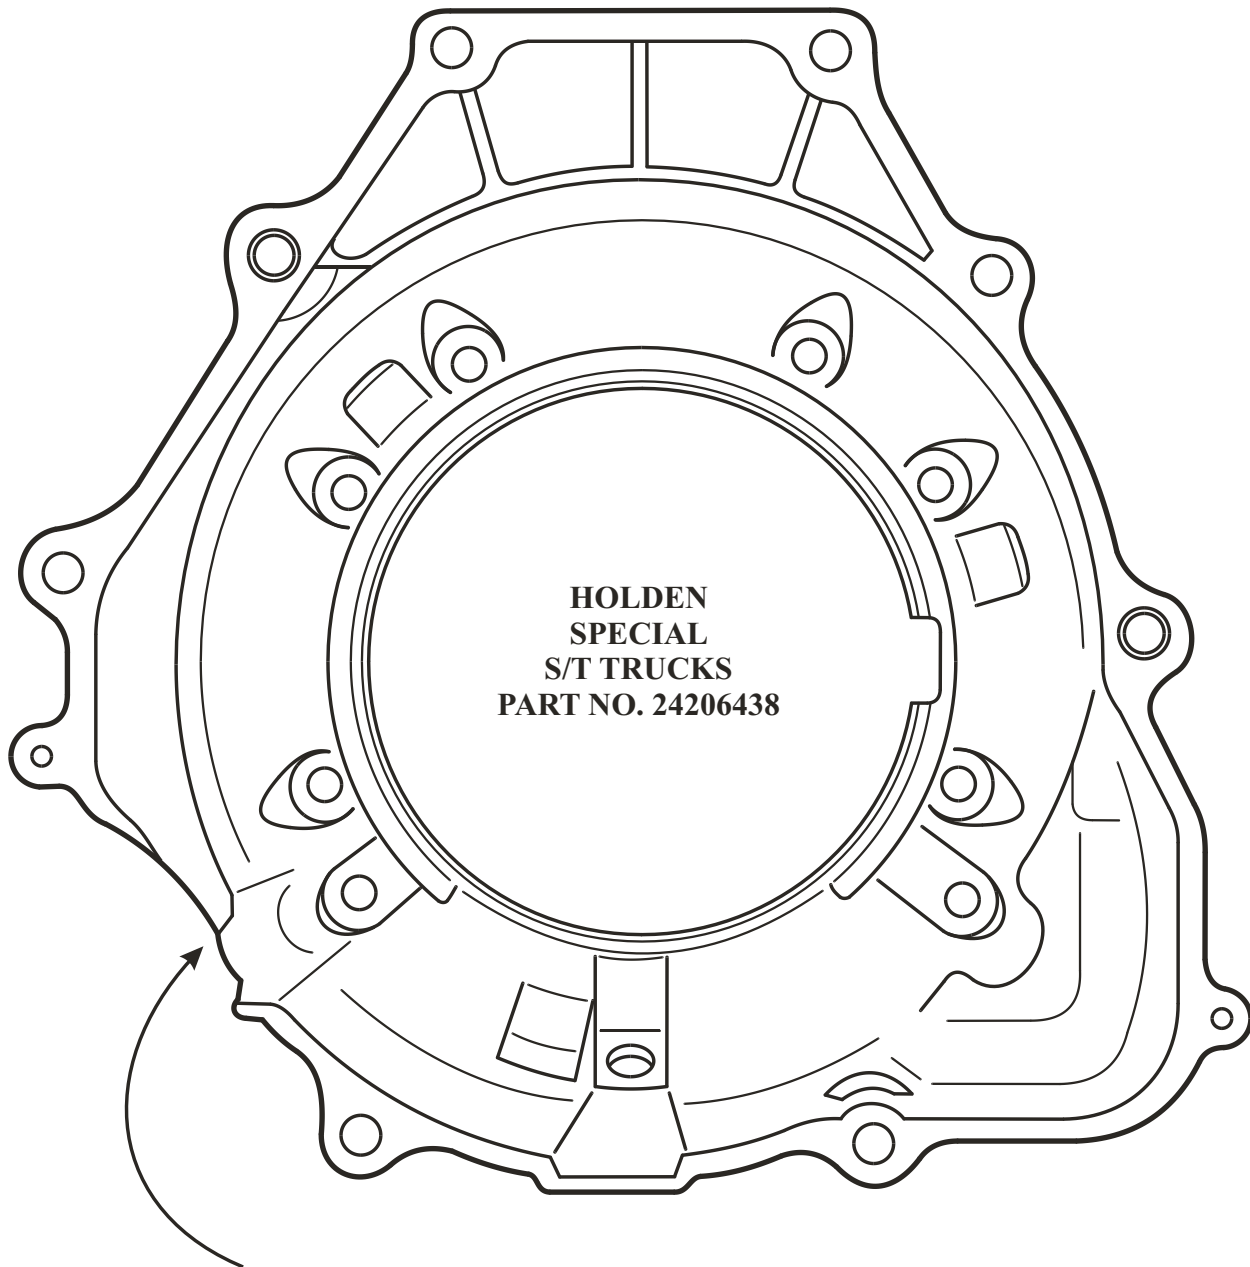
Figure 6

The Bellhousing shown in Figure 6, is the Holden "Special" S/T Truck bell that is export only and shipped mainly to Australia. This bell has part of the housing cast out as compared to the Regular S/T Truck bell that is shown in Figure 7.

**SECTION CAST OUT
OF BELLHOUSING**

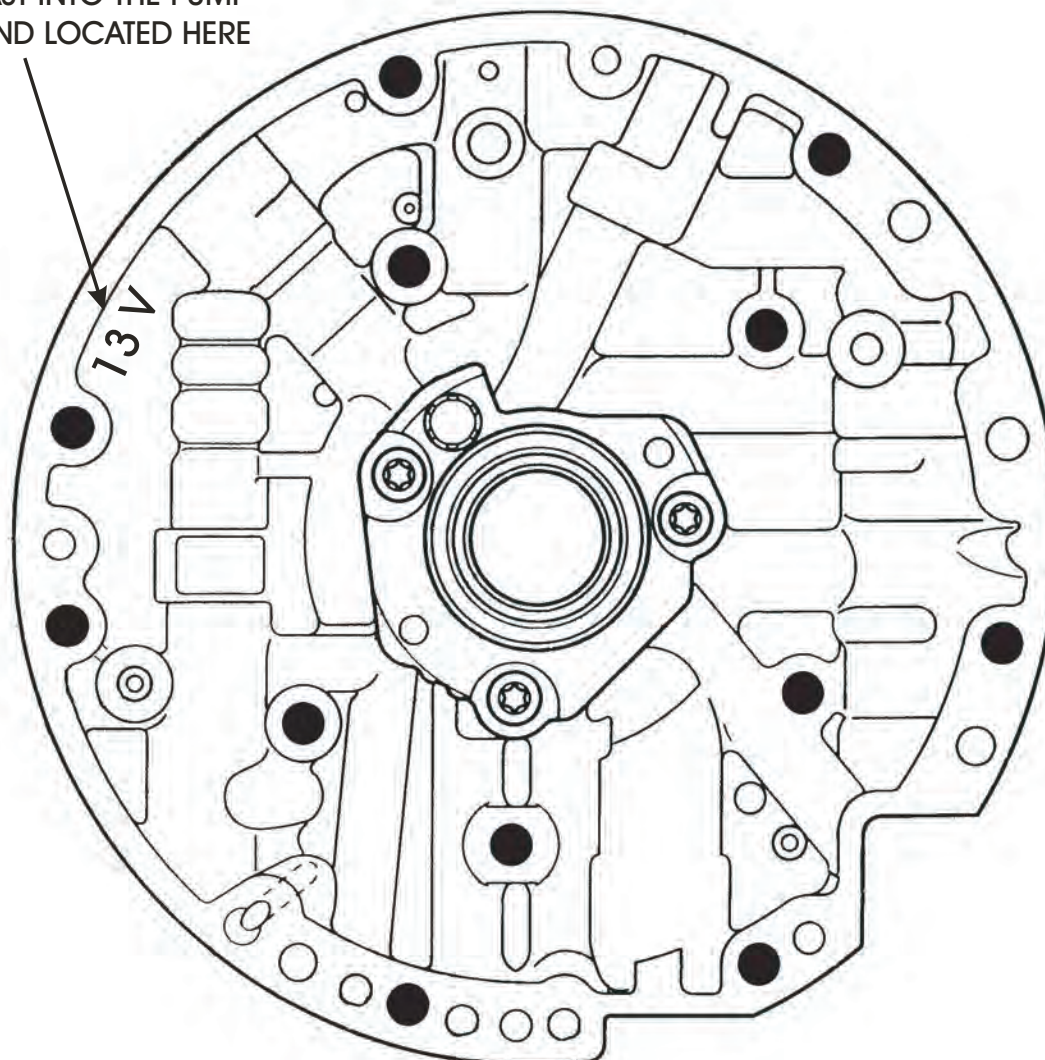
Figure 3

1997 13-VANE PUMP COVER IDENTIFICATION

"13 V" CAST INTO THE PUMP
COVER AND LOCATED HERE

***THIS PUMP COVER WILL NOT INTERCHANGE WITH PREVIOUS MODELS.
IT MUST BE USED WITH THE 13 VANE ROTOR AND SLIDE.***

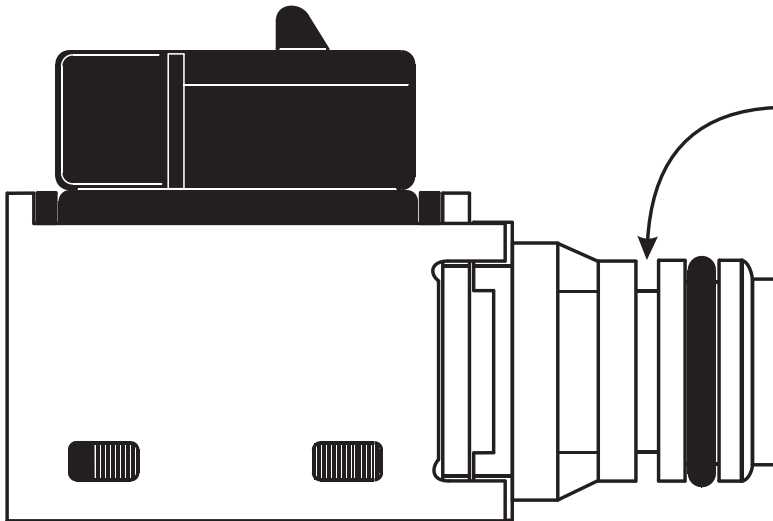
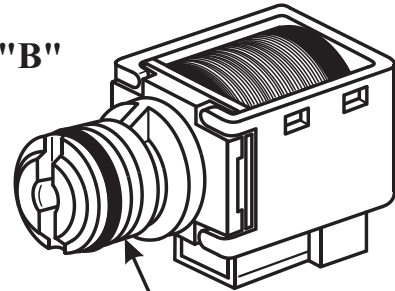
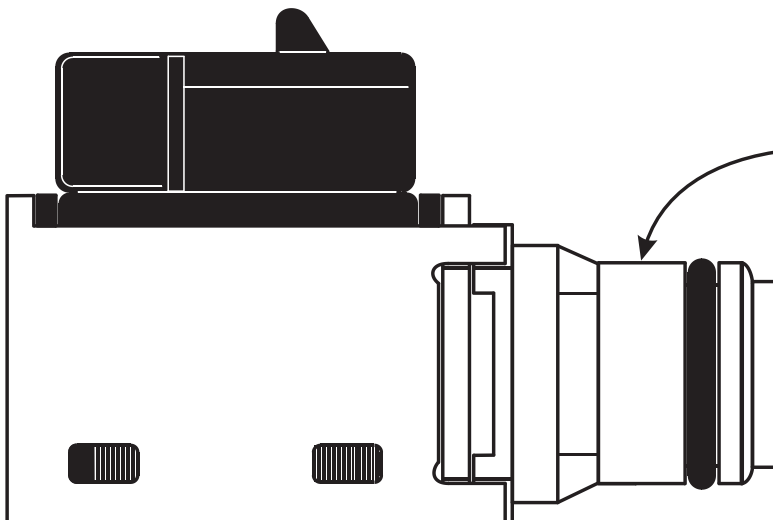
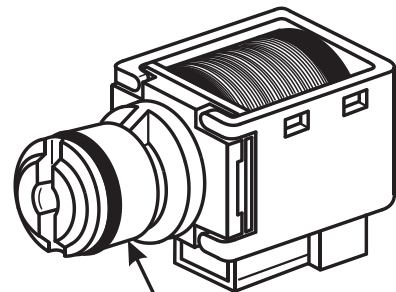
Figure 2

THM 4L60-E SHIFT SOLENOIDS "A" AND "B" 1993-1996 MODELS

THIS GROOVE REMOVED
TO PREVENT MIS-ASSEMBLY,
AS RETAINING CLIP CAN BE
INSTALLED IN THIS GROOVE

THM 4L60-E SHIFT SOLENOIDS "A" AND "B" 1997 AND LATER MODELS PART NO. 10478131

GROOVE REMOVED
AND WILL RETRO-FIT
BACK TO ALL MODELS

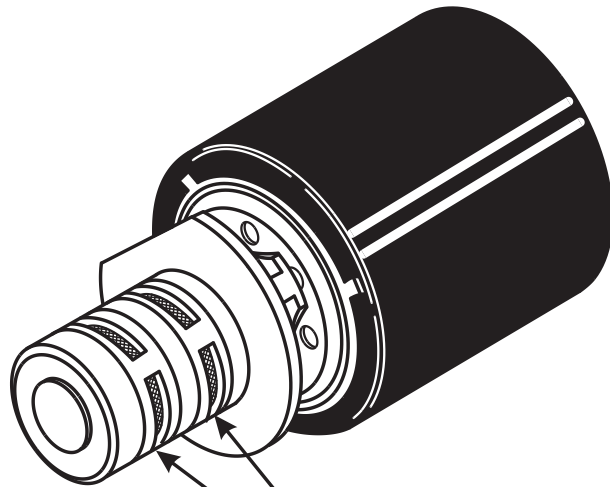
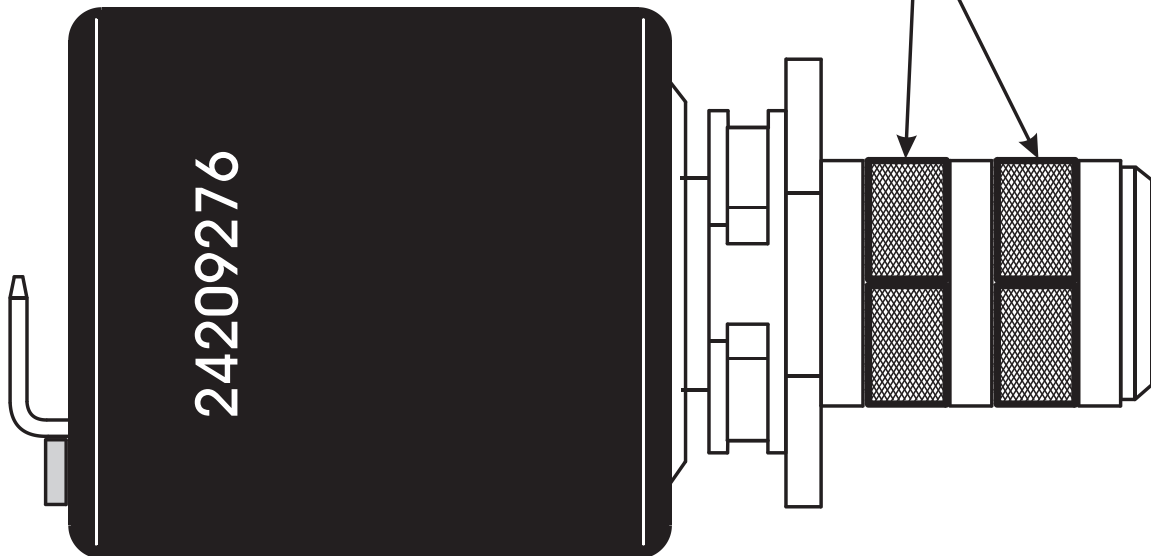
Figure 3

NEW ELECTRONIC PRESSURE CONTROL SOLENOID PART NUMBER 24209276

SCREENS HAVE A LARGER
MICRON, FOR IMPROVED
COLD WEATHER OPERATION

CAUSE: The cause may be, one or both of the screens in the spacer plate collapsed shut, and restricting solenoid feed oil or actuator feed oil to the Pressure Control Solenoid.

CORRECTION: Replace both screens in the spacer plate as shown in Figure 1, with the part numbers listed below. These *new part numbers* are screens with a larger micron screen that will pass more oil easier.

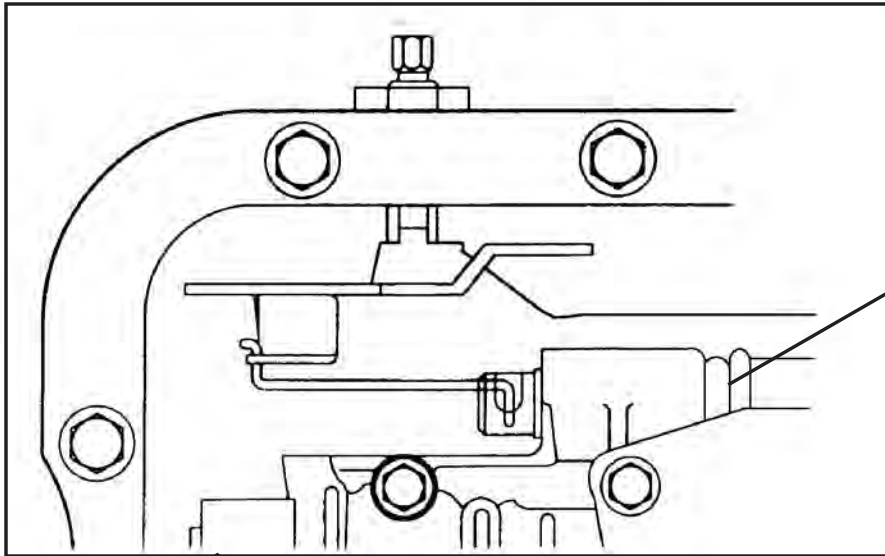
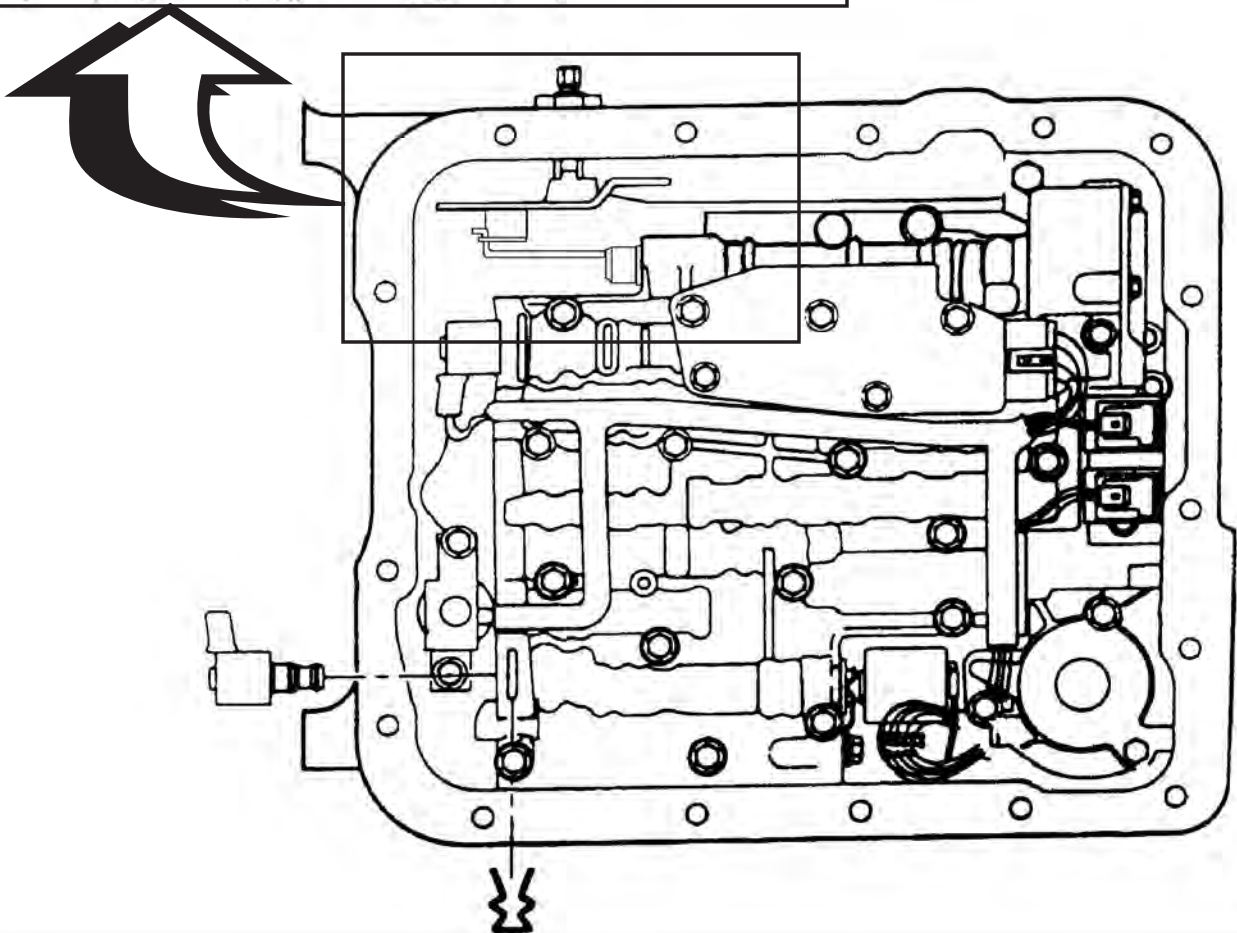
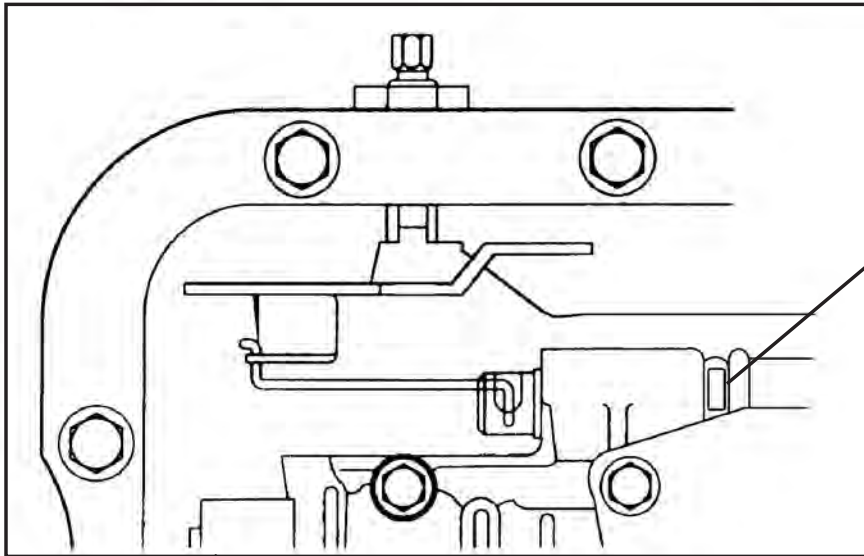
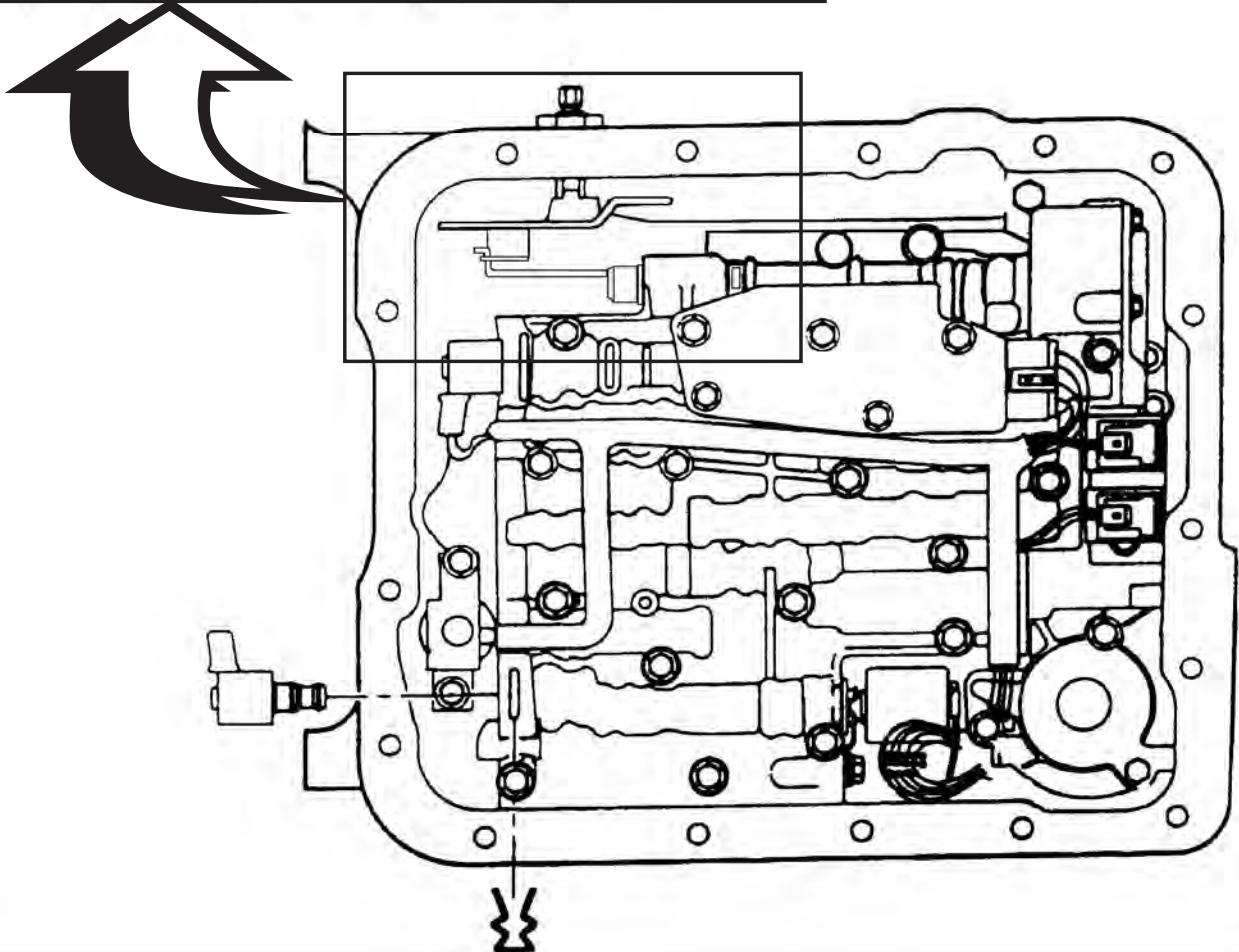
Figure 2
AUTOMATIC TRANSMISSION SERVICE GROUP

CAUSE: The cause may be, the Low/Reverse Clutch not totally exhausting the apply oil when the shift lever is moved from Park to the Drive position. On 1993-1995 models, the exhaust path for L/R apply oil is not large enough.

1995 MANUAL VALVE AND VALVE BODY CASTING

1996 MANUAL VALVE AND VALVE BODY CASTING

EXHAUST HOLE ADDED IN
VALVE BODY CASTING HERE

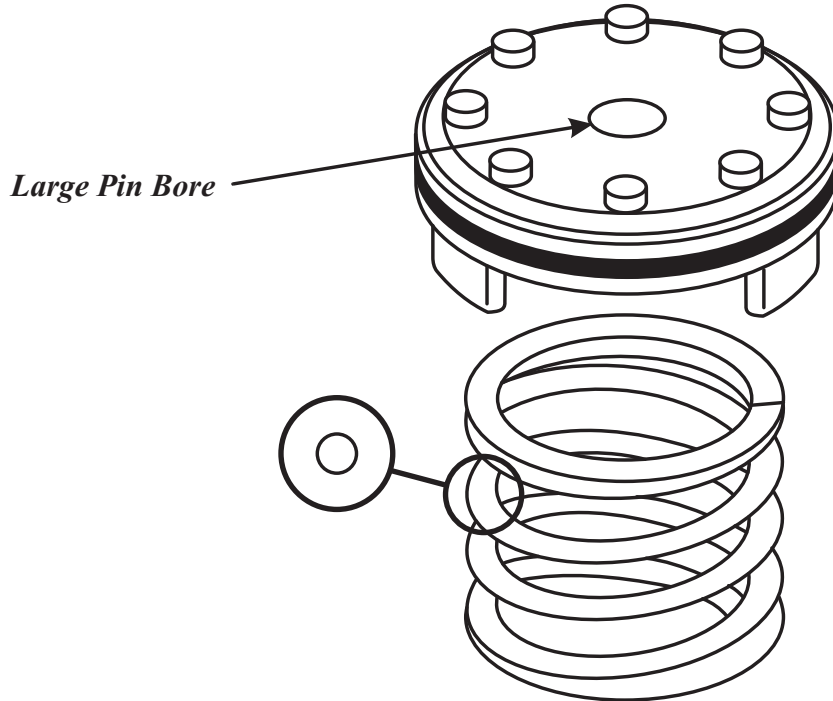
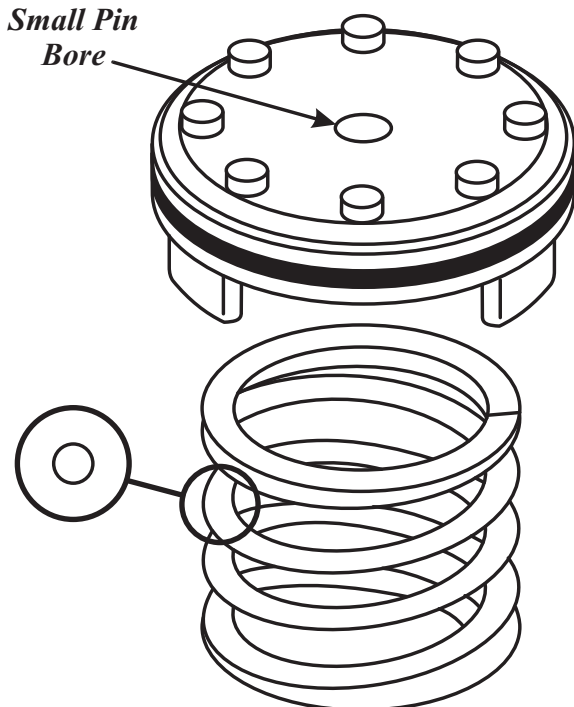
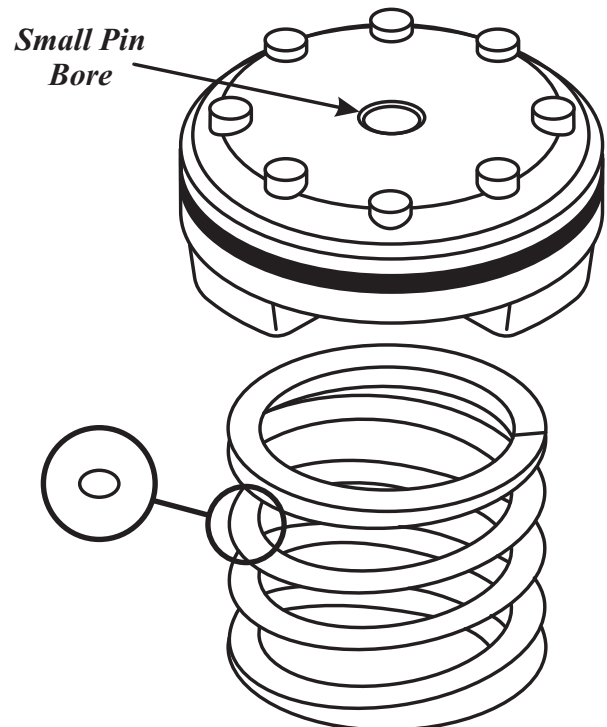
Figure 1

CAUSE: The cause may be, a worn accumulator piston pin bore (See Figure 1).

CHANGE: Beginning on May 11, 1998 (Julian Date 131) all THM 4L60-E transmissions were built with a new design plastic 1-2 Accumulator Piston, and an ovate (oval) wire outer accumulator spring, to replace the previous design aluminum piston and round wire outer accumulator spring, as shown in Figure 1.

CORRECTION: Replace the accumulator piston with the proper part number from "Service Information" as shown below.

*Aluminum 1-2 Accumulator Piston
"Round Wire" Outer Spring
1982-1993 Only
Part Number 24204495*

*Aluminum 1-2 Accumulator Piston
"Round Wire" Outer Spring
1984-1997 Only
Part Number 24204496*

*Aluminum 1-2 Accumulator Piston
"Round Wire" Outer Spring
1998-1999 Only
Part Number 24214343*

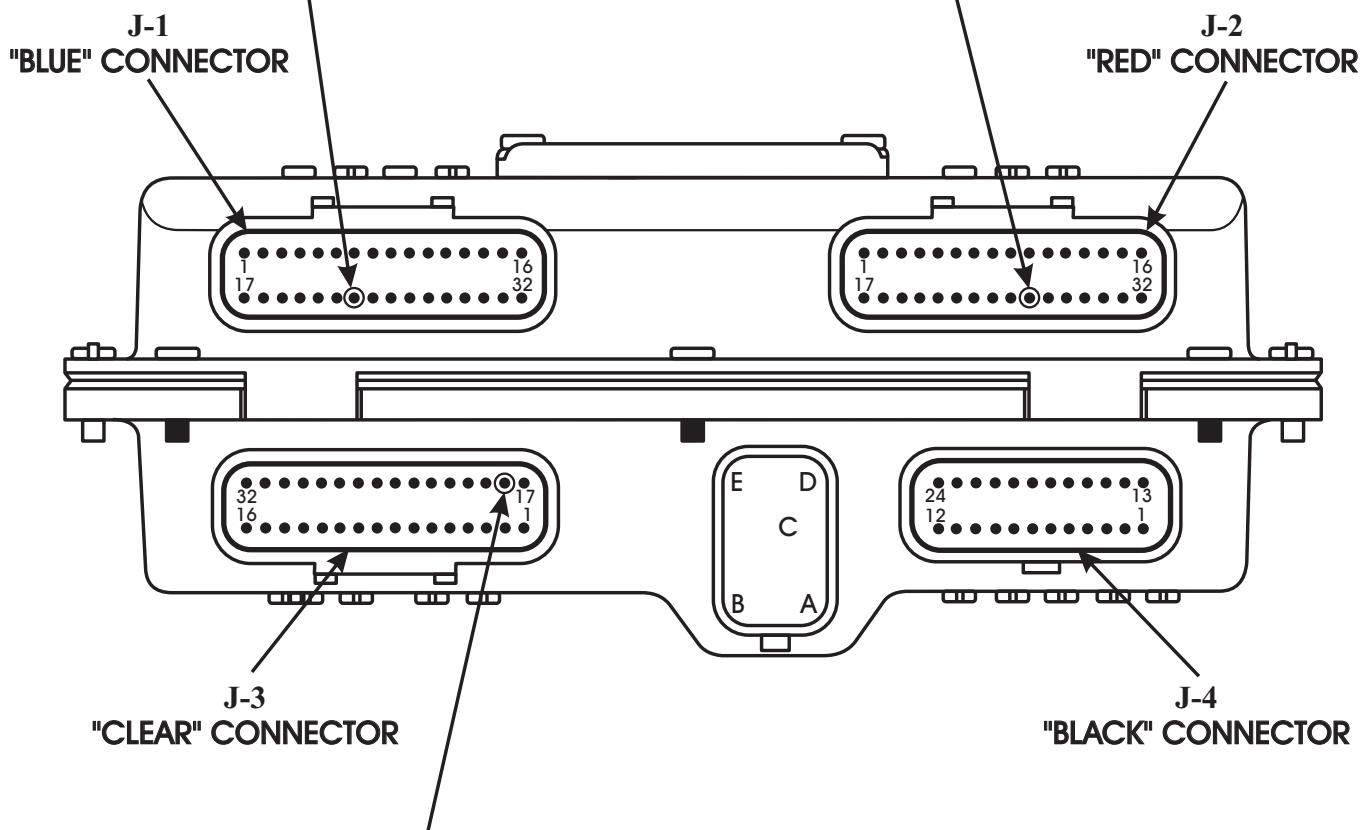
CAUSE: Bad ground connection from one printed circuit board to the other.

INSTALL THE OTHER END OF THE INCLUDED JUMPER WIRE THAT WAS PREVIOUSLY INSTALLED INTO THE CLEAR CONNECTOR, INTO CAVITY LOCATION 26 OF THE RED CONNECTOR.

Step Number One

REMOVE THE WIRE AND TERMINAL FROM LOCATION 18 ON THE CLEAR CONNECTOR, AND INSTALL ONE END OF THE INCLUDED JUMPER WIRE INTO LOCATION 18 ON THE CLEAR CONNECTOR.

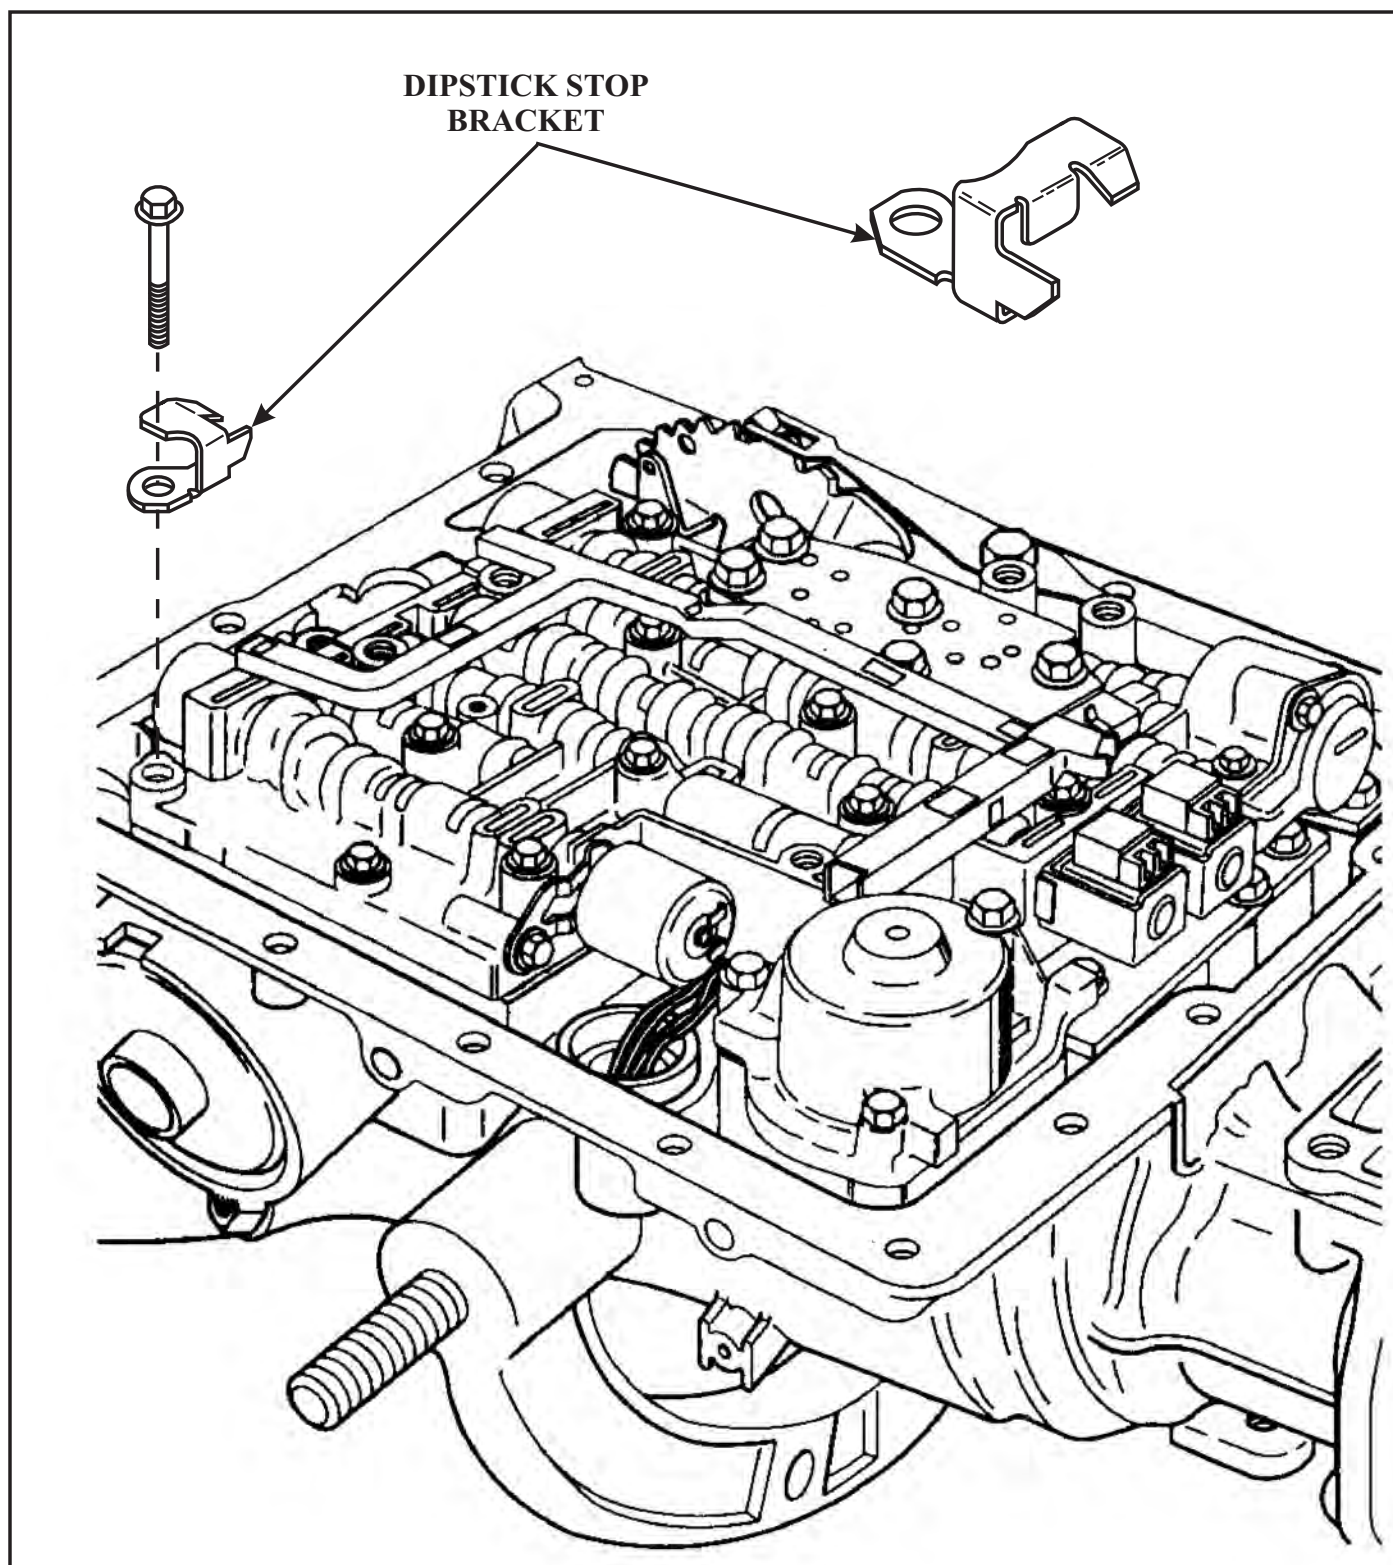
NEW 1998 VALVE BODY WITH CHAMFER FOR THE NEW DIPSTICK STOP BRACKETS

Dipstick stop bracket # 3 is to be used **only** with deep pans on valve bodies **with** the additional chamfer (See Figure 2 and 3).

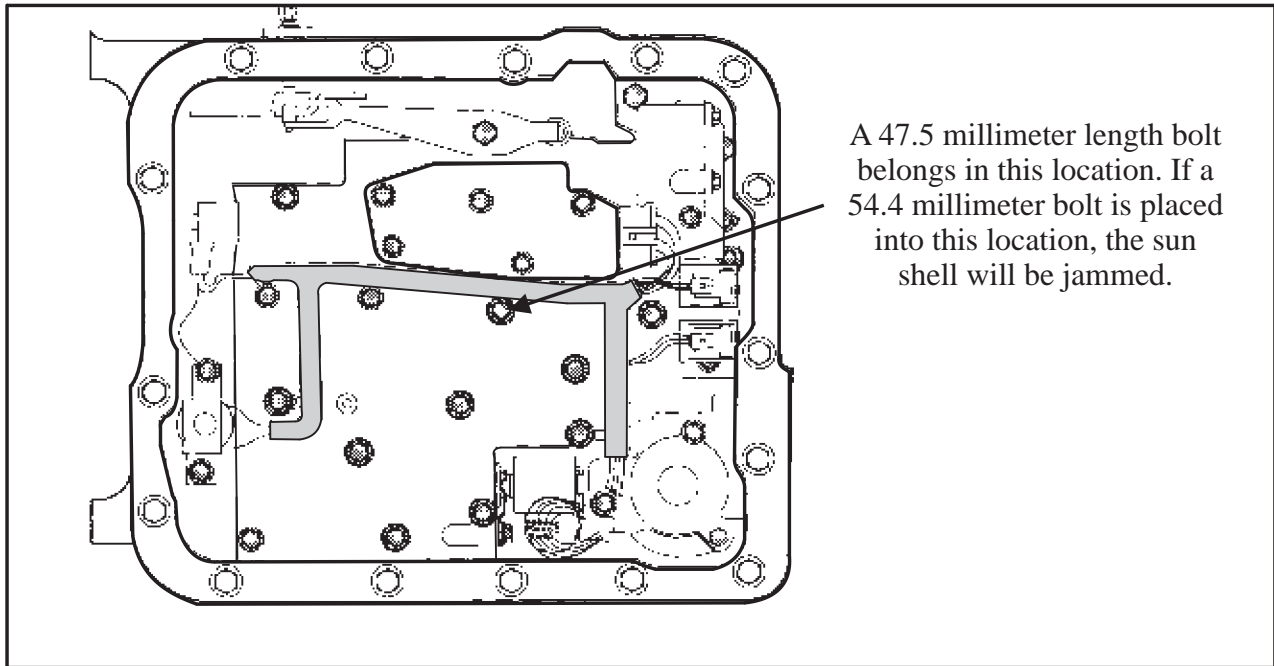
Figure 2

CAUSE: There are different length valve body bolts which can be easily mis-positioned (See Figure 1). A **common** error is placing a 54.4 millimeter length bolt into a location designed for a 47.5 millimeter length bolt (See Figure 2). The mis-located bolt will extend into the barrel of the case and into the sun shell. The bolt now being screwed into the sun shell inhibits the rotation of the shell causing the above complaint.

CORRECTION: Relocate the necessary valve body bolts to their proper location. Use figure 3 to locate the proper positions for the 47.5 and 54.4 millimeter bolt lengths. In severe cases, it may be necessary to remove the transmission in order to replace the damaged sun shell.
