THM 4L60-E/4L65-E "UPDATE HANDBOOK"

INTRODUCTION

THM 4L60-E/4L65-E

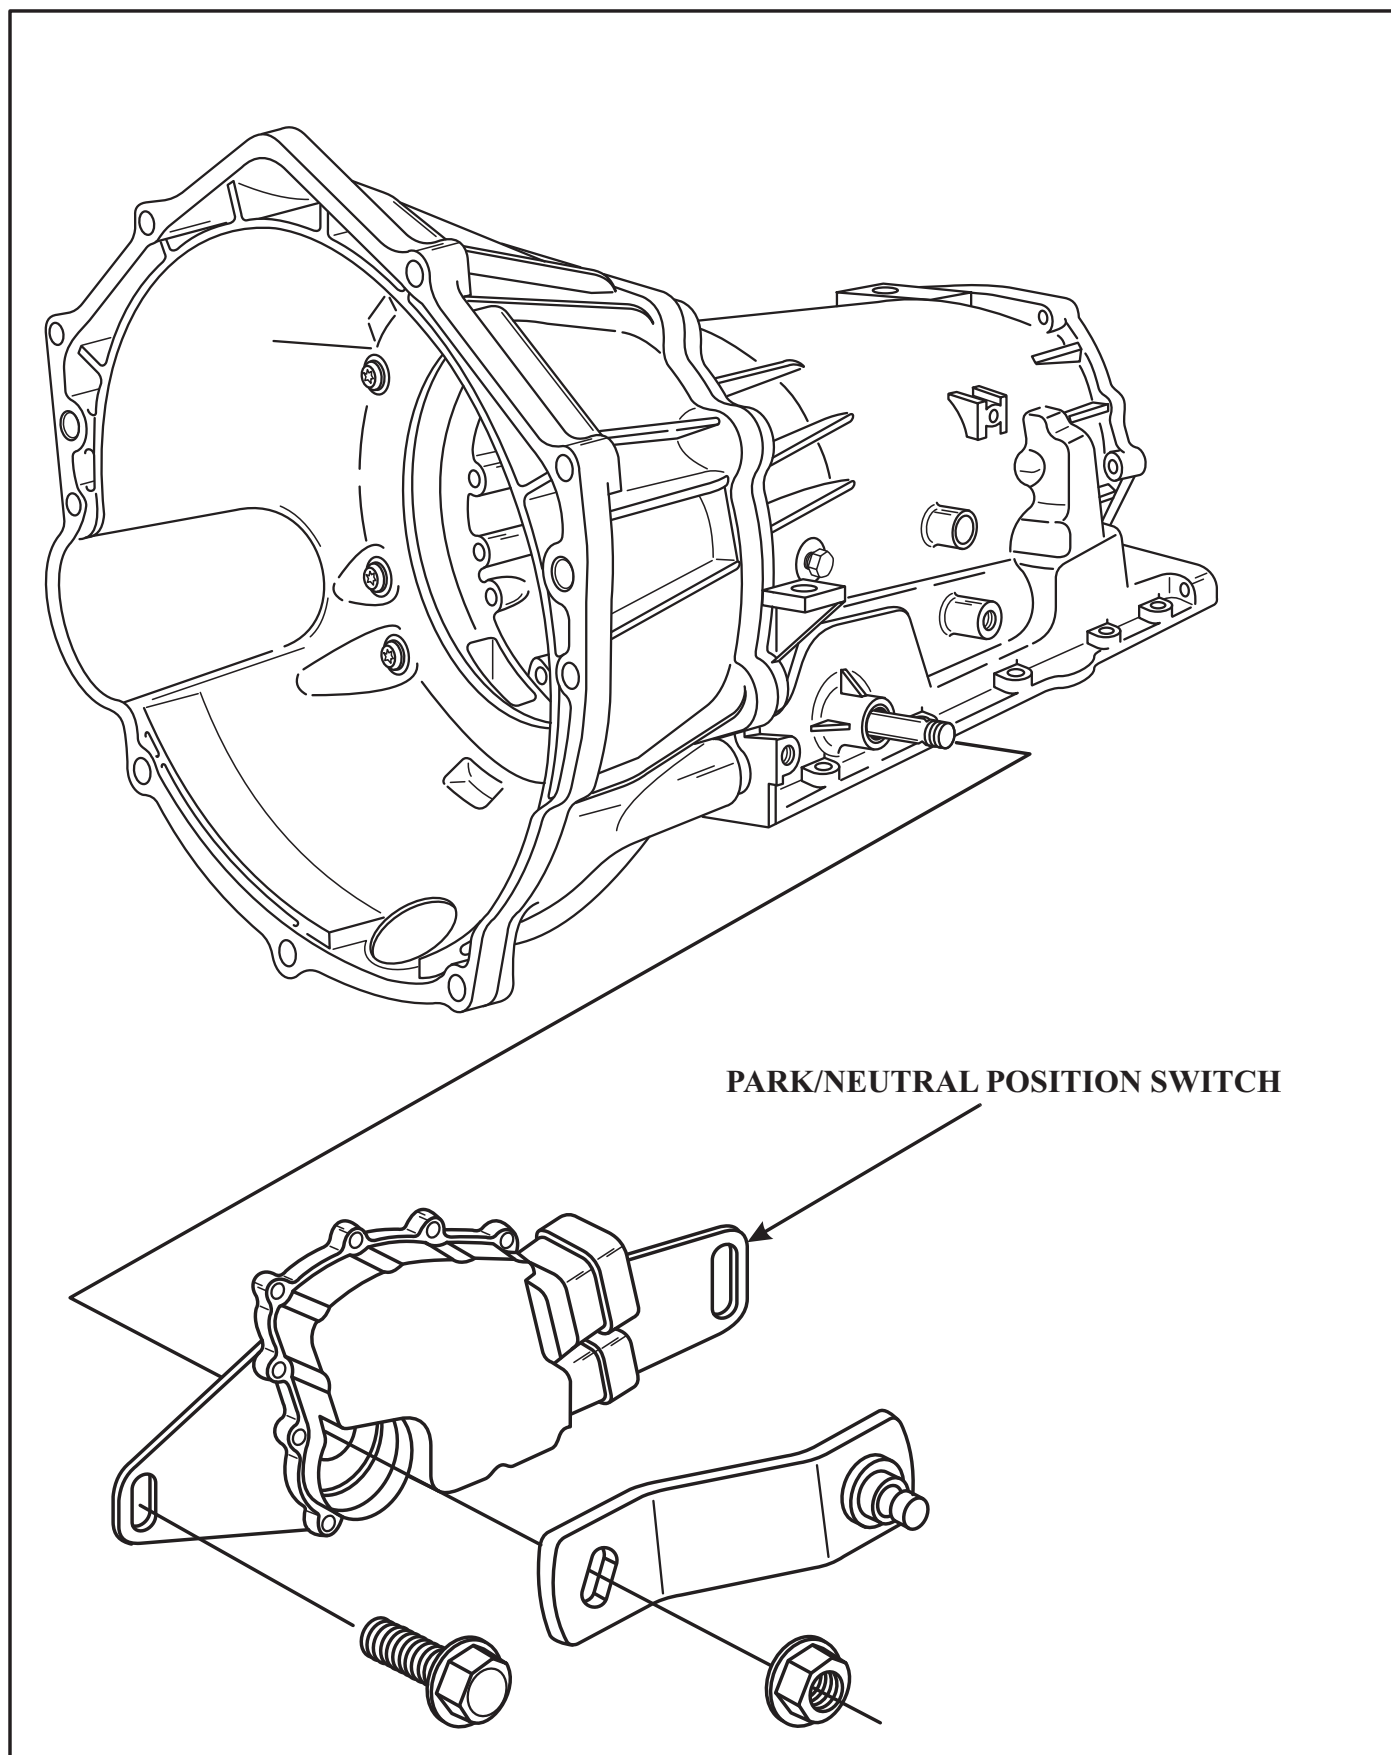
Figure 1

COMPLAINT: Technicians may experience difficulty in removing the connector from the Park/Neutral Position Switch, on some 1995-1998 model trucks and vans, usually when trying to remove the switch during transmission service. In rare cases the customer may report switch related electrical problems, such as improper or no shift indication on the dash indicator, or no back-up light operation.

CAUSE: The cause may be high ambient heat causing the sealing compound in the switch to melt and flow into the connectors, sealing the connectors to the switch. This normally causes no customer concerns, but may cause an open electrical circuit in rare cases.

CORRECTION: If the switch is being removed as part of transmission service, *and there are no switch related concerns*, the switch can be removed without removing the connectors, and left hanging until time to be re-installed. However, some models have a mounting bolt directly behind the switch connectors, which requires removing the connectors, and the switch *will be damaged* in the process (See Figure 3).

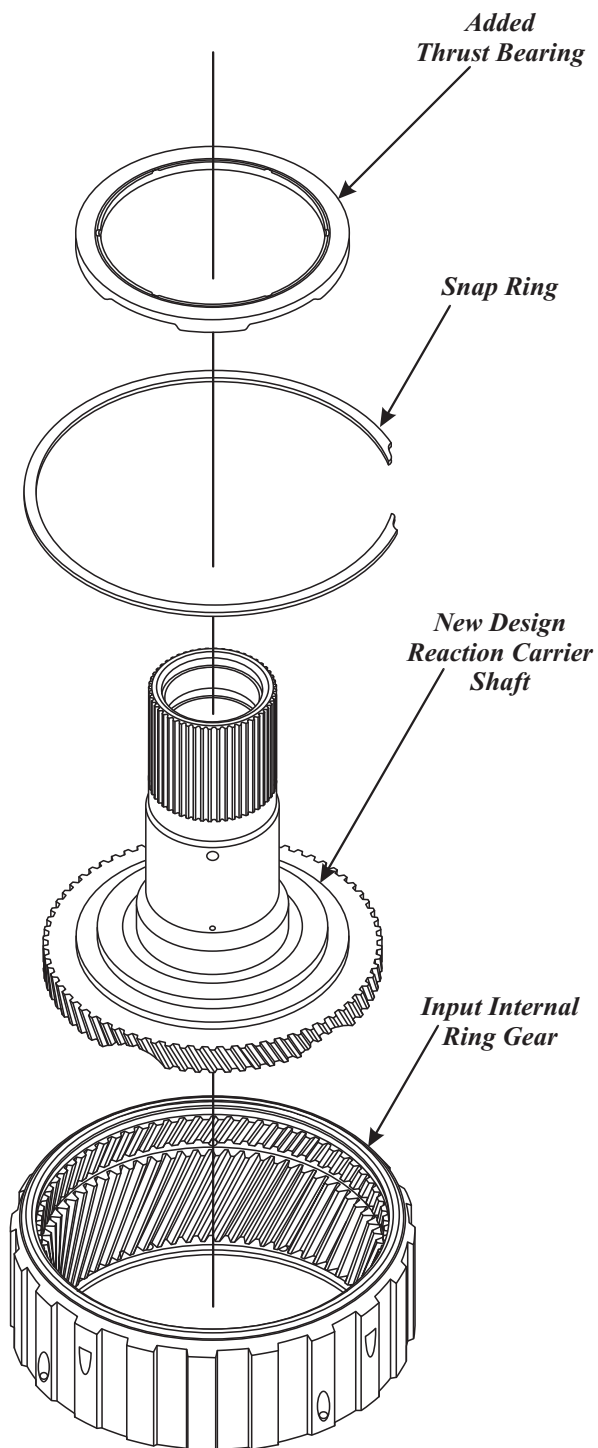
Figure 3

THM 4L60-E/4L65-E REACTION SHAFT AND NEW THRUST BEARING

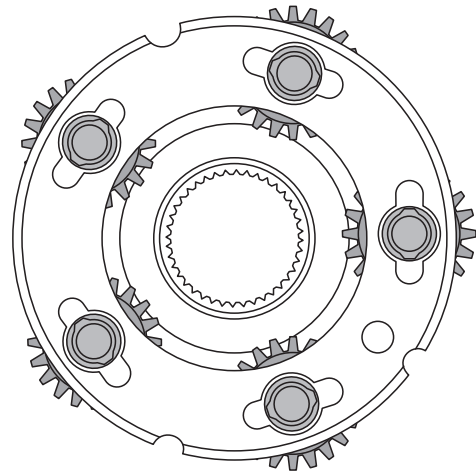
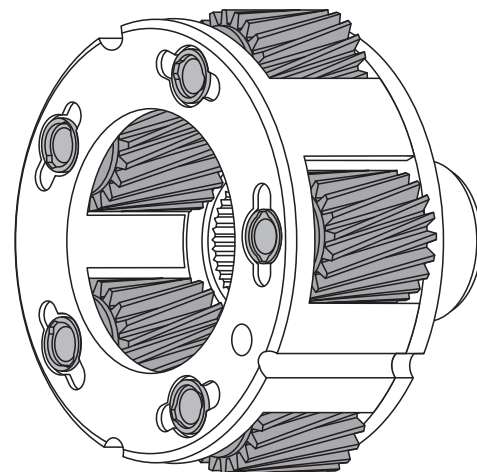
Figure 2

ATSG has recieved several calls on these units with the reaction (rear) ring gear broken. Since the part number changed but the dimensions did not, it would be logical to assume that the manufacturing process changed in some manner. Our recommended procedure, at this time, is to replace it with a reaction ring gear from a THM 4L60-E transmission and available under OEM part number 8667055.

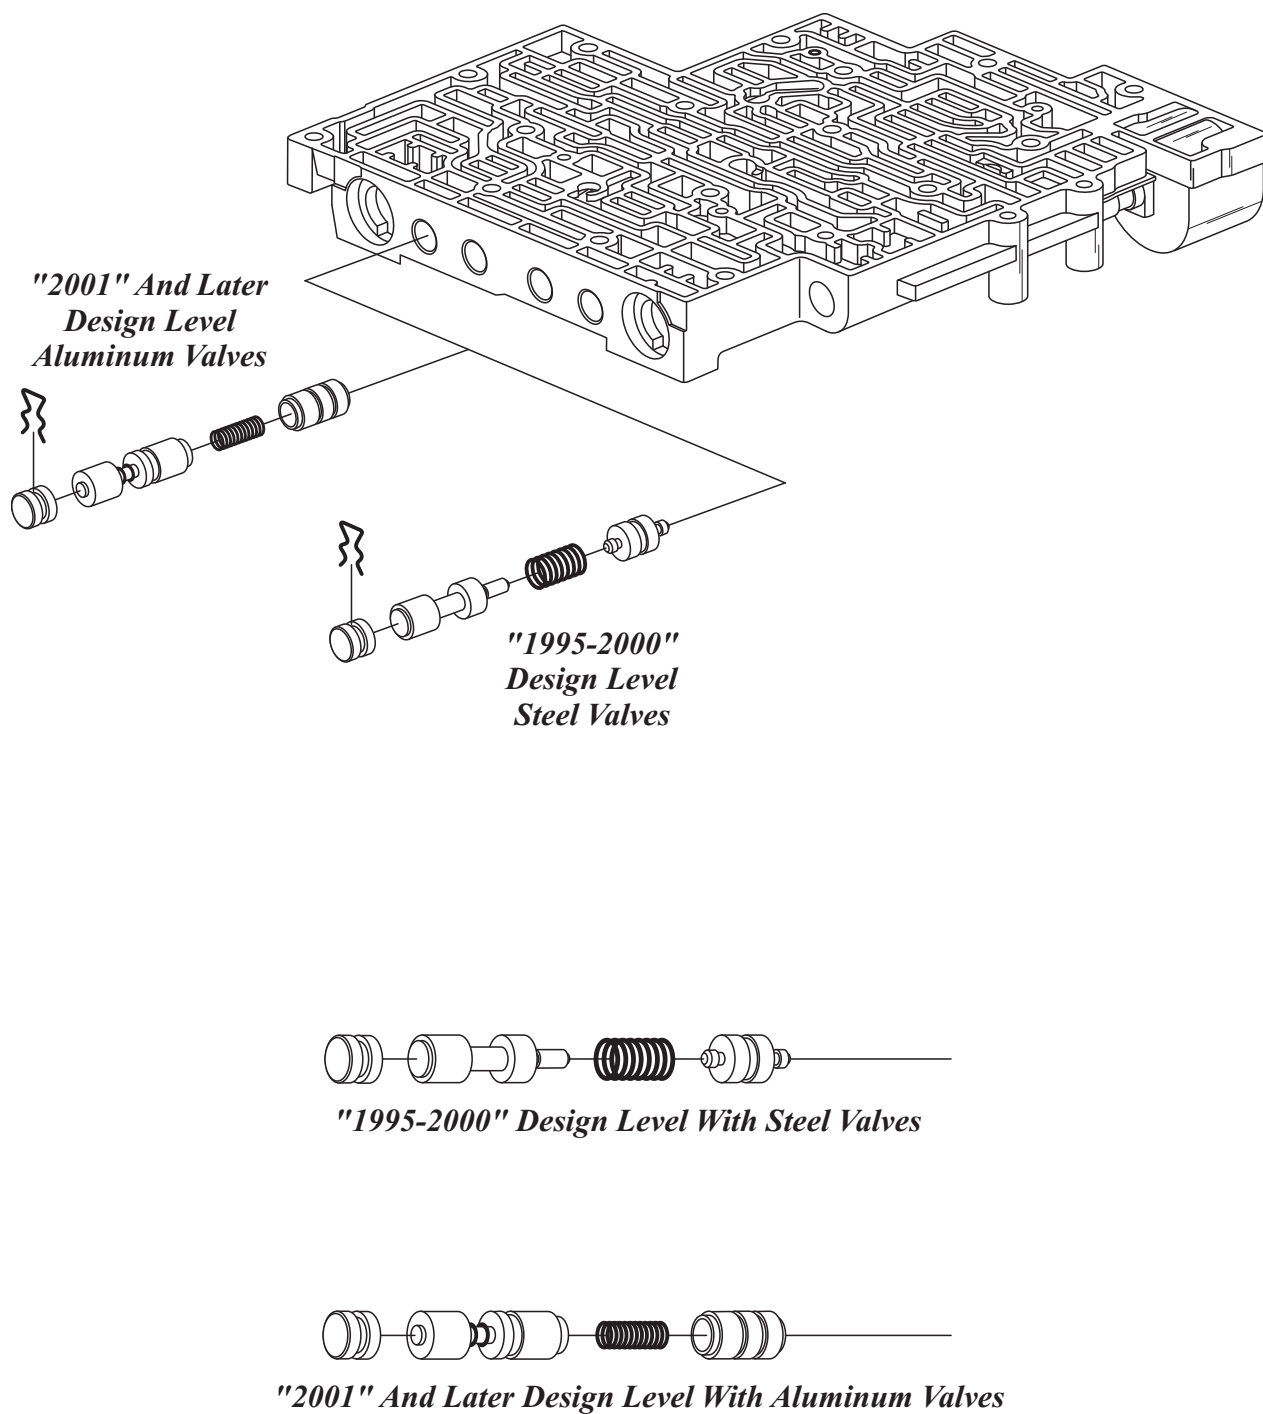
Figure 1

REASON: Reduced bore wear and improved performance for apply and release of the converter clutch.

CONVERTER CLUTCH REGULATOR VALVE LINE-UP

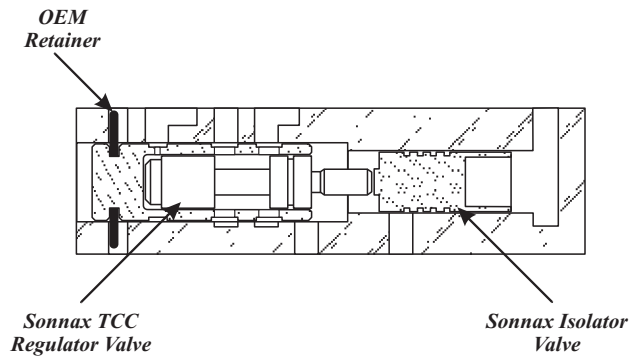
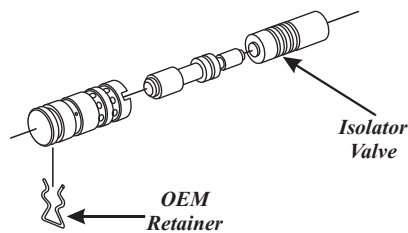
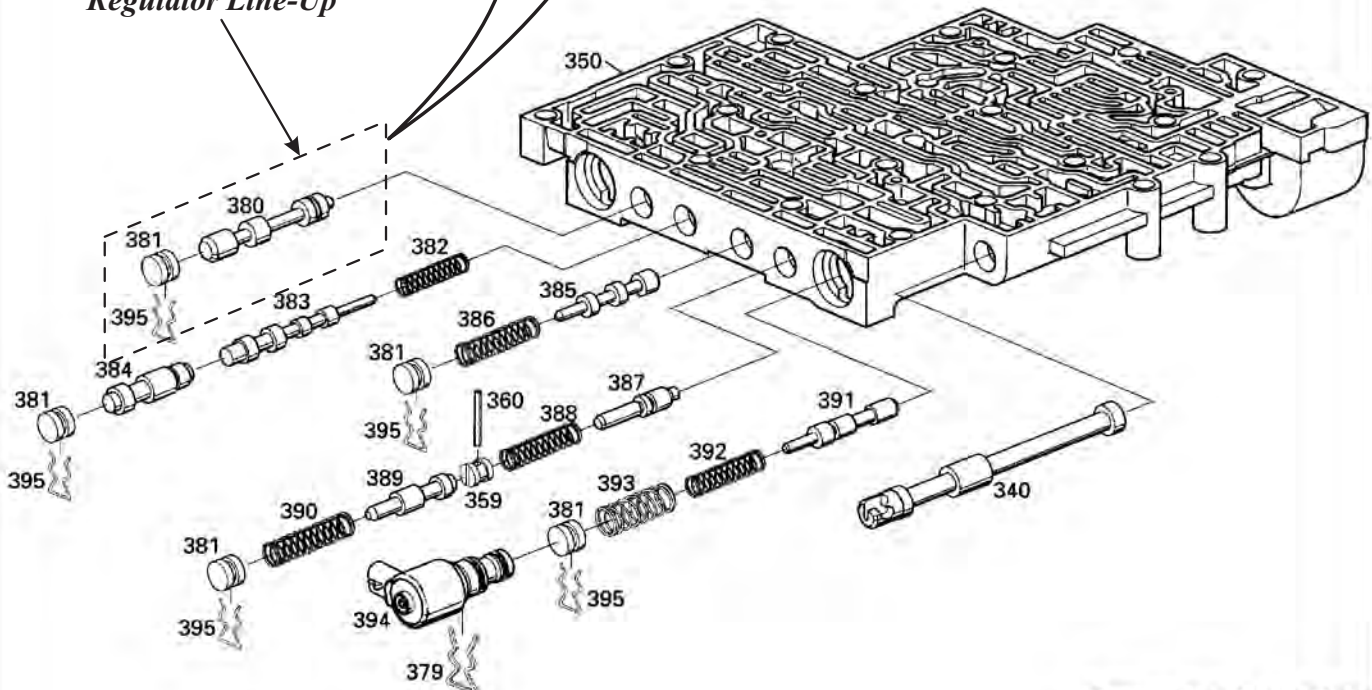
CAUSE: The cause is usually Torque Converter Clutch slippage, created by a badly worn valve body casting in the Converter Clutch Regulator Valve bore.

CORRECTION: Sonnax manufactures two different kits to repair the current valve body castings, both of which require a reamer, also available from Sonnax. One of the kits, Sonnax part number 77754-03K, fits 1993 thru 1997 model transmissions, but they require different assembly processes. Refer to Figure 1 for the 1994-1994 models and Figure 2 for the 1995-1997 models, for the proper assembly. The other kit, Sonnax part number 77754-04K, fits only the 1998 and later ECCC models, as it is a different calibration. Refer to Figure 3 for proper assembly of the 1998 and later models. The reamer required is the same for either kit and is available under Sonnax part number 77754-R2.

Sonnax kit for 93-94 NON-PWM Models:
Install Isolator Valve as shown below
and use OEM retaining clip.

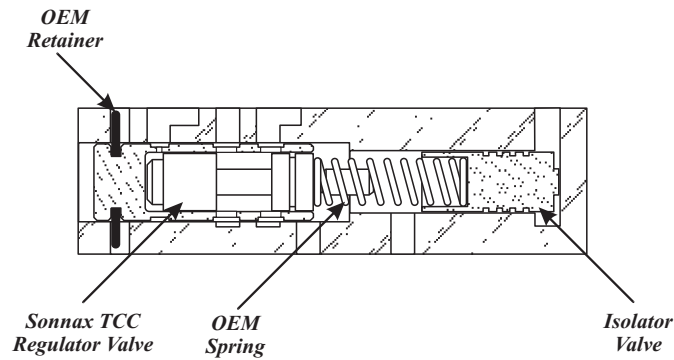
Figure 2

1998-Up Models, The TCC Regulator Valve is .440" in diameter, which is the same diameter as the Isolater Valve, and is **not recommended** for the earlier models.

1998-UP ECCC MODELS ONLY ASSEMBLY PROCEDURE

Sonnax kit for 1998-UP ECCC Models:
Install Isolator Valve as shown below
and use OEM spring and clip.
