2004

TECHNICAL SEMINAR

The Automatic Transmission Rebuilders Association

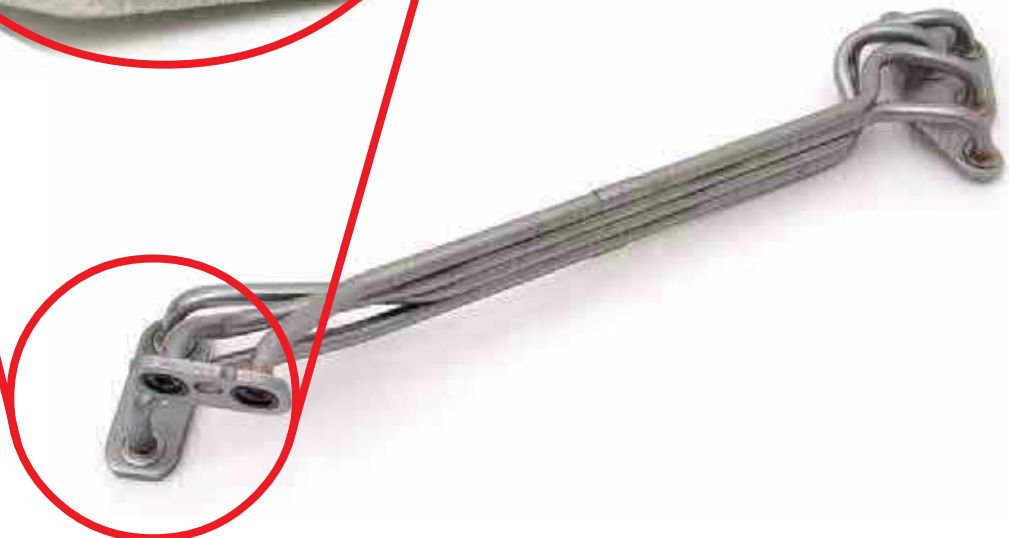
Cracked Oil Feed Tube

A cracked Oil Feed Tube may be the cause of a no forward or slips in forward condition. When installing the tube assembly to the case make sure there is no debris caught under the plate area before torquing the tube bolts. This may cause the tube assembly to crack. Make sure to check all tubes during disassembly and reassembly.

**Torque the feed
pipe bolts to
106 inch lbs**

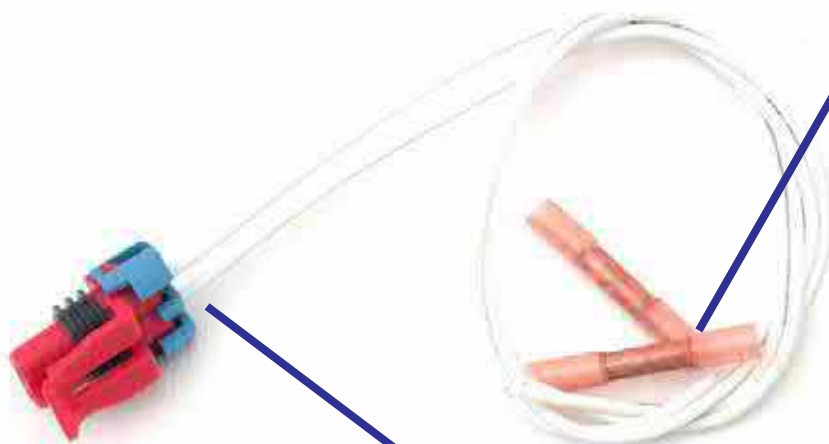
Cause #2 The Evaporative Emissions Canister Vent Solenoid retainer may have come loose, allowing the associated wire harness to contact the axle. Abrasion of the wire against the axle may rub through the insulation creating a short to ground.

1. The Evaporative Emissions Vent Solenoid is retained by a molded in, plastic extension. The retainer has molded in ridges that create an interference fit to the underbody. Under some instances, the retainer may have not been fully seated when installed.
2. Remove the jumper harness from the Evaporative Emissions Vent Solenoid and repair the harness as necessary.

Connector, GM Crimp n' Seal Butt End Part# 12089189

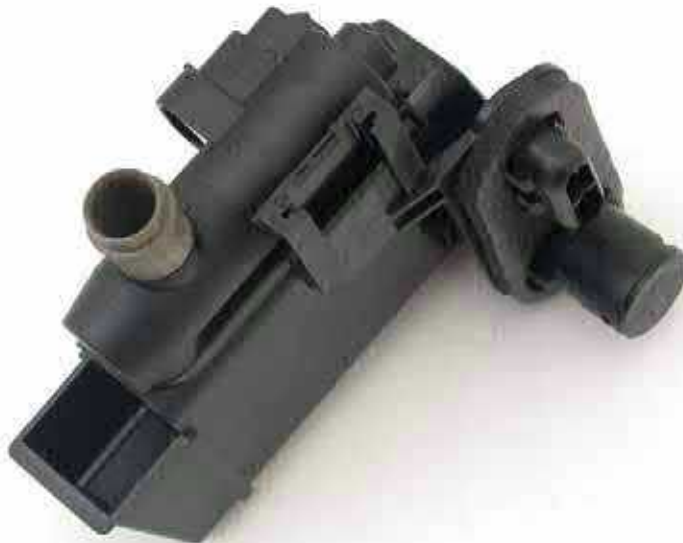
Inspect the retainer for damage. Additionally, examine the solenoid body for any signs of damage. If the retainer and solenoid body appear in good condition, verify that the fastener holds properly by pulling on the solenoid body to check that it is retained. If the fastener will not retain properly or there are signs of damage, replace the Evap Vent Solenoid.

Discard and replace the jumper harness with P/N 12101858, lower the vehicle and clear all DTCs.

Part Number
22622022

Description
Valve, Evap Canister Vent

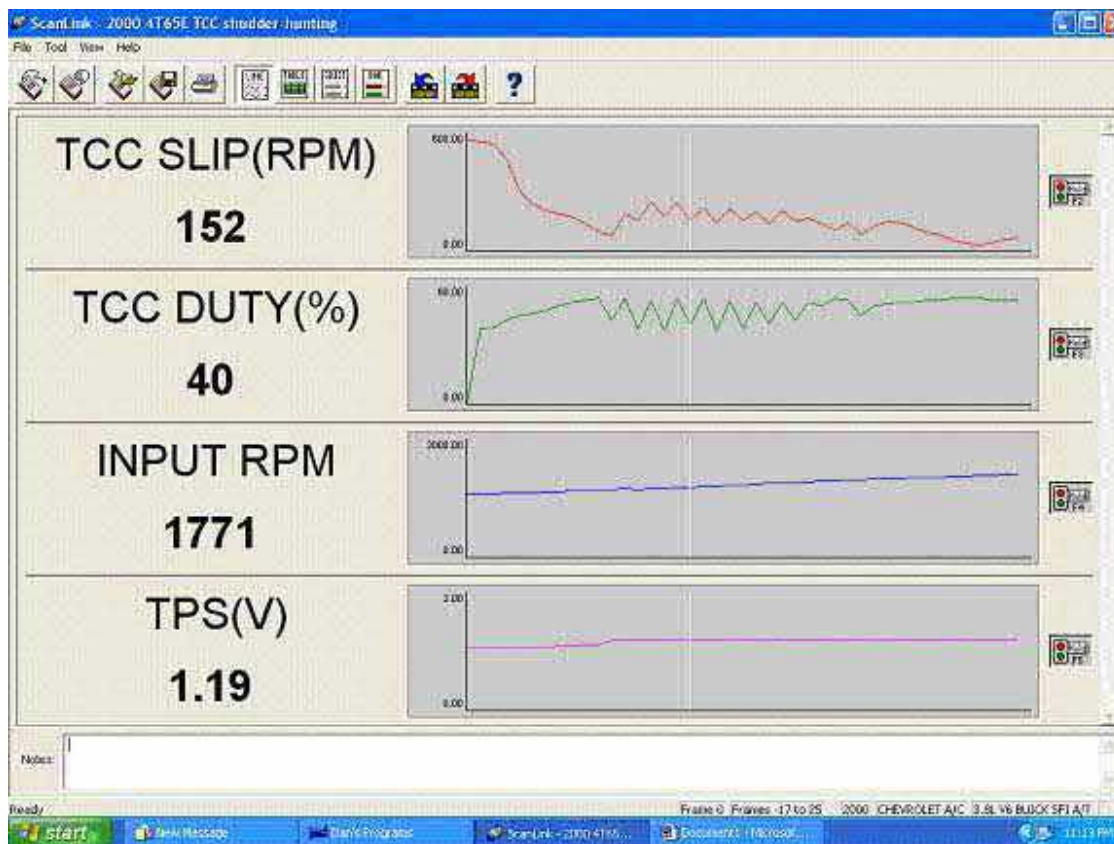
Many TCC related complaints are caused by computer programming problems. The chart below shows the TCC Slip speed is varying about 100 RPMs about every 1.5-2 seconds. This isolation feels a little like an engine misfire, but smoother. It is apparent the computer is commanding the TCC to be erratic. First determine if there is a input causing your problem. If all of your inputs are at their perspective specifications, try reprogramming the computer.

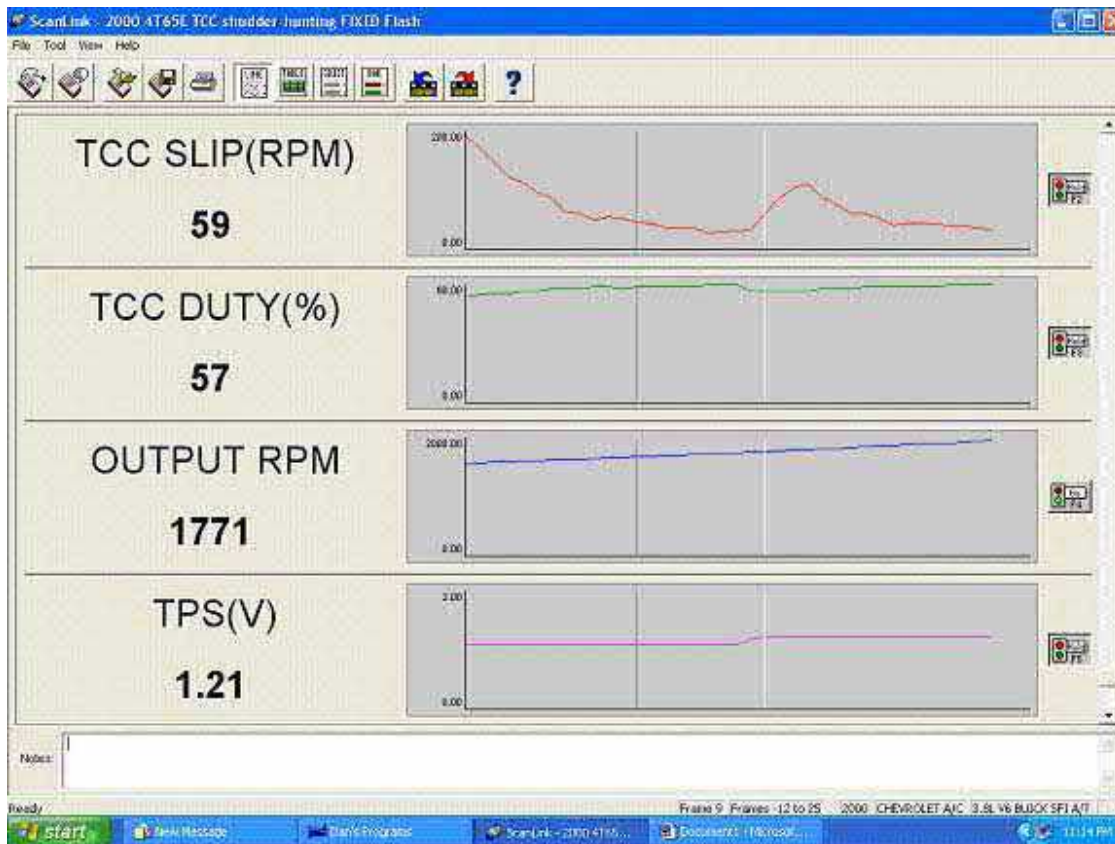
Here's the same vehicle after the processor was reprogrammed. Notice the TCC duty cycle is steady, as well as the slip. The slight increase in the TCC slip is from a slight dip of the throttle. Trying to correct this problem mechanically might be impossible.

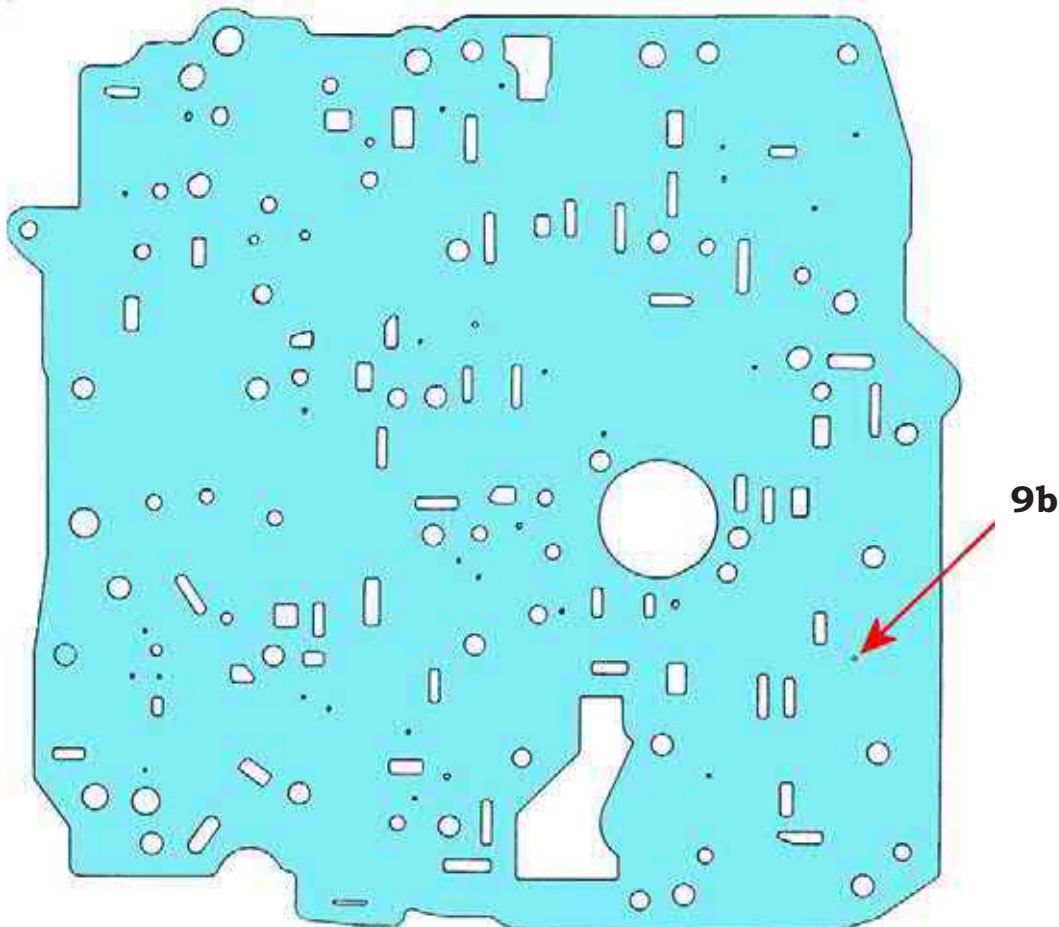
P0741, Excessive TCC Slip, No TCC Apply

Orifice 9b is too small, not allowing enough TCC Signal / PWM oil to the TCC Reg. Apply valve

Enlarge orifice 9b with .020" to .030" drill

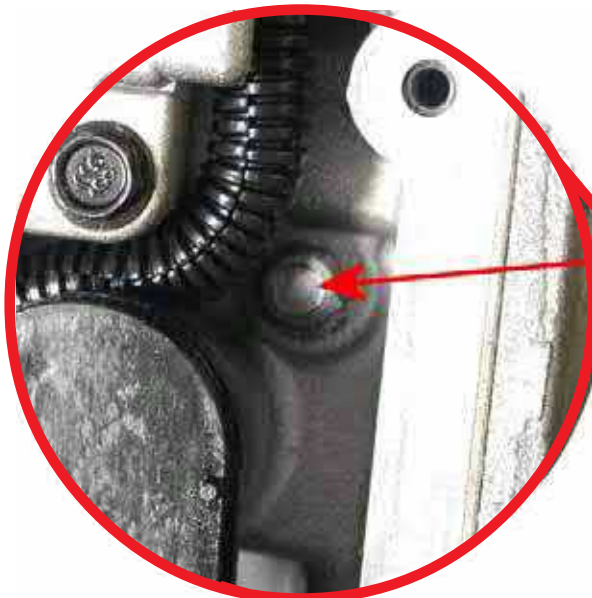
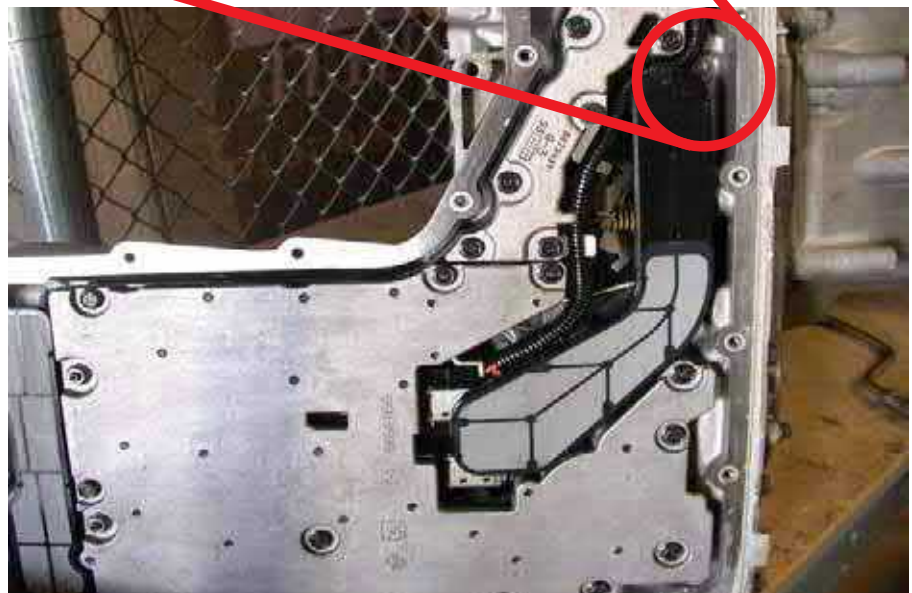
Refill Procedures

When servicing a 4T80E transmission it is necessary to remove the plug from inside the case to drain the side cover of it's oil. This plug is located near the chain cover. Fluid level that is not correct may be caused by not reinstalling the plug.

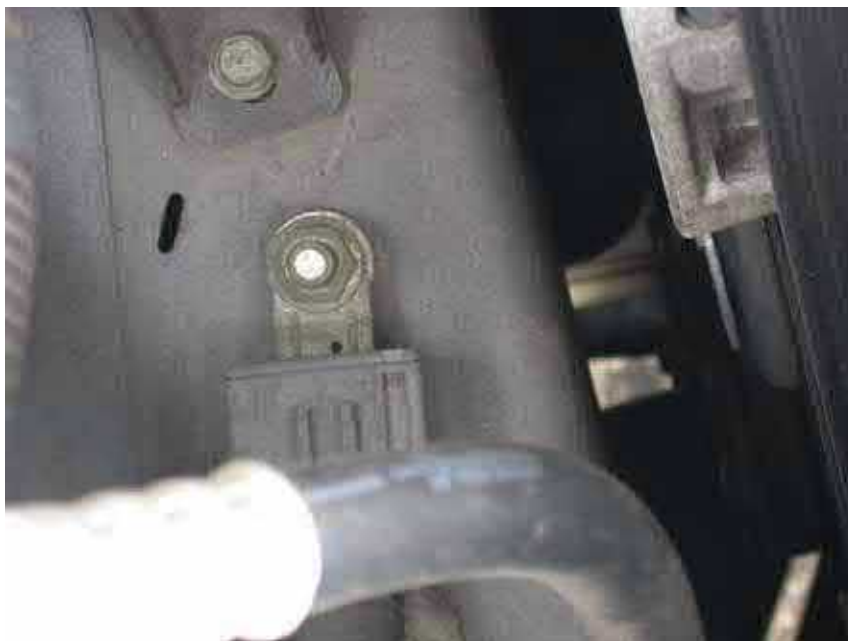
4T80E Northstar applications may experience an erratic speedometer reading, as well as other conditions such as a TCS (Transmission Control Switch) light on, and a possible C1295 DTC. Some conditions may also lead to shift related concerns.

- 1. A bad 3A ground wire typically located near the alternator**
- 2. The Transmission harness is rubbing on the cooling hose clamps in the area of the coolant recovery jug.**

Repair the harness or ground connection

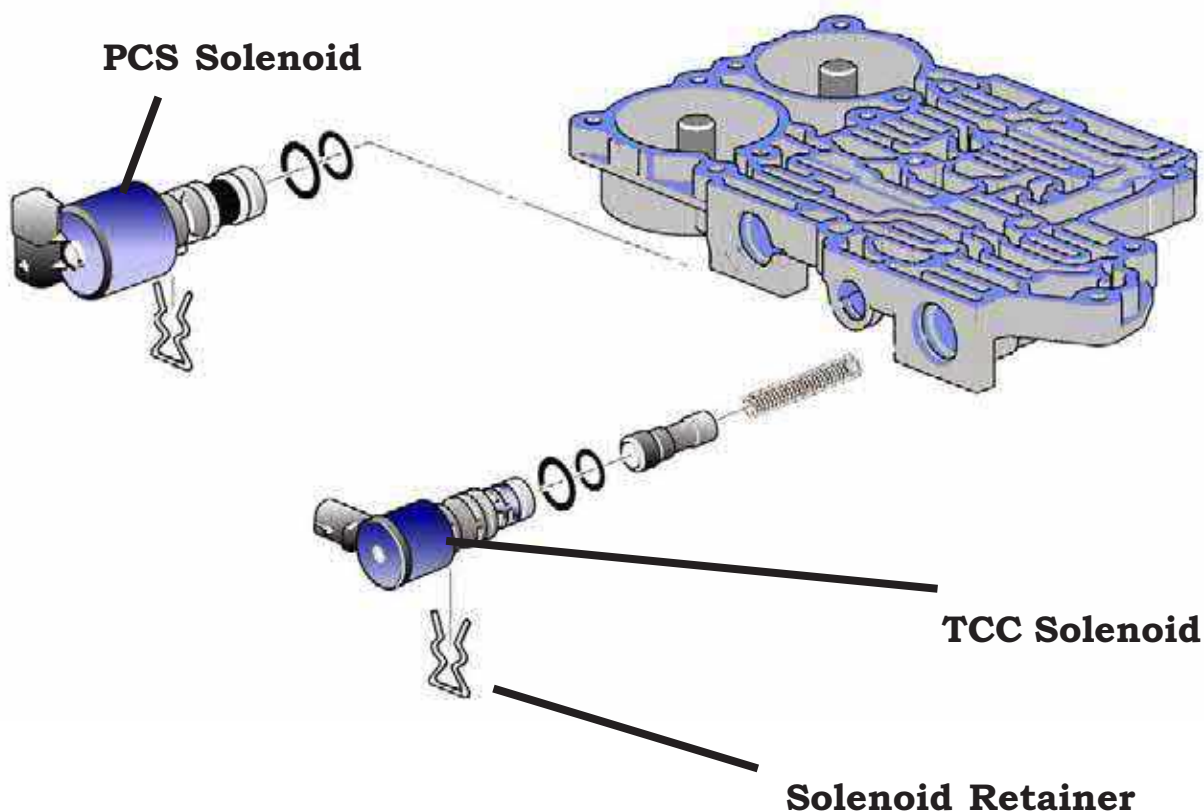
Part Number
96042599 TCC PWM Solenoid

Remove and inspect the TCC solenoid from the transmission. The plastic connector may be labeled "2690". The "2690" TCC PWM solenoid is the suspect solenoid and should NOT BE REUSED. The new TCC PWM solenoid, P/N 96042599, is labeled "7792" and should be the ONLY solenoid used.

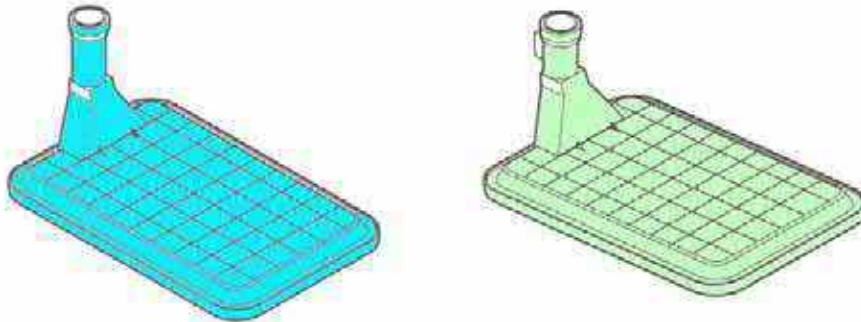
Cause/Correction: Several items can lead to excessive pump noise, they include: Restricted filters - The LCT 1000 uses two filters, one is a spin-on design while the other is similar to other GM applications. Both filters have undergone updates. The spin-on filter seal material was changed to improve its elasticity in cold temperatures.

1. Making the body wider to increase the flow area.
2. The filter material was changed to improve the filtration rate while reducing the amount of contamination that the control main filter would need to control
3. A cold temperature bypass was added with a “screen over bypass” incorporated to prevent large debris from entering the pump during bypass operation

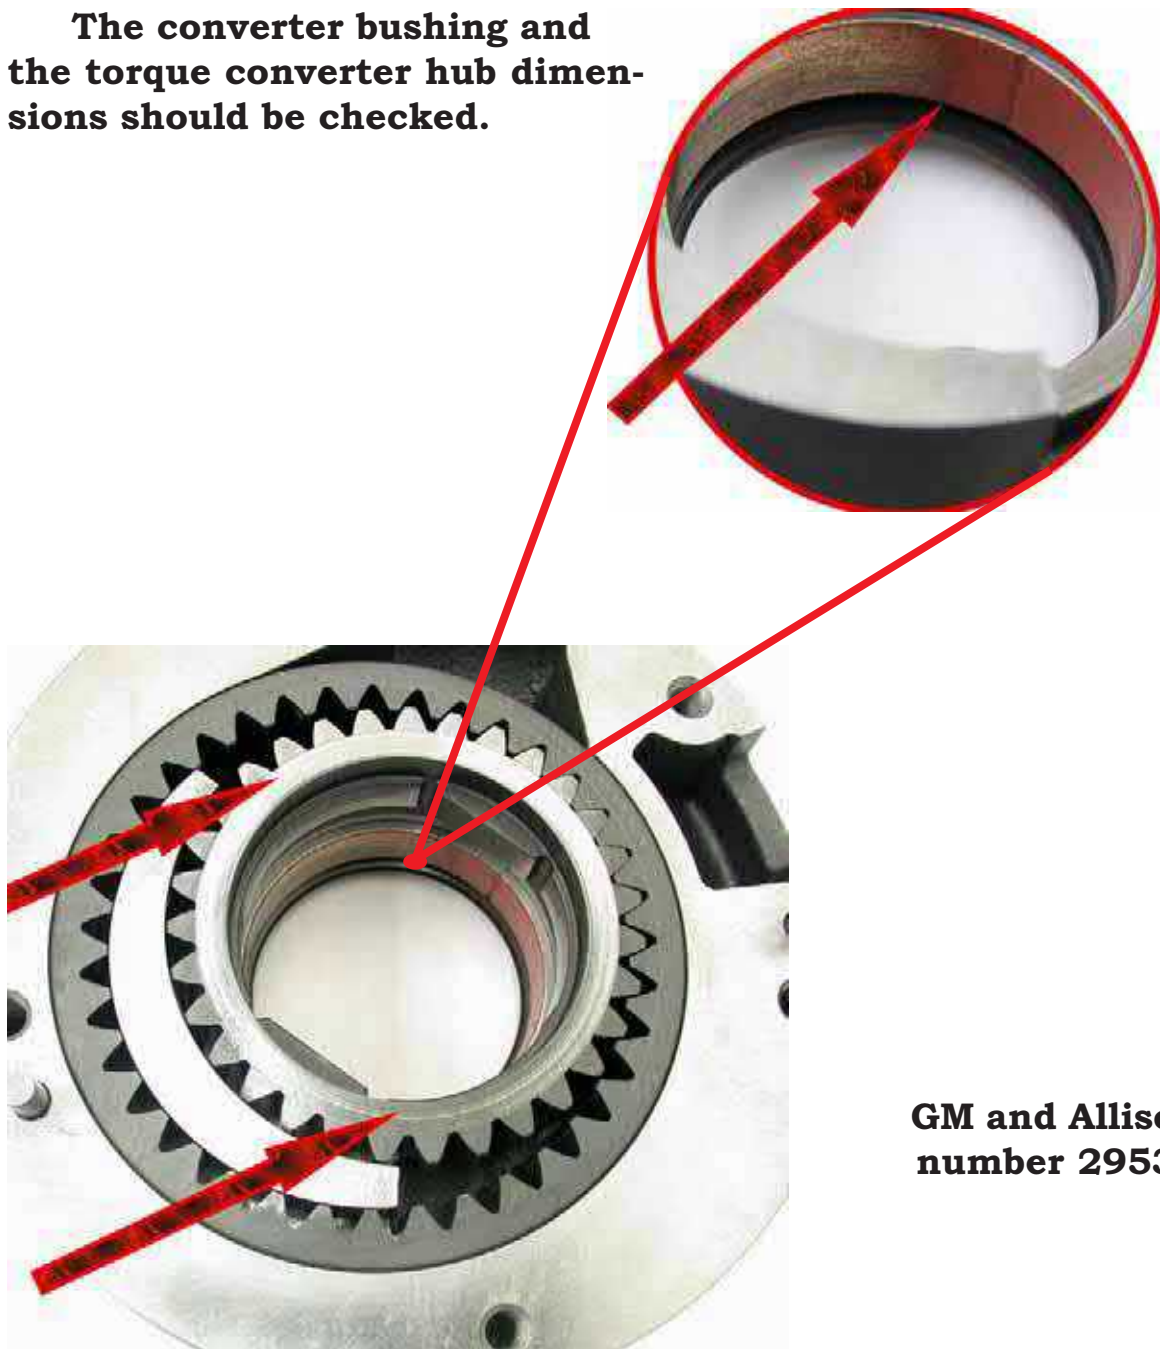
**GM and Allison part
number 29539580**

The pump may have excessive wear. Several pumps have been found to have opposite corner wear leading to very excessive pump noise (See Illustration) Visually inspect the pump, measure the pump for wear as outlined in the service manual. If the pump is worn replace the pump or the damaged parts. Several updates have been made to the pump, housing gasket and pump wear plate.

The updated pump is available under GM and Allison part number 29539580. The updated pump eliminated the two finger slots, cast into the body of the pump. In addition, the position of the crescent was also offset. It can be identified by the updated casting number 29539852 stamped into the body of the pump. The updated pump wear plate. Allison part number 29539616 added a metering groove in the pumping chamber area. The updated housing gasket (GM and Allison part number 29540130) eliminated two pressure slots in the pump area and strengthened the gasket by adding material to the gasket, in the pump area. The updated parts will back service the previous applications if used as a complete package.

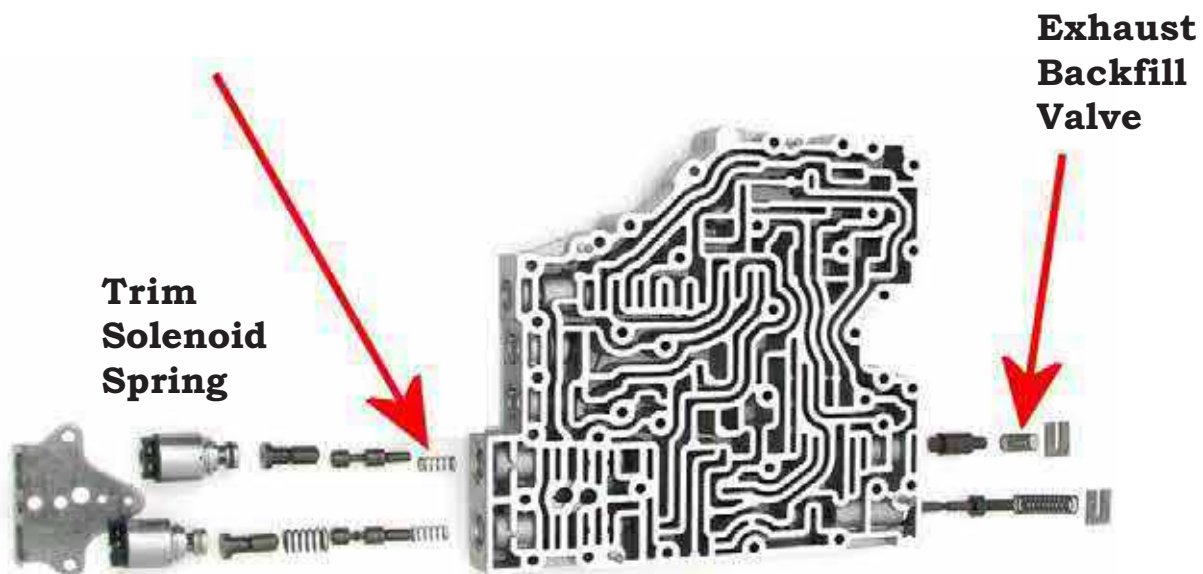
During repairs on the LCT 1000 it is common for technicians to clean and inspect the various valves and springs. One area that has been a concern with this unit is intermixing springs as they sometimes appear to be the same. Even though the springs may appear to be the same in size and shape they may not be. If the “exhaust backfill” spring is intermixed with the “Trim solenoid” gain spring clutch failure will occur as the back fill pressure will be high enough to keep the clutch partially applied.

1. **NO COLOR- Introduced 6/99**
2. **Orange stripe- Introduced 7/00**
3. **Light green stripe- Introduced 7/01**
4. **Solid Green- Introduced 9/01**

CAUSE/CORRECTION: In an attempt to limit the chances of this type of failure from occurring in your shop always keep the springs separated and in the correct positions on your work bench as perform repairs on the hydraulic system. To help identify the exhaust back fill springs they have now been color coded. The color codes are as follows:

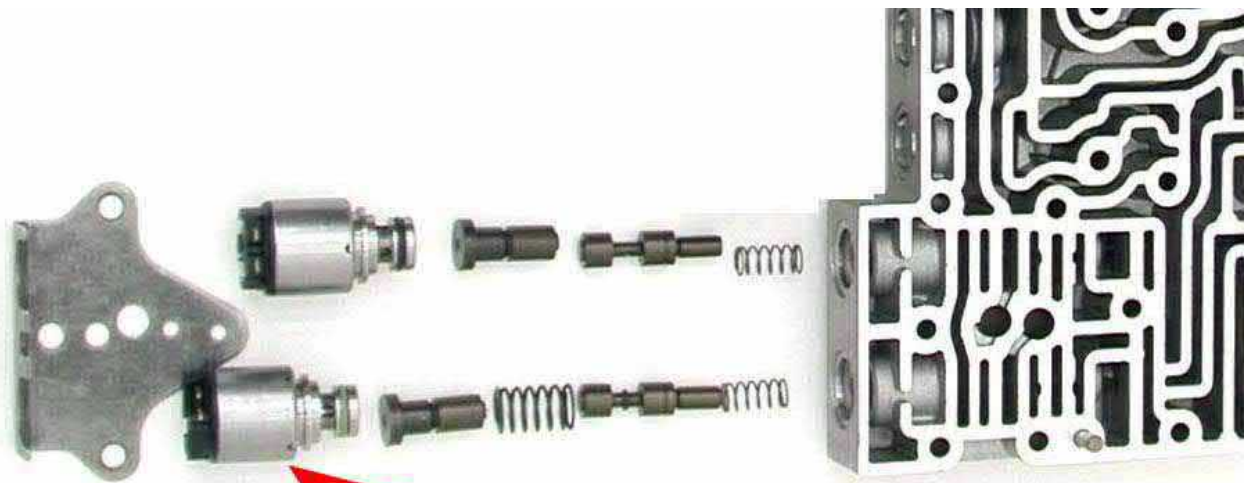
**Trim
Solenoid A**

1. Incorrect TCM software calibration
2. Hydraulic or mechanical problems with the C1 or C5 Clutch (Do a clutch test) (C1 clutch has had apply issues on 01-03 models)
3. Solenoid failure (Trim A)
4. Trim Valve sticking
5. Poor connection at the Transmission pass through connector (Common)
6. Erratic VSS or Turbine sensor values (a common cause is terminal 15, connector C2, circuit 821 not seated properly at the TCM connector)

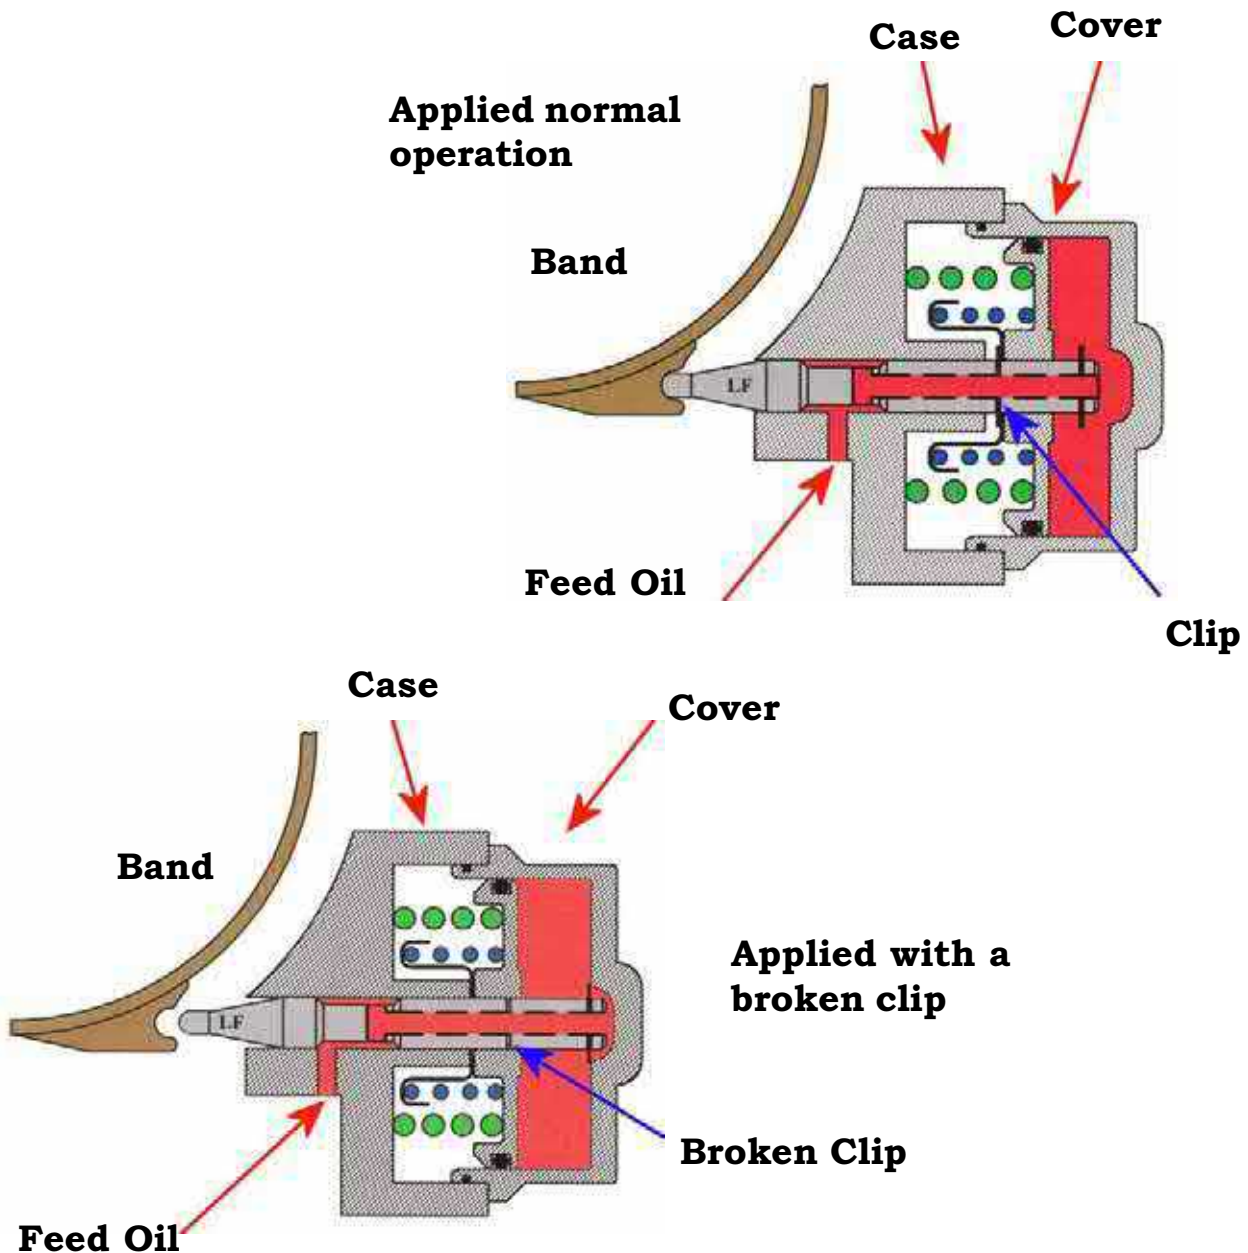
Oil enters the servo through the case and is directed to the top of the servo piston. If the clip is broken the piston will bottom out and the servo apply rod will be stationary and not apply the band.

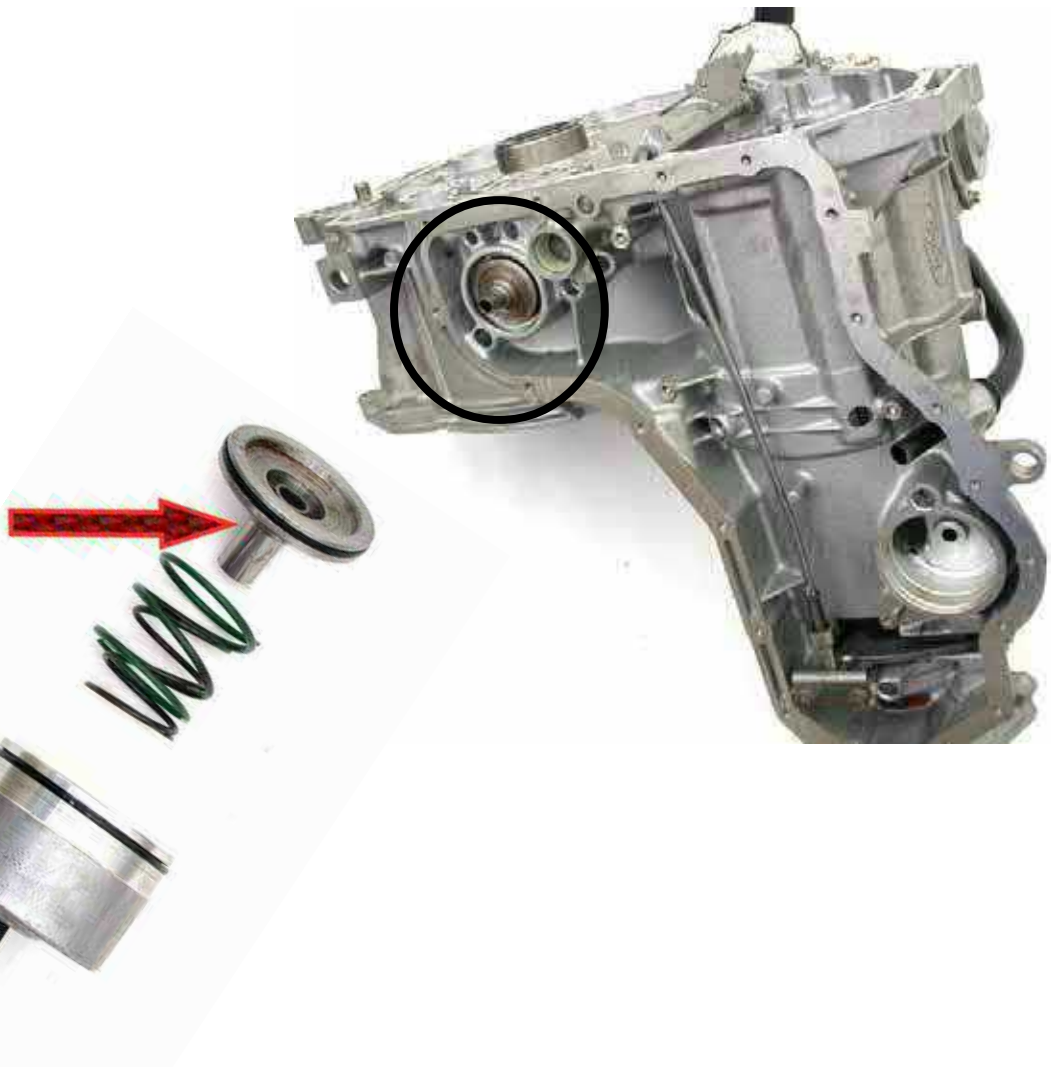
AX4N

Delayed Engagement

A delayed engagement may be caused by a worn or damaged neutral drive accumulator pin. The pin seals the oil between the accumulator and the forward clutch. When the pin is worn or damaged the forward clutch oil pressure is lost.

Check for wear here.

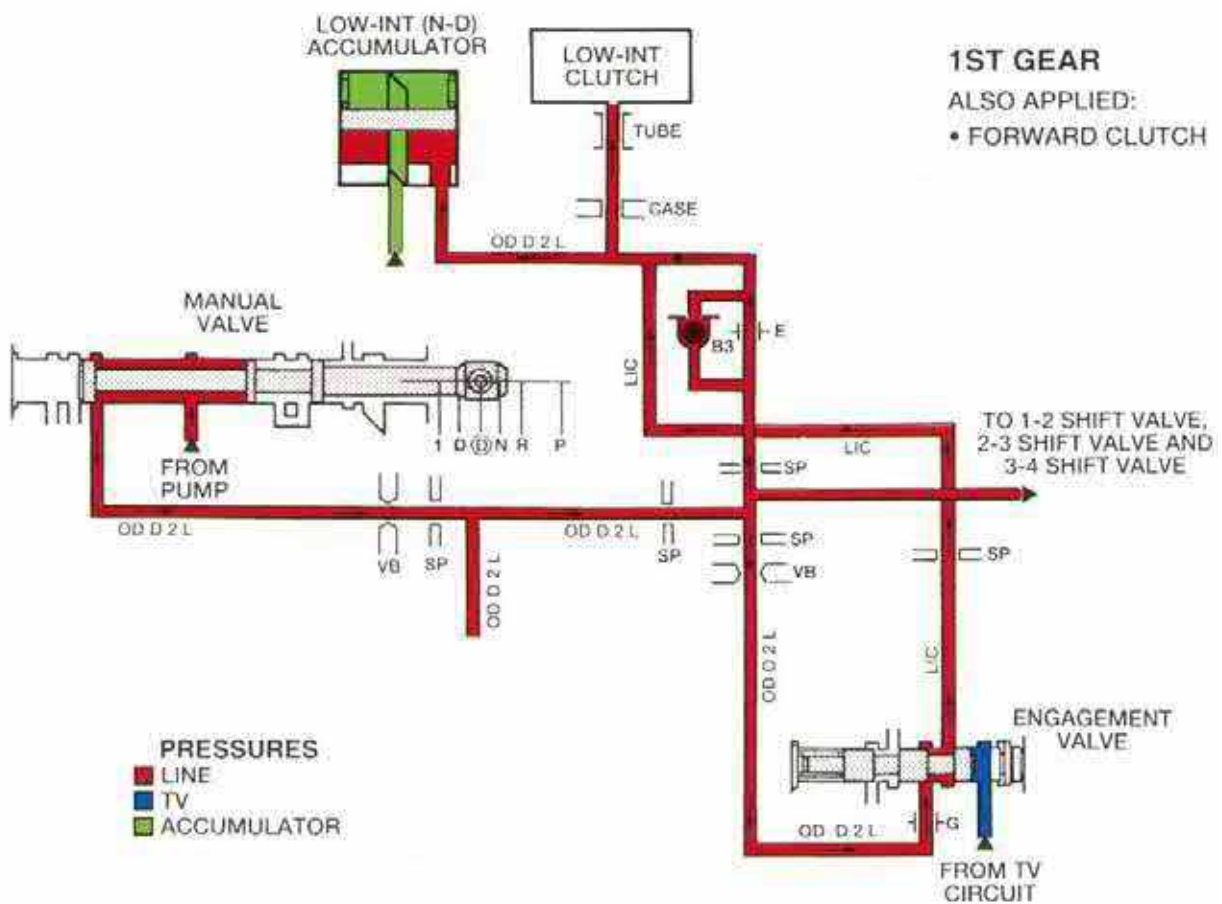
AX4N

Delayed Engagement (continued)

The green oil is modulated pressure from the line modulator valve. It enters the accumulator through the accumulator pin. The Red oil is line oil that comes from the 1-2 shift valve and applies the forward clutch while using the N-D accumulator to cushion the application. If the pin becomes worn it allows the line oil to enter the accumulator regulaotr circuit.

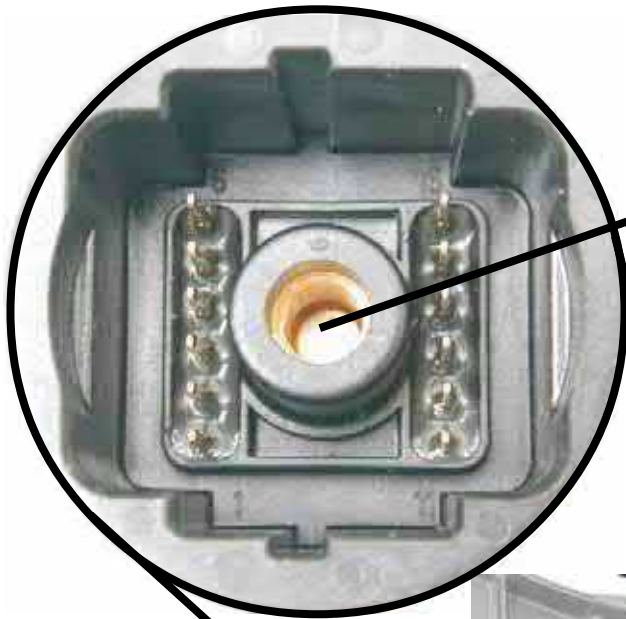
5R55N/W/S

Multiple Solenoid Codes

Multiple codes that won't clear may be caused by a bad or loose connection at the solenoid connector. This concern is especially found after overhaul and during the installation. The bolt on the connector has to bottom out on the solenoid block.

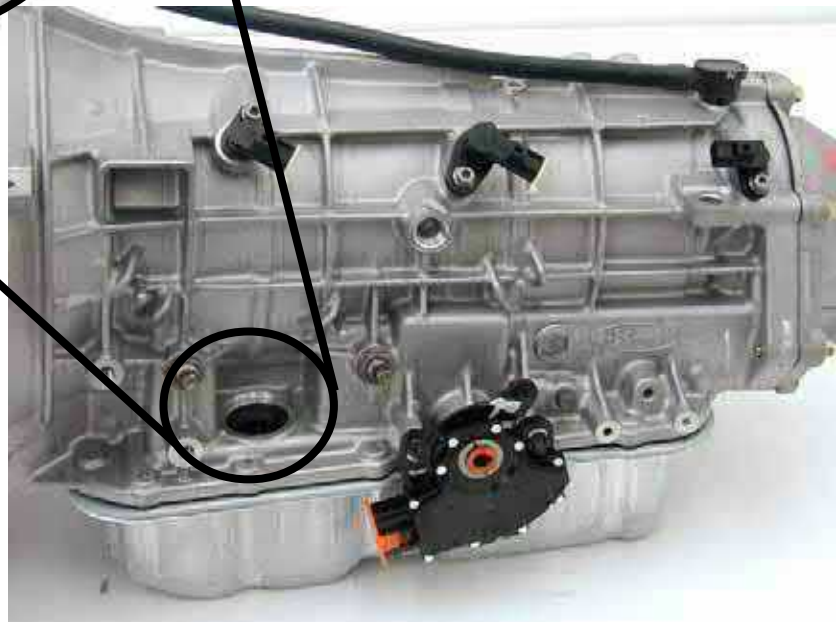
The Depth of the solenoid bolt hole is 0.470”.

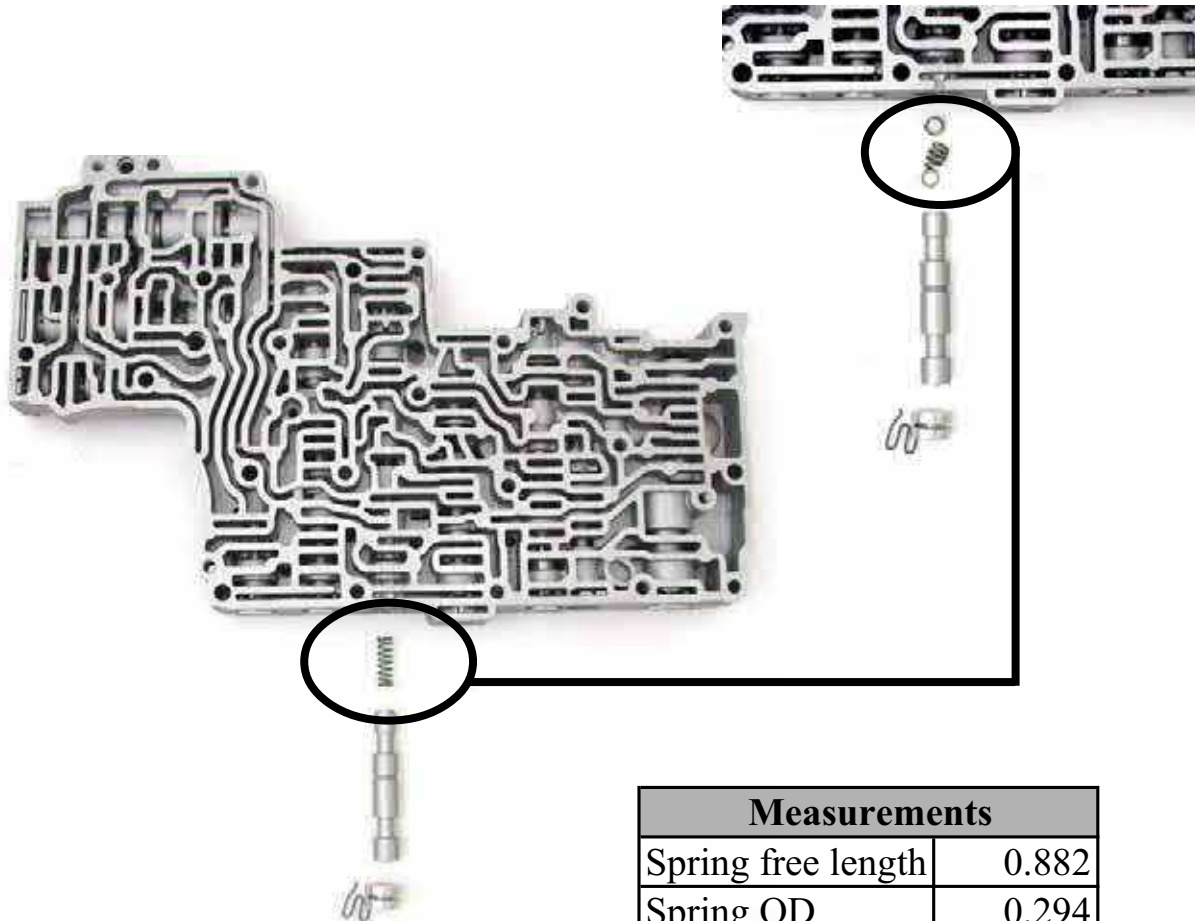
5R55N only

No 4th and No 5th

The 4-3 pre-stroke intermediate band control valve spring may break due to the spring being machined incorrectly. Also, a code P0795 (Pressure Control Solenoid C circuit failure or shorted) may be present.

Measurements	
Spring free length	0.882
Spring OD	0.294
Spring wire size	0.034

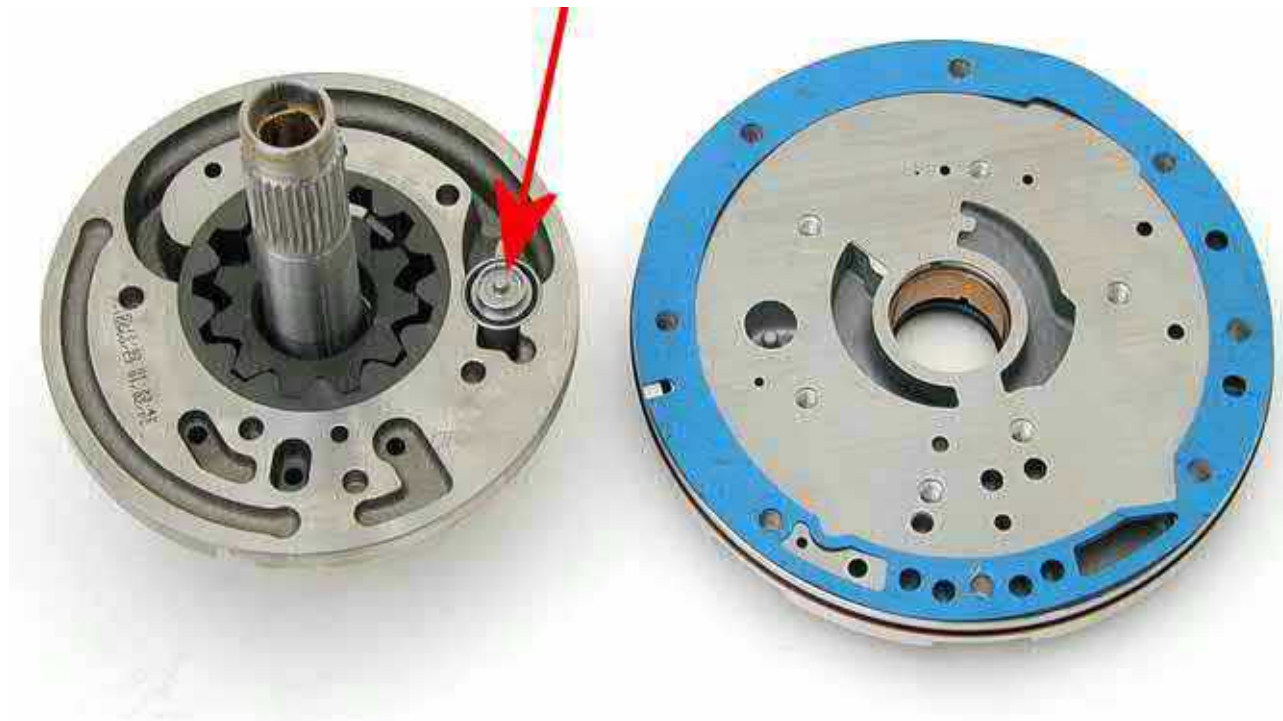
**Control valve
and O-Ring**

A Delayed engagement after sitting when hot or cold may be caused by the flow control valve o-ring missing, destroyed, or the control valve is stuck in the OPEN position.

The flow control valve is used to help control the volume output of the pump.

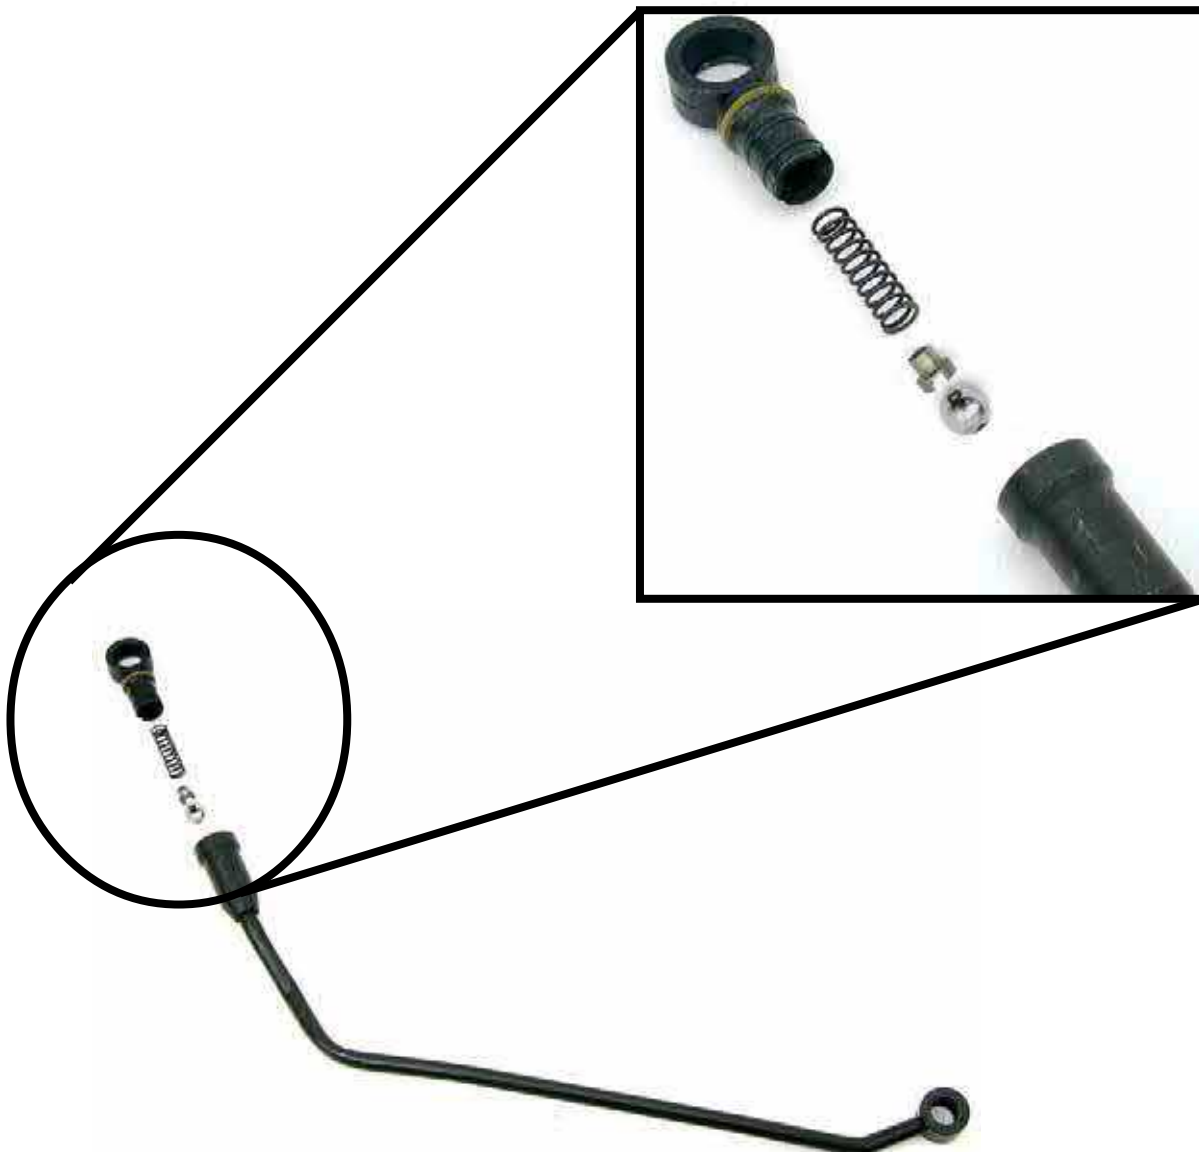
Bypass Tube

Dissassembly and re-Assembly of the bypass tube may be necessary due to heavy contamination. Simply pull the top off the cooler fitting adapter while holding the tube, and the sealed fitting will release from the tube assembly.

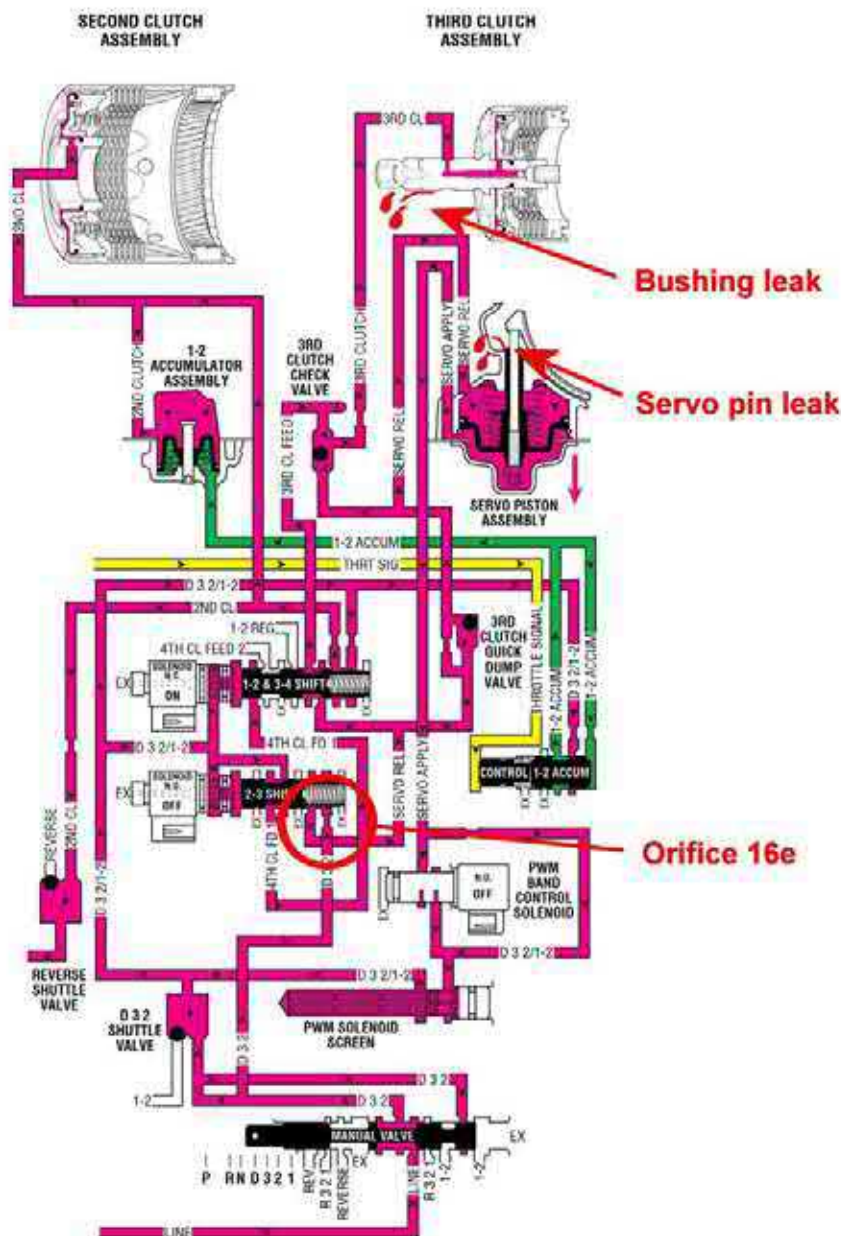
A common cause for the Band failure is the band being partially applied and dragging in 3rd or 4th gear. This is usually caused by insufficient servo release pressure, which can be the result of leaks in the 2nd clutch and/or 3rd clutch circuits. In this section we are going to review the servo release and related oil circuits, as well as what you need to check on every overhaul to prevent band failure.

Band Failure, Binds In 3rd or 4th, Dragging Sensation (continued)

In third gear, the servo release and 3rd clutch are being fed through the #16e orifice.

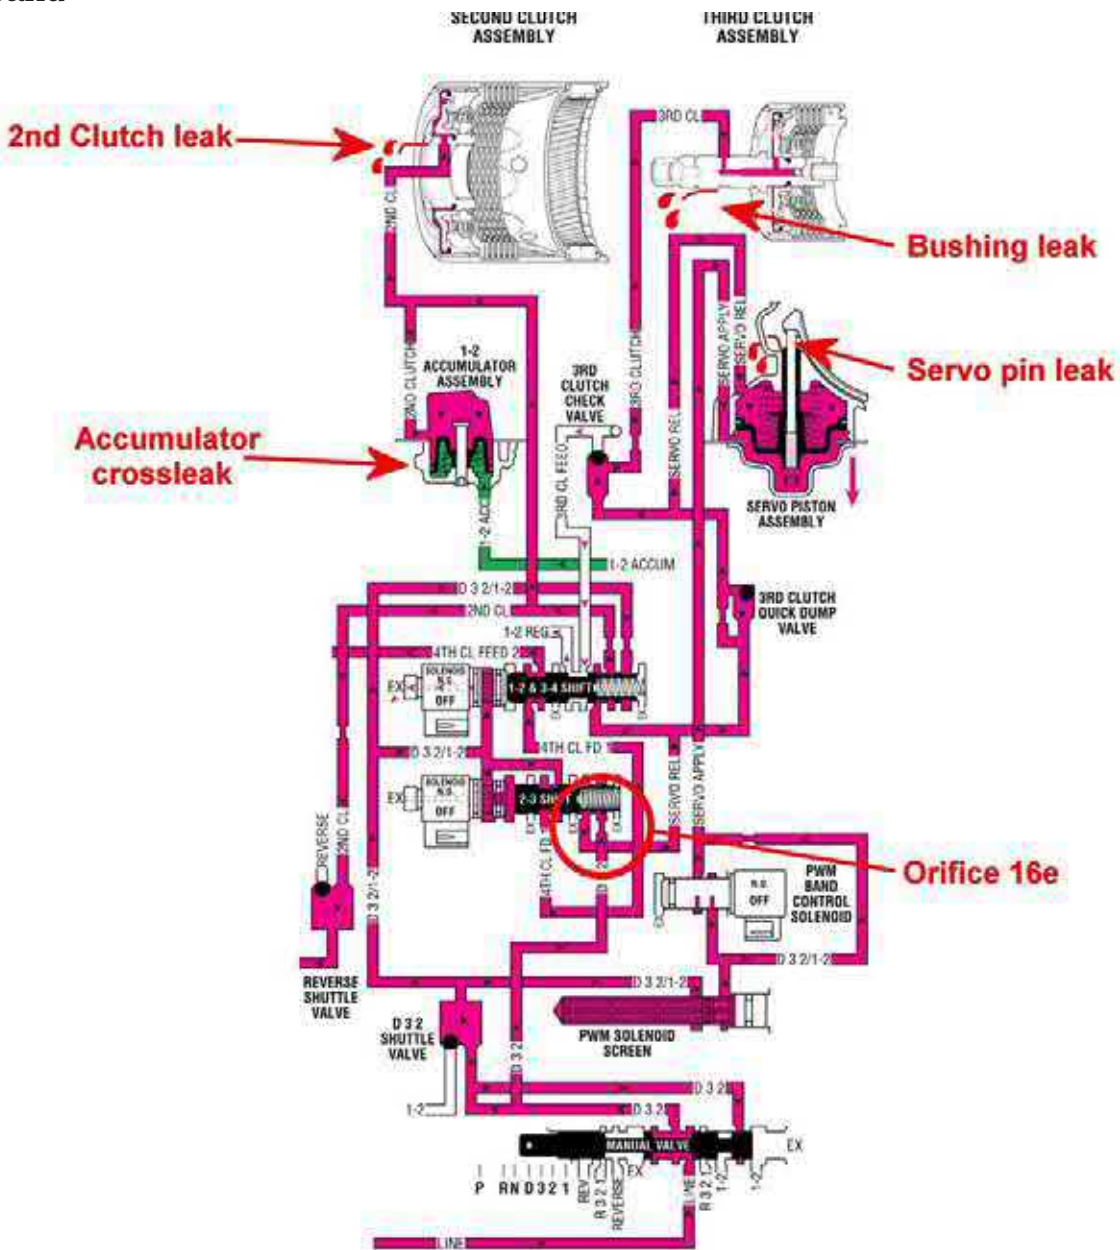
Band Failure, Binds In 3rd or 4th, Dragging Sensation (continued)

In fourth gear the 2nd clutch, is also fed through the #16e orifice. A leak in the second clutch circuit will cause a loss of servo release oil, resulting in a dragging band
