2004

TECHNICAL SEMINAR

The Automatic Transmission Rebuilders Association

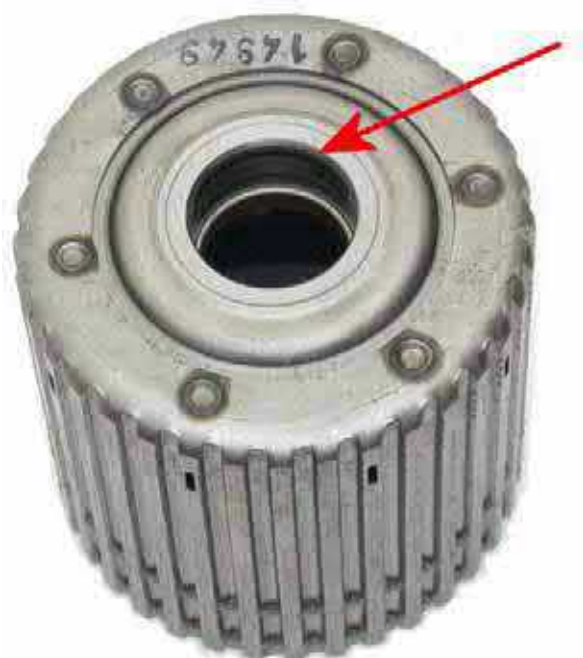
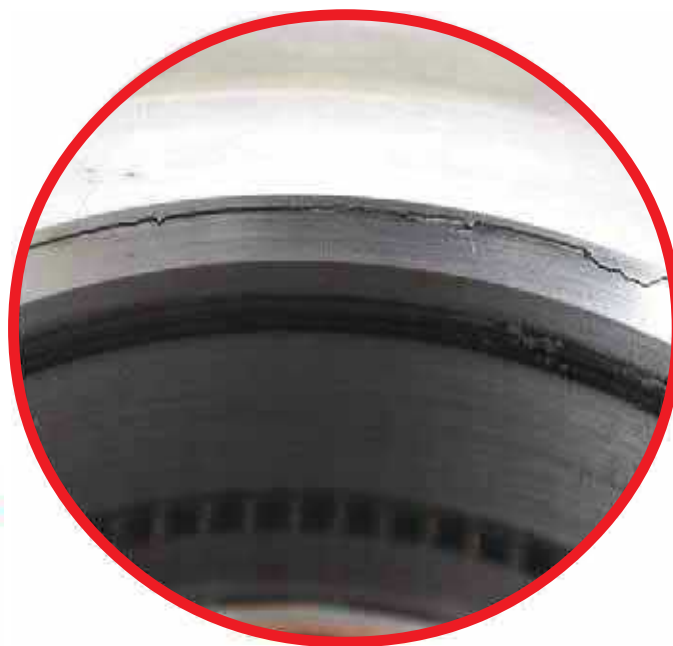
Check here for cracks

Band Failure, Binds In 3rd or 4th, Dragging Sensation (continued)

The 2nd clutch drum is a common failure. Closely inspect the drum for cracks in the ring bore chamfer.

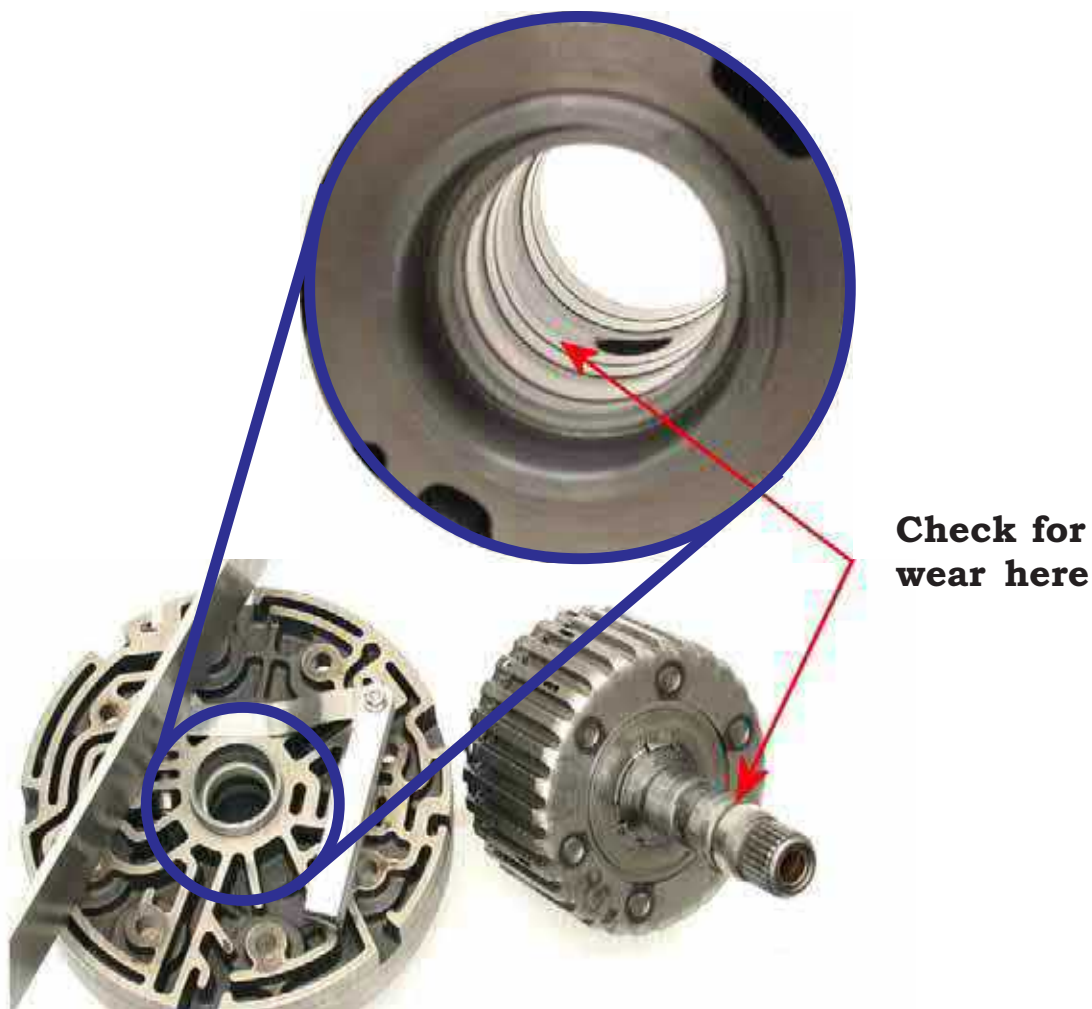
Band Failure, Binds In 3rd or 4th, Dragging Sensation (continued)

When checking the center support for warpage, use the same technique as the adapter case. Center support warpage should not exceed 0.0015". Check the 3rd clutch drum shaft and center support bushing for wear or scoring. Keep in mind, the bushing seals the apply circuit; there are no sealing rings in this location.

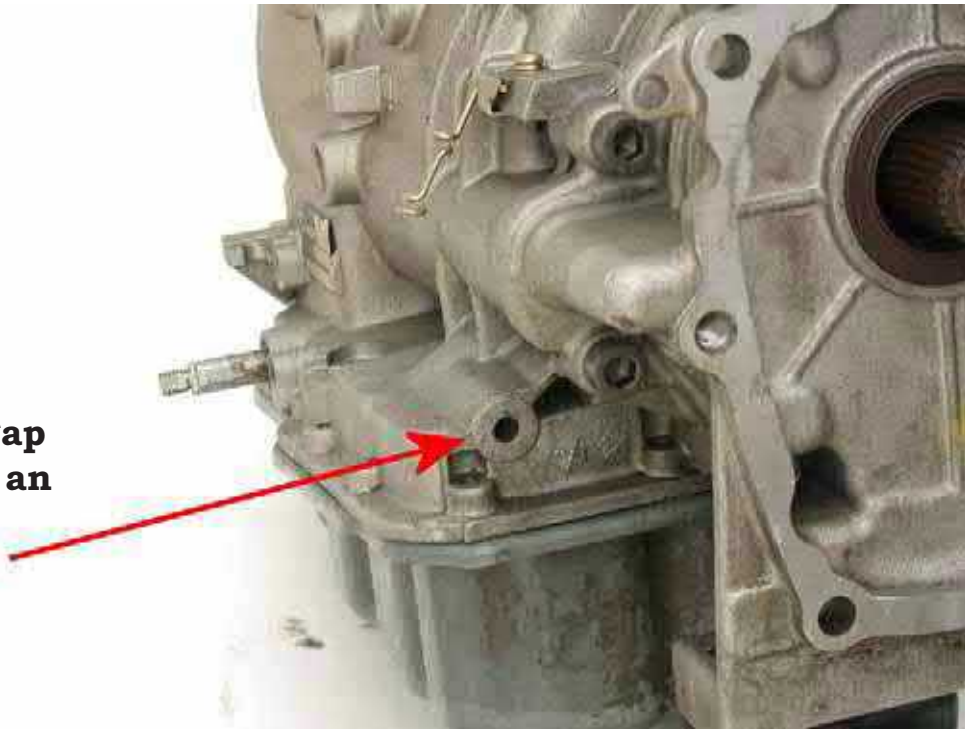
Band Failure, Binds In 3rd or 4th, Dragging Sensation (continued)

The servo release pressure port should always be drilled and tapped in the location shown below. Servo release pressure should be checked after every rebuild. There should be no more than 10 psi difference between the servo release pressure and main line pressure in 3rd and 4th gear.

**Drill and Tap
the hole with an
1/8" pipe tap**

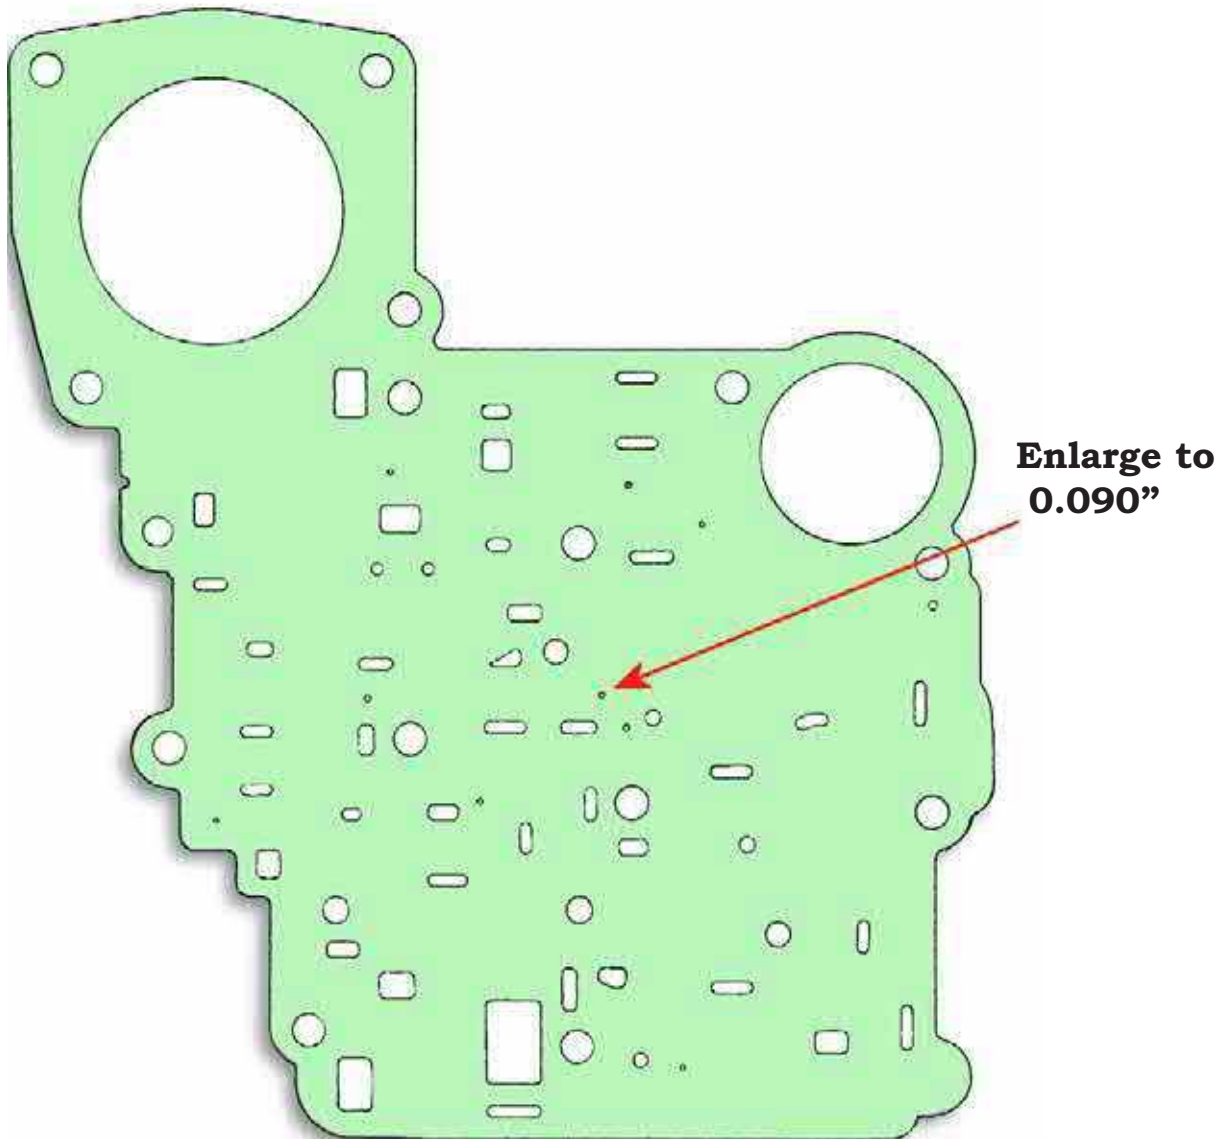
Band Failure, Binds In 3rd or 4th, Dragging Sensation (continued)

As a preventative measure you can enlarge the feed orifice hole #16e to 0.090”.

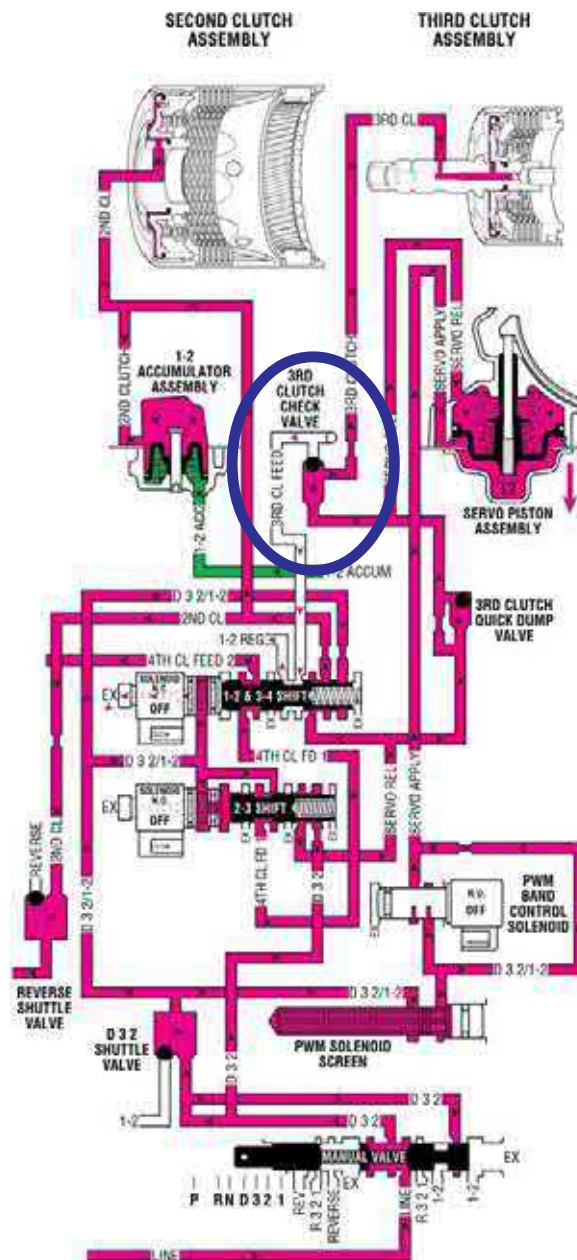
Band Failure, Binds In 3rd or 4th, Dragging Sensation (continued)

A missing or leaking 3rd clutch checkball can cause the 1-2 servo release pressure to leak in 4th gear causing the 1-2 band to apply.

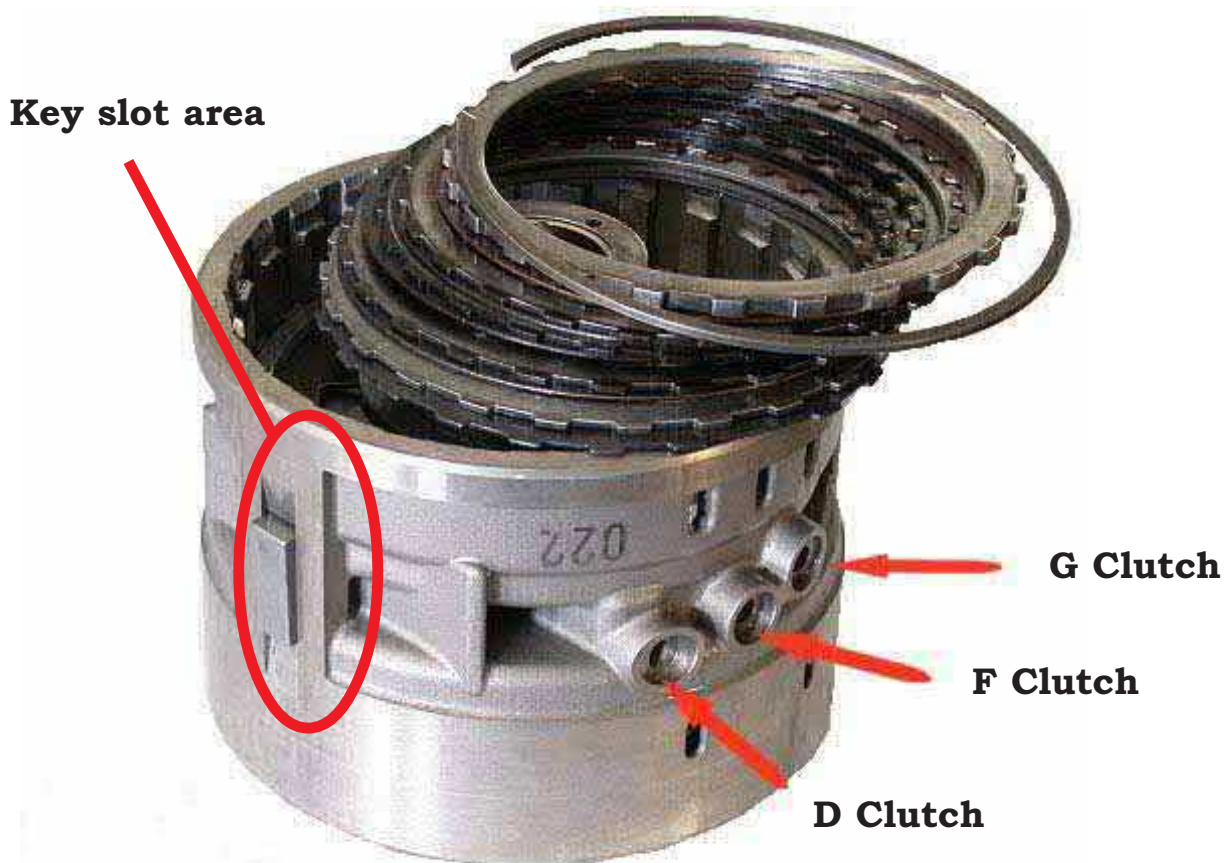
D Clutch Failure, No Reverse

The rear clutch support housing can become damaged at the key slot area. During disassembly pay close attention to the key slot area. It may be necessary to replace the drum assembly.

Note: Also check the case for slot wear.

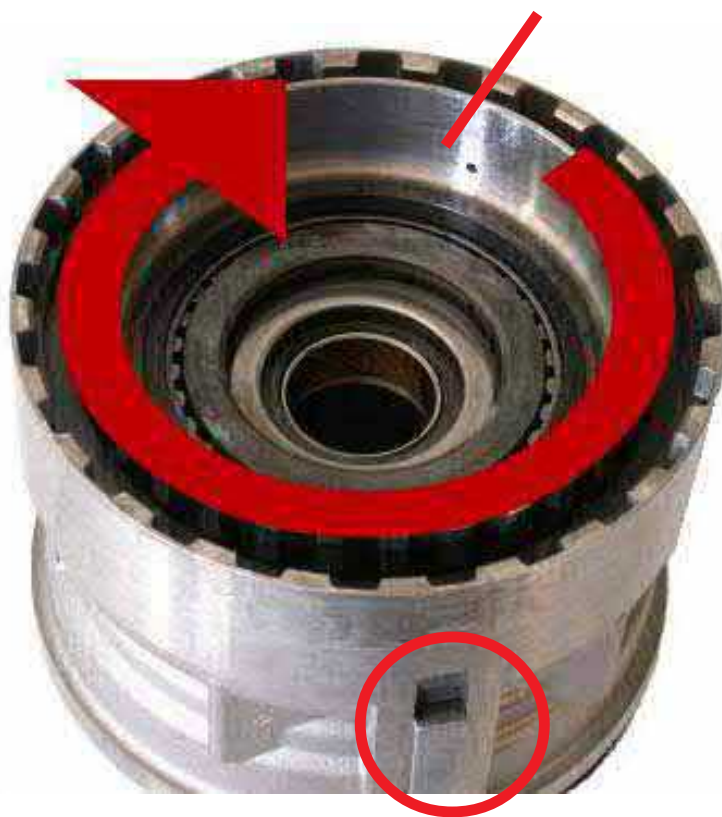
Rear Clutch support

**The support locks into
the case using the outer
key of the drum.**

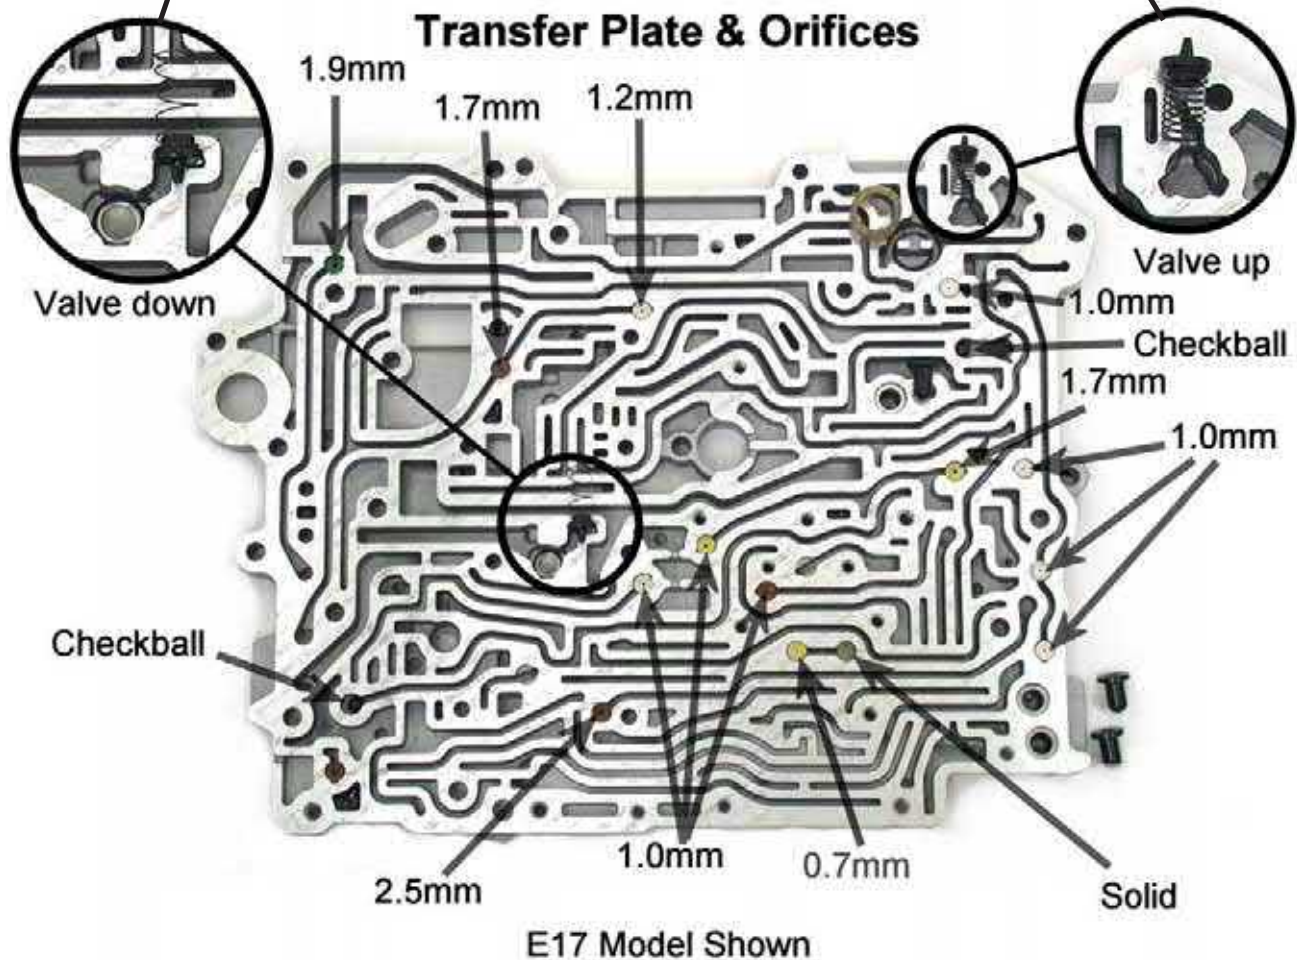
Transfer Plate and Orifices

NOTE: Later units and service updates use a flat disc
