41TE & 42LE CODE BOOK

41TE & 42LE DIAGNOSTIC CODE BOOK

INTRODUCTION

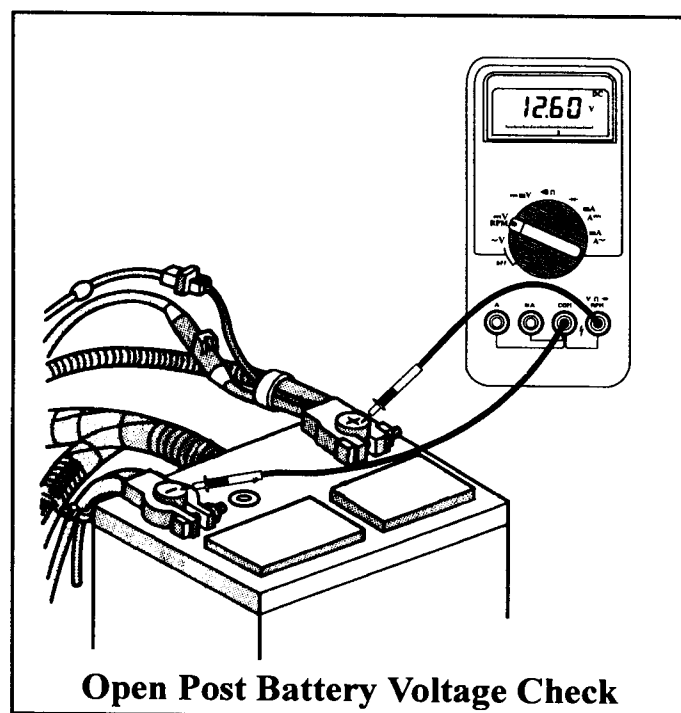
Figure 1

Using a DVOM set to DC volts, measure the open post battery voltage by placing the negative lead to the negative battery post and the positive meter lead to the positive battery post as shown in Figure 1.

With the volt meter connected to the battery as shown in Figure 1, start the vehicle. Turn on the headlights and blower motor to put a load on the voltage system. Approximately 13.5 to 14.4 volts should be seen (See Figure 3). If 15 volts or higher is seen, this may indicate an overcharging alternator which may result in erratic computer behaviour. This problem needs to be rectified before going to the next step.

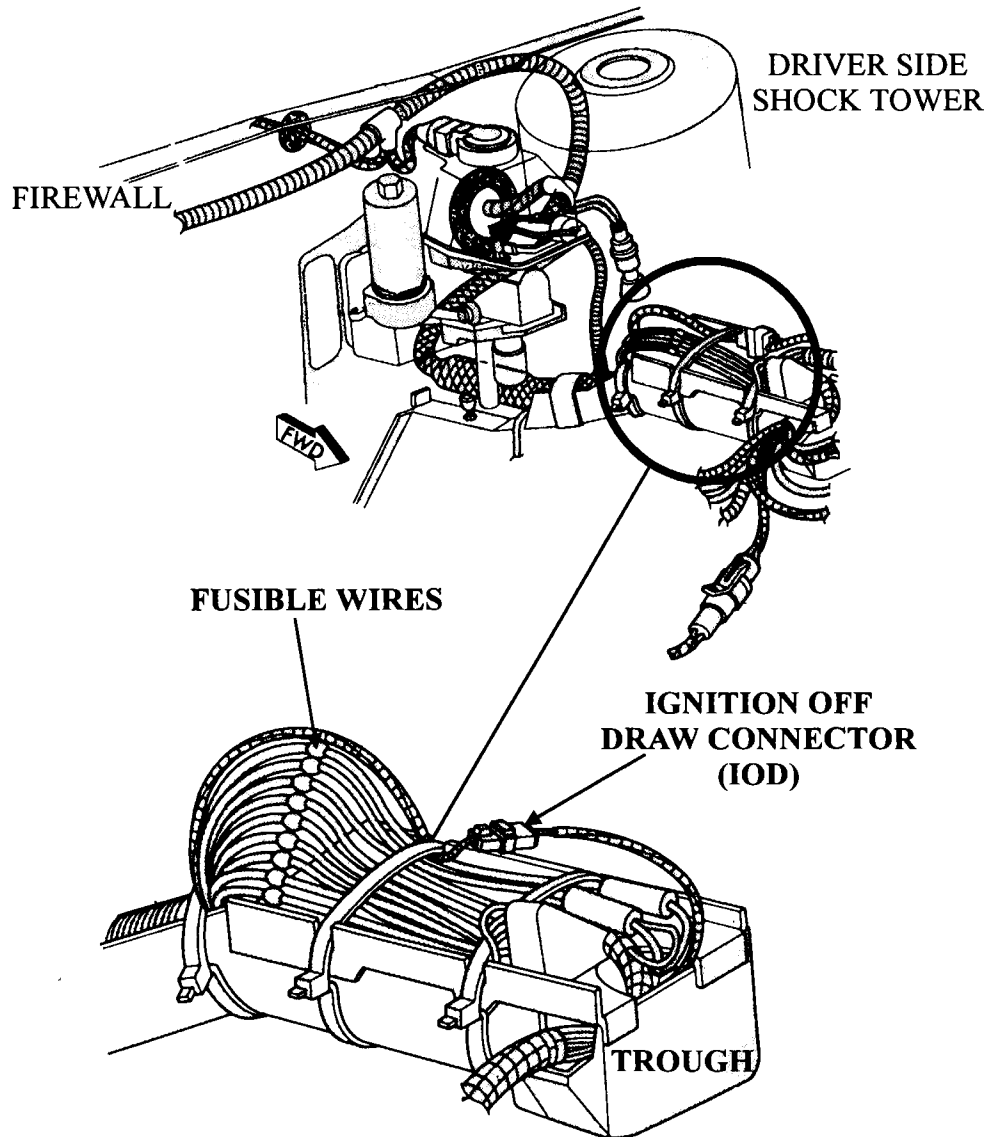
4. If battery voltage is not seen, a fuse or a fusible wire may be blown. Fusible wires are color coded and can usually be found below and between the battery and driver side spring tower as shown in Figure 8. Refer to Figures 9 and 10 for fusible wire color or fuse number.

Typical view of both fusible link and IOD connector location. Not all vehicles have an IOD connector or a trough that the fusible links sit into. All fusible links are located behind and below the battery tray towards the driver side shock tower.

- With the connector unplugged, check cavity # 56 for battery voltage (See Figure 13). While checking for voltage, wiggle the main wiring from the battery to the controller. If battery voltage is lost during this wiggle test, a bad fusible link or a break in the wire has ocured (See Figure 8 for fusible wire location). In Figures 9 and 10 a Fusible Wire Chart can be found showing vehicle application and fusible wire color. In some applications a typical fuse is used and is noted. If a broken wire is in the harness, a continuity check is required at different points across the wire to locate the break.

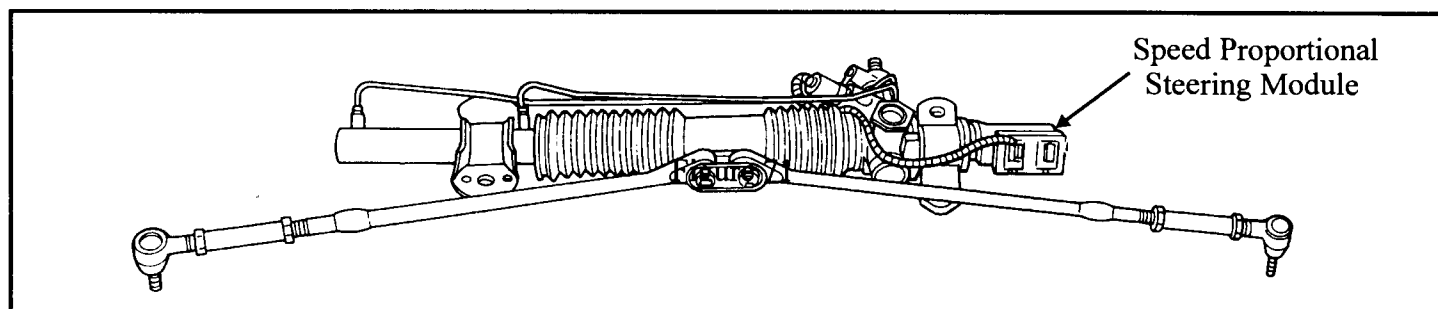
- Locate the Speed Proportional Steering Module on the steering rack as shown in Figure 80 and unplug it. Terminal 1 is battery feed from the ignition switch through either fuse 6 or 20. If battery voltage is not seen with the ignition ON, repair or replace fuse, ignition switch or severed wire. If voltage is seen go to the next step.
