4L60E/65E/70E- 4L80E/85E DIAGNOSTIC CODE BOOK

INTRODUCTION

The GM 4L60E/65E/70E-4L80E/85E Diagnostic Code Book is designed to provide the technician with a step by step diagnostic approach to each and every transmission code available from 1991 to the 2007 model year. This manual can be used in collusion with any type of scanner utilized in retrieving these codes from the computer. As an aid to the technician, component location is recognized throughout the manual.

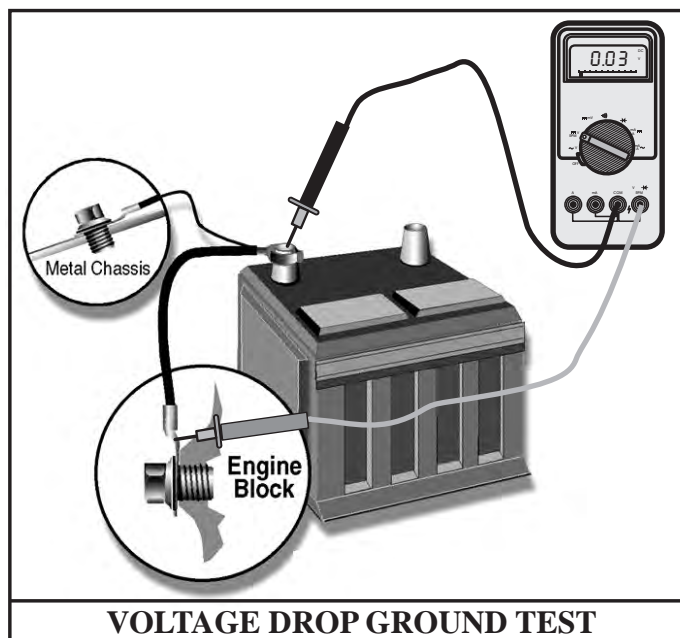
Figure 2

Next, with the engine running, place the negative meter lead to the negative battery POST, and the positive meter lead to the ground wire in question, 0.3 volts or 300 millivolts or less should be seen as illustrated in Figure 2. Any voltage reading higher than this requires attention.

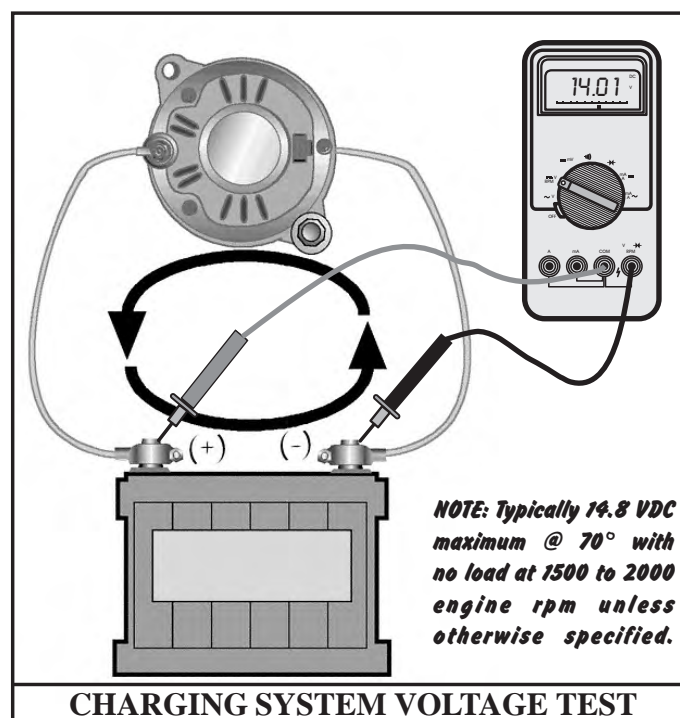
Figure 3

Next, charging system voltage should be verified to manufacturers specs to insure proper alternator output is present as shown in Figure 3. It is also recommended that intermittent voltage spikes do not exist, which can cause erratic and unusual electrical problems which could effect normal transmission operation *especially when pressure control solenoid codes are stored.*

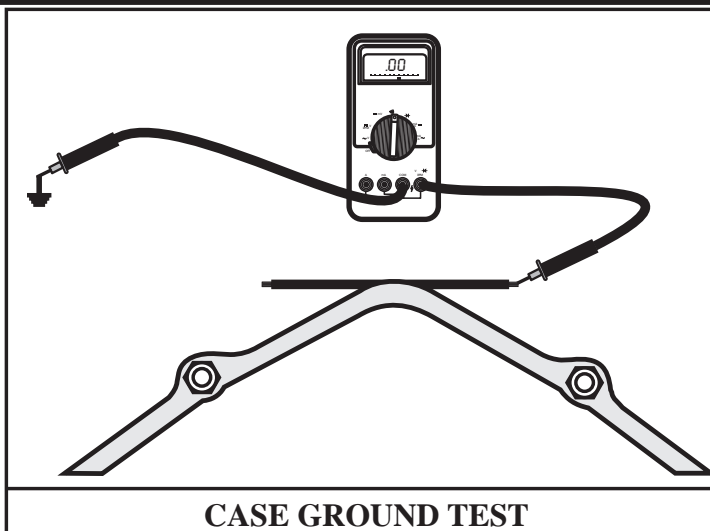
Figure 4

Transmission operation can be impaired as well as internal damage of bushings, washers and other hard parts such as pump rotors, gears or planet carriers. Preferably with the engine running, place the negative meter lead to a good **KNOWN** ground, and the positive lead to the transmission case, as seen in Figure 4. The maximum allowable voltage should not exceed 0.3 VDC or 300 millivolts. If the voltage seen is excessive, one or more ground straps may be necessary.

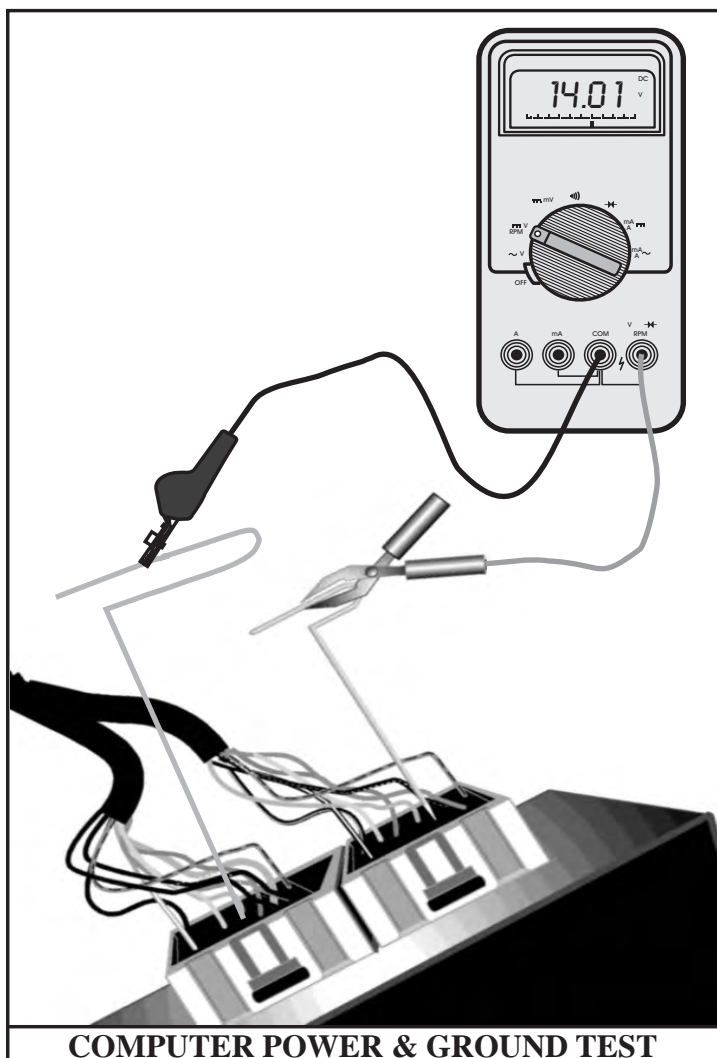
Figure 5

Next, check power and ground at the computer by back probing the computer connector. Battery or charging system voltage should be approximately the same as the readings seen at the battery or alternator. (See Figure 5) The ground readings should be 0.2 or 200 millivolts or less.

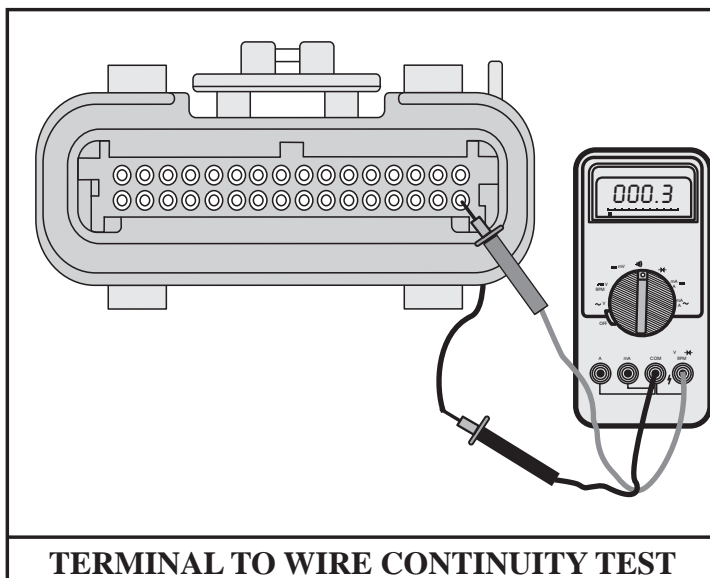
Figure 6

In order to verify the integrity of the wire end connection at the crimp, carefully place one meter lead into the cavity opening and the other meter lead into the wire behind the connector with the DVOM set to OHMS () as seen in Figure 6.

CAUTION: If it becomes necessary to probe into the connector cavity opening, be careful not to expand the cavity opening which could result in poor contact with its connector pin.

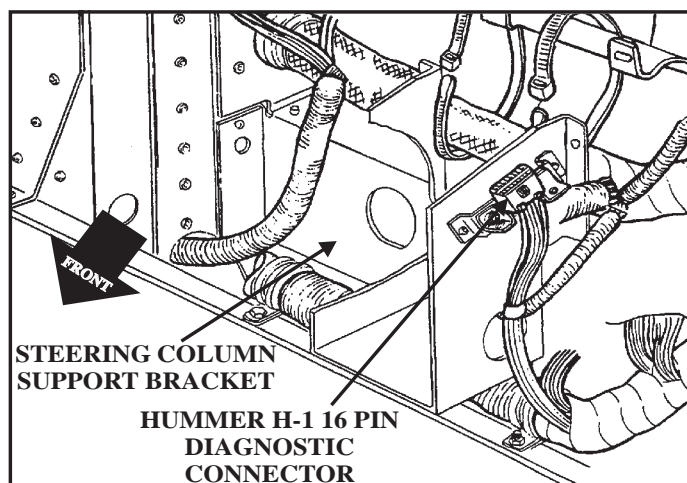
Figure 14

Use the following 10th, 3rd and 8th digits for Hummer VIN ID: **"T" for 1996, "K" for 4WD Pickup and "S" for 6.5 Turbo-Diesel Engine**. You may be asked to locate the 12 pin connector on some scan tools, disregard this and locate the 16 pin OBD-II connector located on the left side of the steering column support bracket as seen in Figure 14.

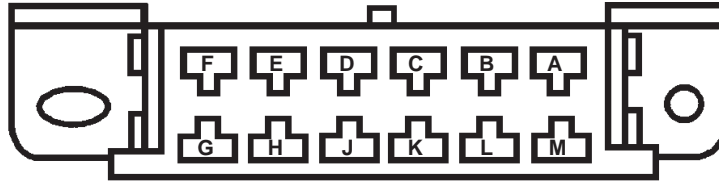
Figure 18

TERMINAL	FUNCTION
A	GROUND
B	ECM/PCM DIAGNOSTIC REQUEST
C	AIR MANAGEMENT SYSTEM (AIR CONTROL SOLENOID)
D	POWER STEERING CONTROL MODULE
E	SERIAL DATA LINE
F	TCC ENABLE SIGNAL
G	FUEL PUMP TEST CIRCUIT (C/K TRUCKS ONLY) KEYLESS ENTRY MODULE (ALL EXCEPT C/K TRUCKS)
H	ANTI-LOCK BRAKE MODULE
J	TRANSFER CASE CONTROL MODULE
K	SIR MODULE
L	SIR MODULE
M	SERIAL DATA LINE

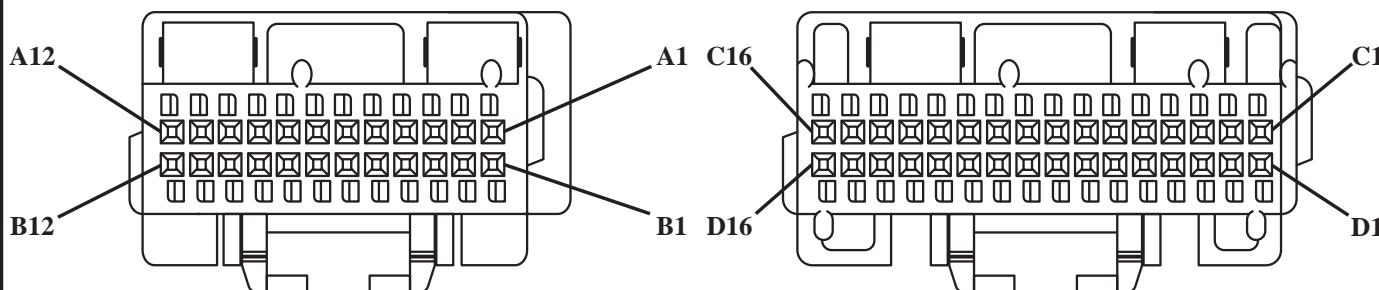
Figure 22

24 PIN "A-B" (C2) CONNECTOR
PCM - BROWN CONNECTORS
TCM - PURPLE CONNECTORS

32 PIN "C-D" (C1) CONNECTOR
PCM - BROWN CONNECTORS
TCM - PURPLE CONNECTORS

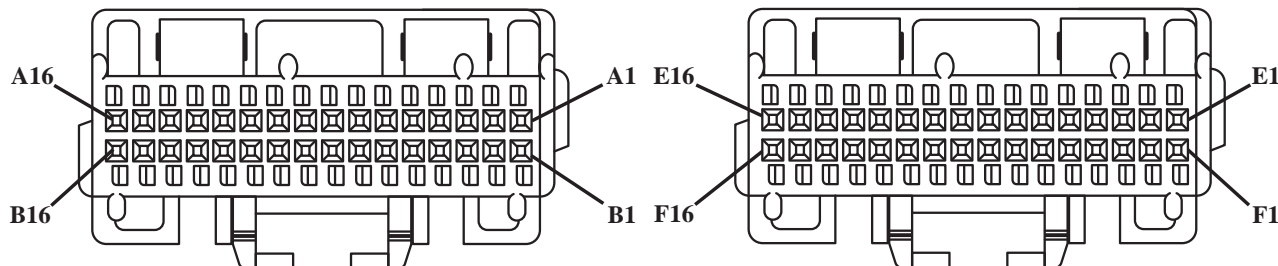
Figure 23

**1993-1995 C/K WITH V8 & S WITH 2.2L & M/L GAS TRUCK & VAN WITH 4L60E
1993-1994 T TRUCK WITH 4.3L ENGINE & 4L60E
1994-1995 C/K/G/P GAS WITH 4L80E**

32 PIN PCM "A-B" RED CONNECTOR

32 PIN PCM "E-F" BLUE CONNECTOR

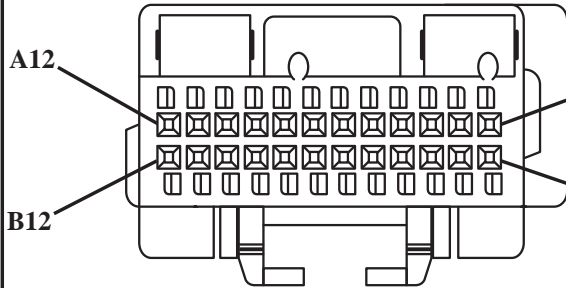
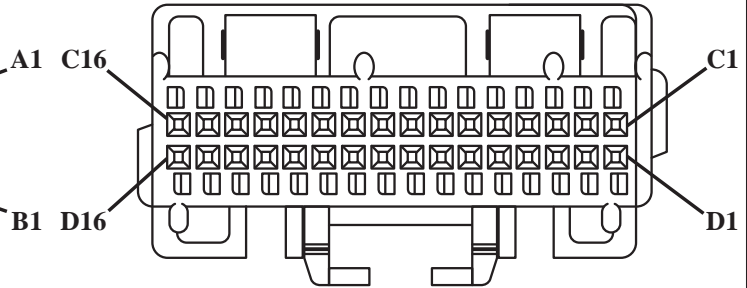
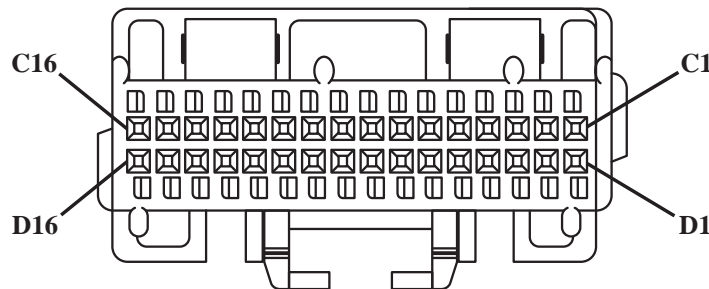
Figure 24

1996-1999 C/K/G/P* 6.5L DIESEL TRUCKS AND VANS WITH PCM AND 4L80E
2001-2002 C/K/G 6.5L DIESEL TRUCKS AND VANS WITH PCM AND 4L80E
***P Vans With 4 Digit Codes**

24 Pin PCM "A-B" (C2) Connector (Brown)

32 Pin PCM "C-D" (C1) Connector (Brown)

32 Pin PCM "C-D" (C3) Connector (Blue)

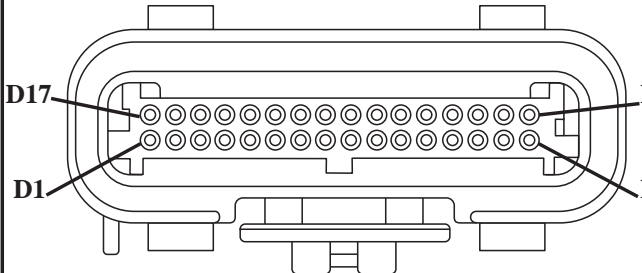
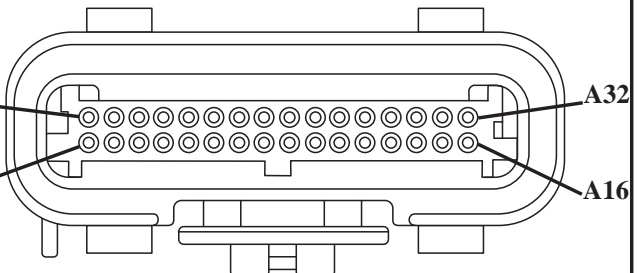
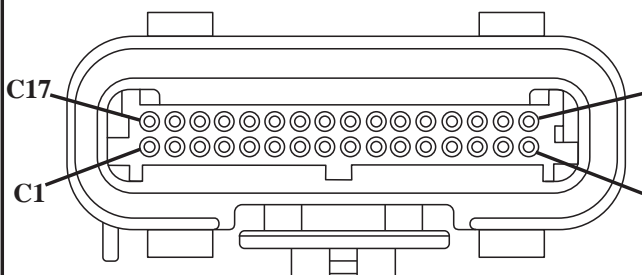
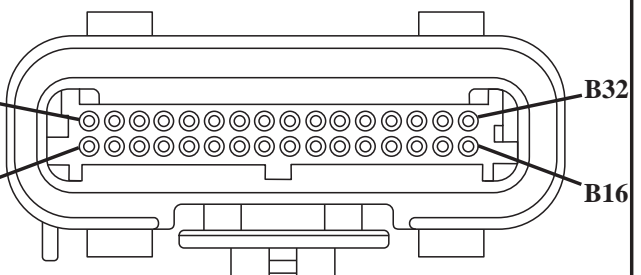
Figure 25

1994-1996 B/D/F*/Y CAR WITH 4L60E
1997 F CAR WITH 4L60E
***With 5.7L Engine**

32 Pin PCM "D" Connector (Blue)

32 Pin PCM "A" Connector (Red)

32 Pin PCM "C" Connector (Clear)

32 Pin PCM "B" Connector (Black)

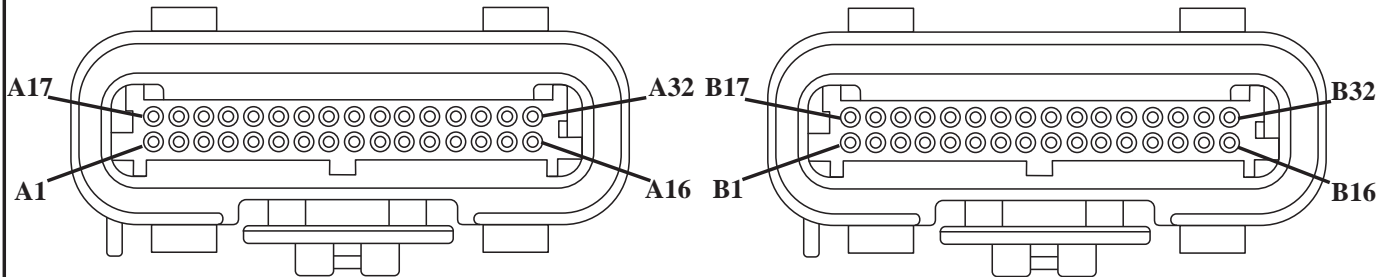
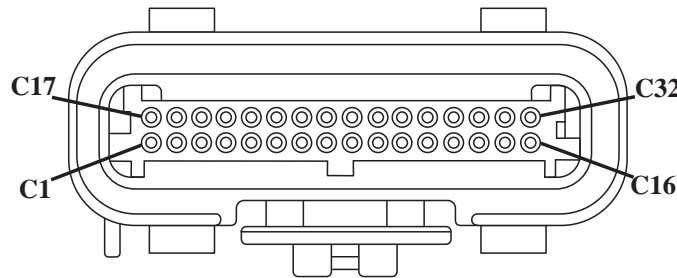
Figure 26

32 Pin PCM "C" (C2) Connector (Clear/Gray)

32 Pin PCM "B" (C1) Connector (Black)

32 Pin PCM "D" (C3) Connector (Blue)

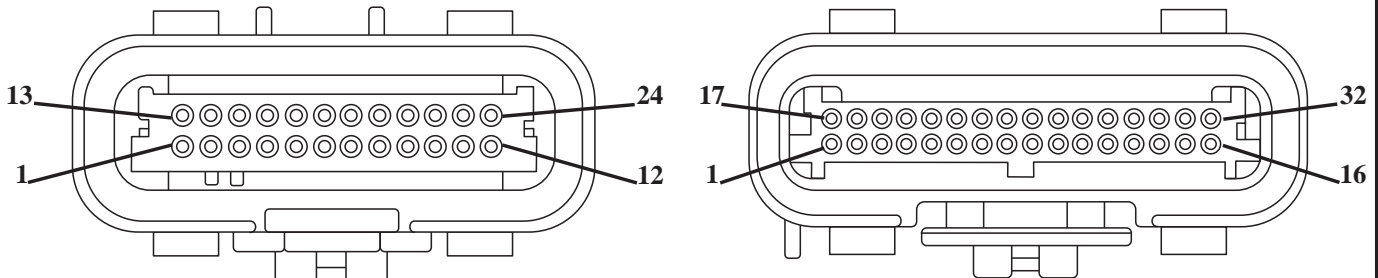
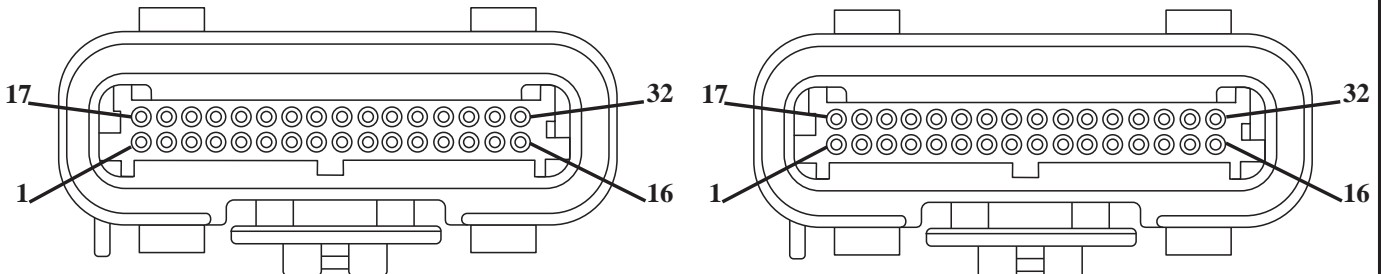
Figure 27

1995-2000 S/T* TRUCK AND 1996-2000 M/L VANS WITH 4L60E

24 Pin VCM (C4) Connector (Black)

32 Pin VCM (C2) Connector (Red)

32 Pin VCM (C3) Connector (Gray)

32 Pin VCM (C1) Connector (Blue)

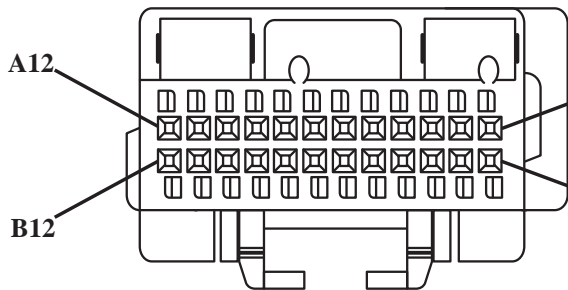
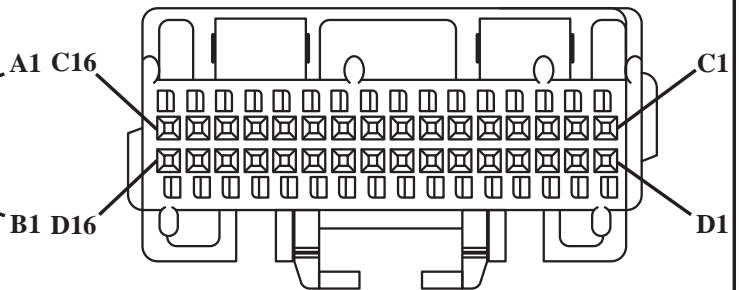
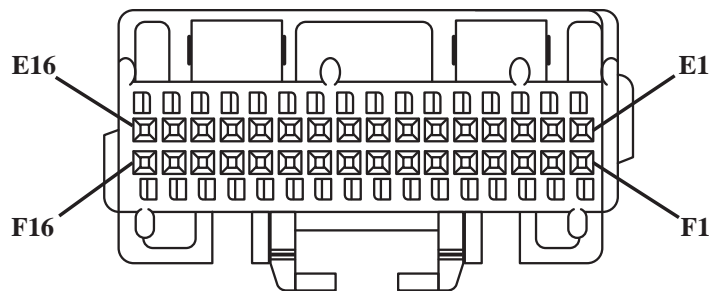
Figure 28

1994-95 C/K/G/P DIESEL TRUCK & VAN WITH/4L80E

24 Pin PCM "A-B" Connector (Pink)

32 Pin PCM "C-D" Connector (Pink)

32 PIN PCM "E-F" Connector (Blue)

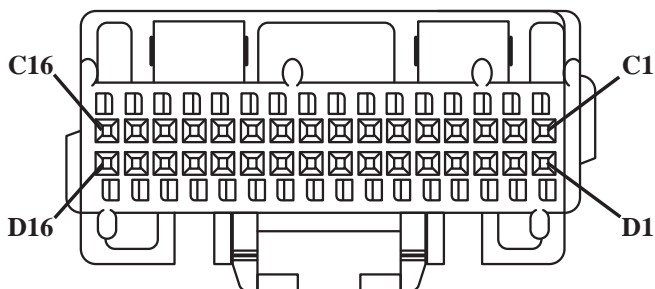
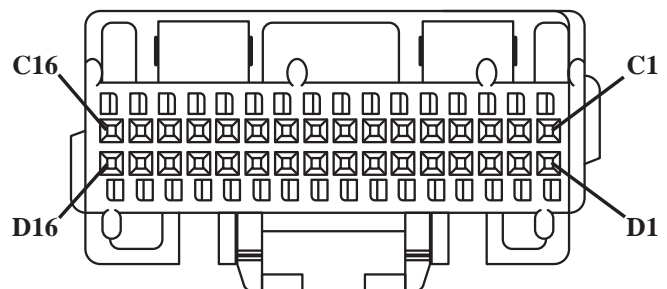
Figure 29

1997 P VANS GAS WITH 2 DIGIT CODES AND 4L80E

32 Pin PCM "A-B" Connector (Purple)

32 Pin PCM "E-F" Connector (Purple)

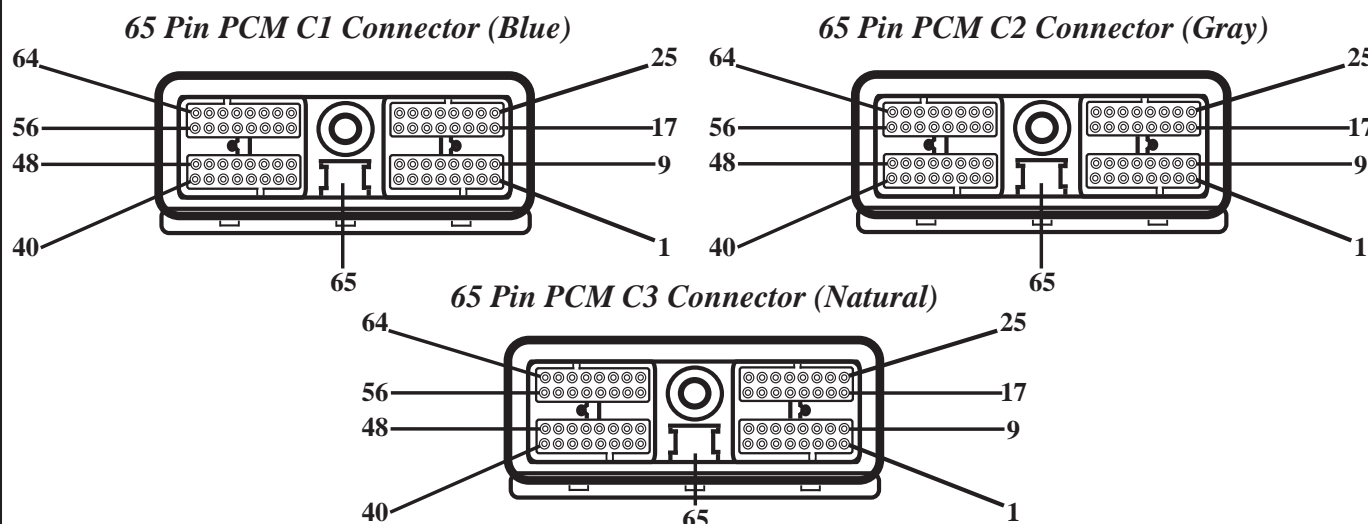
Figure 30

2002-2003 S/T TRUCKS WITH 4.2L ENGINE AND 4L60E

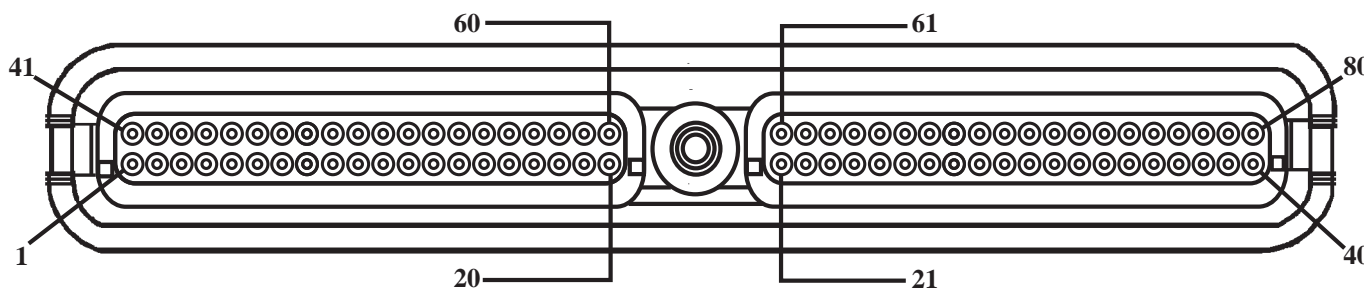
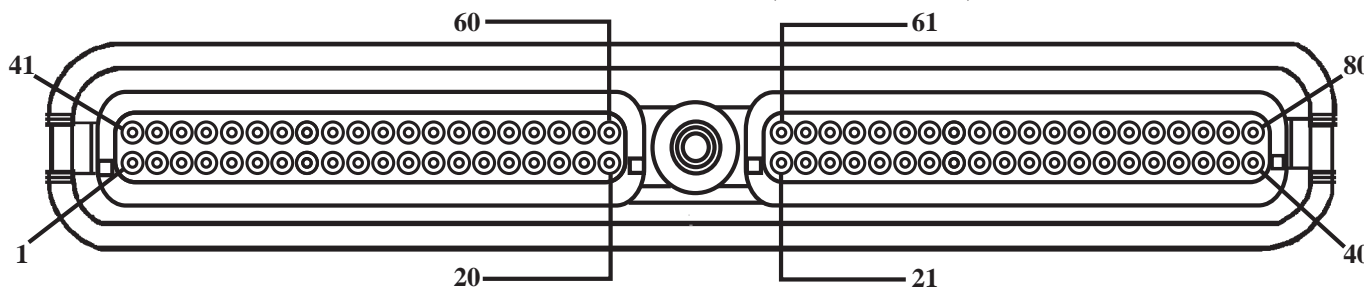
Figure 31

1996-2002 F CAR WITH 3.8L ENGINE AND 4L60E
 1998-2003 "F" AND 1997-2004 "Y" CAR WITH 5.7L ENGINE AND 4L60E
 2003 S/T TRUCKS WITH 5.3L ENGINE AND 4L60E
 2005 S/T TRUCKS AND M/L VANS WITH 4.3L ENGINE AND 4L60E
 1999-2006 C/K TRUCKS WITH 4.8L, 5.3L & 6.0L ENGINES AND 4L60E
 1999-2006 C/K TRUCKS WITH 5.3L, 6.0L & 8.1 ENGINE AND 4L80E
 2002-2006 C/K/G TRUCKS & VANS WITH 4.3L, 5.0L, 5.7L, 4.8L & 6.0L ENGINES
 2006 H2 WITH 6.0L ENGINE AND 4L65E

80 Pin PCM C1 Connector (Blue or Red)

80 Pin PCM C2 Connector (Blue or Green)

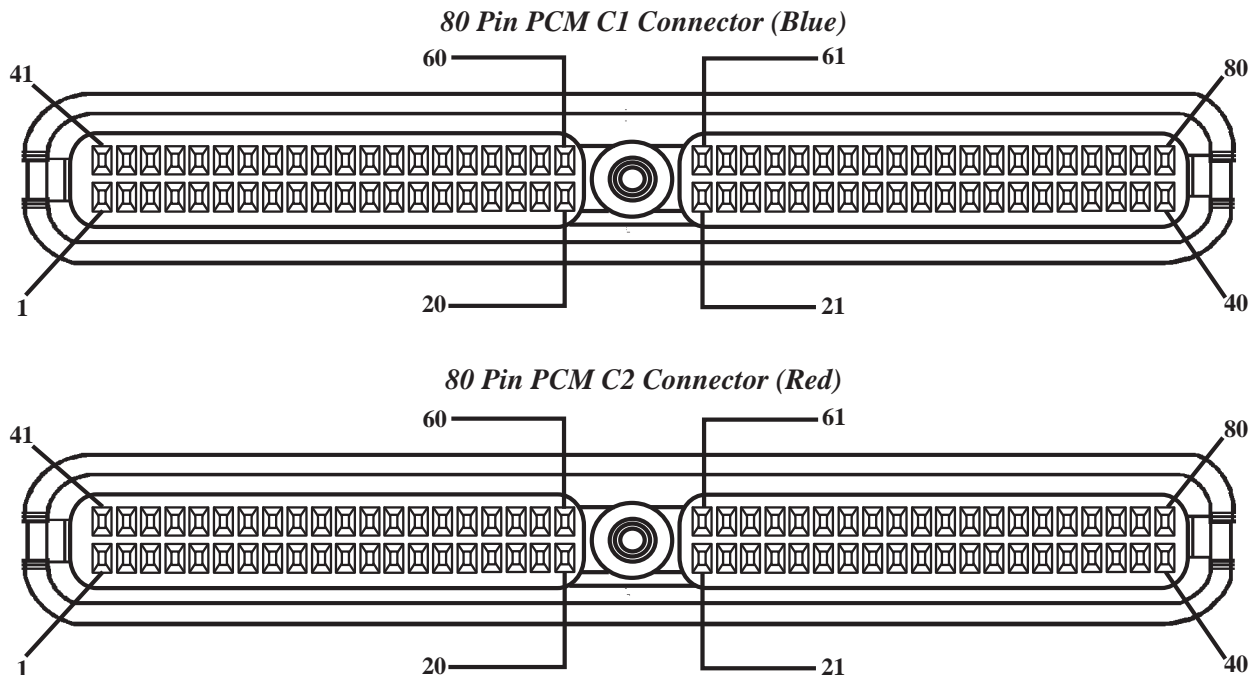
Figure 32

1997-2003 S TRUCK WITH 2.2L ENGINE AND 4L60E
2001-2003 C/K/G TRUCKS & VANS WITH 8.1L ENGINE AND 4L80E
2001-2004 S /T/ L/M TRUCKS & VANS WITH 4.3L ENGINE AND 4L60E

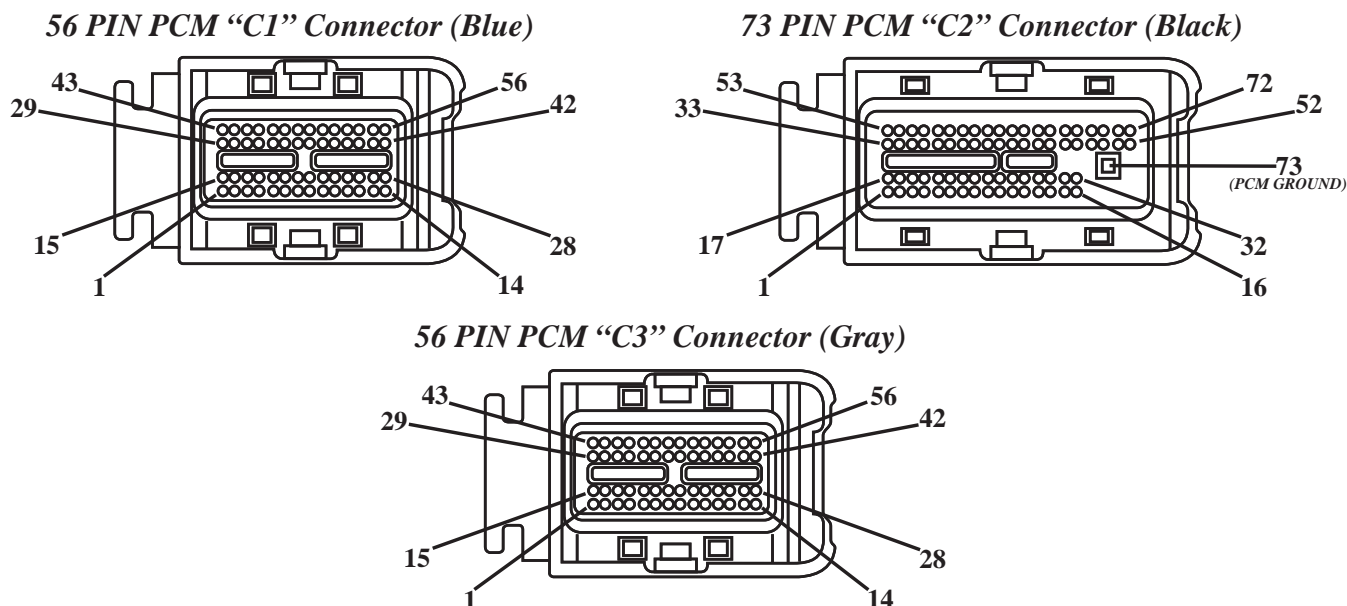
Figure 33

2005 Y CAR WITH 6.0L ENGINE AND 4L65E
2004-2006 S/T WITH 2.8L, 3.5L & 4.2L, ENGINE AND 4L60E/4L70E
2006 HUMMER H3 WITH 3.5L ENGINE AND 4L70E

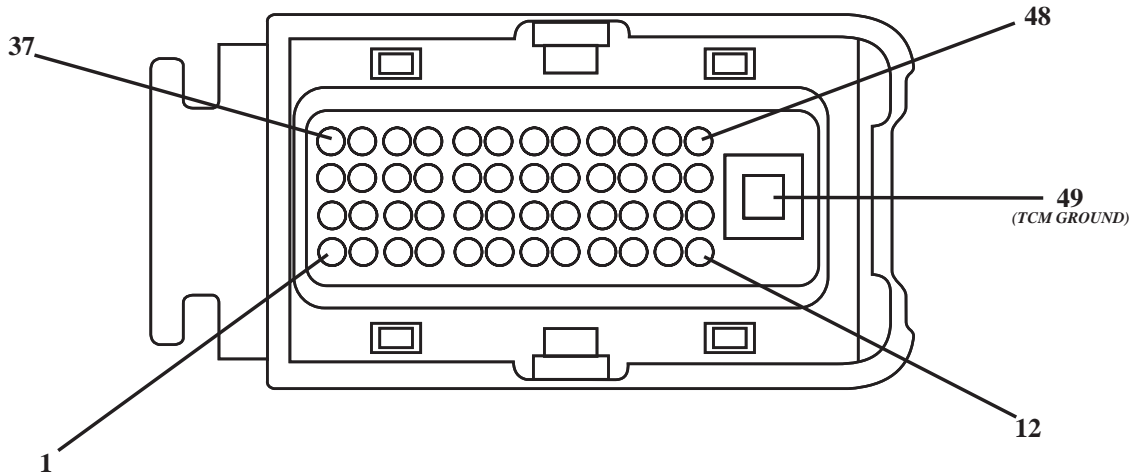
Figure 33a

**2006-2007 S/T WITH 5.3L & 6.0L, ENGINE AND 4L70E
WITH SEPARATE TCM**

49 PIN TCM Connector

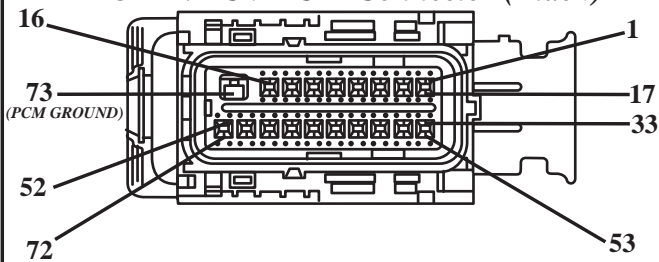
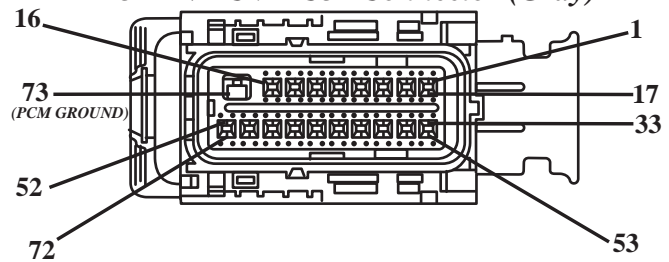
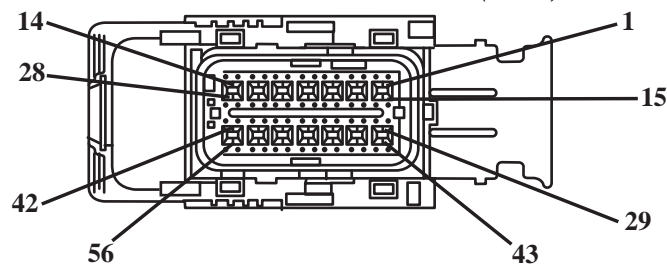
Figure 33b

**2006-2007 S/T WITH 5.3L & 6.0L, ENGINE AND 4L70E
WITH SEPARATE ECM**

73 PIN PCM "C2" Connector (Black)

73 PIN PCM "C3" Connector (Gray)

56 PIN PCM "C1" Connector (Blue)

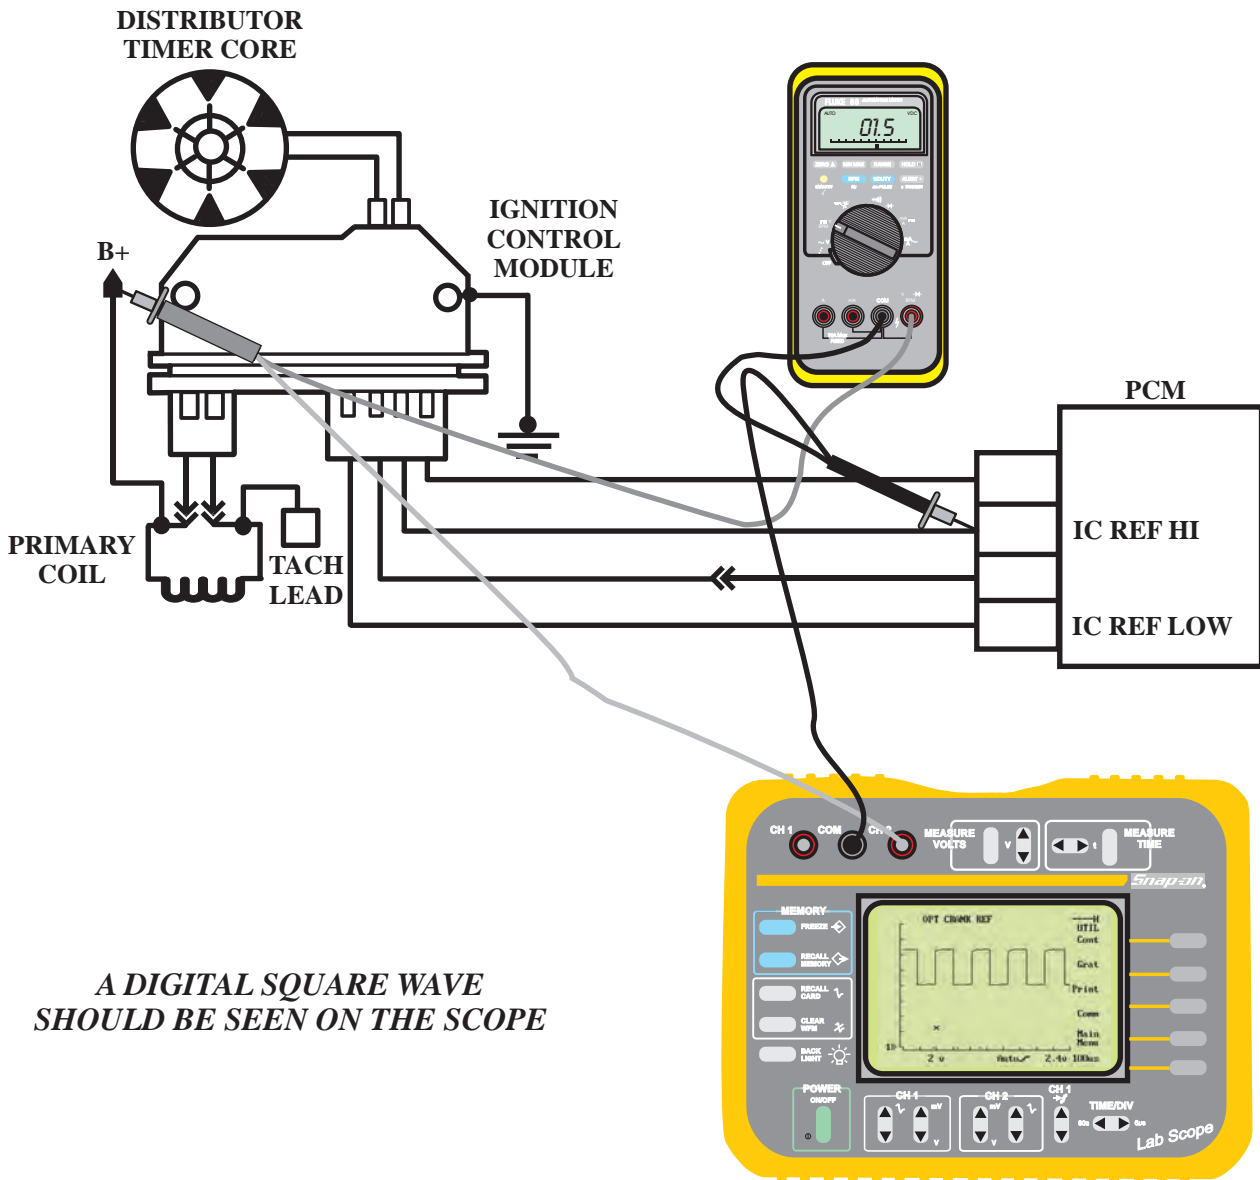
Figure 34

- With a voltmeter connected to the IC Reference High circuit and B+, as shown in Figure 34, a zero to approximately 1.5 volts signal should be seen. This is NOT the best method of checking this signal.
- Since the distributor timer core is responsible for creating this AC voltage signal, it is the Ignition Control Module that converts this signal into a digital square wave for the PCM to use for engine speed calculations.
- The digital square wave can be monitored with an oscilloscope or a graphing voltmeter as also seen in Figure 34.

DISTRIBUTOR IGNITION SYSTEM

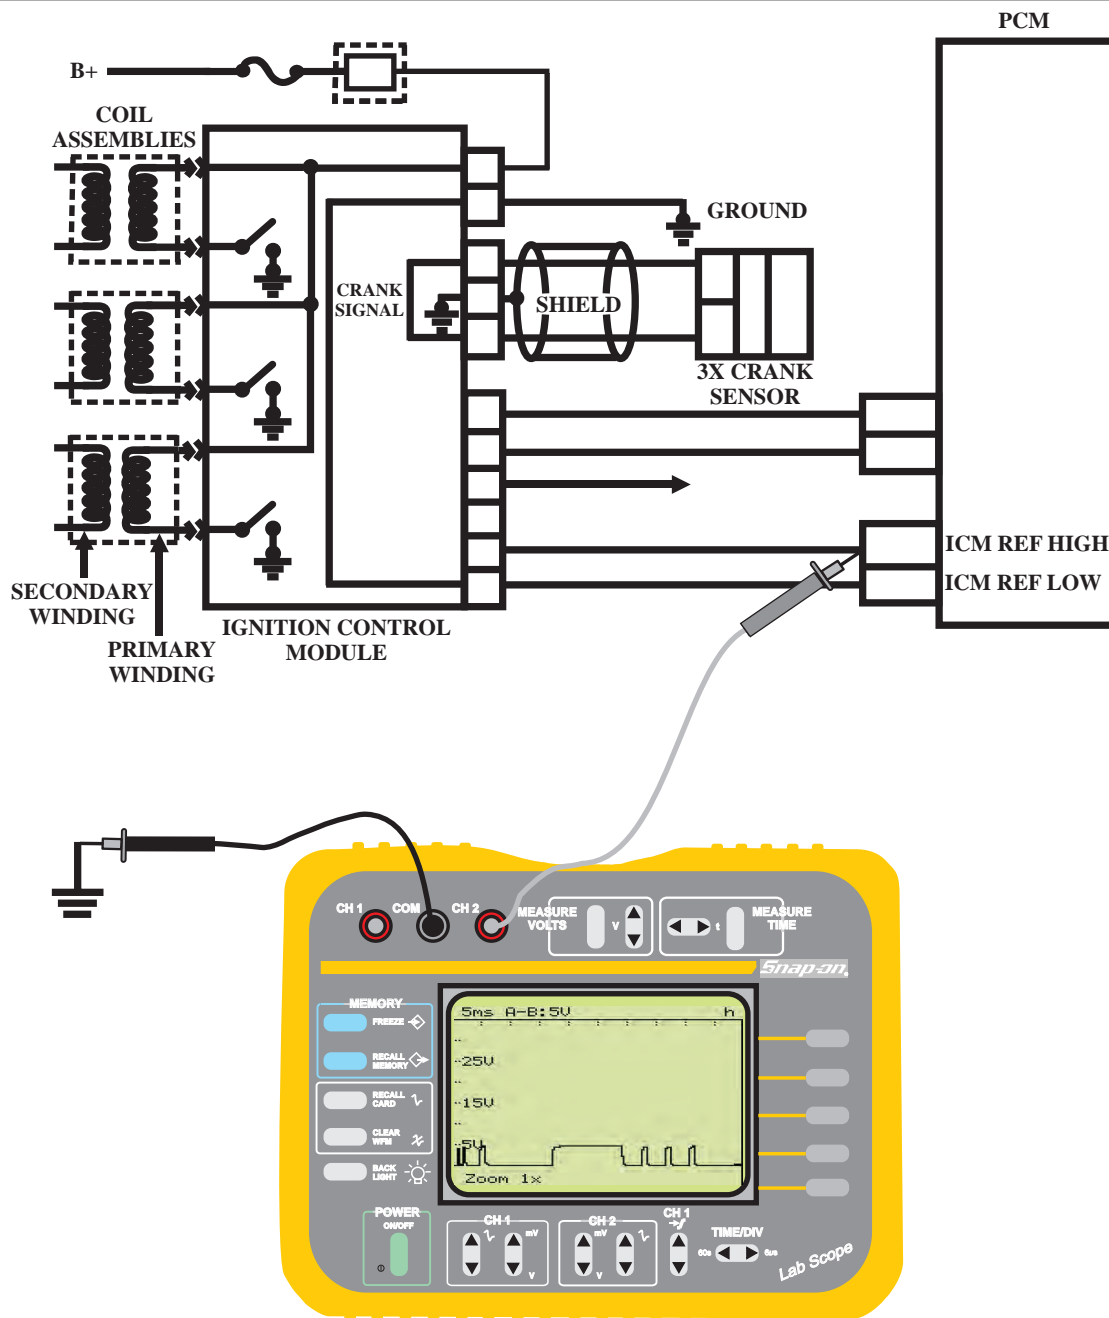
Figure 35

• With an oscilloscope or graphing voltmeter connected to ground and the ICM Reference High terminal at the computer, the waveform in figure 35 should be seen.

NOTE: Failure of any of the main components of this system will result in a no start condition, therefore further diagnosis of the Engine Speed Signal is unnecessary. Beware, CKP Sensors can check good with a DVOM or an Oscilloscope, but not be good.

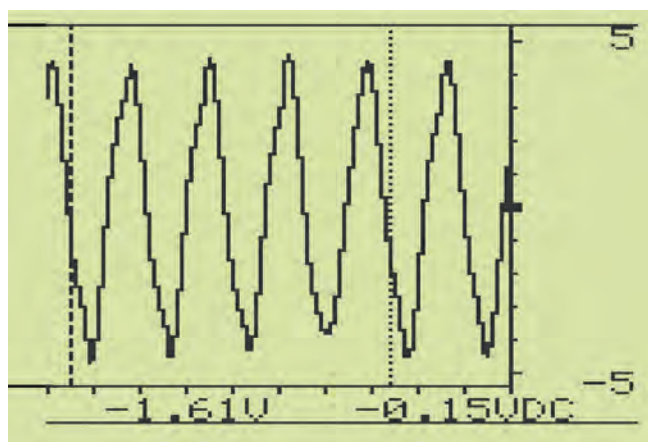
When checking the raw signal from the output speed sensor, this is the waveform that should be seen, this is a good sine wave with no drop out and good strength of signal. If the speed sensor is checked using a DVOM and Hertz, use the sensor value chart in Figure 52 for specs.

1. No signal from the Vehicle Speed Sensor (circuits 821 or 822) to the DRAC due to a faulty speed sensor, its wiring or, an output carrier without a tone ring was installed. A good signal from the speed sensor and from the "DRAC" can be seen in Figure 49.

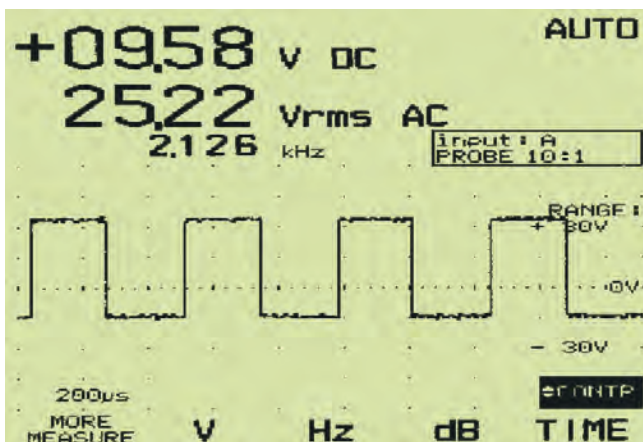
Figure 49

When checking the conditioned signal coming out of the "DRAC" on circuit 437, a digital square wave signal is what should be seen. This is a good signal with very little noise and good amplitude.

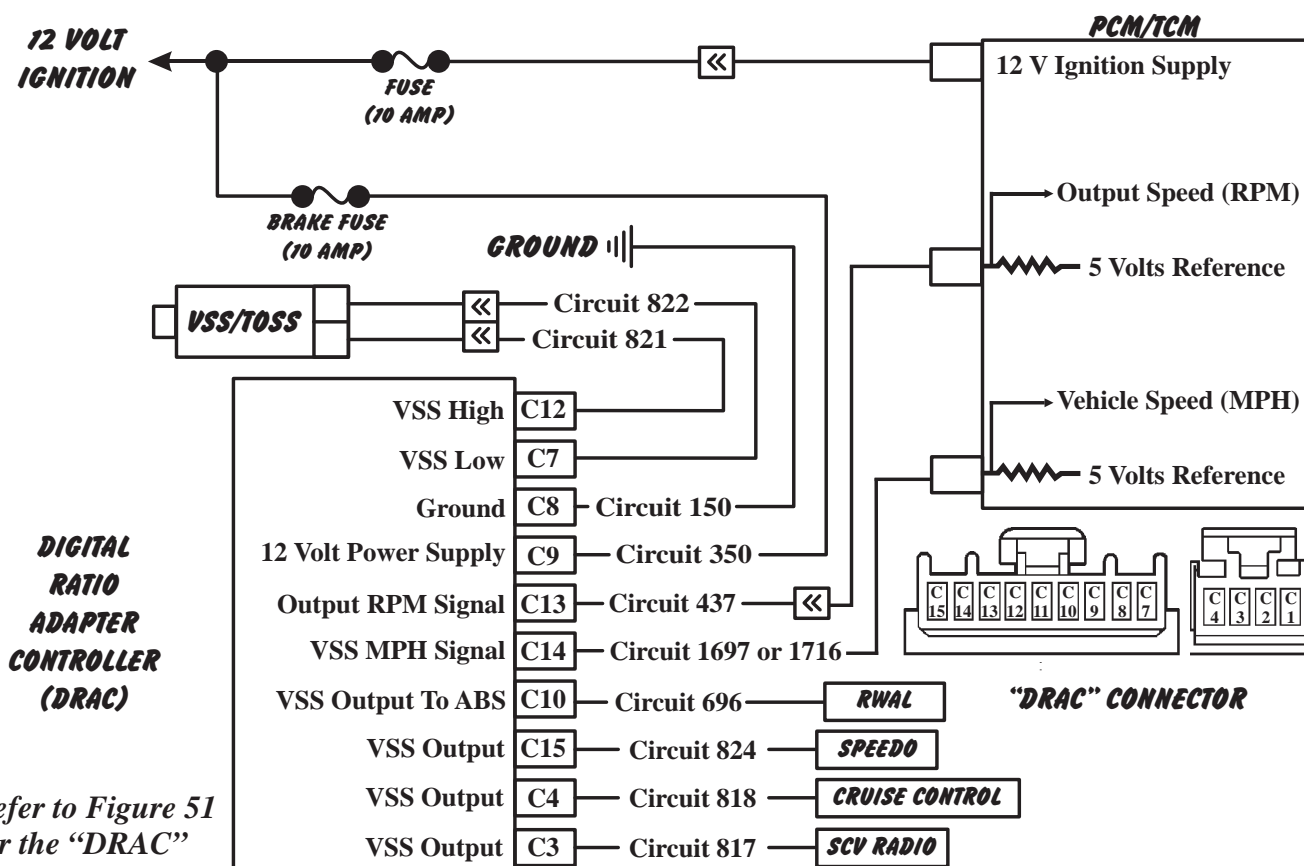
"DRAC" Circuit Diagram (Typical) 2 Wheel Drive NON-OBD-II "C" & "S" TRUCKS; "G", "P" & "M" VANS

Refer to Figure 51
for the "DRAC"
Trouble Tree

- At the start of production for the 1992 model year, the "C/K" trucks began using the externally mounted "DRAC".
- ISUZU NPR, Chevy Forward and GMC Tiltmaster Tilt cab trucks, when equipped with the GM 5.7L gas engine and 4L80E transmission will have the same VSS system with a DRAC as a GM built "P" van and is diagnosed the same as the system in Figure 50 also using the diagnostic tree in Figure 51.

If all the above complaints exist, check these items **FIRST!** (Refer to Figure 50)

- A short or open in circuit 1697 or 1716, (Refer to Figure 50).
- An internal DRAC fault, Refer to Figure 53 for DRAC locations.
- The PCM is not sending 5 volts on circuit 1697 or 1716 or does not read the voltage toggle between 0 and 5 volts. (Refer to Figure 48 for computer locations).

- A short or open in circuit 437, this will affect transmission shifting.
- A fault in the output speed sensor, its wiring (Circuits 821 or 822, Refer to Figure 50) or connector, (See Chart in Figure 52).
- Corrosion at connector C101, ("G" Vans ONLY), (Refer to Figure 54).
- A faulty DRAC internal circuit, Refer to Figure 53 for DRAC locations.
- A faulty ignition switch causing an intermittent loss of power to the DRAC.
- A poor ground to the DRAC.
- Loss of terminal contact between the DRAC and its connector.
- A faulty PCM/TCM, not sending 5 volts out on circuits 437 (Refer to Figure 48 for computer locations).

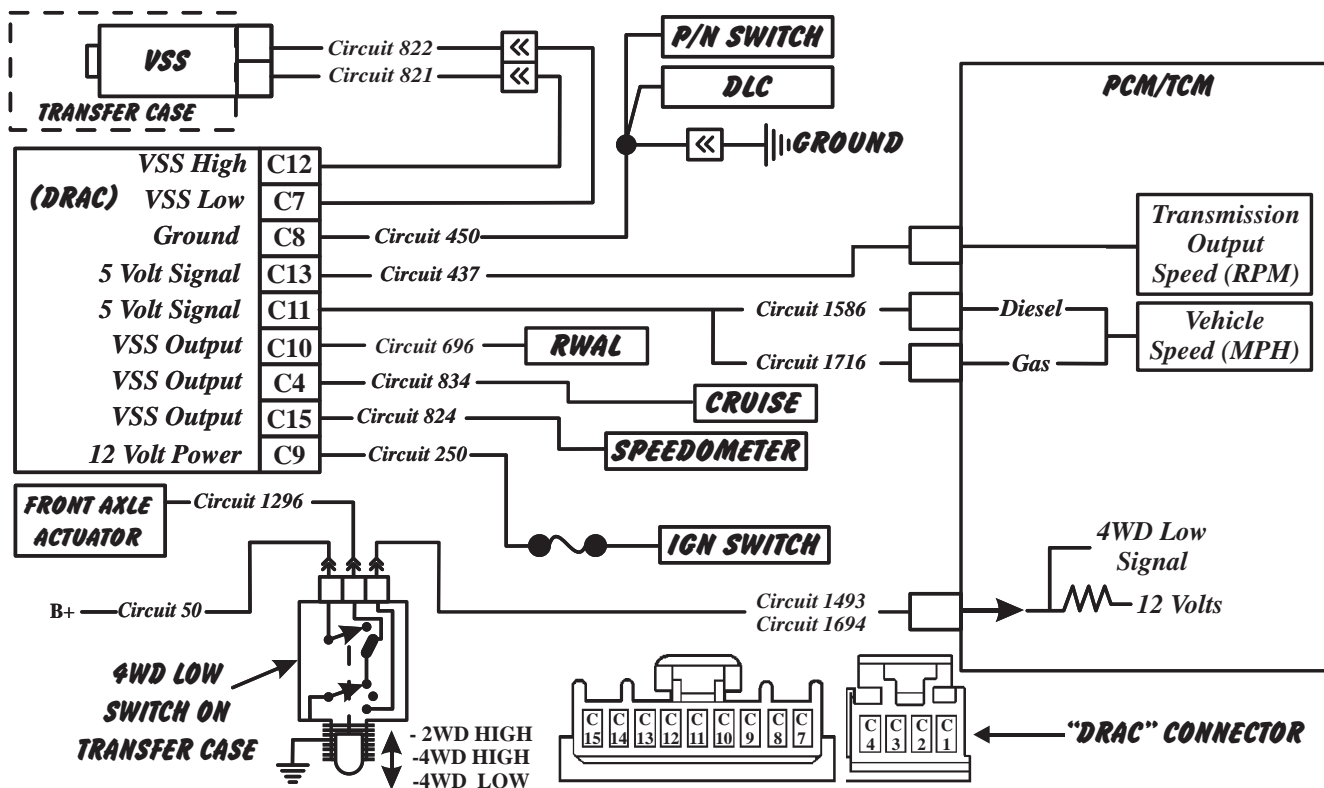
1994 & 1995 4WD "K" TRUCKS NON-OBDI WITH 4L60E OR 4L80-E 1993 & 1994 4WD "T" TRUCKS NON-OBDI WITH 4L60-E

The "DRAC" diagnostics in Figure 62 and the diagnostic trouble tree in Figure 60 can be used for the vehicles listed below.

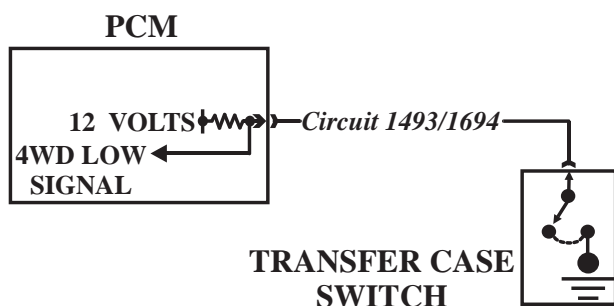
Figure 63

MECHANICAL SHIFT TRANSFER CASE

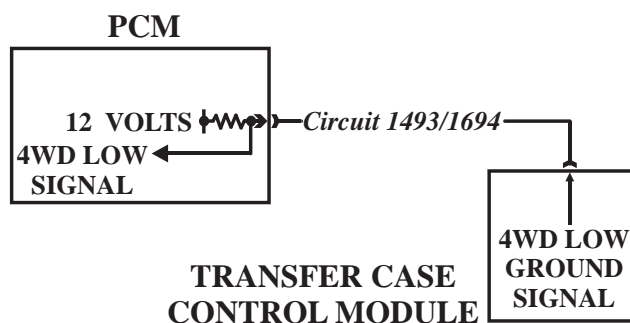
Figure 64

ELECTRONIC SHIFT TRANSFER CASE

- The Transfer Case Control Module is located either under the center of the dash, or behind the passenger side kick panel on some "T" trucks.
- The diagnostics for Circuit 1493/1694 are exactly the same as the Four Wheel Drive Low Switch, with the following exceptions:
- When the 4WD LO range switch on the dash is pushed, it is the Transfer Case Control Module that grounds Circuit 1493/1694. If battery volts are present and that parameter on the scan tool data list changes state, it is the TCCM that is faulty. This is a common failure as well as corrosion on "T" trucks that have the TCCM located behind the passenger kick panel. It is the HVAC system that dumps condensate on the TCCM connectors, (Refer to Figure 64).

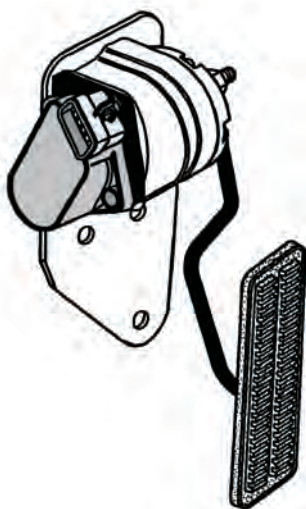
Figure 66

ACCELERATOR
PEDAL
POSITION (APP)
MODULE

THROTTLE
PEDAL
ASSEMBLY

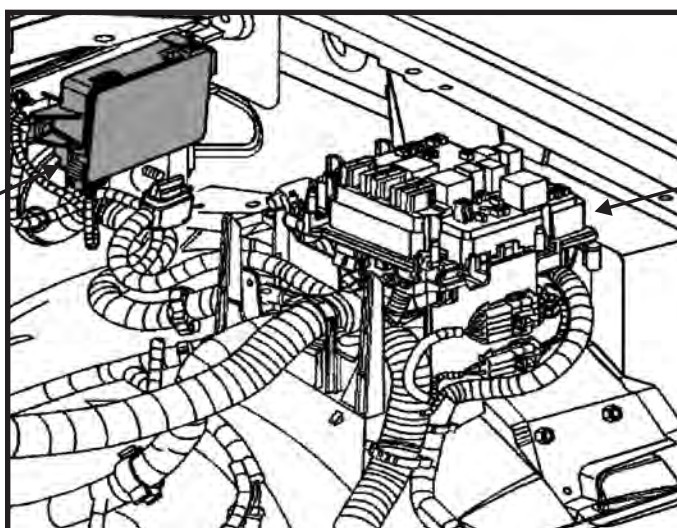
Figure 70

Typical location of the TAC Module...Driver side, rear corner of engine bay.

UNDERHOOD
FUSE BOX

- The **TAC Module** is responsible for controlling throttle positioning, based on input from various sensors as well as data from the PCM over a dedicated serial data line. The TAC and the PCM monitor the commanded (desired) throttle position and compare it to the actual throttle position. This is accomplished by monitoring the APP Sensors and the TP Sensors. These two values must be within a target value of each other, if they are not, the appropriate fault codes will be stored. The TAC Module is usually located in the driver side, rear, of the engine bay, as shown in Figure 70.

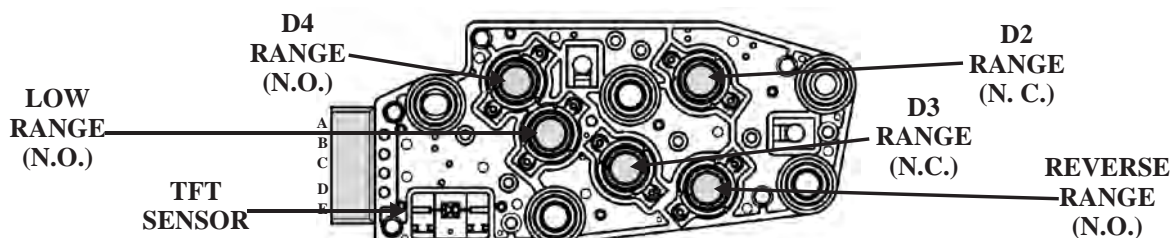
Figure 77

4L60E TRANSMISSION FLUID PRESSURE SWITCH ASSEMBLY

- The TFP Switch assembly in a 4L60E transmission (See Figure 77) ranges differently than the TFP Switch assembly in a 4L80E, (Refer to Figure 78). The 4L80E TFP Switch assembly contains 5 normally open pressure switches. The 4L60E TFP Switch assembly contains 3 normally open and 2 normally closed pressure switches and also contains the Transmission Fluid Temperature Sensor.

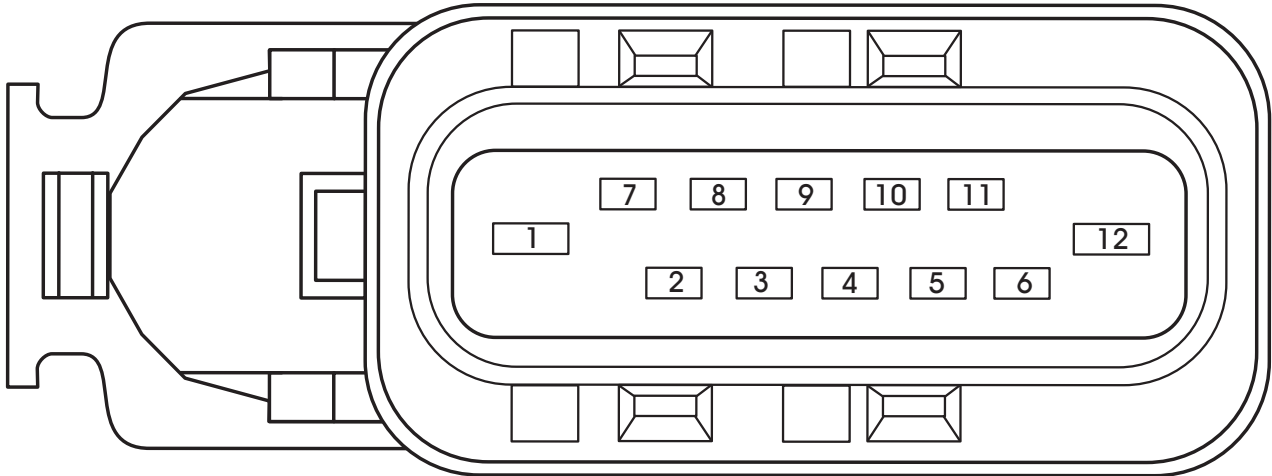
2004 & LATER TRANSMISSION RANGE SWITCH			
PIN	Wire Color	Circuit	Function
1	Dk Green	1433	Clutch Start Switch
2	-----	-----	Not Used
3	-----	-----	Not Used
4	Yellow	772	Transmission Range Switch "B"
5	Black/White	771	Transmission Range Switch "A"
6	Gray	773	Transmission Range Switch "C"
7	Black/White	451	Ground
8	White	776	Transmission Range Switch "P"
9	Lt Green	275	Park/Neutral Position Switch Signal
10	Gray	1524	Back-Up Lamp Supply Voltage
11	Pink	839	Ignition 1 Voltage
12	Purple	639	Ignition 1 Voltage

VEHICLE HARNESS VIEW

- Disconnect the 4-Way connector if it is the 2003 design switch or earlier, or the single connector if it is the 2004 or later design switch, and check range circuits "A", "B", "C" and "P" for approximately 12 volts using Figure 84 for the 2003 and earlier design level switch and Figure 85 for the 2004 and later design level switch.
