4L60E/65E/70E- 4L80E/85E DIAGNOSTIC CODE BOOK

INTRODUCTION

The GM 4L60E/65E/70E-4L80E/85E Diagnostic Code Book is designed to provide the technician with a step by step diagnostic approach to each and every transmission code available from 1991 to the 2007 model year. This manual can be used in collusion with any type of scanner utilized in retrieving these codes from the computer. As an aid to the technician, component location is recognized throughout the manual.

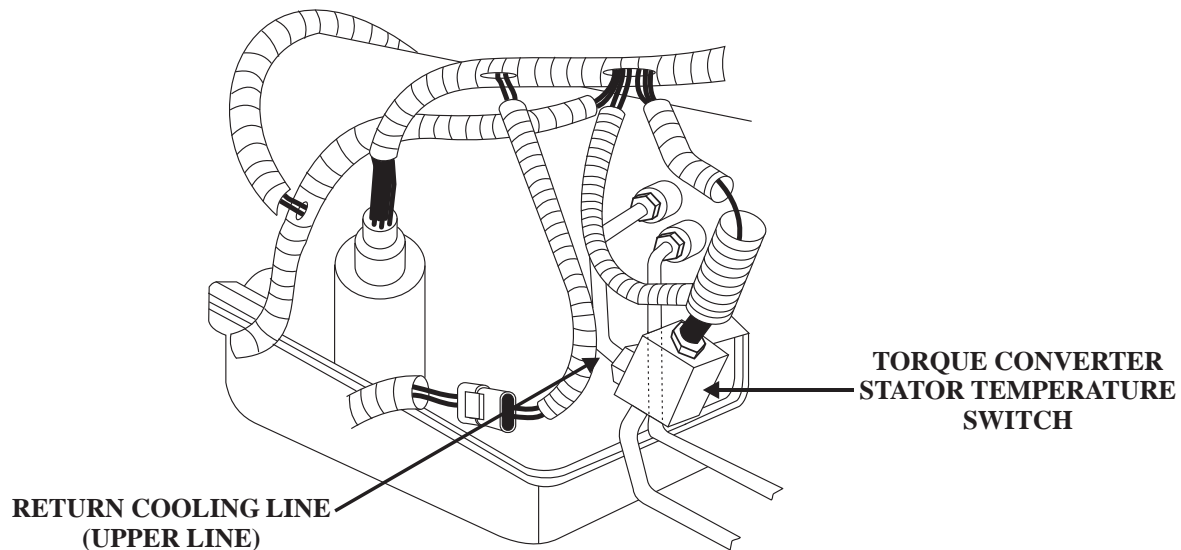
Figure 95

4L60E TORQUE CONVERTER STATOR TEMPERATURE SWITCH

- The TC Stator Temperature Switch is located in the return cooler line as shown in Figure 95. This switch is a single wire, normally open switch which grounds through the cooler line. The switch closes at a temperature of 327°F (164°C), at which time this signal is sent to the PCM. The PCM will now take steps to cool the torque converter by commanding TCC after second gear.

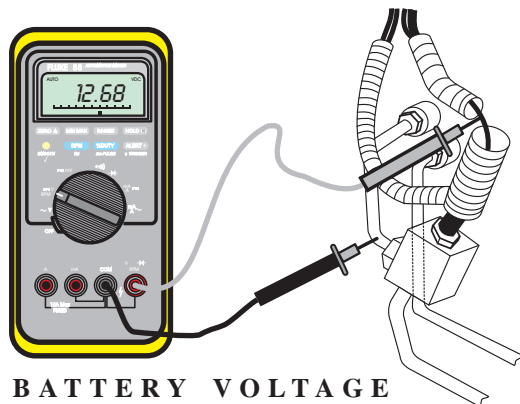
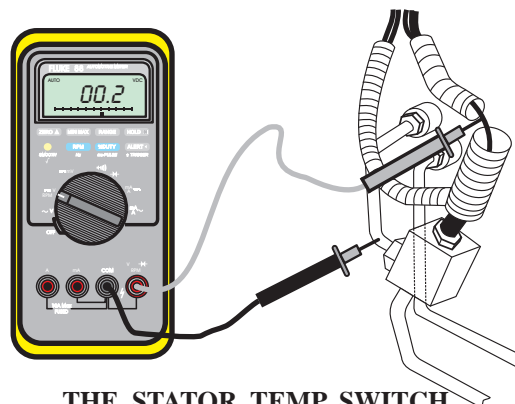
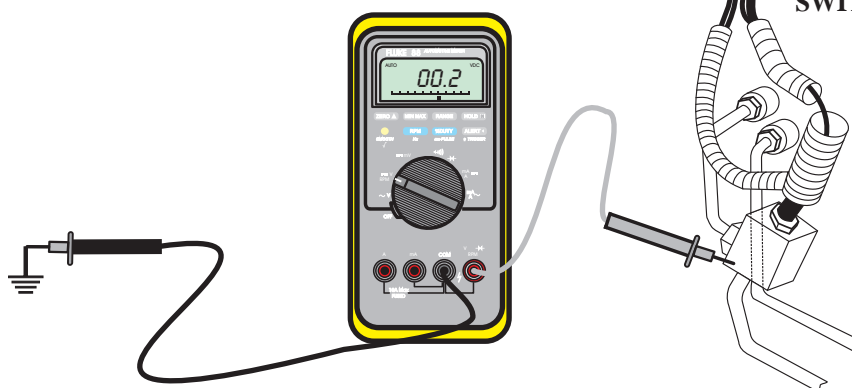
Figure 97

**BATTERY VOLTAGE
SUPPLY FROM PCM TO
STATOR TEMP SWITCH
WHEN THE SWITCH IS OPEN**

**THE STATOR TEMP SWITCH
CIRCUIT SHOULD HAVE LESS
THAN 1 VOLT WHEN THE
SWITCH IS CLOSED**

**WHEN CHECKING THE
STATOR TEMP SWITCH
GROUND, 0.2 VOLTS OR
LESS SHOULD BE SEEN
BETWEEN THE SWITCH
AND A GOOD KNOWN
GROUND**

- If Circuit 585 has less than one volt when disconnected, then the wire is grounded. Cut the wire approximately three inches from the PCM and check the voltage on it coming from the PCM. If it has battery voltage, the wire is grounded. If it has less than one volt, the PCM is grounding it at all times, replace or repair the PCM, (Refer to Figure 97).

- If the switch is not stuck open and it is well grounded, then the Circuit 585 wire is shorted to power or it is shorted to power inside the PCM, (Refer to Figure 97).

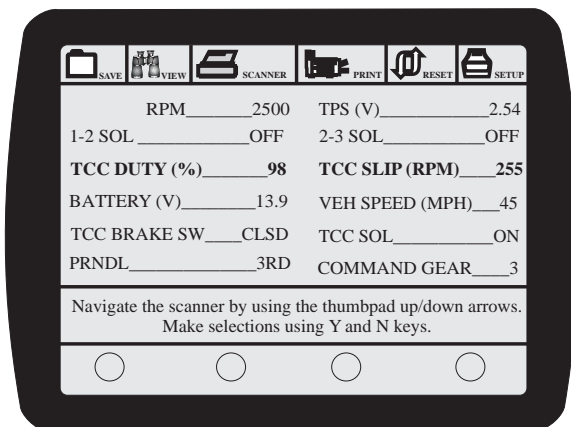
IMPROPER OPERATION

- Use your scan tool to monitor TCC Duty Cycle and TCC Slip on transmissions using PWM TCC systems. During initial apply of the converter clutch, duty cycle should be at 98% and slip should be less than 10, (Refer to Figures 99 and 100).
- 1998 and Later 4L60E transmissions in all but high performance applications will have the EC³ system. Duty cycle will vary after the 1-2 shift and TCC Slip will also vary but should not exceed a sustained slip of 130 rpm, for longer than 20 seconds (Refer to Figures 101, 102 and 103).
- If excessive slip is seen, use the available valve repair kits and/or component parts replacement as required.
- If the TCC orifice is broken, it can be removed and replaced with an orifice cup plug with a .028” (.7112mm) hole drilled through the cup plug.

- The data list in Figure 99 is that of a 4L60E with a conventional PWM TCC system. The transmission is in 3rd with the shift lever in the D3 position and the PWM TCC solenoid at maximum duty cycle and the TCC Enable Solenoid is on, yet the TCC slip is 255 rpm.
- This data indicates that we have the proper signals for TCC application, but the converter clutch is **mechanically** slipping which will generate code P0741 or 39 with the 4L80E transmission. In Figure 100 the TCC system is operating properly, slip is near zero rpm.

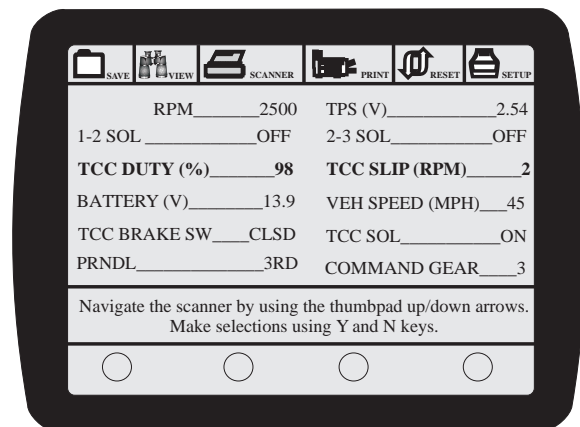
Figure 100

PROPER OPERATION

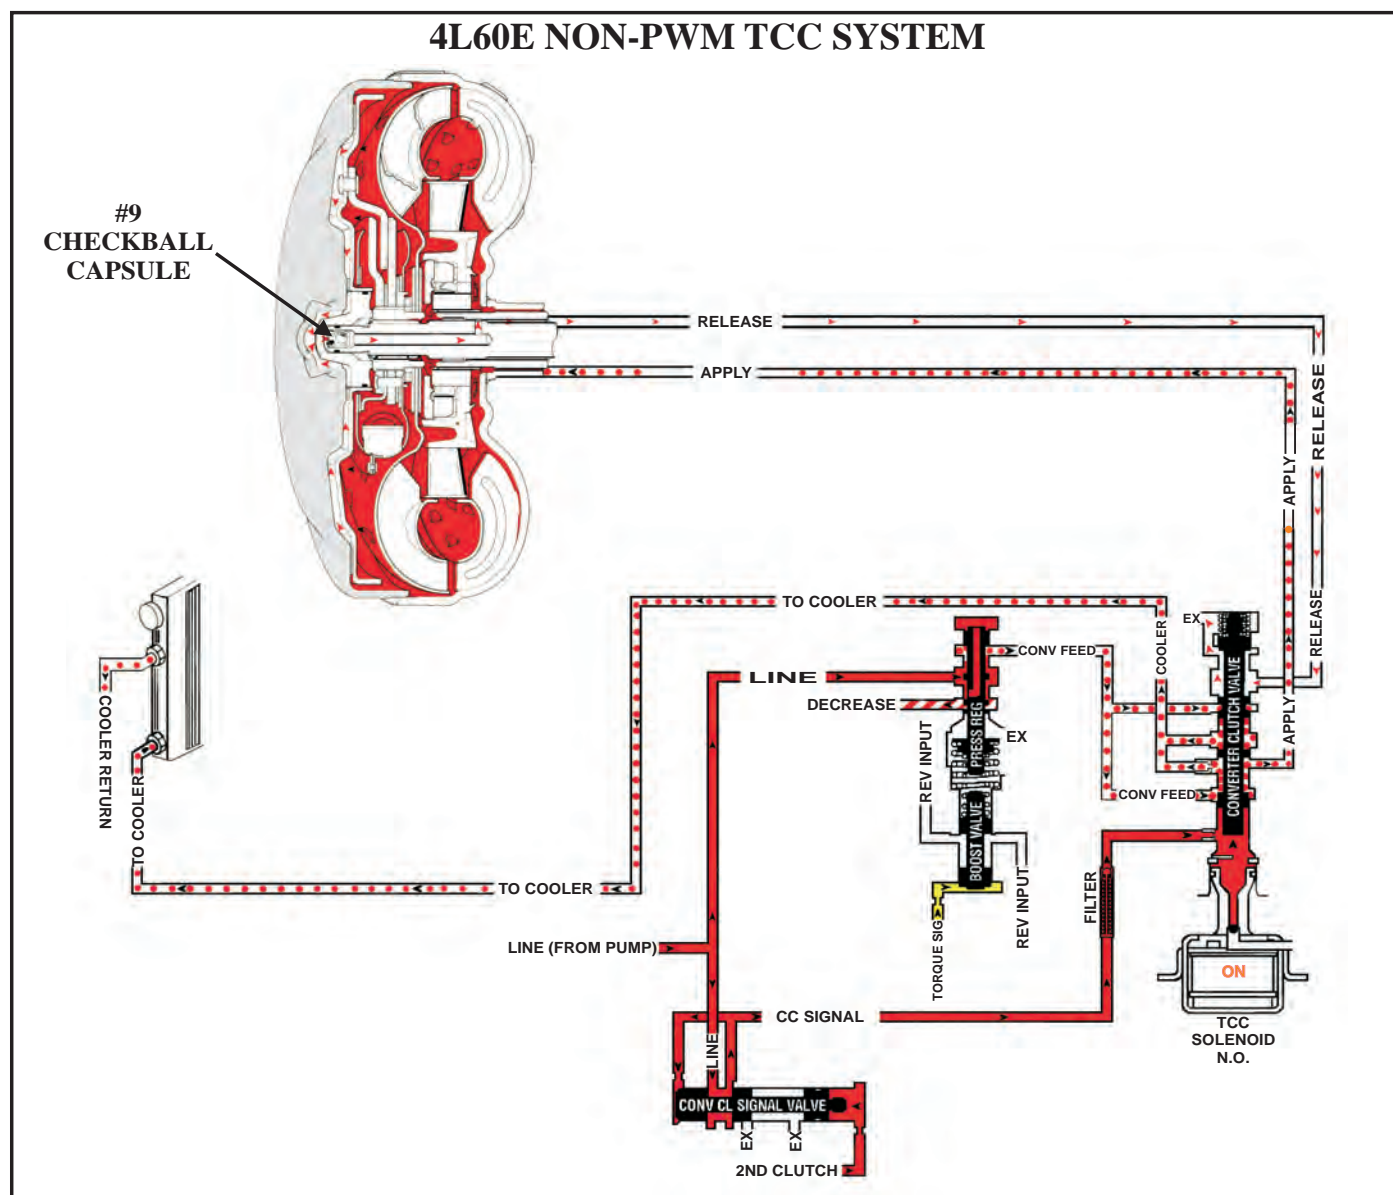
- The 4L60E NON-PWM TCC system in the hydraulic schematic in Figure 104 shown below shows the flow of the TCC apply and release circuits.
- Check for proper operation of the TCC Enable Solenoid as well as the Converter Clutch Apply Valve located under the TCC solenoid, in the pump cover and the Converter Clutch Signal Valve located in the valve body. These valves are prone to wear.
- Make certain the #9 checkball is not stuck.
- Make certain the cooling system has proper cooler flow.

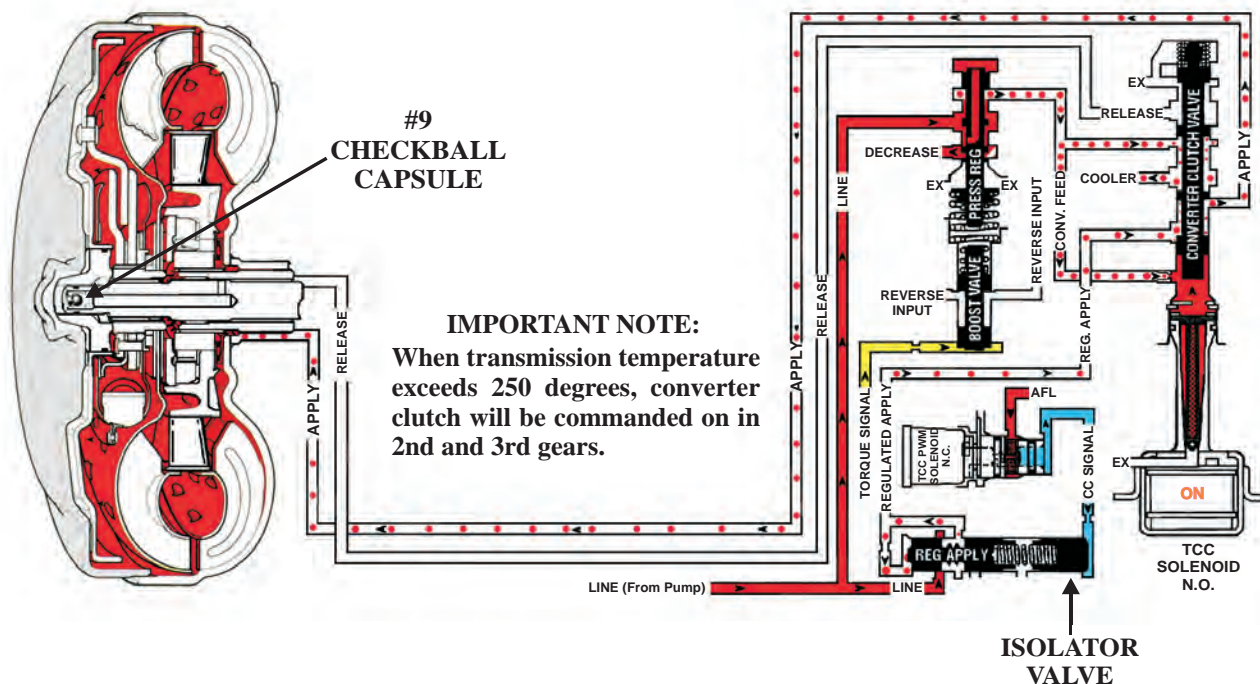
4L60E PWM TCC/ECCC SYSTEM

- The 4L60E PWM TCC/ECCC system in the hydraulic schematic in Figure 105 shown below shows the flow of the TCC apply and release circuits.
- Make certain the TCC solenoid is mechanically open when it is off. Make sure the TCC PWM solenoid is not stuck in the full apply position, (solenoid exhausts at the base of the stem).
- Check converter clutch apply and regulator isolator valves.
- Make certain the #9 checkball is not stuck.

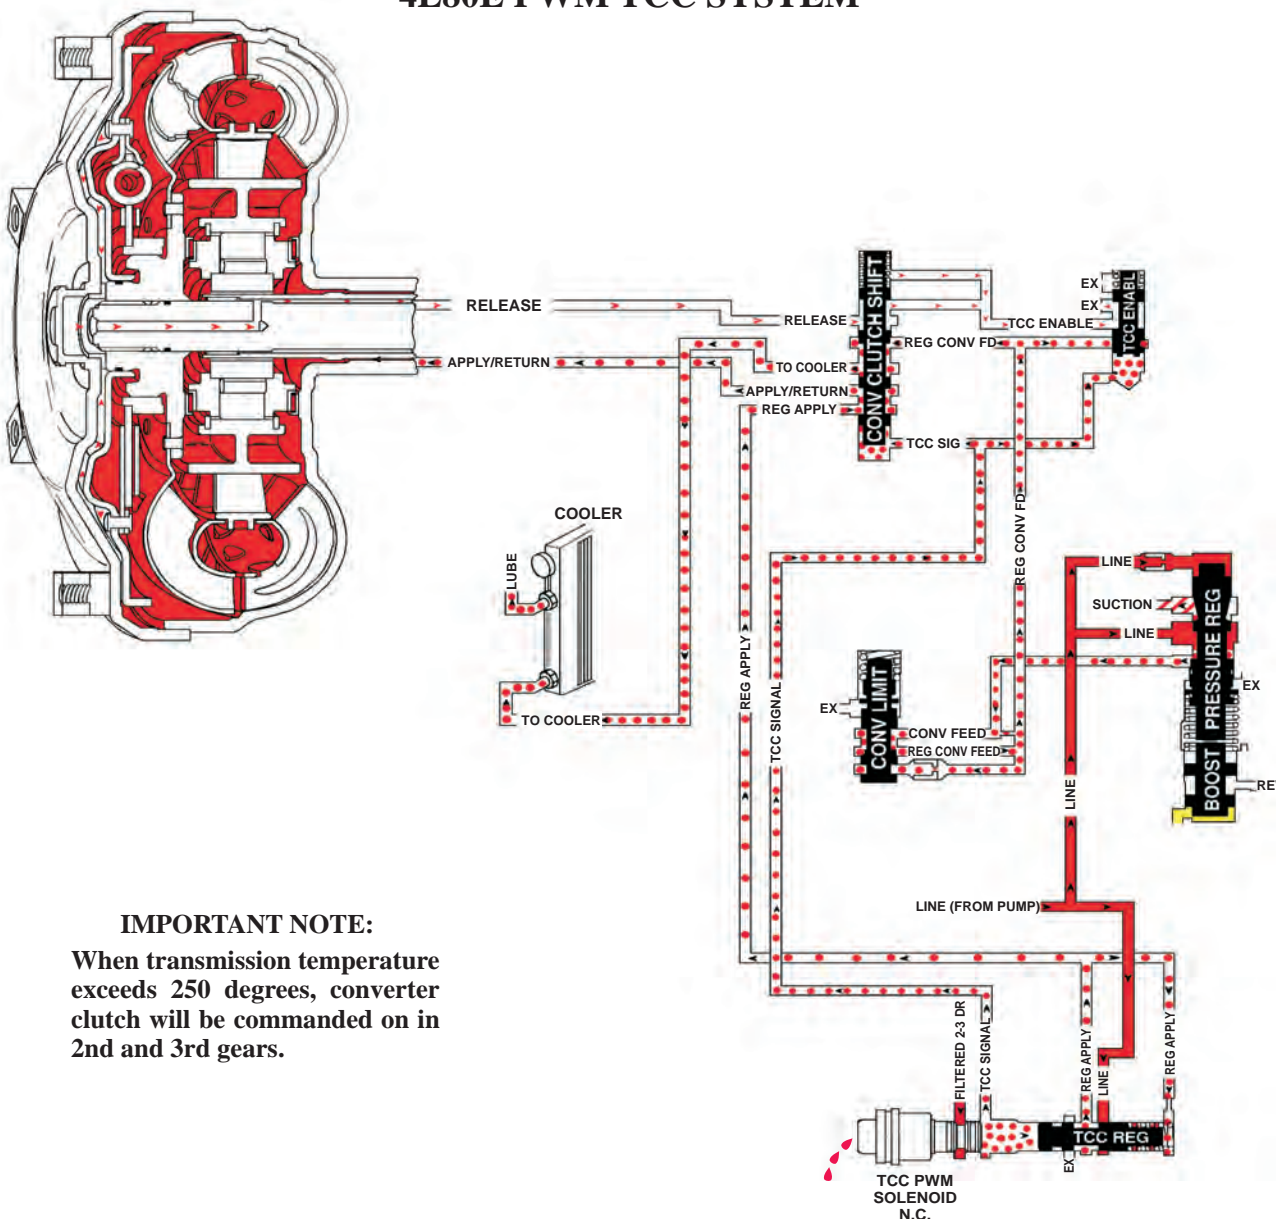
4L80E PWM TCC SYSTEM

- The 4L80E PWM TCC/ECCC system in the hydraulic schematic in Figure 106 shown below shows the flow of the TCC apply and release circuits.
- If a code 83 or P1860 is stored for a TCC PWM Solenoid electrical circuit fault, address those codes first, which once repaired, could eliminate the above listed codes.
- Make certain the Normally Closed TCC PWM Solenoid exhausts when energized and holds pressure without power.
- Check TCC Enable and Shift Valves in the pump for proper operation as well as the TCC Regulator Valve in the valve body.

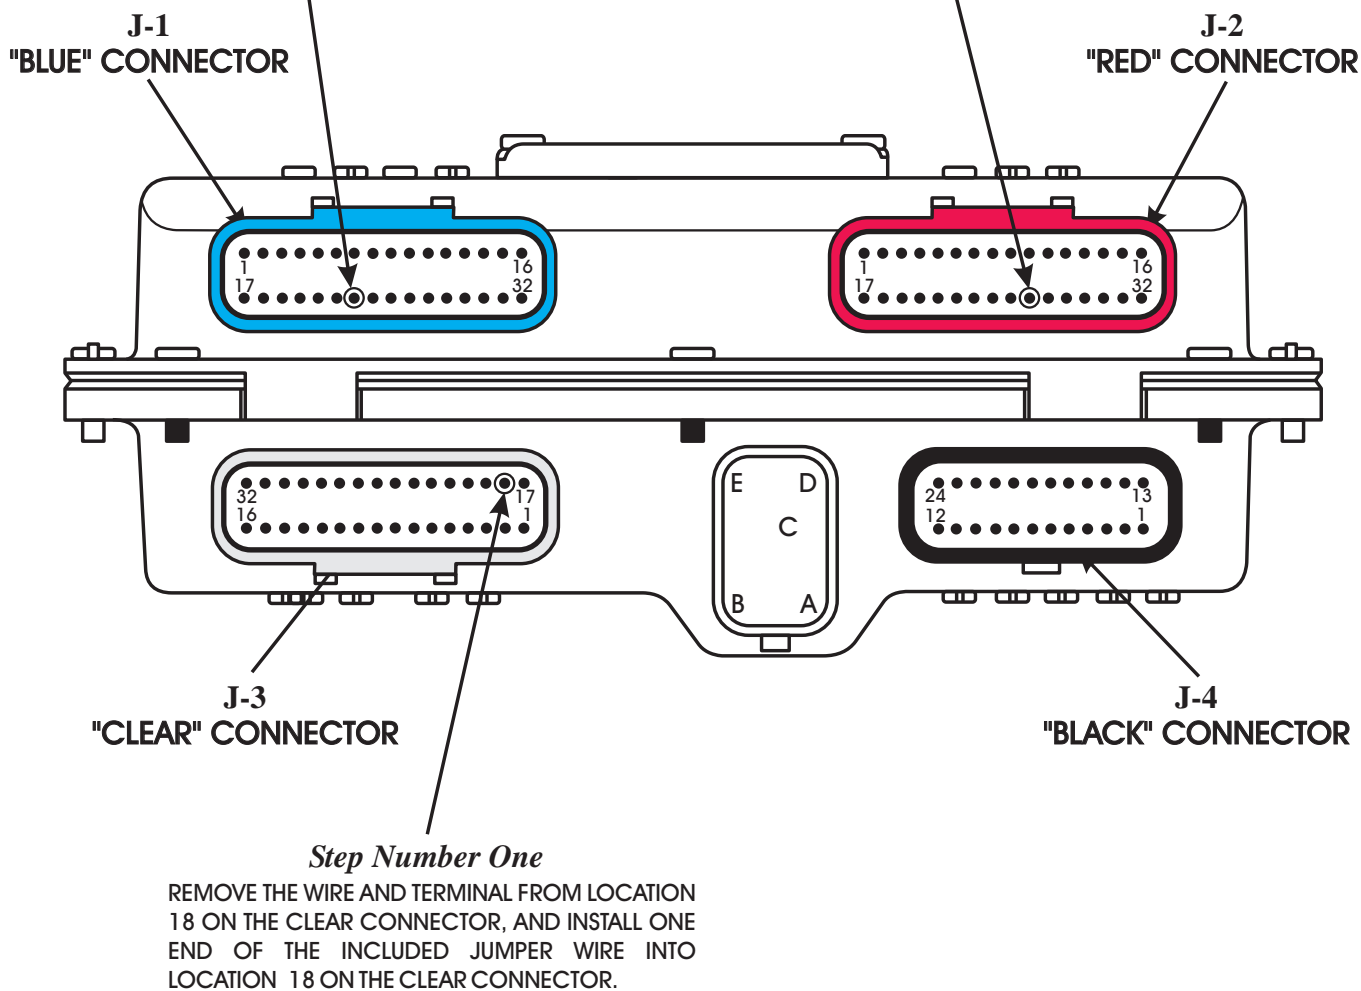
Figure 110

INSTALL THE OTHER END OF THE INCLUDED JUMPER WIRE THAT WAS PREVIOUSLY INSTALLED INTO THE CLEAR CONNECTOR, INTO CAVITY LOCATION 26 OF THE RED CONNECTOR.

"REFERENCE COLORS NOT VISIBLE UNTIL CONNECTOR IS REMOVED"

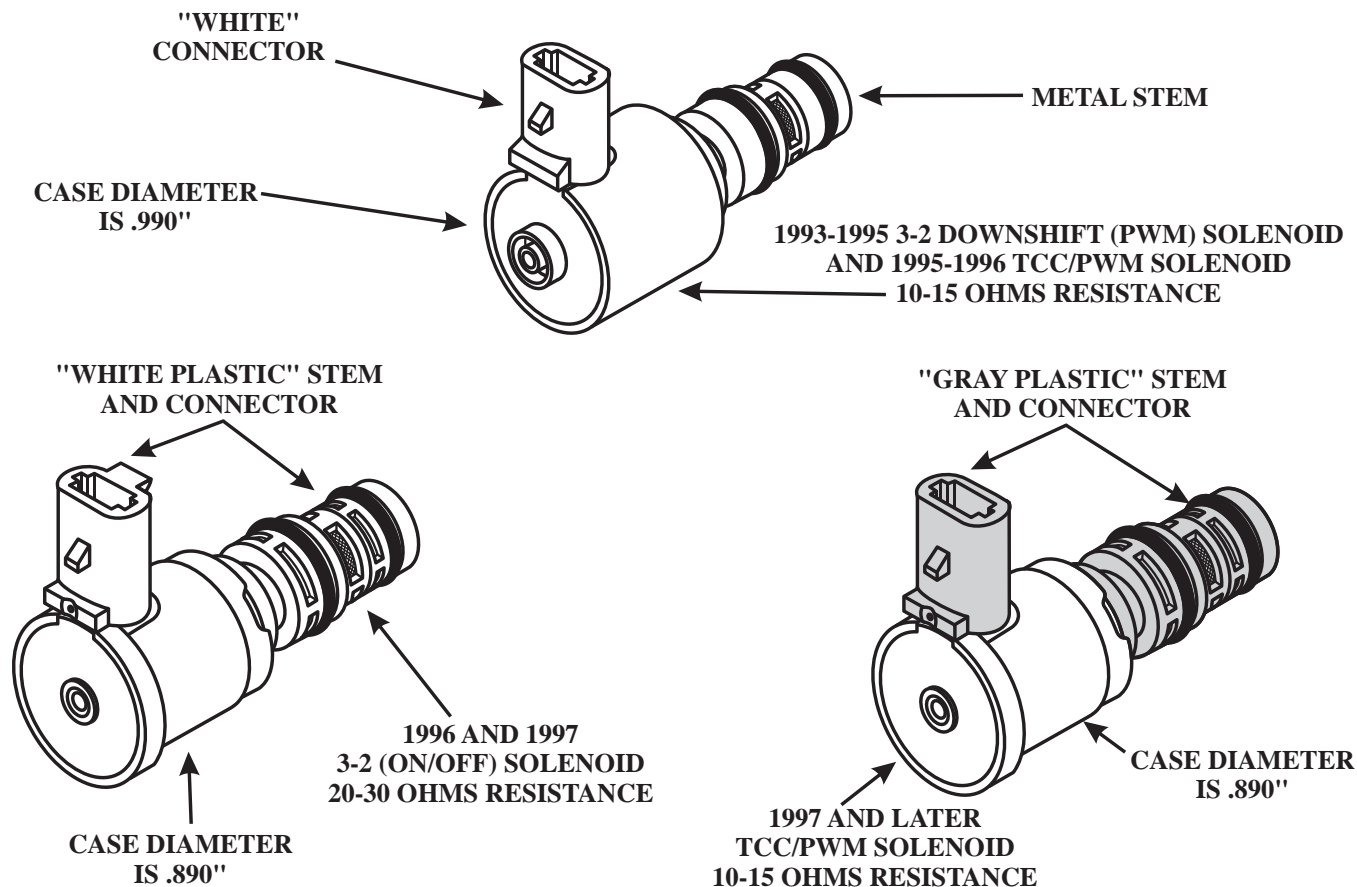
Figure 117

3-2 SOLENOID AND TCC/PWM SOLENOID IDENTIFICATION

- Replace 3-2 solenoid.
- Make certain the correct 3-2 solenoid is used for the application, PWM 1993-1995(10-15 Ohms), ON/OFF 1996 and later, (20-30 Ohms), Refer to Figure 117.
- Replace wire harness, aftermarket parts are available.
- Repair wiring as necessary by referring to the diagram in Figure 116.
- Check terminal end cavities with a #59 wire gauge drill bit. Refer to Figure 118 for terminal location. Transmission wiring on "G" Vans is routed between the floor of the van and a sheet metal plate, wiring can deteriorate in this area, check for bulk head connector damage as well.
- Repair short and replace fuse.
- Replace ignition switch or use relay wire harness as shown in Figure 125.
- Replace computer, new or rebuilt computers must be programmed or vehicle will not start.

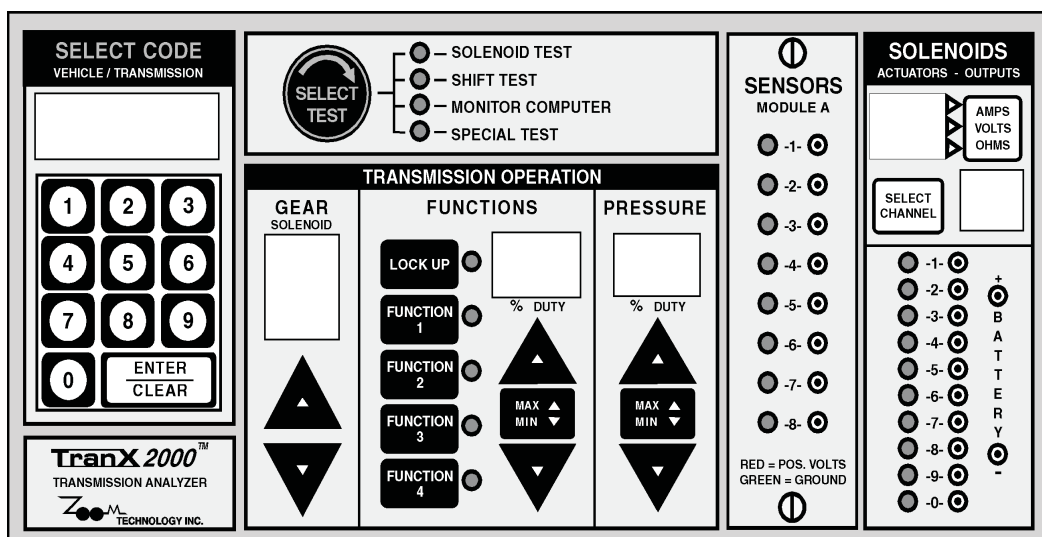
- There will be times when the diagnostic process calls for manual control of a solenoid. If the scan tool is incapable of bi-directional control then a transmission tester would do the job, preferably one that will display what the PCM is telling the solenoid to do as well as operating it independently of the computer as seen in Figure 120 below.

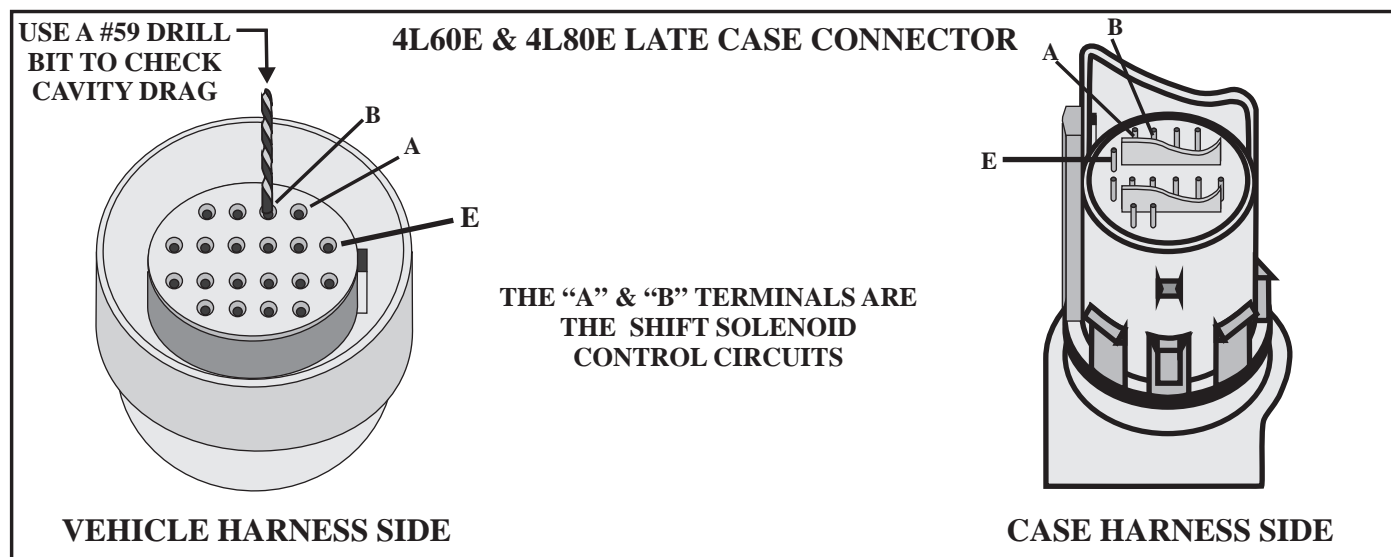
Figure 123

- When disconnecting the case connector plug from the transmission, the plug may be wiggled sideways to get it unplugged. This can cause expansion of the female cavities in the vehicle connector as well as bent pins in the case connector. The female cavity can be checked for size by using a #59 wire gauge drill bit as shown in Figure 123. The drill bit measures .041" and a firm drag on the drill bit should be felt. Make certain all male pins are not bent, broken or pushed back into the plastic connector. Kent-Moore Tool J-39775 can be ordered which is a test harness and comes with adaptors that can check the drag on both the female cavities and the male pins in the connectors.

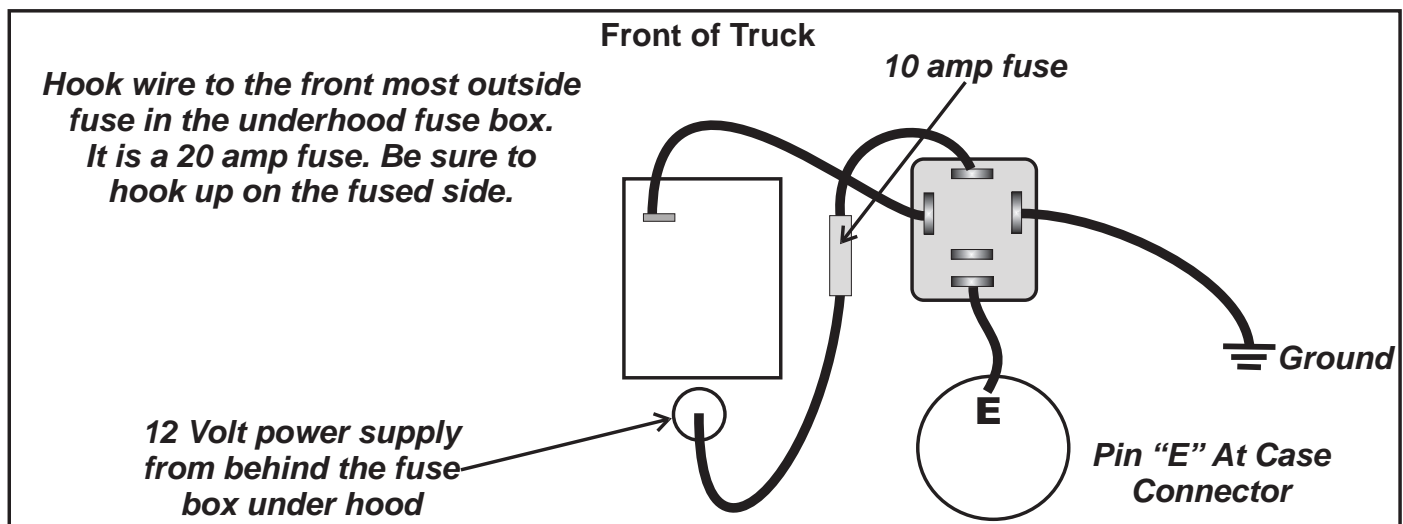
- When solenoid codes are stored due to a voltage drop at case connector terminal "E" caused by a faulty ignition switch, either replace the ignition switch or make the harness using a standard relay as seen in Figure 125 below to bypass the ignition switch and eliminate the codes. These codes are usually stored after engine startup. It is a good idea to put a function explanation tag on the harness.

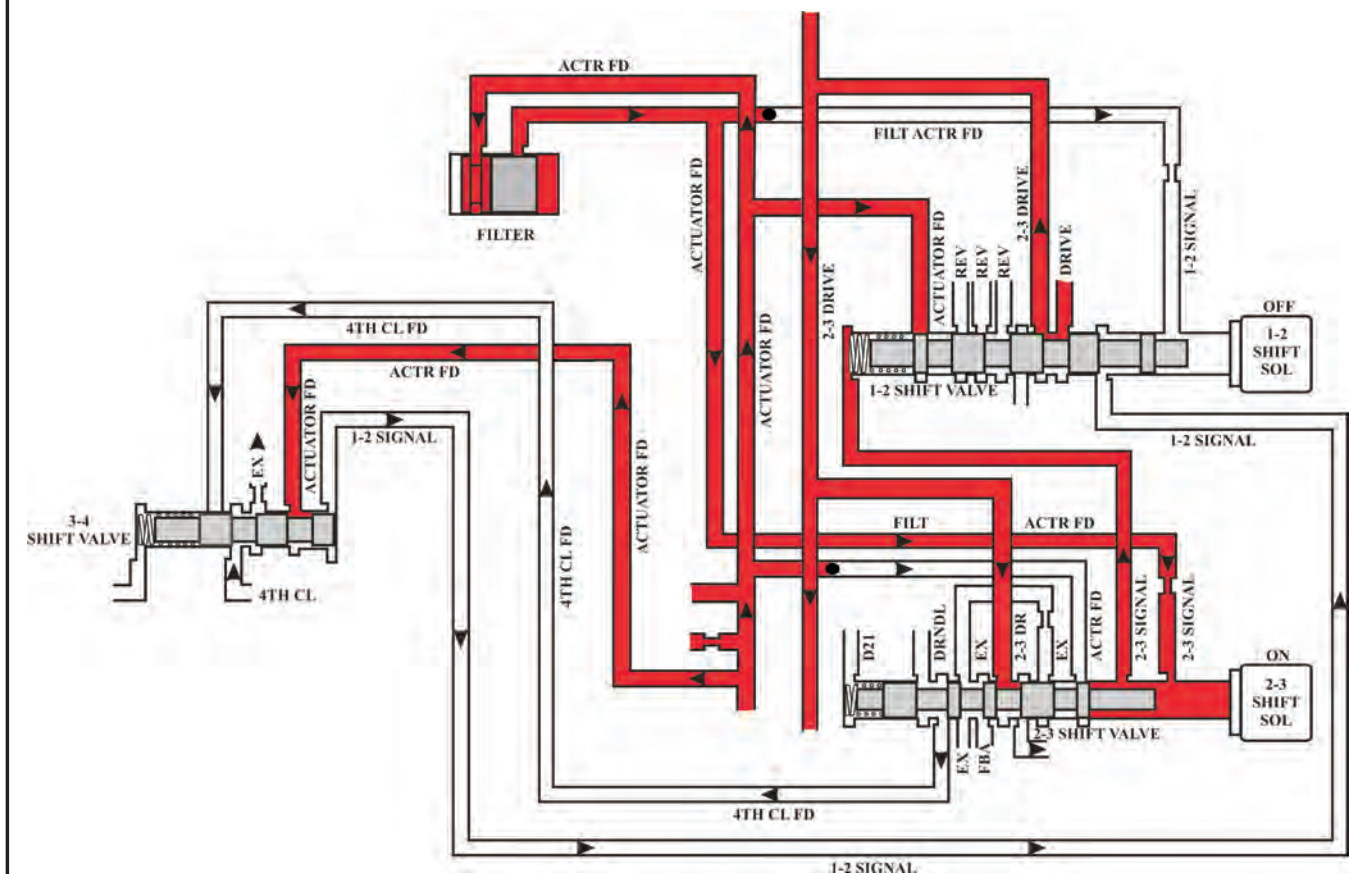
Figure 126

OVERDRIVE RANGE - SECOND GEAR (4L60E SERIES)

- Make certain solenoid o-rings fit properly and shift valves are free and valve springs are good, Refer to Figure 126.
- If the transmission exhibits the same problem as it came in with after overhaul, the valve body or case would be suspect.

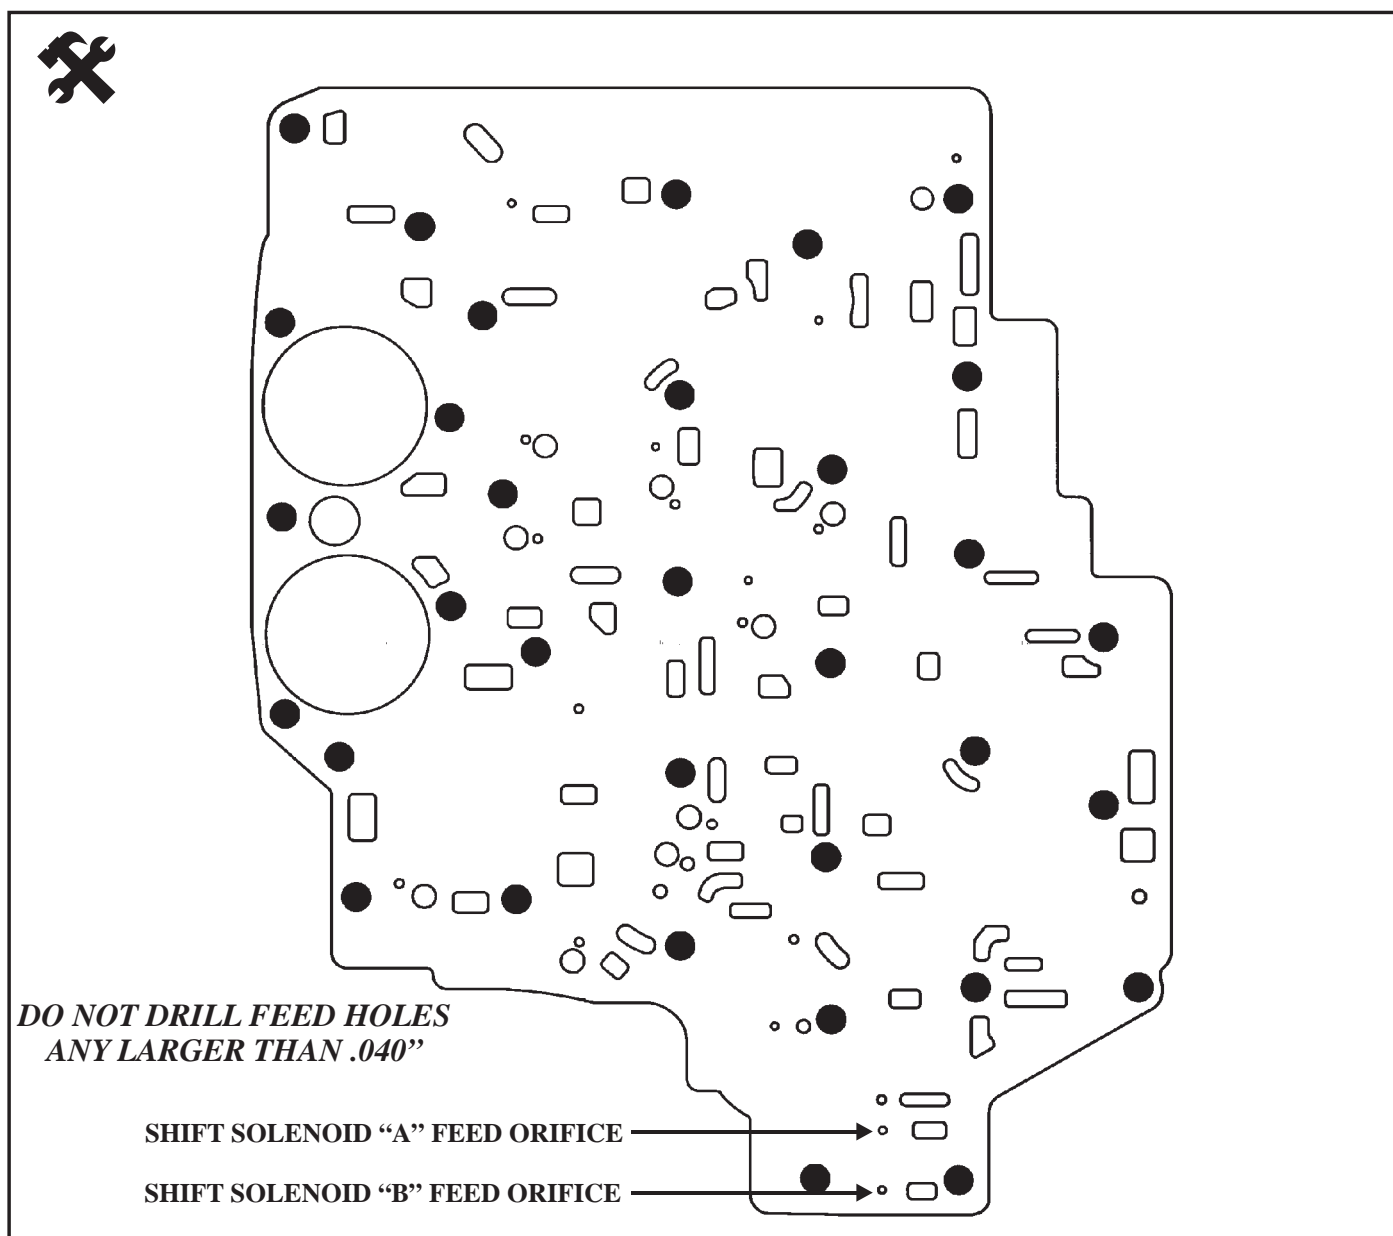
Figure 132

- Electronic aftermarket equipment installed in the vehicle can cause EMI/RFI interference with speed sensor circuits causing **ONLY** gear ratio error codes to be set. Care should be taken on the placement of this equipment as well as how it is wired.
- As the vehicle ages, the window for setting code 87 or incorrect ratio codes becomes overly sensitive. This can easily be compensated for by enlarging the shift solenoid feed holes to .035" to .040". The shift solenoid feed holes are shown in Figure 132.

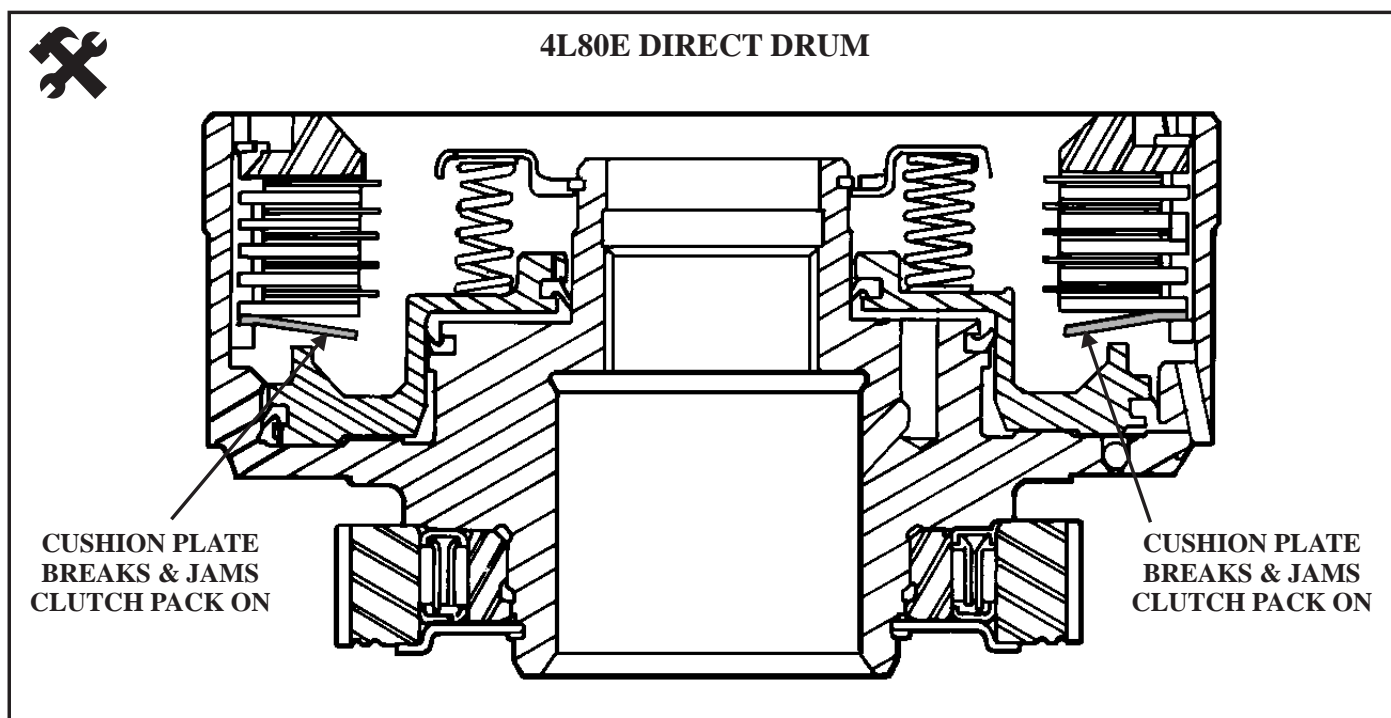
Figure 133

- The dished plate in the direct clutch pack can break and jam the clutch on, use the updated cushion plate, or the plates are welded together, Refer to Figure 133. This will cause code 86 or incorrect gear ratio codes to set.
- Welded planetaries are usually the result of poor cooler flow or too much end play causing misalignment of lube feed holes. Bushing wear can also be the cause. This will cause code 86 or incorrect gear ratio codes to set.
- 1994 to 1996 OBD-I vehicles can set code 87 due to a defective EPROM. Replace the EPROM according to the vehicles VIN number as described in factory bulletin **67-71-53B**.
- A restricted fuel delivery system can cause gear ratio error codes due to the shift solenoid command signaling for higher gears, but the transmission does not respond due to poor engine performance.

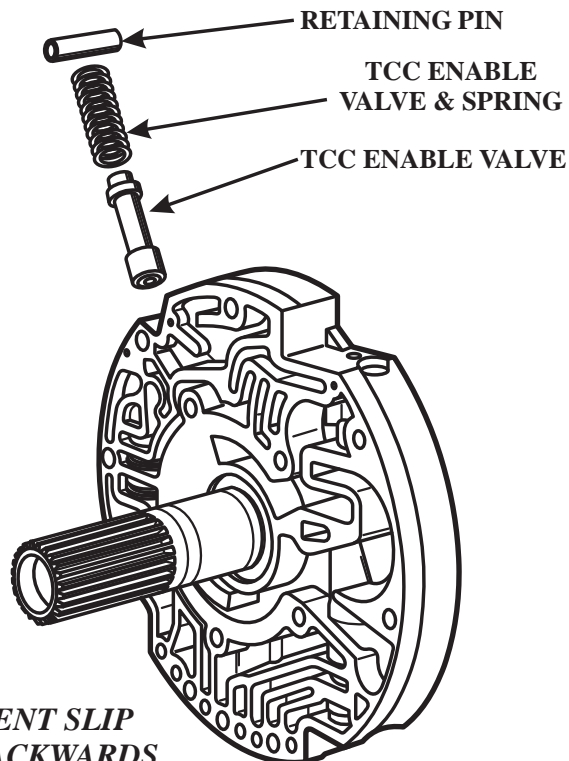
Figure 136

4L80E/4L85E PUMP COVER

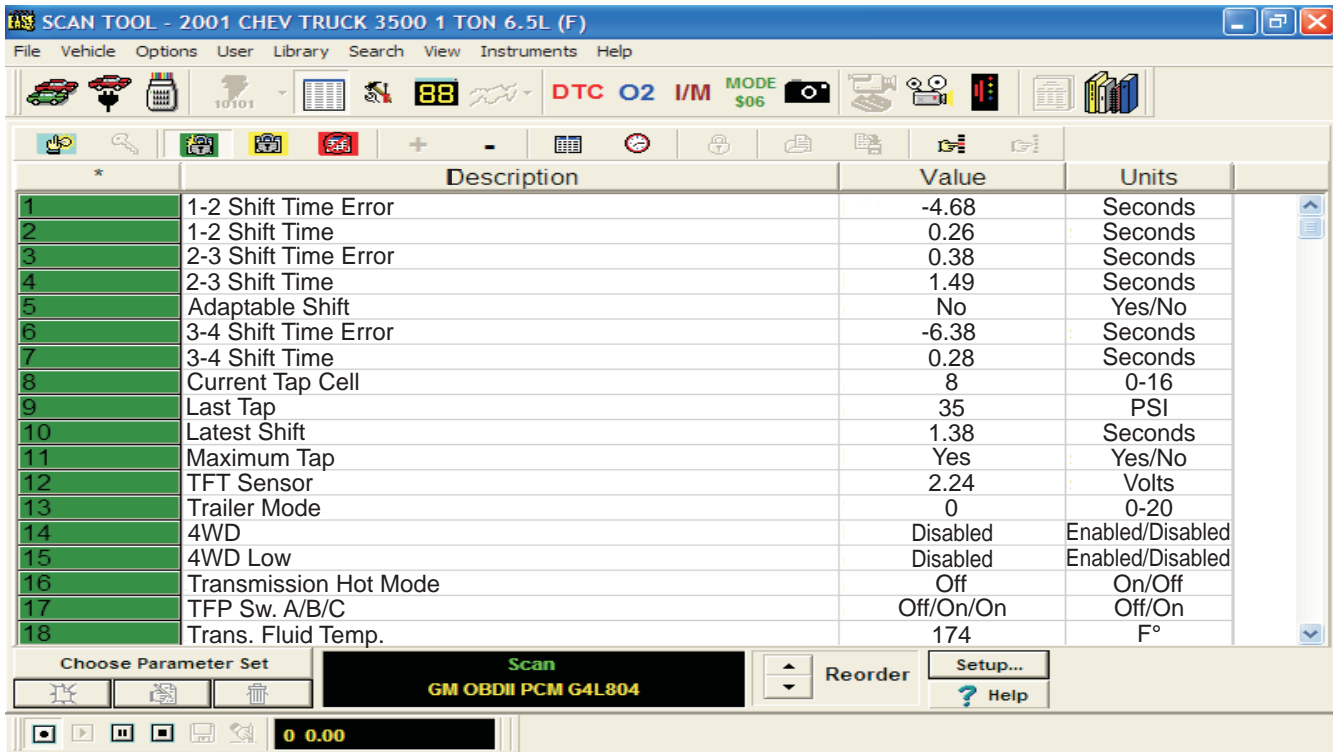
THIRD GEAR PROBLEM

Description	Value	Units
1	1-2 Shift Time Error	-4.68	Seconds
2	1-2 Shift Time	0.26	Seconds
3	2-3 Shift Time Error	0.38	Seconds
4	2-3 Shift Time	1.49	Seconds
5	Adaptable Shift	No	Yes/No
6	3-4 Shift Time Error	-6.38	Seconds
7	3-4 Shift Time	0.28	Seconds
8	Current Tap Cell	8	0-16
9	Last Tap	35	PSI
10	Latest Shift	1.38	Seconds
11	Maximum Tap	Yes	Yes/No
12	TFT Sensor	2.24	Volts
13	Trailer Mode	0	0-20
14	4WD	Disabled	Enabled/Disabled
15	4WD Low	Disabled	Enabled/Disabled
16	Transmission Hot Mode	Off	On/Off
17	TFP Sw. A/B/C	Off/On/On	Off/On
18	Trans. Fluid Temp.	174	F°

- The screen capture using a computer based scan program in Figure 138 is a customized data list of relevant parameters to the setting of Code P1811. These are the parameters that will answer the when, what and which that are causing P1811 to set. But first it is necessary to understand what these parameters represent.

- **Last Tap** - The display is in PSI. This is the amount of line pressure that was added to the base line pressure to adjust the clamping ability of a clutch or band on the last shift. Notice in Figure 138 that the PCM is attempting to add 35 PSI of line pressure on the 2-3 shift, this indicates a problem.

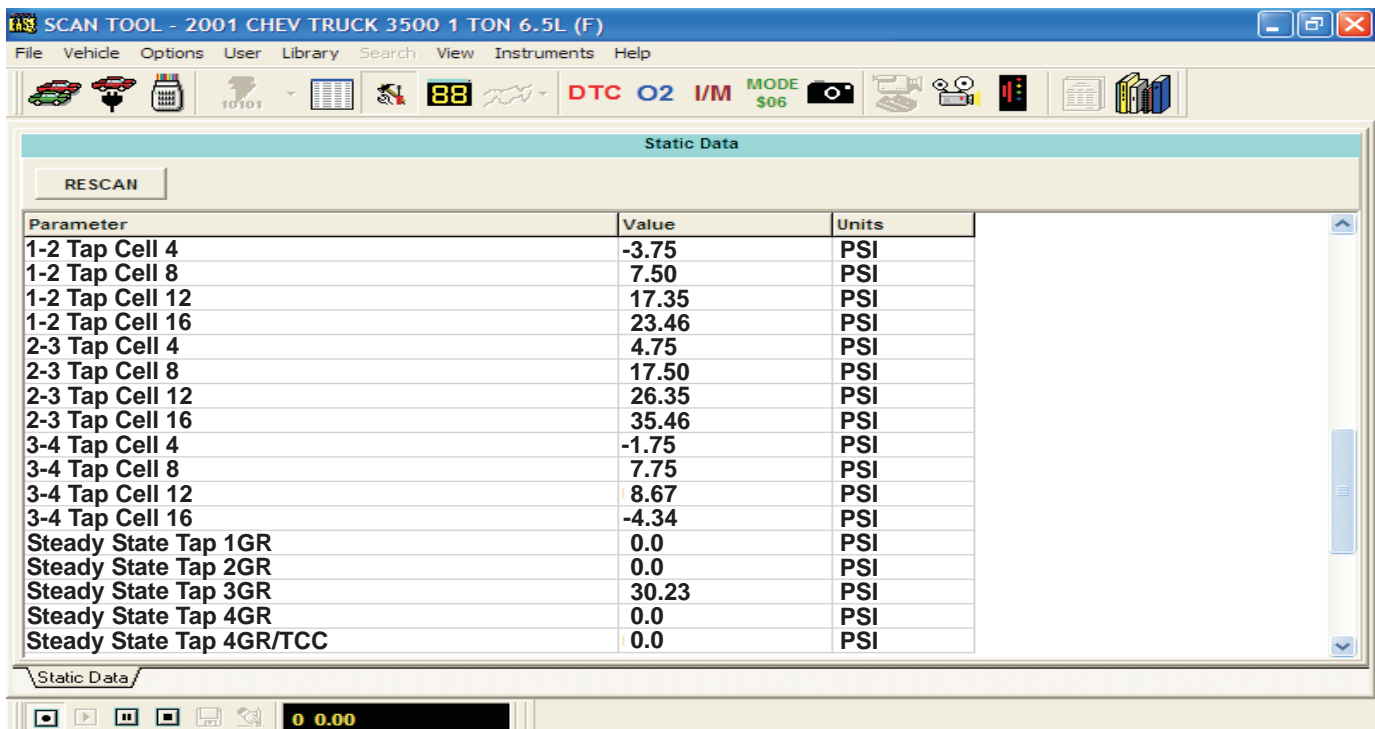
Figure 139

Parameter	Value	Units
1-2 Tap Cell 4	-3.75	PSI
1-2 Tap Cell 8	7.50	PSI
1-2 Tap Cell 12	17.35	PSI
1-2 Tap Cell 16	23.46	PSI
2-3 Tap Cell 4	4.75	PSI
2-3 Tap Cell 8	17.50	PSI
2-3 Tap Cell 12	26.35	PSI
2-3 Tap Cell 16	35.46	PSI
3-4 Tap Cell 4	-1.75	PSI
3-4 Tap Cell 8	7.75	PSI
3-4 Tap Cell 12	8.67	PSI
3-4 Tap Cell 16	-4.34	PSI
Steady State Tap 1GR	0.0	PSI
Steady State Tap 2GR	0.0	PSI
Steady State Tap 3GR	30.23	PSI
Steady State Tap 4GR	0.0	PSI
Steady State Tap 4GR/TCC	0.0	PSI
