THM 350C

The THM 350C transmission, first introduced in model year 1980, is a modified version of the previous THM 350 transmission, with the addition of a Torque Converter Clutch. The similarity of the THM 350C and the THM 350 are covered in this manual, along with some of the 350 updates

This booklet covers the procedures necessary to diagnose, repair and/or overhaul the 350C transmission and the 350 transmission.

THM 350 / 350C

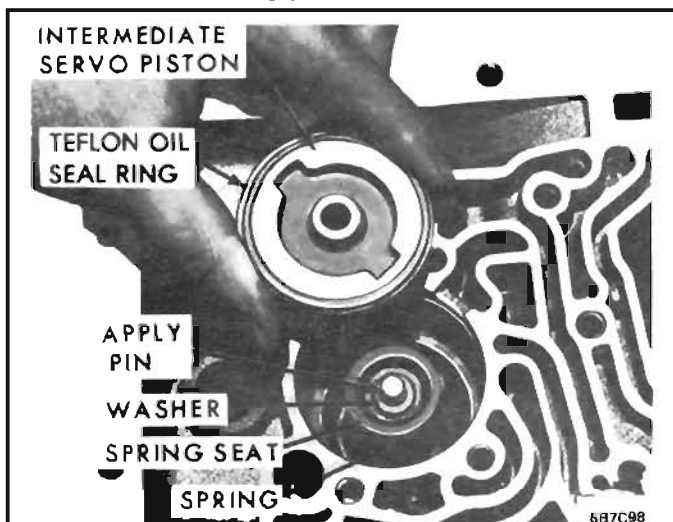
Figure 28 Intermediate Servo Assembly

31. If the piston or seal requires replacement the piston assembly will have to be replaced. (Piston and Seal are one assembly.)

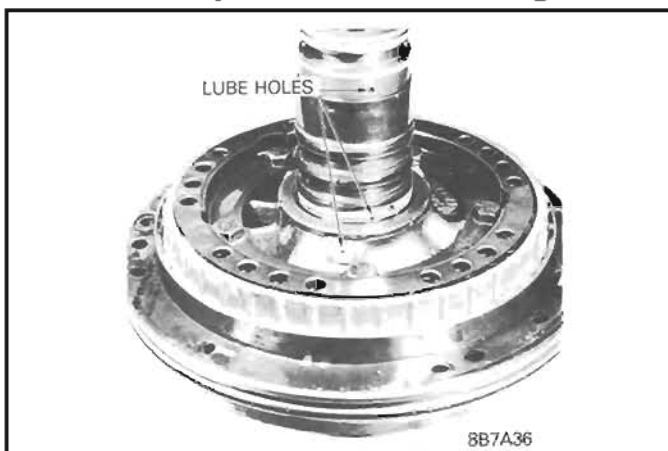
Figure 52 Lube Hole Location

3. Assemble pump cover to pump body. *See Figure 48.*
4. Install intermediate clutch piston new inner and outer seals. *See Figure 47.*
5. Install intermediate clutch piston assembly into pump cover with J-26744-A.
6. Install spring retainer and install five (5) attaching bolts, finger tight. *See Figure 47 and 46.*
7. Place pump aligning strap, J-21368 over pump body and cover and tighten.
8. Torque attaching bolts to 18 ft. lbs. (24 N*m)
9. Install pump outside diameter to case square cut seal. *See Figure 47.* Use new seal if necessary.
10. Install three (3) direct clutch to pump hub scarf cut oil seal rings. Inspect two (2) forward clutch to pump hub oil seal rings, (some rings will be solid new
11. Check three (3) pump cover hub lube holes. Make certain they are not restricted. *See Figure 52.*

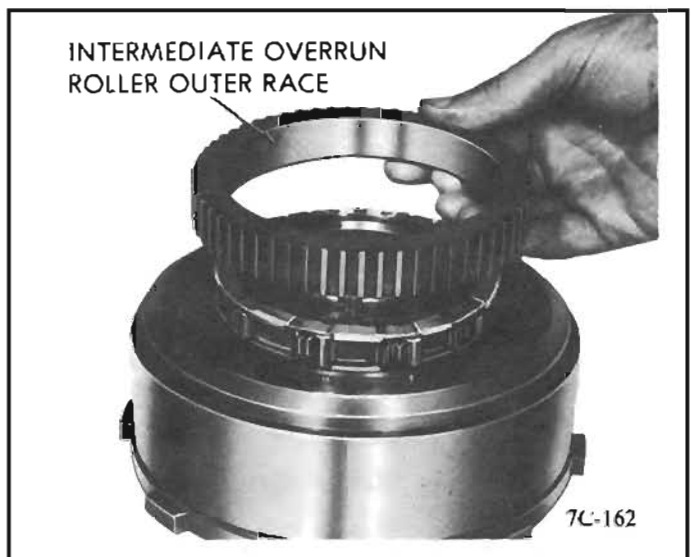
Figure 54 Roller Clutch Outer Race

2. Remove intermediate clutch overrun outer race. *See Figure 54.*
