FORD C-6

AUTOMATIC TRANSMISSION SERVICE GROUP
18639 S.W. 107TH AVENUE
MIAMI, FLORIDA 33157
(305) 670-4161

INTRODUCTION C-6 TRANSMISSION

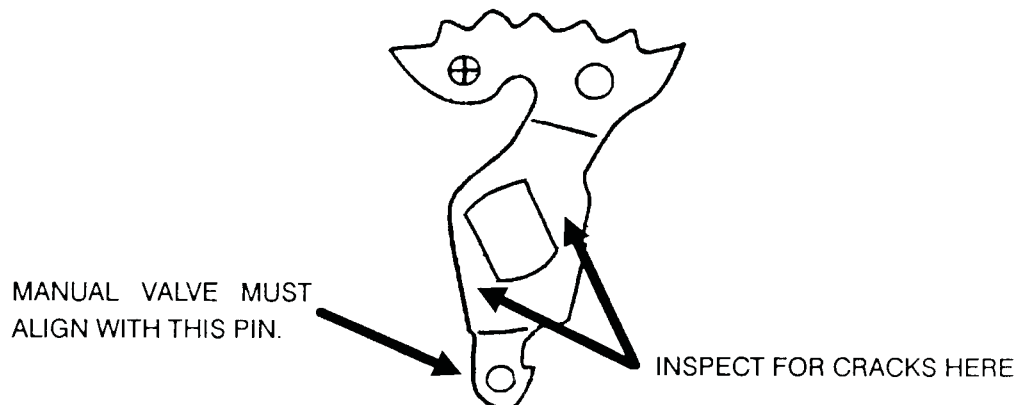
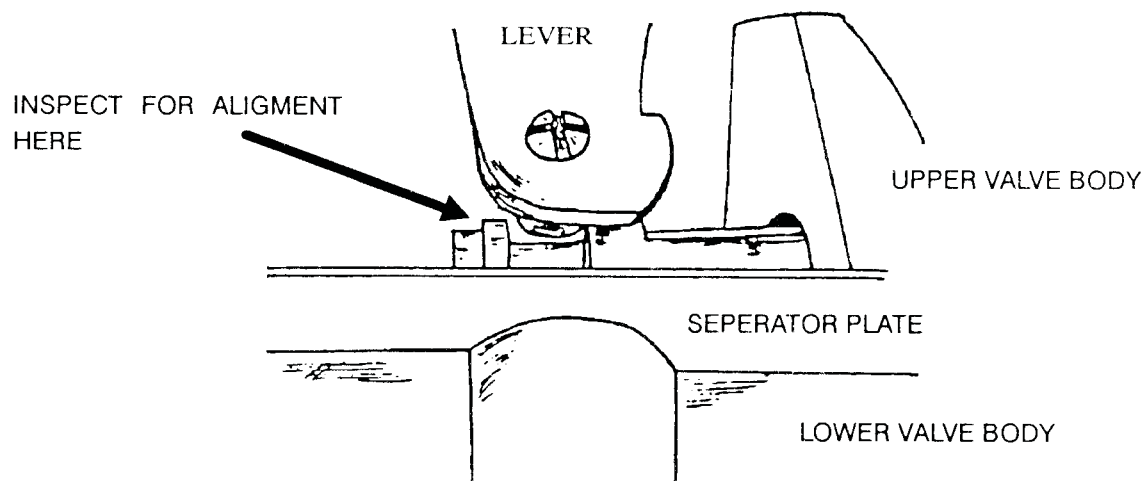
CAUSE: The cause can be a bent or cracked internal detent lever.

CORRECTION: The way to check the alignment is to use an old style C-6 valve body that has the detent in the valve body. On that assembly, place the manual valve in the drive position. With the detent lever in the case, in drive, set the old style valve body on the transmission, and check that the manual valve lines up with the pin in the detent valve. If the valve and pin do not align, replace the the linkage.
