FORD CD4E

AUTOMATIC TRANSMISSION SERVICE GROUP
18639 S.W. 107TH AVENUE
MIAMI, FLORIDA 33157
(305) 670-4161

The FORD CD4E is a computer controlled, four speed automatic overdrive transaxle and first appeared in the 1994 Probe with the 2.0 Liter engine. This unit is also found in the Ford Contours and the Mercury Mystique. This manual covers the procedures necessary for diagnosis, teardown, repair and overhaul of the CD4E transaxle.

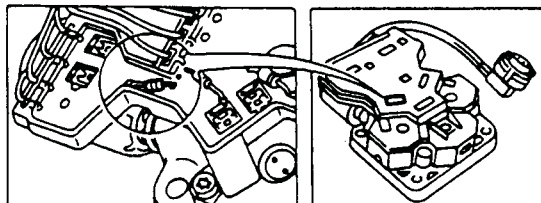
The Transmission Oil Temperature (TOT) sensor is located on the solenoid valve body. It is a temperature-sensitive device called a thermistor. The resistance value of the TOT sensor will vary with temperature. The Powertrain Control Module (PCM) monitors the voltage across the TOT sensor to determine the temperature of the transmission oil.

Transaxle Function: The PCM uses this signal to determine shift scheduling and control of line pressure for cold and hot temperatures operation. The PCM also inhibits Torque Converter Clutch (TCC) operation at low transmission temperature. Adjusts Electronic Pressure Control (EPC) pressures for temperature.

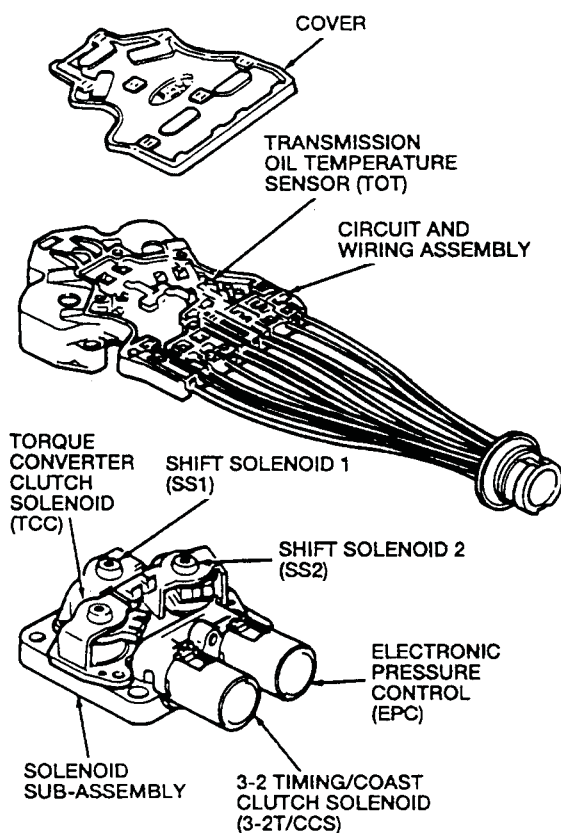
- Electronic Pressure Control (EPC) solenoid
- Shift Solenoid # 1 (SS1)
- Shift Solenoid # 2 (SS2)
- 3-2 Timing / Coast Clutch Solenoid (3-2 T/CCS)
- Torque Converter Clutch (TCC) solenoid

The PCM controls the operation of the transaxle through wiring to the solenoid valve body assembly mounted on the main control assembly. An electrical connector from the solenoid valve body assembly fastens to the top of the transaxle case, where it connects to PCM wiring.

The solenoid valve body assembly is serviced as one part when any of its components require replacement.

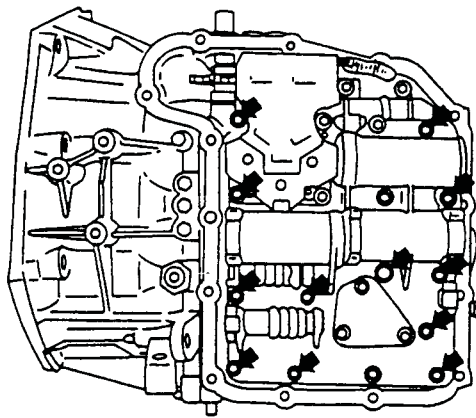
Remove the twelve main control bolts.

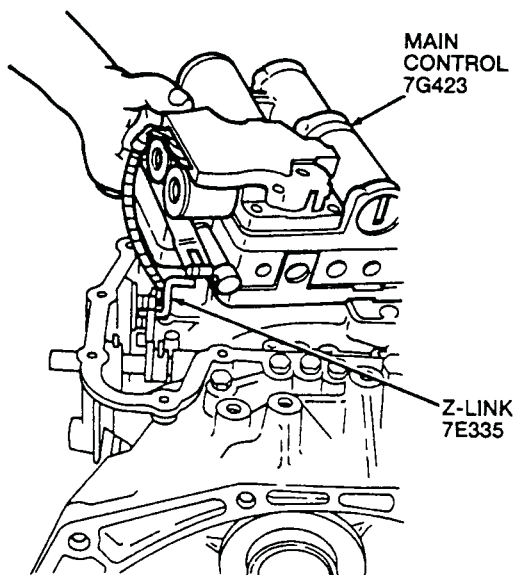
Pull the main control slightly away from the transaxle case. Disconnect the Z-link from the manual valve.

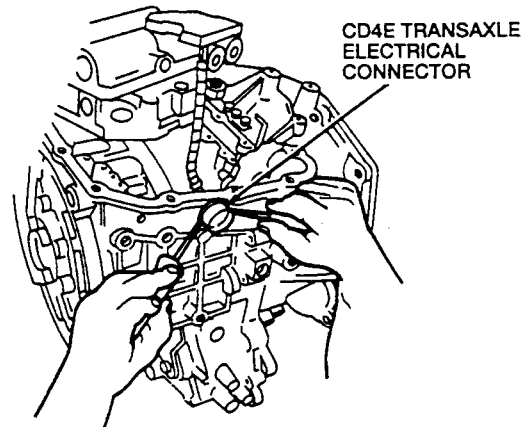
Squeeze the retainer tabs of the electrical connector and remove the connector from the bore in the case. Inspect the O-ring for damage.

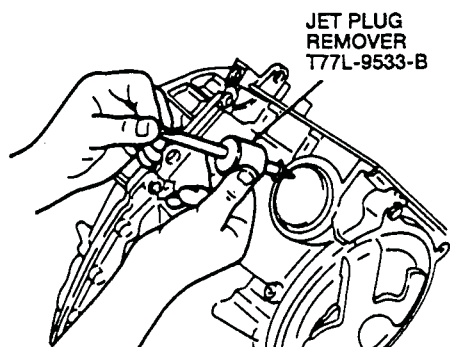
Remove servo cover cap from the transaxle case using Jet Plug Remover T77L-9533-B. Discard servo cover cap.

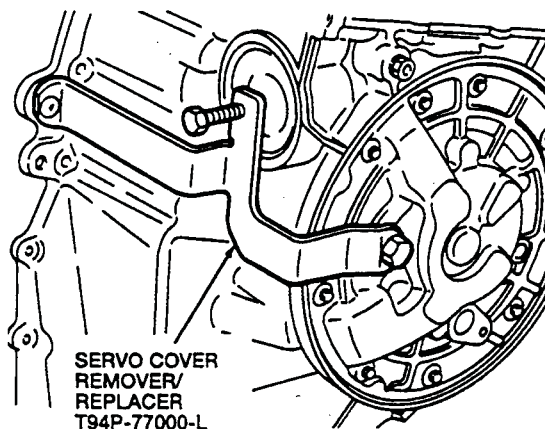
Using a 17mm socket, attach the Servo Cover Remover / Replacer T94P-77000-L to the oil pump assembly.

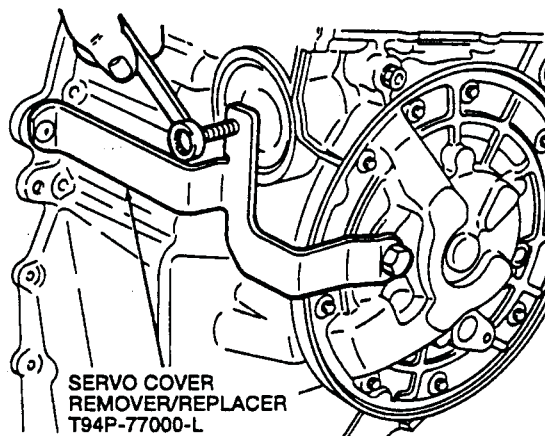
Use a 15mm socket and screw in the bolt to compress the servo cover assembly and remove the servo cover retaining ring.

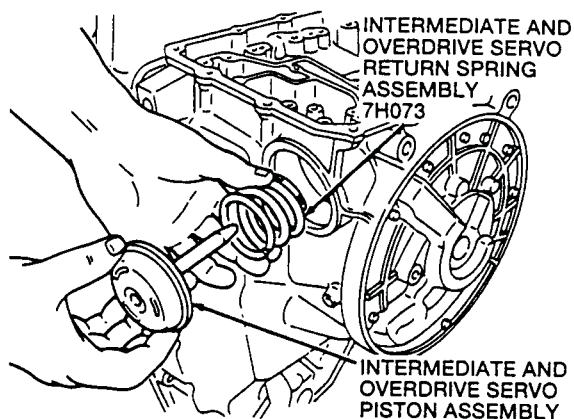
Remove the intermediate and overdrive servo piston and return spring.

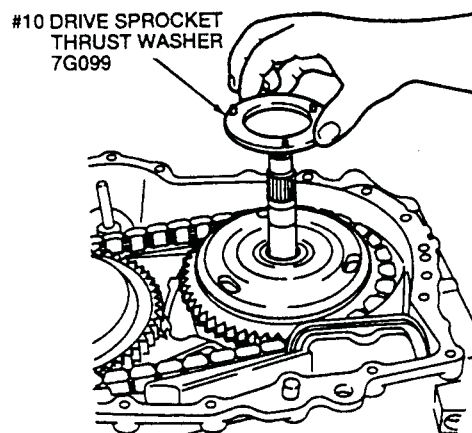
Remove the # 10 drive sprocket thrust washer from the Reverse / Overdrive ring gear assembly.

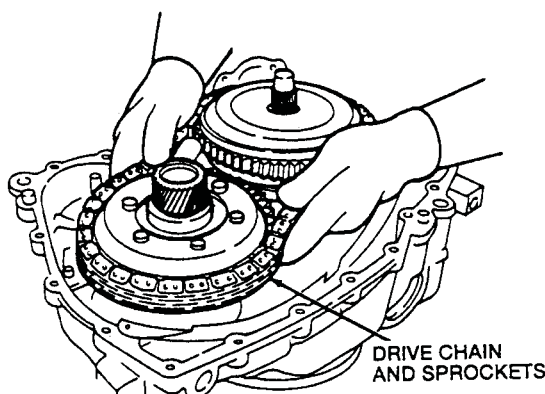
Lift the drive chain assembly, driven sprocket assembly, and the Reverse / Overdrive ring gear assembly together from the transaxle case.

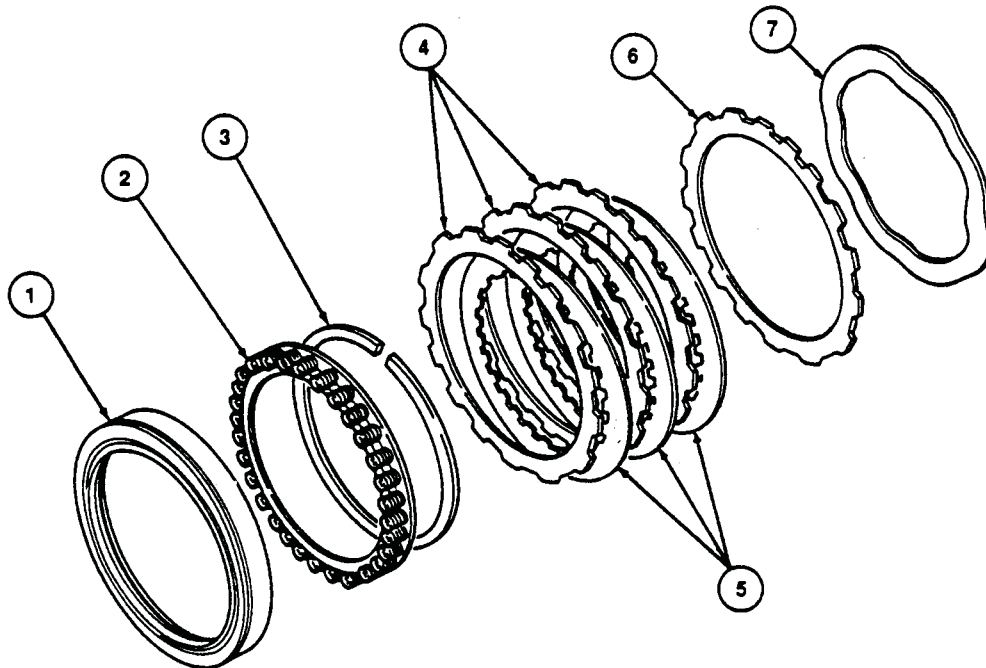
Item	Part Number	Description
1	7D402	Low / Reverse Clutch Piston
2	7H064	Low / Reverse Clutch Return Spring Assembly
3	7D483	Low / Reverse Clutch Return Spring Assembly Retaining Ring
4	7B442	Low / Reverse Clutch External Spline Clutch Plates (Steel)

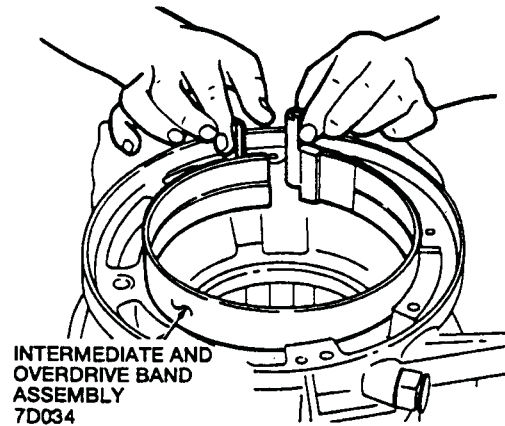
Slide the intermediate and overdrive band assembly from the case.

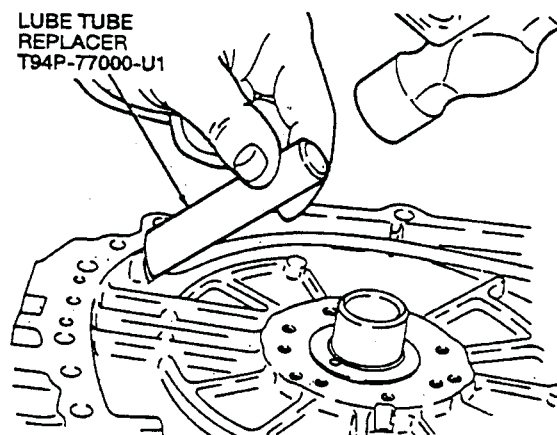
LUBE TUBE REPLACER T94P-77000-U1

Seat the end of the differential lube tube with a Lube Tube Replacer T94P-77000-V1 (part of Lube Tube Replacer Set T94P-77000-U).

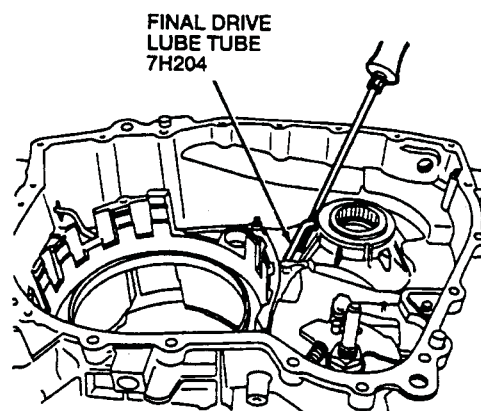
Use a screwdriver to remove the final drive lube tube from the transaxle case.

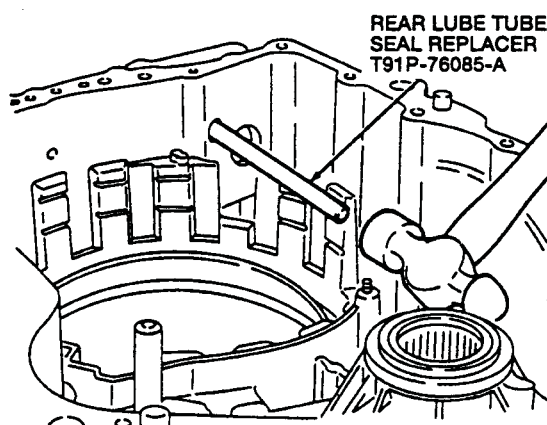
Use Rear Lube Tube Seal Replacer T91P-76085-A to remove the final drive lube tube seal from the transaxle case.

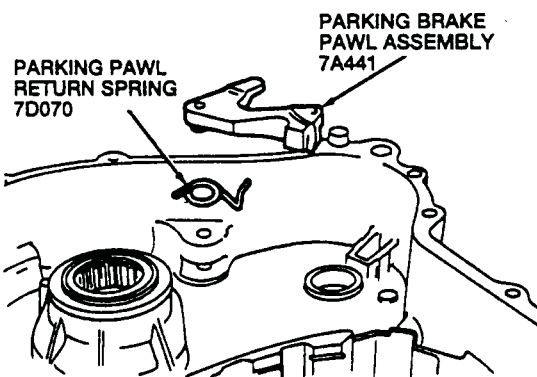
Remove the parking brake pawl assembly and parking pawl return spring.

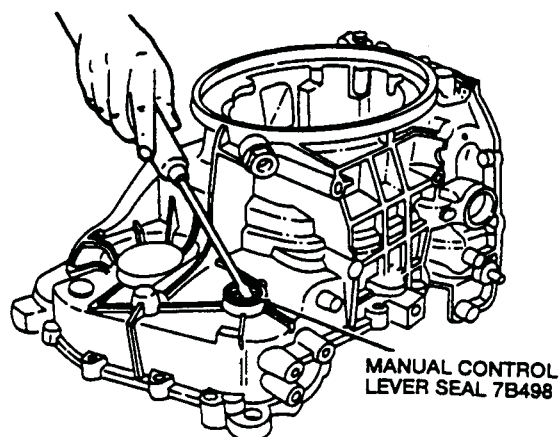
Use a screwdriver to remove the manual control lever seal. Discard the seal.

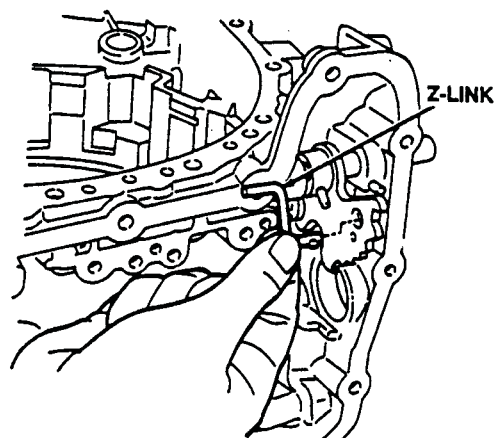
Remove the manual valve actuator rod (Z-link).

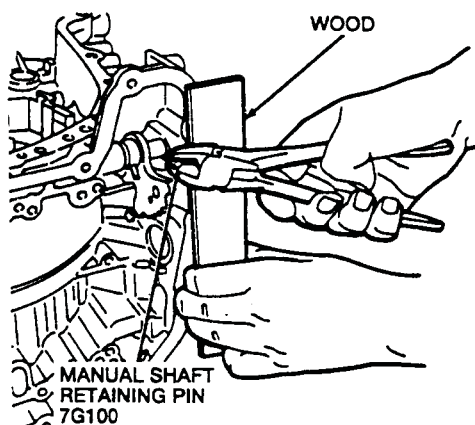
Protect the case with wood and use a pair of side cutters to remove the manual shaft retaining pin (7G100). Discard the manual shaft retaining pin.

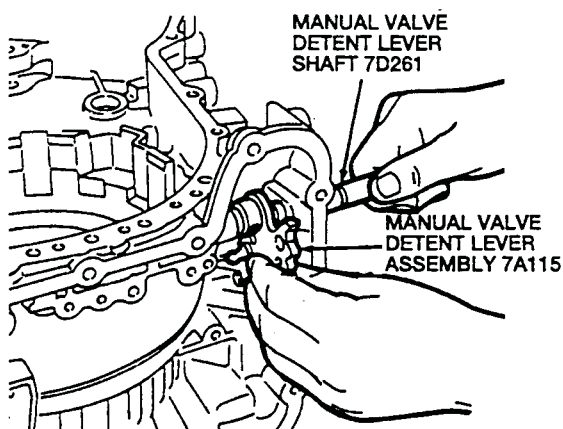
Remove the manual valve detent lever assembly and manual valve detent lever shaft from the transaxle case.

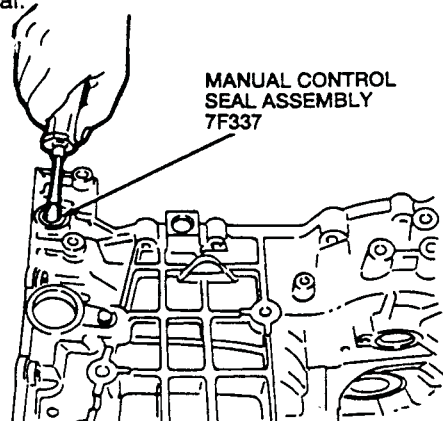
Use a screwdriver to remove the manual control seal assembly from the transaxle case. Discard the seal.

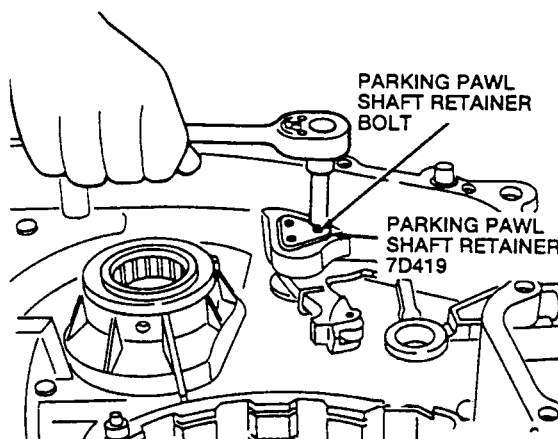
Install the parking pawl shaft retainer and bolt assembly. Use a 7mm socket to tighten the parking pawl shaft retainer bolt to 8 N·m (6 lb-ft).

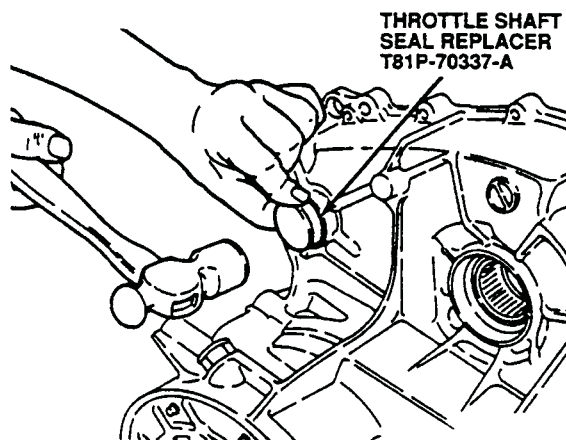
Use Throttle Shaft Seal Replacer T81P-70337-A or equivalent to install the manual control lever seal.

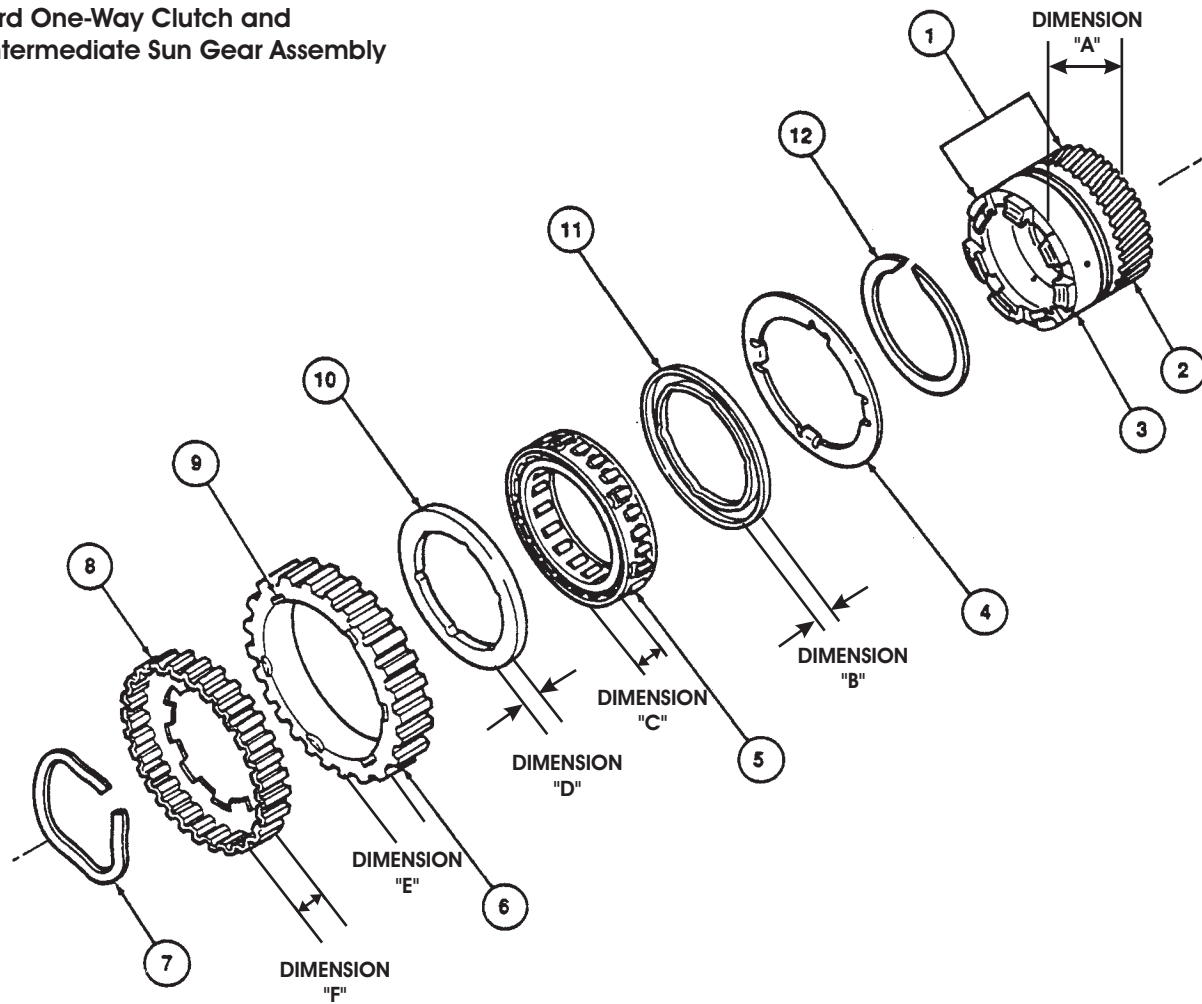
Forward One-Way Clutch and Low-Intermediate Sun Gear Assembly

Item	Part Number	Description
1	—	Low-Intermediate Sun Gear Assembly (Part of 7A089)
2	—	Low-Intermediate Sun Gear (Part of 7A089)
3	—	Forward One-Way Clutch Inner Race (Part of 7A089)
4	—	Forward One-Way Clutch Retainer (Part of 7A089)
5	—	Forward One-Way Clutch Sprag Assembly (Part of 7A089)

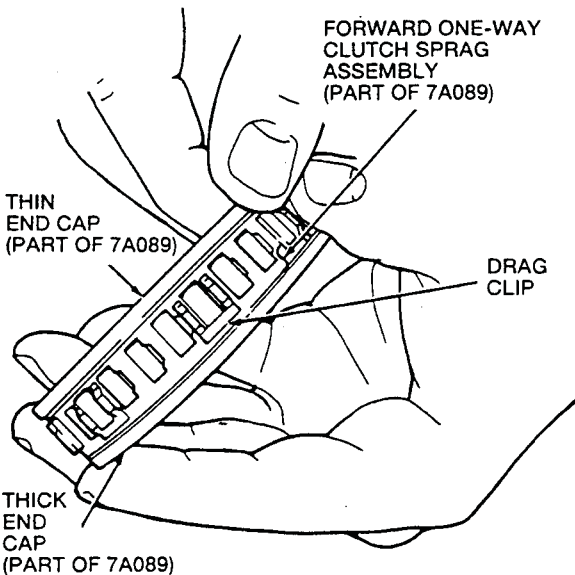
Assemble the forward one-way clutch sprag assembly and end caps.

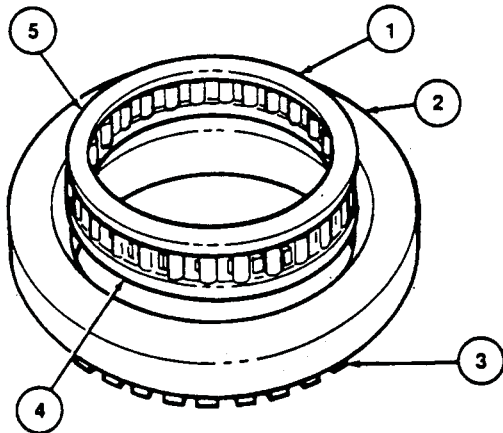
Item	Part Number	Description
1	—	Forward One-Way Clutch Sprag Assembly (Part of 7A089)
2	T94P-77000-J	Sprag Replacer
3	—	Forward One-Way Clutch Outer Race (Lube Grooves Down) (Part of 7A089)
4	—	Thick End Cap (Part of 7A089)
5	—	Thin End Cap (Part of 7A089)

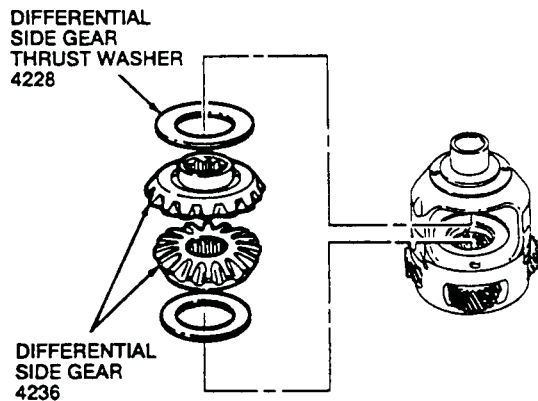
Remove the differential side gears and differential side gear thrust washers (4228).

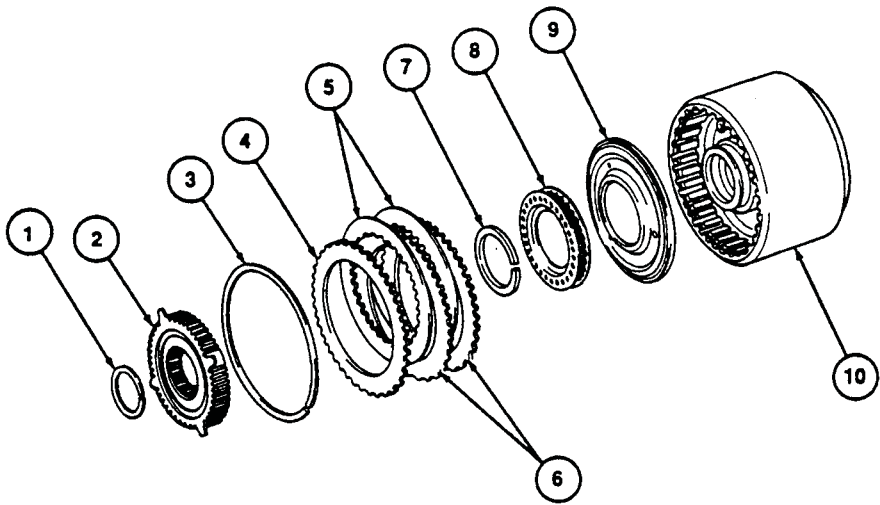
Item	Part Number	Description
1	7D256	Reverse Clutch Hub Retaining Ring
2	7D391	Reverse Clutch Hub
3	7D483	Reverse Clutch Pressure Plate Retainer Snap Ring
4	7D408	Reverse Clutch Pressure Plate
5	7B164	Reverse Clutch Internal Spline Clutch Plates (Friction)

Item	Part Number	Description
6	7B442	Reverse Clutch External Spline Clutch Plates (Steel)
7	7H225	Retaining Ring
8	7G335	Reverse Clutch Return Spring Assembly
9	7E079	Reverse Clutch Piston Assembly
10	7D044	Reverse Clutch Drum Assembly

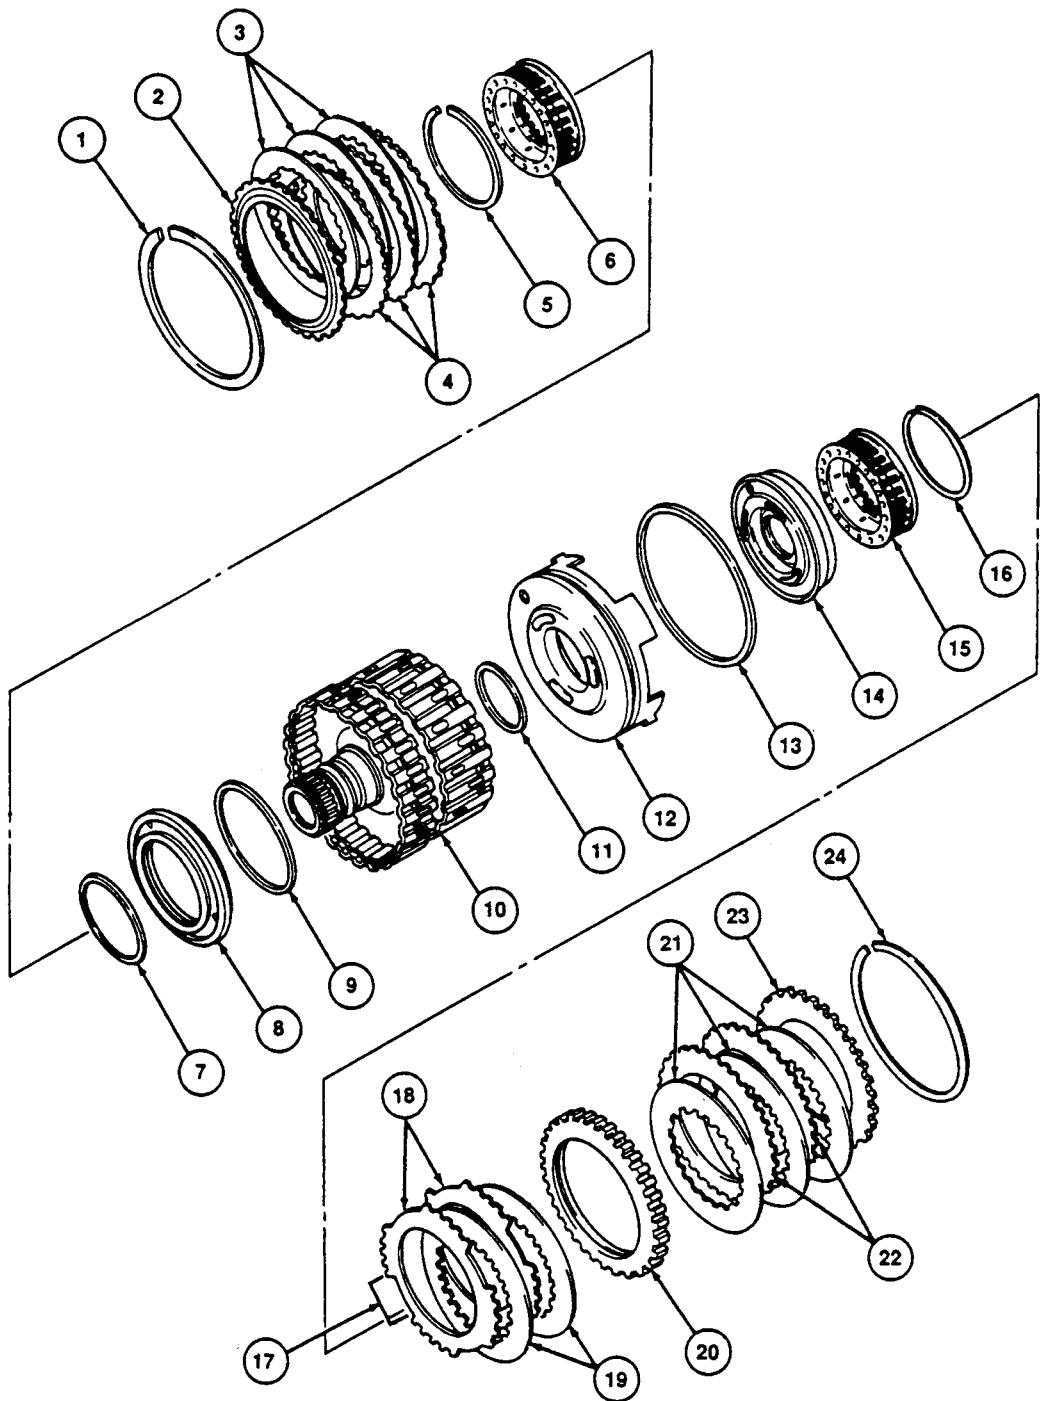
Forward/Coast/Direct Clutches

Item	Part Number	Description
1	7D483	Direct Clutch Pressure Plate Retaining Ring
2	7B477	Direct Clutch Pressure Plate
3	7B164	Direct Clutch Internal Spline Clutch Plates (Friction)

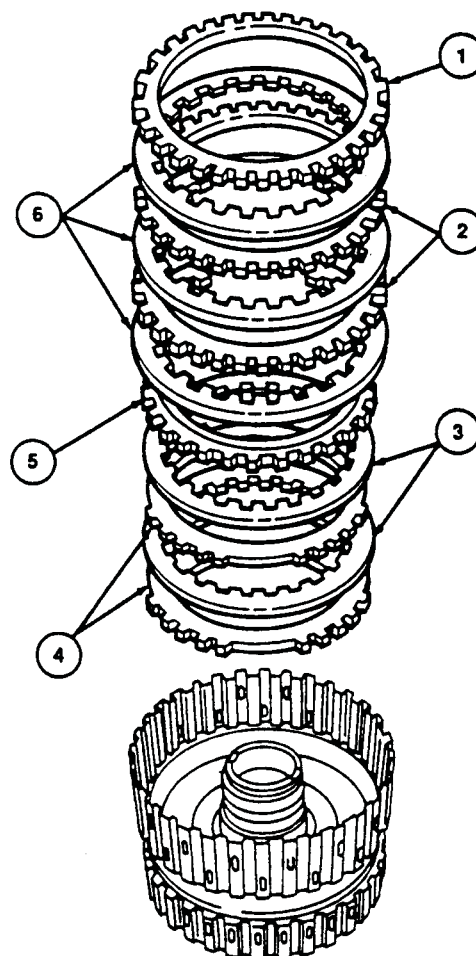
Remove the forward and coast clutch plates.

Item	Part Number	Description
1	7B066	Forward Clutch Pressure Plate
2	7B442	Forward Clutch External Spline Clutch Plates (Steel)
3	7B164	Coast Clutch Internal Spline Clutch Plates (Friction)
4	7B442	Coast Clutch External Spline Clutch Plates (Steel)
5	7B066	Coast Clutch Pressure Plate
6	7B164	Forward Clutch Internal Spline Clutch Plates (Friction)

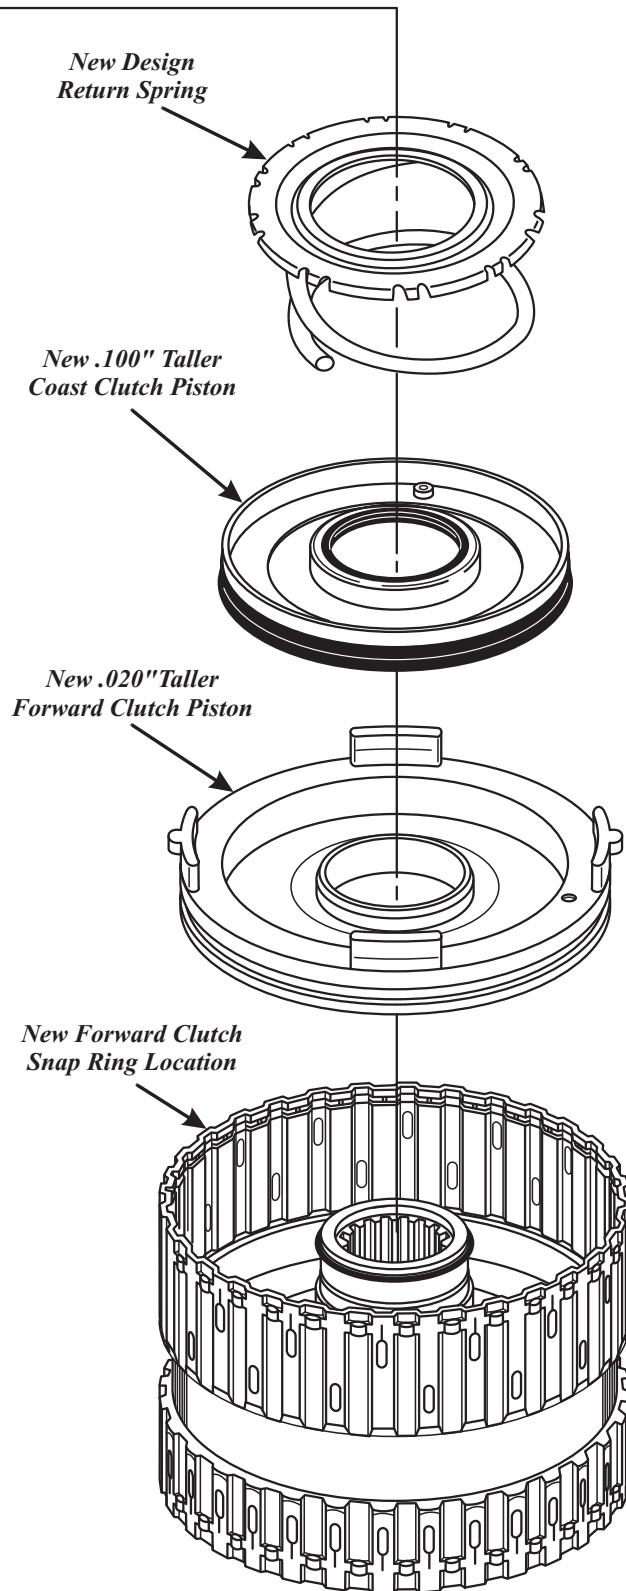
1998 and UP Forward and Coast Clutch Drum

NOTE: The 98 and UP Drum requires the use of the 98 and up Forward Sprag assembly. The dimensions are listed on Page 70.

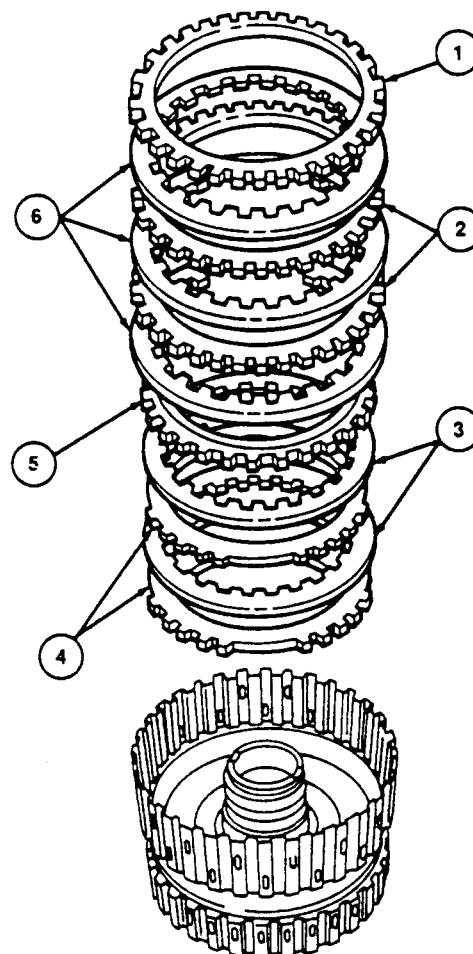
Remove the spring compressor.
Install the forward and coast clutch plates.

Item	Part Number	Description
1	7B066	Forward Clutch Pressure Plate
2	7B442	Forward Clutch External Spline Clutch Plates (Steel)
3	7B164	Coast Clutch Internal Spline Clutch Plates (Friction)
4	7B442	Coast Clutch External Spline Clutch Plates (Steel)
5	7B066	Coast Clutch Pressure Plate
6	7B164	Forward Clutch Internal Spline Clutch Plates (Friction)

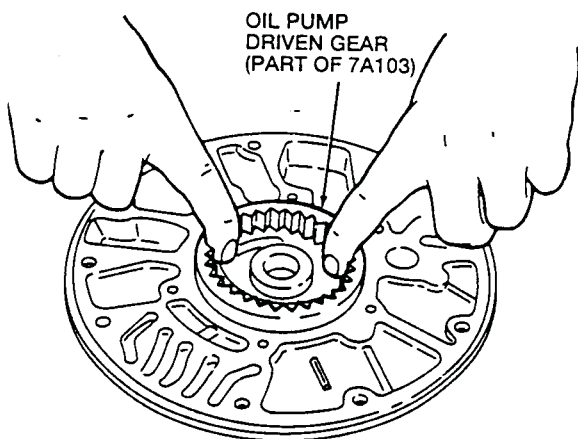
Remove the oil pump driven gear from the oil pump body.

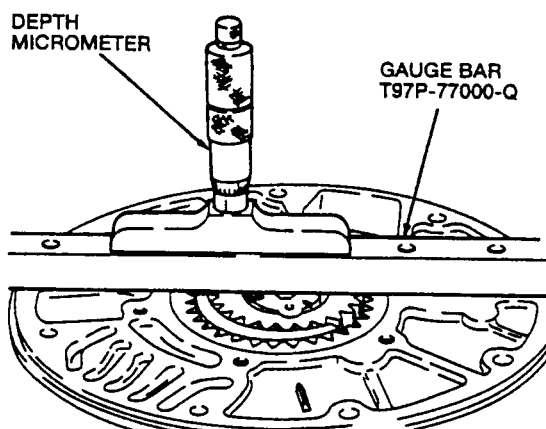
GAUGE BAR
T97P-77000-Q

The allowable clearance for each gear is .027 to .060mm (0.001 to 0.002 inch). If the clearance exceeds the specification, replace the oil pump assembly.

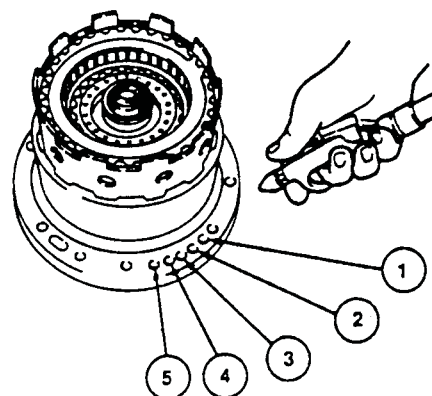
Item	Part Number	Description
1	—	Converter Clutch Bypass (do not apply air pressure)
2	—	Reverse Clutch Passage

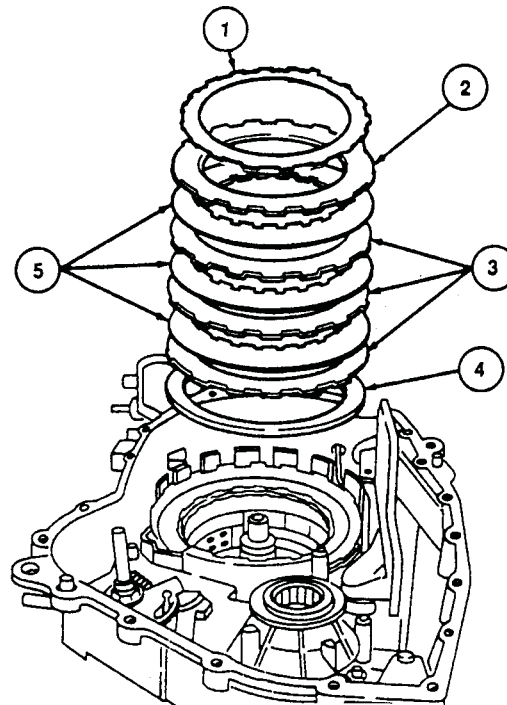
Item	Part Number	Description
1	7B066	Low One-Way Clutch Thrust Plate
2	7B066	Low / Reverse Clutch Pressure Plate
3	7B442	Low / Reverse Clutch External Spline Clutch Plates (Steel)
4	7B070	Low / Reverse Clutch Wave Spring
5	7B164	Low / Reverse Clutch Internal Spline Clutch Plates (Friction)

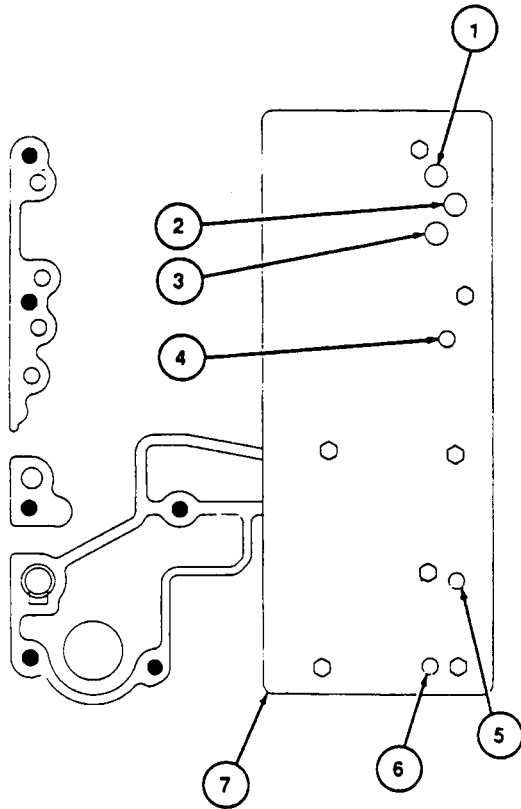
Item	Part Number	Description
1	—	Reverse Clutch
2	—	Forward Clutch
3	—	Direct Clutch
4	—	Low / Reverse Clutch
5	—	Servo Release
6	—	Servo Apply
7	T94P-77000-S	Transmission Test Plate

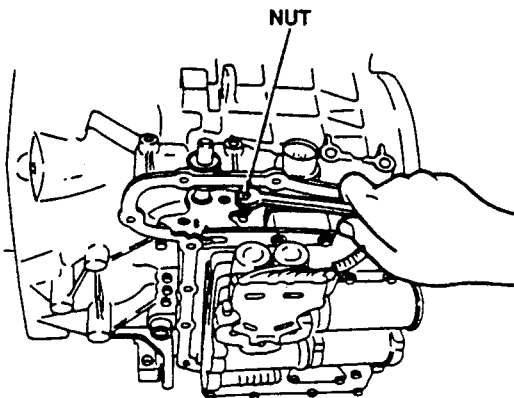
Loosen the nut on the ball stud for the manual valve detent lever actuating rod assembly.
