# SATURN TAAT INDEX

# INTRODUCTION SATURN TAAT

The Saturn TransAxle Automatic Transmission (TAAT) first appeared in the 1991 Saturn vehicles. The general design of the Saturn automatic transaxle is a parallel shaft front wheel drive transmission which also contains the final drive. The transaxle provides four speeds forward and one reverse using four multiple disc clutches, a four element torque converter with a lock up clutch, 1st gear sprag clutch, and a servo actuated dog clutch. The most significant departure from the traditional automatic transaxle comes from the use of electronic controls. This unit utilizes five electro-hydraulic actuators in conjunction with a powertrain control module (PCM) and it's sensors to control shift timing, shift feel, and provide on-board diagnostics.

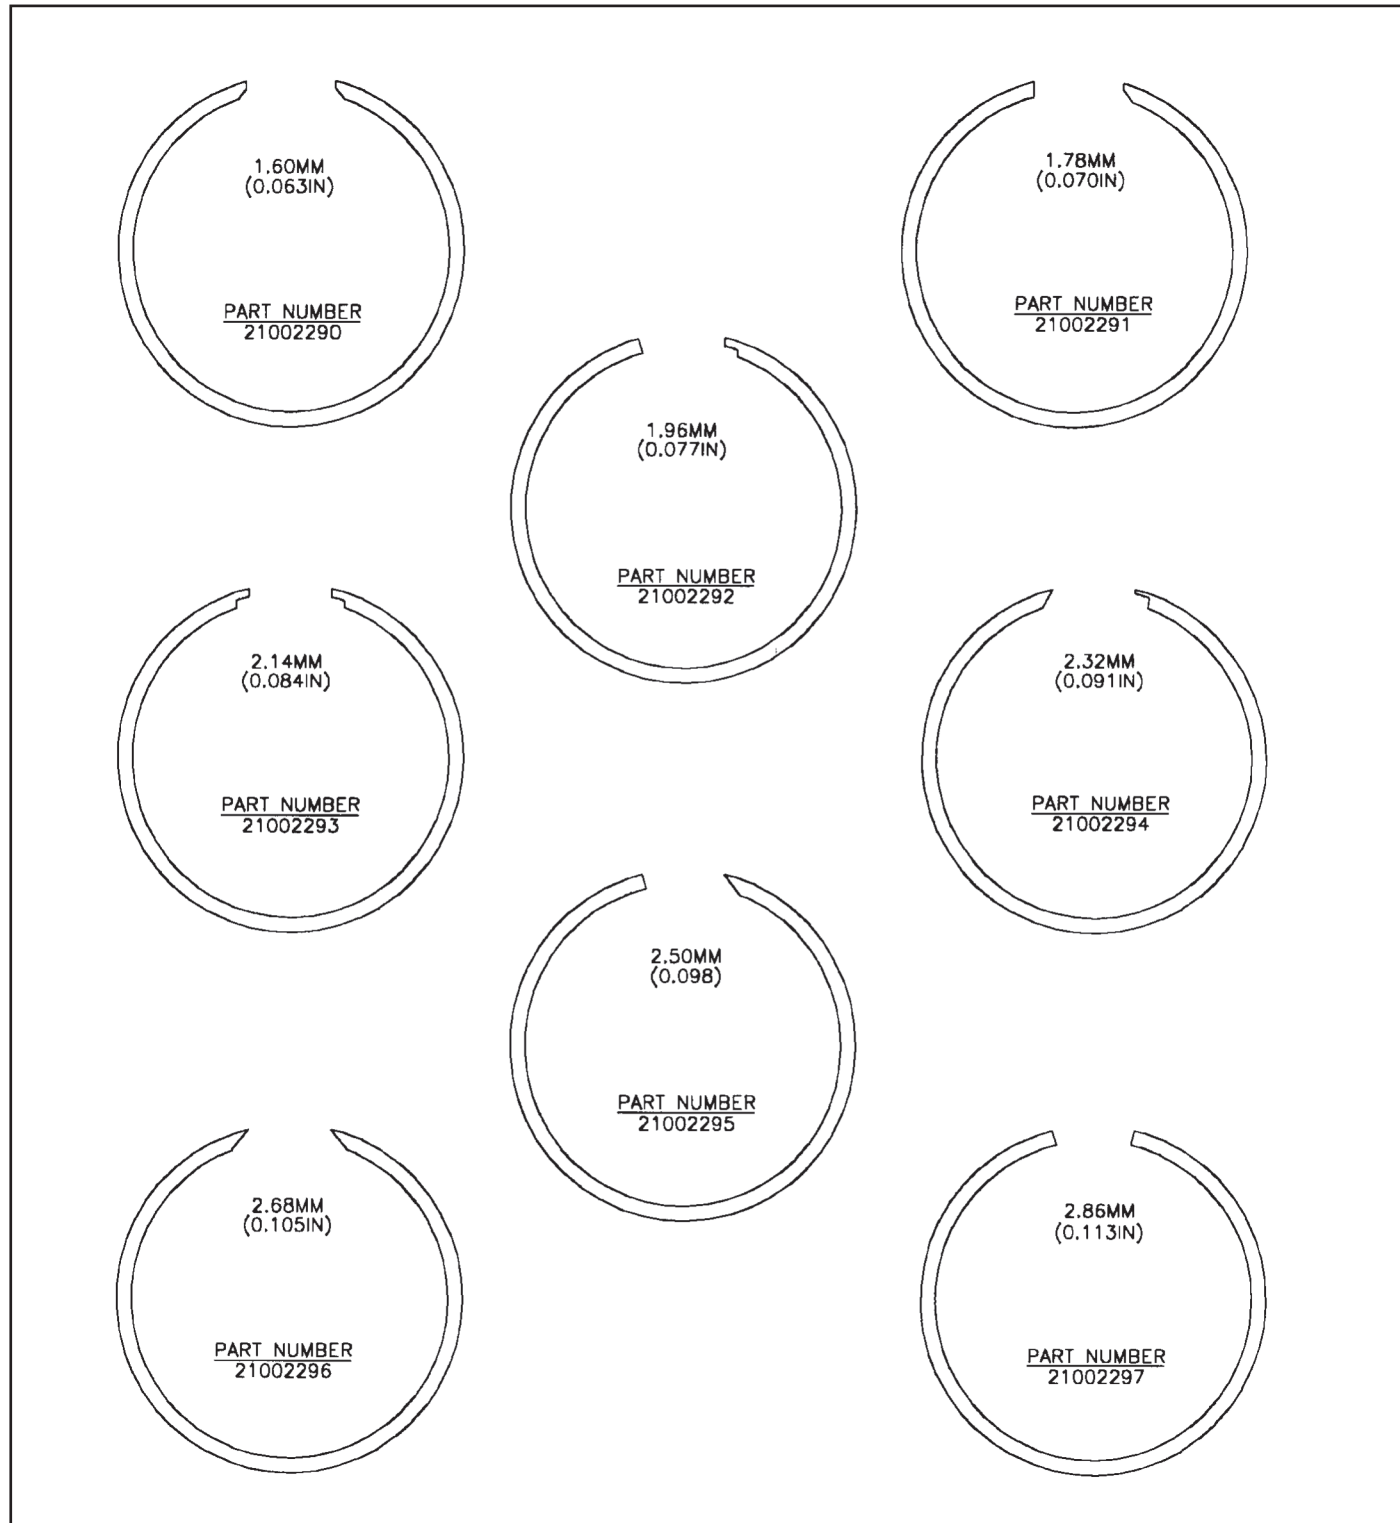
Figure 118

The selective backing plate snap ring is used to adjust all four clutch pack assemblies. Each snap ring below can be identified by the different tip or end configuration. If a clutch pack is either too loose or too tight, determine the proper thickness snap ring to bring the adjustment within the factory specifications.
